# CULTURAL LANDSCAPE REPORT FOR EISENHOWER NATIONAL HISTORIC SITE

VOLUME 2: TREATMENT

Prepared by  
Jeffrey Killion  
Margaret Coffin Brown  
J. Tracy Stakely

Olmsted Center for Landscape Preservation  
National Park Service, Boston, Massachusetts 2006

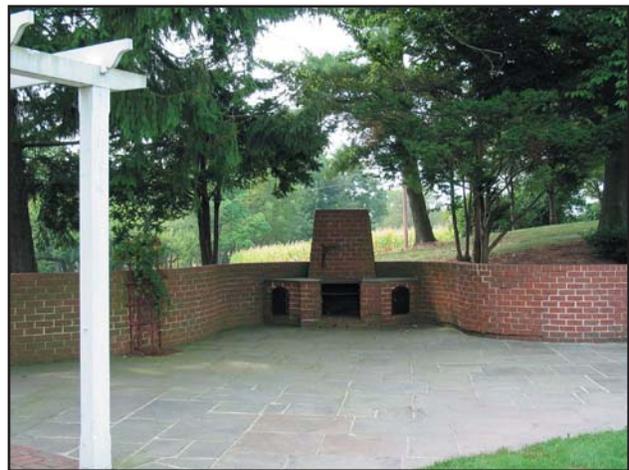
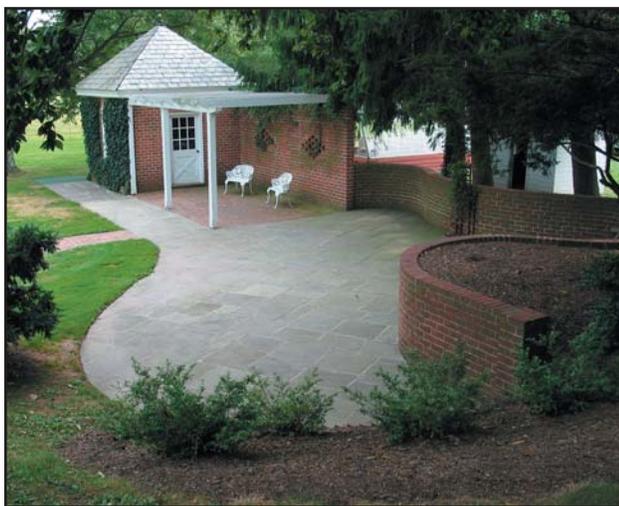
Figure 2.32. North elevation of barbecue/teahouse, 13 September 2005. Note the open view beyond the barbecue compared to 1967. (Photo by OCLP, 2005)

Figure 2.30. View of recently installed plantings, 13 September 2005. (Photo by OCLP, 2005)

dwarf yew, rose-of-sharon, Japanese holly, and Japanese flowering cherry, with English ivy climbing the teahouse walls and clematis growing on the brick serpentine wall. These plants remain or have been replaced, except for a rose-of-sharon and the flowering cherry. (figs. 2.28-2.30)

Many missing historic plants have recently been replaced and their health should continue to be closely monitored, especially those around the patio due to the excessive shade cast by the mature spruces and the beech tree. It is because of the age of these historic trees that the character of this area has changed. In particular, the three spruces and two yews on the south side have grown taller and have thinned at the base, meaning they no longer have low branches that can provide the sense of enclosure that is illustrated in historic photographs. (figs. 2.31, 2.32) When the spruce trees decline, the park should replace them, and at the same time the yews and the missing cherry tree so that the plants mature evenly.

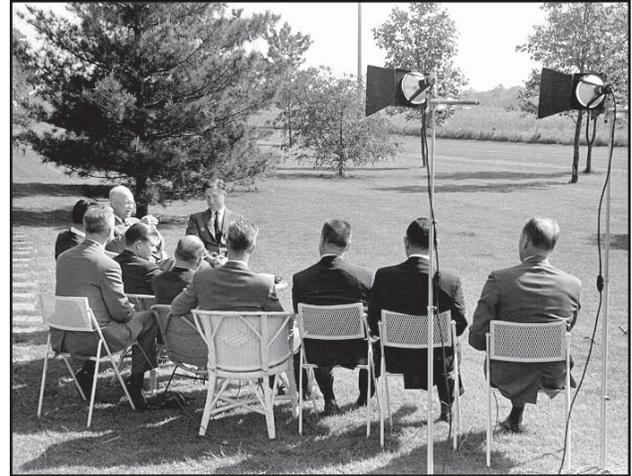
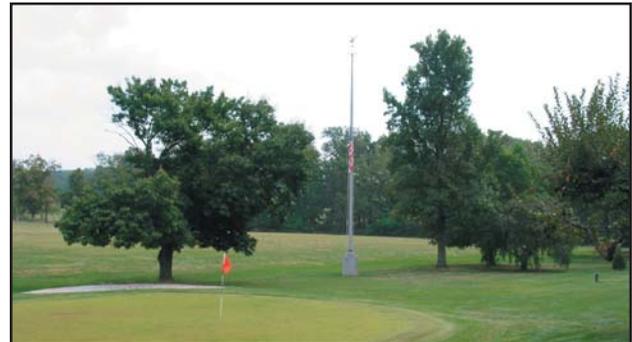
By the end of the historic period, several white pines and tuliptrees, a weeping crabapple, and a magnolia were scattered in the east lawn area between the teahouse and the flagpole.<sup>30</sup> The lawn area between the flagpole and the putting green was mainly open save for a sugar maple, probably because Mrs. Eisenhower preferred pristine lawns and enjoyed the views of the fields to the east.<sup>31</sup> Most of these trees remain today either as the originals or as replacements. (figs. 2.33, 2.34)

Figure 2.33. *White pines, crabapples, and tulip poplars in the eastern lawn, view to northeast, 6 June 1961. (Lane Studio, EISE NHS files, #2689)*

Figure 2.34. *View looking southeast at the shade trees in the east lawn. (Photo by OCLP, 2005)*

There is a missing tuliptree between the teahouse and flagpole that should be replaced. There is also a red maple that was historically a tuliptree; when it declines it should be replaced with a tuliptree.

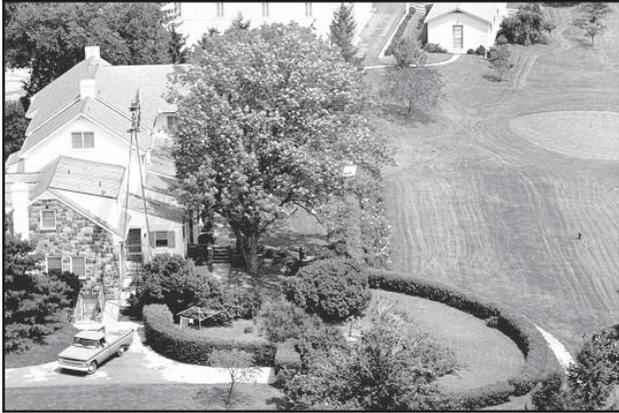
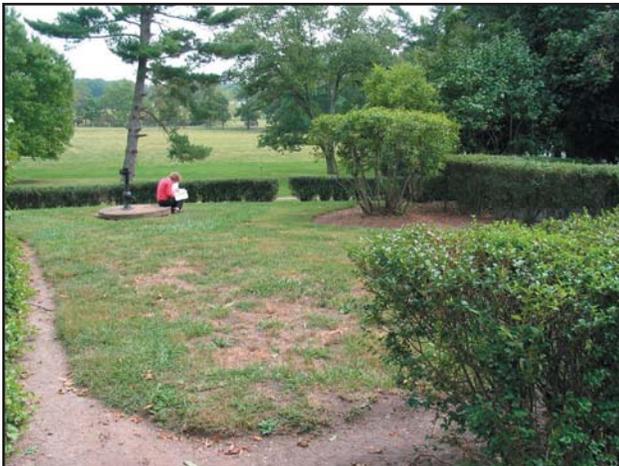
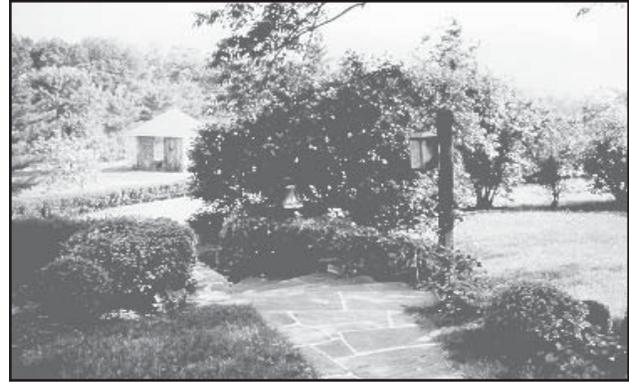
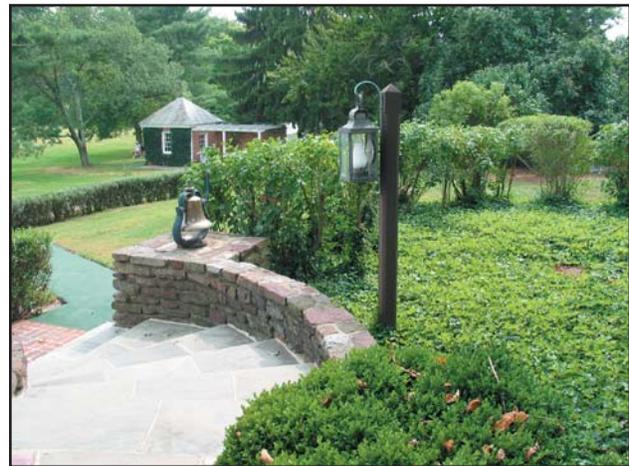
few lilacs remained along with some replacement plants – an almond and a magnolia. By this time, a semicircular-shaped privet hedge centered about the hand pump enclosed much of the south lawn and the drying yard. The hedge was maintained at a height of about two and a half to three feet. Within this enclosure, more extensive gardens of roses and dogwoods had been planned and some installed, but Mrs. Eisenhower had them removed and replaced with grass after human bones were found, likely from when the farm was used as a hospital during the Civil War.<sup>32</sup> (figs. 2.35-2.38)

Figure 2.35. Semicircular privet hedge defining the south lawn and drying yard, 9 August 1967. (A.J. Paronese, US Marine Corps, EISE NHS files, #3014)

Figure 2.36. View looking east at the hand pump in the south lawn area and the privet hedge, lilacs, and almond. (Photo by OCLP, 2005)

Figure 2.37. View southeast of lilacs and privet hedge in the drying yard/south lawn area, May 1969. (W. E. Dutton, EISE NHS files)

Figure 2.38. Contemporary view of the lilac and privet hedges. Note the privet interspersed within the lilac hedge at far right. (Photo by OCLP, 2005)

The lilacs in the drying yard and south lawn need rejuvenative pruning: one-quarter to one-third of the oldest trunks of each lilac cluster should be cut and several of the young shoots coming from the ground should be encouraged. The privet growing within the lilac hedge should be removed and replaced with a common lilac, possibly one of the two just to the south that are supposed to be Chinese lilacs.

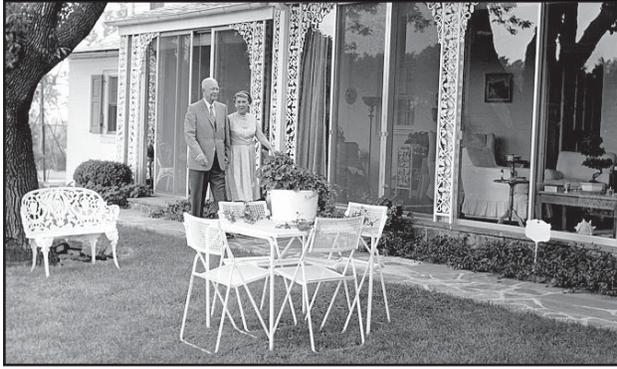
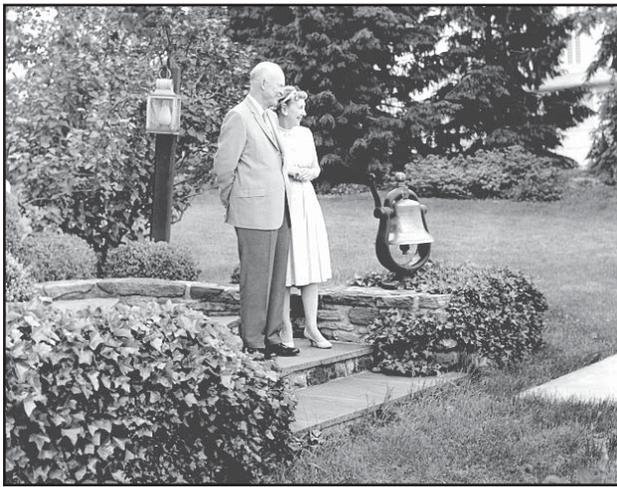
When the Eisenhowers purchased the farm from the Reddings, the east side of the house featured three green ashes Mrs. Eisenhower wished to preserve. To accomplish this, and to connect the house to the surrounding farm landscape, the existing grade was raised to the level of the back porch with several stone retaining walls and by constructing tree wells around the three ash trees.<sup>33</sup> By 1969, these trees, as well as original plantings of boxwoods along the paths and English ivy on top of the wall from the 1950s were extant and still are today. Later plantings of lilac, periwinkle, and pink geraniums (in pots) also remain. (figs. 2.39, 2.40)

Figure 2.39. View of the rear terrace and the boxwoods and vinca along the porch foundation, 27 June 1966. (AP photo, Lane Studio, EISE NHS files, #2405)

Figure 2.40. Detail of ivy on rear terrace retaining wall and lilacs and boxwoods bordering the north steps and the ivy growing over the rear terrace wall, 27 June 1966. (AP/Lane Studio, EISE NHS files, #2415)

The three green ash trees are in good-fair condition with moderate die-back and should be carefully monitored as they are the primary character-defining features in this area. Several historic boxwoods are missing and should be replaced, as should the bed of English ivy in the foundation bed between the two porch steps. Conversely, two boxwoods in this same bed, one in the grouping at the northeast corner of the house, and two next to the north set of steps leading to the east rose garden should be removed as indicated by the 1969 plan. In the mid-1950s, azaleas were grouped around the south porch steps but were not extant by 1969; their replacements should therefore be removed.<sup>35</sup> At the retaining wall, the planting of English ivy should be allowed to grow

over the wall (but not onto the brick path that fronts it). To maintain a neat appearance, it should be clipped at four or five inches.<sup>36</sup> Wooden planters with annuals were placed throughout the rear terrace, often on steps, wing walls, or on tables. They should be painted white or green as indicated on the 1969 plan and in historic photographs.<sup>37</sup>

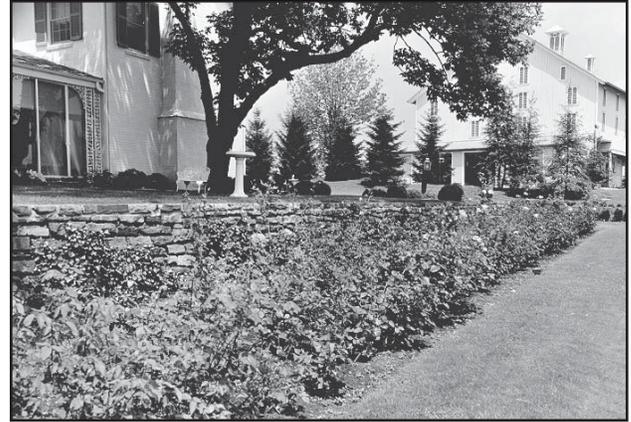
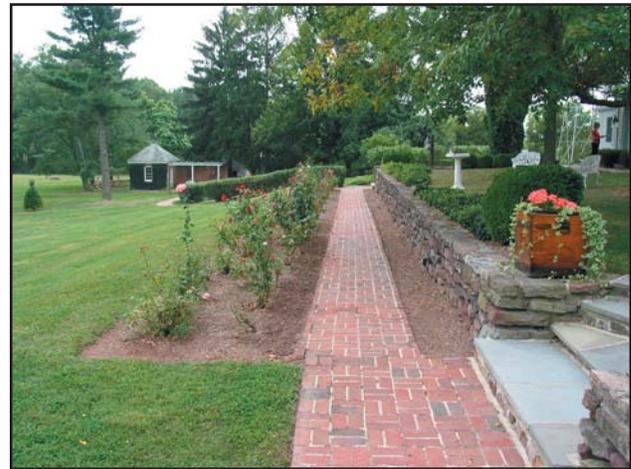
sides by grass and featured roses in two alternating rows maintained at a height of two feet.<sup>34</sup> (figs. 2.41, 2.42) Over the years, a wide variety of roses were planted and by the end of the historic period a new generation of hybrid tea roses were in place.

Figure 2.41. In the mid-1950s, shrubs in the east rose garden were maintained at a height of two feet. (US Navy, EISE NHS files, #2931)

Figure 2.42. View looking south at the north terrace steps showing the potted pink geraniums, boxwoods, and English ivy in the bed above the retaining wall, and the east rose garden and brick path. (Photo by OCLP, 2005)

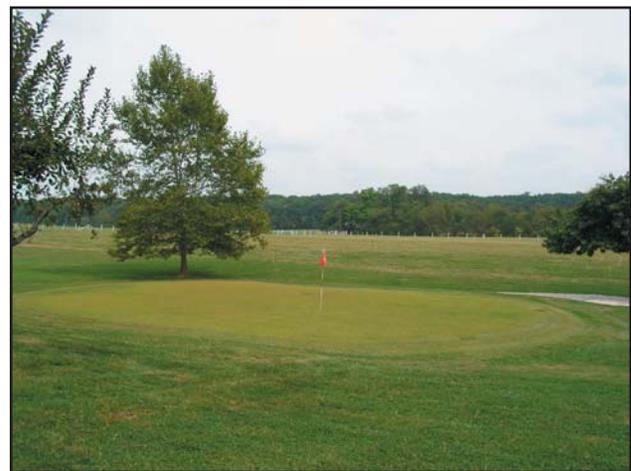
Figure 2.43. View northeast of the putting green and sand trap. (Photo by OCLP, 2005)

maintain plant vigor and reduce weeds. (fig. 2.43) The green requires a high level of maintenance, crabgrass weed control, and irrigation to preserve its character.

The putting green is a very popular and admired site feature, and most visitors do not walk on it. The GMP recommended to “restore the golf tee and mark site in field.” This feature should be restored.

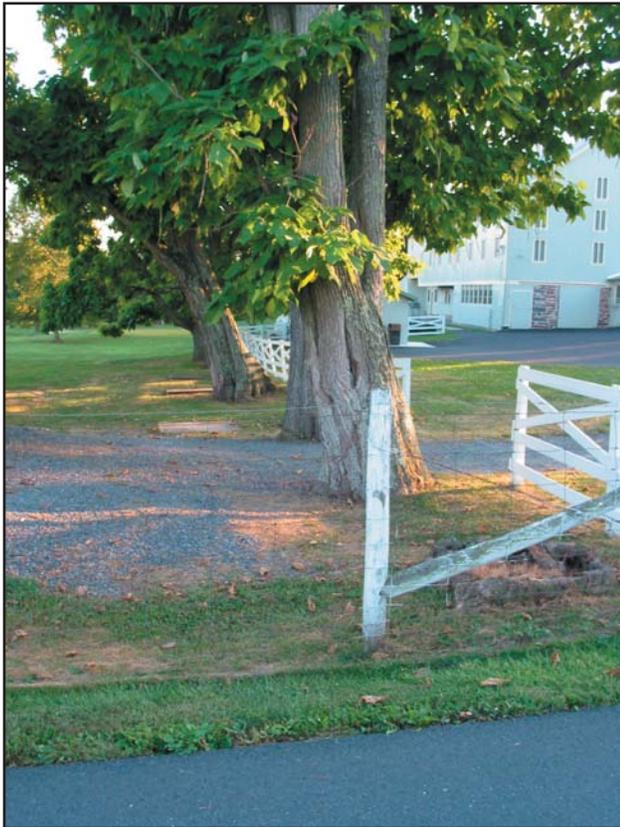
Figure 2.44. View looking south at the remaining old catalpas. (Photo by OCLP, 2005)

building (now visitor reception center).<sup>40</sup> Only five of the trees remain today and they constitute the only landscaping in this area, as was the case historically. The Eisenhowers likely retained this old fencerow to screen the Quonset hut from view and to provide shade for the dog kennels.<sup>41</sup> (fig. 2.44)

The missing catalpa trees should be replaced but only when a majority of the remaining trees begin to decline. Around the storage building, many of the plantings are missing and should be replaced including the pin cherries in the east lawn; English yew, common boxwood, and Canadian yew along the east foundation; a Japanese holly at the southwest corner; and Canadian yews at the fence at the northwest corner. The dying weeping cherry on the east side will need to be replaced soon. The boxwoods between the Adenauer rose garden and walkway should be encouraged to grow into a continuous hedge rather than pruned as individual plants. New General Eisenhower hybrid tea roses should be developed to replace those lost in June 2006.

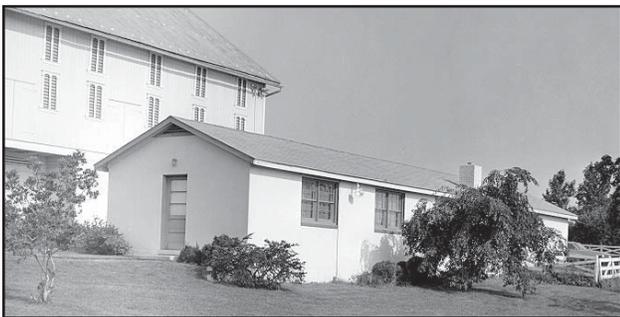
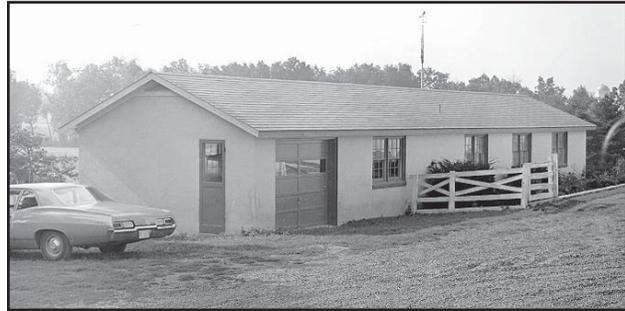
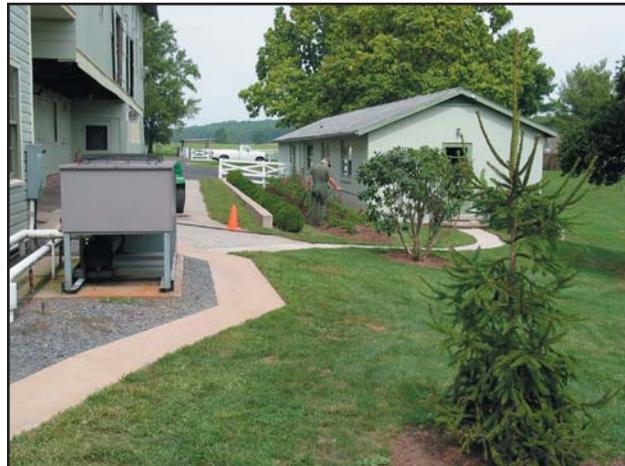
Figure 2.45. Storage building, south and east facades, various shrubs along foundation and weeping cherry adjacent to east facade, 8 September 1967. (Lane Studio, EISE NHS files, #2832)

Figure 2.46. Storage building north and west facades, original garage door on northwest corner, 8 September 1967. (Lane Studio, EISE NHS files, #2828)

Figure 2.48. Adenauer rose garden and plantings south and west of the reception center; view north. (Photo by OCLP, 2005)

the surroundings.<sup>42</sup> By the late 1960s original plantings of common boxwood, Japanese holly, Canadian yew, and English yew were still present as were later additions such as a star magnolia near the south entrance (not on 1969 plan but visible in 1967 photograph), a weeping cherry on the east side, and two pin cherries in the lawn east of the building. (figs. 2.45, 2.46) Most of these plants are gone today except for a few of the common boxwood and the magnolia at the south entrance and a recently replanted weeping cherry on the east side that is in poor health. (figs. 2.47, 2.48)

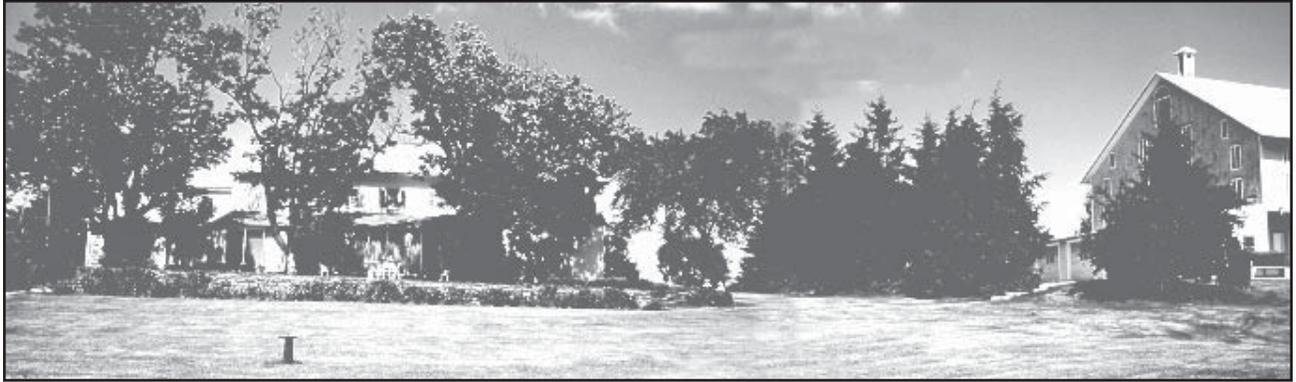
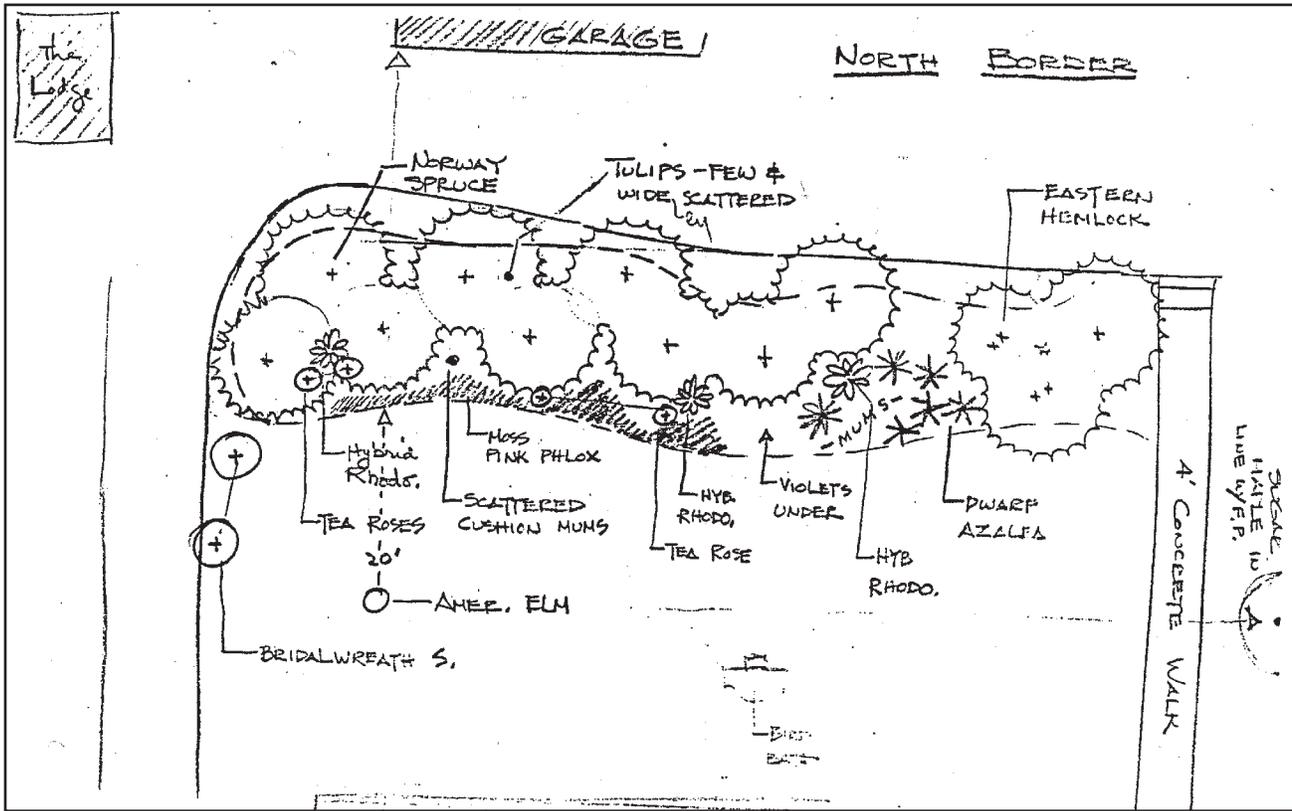
Figure 2.49. Mature trees in barn screen underplanted with shrubs, view across lawn to west, May 1969. (W. E. Dutton, two images combined into panorama, EISE NHS files)

Figure 2.50. Existing conditions of plants in barn screen as documented by Thomas C. Dall, May 1969. (Memorandum to Chief, PSC, from Thomas C. Dall. Trip Report, Gettysburg NMP, Gettysburg, PA, May 26-29, 1969. EISE NHS files)

for two bridalwreath spiraea at western edge. However, a NPS survey initiated by landscape architect Thomas Dall in 1969 did identify some additional plantings. (fig. 2.50)

Much of the current palette of shrubs and flowers is not historic and should be removed in favor of those shown on the Dall drawing, which currently provides the only known detailed documentation of this area (see fig. 2.50). However, this work should be implemented only after the eventual replacement of the spruce and hemlock trees. As with the trees, a weekly watering program will be essential for the shrubs to survive in what will initially be a very sunny and exposed area. Once the correct plants are installed, pruning should be less rigid so that the area looks more natural. As suggested in both the 1969 plan and the Dall drawing, the two historic bridalwreath spiraea at the west end should not be part of the mulched bed and should be pruned less to achieve their “bridal” or cascading branch habit.

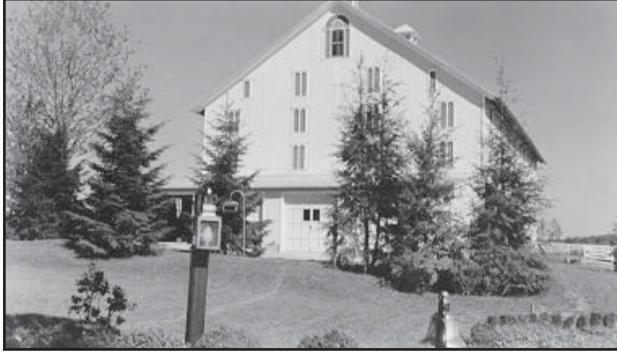
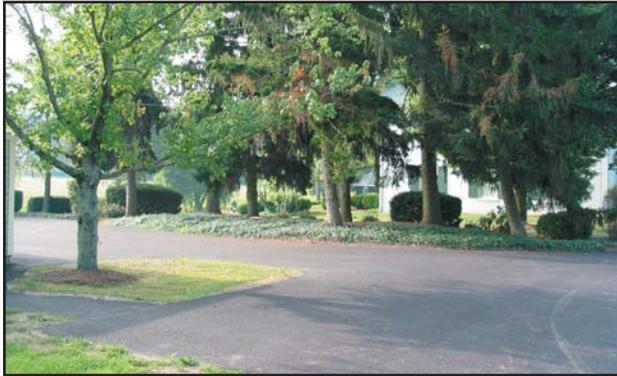
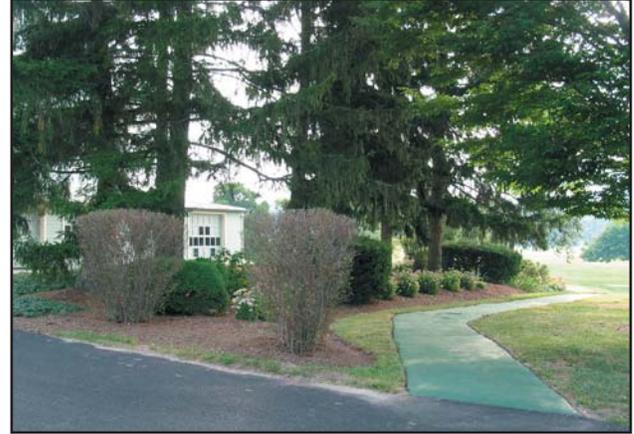
Today, the spruce trees are now mature and thin at their bases and no longer visually screen the barn from the house. The hemlocks are in very poor condition, mostly likely due to recent drought conditions. (figs. 2.51, 2.52) One of the trees was struck by lightning and removed as a safety precaution.<sup>48b</sup> Despite the shade, the understory appears to be performing relatively well. Some of these plants have been heavily pruned and collectively no longer convey the somewhat overgrown appearance that was present near the end of the historic period. (fig. 2.53) Additionally, according to the Dall drawing, some of the plants are not historic.

Figure 2.51. View looking north at the barn screen approximately one year after installation, no shrubs have been installed, fall 1955. (EISE NHS files, #1176)

Figure 2.52. The mature evergreens in the barn screen no longer block the view between the house and barn, view southeast. (Photo by OCLP, 2005)

Figure 2.53. View looking northeast at the barn screen plantings. Many of the understory shrubs are not historic and are too pruned. (Photo by OCLP, 2005)

trees at the same time. It is recommended that the third option be pursued so that new trees can mature evenly. Until then, for trees that are stressed, or when trees are replaced, a weekly watering program of one inch a week by rainfall or watering with a water truck or gator bags during summer months will improve the vigor of the trees.

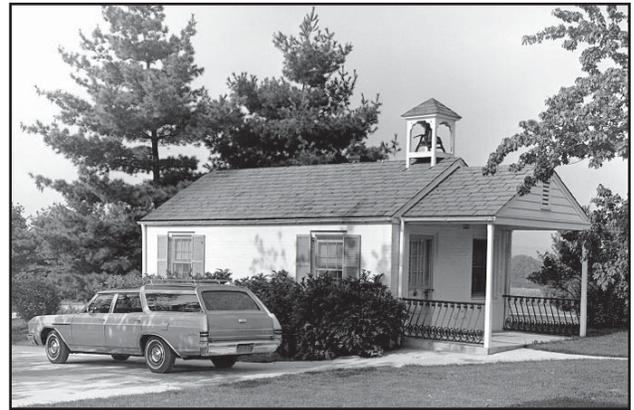
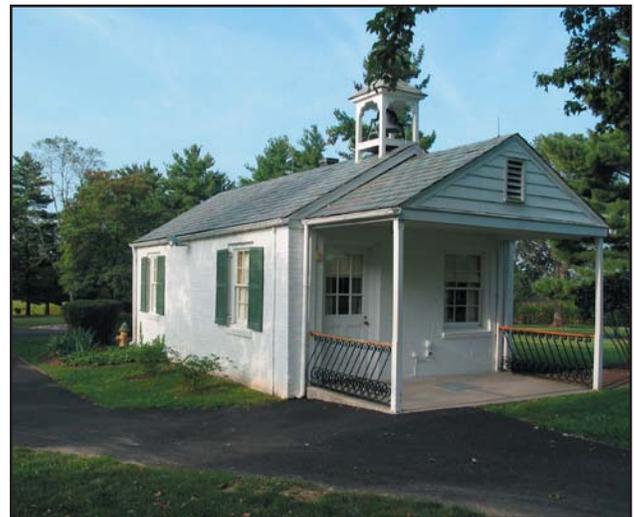
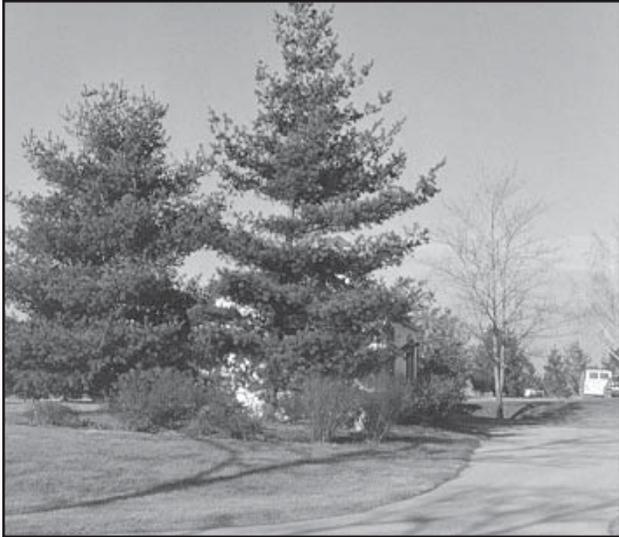
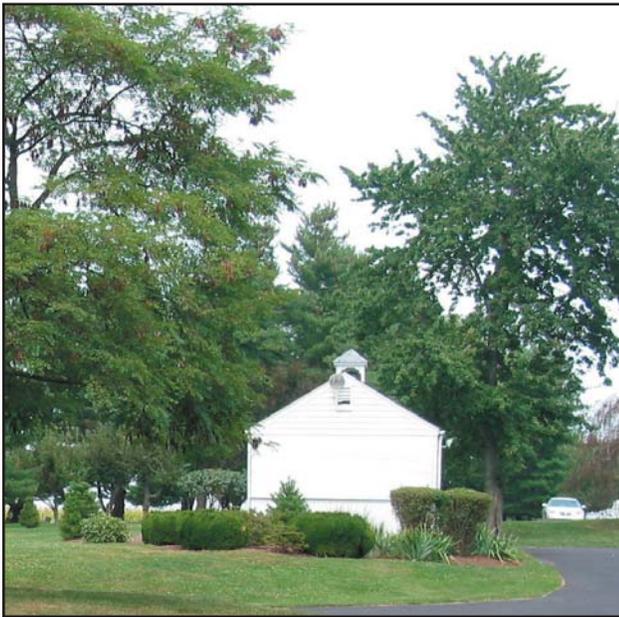
Figure 2.54. Guesthouse east facade, after porch addition and with mature wisteria along foundation, 8 September 1967. (Lane Studio, EISE NHS files, #2155)

Figure 2.55. View looking southwest at the guesthouse plantings and young wisteria along the east foundation. (Photo by OCLP, 2005)

Figure 2.56. Mature white pines dominate the south side of the guesthouse, May 1966. (Eisenhower Family Collection, EISE NHS files, #3436)

Figure 2.57. The planting bed on the south side of the guest house, view north. (Photo by OCLP, 2005)

to the absence of the large white pines and the small size of their replacements.

In time the new plantings around the guesthouse will mature and the character will gesture to that at the end of the historic period. In the meantime, several plantings, such as the boxwoods, should be removed as they were not present historically. Several historic plants are missing, such as the wisteria southwest of the guesthouse as indicated on the 1969 plan. Annuals should be limited to daffodils and violets that were known to exist in these

beds during the historic period. The two historic spirea plants need to be pruned less to achieve their naturally cascading habit.

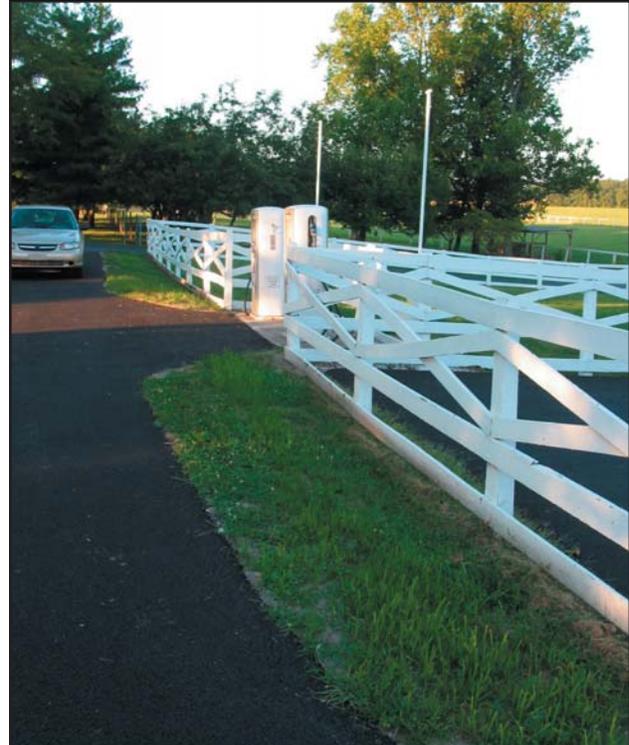
Figure 2.58. View looking north at the fence and gas pumps north of the barn. In 1969, six red rambling roses grew along this section of fence. (Photo by OCLP, 2005)

When the red maple at the southwest corner of the barn declines, it should be replaced with a sugar maple. North

of the barn, red rambling roses should be planted along the fence on either side of the gas pumps. (fig. 2.58)

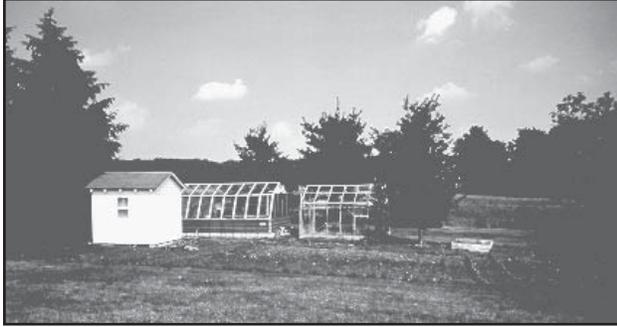
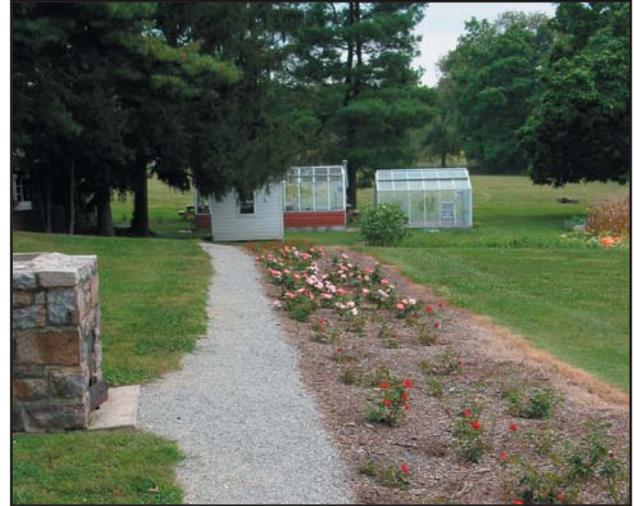
Figure 2.59. Greenhouses and playhouse, view to the east across the vegetable garden, with trees along the boundary with the eastern field in the background, May 1969. (W. E. Dutton, EISE NHS files)

The south gardens featured two greenhouses, the playhouse, a vegetable garden, and a rose garden. Soon after construction of the greenhouses in 1956, two pin cherries were placed directly south of the structures. A Norway spruce was located on the northwest corner of the larger greenhouse, and a row of white pines was placed along the fence line of the eastern field. A sporadic fencerow with occasional gaps grew between the eastern field and the field south of the house and included catalpas. By the late 1960s, all of the trees were still extant except for the Norway spruce, but a white pine and both pin cherries have died since that time.<sup>51</sup> (figs. 2.59, 2.60)

Figure 2.60. View looking east at the south rose garden, vegetable garden, and white pines and catalpa along the eastern field edge. The path is a recent rehabilitation. (Photo by OCLP, 2005)

When one of the two extant white pines declines, the other should be removed so that all three trees, along with the two missing pin cherries, can be replaced and mature as a group. Historically, the Eisenhower's vegetable garden was larger than the current vegetable garden and was well tended. With a rehabilitation treatment approach, it is acceptable to alter the size of the garden in order to reduce the amount of maintenance necessary

The non-historic path connecting the south side of the Eisenhower home to the playhouse and greenhouses is quite steep. Except for a level segment between the teahouse and the playhouse, this path should be eliminated. An alternate route should be developed from this level section to the beginning of the path between Farms #1 and #2, paralleling the south rose bed and using the path reconstructed in the 1990s as recommended in the GMP.<sup>70a</sup> This new route will feature slopes around five percent, and will require minor regrading near the playhouse (see fig. 2.60).

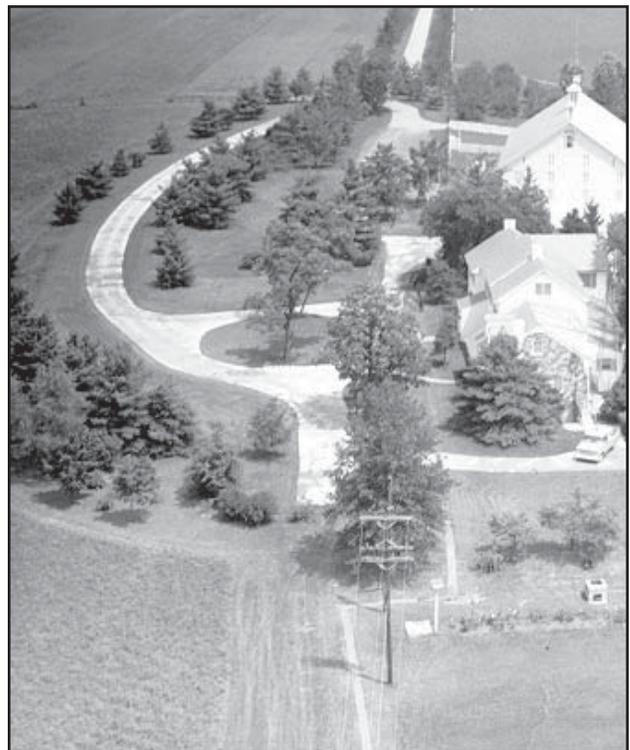
A portion of the path between Farms #1 and #2 was originally a farm lane when the Eisenhowers purchased the property. During renovations to the house it was used as construction access, and then the lane was removed in favor of an unpaved and informal path between the two farms.<sup>73a</sup> (fig. 2.93) Farm #2 continues to be an important component of the Eisenhower NHS and provides visitors with a greater understanding of General Eisenhower's cattle and farming operations. Unfortunately, the path may be difficult for some visitors to walk on. The route and distance are identified with a wayside.

Figure 2.93. Aerial of Farm #1 from south showing the path between Farms #1 and #2 at lower center, 9 August 1967. (A. J. Parsonese, US Marine Corps, EISE NHS files, #2988)

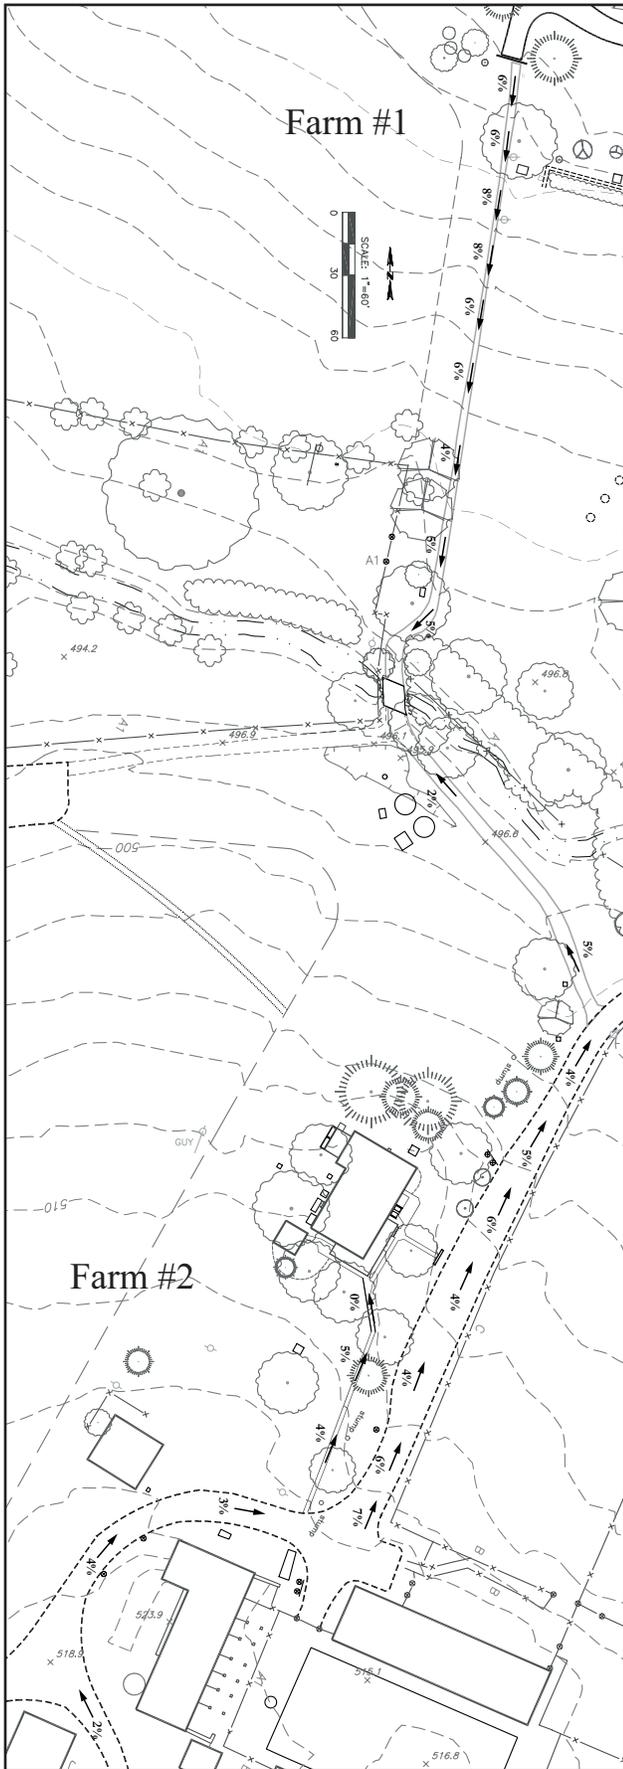
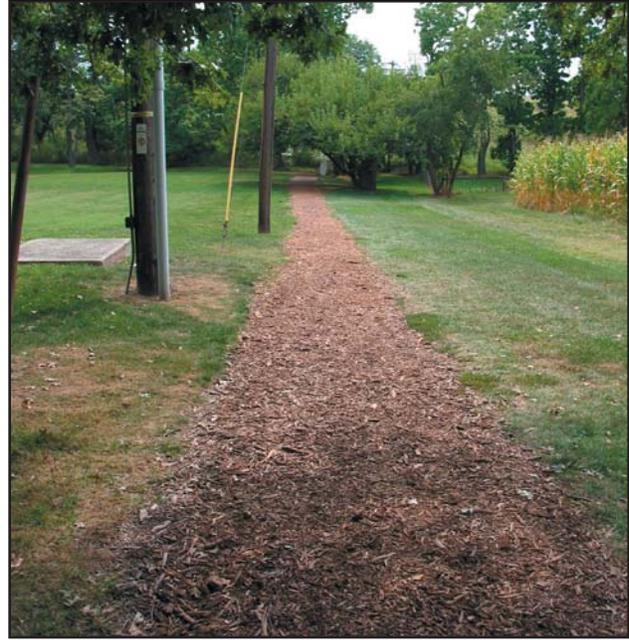
The path serves as the primary pedestrian route between the two farms for visitors and park staff, and in an effort to provide a comfortable walking surface, the park has applied woodchips that unfortunately tend to wash away in heavy rains. A French drain was recently installed at the north end of the path to catch stormwater runoff from the drive and seems to be helping the problem, but is nonetheless a modern intrusion. Drainage continues to be a problem, however, at the lower end of the trail from water flowing diagonally from northeast to southwest.<sup>73b</sup> The slope of the path is uneven with slopes ranging from two to eight percent; the steepest section is near the former guardhouse foundation. (figs. 2.94, 2.95)

Figure 2.94. View south of the wood chip path that leads to Farm #2. (Photo by OCLP, 2005)

The woodchip surface should be removed and replaced with a gravel aggregate/clay/sand mix. The clay serves as a binder to stabilize the aggregate, and the sand helps interlock the aggregates creating a tight water-resistant surface. The addition of a clay stabilizer can aid in forming a compacted tread with a crown, much like a road. Commercially available soil stabilizers may also be added, such as EMC2™ or Road Oyl™ (a pine resin binder), both by Soil Stabilization Products.<sup>74</sup> See Appendix C for other examples of trail specifications. The color of the stone should be gray to match other historically earthen/gravel paths at the site.

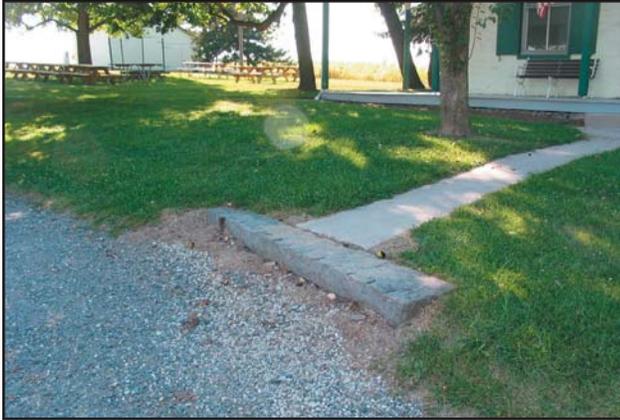
Figure 2.96. Granite step in front of farmhouse at Farm #2. (Photo by OCLP, 2005)

The Farm #2 Lane in front of the farmhouse is wide enough to provide adequate space for parking. Although a 6"-high granite step at the head of the main walk leading to the house would likely prevent unaccompanied disabled visitors from parking here, they could instead park farther up the lane and use the long sidewalk that leads from near the bank barn to the house. (figs. 2.96, 2.97) However, this walkway is only about sixteen inches wide and is beginning to lift near a spruce tree. There is currently no accessible entrance into the house.

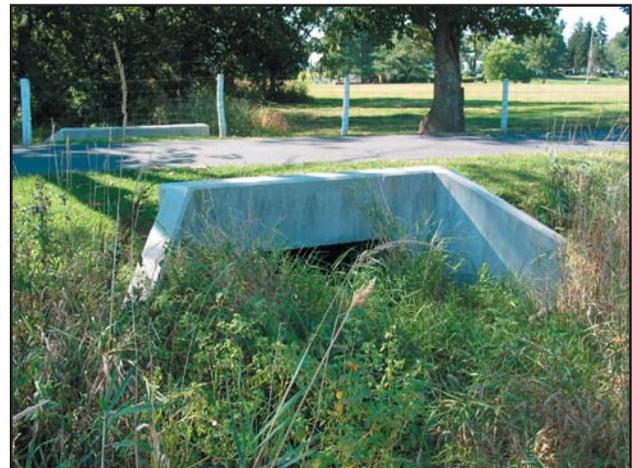
Figure 2.99. The box culvert along Nevins Lane would be an appropriate solution along the path between Farms #1 and #2. (Photo by OCLP, 2005)

A box culvert, similar to the one installed upstream on Nevins Lane or along the Skeet Range Lane would be more effective as it will manage water flow more effectively and improve visitor safety. (fig. 2.99) An engineer should prepare specifications and oversee replacement, and consider a structure that is either wider or has higher sidewalls that can safely and effectively accommodate peak stormwater flows. If the walking area on the top of the culvert is greater than thirty-six inches from the ground, a railing should be incorporated into the design. If the culvert can be designed to keep the walking surface less than thirty-six inches from the ground below, this would be preferable so as to not introduce a highly visible and non-historic feature (railing) to the historic landscape.

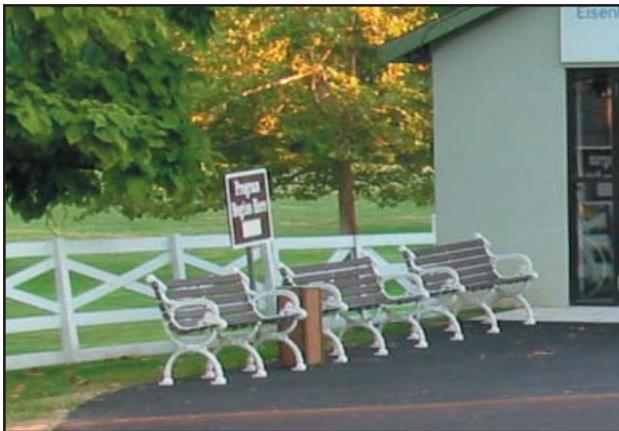
Figure 2.101. Park benches at the Reception Center. (Photo by OCLP, 2005)

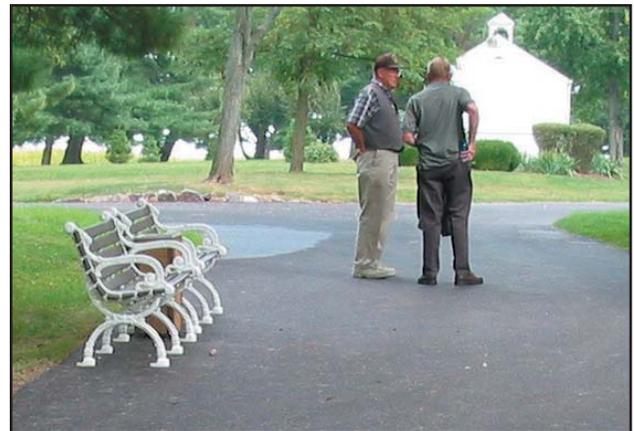
Figure 2.102. Park benches at the head of the path to Farm #2. (Photo by OCLP, 2005)

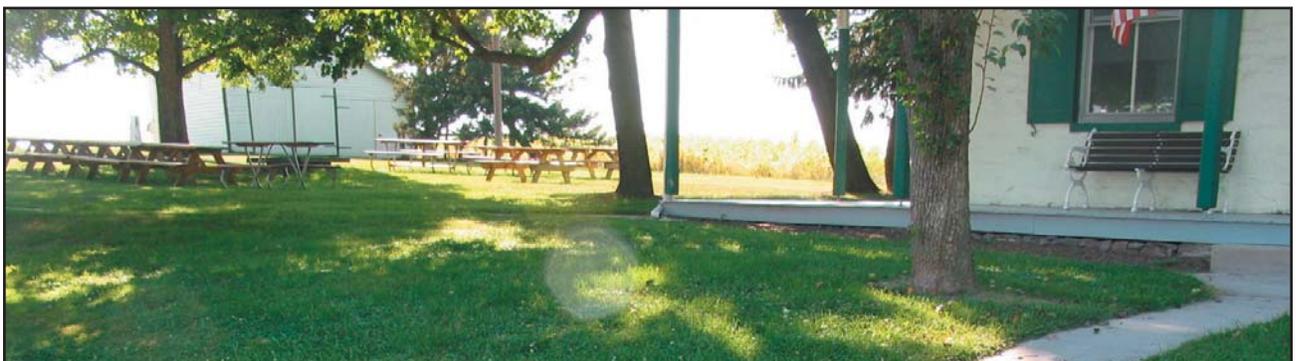
Figure 2.103. Picnic tables and park bench at Farm #2. (Photo by OCLP, 2005)

Farm #2, south of the house, although the half-dozen or so of them are viewed by some park staff as visually intrusive in this location.<sup>88b</sup> (figs. 2.101-2.103) Waysides are located at the skeet range, the trailhead to Farm#2, and in several areas throughout Farm #2. Additional waysides for Farm #1 are in development.

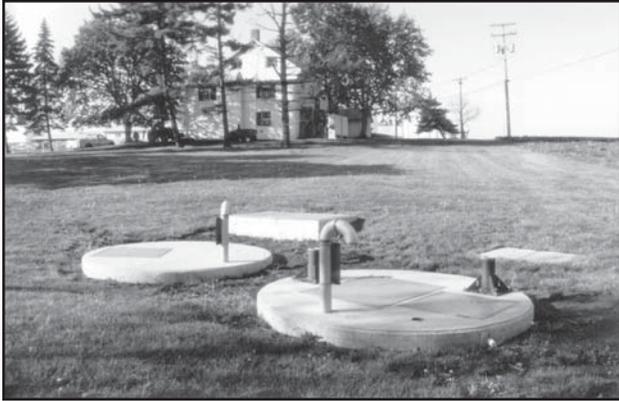
Figure 2.104. View looking south at the septic system structure on Farm #2 in clear view from the main path that leads to the farmhouse. (Photo by OCLP, 2002)

In 1999, a new septic system was installed to accommodate the needs of both Farm #1 and Farm #2. The concrete tanks for this system were placed on Farm #2, just east of the employee parking lot, directly across from the stream crossing between the farms.<sup>91</sup> The tanks are below ground with three concrete pads exposed above grade. Ventilation pipes and mechanical access panels are located on these pads. The pads, panel doors, and pipes are very visible and unattractive, especially when seen from the culvert bridge looking south up to the farmhouse at Farm #2. (fig. 2.104)

The tops and sides of the concrete pads, panel doors, and pipes should be painted a flat dark brown color so that they are less noticeable from the culvert bridge, which is where visitors catch their first glimpse of the farmhouse on Farm #2. To further obscure the structures, approximately ten yards of loam should be added around the concrete pads and seeded with grass. The new fill should be feathered into the existing grade. However, the park should consult experts on the septic system first so that the fill does not block some of the small vents on the sides of the tanks and inhibit

its operation. No shrubs or other vegetation should be planted in this area as that will tend to draw more attention to the structures.

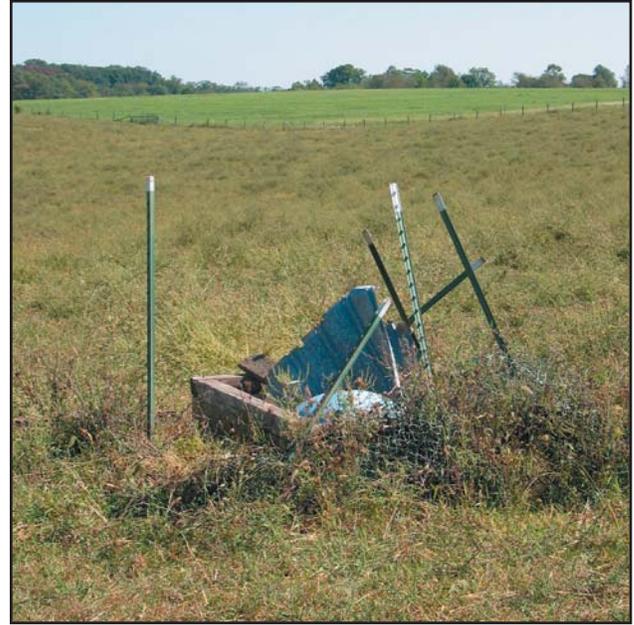
Figure 2.107. View looking east at the well and pump on Farm #2, in the pasture east of the show barn. (Photo by OCLP, 2005)
