Tech Notes

WINDOWS NUMBER 17

Repair and Retrofitting Industrial Steel Windows

LIPPINCOTT PRESS BUILDING Philadelphia, Pennsylvania

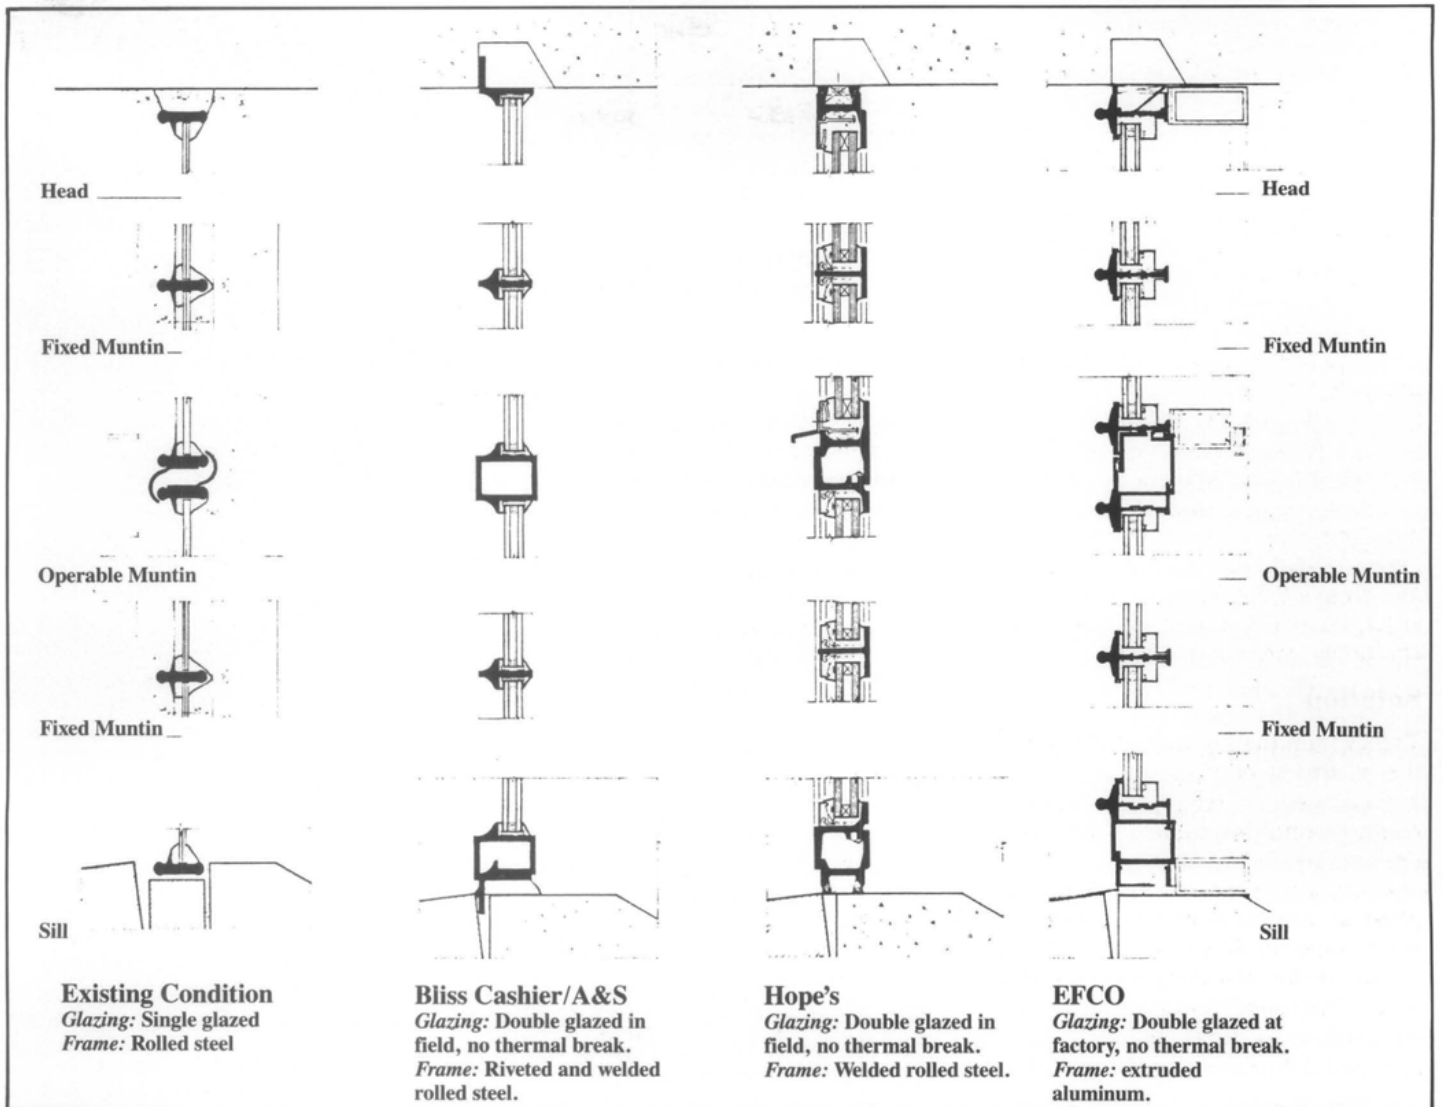
Figure 3. Comparative window sections showing the existing steel window on the left and the three thermally glazed replacement proposals on the right. Drawing: H2L2 Architects.

3. An EFCO, non-thermally broken aluminum sash with double-glazing—exterior pieces would be extruded with a bullnose shape.

In addition to the comparative drawings, mock-ups of the windows manufactured by Hope's and EFCO were installed on the third floor of the south elevation to evaluate how closely the replacements matched the historic windows.

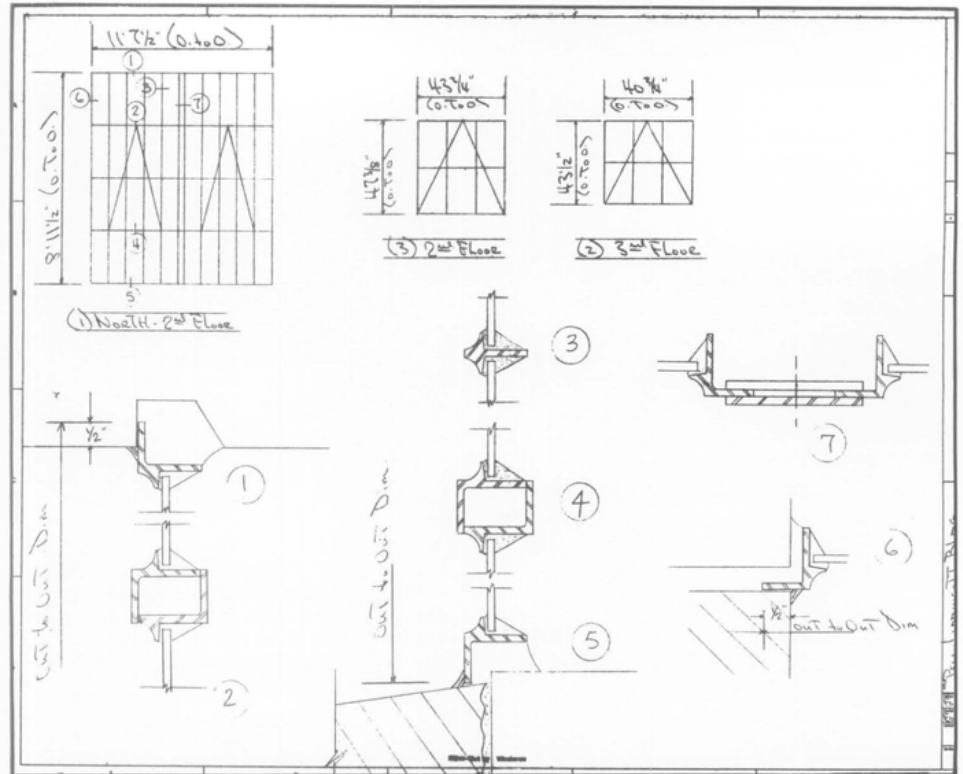
Figure 9. Sectional drawings of replacement window manufactured by A & S Window. Drawing: Winderco, Inc.

The rehabilitation included replacing the deteriorated steel sections, particularly in the sill areas, and replacing the missing and nonrepairable windows with new single-glazed steel windows similar in profile and configuration to the existing windows. As part of the repair process, the existing ventilator windows would be modified from center pivoting sash to projecting sash (to meet Philadelphia code for emergency egress), and both the repaired and new steel windows would receive interior storm windows to bring the windows into compliance with the Pennsylvania State Energy Code requirements for heat loss, air infiltration, and other energy/comfort criteria.

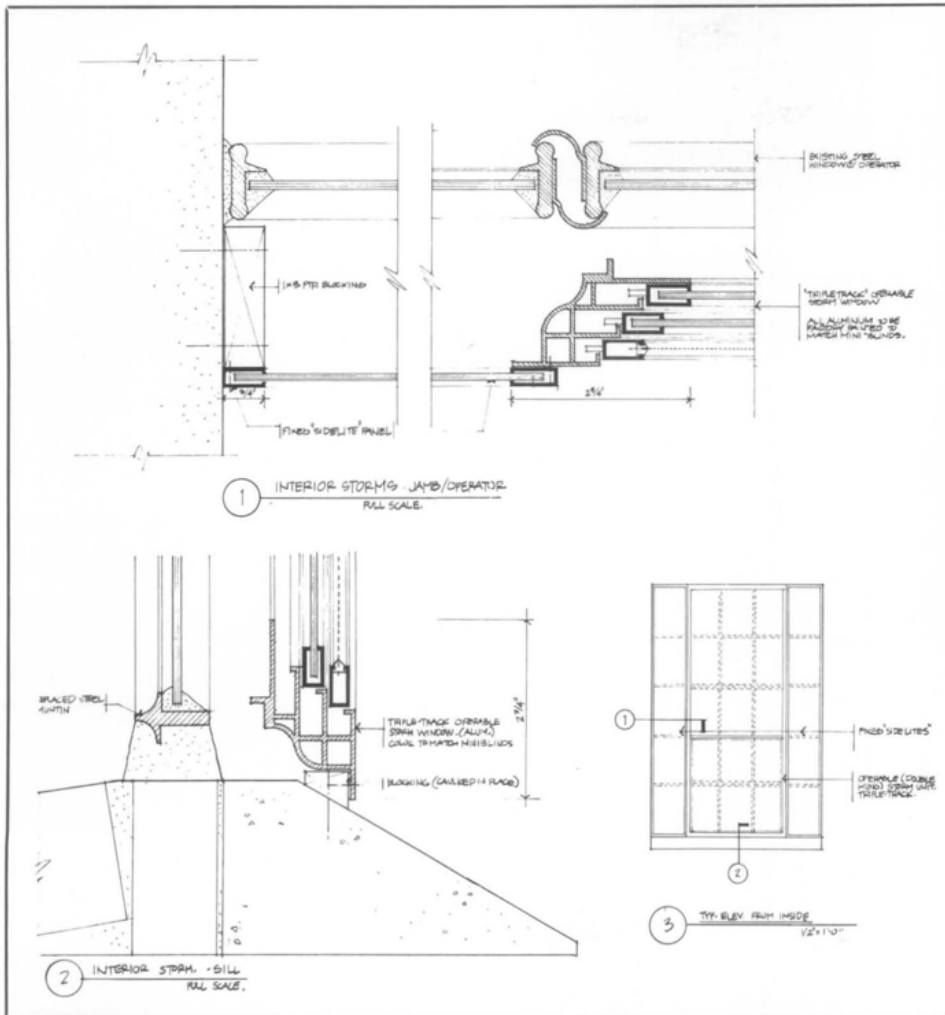
Figure 11. Interior storm window drawings, showing the alignment of the storm and steel window members. Drawings: H2L2 Architects.

the existing steel windows in and of itself was not sufficient in bringing the windows up to code. The development of an interior storm window system provided the additional thermal performance for code compliance. The solution involved an aluminum, triple-track, interior storm unit with flanking, fixed "sidelites" (see figure 11). A major consideration in the development of this storm system was the desire to minimize the outside visibility of the storm unit by aligning as closely as possible the meeting rails and other aluminum members with the steel window members (see figure 12). The exterior face of the storm windows was painted the same color as the steel windows so as to be as inobtrusive as possible (see figure 13). Although, the aluminum members do not match exactly the width of the opposite steel members, the storm windows were not readily visible from the exterior.
