Emergency Stabilization & Rehabilitation Plan

KNP Complex

Sequoia and Kings Canyon National Parks, CA

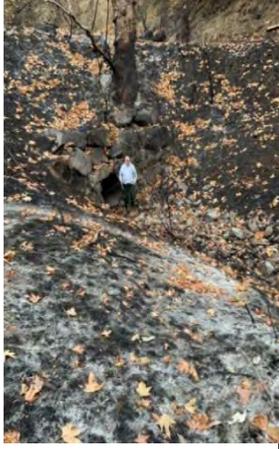
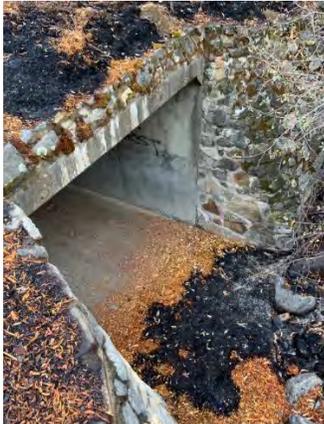
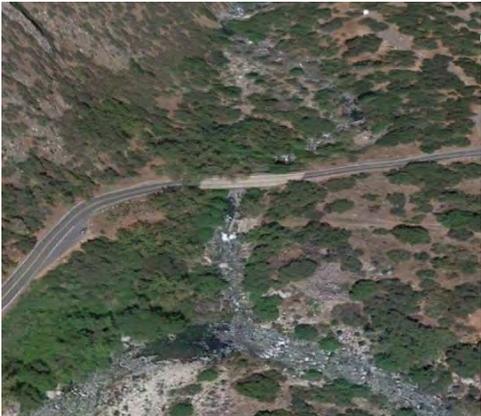
<p>Alder Creek at ~MP 1.3 near Park HQ has a 48" culvert set under deep road fill</p>	<p>Elk Creek near MP 4 has an 8x10 foot box culvert draining this stream.</p>	<p>The highway crosses the Marble Fork of the Kaweah River at MP 4 on a substantial bridge</p>

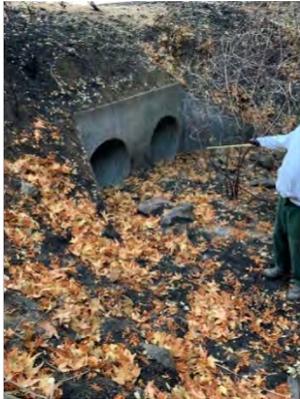
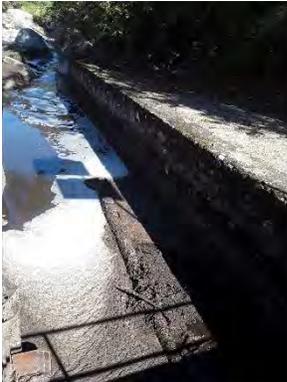
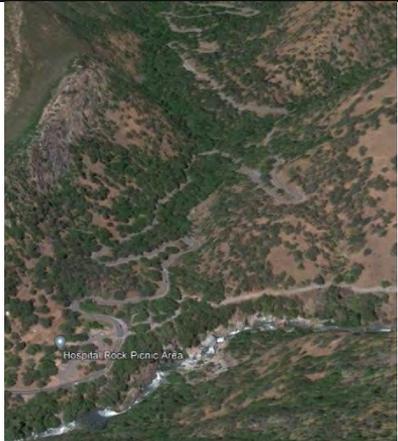
<p>Un-named stream near MP 6 has two 48" culverts</p>	<p>The hydroelectric intake infrastructure has and will continue to accumulate debris</p>	<p>There are several road crossings of an un-named drainage near Hospital Rock and the highway switchbacks (including MP 7)</p>

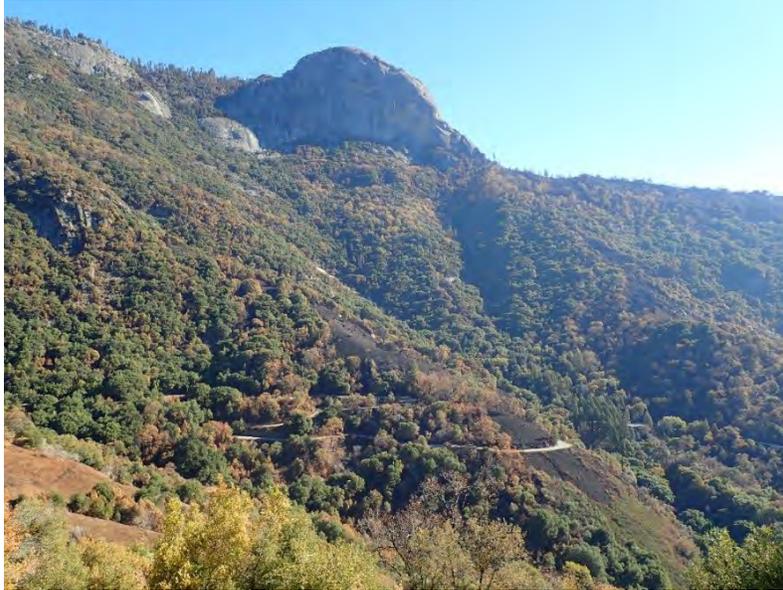
Unburned and low soil burn severity with patches of moderate and high soil burn severity above the General's Highway between Hospital Rock and Amphitheater Point.

This area of the General's Highway was visually observed following a rain event. Aside from very small rocks on the road, only one substantial rock fall was observed; a boulder approximately 4 feet in diameter detached from far above the road, tumbled down a drainage and landed just above the road. The boulder broke into several pieces, with one fragment punching a hole in the uphill lane and continuing down to the next road segment below the switchback.

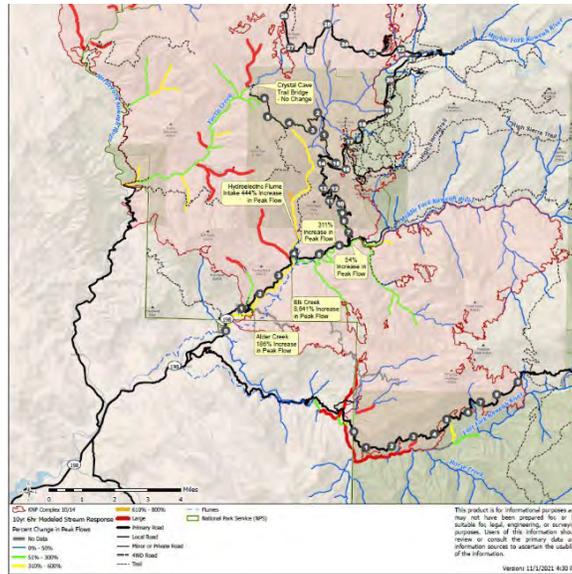
AGWA model showing reaches with the greatest change in peak flows.

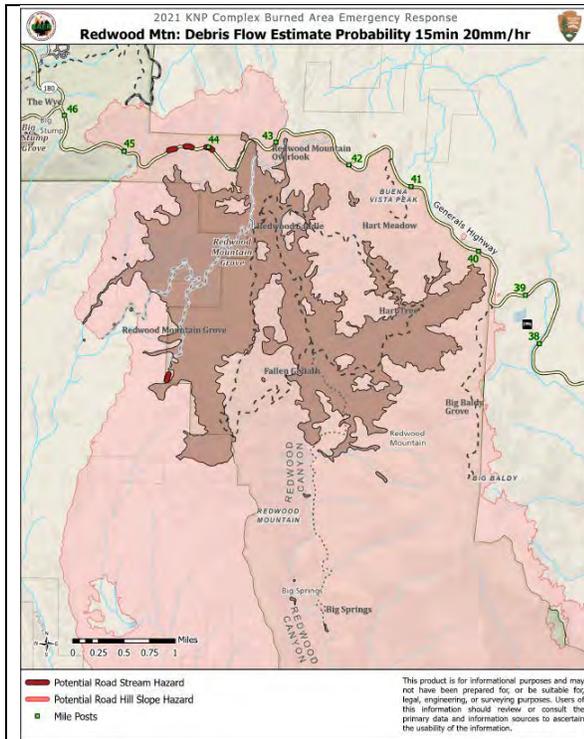
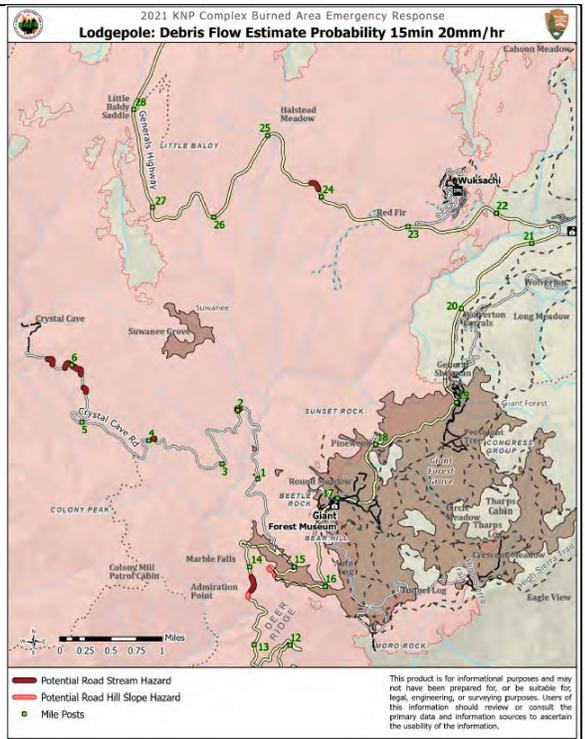
Locations of probable debris movement onto roadways near Redwood Mountain

Locations of probable debris movement onto roadways near Giant Forest

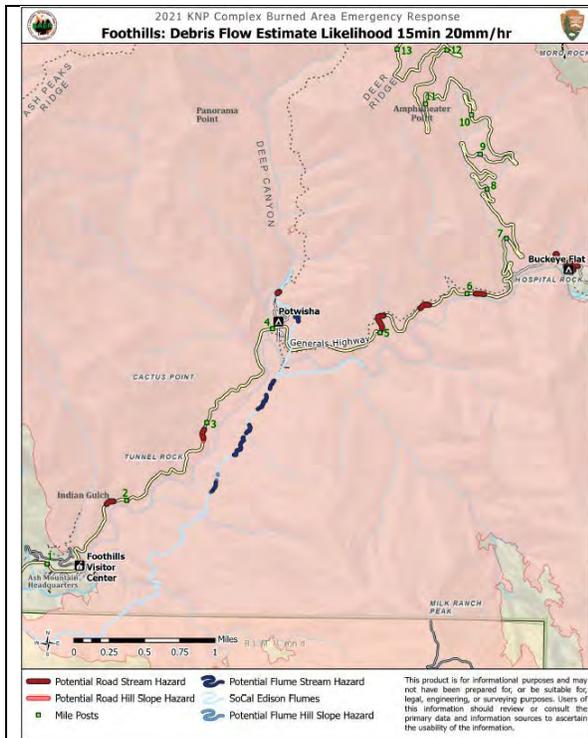
Locations of probable debris movement onto roadways and hydroelectric flumes near Potwisha

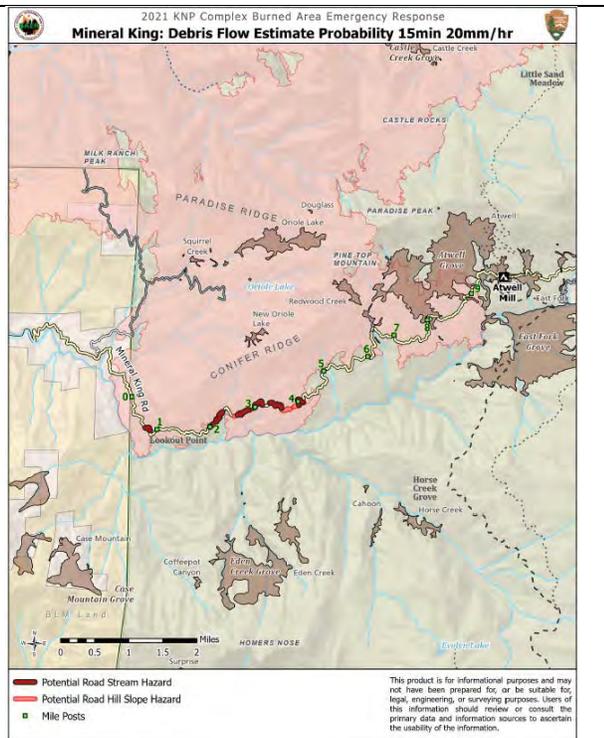
Locations of probable debris movement onto the Mineral King Road

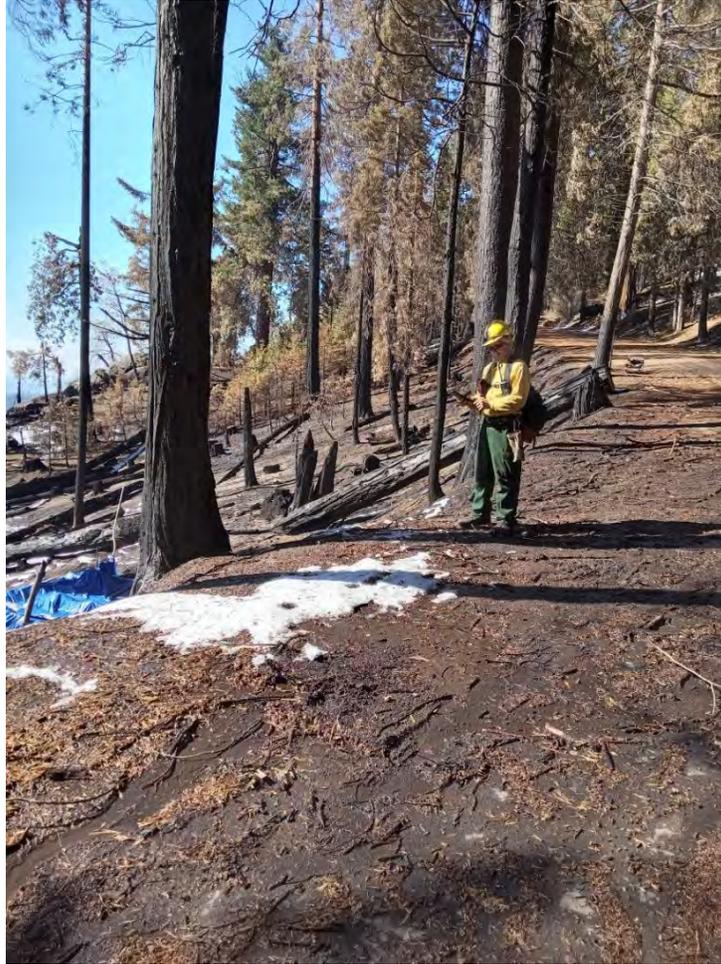
Clark Cowan, Moro Rock Comfort Station Remains

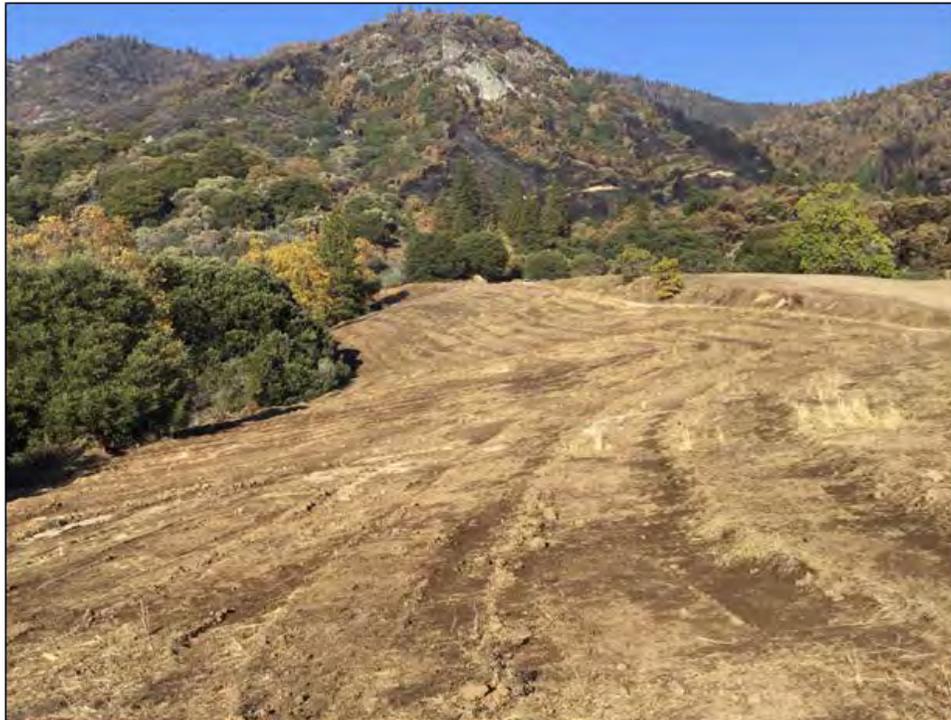
Fire suppression activities often include clearing burnable material from the soil surface to create fuel breaks, firefighter safety zones, or helicopter drop zones. The most dramatic examples of soil disturbance on the KNP Complex in SEKI were the large-scale disturbances created along Milk Ranch Road. Bulldozers cleared an approximately five-acre safety zone and constructed firelines averaging 75 feet wide (Figure 3). While suppression damage repair will restore some physical impacts, these areas are now primed for infestation by annual invasive grasses known to occupy adjacent foothill plant communities.

Figure 3. Large safety zone on Milk Ranch Road.

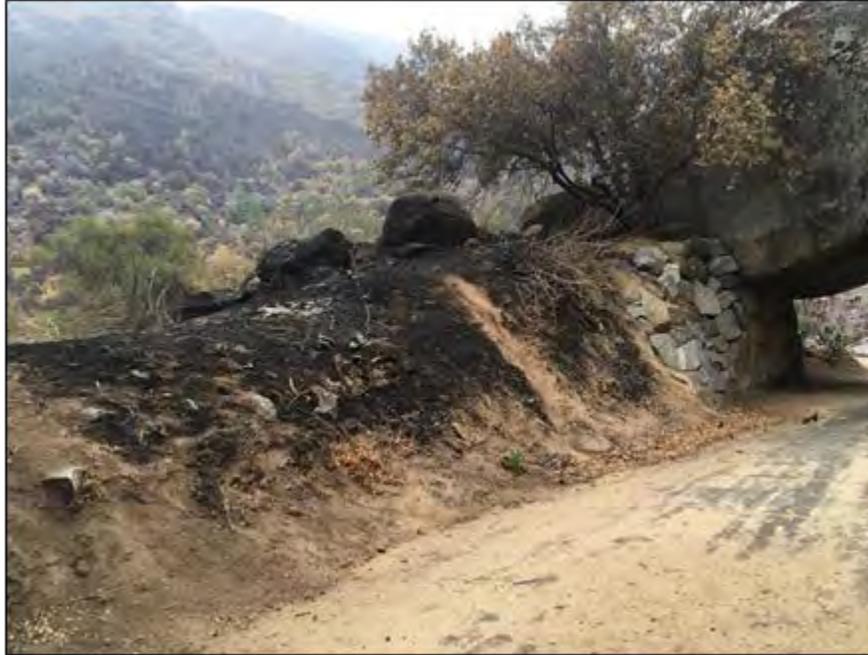
Tunnel Rock (above) is a popular stop for visitors, who use social trails to climb the slopes at either end of the rock that forms the “tunnel”. Eroded areas around the rock were planted to help slow erosion that was threatening the rock’s stability. The plantings were killed by the KNP Fires, exposing the area to renewed social trailing and erosion.

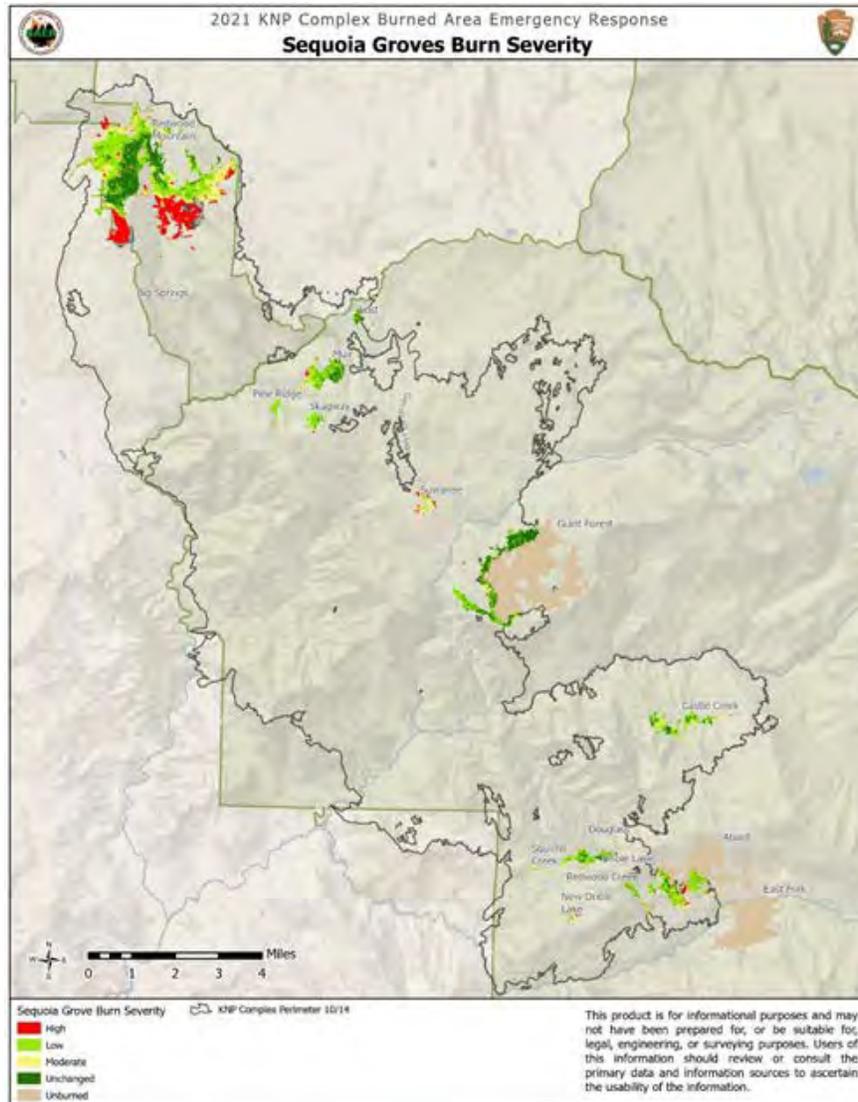
A total of 4,320 acres of sequoia groves burned in the KNP Complex which included portions of 16 distinct groves. In the limited areas that the BAER Team was able to ground truth or observe burn severity via helicopter, the areas designated as “undetected change” typically display some degree of low-intensity consumption. More detailed surveys are needed to confirm the extent of this pattern. Low severity fire was likely largely restorative and represents the largest proportion by severity class of total grove area burned (42%). While undetected change within the fire perimeter and low severity represent 70% of the burned grove area, the absolute acreage of high and moderate severity, where most mortality of large sequoias is expected to occur, is substantial (Tables 5a and 5b, Figure 9).

Figure 9. Map of groves with burn severity, correlating roughly with loss of canopy.

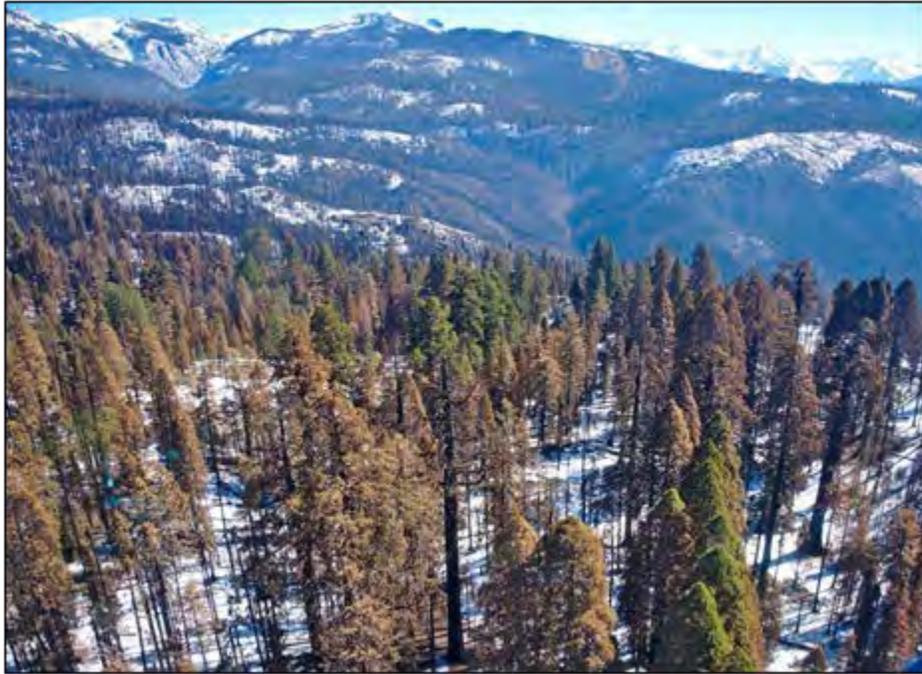
Redwood Mountain Grove had the most substantial acreage impacted by high severity fire (Figure 10a, 10b) followed by Atwell and Suwanee. In the areas in which the Atwell Grove burned severely, the forest was mostly second growth. Reconnaissance via helicopter over the Suwannee Grove indicated that the areas classified as moderate severity were underpredicted in the severity map, potentially resulting in more mortality than expected (Figure 11).

Figure 11. Suwanee Grove. View of high and moderate severity across the grove from 10/27/2021.

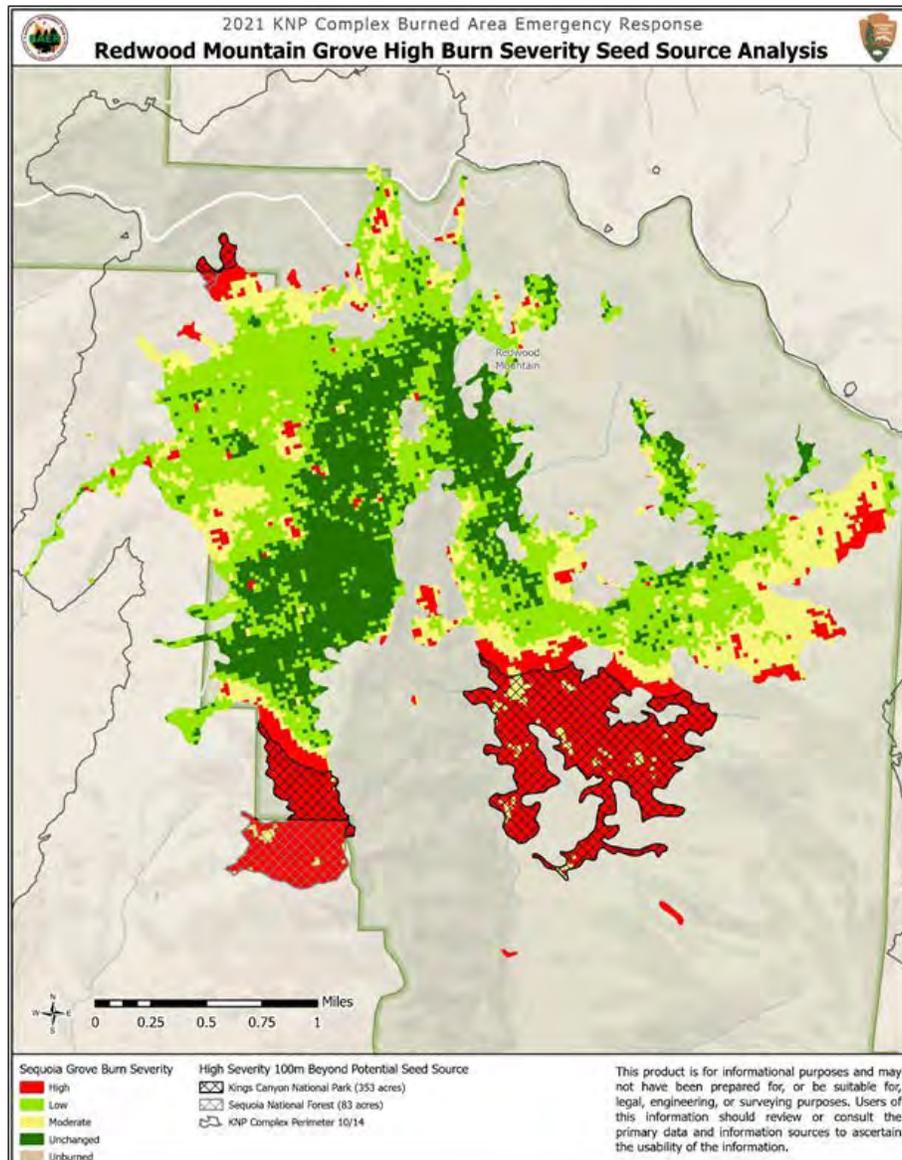
Of the 207 distinct patches of high severity, only five patches are >10 acres. Where the patches were smaller, they may have contributed to heterogeneity. Two areas of Redwood Mountain Grove had 436 acres >100m from a likely surviving giant sequoia seed source; 353 acres of these are within SEKI (Figure 12). These acreages were calculated to exclude some very small patches of moderate severity within the larger high severity patches, because drone imagery suggests that these areas may be fully or near-fully scorched (Paul Hardwick, personal communication, Figure 13). Active reforestation may be needed in this area for giant sequoia, with the extent of this need to be determined by field surveys in 2022.

Figure 12. Southern end of Redwood Mountain Grove with significant patches of high severity.

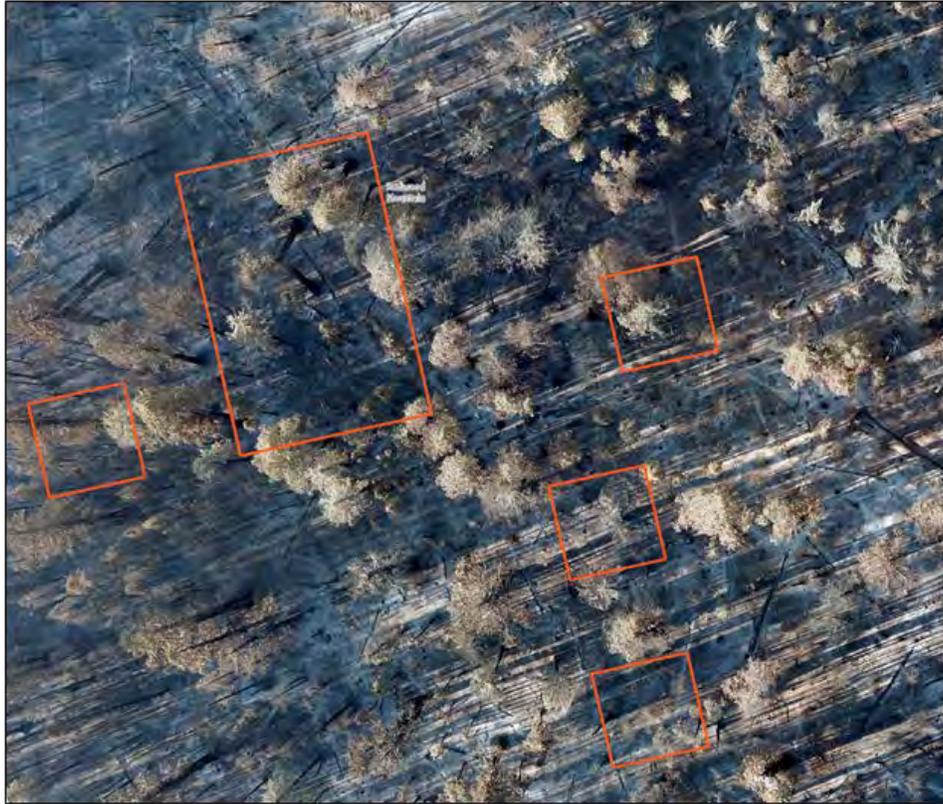
Figure 13. Ortho-rectified drone imagery of small moderate severity patches within the large high severity patch of Redwood Mountain Grove. Because surviving trees in these patches could be limited, the acreage calculation for distance to live tree excluded these for the regeneration analysis (Paul Hardwick, personal communication). Orange squares are classified as moderate severity in RAVG.

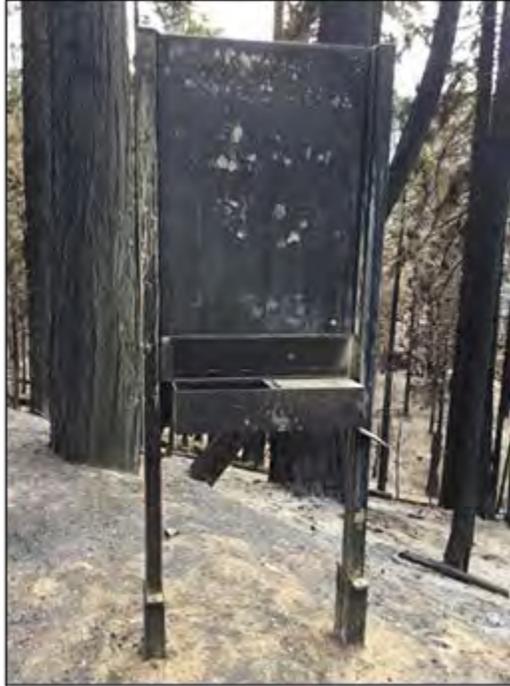
Wilderness Permit Station on Mineral King Road

3. The KNP Complex has destroyed a number of road and regulatory signs throughout the Park, particularly along the Generals Highway. A wilderness permit station was destroyed along the Mineral King Road.
4. Burned terrain may produce hazards on roads and trails (rockfall, flash floods, mudslides, roadway debris, falling trees, etc.). The potential for these hazards will need to be communicated to the public.
5. Sections of Park roads and trails may need to be periodically closed to prevent public exposure to post-fire hazards.
6. Burned vegetation and consumed logs may expose sensitive natural and cultural resources and change visitor use patterns via the creation of new social trails

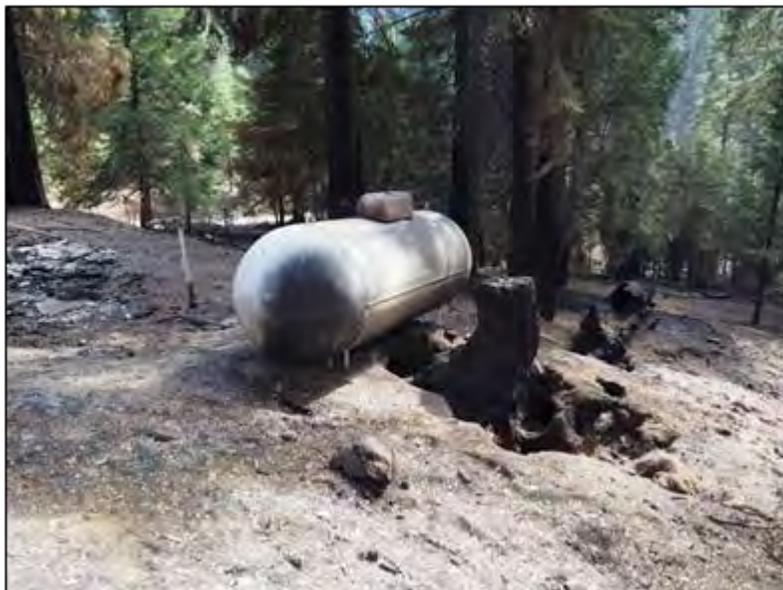
A wood hose box for fire protection is located near the entrance walk to the Ranger Station and displayed only surface fire damage. A propane tank on the site between the Ranger Station and Garage/Equipment Shed shows severe burn marks on its exterior and is in direct proximity to a burned tree stump. The smell of propane near the tank was noted while the BAER team was on site. (See Photo 3)

Photo 3 Redwood Mountain Ranger Station propane tank. View looking southeast.

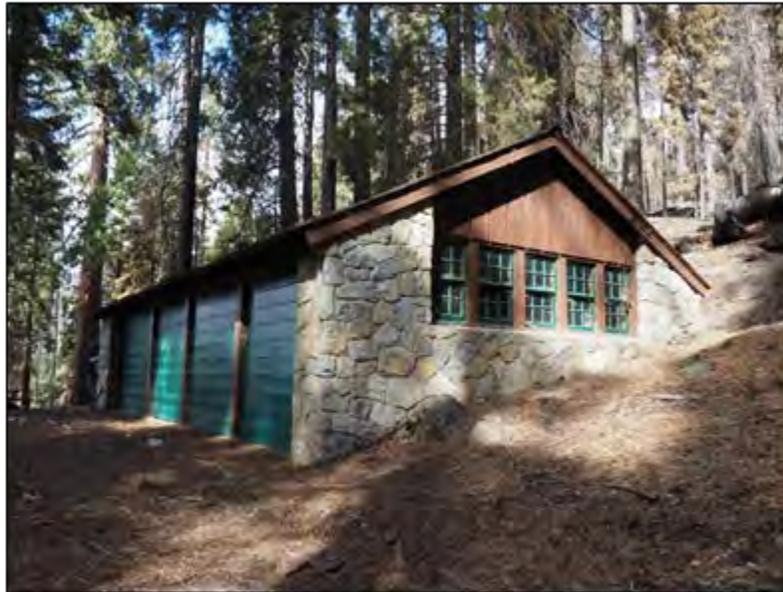
Garage Storage Garage – The Garage structure is located immediately downslope to the southwest from the primary Ranger Station. No fire or suppression damage is apparent on the structure and only a single charred piece of tree bark is visible on its wood shingled roof. (See

Photo 4) The fire appears to have jumped over and around the garage, but possibly due to expanded boundary areas on three sides without direct tree or foliage exposure the garagesurvived with no visible damage.

Photo 4 Redwood Mountain Garage/Equipment Shed. View looking west.

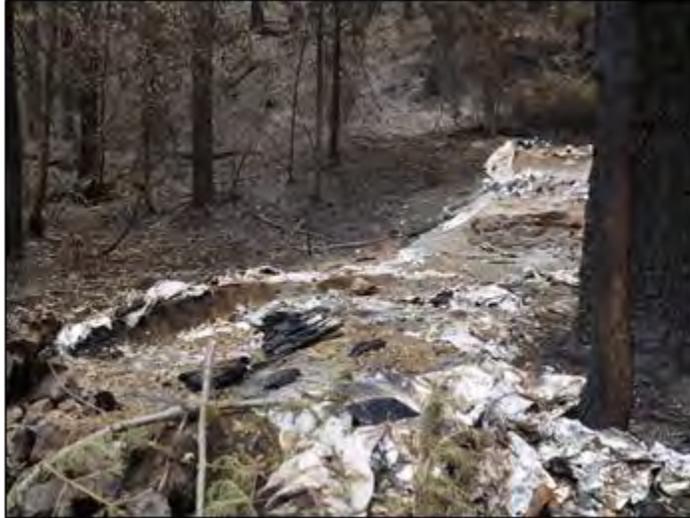
The entire structure was lost as a direct result of fire except for one short rock wall at the mid- point of the footprint where the interior had been elevated, and a crumbling granite wall at the southwest end used as both an end wall and fireplace. The hollowed log/cabin was wrapped in its entirety with structure wrap to resist effects from heat and fire once wildfire spread was indicated for the Redwood Mountain Grove area. Remnants of the structure wrap are found within and around the footprint of the cabin. Very little other construction debris is evident. (*See Photo 5*)

Photo 5 Barton's Log/Croser's Cabin remains. View looking north.

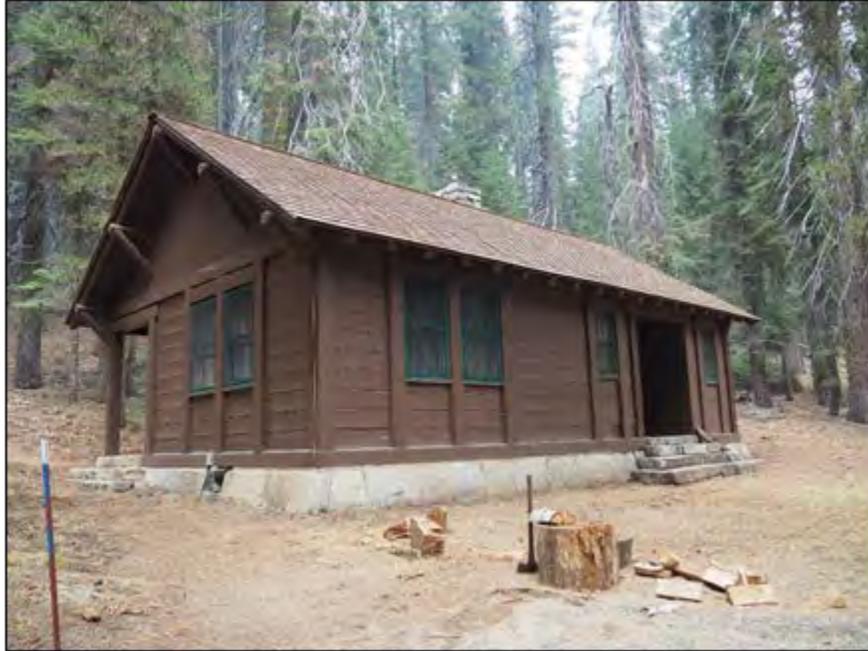
The properties were threatened by the fire from the west and south and a fire break was created to help protect the structures and surrounding property. The site currently does not show any signs of fire damage and it appears that fire did not cross the Generals Highway from the south. Trees are in direct contact with the Dormitory and there is branch damage to an eave section of the Ranger Station, but these conditions were not caused by the fire or any fire activity. *(See Photos 9 & 10)*

Photo 9 Cabin Creek Ranger Station. View looking northwest.

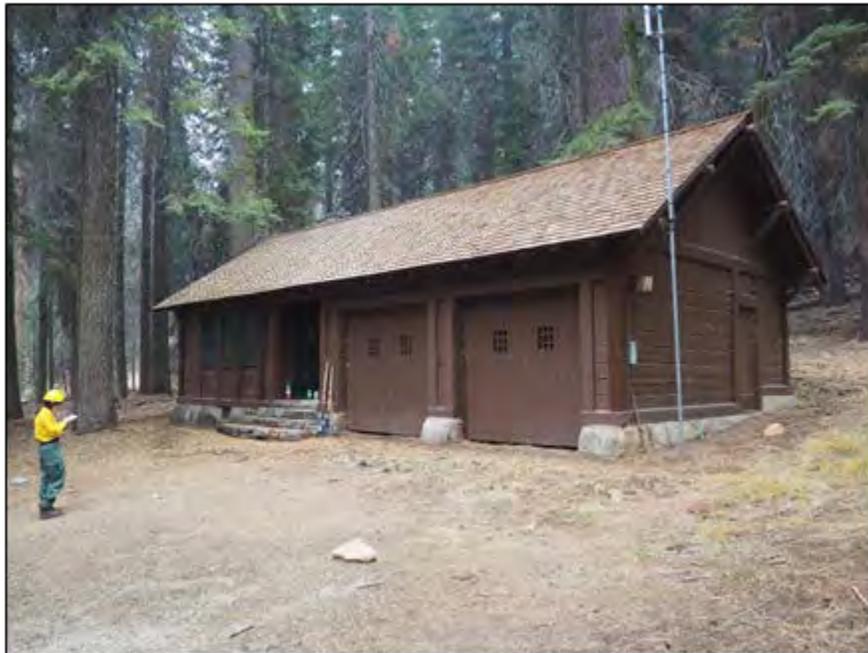
Photo 10 Cabin Creek Dormitory. View looking southwest.

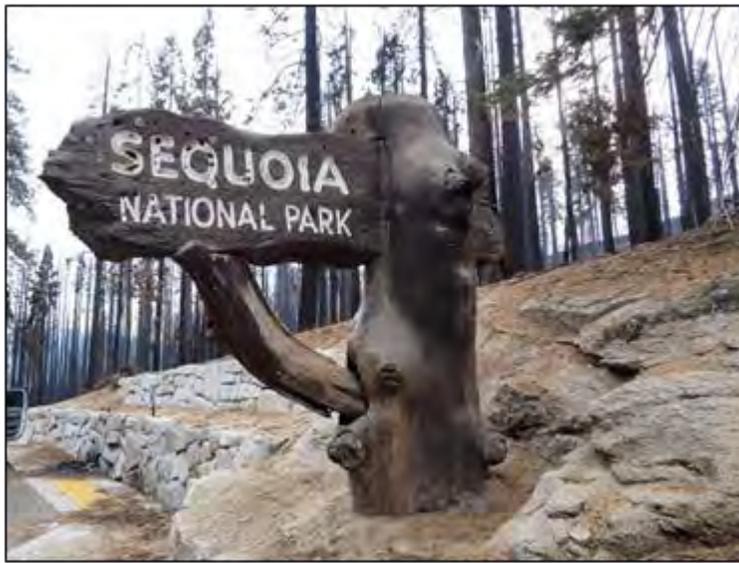
Sequoia National Park North Entrance Sign – The Sequoia North Entrance Sign was constructed in the 1930s during the CCC era. It is the most iconic sign located in Sequoia National Park and is an important feature of the Generals Highway Cultural Landscape at the border of Sequoia National Forest along the Generals Highway. The sign was located within the fire perimeter and evidence of fire activity can be found within 40' of the sign. The sign is not painted and shows weather effects due to age and exposure, but there is no specific evidence of fire or suppression effects on the surface or at its base. Hazard trees are in proximity to the sign to the west and will need to be addressed to reduce further threats to the sign's integrity. (See *Photo 11*)

Photo 11 Sequoia National Park North Entrance Sign. View looking south.

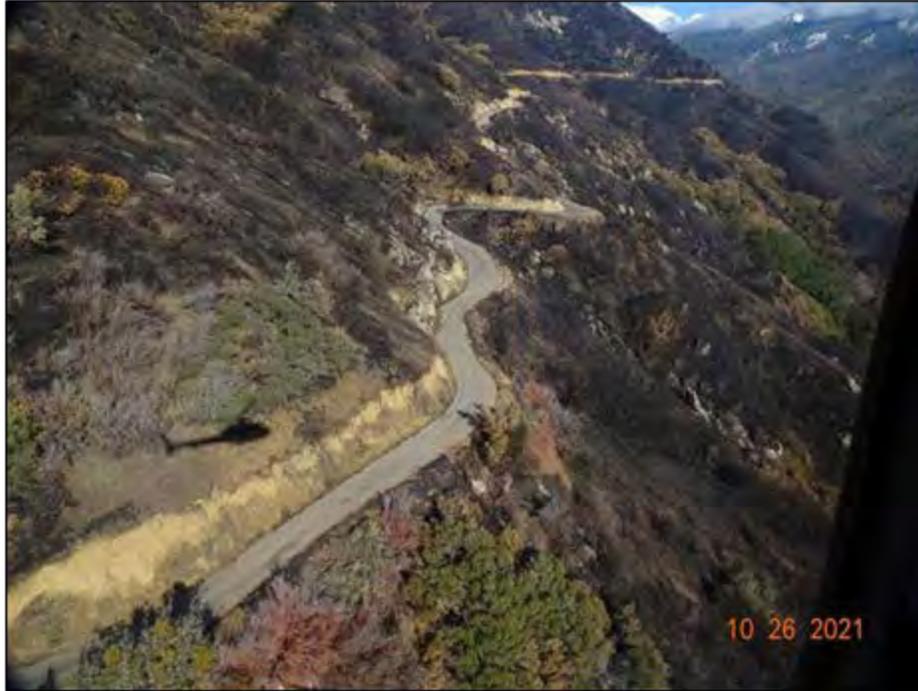
Due to post-fire erosion conditions, the Mineral King Road was impassible, and helicopter reconnaissance indicated there were several mudslides impacting the roads. The debris flow model generated for the incident showed many areas of the road that are predicted to continue to see debris flow. Without a historic landscape architect, the BAER team was unable to confirm the condition of many features of the Mineral King Road Historic District.

Photo 13 Mineral King Road. View looking northwest from helicopter.

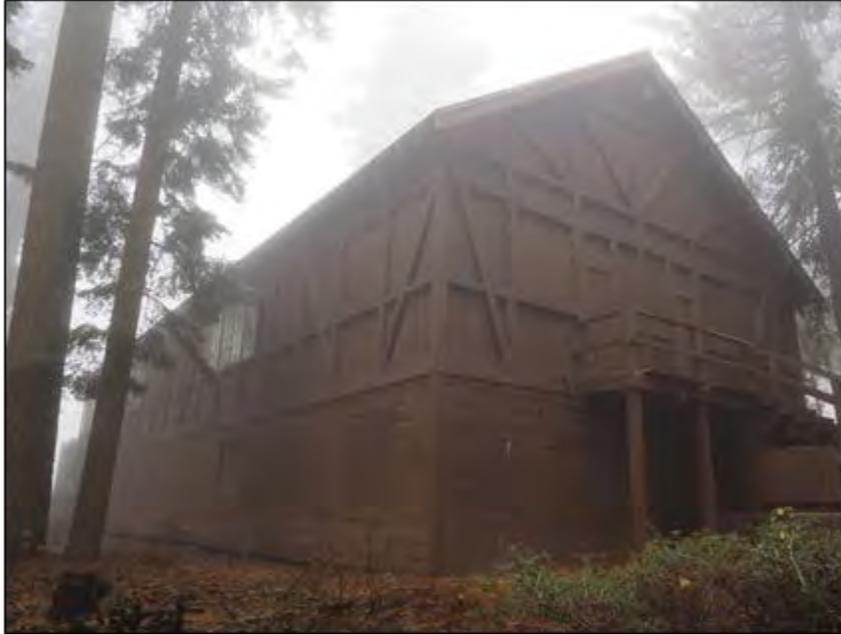
Observed fire activity near both the Giant Forest Ranger Residence and Beetle Rock Building is thought to be the results of a backburn closest to the development of the Giant Forest area. This backburn was completed to reduce the vegetation immediately in proximity to threatened resources. The effort to protect the Giant Forest Village/Camp Kaweah Historic District with a backburn was successful, as no buildings within the district show signs of either fire or suppression effects. Hazard trees could be in the area of both the Giant Forest Ranger Residence and Beetle Rock Building, either as a result of the backburn or wildfire.

Photo 14 Beetle Rock Building (Assembly Hall). View looking west.

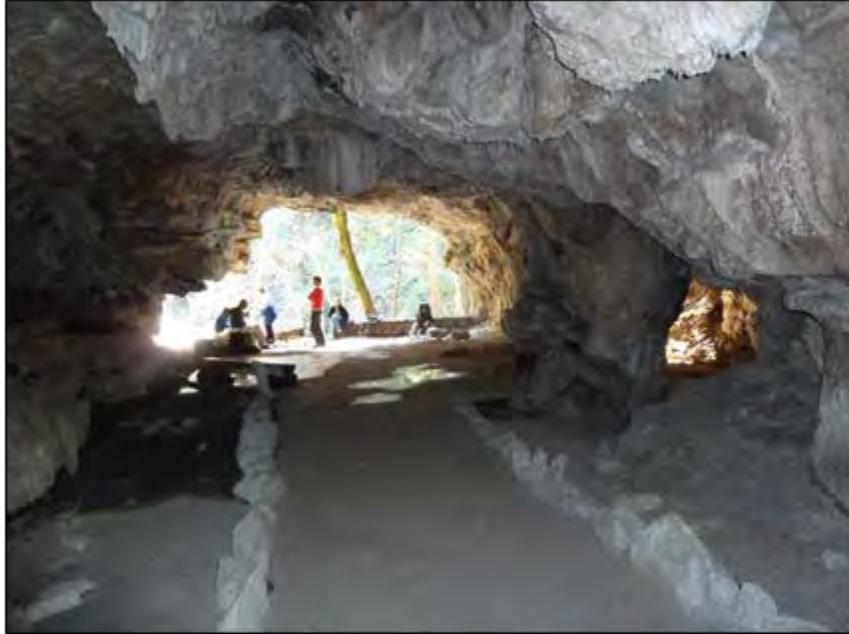
The Crystal Cave Historic District is located in the Crystal Cave area west of the Giant Forest Grove. A trail originally built by the CCC between 1938 and 1941 facilitates the popular tours offered by the park in summer. The period of significance is 1933 to 1965. The contributing features of the Crystal Cave Historic District include the Crystal Cave Road, the Crystal Cave Parking Area, Comfort Station, Access Trail, and Interior Trail. Because of fire conditions and the impassable road hazards, the BAER team was unable to confirm the condition of the Crystal Cave Historic District or make any further assessments.

Photo 15 Crystal Cave Trail

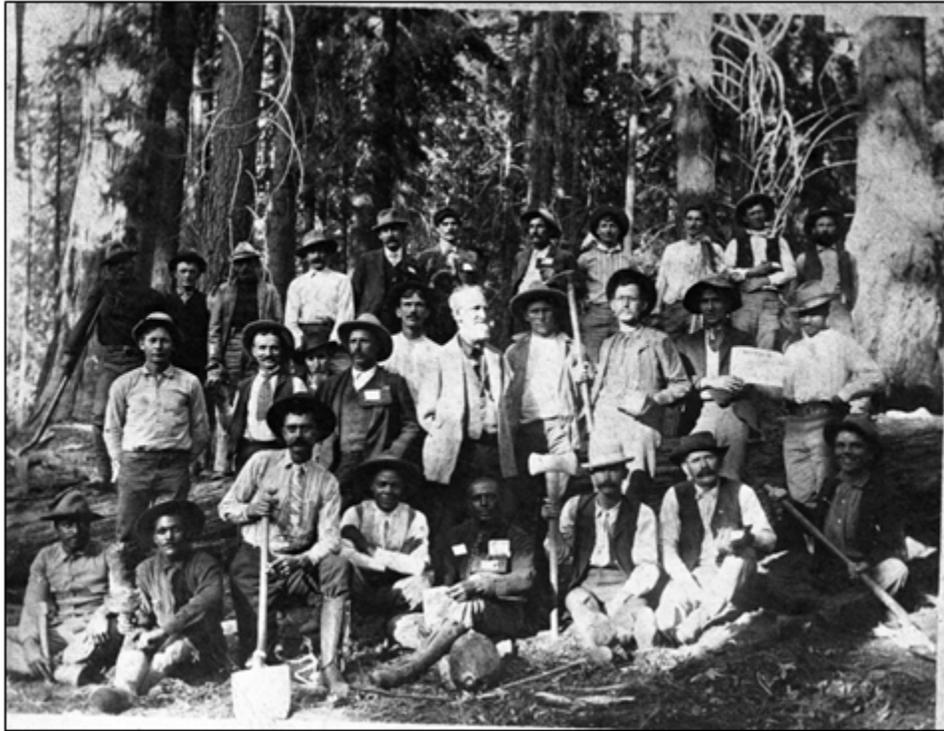
The Colony Mill Road was partially constructed by the Kaweah Colony, a utopian group who sought to claim the land and create a logging cooperative. The portion of the road closest to the Giant Forest was completed by the Buffalo Soldiers in 1903. This road was previously known as the Giant Forest Road. Due to fire conditions and the impassable road conditions, the BAER team was unable to confirm the condition of any of the Colony Mill Road features or make any further assessments.

Photo 16 Historic Photo of Capt. Charles Young of Buffalo Soldiers with crew upon completion of road into Giant Forest. Colony Mill Road was called Giant Forest Road.
