**Re: Vessel, “DESERT PRINCESS” Official Number 978704  
Alternate Hull Examination with Diver Video and UT Gauging/Diver Survey**

## ***M/V DESERT PRINCESS, O.N. 978704***

### **ALTERNATE HULL EXAMINATION (AHE) & ULTRASONIC GAUGING SURVEY**

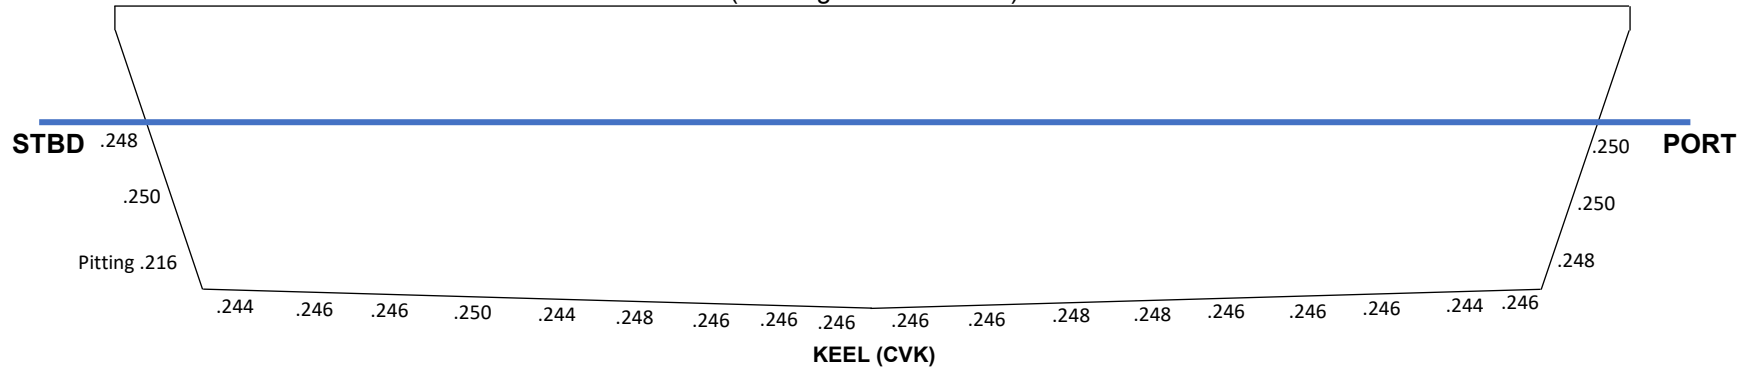
### FRAME 44 TRANSVERSE SHELL

| <b>9-11-25 Hull Inspection Video Log</b> | | |
|---|---|---|
| 11:45:37 | Frame 44 | STBD intake between Frame 44 and Frame 46 in good condition. |
| 11:46:19 | Frame 44 | PORT intake between Frame 44 and Frame 46 in good condition. |
