## Structures

**Summary Analysis.** Four types of structures are present within the park. These include the remnant earthworks associated with the siege, large monuments such as state memorials, engineered features such as bridges and culverts, and a tensile structure.

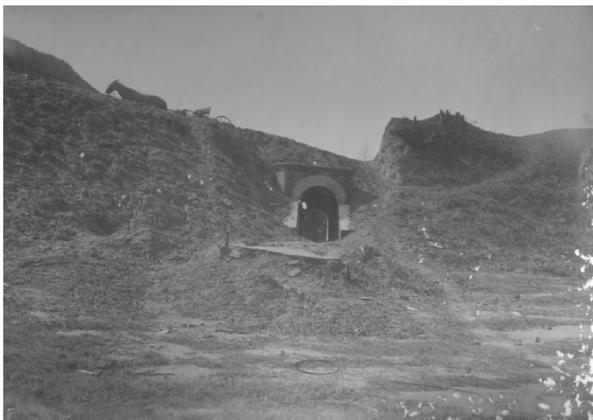
**FIGURE 220.** Thayer's Approach Tunnel, undated photograph, early twentieth century.

- *Engineered Structures.* Numerous bridges were constructed during the early park establishment period as part of the road network that provided visitor access to the important resources of the park. Those that survive are contributing resources. A few of these bridges have been replaced with contemporary bridges and box culverts. These replacement structures are non-contributing. Three towers established during the early park development period were removed in the 1960s and constitute missing historic features. The concrete tunnel beneath Union Avenue at Thayer's Approach is visible in an early twentieth century photograph. The feature appears to date from the early park development period, although a tunnel existed in this location during the siege (Fig. 220 and Fig. 221).

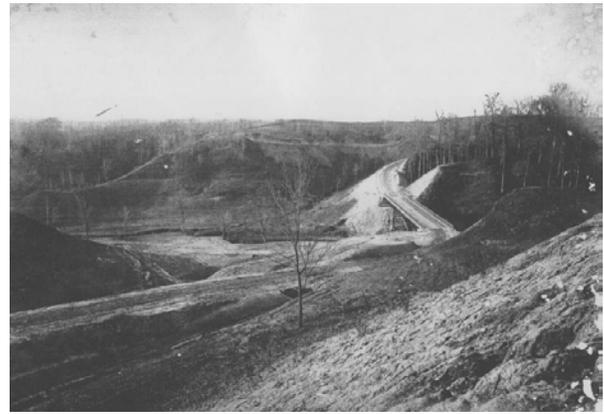
**FIGURE 222.** View north from behind the Illinois State Memorial toward the site of the Wisconsin State Monument, circa 1903, showing a bridge crossing Glass Bayou.

**FIGURE 223.** A similar view, 2007. Woody vegetation in the contemporary photograph obstructs views. The early bridge was removed and replaced circa 1970.

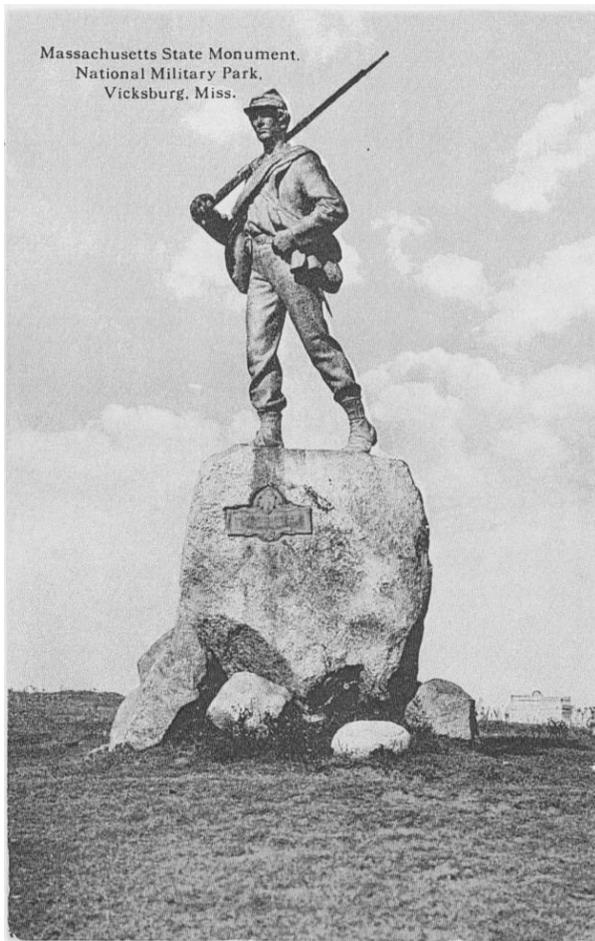
**FIGURE 224.** The Massachusetts State Monument, looking north, circa 1908

**FIGURE 225.** The same view, 2007. The monument appears to survive in good condition, although some of the boulders at the base of the monument shown in the historic image appear to have been moved in the 2007 image. Otherwise the primary difference in the views is the dramatic increase in vegetation seen behind the monument.

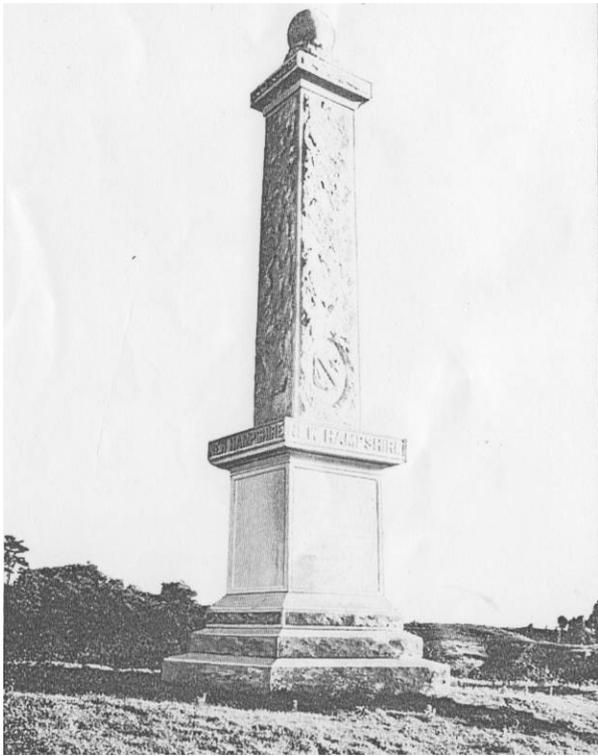
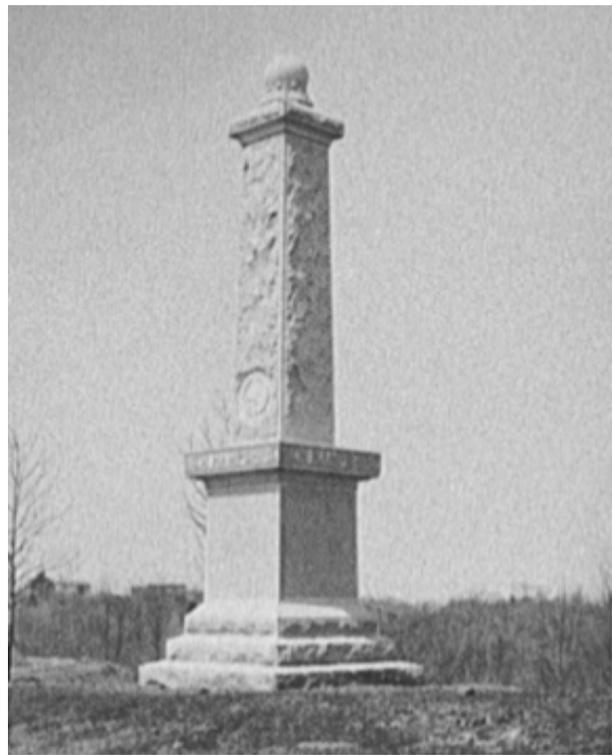
**FIGURES 226 and 227.** The New Hampshire State Memorial, looking west, circa 1908; looking east, circa 1910–1920.

**FIGURES 228 and 229.** The New Hampshire State Memorial, similar views, 2007. Located with many other state monuments along Grant Circle, the New Hampshire State Memorial was the second state monument placed at the park. Both views indicate that the monument itself retains a high degree of integrity, and continues to be set on a knoll maintained in open turf lawn. Behind the monument both to the east and to the west, however, the setting has changed through the addition of extensive expanses of woodland. The woodland cover obscures views of the park to the west, and the rolling terrain to the east. In the contemporary view looking east, a transmission tower is visible in 2007 that was not present during the early twentieth century.

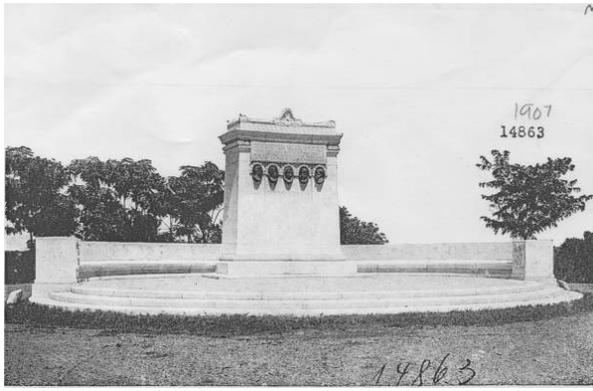
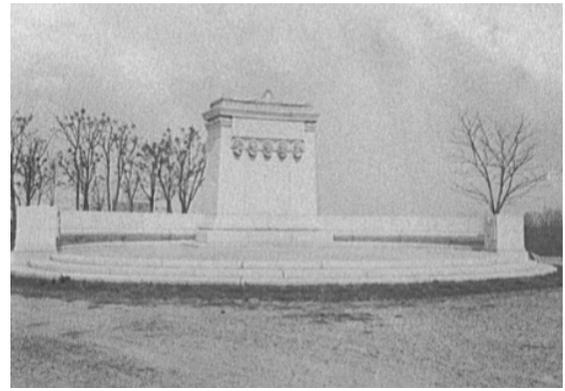
**FIGURE 230 and 231.** Left: The Pennsylvania State Memorial, looking east, 1907. Right: The same view, circa 1910–1920.

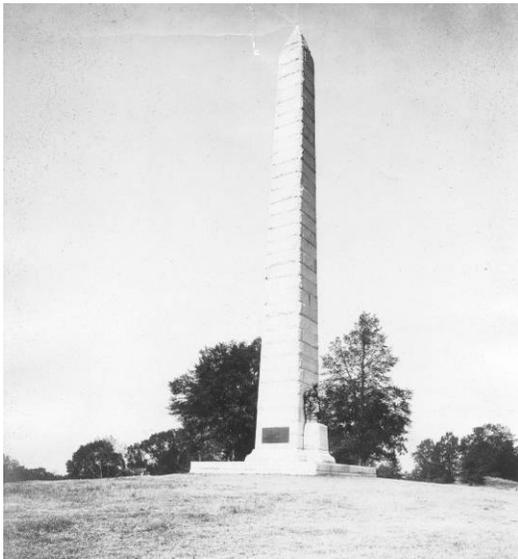
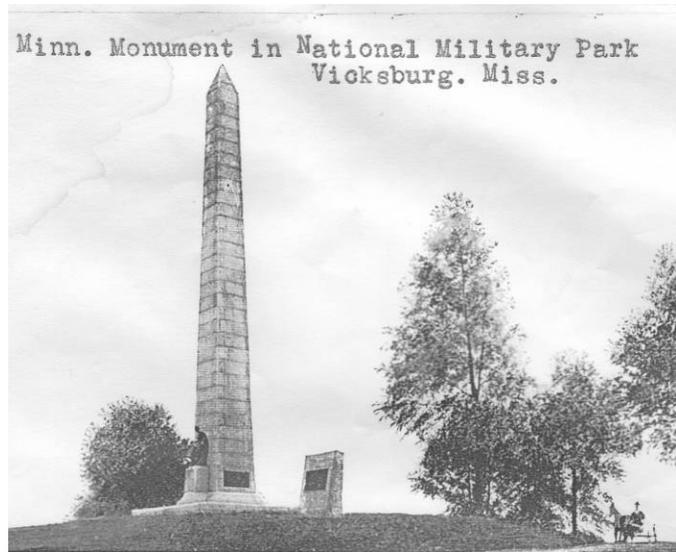
**FIGURE 235 and 236.** Left: The Minnesota State Monument, looking northwest, circa 1907. Right: looking south, no date.

**FIGURE 237.** The Minnesota State Monument, looking south, 2007. Erected in 1907, the Minnesota State Monument was recently recognized for its centennial. Comparison of historic and contemporary views of the monument indicates the changes that have occurred to the structure and its setting over the past 100 years. The contemporary photograph includes temporary interpretive signage marking the centennial. The photographs suggest that the monument itself is little changed since its dedication. In addition, it continues to be sited on a broad, gently-sloping knoll maintained in turf grass that edges Union Avenue. Changes to its setting include the large increase in woodland behind the monument, loss of the circle drive that once afforded views of the monument from all sides, and the more open nature of the knoll that allowed for these views.

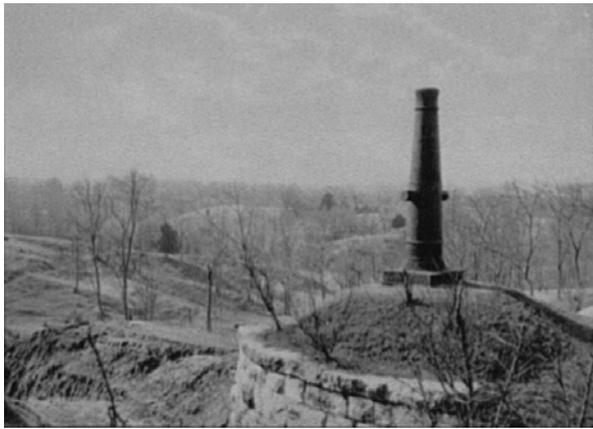
**FIGURE 252.** View south from the vicinity of the Surrender Interview Site Monument, circa 1900.

**FIGURE 253.** Attempt to photograph a similar view, 2007. This pair of images suggests a great degree of change has occurred in the landform and topography below the monument. Given the more steeply sloped landscape below the monument in the historic image, this photograph may have been taken from a different angle. However, the monument and its surrounding stone wall appear similar in the two images.

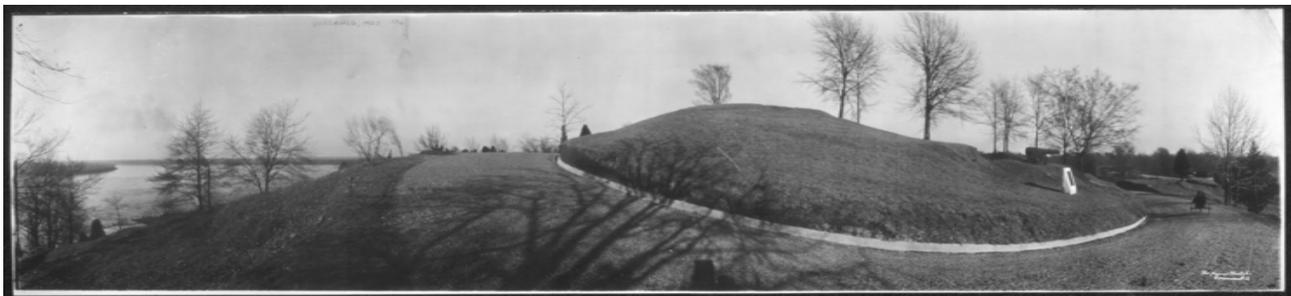
The photograph indicates that by this time the landscape of the fort remained predominantly open, although a few deciduous trees had grown up around its perimeter. The photograph also shows that the existing circular access road, at least one of the existing granite monuments, and an emplaced artillery piece had been established. The surface of the circular access road during this early part of the twentieth century road was hard-packed earth, edged by curbing on the uphill side. The landscape to the center of the access road was maintained in mown grass. The landscape of the early twentieth century can be compared with the contemporary landscape through repeat photography (Fig. 262). Differences include the establishment of the guard rail, stairs, signage, and site furnishings. It is likely that the remaining four existing granite monuments and the cast-iron tablet were added relatively soon thereafter by the War Department. A 1925 bird's eye view shows "South Fort" encircled by a ring road arising from adjacent Warrenton Road (Fig. 258). It is likely that this map is mislabeled and the earthwork shown is actually Louisiana Circle. A postcard

**FIGURE 261.** Panorama of Louisiana Circle, early 1900s.

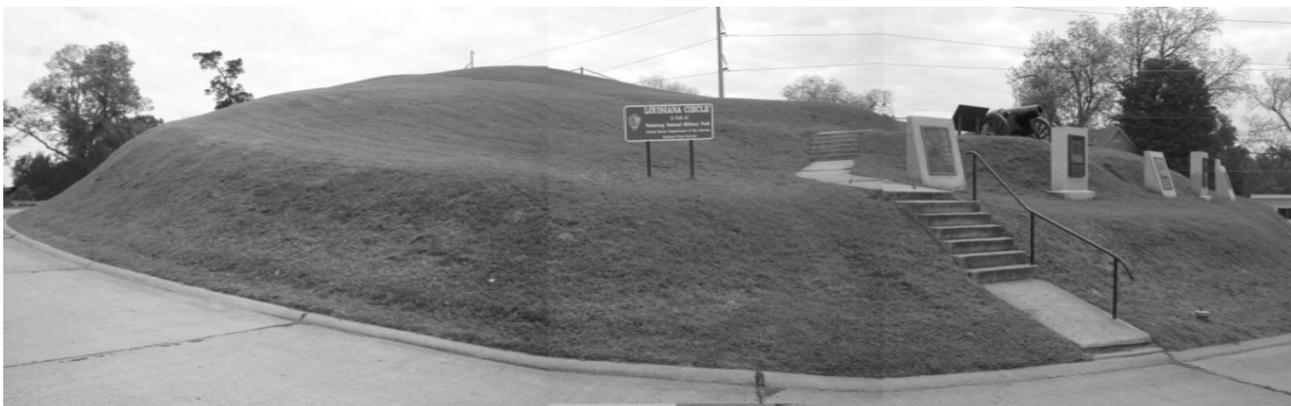
**FIGURE 262.** Contemporary panorama of Louisiana Circle, 2007.

that probably dates from the 1920s or 1930s shows the cannon and an associated cast-iron tablet (Fig. 263). Two of the five existing granite monuments are visible below the brow of the parapet. This postcard also depicts trees partially blocking the view toward the river. Comparison of the landscape through contemporary repeat photography (Fig. 264) indicates the similarity of the view today, with the exception of the addition of contemporary development along the river that has altered the view from the fortification.

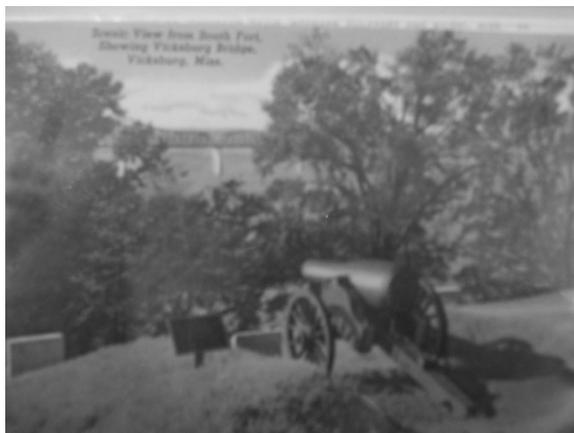
**FIGURE 263.** Postcard view from Louisiana Circle. Although the postcard text says “South Fort,” this view is actually the Louisiana Circle parcel.

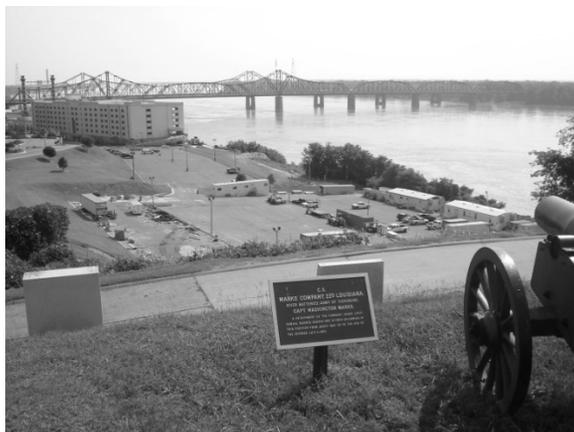
**FIGURE 264.** Contemporary view from Louisiana Circle, 2007.

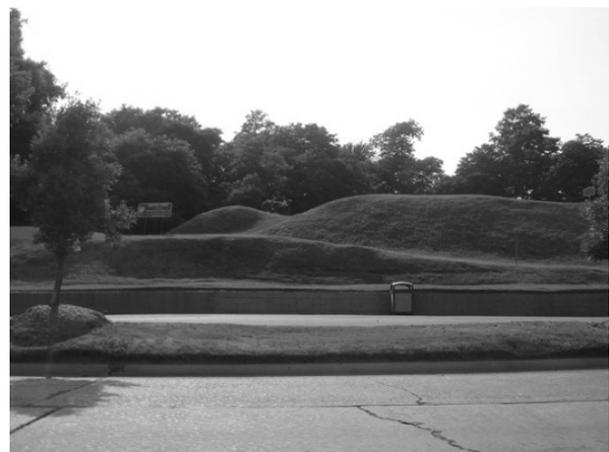
**FIGURE 266.** Contemporary view of South Fort, 2007.

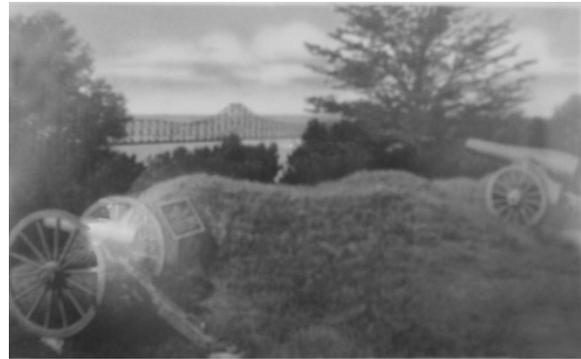
An early twentieth-century postcard view of the site also provides information about the landscape during the periods of significance (Fig. 268). The postcard shows two artillery pieces pointing across the parapet toward the road corridor and the river, and indicate the presence of at least one cast iron tablet. Trees are beginning to grow up in front of the cannon and block the view. Contemporary repeat photography shows the extent to which tree cover has grown up to obscure the key visual relationship between the fort and the approaches that it defended (Fig. 269).

**FIGURE 268.** Postcard view of South Fort.

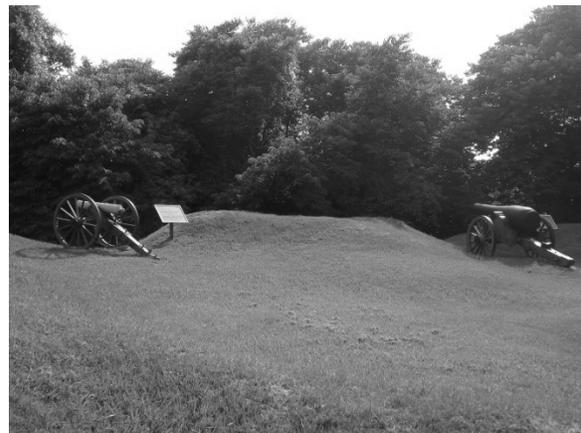
**FIGURE 269.** Similar contemporary view of South Fort, 2007.
