# Merced River and Riparian Vegetation Assessment

June 2012

Prepared For  
Yosemite National Park, National Park Service

**Cardno ENTRIX**  
2300 Clayton Road, Suite 200, Concord, CA 94520  
Tel 925 935 9920 Fax 925 935 5368 Toll-free 800 368 7511  
[www.cardnoentrix.com](http://www.cardnoentrix.com)

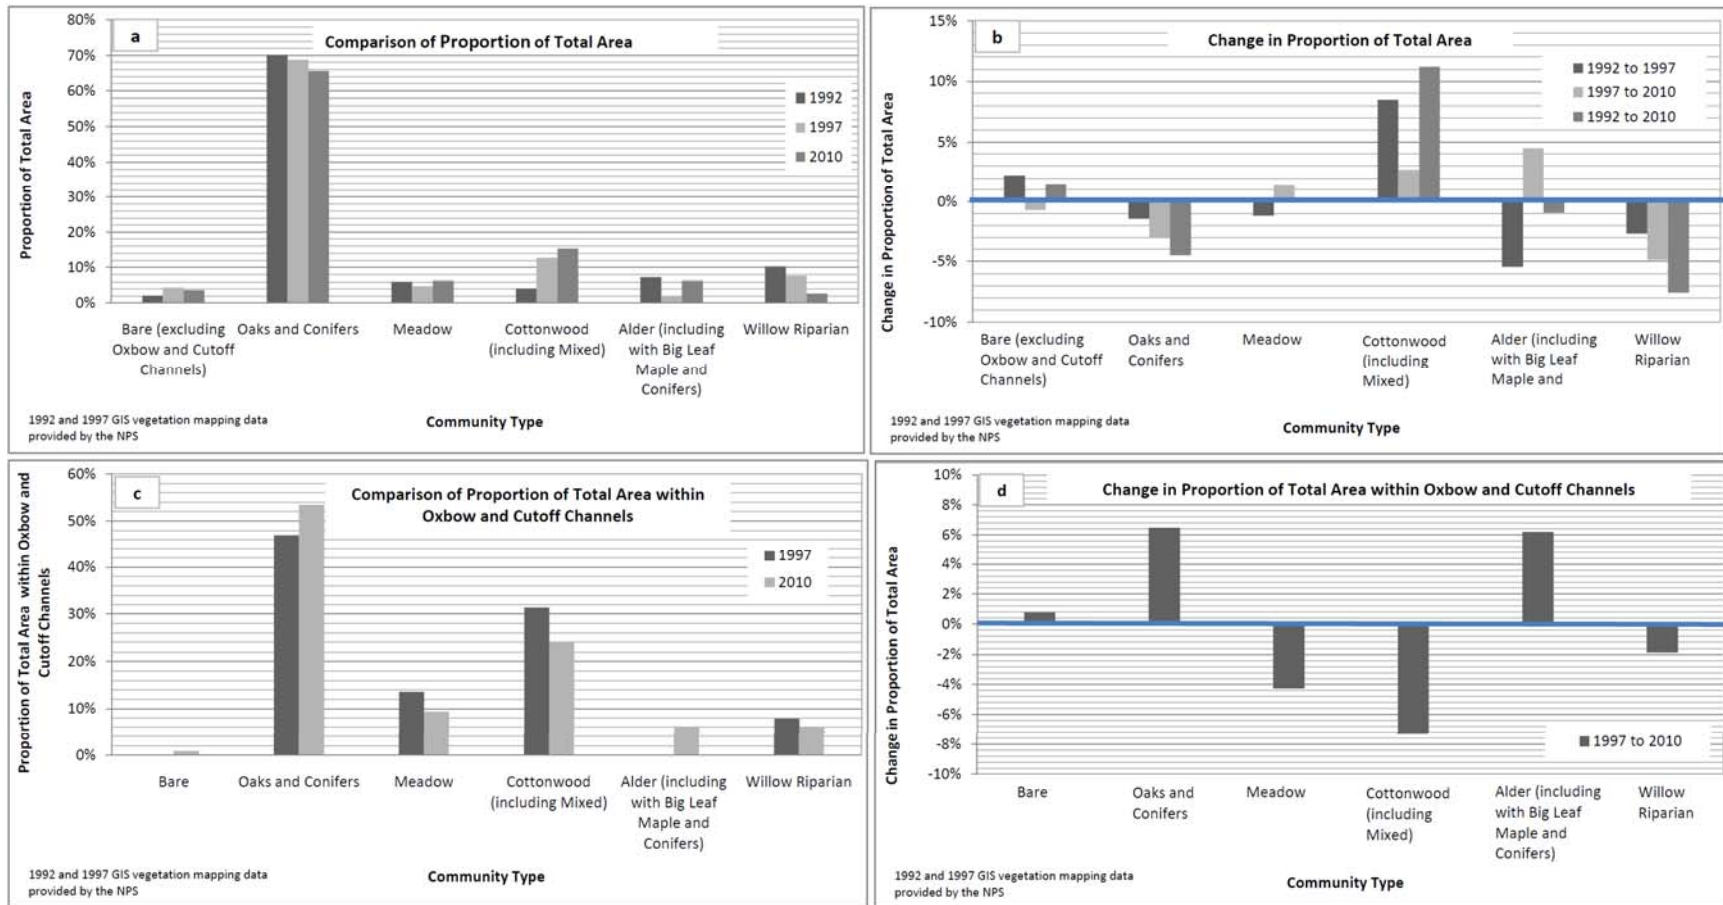
Figure 3-1. Comparison of the Proportion of Total Area of Each Community Type(a) and Change in the Proportion of Each Community Type (b) within the Merced River Corridor (1992, 1997, and 2010) and within Oxbow and Cutoff Channels (c and d)<sup>1</sup>.

Oak and conifer communities dominated the study reach in all three years (66 to 70 percent of total area), decreasing slightly (5 percent from 1992 to 2010 (Figure 3-1 and Appendix A [1992 to 1997 and 1997 to 2010 Riparian Vegetation Map Series]). The proportion of meadow vegetation within the riparian corridor remained similar from 1992 to 2010, while black cottonwood forest communities increased in area by nearly 10 percent, and the area of willow-dominated communities decreased by 8 percent. Bars and channel margins with established willow communities in 1992 were mapped as bare in 1997 and 2010, likely reflecting scour by the January 1997 flood (Appendix A, 1992 to 1997 Riparian Vegetation Map Series Map 4). Prescribed burns in the Upper, Inter-, and Lower Meadows reaches in the early 1990's that burned through the riparian corridor may also resulted in the decrease in the proportion of willow communities, particularly with more severe burns. The oxbow and cutoff channels (about 10.4 ha in total within the study reach) were vegetated primarily with oak and conifer communities and black cottonwood, including mixed with willow in both 1997 and 2010 (78 percent). The proportion of each vegetation communities mapped within the oxbow and cutoff channels were similar in 1997 and 2010 (Figure 3-1)<sup>12</sup>.

The majority of the riparian corridor within the study reach is dominated by community types comprised of different combinations of late seral species, including conifers, oaks, and incense cedar (Figure 3-1). These communities generally occur in fairly long continuous corridors along the stream banks (Appendix A, 2010 Riparian Vegetation Map Series). The proportion of these community types decreased slightly between 1992 and 2010 (4.5 percent) (Appendix A, 1992 to 1997 and 1997 to 2010 Riparian Vegetation Map Series). The proportion and distribution of meadow and herbaceous communities have also remained relatively constant over time. The proportion of bare areas decreased by less than 1 percent between 1997 and 2010<sup>15</sup>. The proportion of alder dominated communities has remained similar between 1992 and 2010 (1 percent decrease). The proportion of bare areas increased between 1992 and 1997, likely caused by scouring of vegetation by the January 1997 flood (a 2.2 percent increase). Some of these areas have been naturally revegetated (0.7 percent).

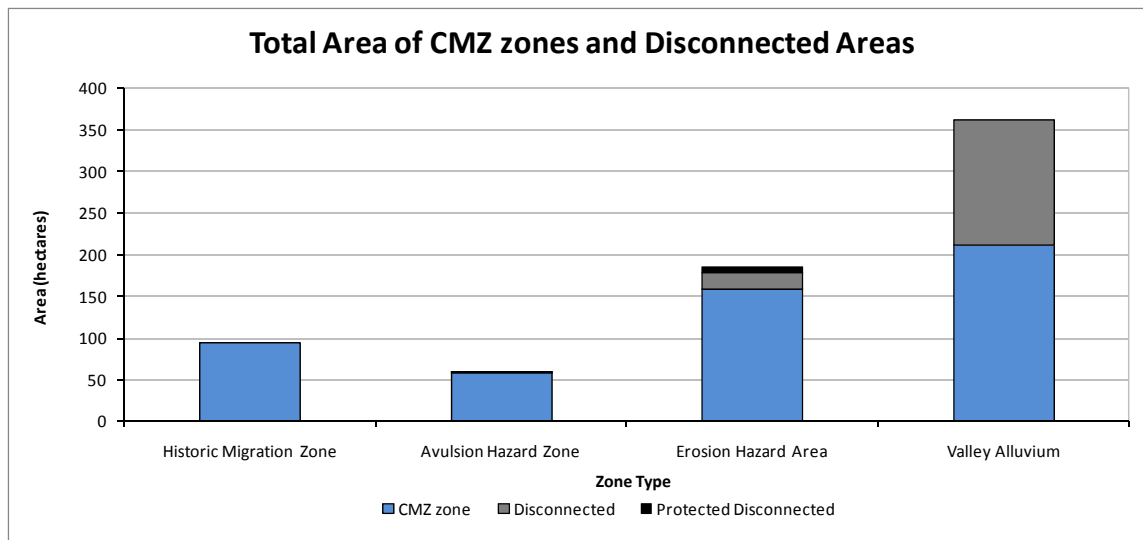
Figure 3-6. Summary of Area for Each CMZ Zone and Protected Disconnected Areas within the Project Area.

Valley Alluvium (VA) accounted for 52 percent of the Channel Migration Zone (CMZ)<sup>14</sup> with 41 percent of the VA disconnected (Figure 3-6). The Historic Migration Zone (HMZ), Avulsion Hazard Zone (AHZ), and Erosion Hazard Area (EHA) made up the remaining 48 percent of the CMZ. The EHA accounted for 26 percent of the CMZ and 55 percent of the area with a moderate to high probability of lateral channel erosion or channel avulsion. Approximately 14 percent of the EHA was disconnected. At 8 percent of the total CMZ area, the AHZ was the smallest of the CMZ zones delineated. Less than 1% of the AHZ was disconnected. The HMZ made up 28 percent of the total CMZ area delineated, with no part disconnected.

Disconnected AHZ and EHA areas accounted for 3 percent of the total CMZ area, with 1 percent identified as Protected Disconnected (PDEHA) (Figure 3-6). Disconnected areas accounted for 41 percent of the VA, 14 percent of the EHA (11 percent DEHA and 3 percent PDEHA), and 1 percent of the AHZ.

Disconnected AHZ and EHA areas accounted for only 3 percent of the total area delineated, with 1 percent of the total area identified as disconnected protected (PDEHA) (Figure 3-6).

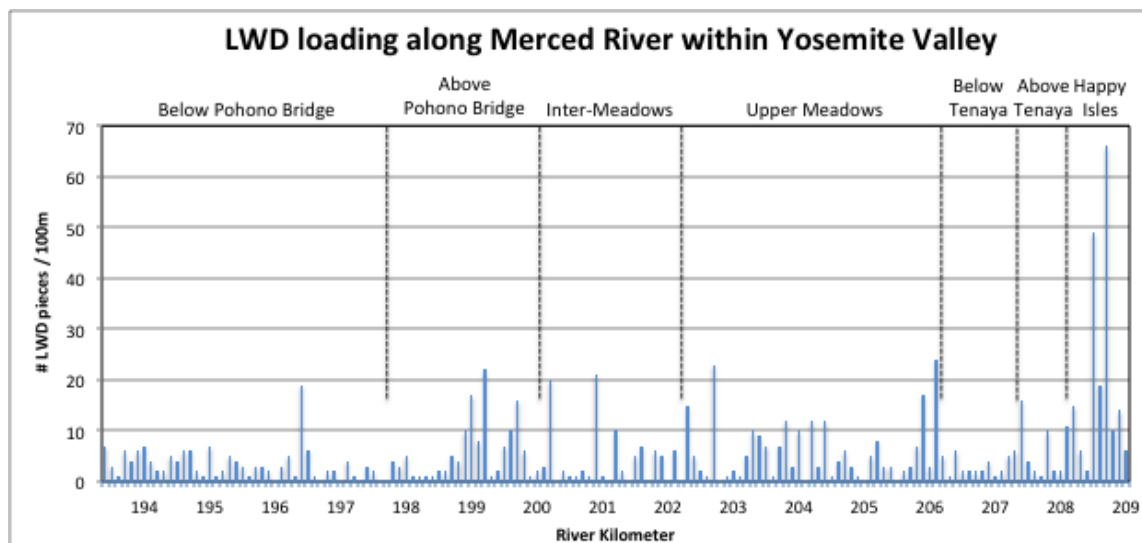
Figure 3-9. LWD Loading Along the Merced River through Yosemite Valley

The inventory counted 835 pieces or 2,273 m<sup>3</sup> of LWD along 16 km, with wood loading along the channel ranging from 0 pieces/100 m to 66 pieces/100 m (Figure 3-9). The greatest wood loading occurred in the Happy Isles and Above Tenaya reaches at the upstream end of the study reach.

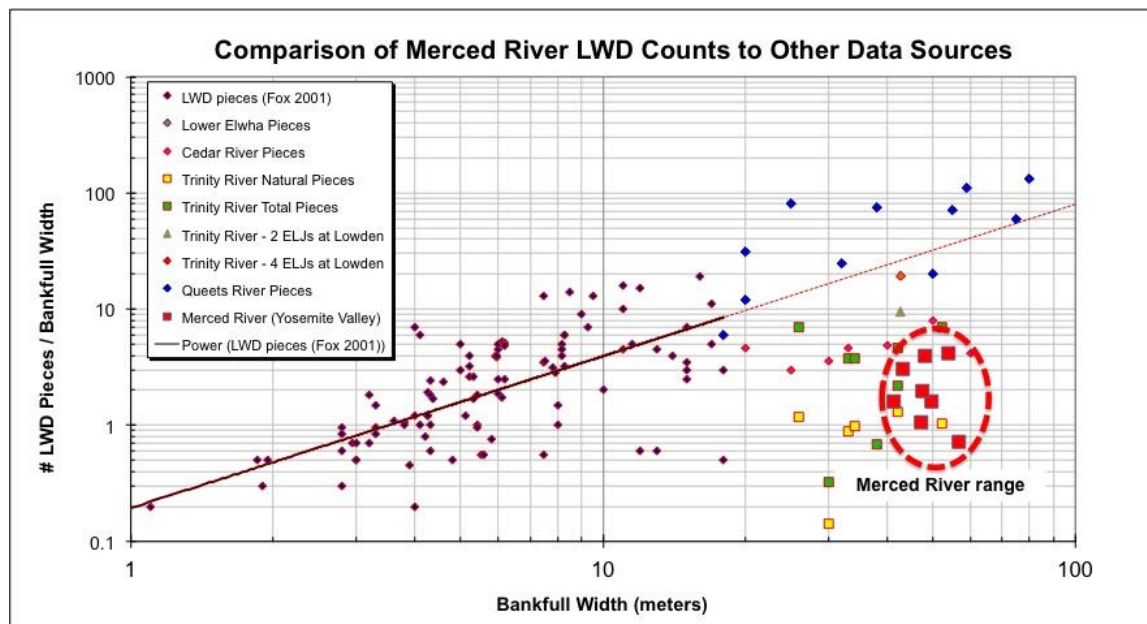
Figure 3-10. Regional LWD Loading

Wood loading in the Merced River was compared with data from other rivers in northern California and Washington State (Figure 3-10) (Fox 2001, Herrera 2005; USFWS 2010). LWD loading in the Merced River is comparable to the Trinity River in Northern California (with both natural and placed pieces as part of restoration actions). Key differences influencing LWD

loading between the Merced and Trinity Rivers include that the Trinity River is a regulated system with historic impacts from placer mining, both of which have dramatically decreased LWD recruitment and retention. The Merced River, however, has lower wood loading than other natural (unregulated) river systems with comparable bankfull widths in Washington State (e.g., Elwha River, Queets River); although these rivers have a wider range of channel widths, different stream bank vegetation composition and hydrology than the Merced River. However included in the Fox data are unregulated streams in the Eastern Cascades, with a more comparable hydrology to the Merced River than those in the Western Cascades. The range of wood loading for the Merced River would tend to be on the low range of the Fox (2001) trendline that was developed to describe the relationship between bankfull width and the expected number of LWD pieces within the channel due to the difference in hydrologic regime (Figure 3-10). The range of LWD loading for the Merced River is outlined in red in Figure 3-10 showing roughly an order of magnitude lower wood loading when compared to the Fox (2001) trendline. While it is to be expected that LWD loading on the Merced would be lower than that described by Fox (2001), the degree to which LWD loading likely reflects LWD removal in the Merced River as part of historic and active management practice.

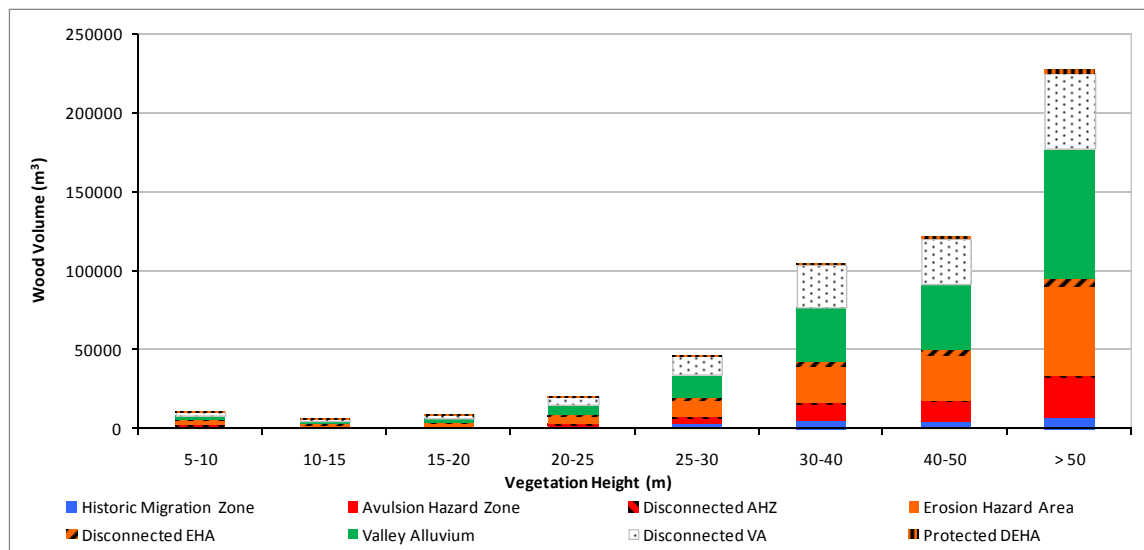
Figure 3-12. Potential LWD Recruitment Volumes for Each CMZ Area by Tree Height Class

The quantity of potential LWD recruitment (wood loading) within each of the CMZ zones by vegetation height class for the entire study reach is summarized in Figure 3-12. Larger trees, by volume, will contribute more to LWD loading within the river system than the smaller trees.

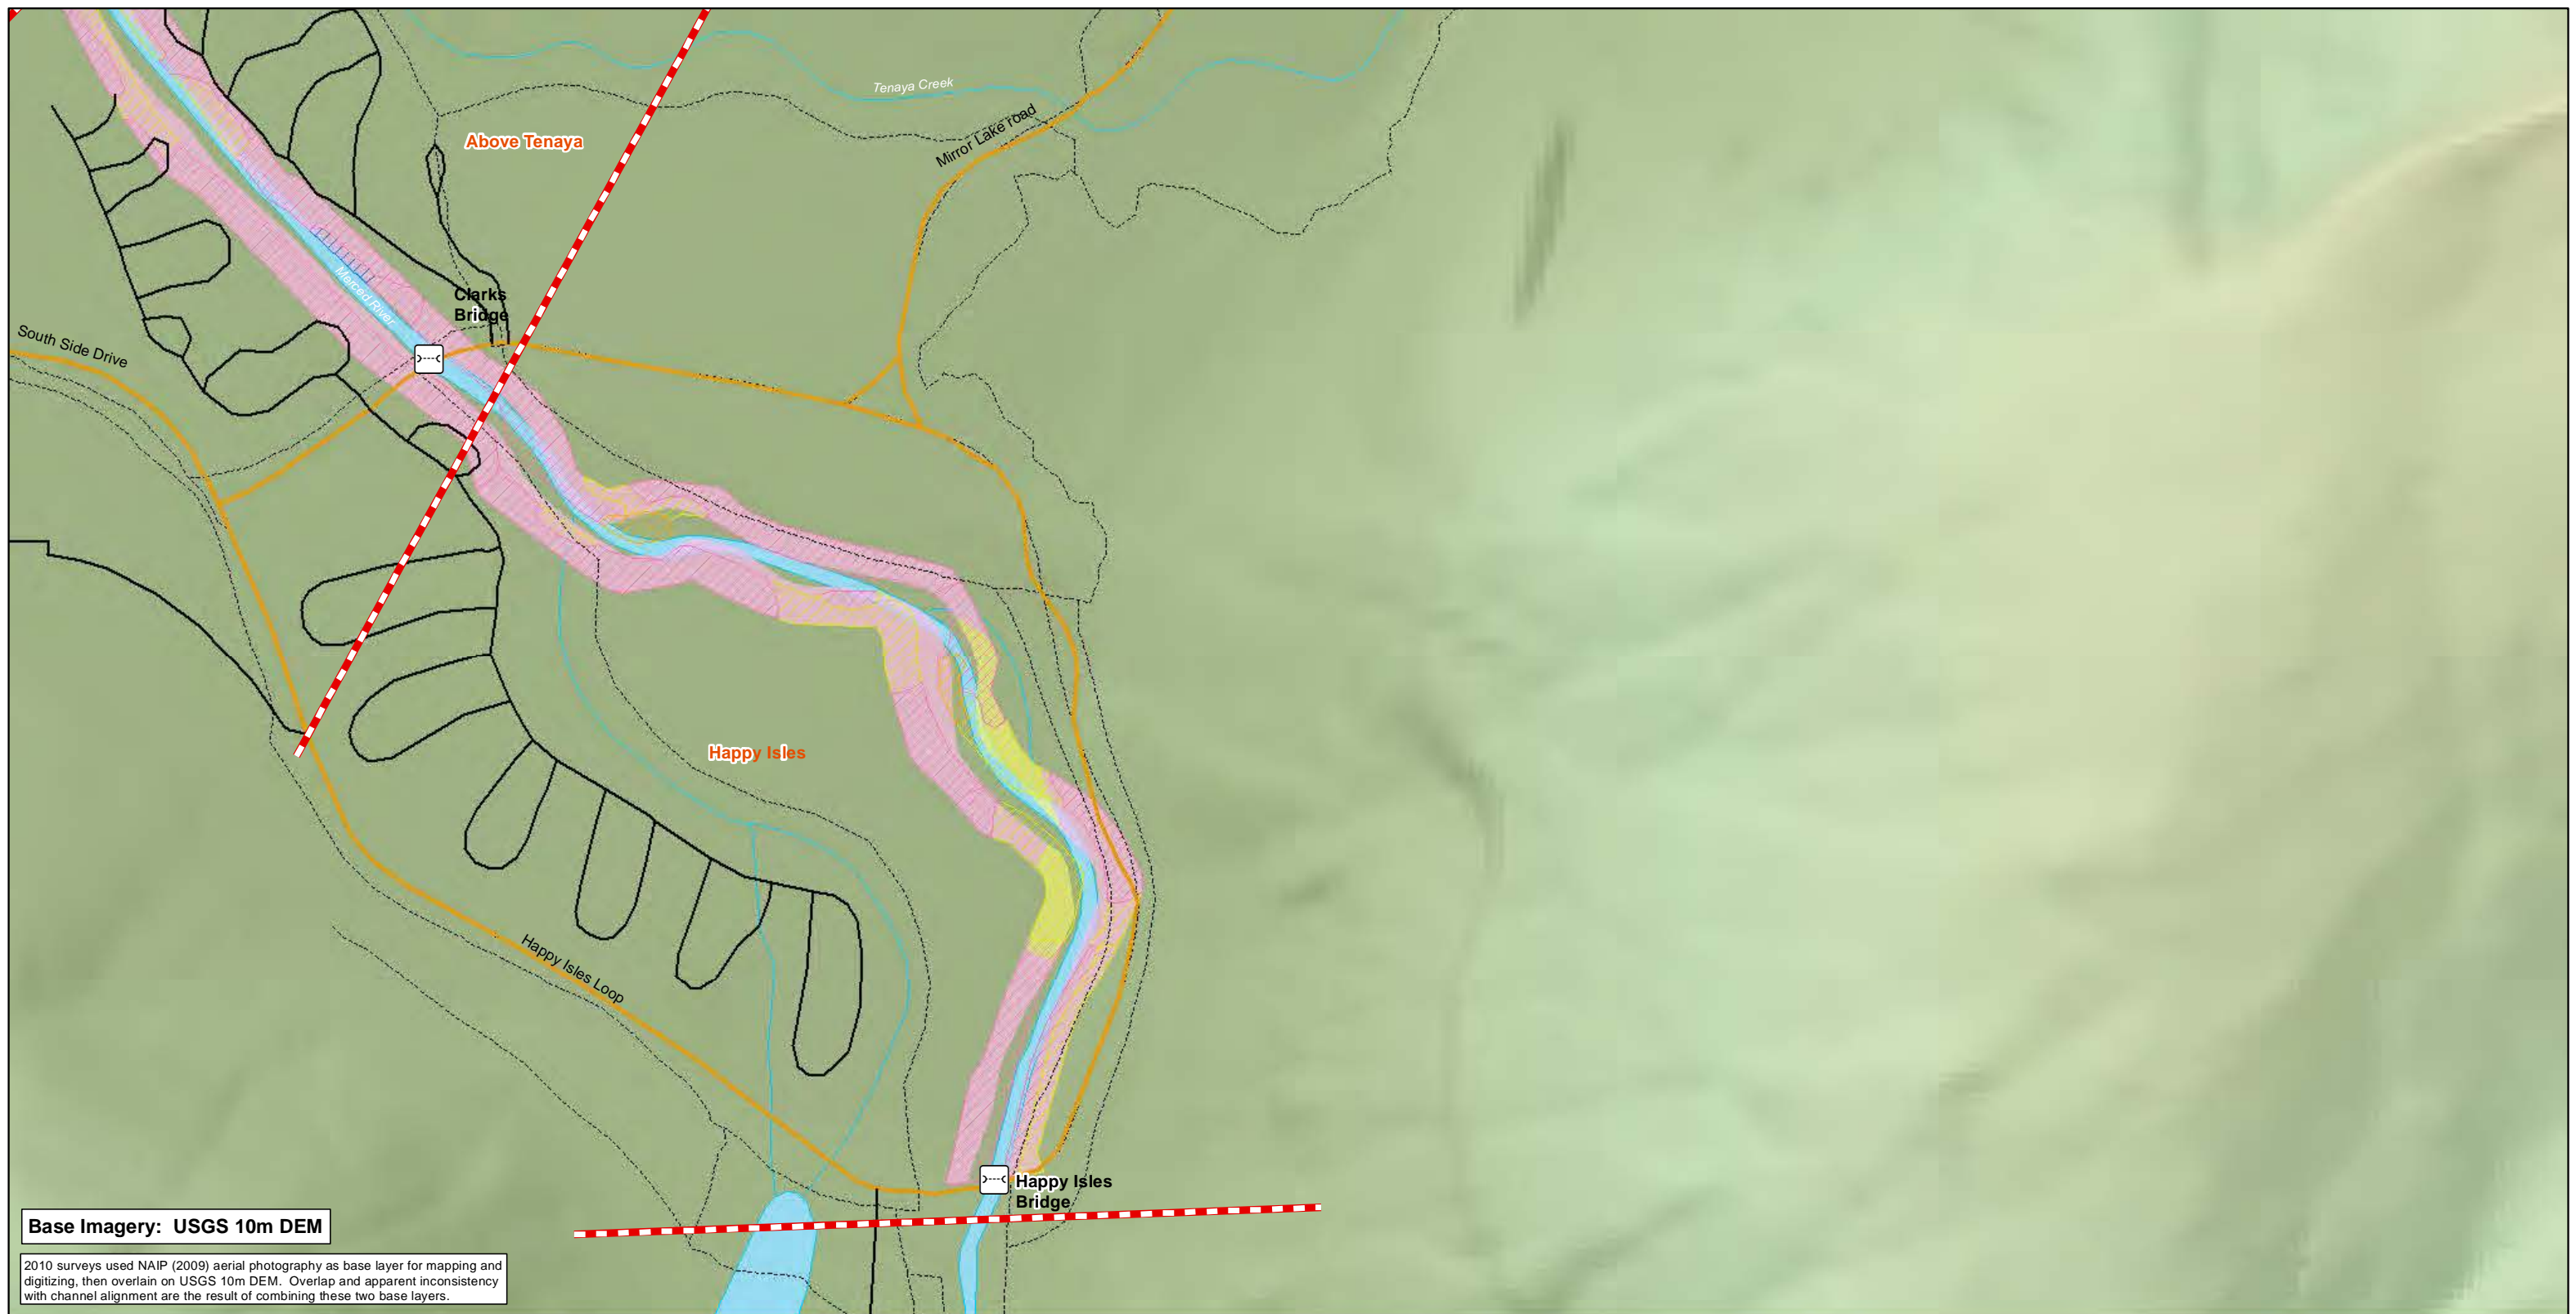
Base Imagery: USGS 10m DEM

2010 surveys used NAIP (2009) aerial photography as base layer for mapping and digitizing, then overlain on USGS 10m DEM. Overlap and apparent inconsistency with channel alignment are the result of combining these two base layers.

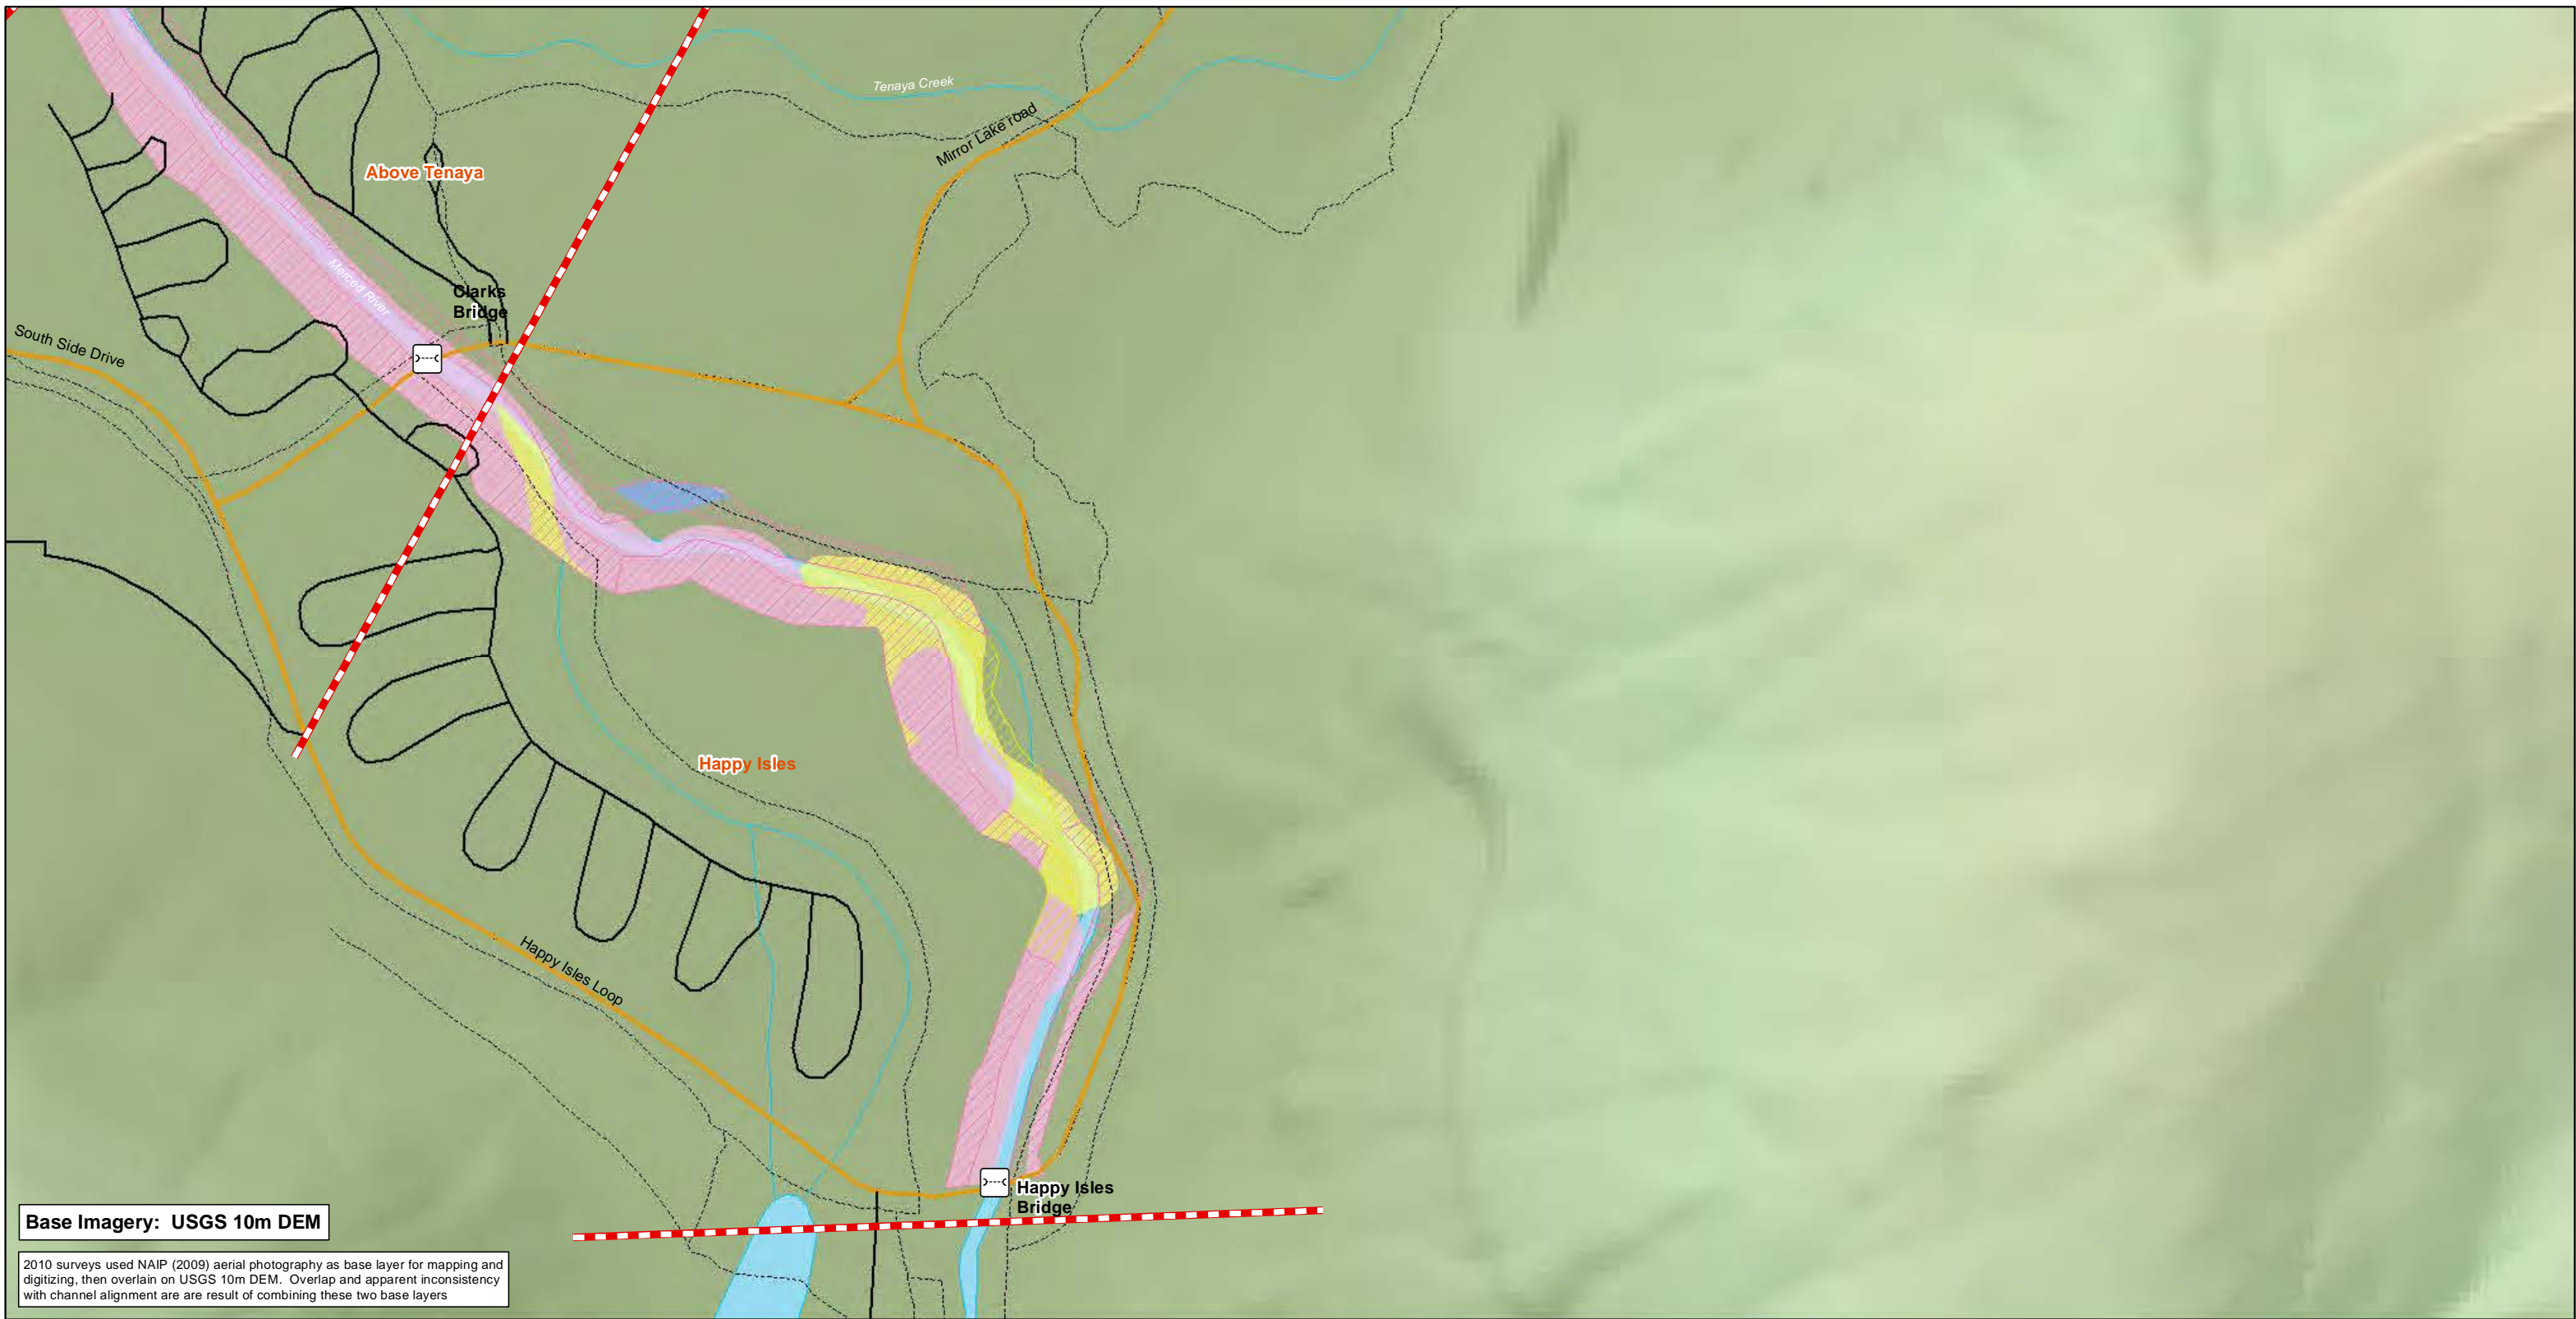
Base Imagery: USGS 10m DEM

2010 surveys used NAIP (2009) aerial photography as base layer for mapping and digitizing, then overlain on USGS 10m DEM. Overlap and apparent inconsistency with channel alignment are result of combining these two base layers

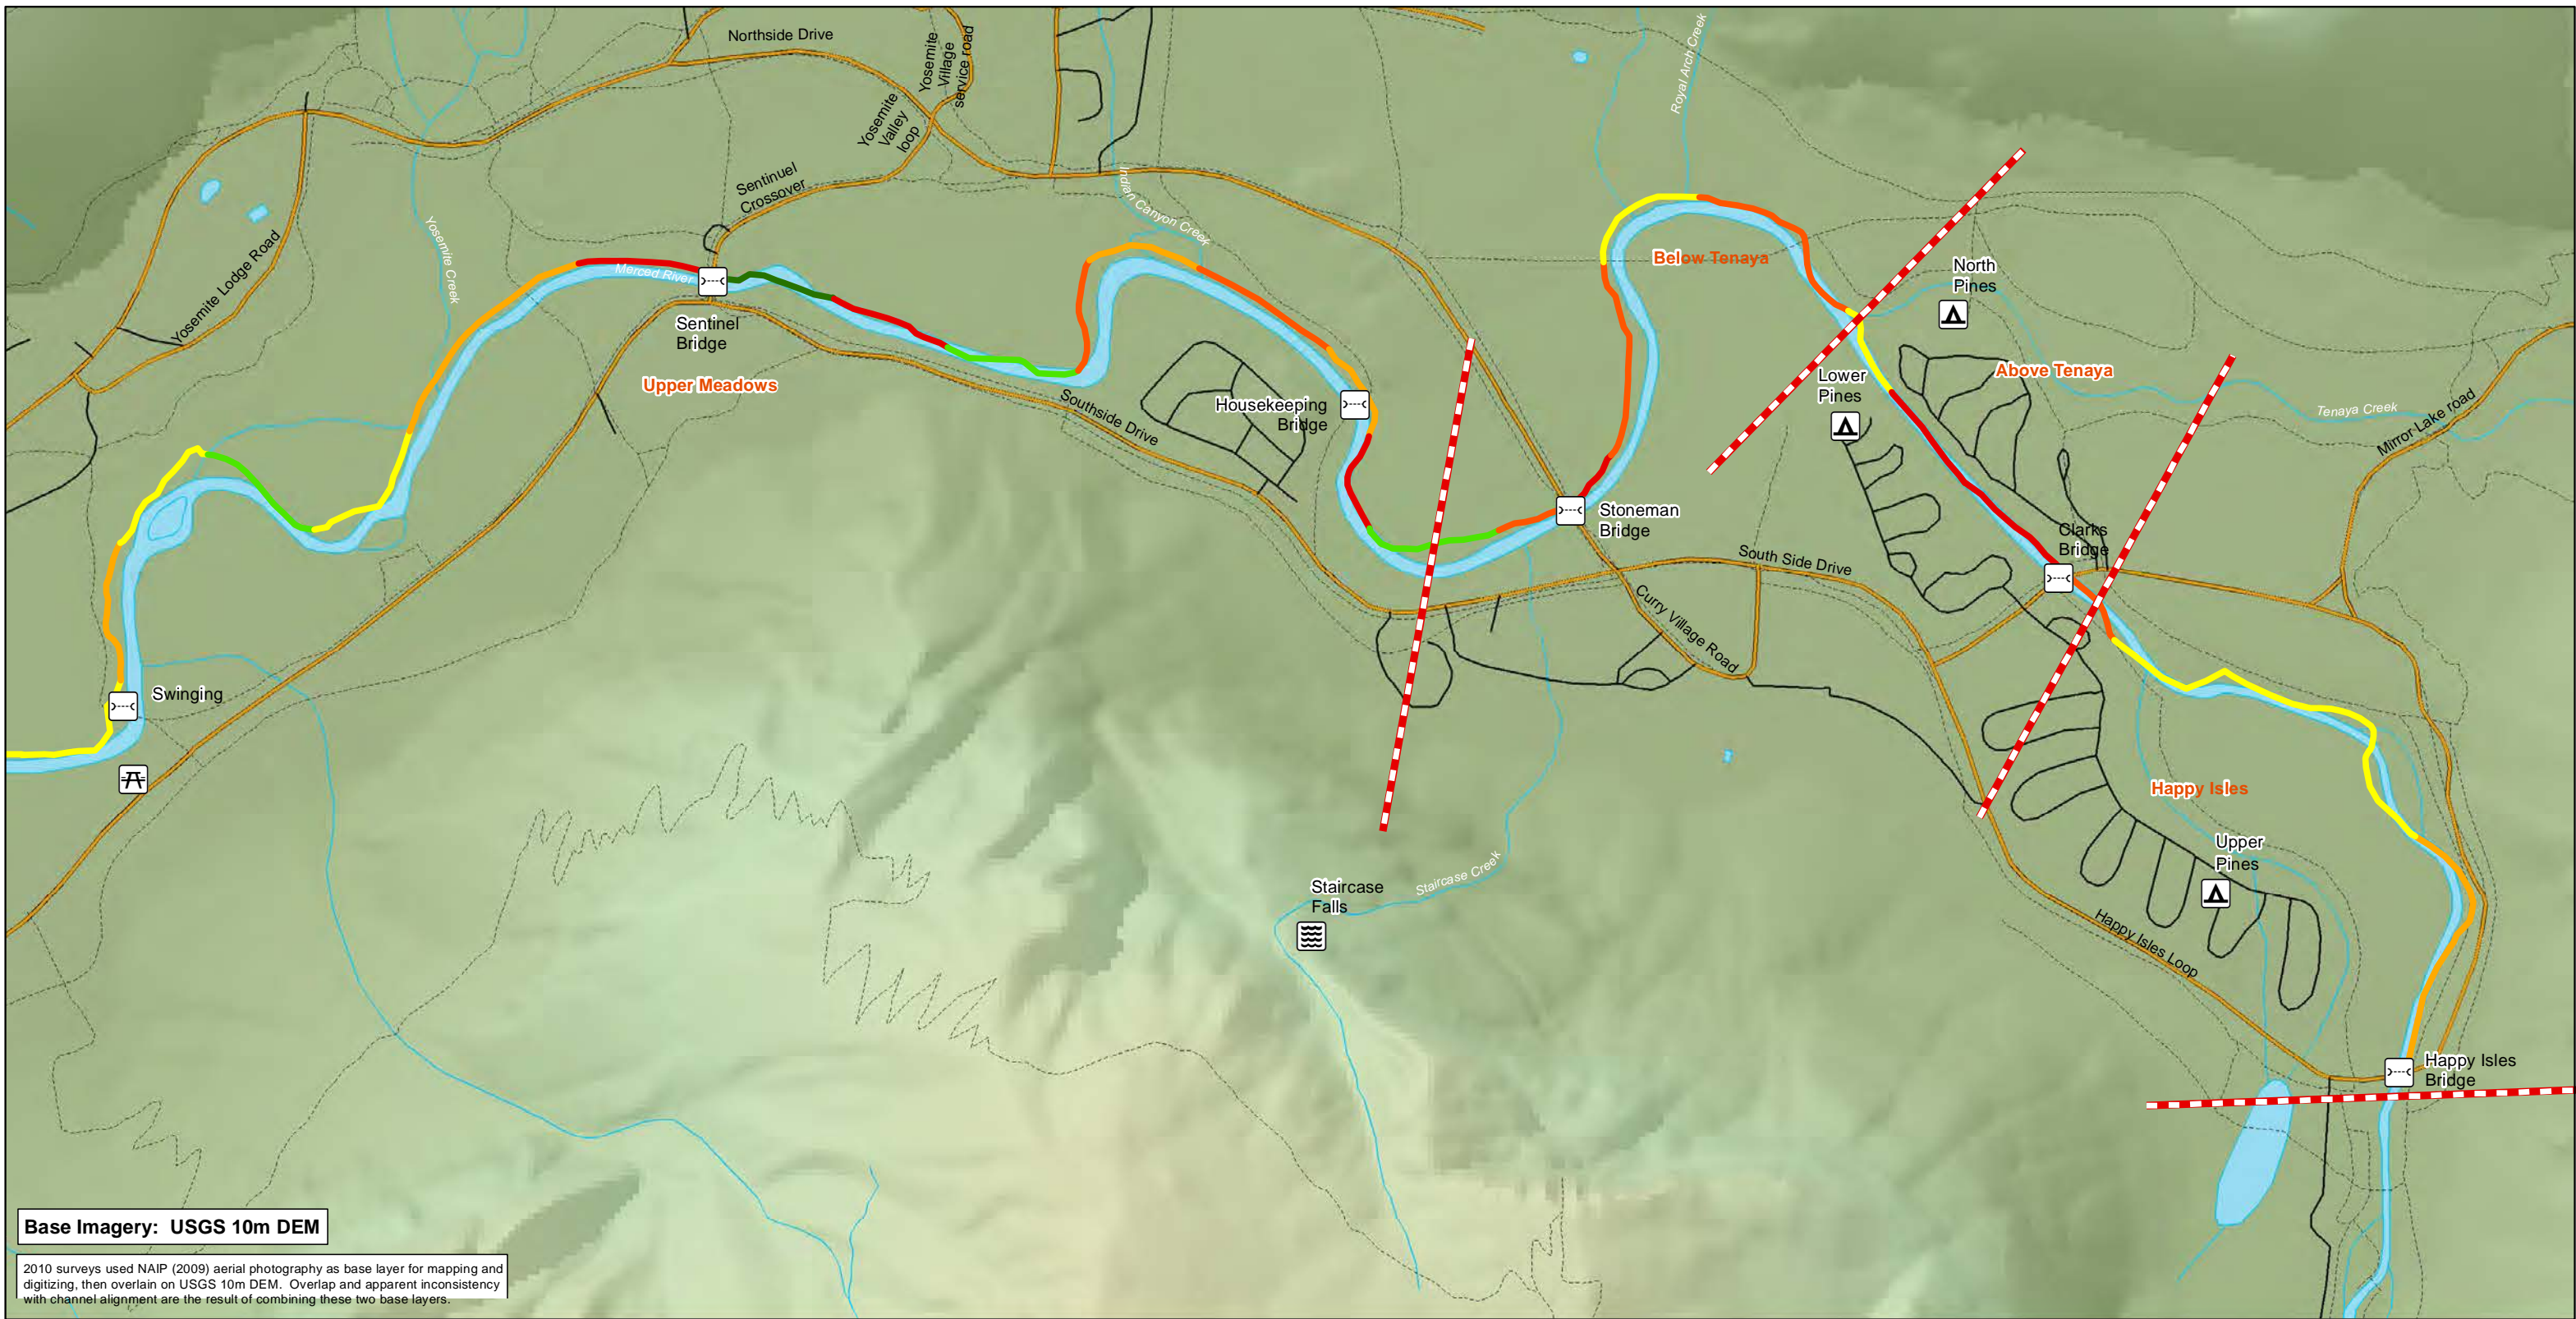
Note: The Physical Structure Attribute includes assessments of the number of different types of physical features or surfaces that may provide habitat, and the overall variability in micro- and macro-topographic relief that may affect moisture gradients and/or flow paths within each assessment area.

**Physical Structure Condition Map Series  
Physical Structure Condition along the  
Merced River within the Study Area (2010)**

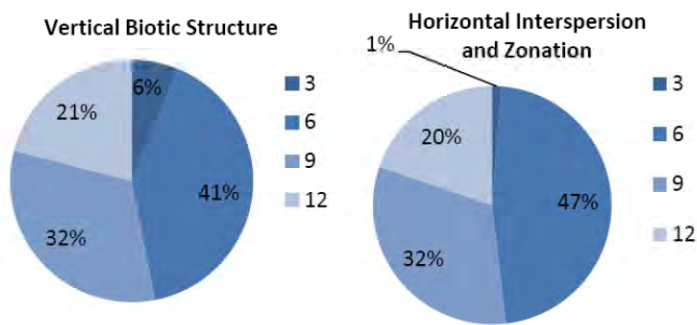
Figure C.3-1 Proportion of California Rapid Assessment Method Metric Scores along the Merced River within the Study Area, continued.

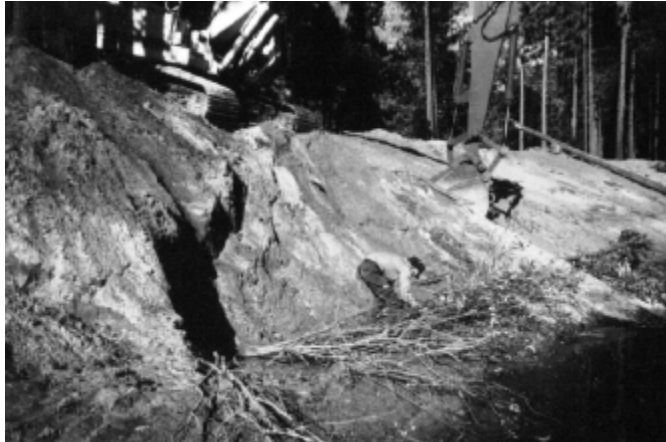
Figure 1: Crew member planting willow and cottonwood cuttings with the aid of the excavator

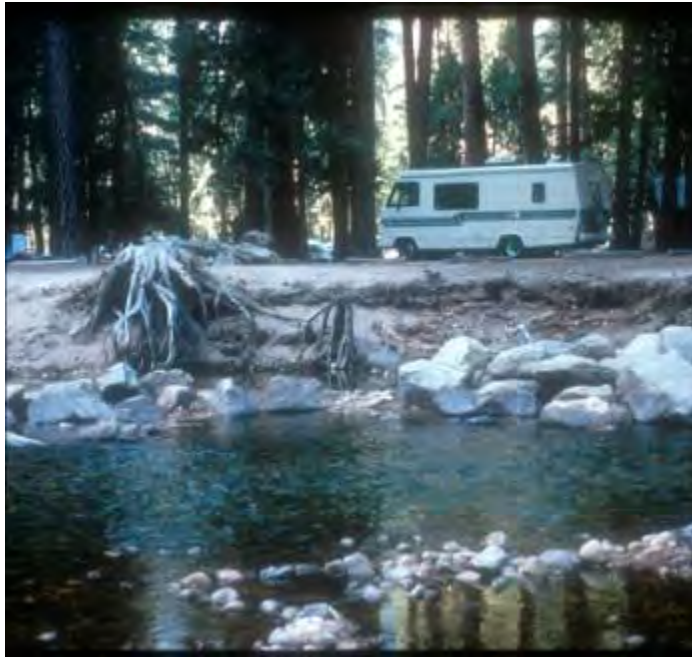
Figure 1: Riverbank at Lower River Campground before restoration, 1991. Note the displaced riprap in the river channel.

Stoneman Bridge, constructed in 1933, has caused significant changes in channel morphology at this location in the last 60 years. The abutments of the bridge extend into the river channel constricting water flow during high-runoff periods in the winter and spring. Water velocities under the bridge reach unnaturally high levels because of this constriction. Large reverse eddies have formed downstream on both the right and left banks and a deep scour pool has formed immediately downstream of the bridge. The river's excavation of the pool has contributed to the formation of a mid-channel gravel bar roughly 500 feet downstream of the bridge. The presence of this gravel bar forced the thalweg (the deepest channel with highest flow velocities) against the right bank, which caused unnatural bank erosion along the edge of Lower River Campground.

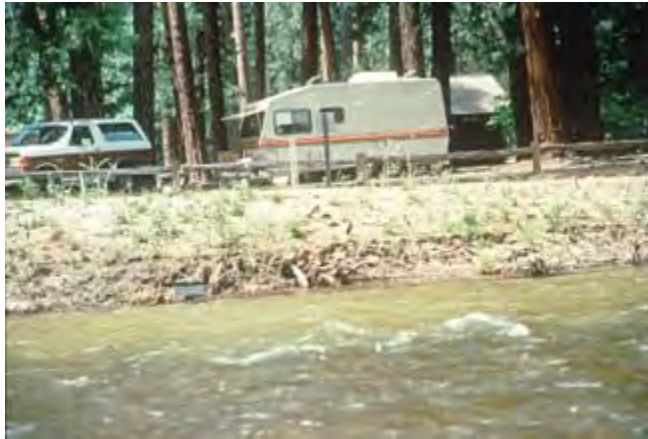
Figure 3: Lower River Campground 1 year after restoration.

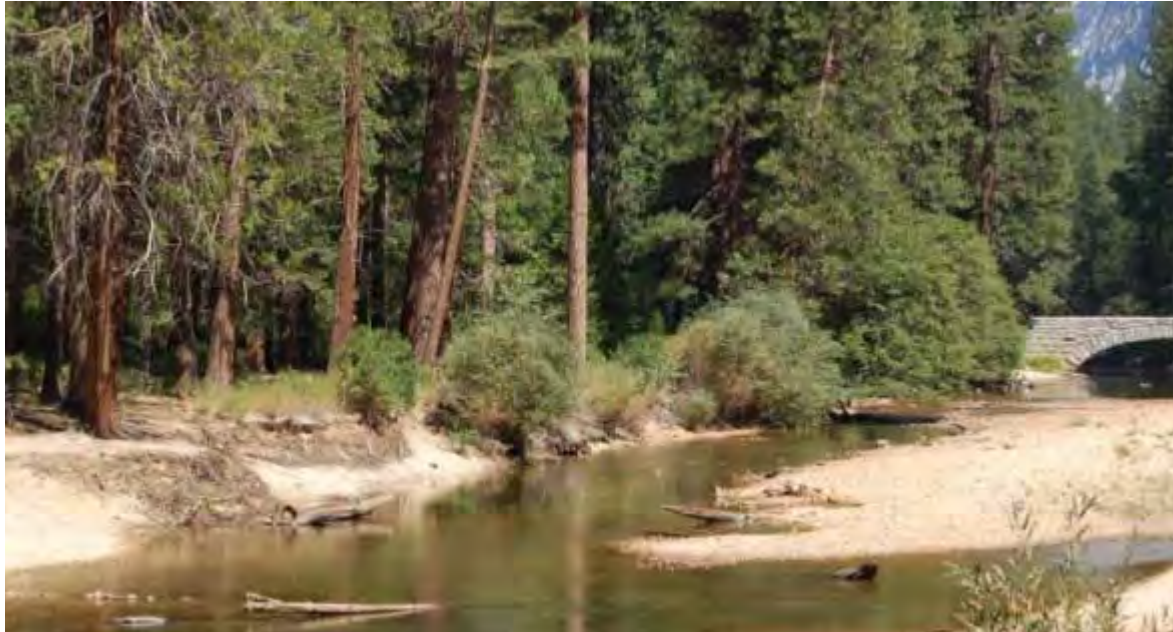
Figure 4: Former Lower River Campground restoration area, 2008.

Two permanent river cross-sections that had already established in 1989 during an initial evaluation of bank erosion were within the boundaries of the project site. Resource management staff surveyed these cross-sections one year after completion of the heavy equipment work. Staff also established 12 photo points prior to project implementation in 1991. The photo points were retaken in 1992, 1993, and 1994, though additional photos of the site have been taken in conjunction with other projects. Below is a photo that was taken in 2008 from river left which includes the 1991 project area (Figure 4).

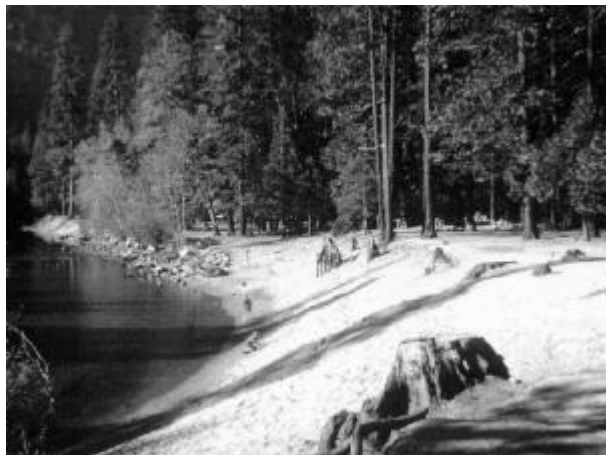
Figure 2: El Capitan Picnic Area before restoration.

The El Capitan Picnic Area was located on a spur road off of Northside Drive, one-half mile east of El Capitan Meadow. The project is located on the outside edge of a meander bend, a river zone highly susceptible to natural erosion processes (Figure 1). The picnic area was a popular site for day-use visitors as well as a raft take-out area used by the concessionaire, both of which lead to trampling of the riverbank vegetation and accelerated erosion rates (Figure 2).

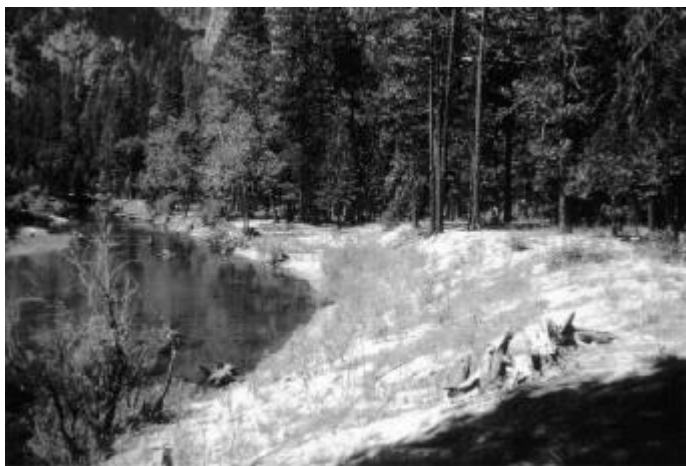
Figure 4: El Capitan Picnic Area after restoration.

In the spring of 1993, minor gullies had developed on the riverbank at the old raft take-out. The crew recontoured the soil and re-planted these gullies with horizontal cuttings. Additional mulch was added to the riverbank and the terrace above this area. Figure 4 shows the re-establishment of vegetation on the riverbank after restoration.

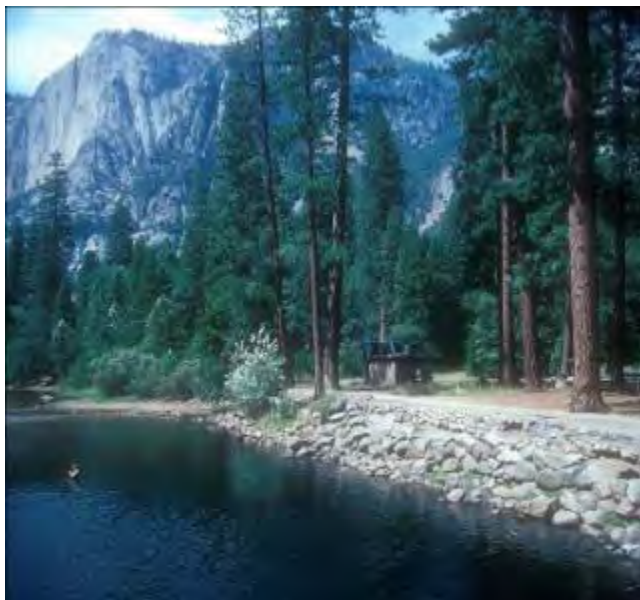
Figure 1: Riprap and paved path on bank below Housekeeping Bridge prior to restoration.

This stretch of the river was not only subjected to heavy day use by visitors, but its channel morphology has also been affected by Housekeeping Bridge. In the mid 1900's, the National Park Service stabilized this section of the bank with riprap boulders ranging in size from 30 pounds to several tons (Figure 1). The boulders helped to prevent further river side-cutting downstream of the bridge, but also created an area that was barren and devoid of riparian vegetation. The boulders on the right bank subsequently deflected the flow of the river and caused cutting on the left bank. The park eventually constructed riprap on the left bank as well, hardening the entire reach below the bridge.

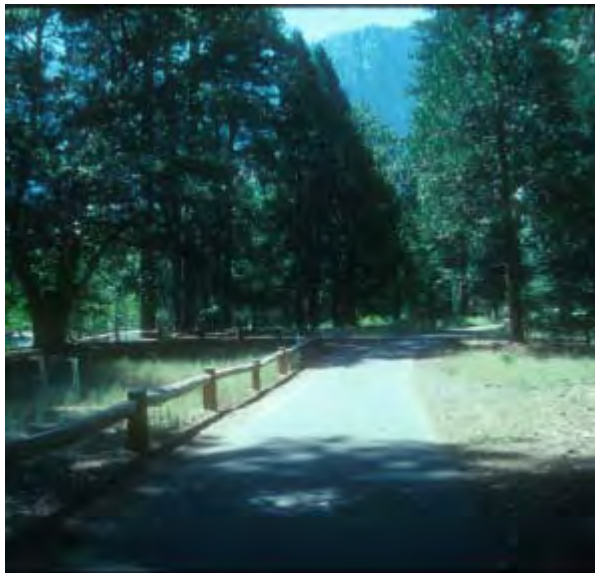
Figure 2: New bike path and fencing.

In 1992, restoration staff used two small tractors to rip up 135 cubic yards of asphalt from the paved path to Yosemite Village. At the edge of the bike path where the terrace sloped towards the river, they loaded the buckets of the tractors by hand to prevent the asphalt from falling into the river. The trail was re-established further back onto the terrace, away from the top of the steep riverbank. Restoration workers and volunteer groups prepared the new trail by laying the base course for the asphalt. They excavated a 9-foot wide swath through the trees to an average depth of 4 inches. They placed the soil removed during the installation of the new trail along the site of the old path to improve the soil and supplement the natural seed bank. Approximately 6000 square feet of the terrace area was uncovered during the asphalt removal. Maintenance staff later paved the new trail (Figure 2).

Restoration workers constructed 1,100 feet of Hetch Hetchy-style cedar split-rail fence to protect the project area (Figure 2). The fence provides river access at a gravel beach 1,000 feet downstream of the bridge and directly across the river from Housekeeping Camp.

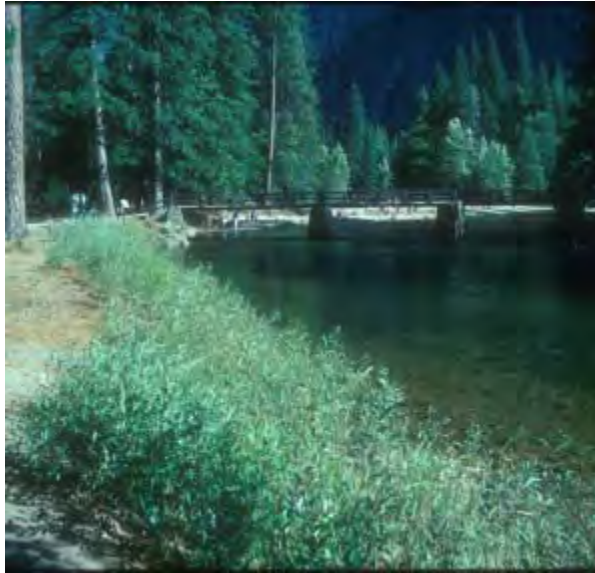
Figure 3: Willow cuttings below Housekeeping Bridge 1 year after restoration.

Workers planted willow and cottonwood cuttings along 700 feet of bank using a hydrodrill. Along the 80-foot section of bank directly below the bridge, they brush layered with willow and cottonwood cuttings to provide additional stability to the bank (Figure 3). Workers planted a total of around 3000 willow and 300 cottonwood cuttings throughout the length of the project.

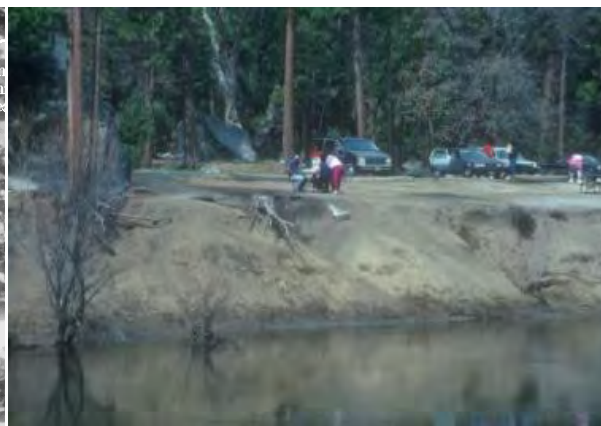
Figure 2: Riverbank at Devil's Elbow picnic area before restoration.

Devil's Elbow is a section of the Merced River located just 0.2 miles upstream of El Capitan Crossover Bridge (Figure 1). The site has a long history as a popular picnic area and river access point for visitors. Up until 1984, it served as the main raft take-out location for the concessionaire, resulting in extreme erosion of the bank (Figure 2).

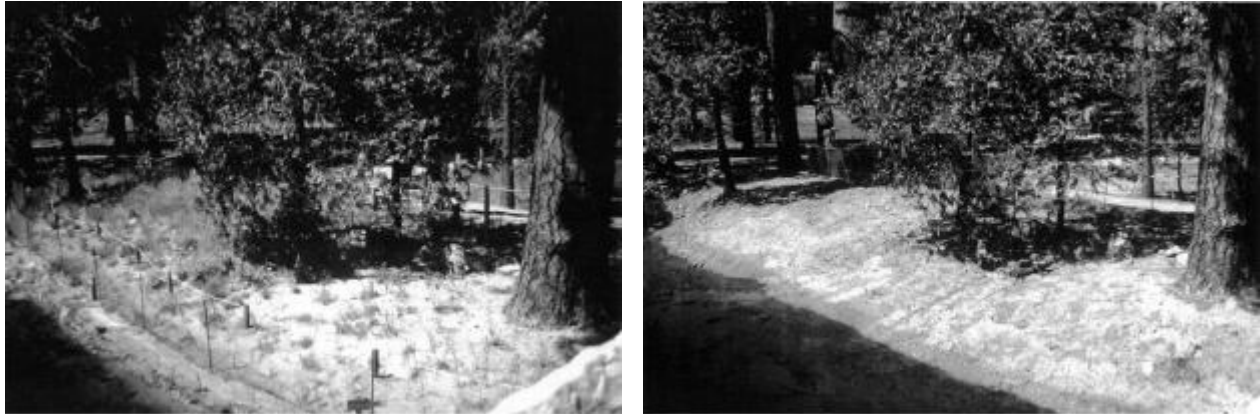
Figure 2: Sentinel Bridge area before and after restoration in 1994 and 1995, respectively.

In the summer of 1994, restoration staff watered the area and eradicated exotic plant species. In the fall, they planted willow and cottonwood cuttings on the north bank using the hydrodrill. They collected, dried, cleaned, scarified, and planted buck lotus seed (*Lotus crassifolius*) in the project site. They also collected and planted deer grass seed (*Muhlenbergia rigens*). In the summer of 1995, they planted more willow cuttings with the hydrodrill on the right bank, downstream of the bridge. Figure 2 shows the site before and after restoration.
