# Merced River and Riparian Vegetation Assessment

June 2012

Prepared For  
Yosemite National Park, National Park Service

**Cardno ENTRIX**  
2300 Clayton Road, Suite 200, Concord, CA 94520  
Tel 925 935 9920 Fax 925 935 5368 Toll-free 800 368 7511  
[www.cardnoentrix.com](http://www.cardnoentrix.com)

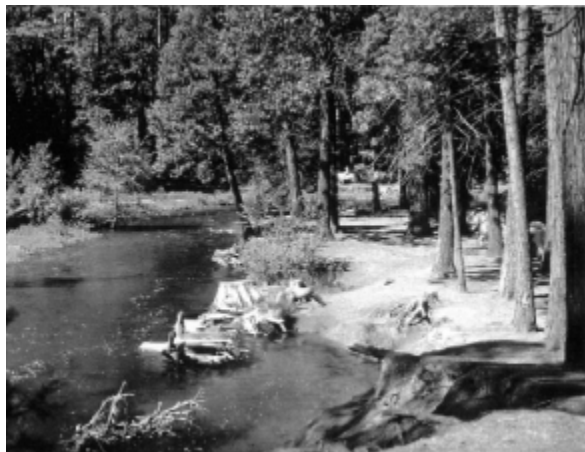
Figure 1: Denuded Bank of Tenaya Creek at North Pines Group Camp prior to restoration.

North Pines Group Camp is located at the east end of Yosemite Valley adjacent to Tenaya Creek. The campground experiences intensive visitor use during the summer months and as a result, a section of riverbank between the creek and the campground became denuded of vegetation and heavily eroded (Figure 1).

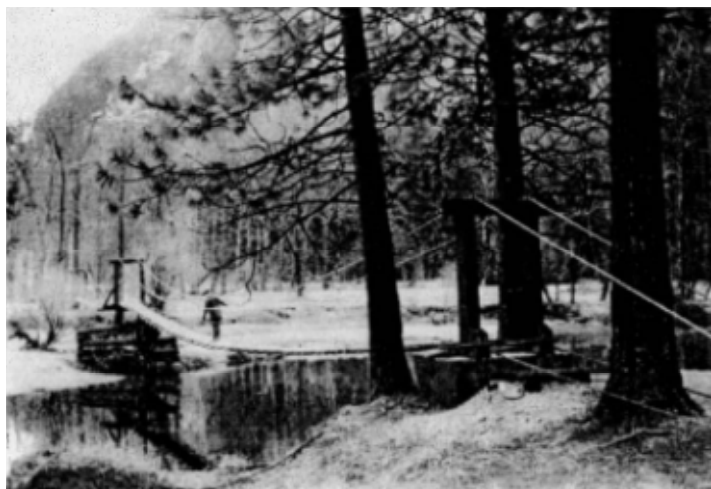
Figure 3: Original Swinging Bridge.

The original Swinging Bridge was built before 1911 as a suspension-style footbridge (Figure 1). After the 1937 flood, the bridge was rebuilt in a different style 300 feet downstream of the former location. The original concrete foundations are still on-site. The current Swinging Bridge has abutments mid-channel which have caused a large scour pool to form downstream, an increase in deposition on the right bank, and erosion of the left bank. The park constructed riprap on the left bank to prevent it from eroding further.

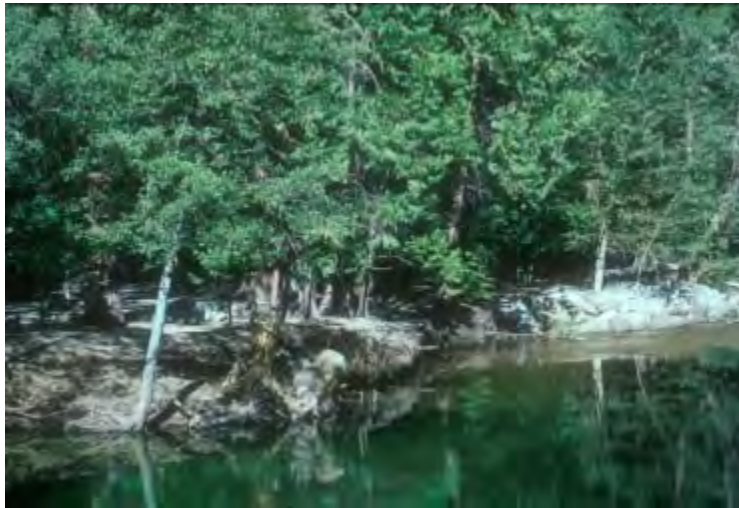
Figure 1: Left bank at Housekeeping Camp. Exposed roots in the foreground; riprap boulders in the background.

Housekeeping Camp is located about one-half mile upstream from Sentinel Bridge and is adjacent to the river for a distance of 1800 feet (0.35 miles). The camp is a popular seasonal lodging area managed by the park concessionaire and is open during the summer months. The Housekeeping Footbridge which spans the Merced River just upstream of the camp has three mid-channel supports with riprap armoring on the downriver side of the supports. Three deep pools have developed immediately downriver of the bridge and a reverse eddy around the left bridge abutment has caused erosion of the riverbank in this area.

More than 40 years ago, large boulders were placed on the bank at Housekeeping Camp, but served little purpose because water flowed behind and over the top of them during flood events, causing erosion of the terrace. Approximately two vertical feet of fine fluvial soil had been lost from the terrace surface behind the boulders. Most of the riverbank and terrace along the edge of the camp was devoid of understory vegetation due to trampling (Figure 1).

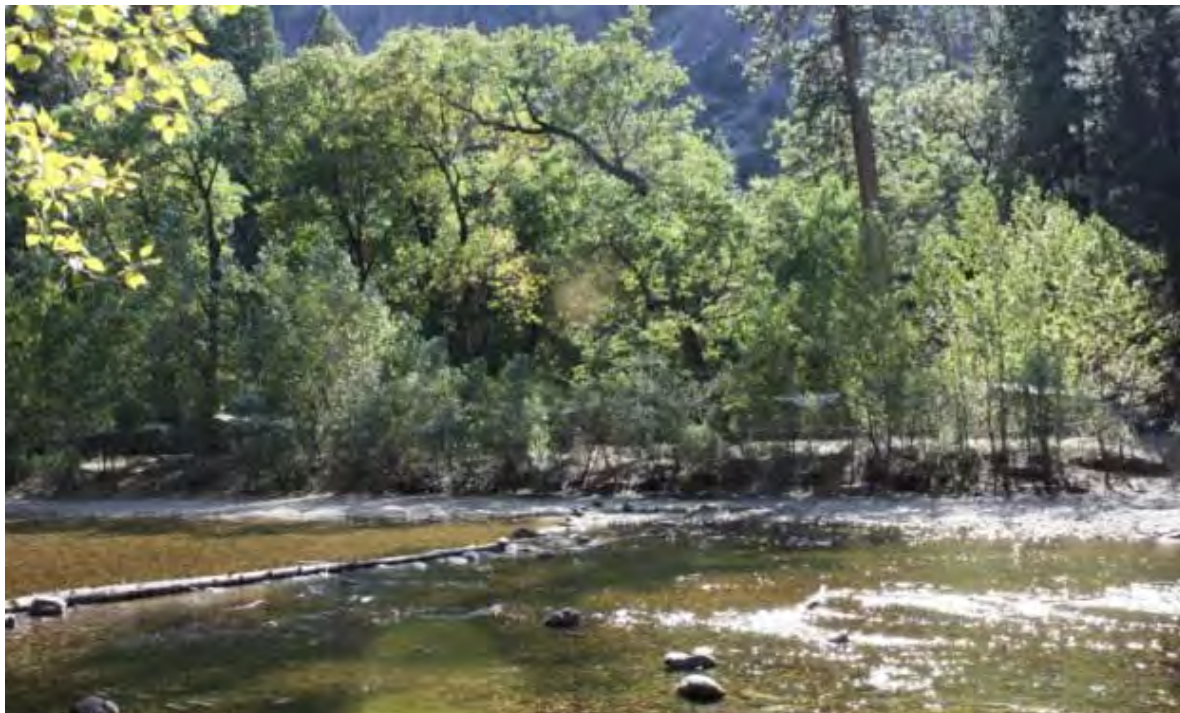
Figure 2: Riverbank at Housekeeping Camp, 2009.

In October of 1995, restoration staff removed 565 cubic yards of riprap revetment boulders from the bank at Housekeeping Camp. They replaced the boulders with large woody debris to provide bank support and increase biomass along the channel. They used the excavator to create 3-foot deep trenches for anchoring the logs. The logs averaged 25 feet in length and 2-4 feet in

diameter. Staff placed them at a 10-20 degree angle to the flow of the river in order to deter the formation of back eddies downstream. They crushed smaller or rotten logs and spread the mulch along the terrace.

Restoration crews brush layered willow and cottonwood cuttings randomly along 550 feet of bank. They also planted cuttings near the buried logs and supplemented the brush layers with hydrodrilled cuttings. Three different species of willows comprised 70 percent of the brushlayers and black cottonwood comprised 30 percent. Staff used only one species of willow or cottonwood within each brushlayer. Figure 2 shows a section of the project area in 2009, 14 years after restoration.

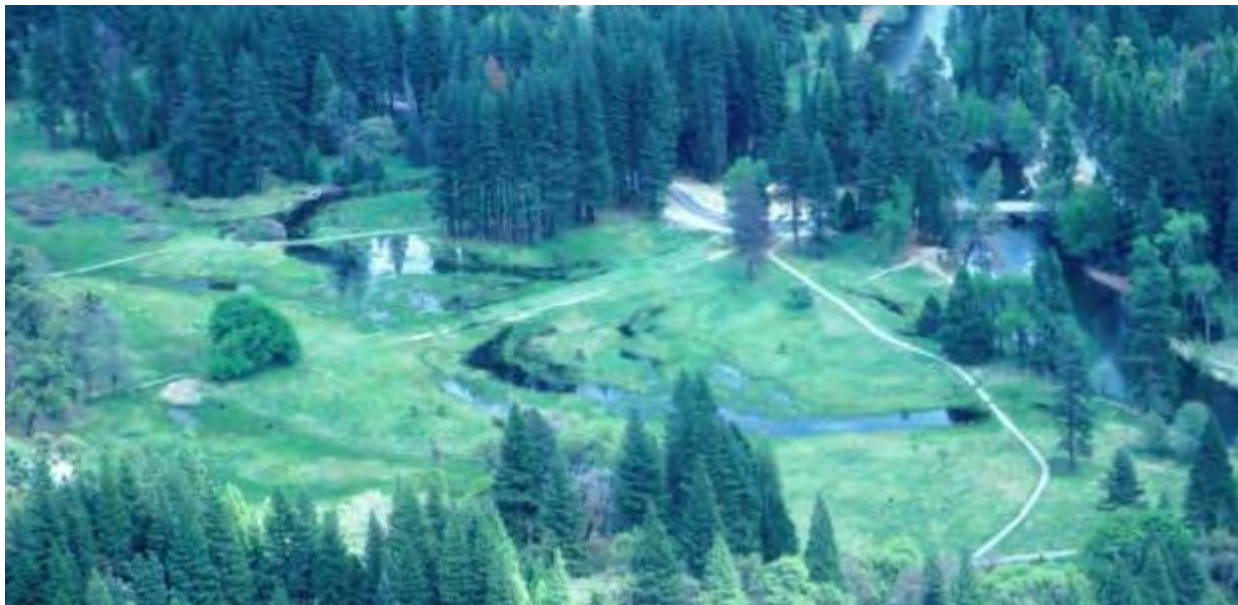
Figure 1: Cook's Meadow with paved trails (left and right) and historic roadbed (center), 1993.

The hydrology of Cook's Meadow was significantly altered in the 1800s when settlers drained certain parts of the meadow with ditches and culverts in order to maintain drier land for pastures and agricultural purposes. A road was also built through the center of the meadow, compacting the soil and impeding the flow of surface water across the land. The subsequently drier soils also promoted the proliferation nonnative upland grass species as well as conifer encroachment into the meadow. In later years, paved interpretive trails were established throughout the meadow as well (Figure 1).

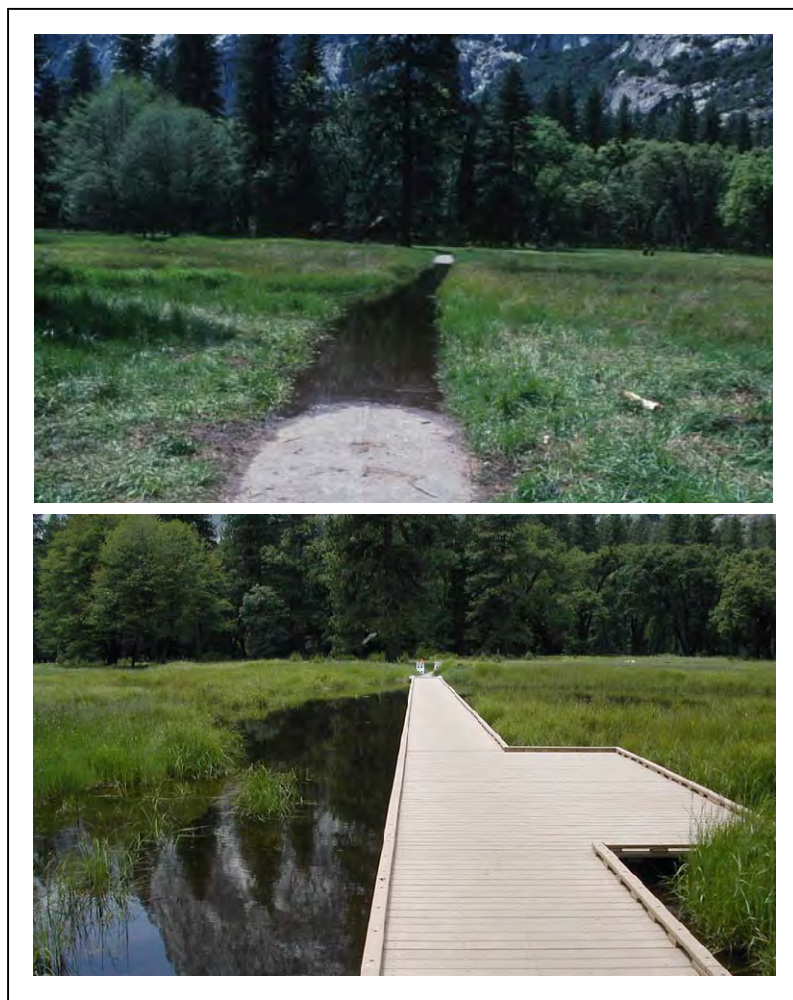
Figure 2: Interpretive trail before (2000) and after (2006) boardwalk installation.

In the fall of 2000, staff excavated the paved interpretative trail that crossed the meadow from Sentinel Bridge to Northside Drive parallel to the natural contour of the meadow. They updated the trail by installing a 500-foot boardwalk constructed of a plastic/wood composite. In 2005, they replaced a portion of the paved trail parallel to the Merced River between Sentinel Bridge and the Superintendent's Bridge with a 200-foot long boardwalk (Figure 3). Staff re-established meadow's natural contour and salvaged vegetation was replanted adjacent to each side of the trail. They installed eight interpretive wayside exhibits along the trails to enhance the visitor experience and provide an opportunity to educate the public on the meadow's history.

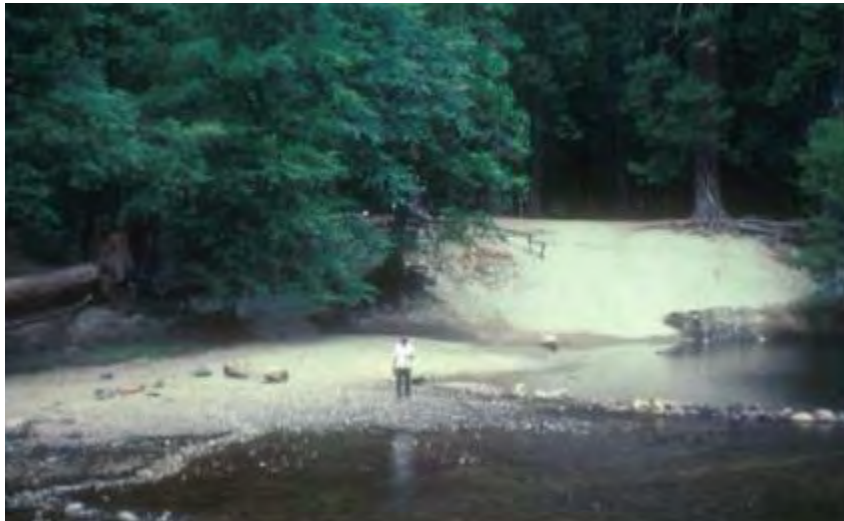
Figure 1: Confluence of Eagle Creek and the Merced River before restoration, 2002.

The short reach of Eagle Creek from Northside Drive down to its confluence with the river was relatively bare of riparian vegetation and exhibited extensive erosion. The area was exposed to frequent day-use traffic, causing ground disturbance and greatly reducing the total coverage of shrubs and herbaceous plants in the understory (Figure 1). The creek bed itself was used as a river access trail during drier portions of the year. The site also contained remnants of infrastructure from the Rocky Point Sewage Treatment Plant which was shut down in 1931. A concrete structure containing an abandoned sewage line spanned the channel of Eagle Creek near its junction with the Merced River, which disrupted the normal flow of the creek.

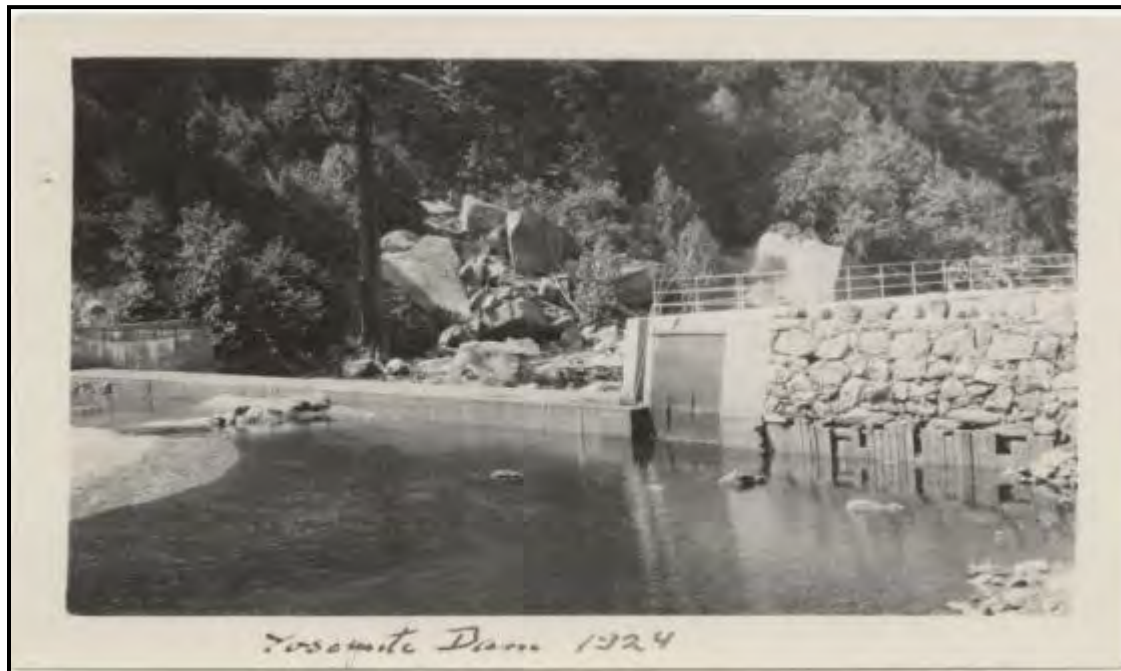
Figure 2: Cascades Dam circa 1924.

The Cascades Diversion Dam, constructed in 1917 to provide hydroelectric power to Yosemite Valley, was located on the Merced River approximately 1.5 miles downstream of Pohono Bridge. In 2001, the dam was identified for removal by the U.S. Bureau of Reclamation due to advanced age and flood damage, and the considerable threat to downstream resources, infrastructure, and human life in the event of sudden failure. The dam was a timber crib construction, 184 feet long and 17 feet high, flanked by 30-foot concrete abutments (Figure 1). The upstream impoundment pool was approximately 1.25 acres in size and stored an estimated 9,600 to 15,000 cubic yards of sediment at the time of removal.

Deconstruction of the dam began in October of 2004 and was completed in November of 2005. Park trail crew staff blasted and removed 37 cubic yards of cement material from the area of the dam (Figure 2). Blasting was accomplished by drilling holes through the structure to determine the thickness of the dam and back filling with explosives sufficient to fracture the dam. One of the intake structures was also blasted and removed by trail crew staff. Approximately 7 cubic yards of concrete and steel were removed with the intake structure. The climbing rungs were also removed from the remaining diversion structure at the head of the pipeline. Stacked rock walls located near the diversion gates were deconstructed and the material positioned in the diversion channel between the removed intake structure and the remaining diversion gate.

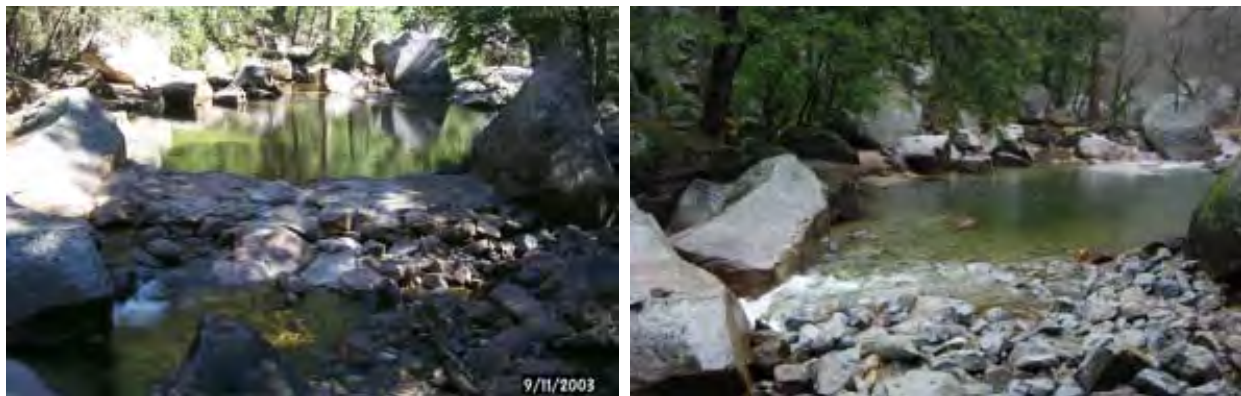
Figure 2: Happy Isles Dam before removal (2003) and after (2005).

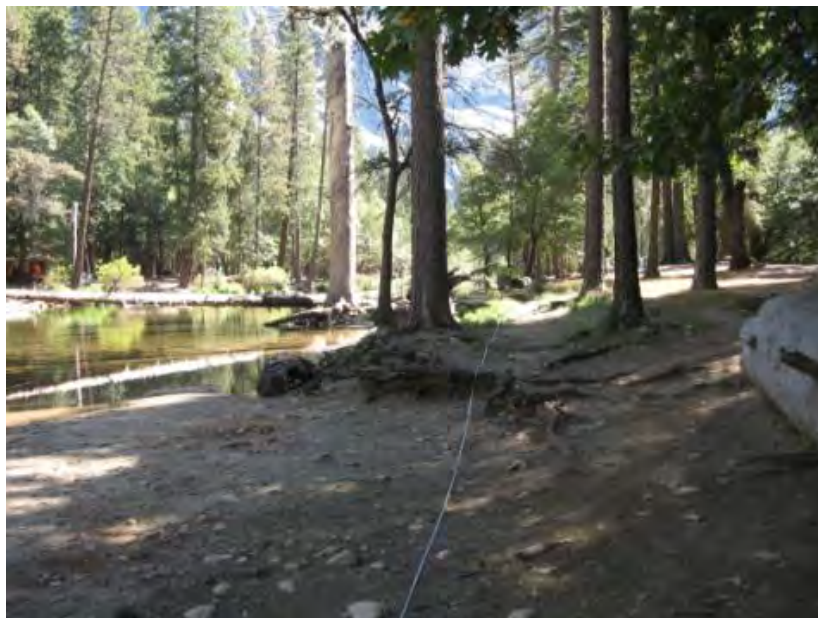
Figure 3: Vegetation establishment in Lower Pines Campground 2 years after fence installation.

They constructed two sections of fencing, totaling 1,200 feet, in Lower Pines Campground with a designated river access point between them (Figure 2). Staff also planted the two enclosed areas with herbaceous and shrub seedlings in the more highly denuded zones. Figure 3 shows vegetation establishment 2 years after fence installation in Lower Pines Campground.

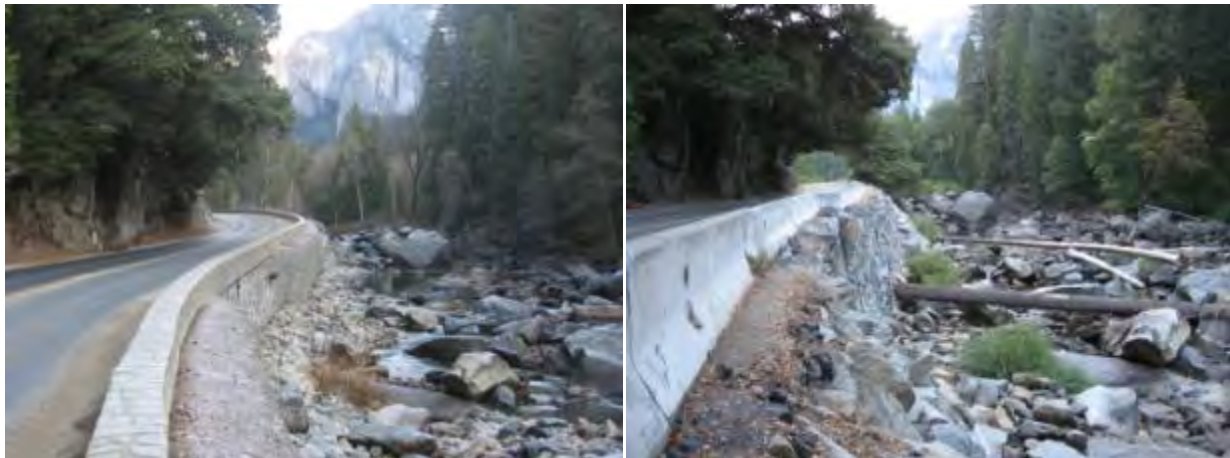
The road rehabilitation itself included the removal of 250 linear feet of historic guard wall, the reconstruction of historic retaining walls in two locations, and the removal of five canyon live oaks, three California Black Oaks, three ponderosa pines, three black cottonwoods, one bay laurel and several seedlings and brush species. Figure 1 shows a small section of the project before and after construction of the new shoulder and MSE wall.

Figure 1: The Narrows before (left) and after (right) construction.

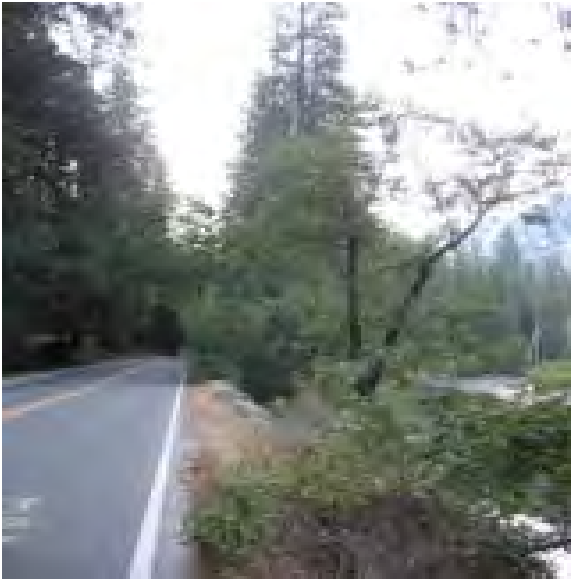
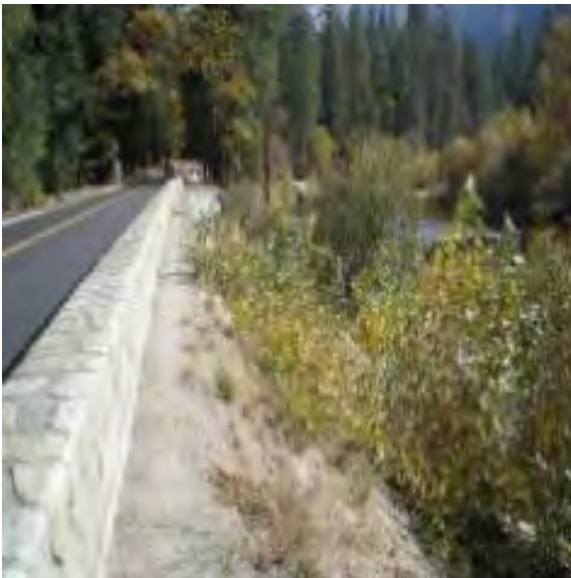
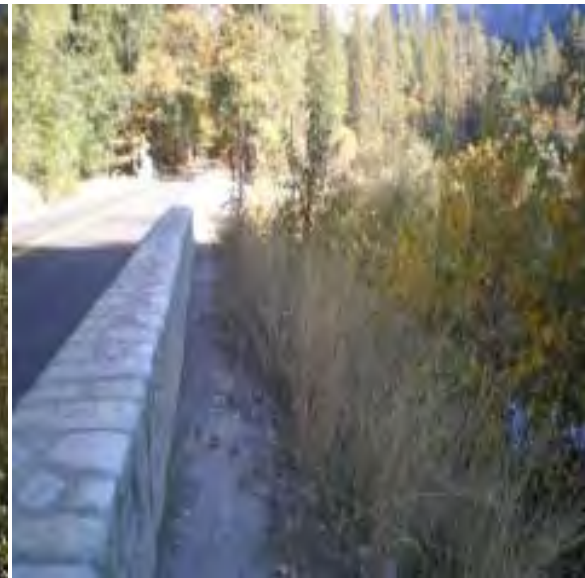
Figure 1: Vegetation recruitment at the Narrows: pre-construction and 3 years post-construction.

Two years following the completion of the project, park ecologists have determined that the mitigation planting was a success. The number of woody vegetation stems and clumps, as well as the basal cover and height of these stems and clumps, has increased each year following planting (Figure 2). Survival of planted species is well over 75 percent, with significant volunteer recruitment. No further mitigation efforts are needed and the next monitoring site visit will occur in the late fall or early winter of 2011.

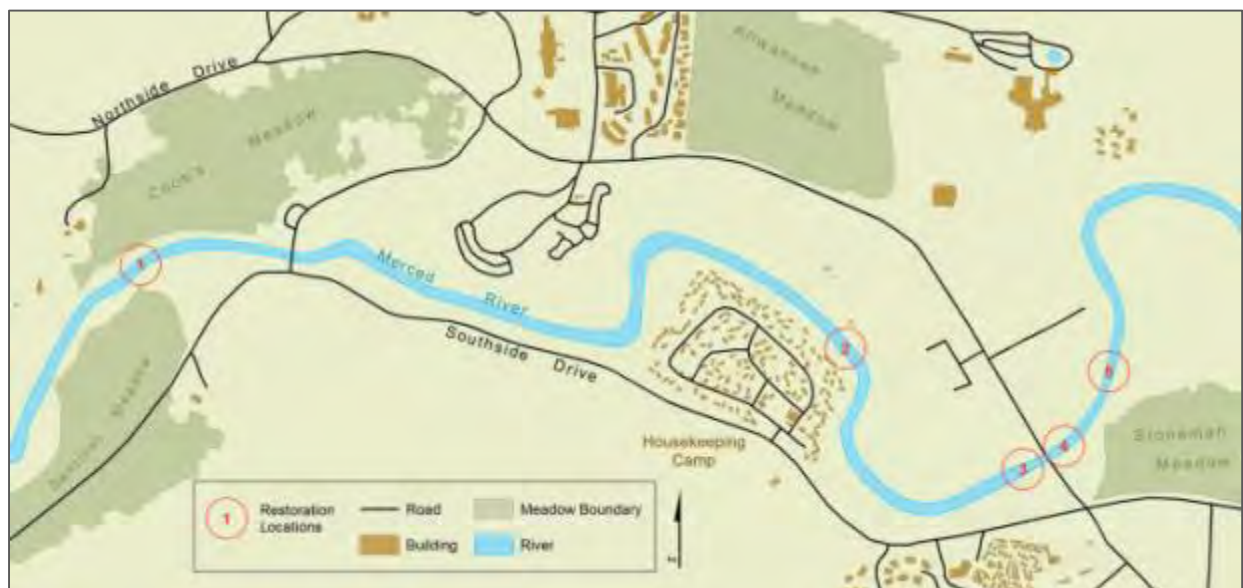
In 2010, the National Park Service and a contractor removed eight utility line crossings from the Merced River, five of which required restoration action in order to stabilize the banks on one or both sides of the river (seven bank locations in all). Figure 1 shows the five general locations requiring restoration action. The site locations that required restoration are described as follows: (1) upstream of Superintendent's Bridge, south side of river; (2) downstream of Housekeeping Bridge, both sides of the river; (3) downstream of Stoneman Bridge, south side of the river; (4) upstream of Stoneman Bridge, south side of the river; and (5) the reach of river at Stoneman Meadow, both sides of the river.

Figure 1: Utility removal restoration locations in Yosemite Valley, 2010.

Several of the utility lines were buried at a very shallow depth below the riverbed and caused pipe dams to form, disrupting the natural flow of the river. The excavation of these lines was accomplished with as minimal impact to water quality and stream bank vegetation as possible. After the lines were removed, park ecologists assessed each bank for impacts and prioritized for additional revegetation and bank stabilization work. Restoration crews used native vegetation to stabilize bank disturbances that occurred during excavation. Excavation of the utility lines included the removal of existing rock revetment and bank material at the utility crossing as well as up to 20 feet upstream and downstream of the lines.
