**OLD HARBOR LIFE-SAVING STATION
Provincetown, Massachusetts**

HISTORIC STRUCTURE REPORT

**Cape Cod National Seashore
South Wellfleet, Massachusetts**

June 1988

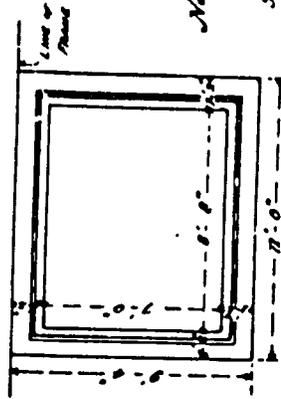
PLAN OF CISTERN.

Note: Place the cistern as low as the grade of site will allow, and set in led and overflow pipes in accordance with it.

The wooden cistern cover is in poor condition, and should be either repaired or replaced. At a minimum, the split board and the cupped battens should be replaced. Any work here should remedy the orientation and construction problems that caused the present cistern cover to deteriorate so rapidly.

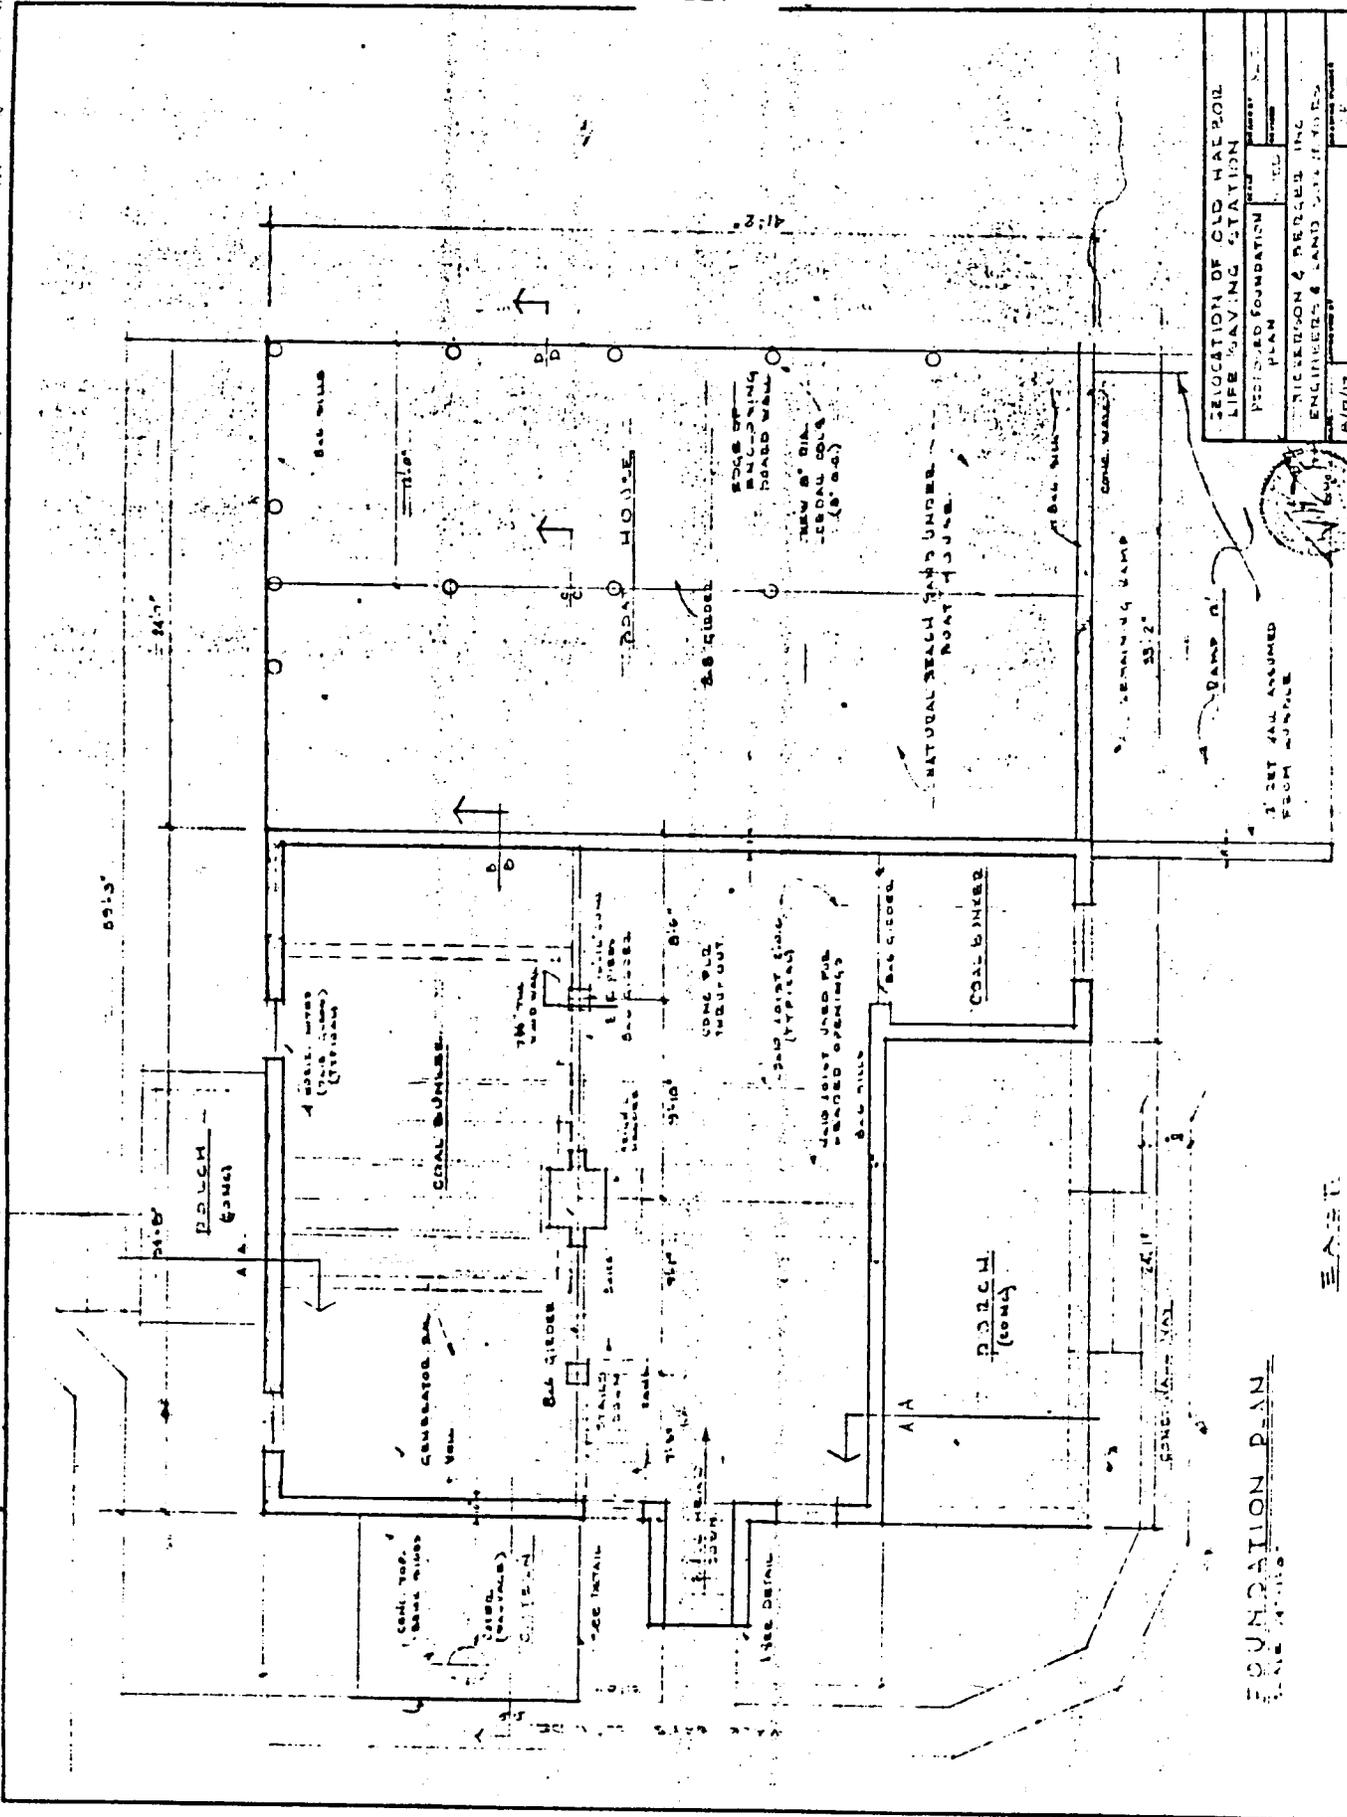
RELOCATION OF OLD HAERROL LIFE SAVING STATION	
PROJECTED FOUNDATION PLAN	DATE: 11/17
ENGINEERS & ARCHITECTS INC.	
11/17/17

NOTE
 ALL ESTIMATED LOADS ASSUME MASTERS ON GAYMENT & 1ST FLOOR FOR MAIN HOUSE BEAM REMOVED, AND 1ST FLOOR FOR BOAT HOUSE ON THE TOWER WALLS HAS BEEN REMOVED.

TYPICAL TEMPORARY SUPPORT OF PORCH ROOF:
 PROVIDE 4" DIAGONALS FROM OUTER PORCH BEAM TO BUILDING SILL AT OR NEAR EACH END, AND FROM POST TO BACK DIAGONALS AT INTERSECTIONS WITH TAUGHT CABLES THROUGH THE BUILDING WALL CAP WINDOW OR DOOR OPENINGS WHERE POSSIBLE. THE CABLES ARE TO BE FASTENED TO THE FLOOR ENGAGING AT LEAST 2 STUDS.

The present foundation walls are part of the basement built at Race Point to receive the main building and the tower of the Old Harbor Life-Saving Station following its move to Nauset Beach. No work needs to be done on the foundation walls themselves.

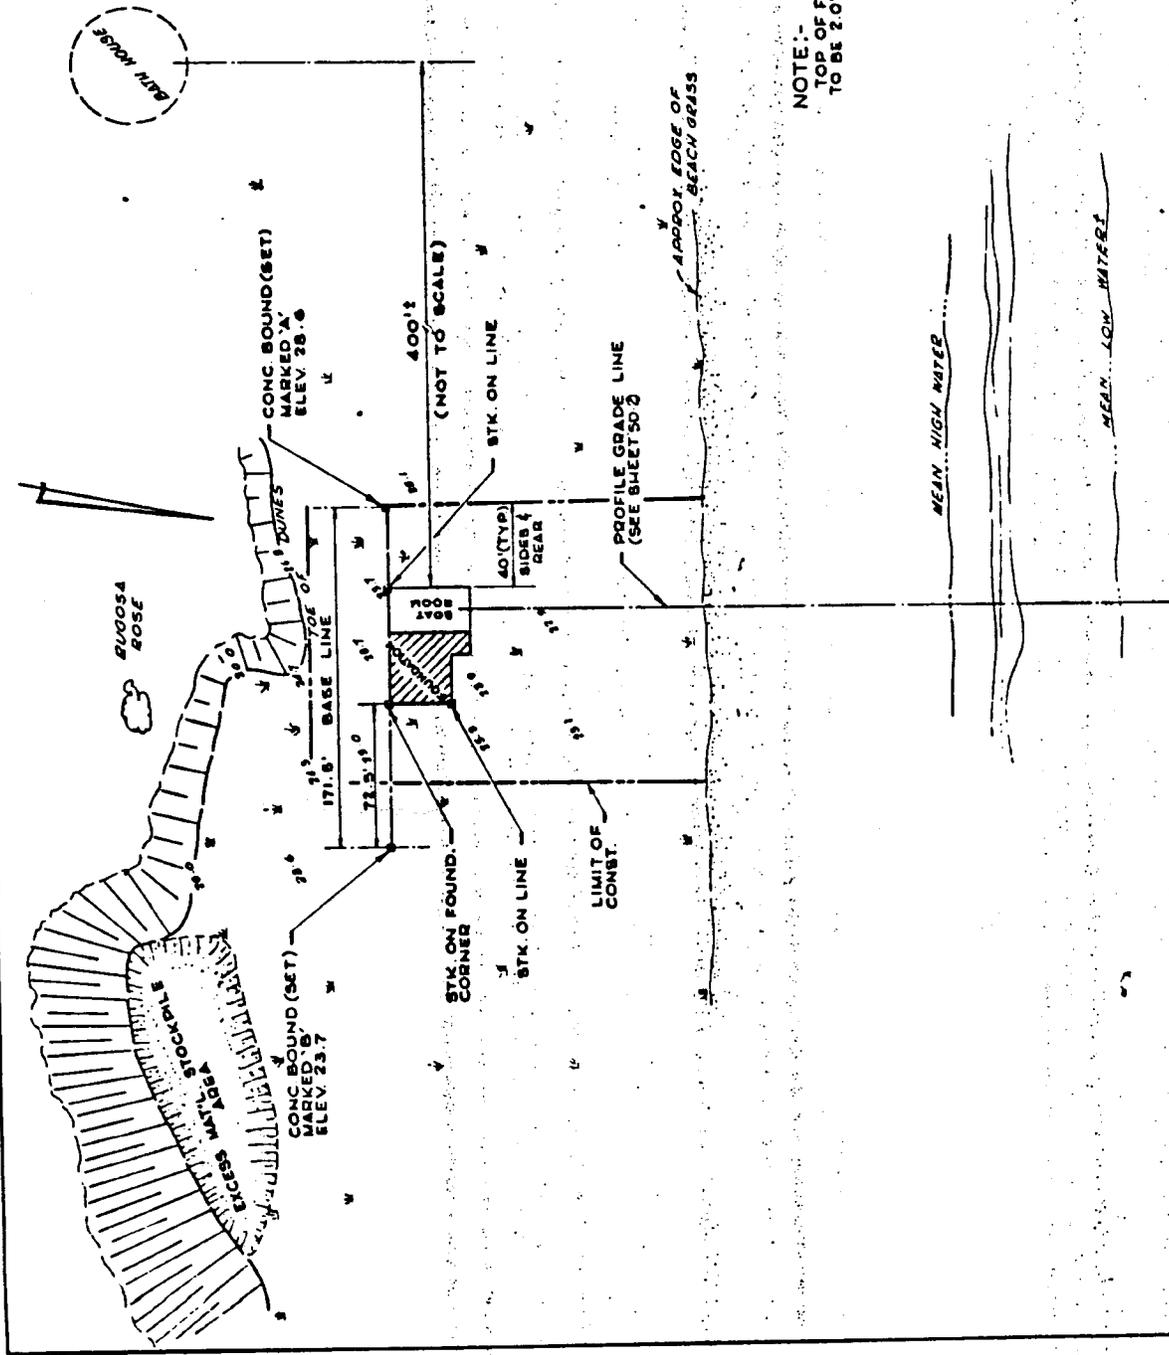
RELOCATION OF OLD HARBOR LIFE SAVING STATION	
SITE PLAN	1" = 40'
NICKERSON & BERGER INC., PEARL S. ORLEANS, MA	
DATE	12 AUG 77
SCALE	SD 1

NOTE:-
TOP OF FOUNDATION REAR WALL
TO BE 2.0' ABOVE FINISHED GRADE.

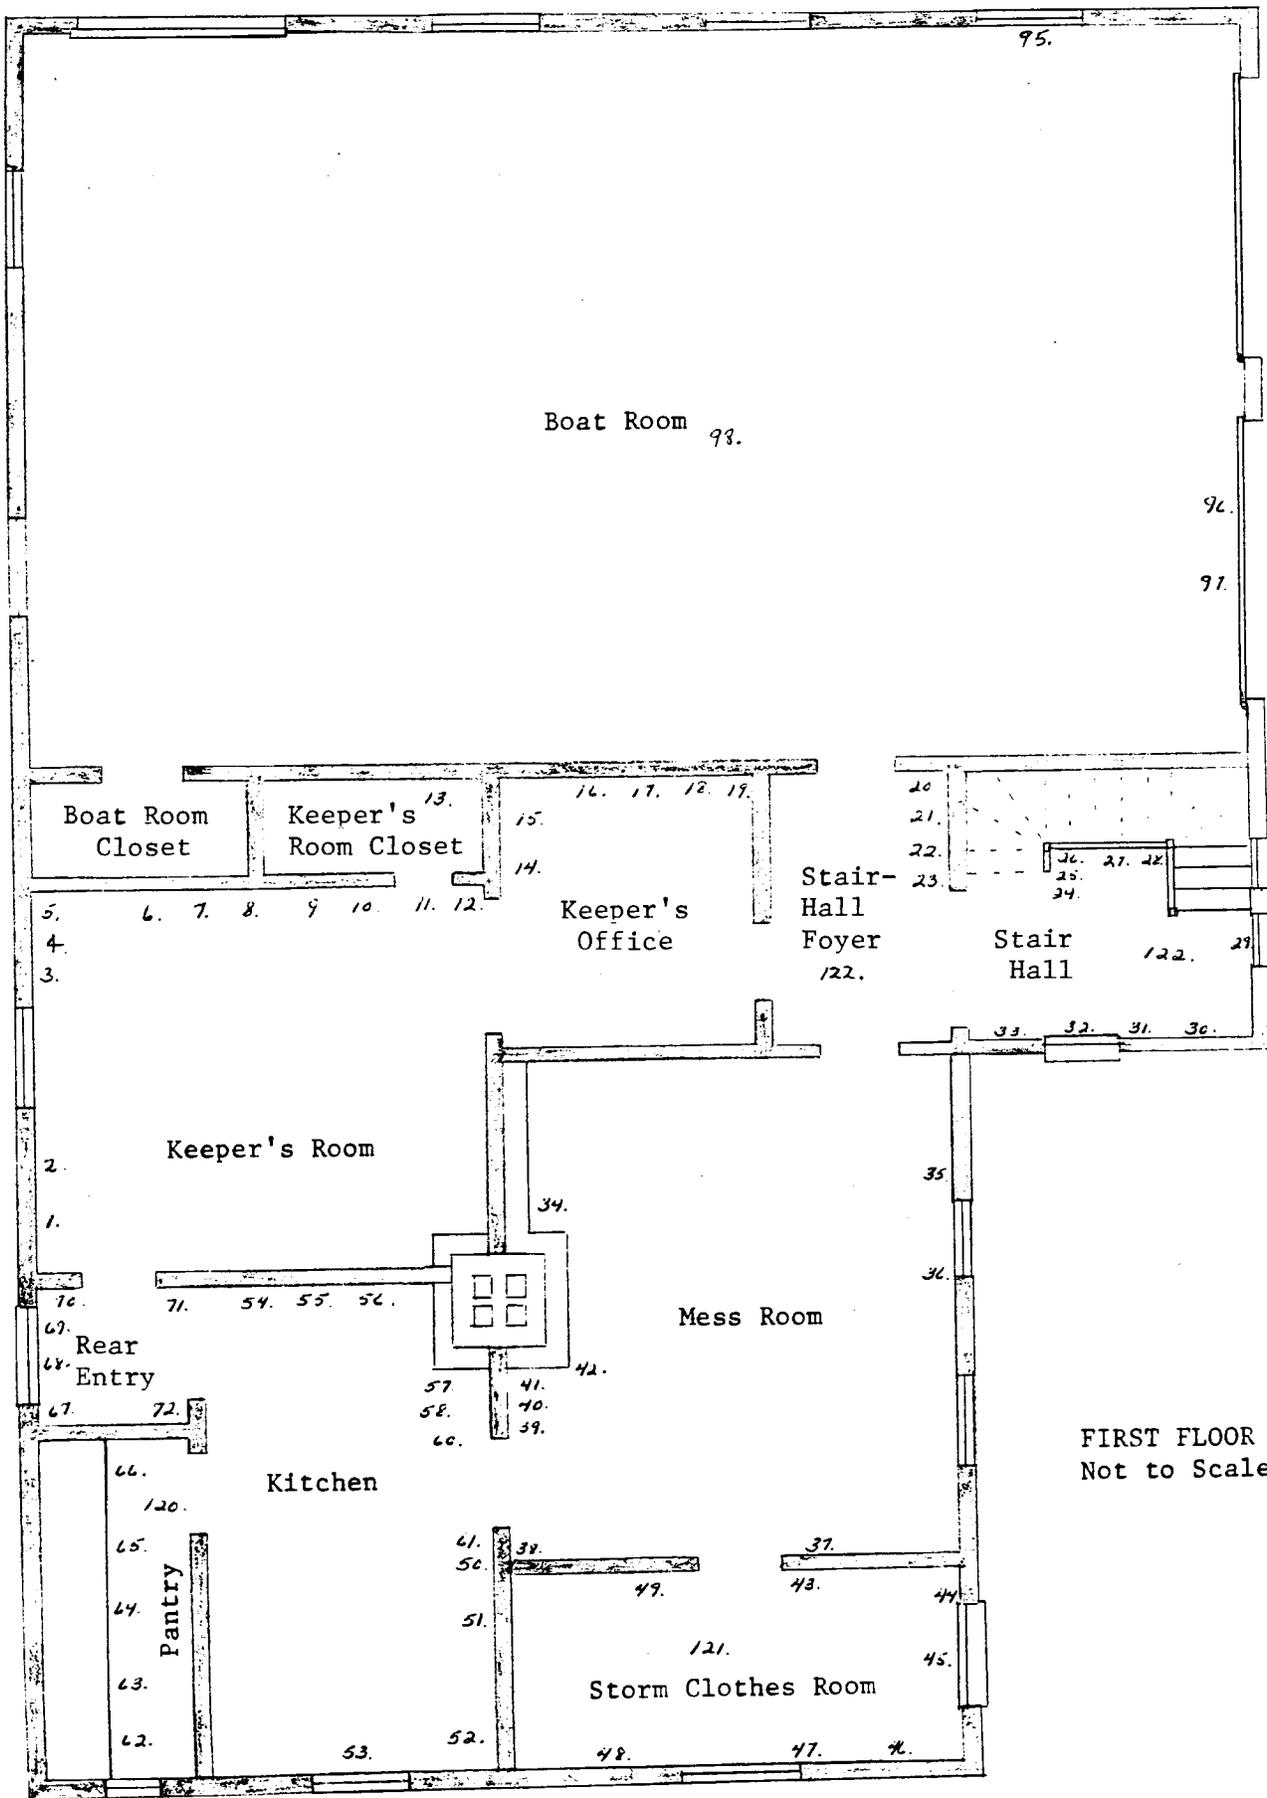
FIRST FLOOR PLAN
Not to Scale

C. Locations of Paint Samples

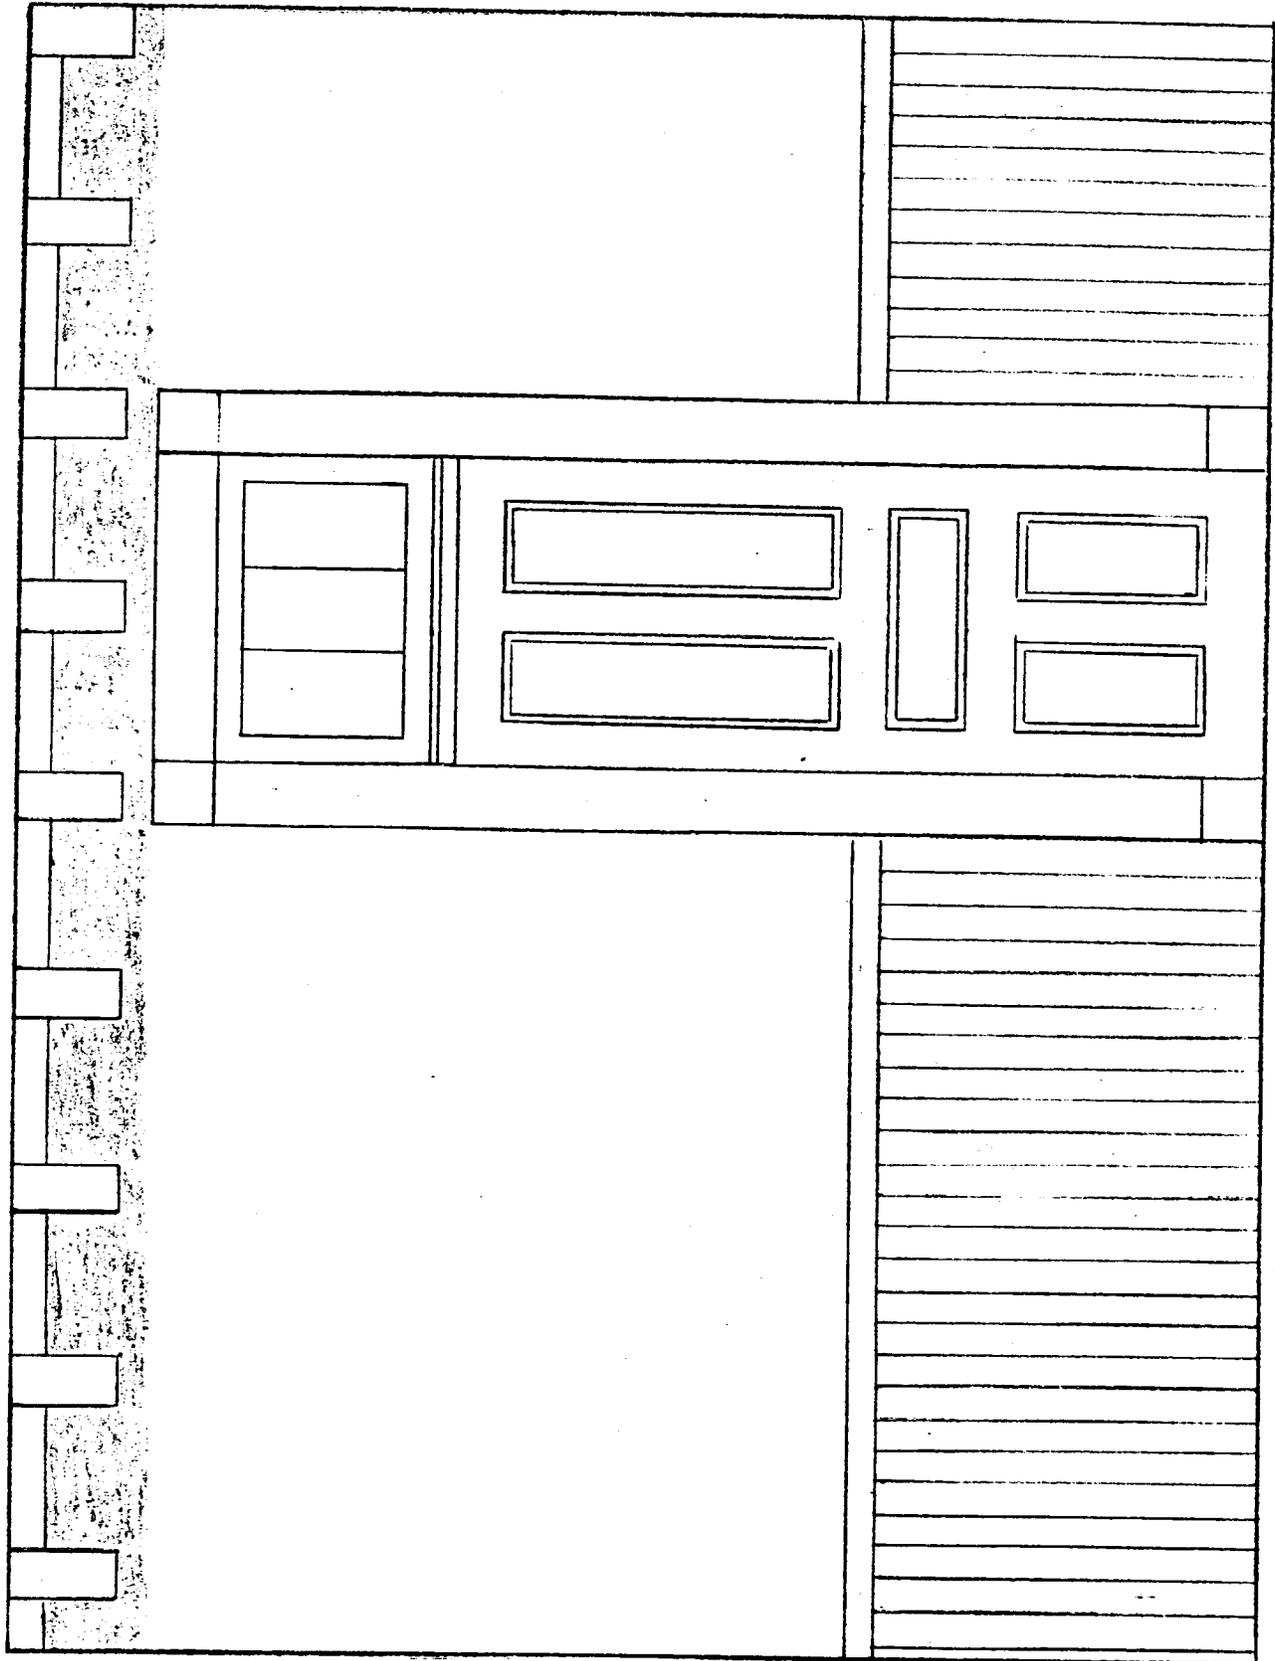
TYPICAL PAINT SCHEME FOR ROOMS WITH DADO
Old Harbor Life Saving Station
Provincetown, Massachusetts

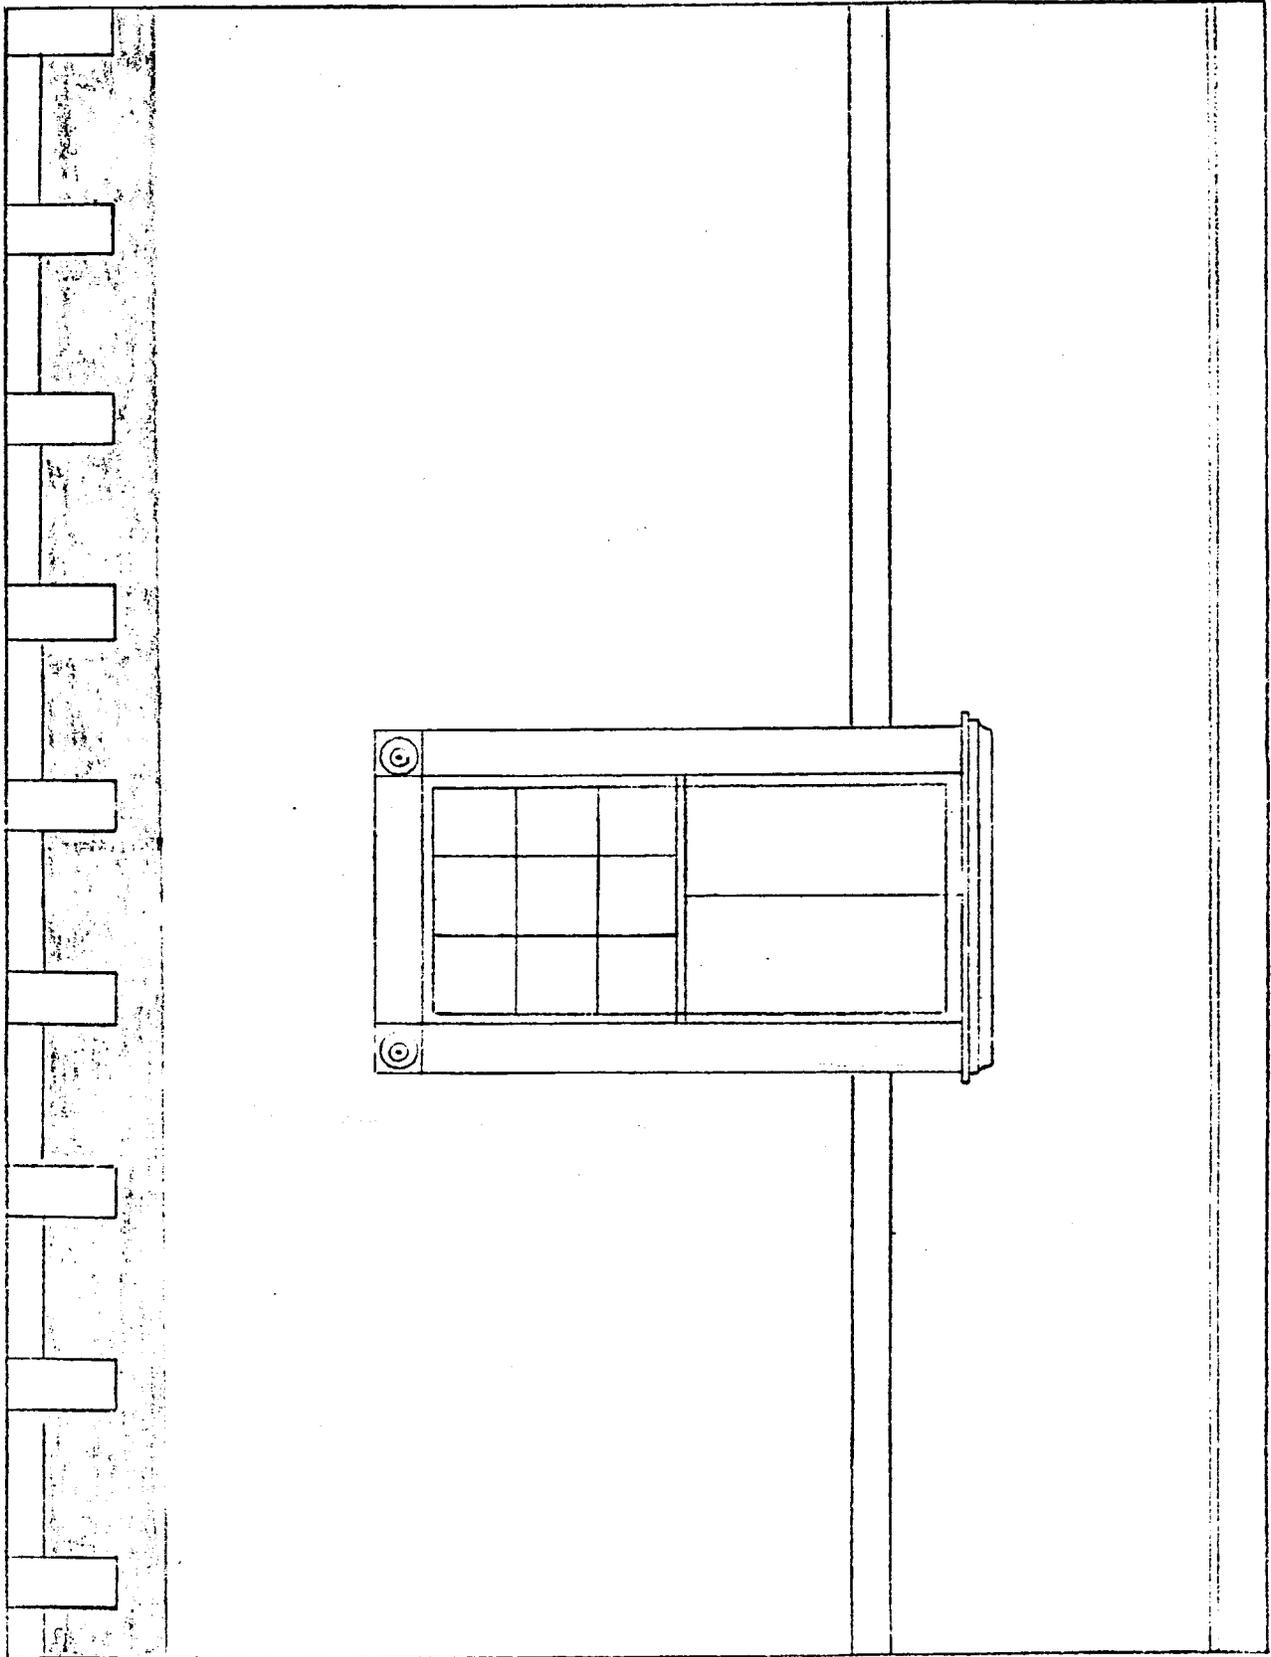
Typical Paint Scheme for Room Without a Dado
Old Harbor Life Saving Station
Provincetown, Massachusetts

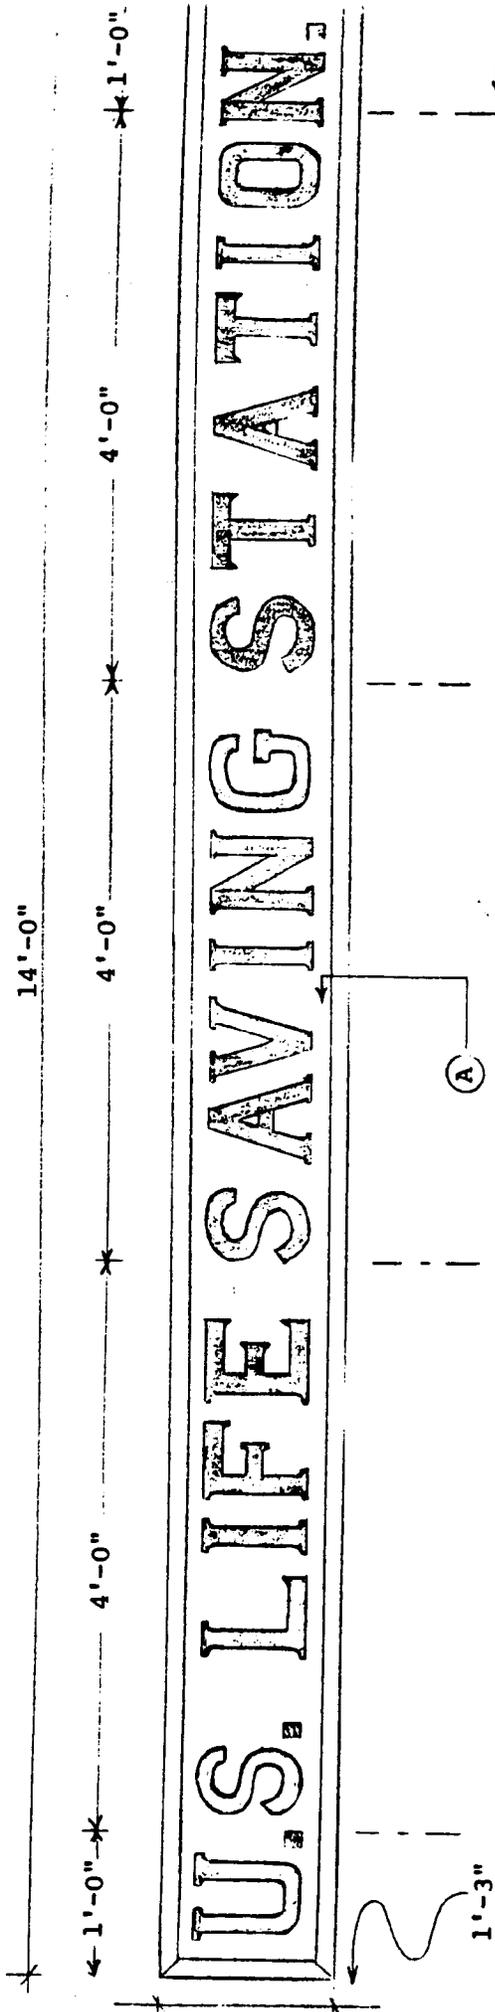
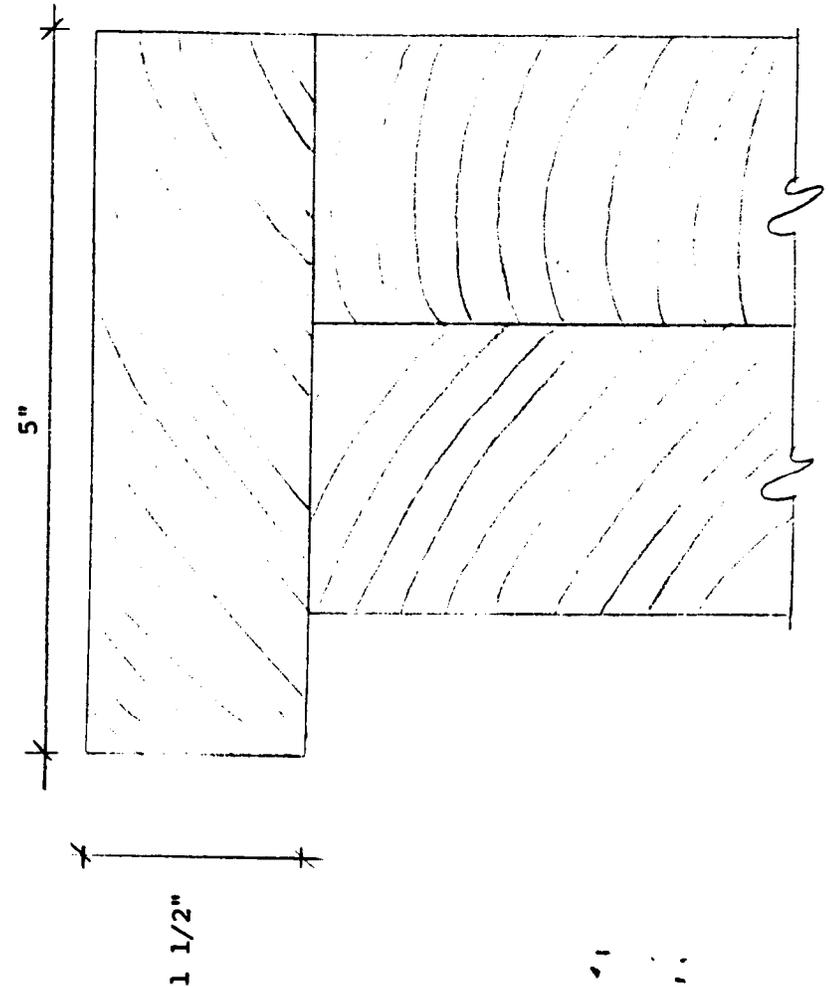
SIGN
OLD HARBOR LIFE SAVING STATION
CAPE COD NATIONAL SEASHORE
PROVINCETOWN, MASSACHUSETTS

SECTION A: EDGEBAND

SCALE: ELEVATION, 3/4" = 1'-0"
SECTION A, 3/4" = 1"

Hanging the sign: (To be done by CACO Staff.) The sign shall be secured to the north roof of the boathouse. The sign shall be placed 5-feet over from the tower and 6-feet, 4-inches over from the east side of the boathouse roof. The sign shall be placed 5-inches up from the north edge of the boathouse roof. The sign shall be secured with "four stout wrought-iron standards, and two 3/4-inch wrought-iron stay braces". The design of these two types of hardware shall be determined later. The wrought-iron standards are to be placed 1-foot in from the ends of the sign and the spaced 4-feet apart. (See elevation for the placement of the standards.)

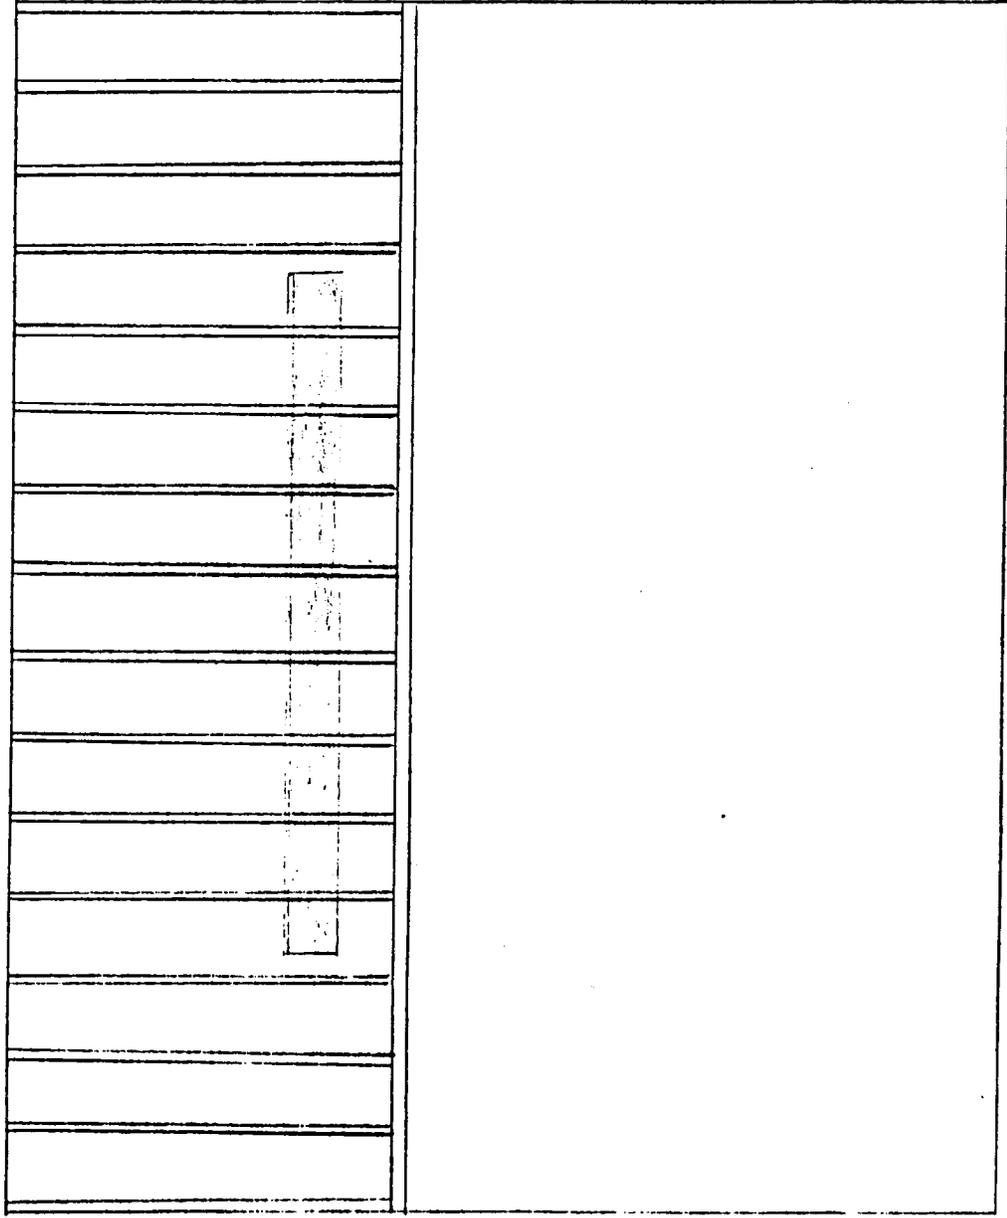
OLD HARBOR LIFE SAVING STATION
CAPE COD NATIONAL SEASHORE
PROVINCETOWN, MASSACHUSETTS
SIGN MOUNTING HARDWARE

ARROWS IDENTIFY THE RAFTERS TO
WHICH THE MOUNTING BRACES ARE TO BE
SCREWED.

SIGN IS TO BE LOCATED
1'-6" UP FROM THE EDGE
OF THE ROOF

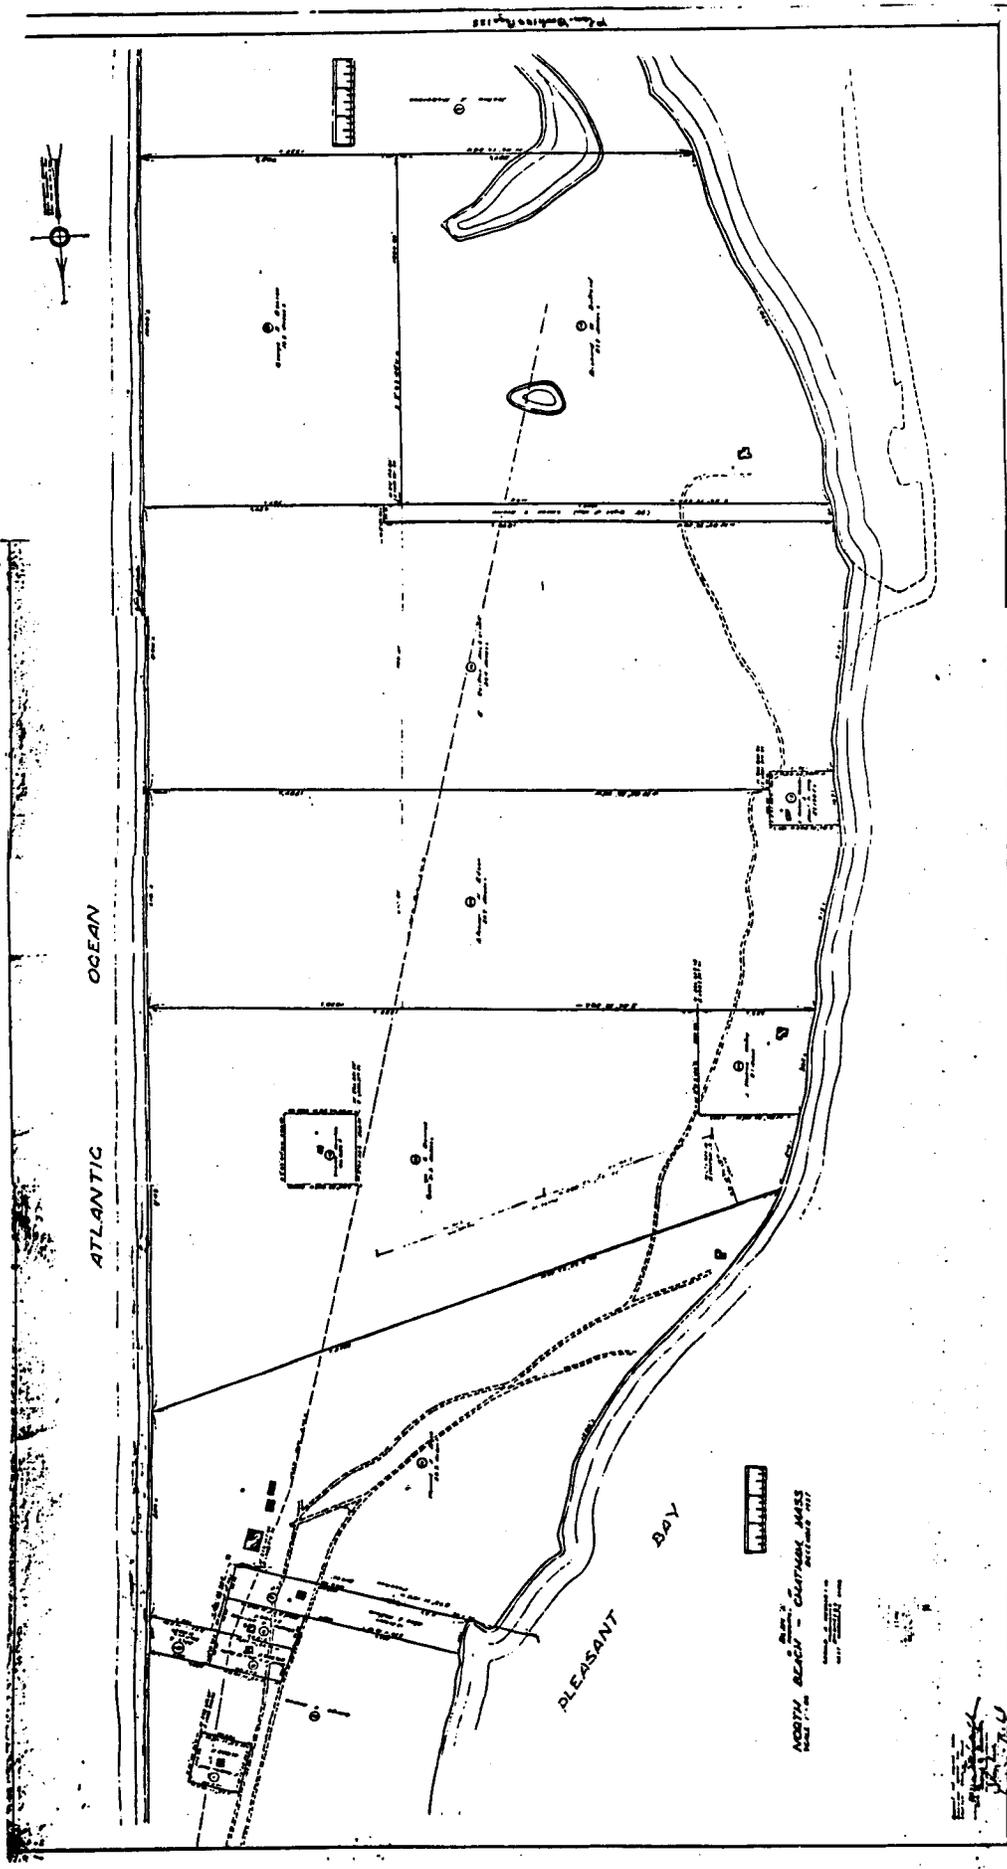
Illustration 3. "Plan 'A' of Properties at North Beach - Chatham, Mass., December 1957."

table manner. The series of Quitclaim Deeds that follow the Final Decree in the deed register suggest that the property on which the Old Harbor station stood was transferred from Albert N. Long to George S. Bearse,¹³ and then to Howard J. Rose.¹⁴ Rose's parcel is reflected in a plan filed with the Barnstable County Registry of Deeds,¹⁵ entitled "Plan 'A' of Properties at North Beach - Chatham, Mass.," dated December 1957 and drawn by Gerald A. Mercer and Co., Inc. (fig. 3).

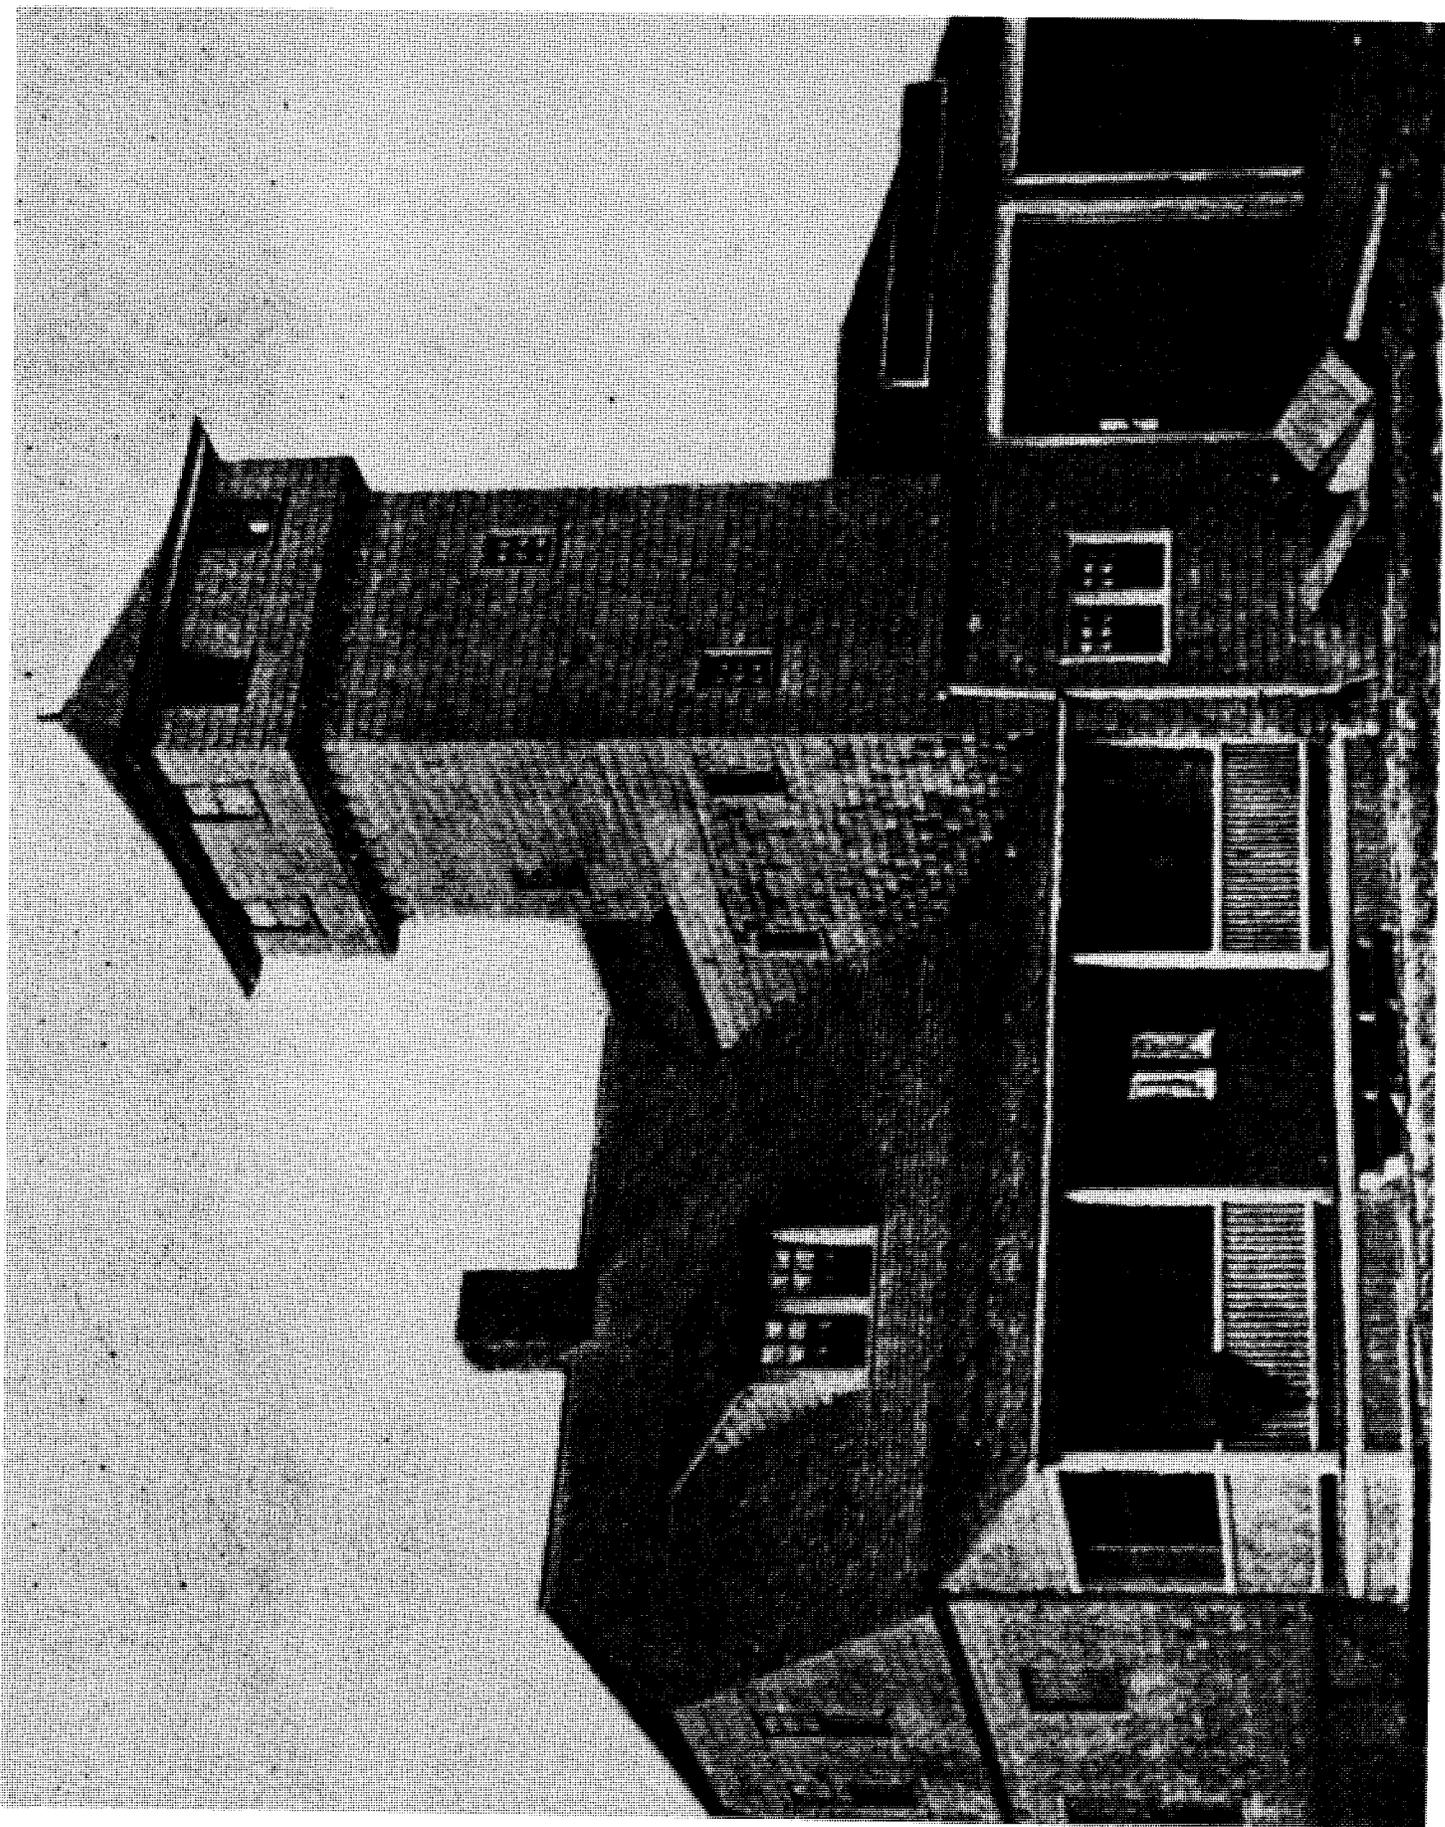
Illustration 6. Exterior View of Old Harbor Life-Saving Station, ca. 1902.

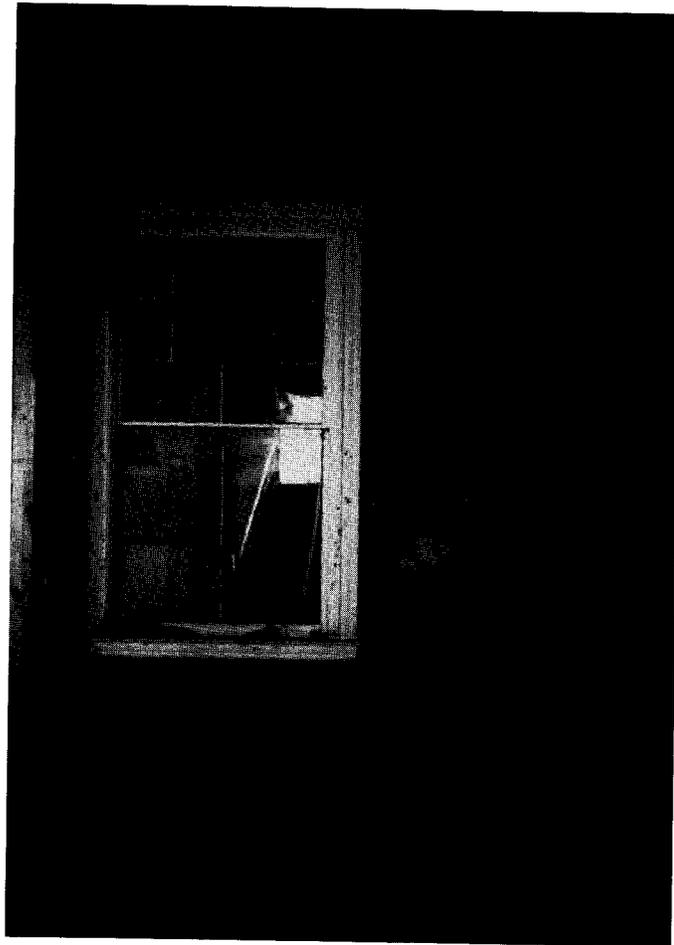
Illustration 7. Window Added in 1900
Between Keeper's Office and Boat Room.

system, and the second set is very crude. The window does appear in the ca.-1927 plans, being located in the wall between the Keeper's Office and the Boat Room. It also can be seen clearly in figure 7, a photograph taken after the Boat Room was removed for the 1977-78 move of the structure.

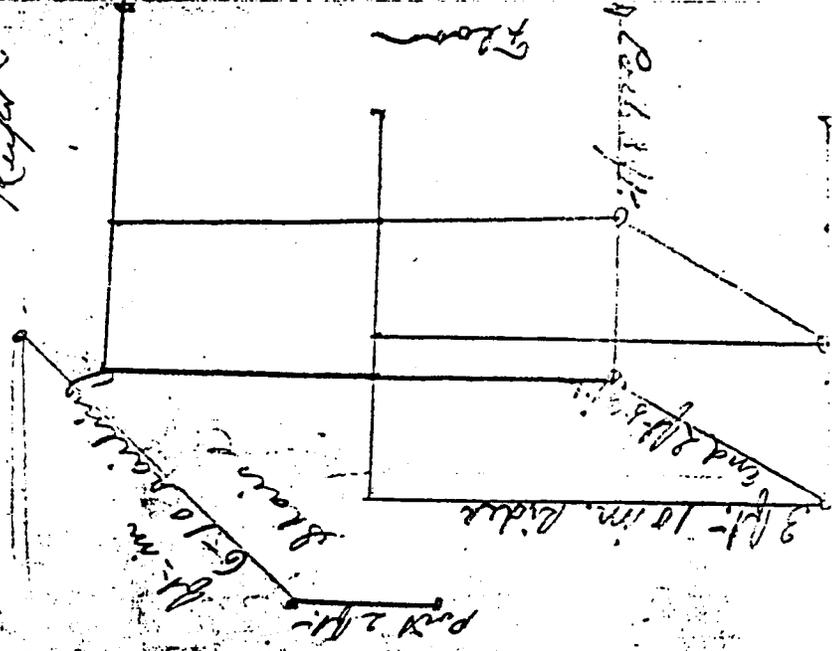
Illustration 8. Diagram of Pipe Railing for Tower Trap Door, Old Harbor Life-Saving Station.

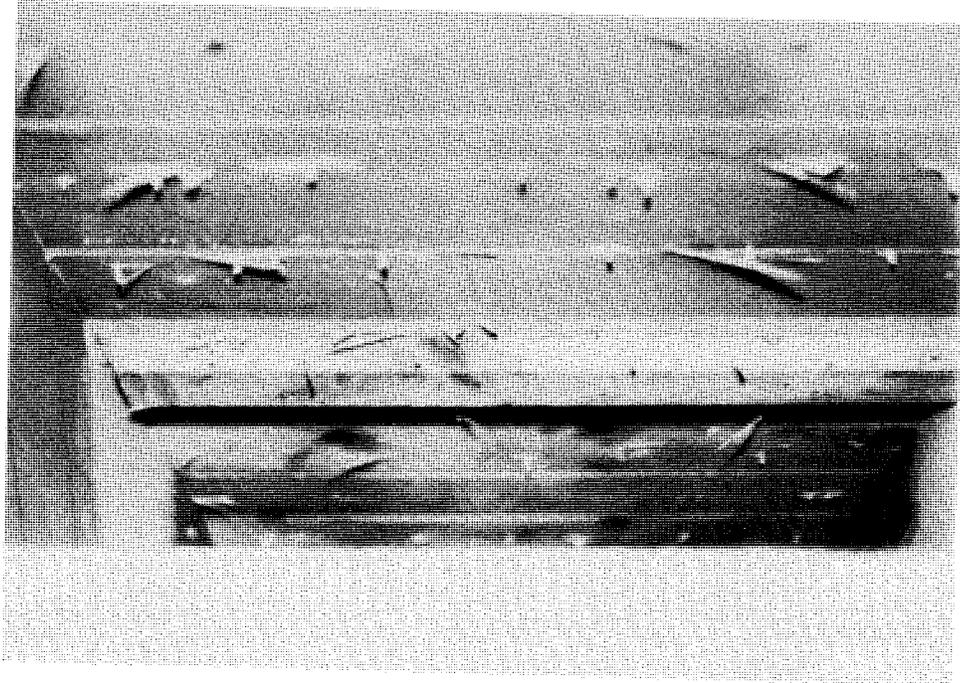
Illustration 9. Ceiling of Quarters, Paint Evidence
of 1910 Relocation of Original Knee Wall.

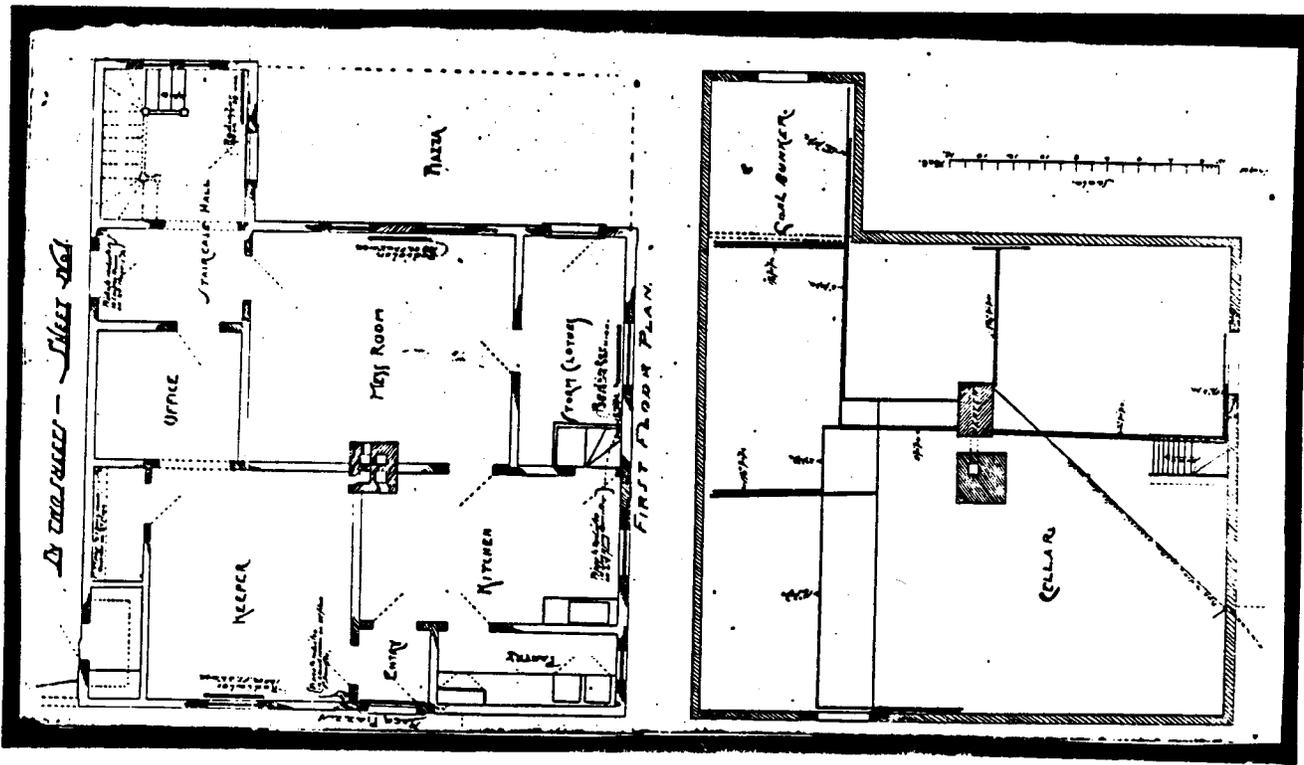
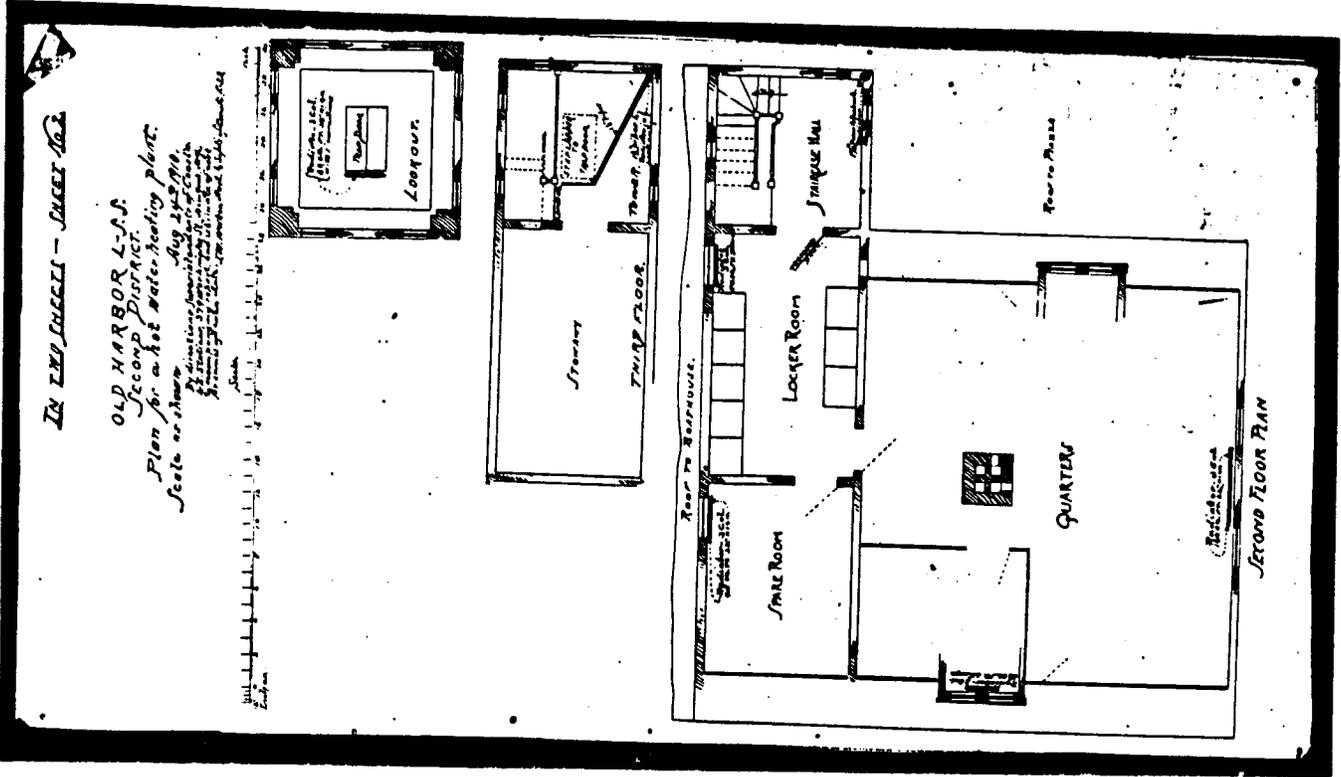
Illustration 10. Plans for a Hot-Water Heating System, Old Harbor Life-Saving Station, August 24, 1910.
