**OLD HARBOR LIFE-SAVING STATION
Provincetown, Massachusetts**

HISTORIC STRUCTURE REPORT

**Cape Cod National Seashore
South Wellfleet, Massachusetts**

June 1988

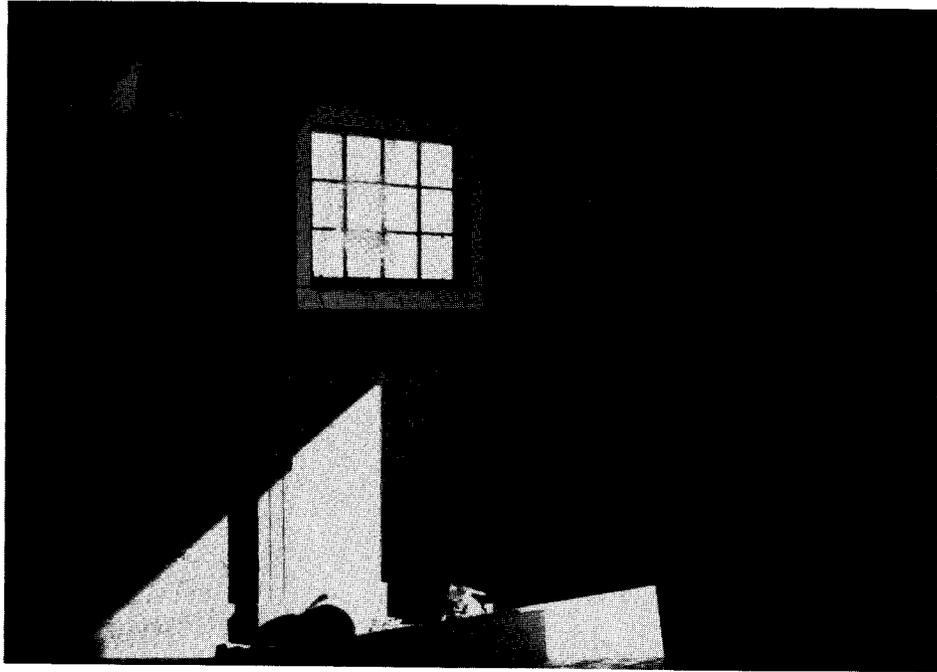
Illustration 12. West Wall of Boat Room, Interior
Sheathing Applied in 1912.

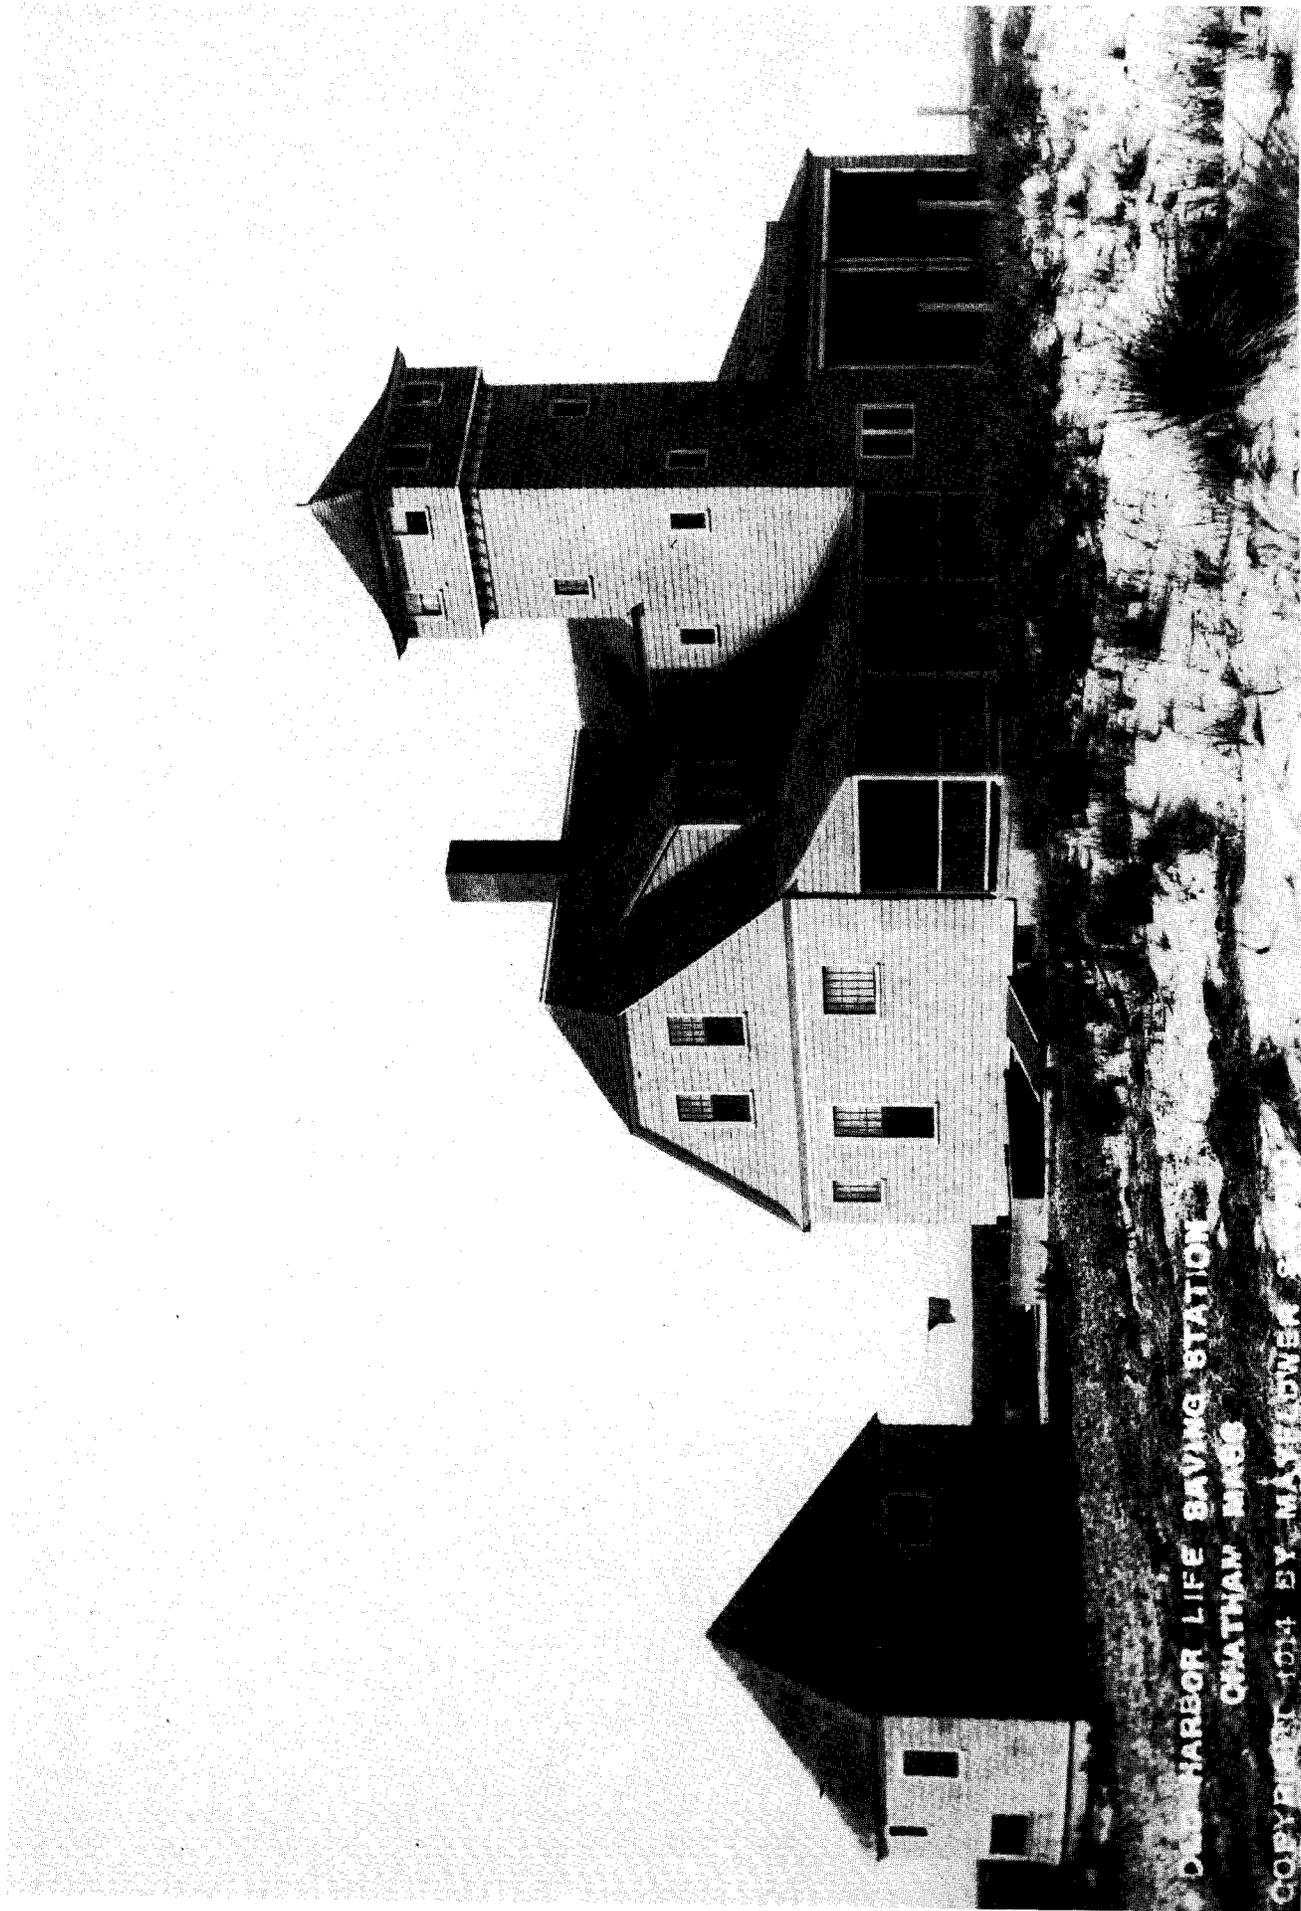
Illustration 13. Exterior View of Old Harbor Life-Saving Station, 1914.

The seacoast environment continued to decay the materials with which the Old Harbor station was built. Figure 13 shows the station in 1914. By that time, the sheathing below the sill board of the Boat Room had rotted, as had the boat ramp in front of the Boat Room's north doors, and the gutter on what is now the east side of the station.¹²⁶ Whether or not these items were replaced is unknown; no authorization for repairs was found, but considering the nature of past approvals, repairs probably were authorized and completed.

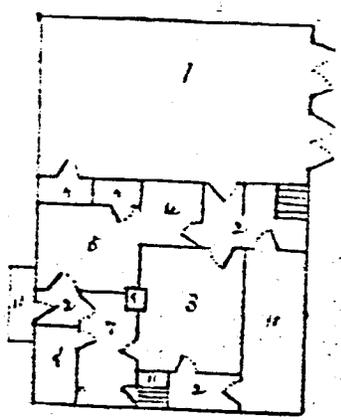
Sketch No. 2
 Old Harbor Life-Saving Station
 March 10, 1916

Illustration 14. Floor Plans, Old Harbor Life-Saving Station, March 10, 1916.

Little documentation was found that recorded site changes or daily life at the station after it came under the control of the U.S. Coast Guard. A very crude set of plans signed by Keeper Joseph Kelley (Keeper Doane may have retired by this time) and dated March 10, 1916 (fig. 14), gives some idea of the appearance of the station at the beginning of the Coast Guard period. These plans show the full cellar added in 1910 and its east-elevation bulkhead entrance. They do not include the cellar opening in the north elevation of the tower, seen in the 1910 plans. (The opening may have been left off the 1916 plans because probably had been converted to a window by this time.) The doors of the Boat Room, which were changed from sliding to swinging action in 1910, are depicted as such in the 1916 plans.

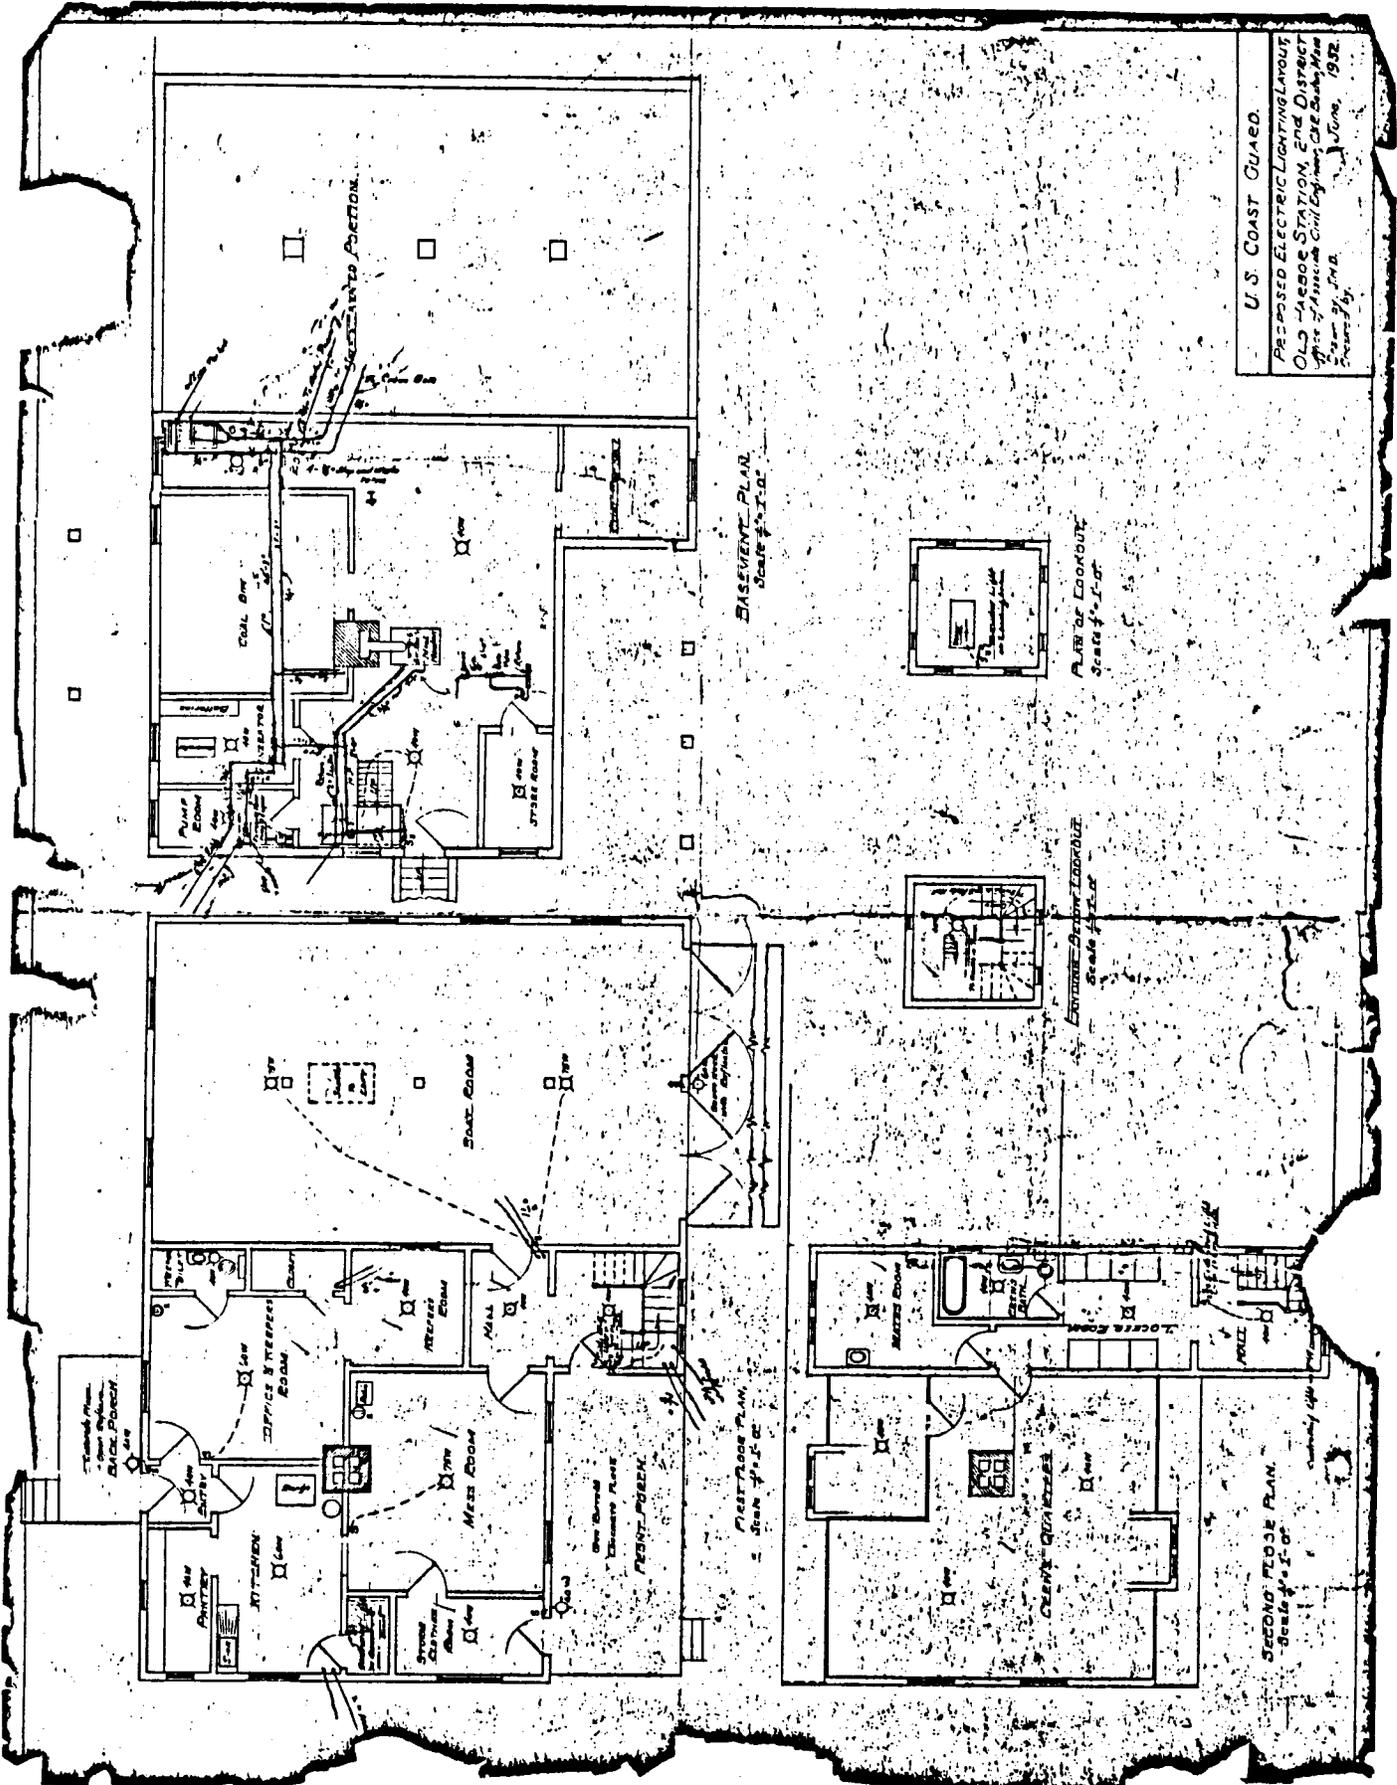
U.S. COAST GUARD.
 PROPOSED ELECTRIC LIGHTING LAYOUT
 OLD HARBOR STATION, END DISTRICT
 OFFICE OF ASSISTANT CHIEF ENGINEER, CHIEF ENGINEER
 STATION, P.O. B.
 JUNE, 1932.

Illustration 16. Floor Plans Showing Proposed Electric Lighting System, Old Harbor Coast Guard Station, June 1932.

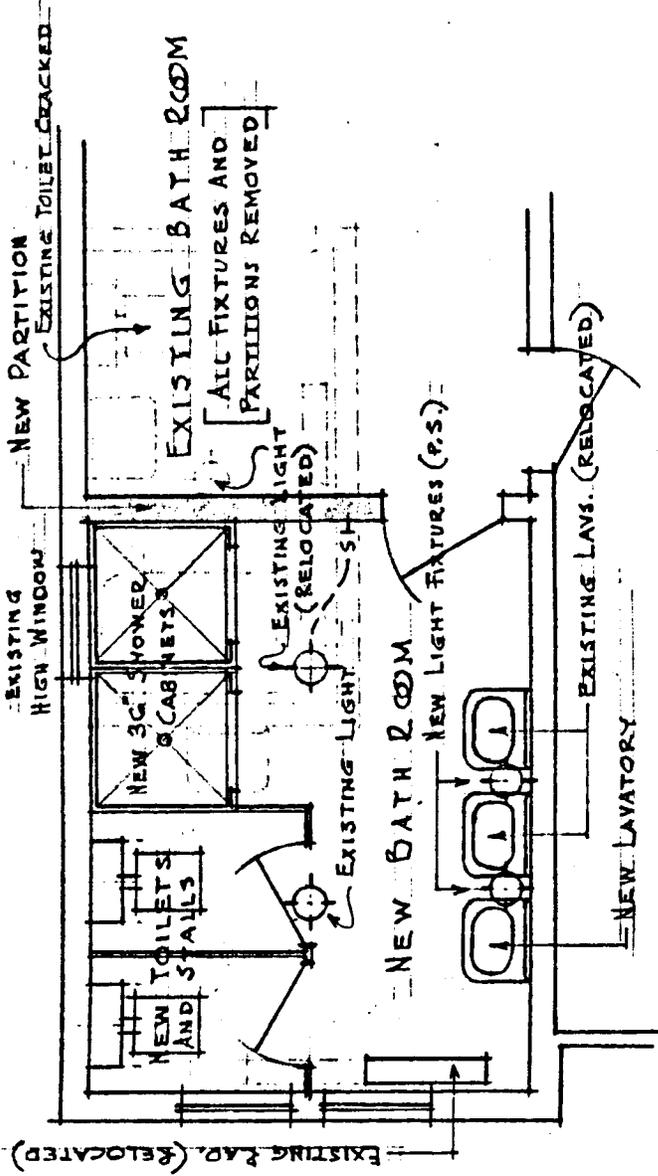
PLAN OF CREW'S NEW BATH ROOM
 [SECOND FLOOR]
 SCALE 1/4" = 1'-0"

Illustration 17. Plan Showing Improvement to Second-Floor Bathroom Facilities, Old Harbor Coast Guard Station, March 9, 1942.

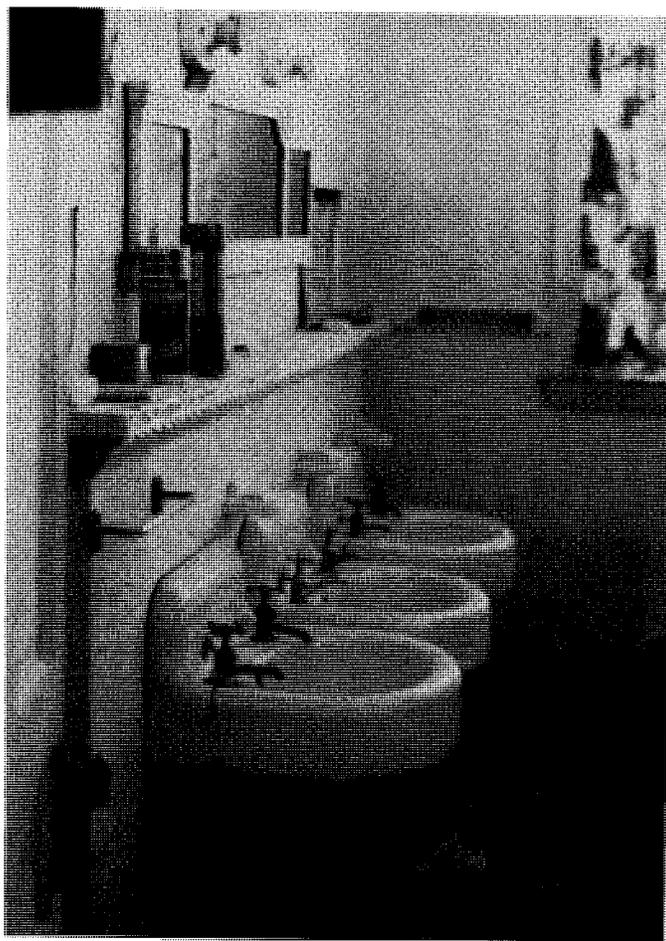
Illustration 18. East Wall of Spare Room,
Sinks Installed During 1942 Improvement
to Second-Floor Bathroom.

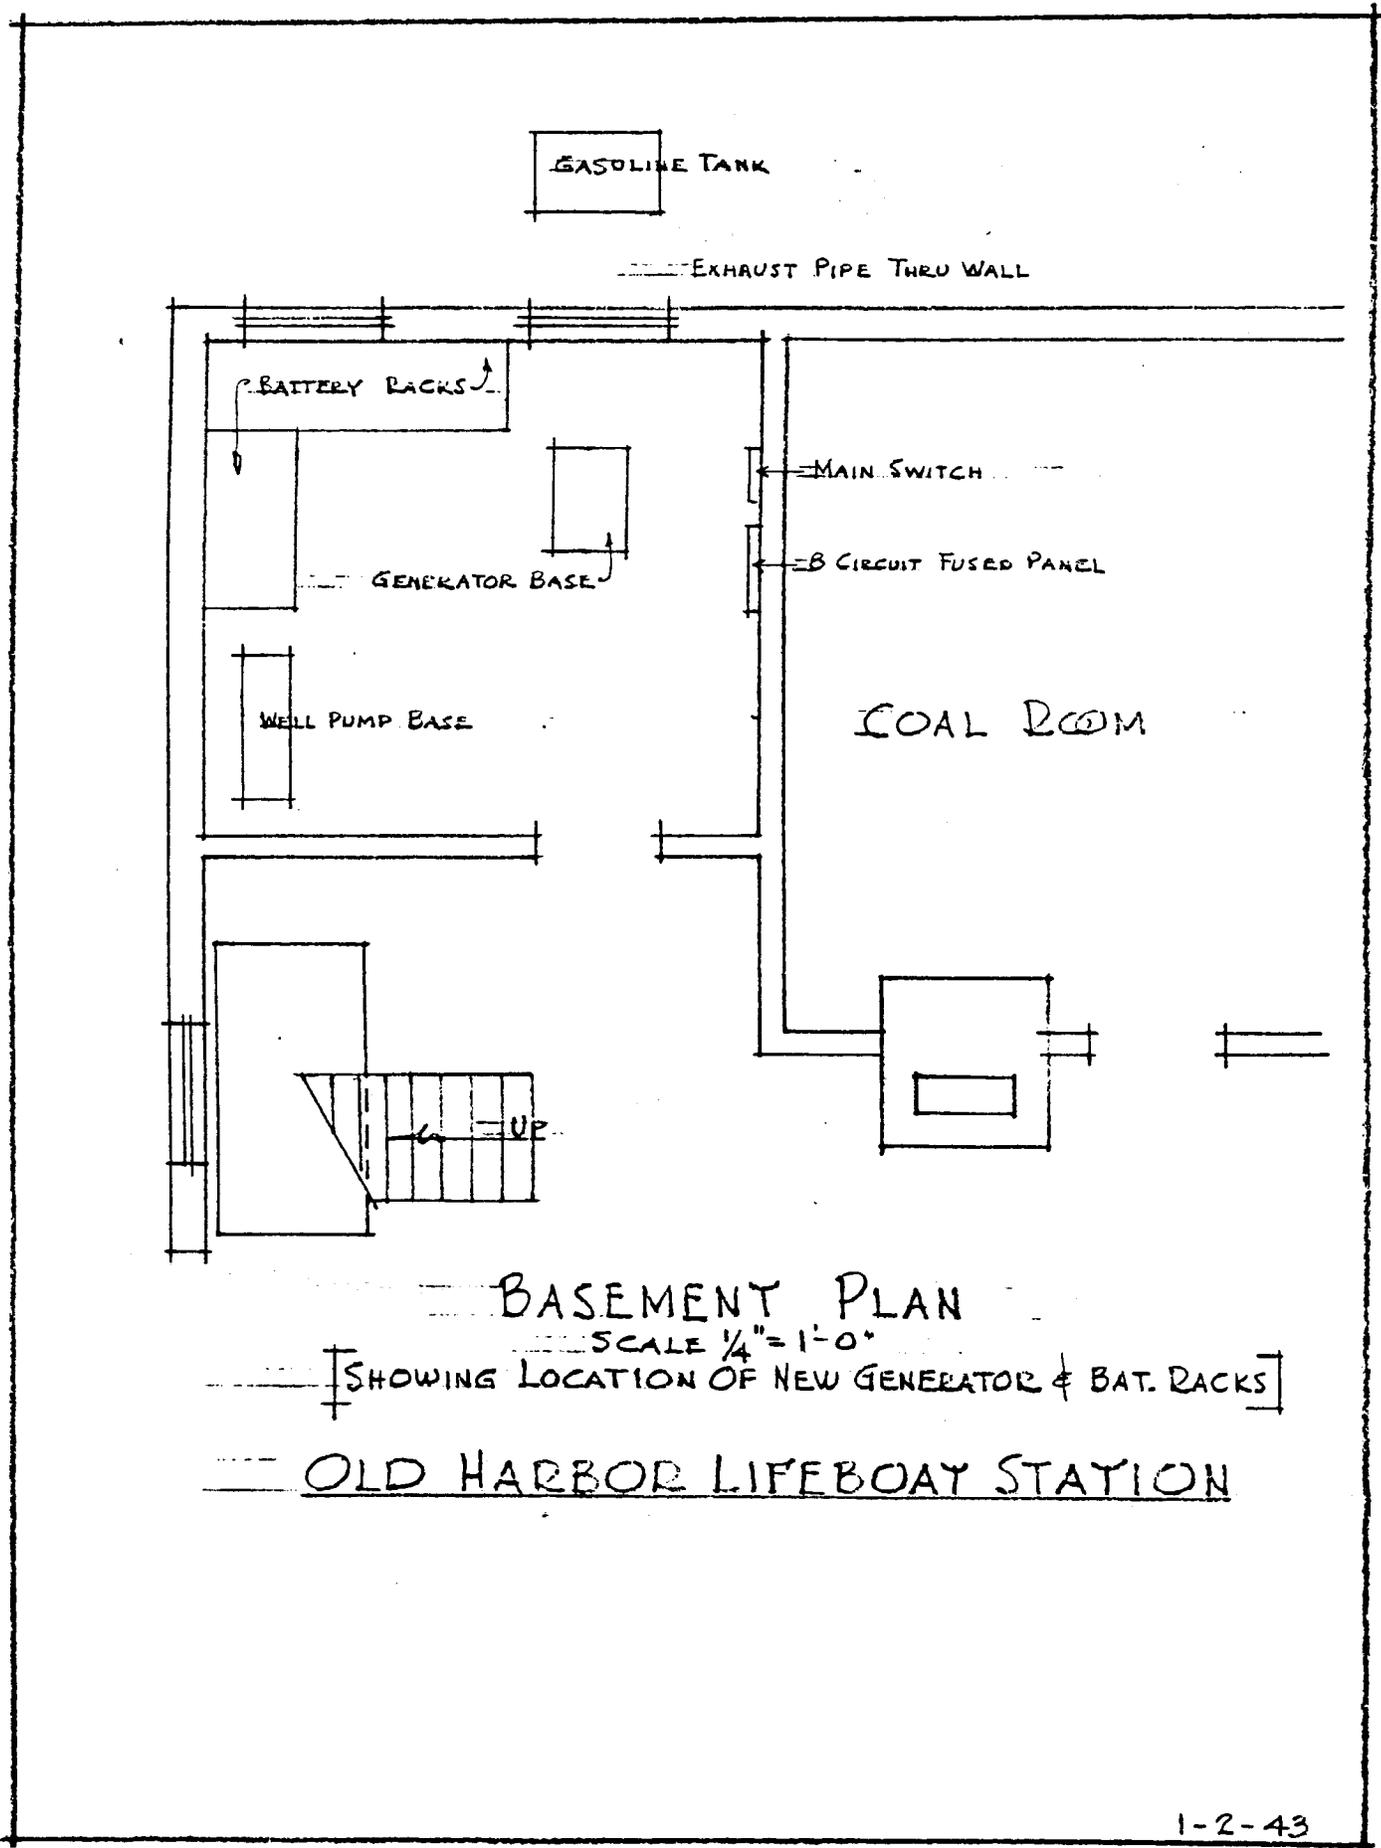
Illustration 19. Basement Plan Showing Location of New Generator and Battery Racks, Old Harbor Coast Guard Station, January 2, 1943.

In March 1942, a request was submitted to replace the existing 32 V/ DC 1500w, gasoline-driven electric generator with a new, more powerful generator.¹³⁷ Two plans for the new installation were found, the most recent of which was dated January 2, 1943 (fig. 19). This plan not only records the location of a gasoline tank outside the station (to its rear), but also denotes the location of the interior cellar stair, created in 1910 and enlarged prior to 1932. According to Coast Guard records, the installation of the new Kohler 110V DC 2kw gasoline-driven electric generating plant was completed by Sager Electric Supply on September 13, 1943.¹³⁸

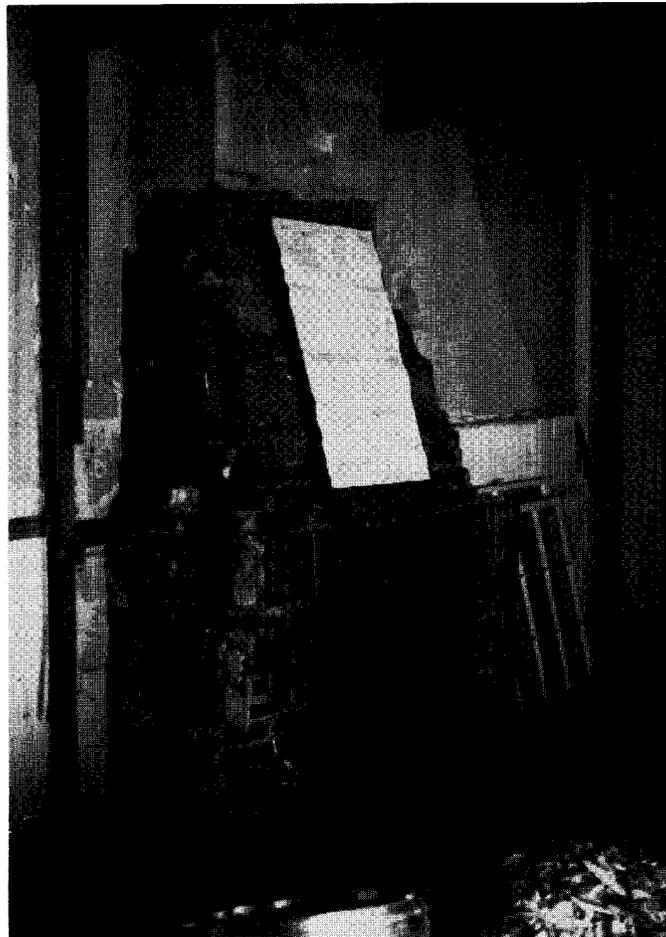
Illustration 22. Mess Room Fireplace Built During Period of Private Ownership.

- 2) the addition of stovepipe flues to the existing chimney in the Mess Room to serve a "Heatilator" fireplace (fig. 22).
- 3) the replacement of the kitchen stove with a large Garland-brand gas range with stainless-steel sheathing behind, and a metal exhaust hood and fan over, the range (fig. 23). An enamel sink with a disposal was added before 1962, and a large Servel-brand gas refrigerator was installed prior to 1972. The 1962 appraisal did mention a refrigerator, but it was located in the Boat Room, and neither its brand or its power source were mentioned.

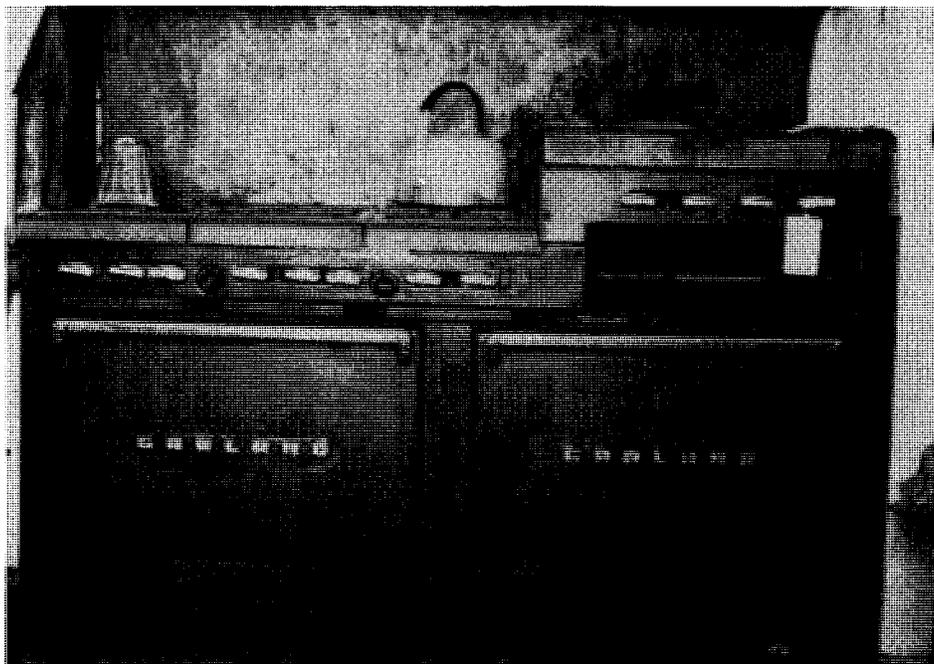
Illustration 23. Kitchen Stove Installed During Period of Private Ownership.

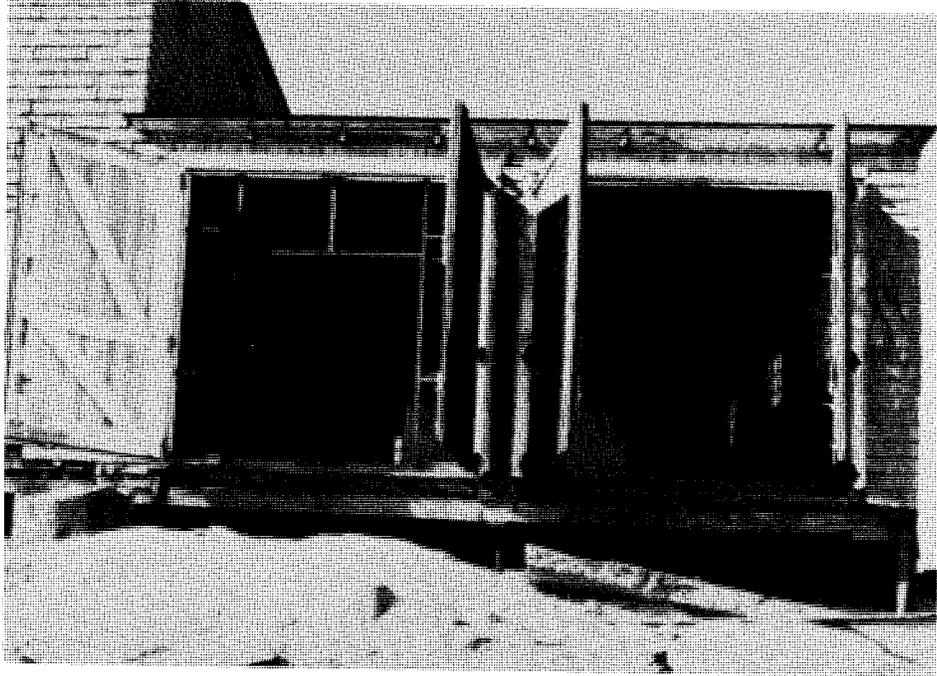
Illustration 26. North-Elevation Boat Room Doorways,
Framing for Screen Within Doorway 115.

- 6) the installation, within the front east Boat Room doorway opening, of frames holding insect screening (fig. 26).
- 7) the subdivision of the second-floor Quarters into four bedrooms. One of these rooms (the southwest bedroom) may have existed before the Coast Guard sold the structure.

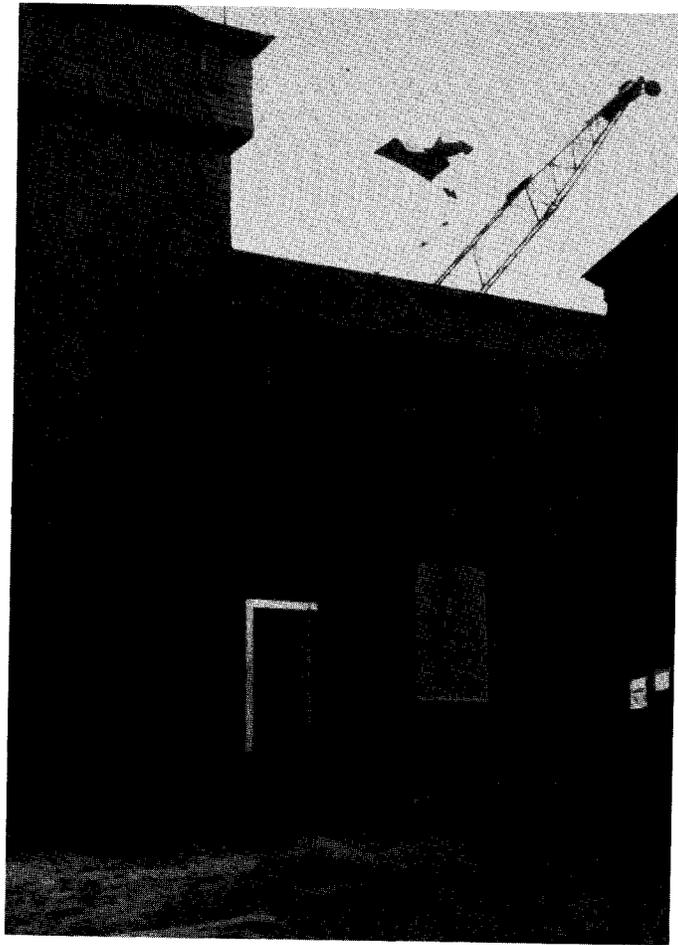
Illustration 27. Separation of Boat Room
from Main Structure, November 1977.

wall between the old Locker Room and the area over the Boat Room (see figure 27), which was outfitted with a floor at some time. It is possible that one of these doorways accessed the new bathroom, if the latter were located above the Boat Room. However, the appraisal states that the walls of the new bathroom consisted chiefly of plaster and wainscot, with some fiberboard wall replacement. This suggests that the bathroom was located inside the former Locker Room.

According to a list found in the Project Supervisor's file, all window sash apparently were labeled and removed before the openings were boarded closed.¹⁷⁰ The building was split in two (fig. 27) and reinforced with steel, the division occurring where the Boat Room met the main building.¹⁷¹ The two structures were then loaded on a barge on November 30, 1977 (fig. 28),¹⁷² which was towed to Provincetown Harbor.

Inside the Boat Room, the east wall was reclapboarded with 2,400 feet of clear white pine. Apparently, the original east-wall clapboards--still in place on the main building at the time of the move (fig. 27)--had accidentally been removed. This may have been done when the posthistoric horizontal sheathing on the interior north, west, and south walls was purposely removed. Three new Boat Room doors were ordered from a millwork house, in addition to interior moldings, doorway trim, cornice, dado and dado cap (the latter two items may have related to chair rails). Three sets of rollers (barn-door hardware) were ordered for the Boat Room doors. Two electrical circuits were brought into the basement, and four light fixtures were installed on the same level. On May 14, 1979, the new Project Supervisor issued drawings to the Exhibit Specialist for repair of the original rear door, and for matching reproductions of the two front doors.²¹⁴ A purchase order for the same followed.

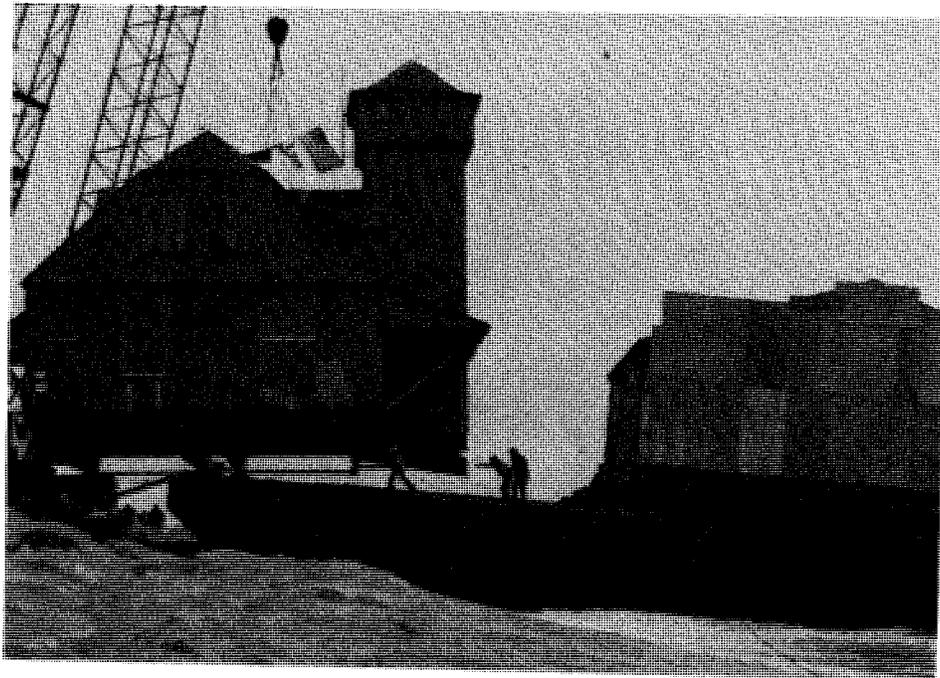
Illustration 28. Loading Boat Room and Main Structure
onto Barge, November 30, 1977.

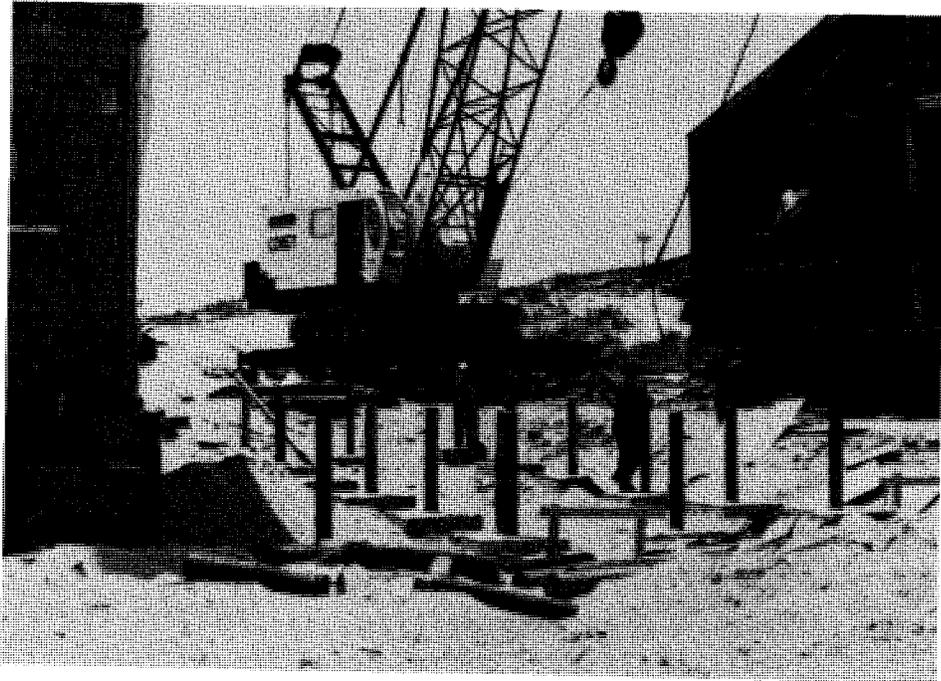
Illustration 33. Riggers Moving Structures onto Foundations, May 23, 1978.

33), such that the station was over the foundation excavation by the 23rd.¹⁹⁰

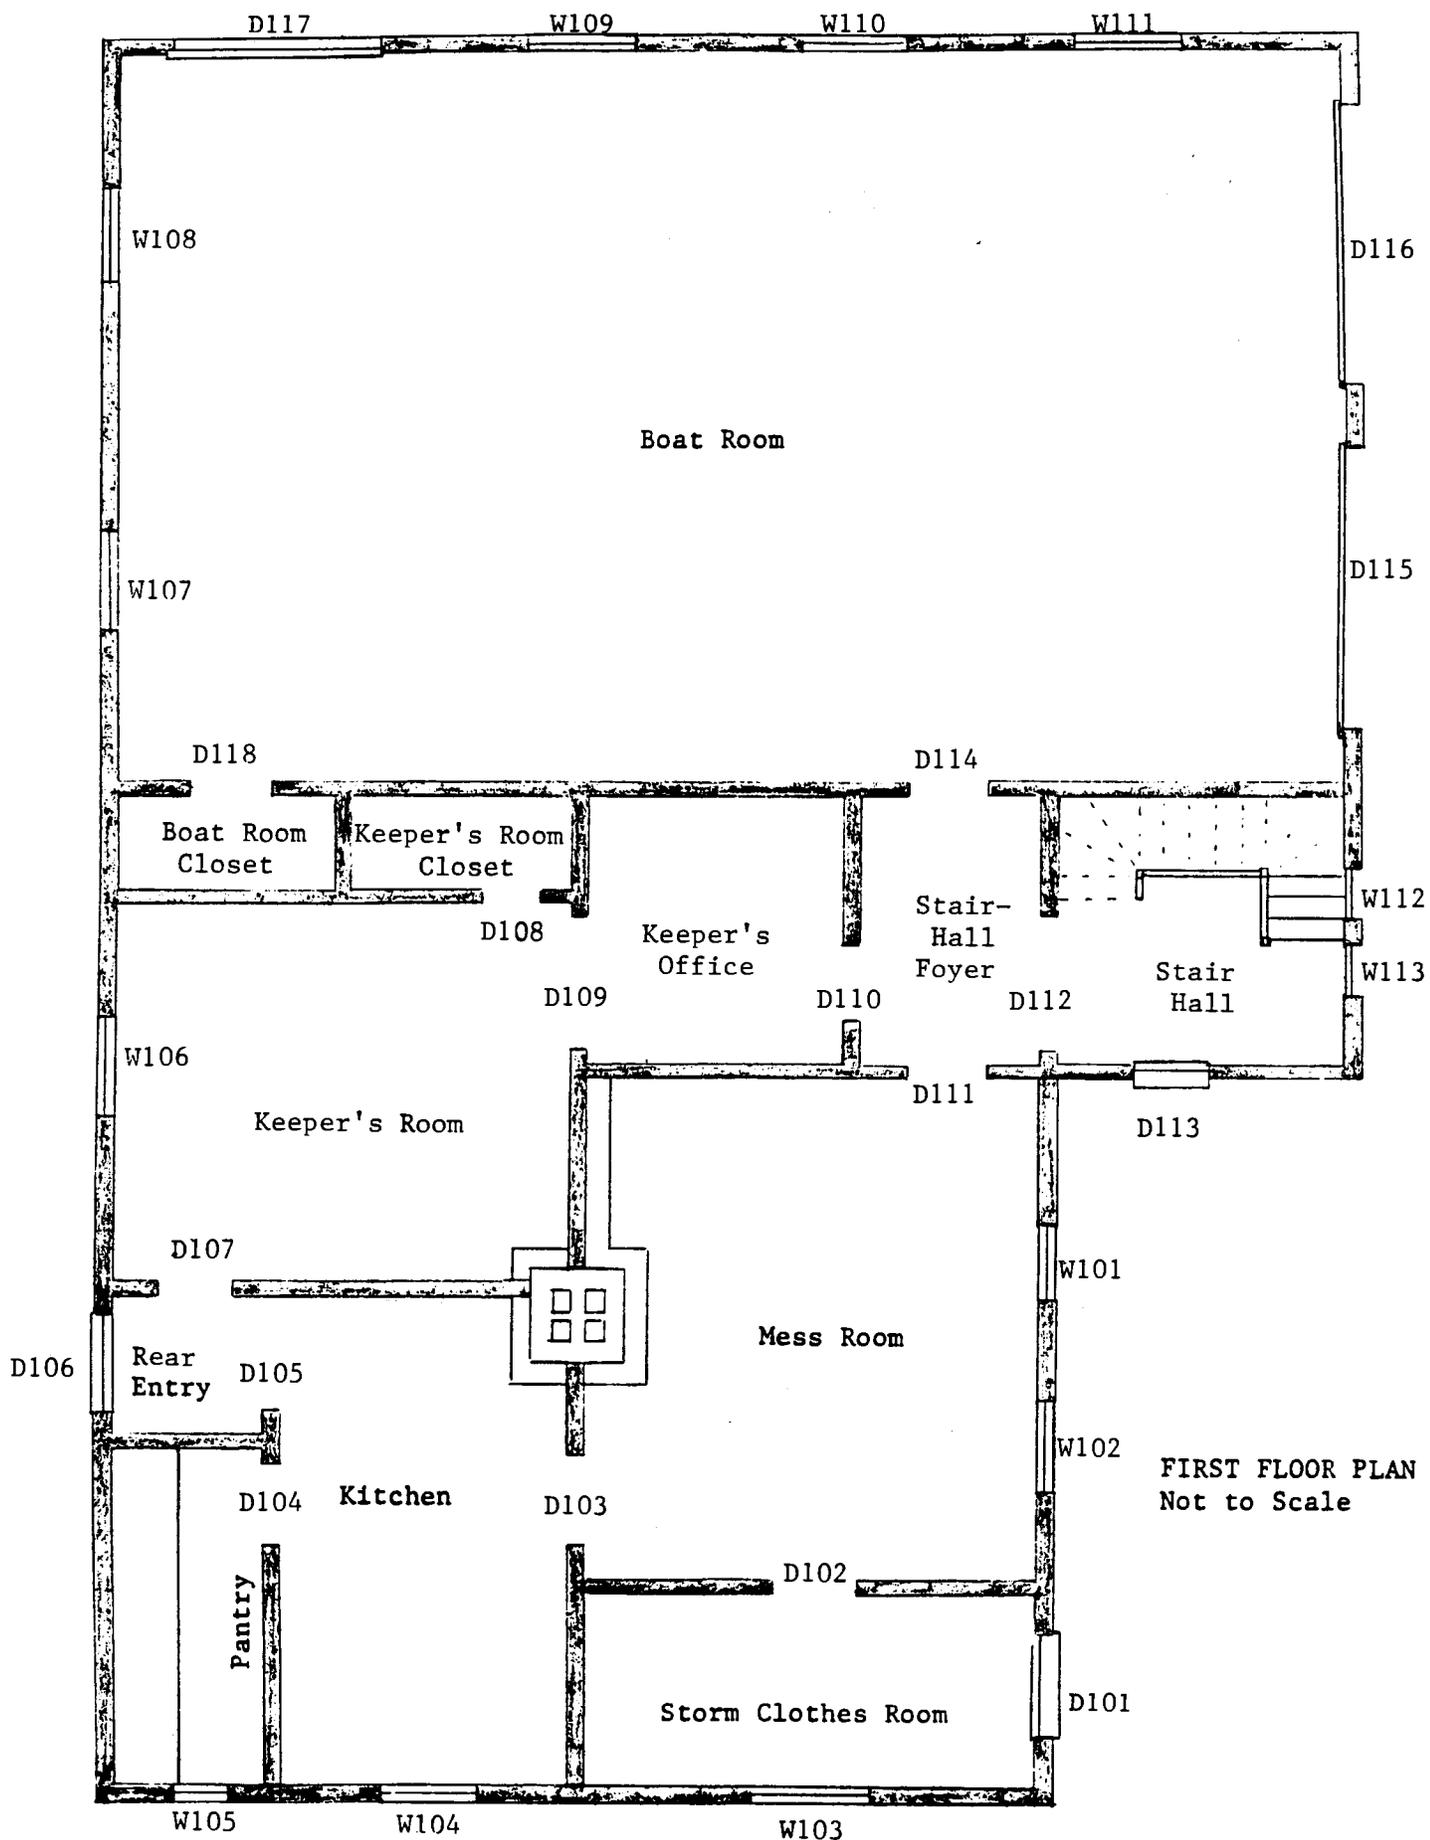
FIRST FLOOR PLAN
Not to Scale

Illustration 35. Key to Numbering of Doorways and Windows, First Floor.

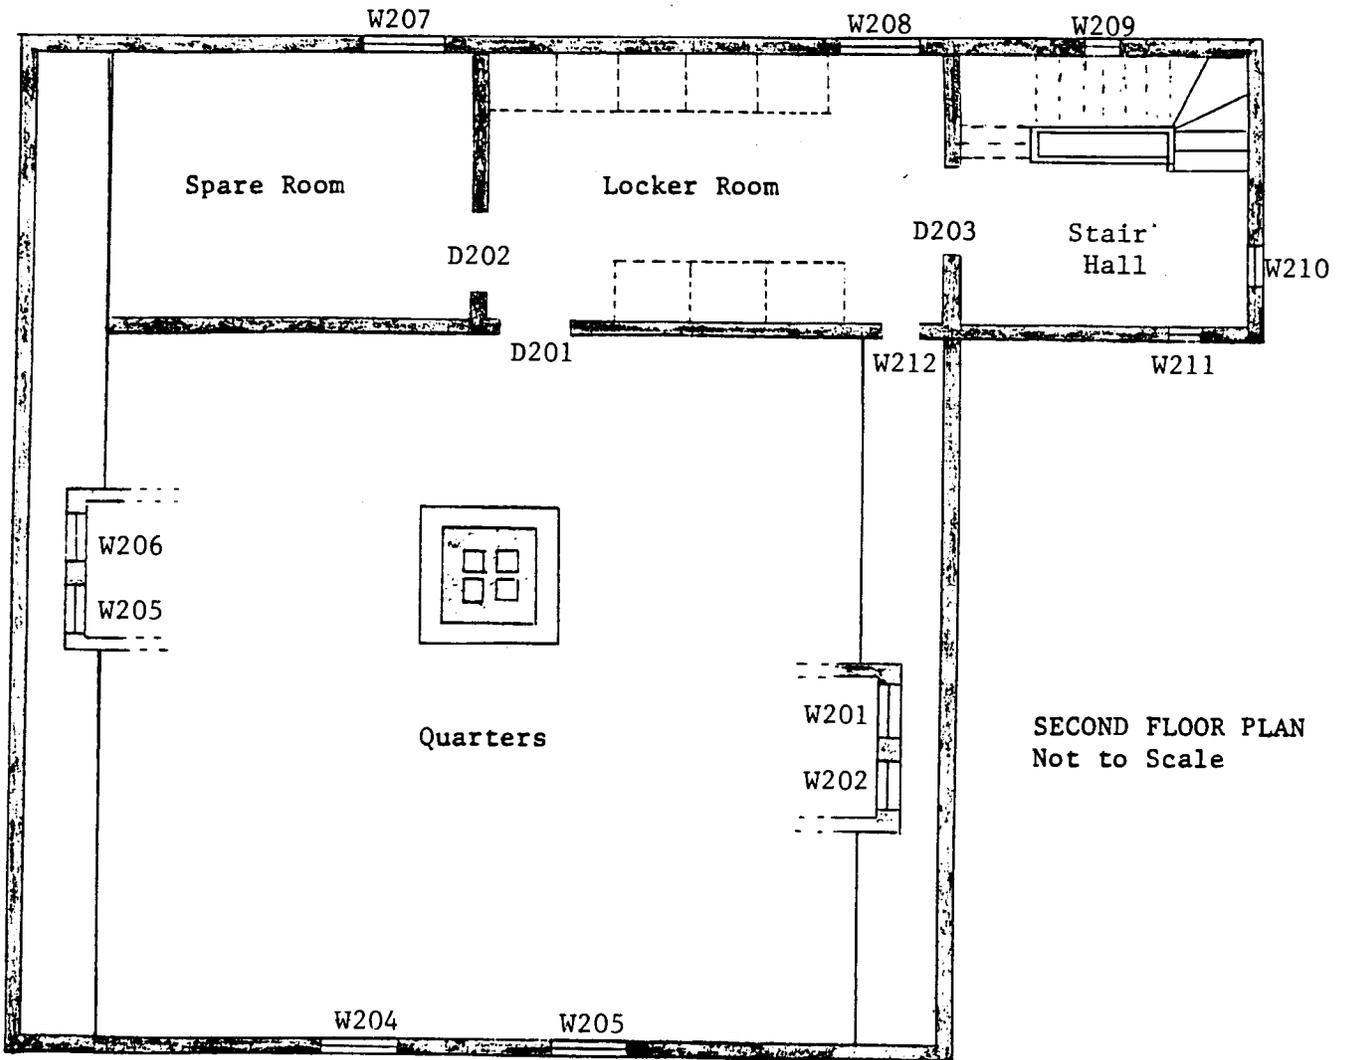
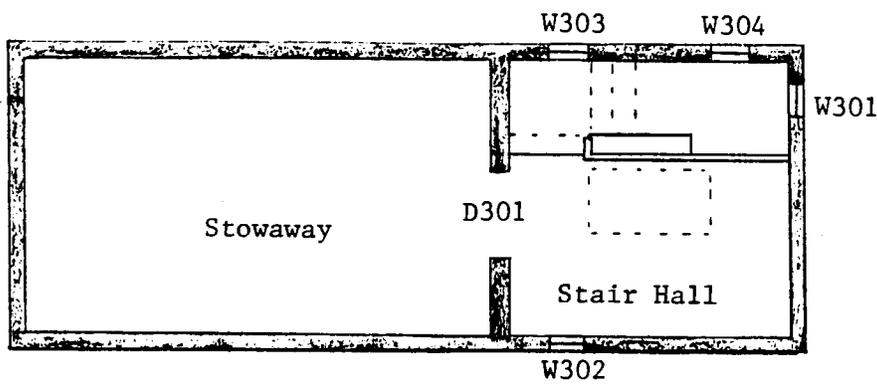
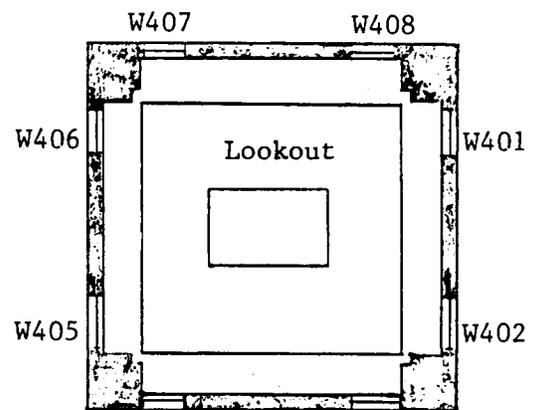
Illustration 36. Key to Numbering of Doorways and Windows, Second, Third, and Fourth Floors.

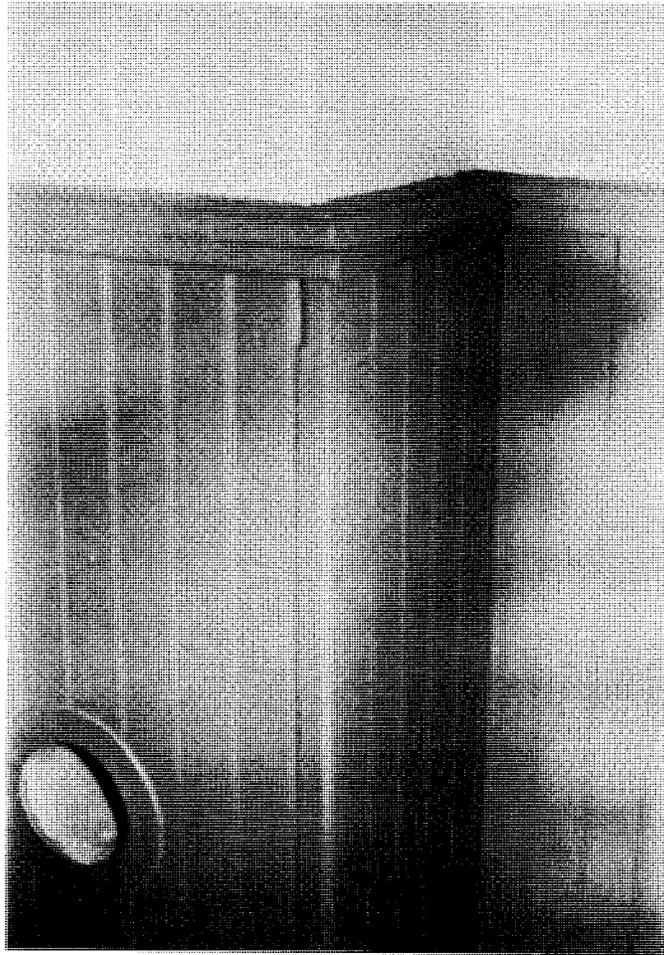
Illustration 38. Mess Room: Reproduction Chimney Wainscot With Original Corner Piece.

The room's extant single-beaded matchboard wainscot is a combination of old and new material, differentiated chiefly by the thickness and condition of the olive-green painted finish. New wainscot, probably installed ca. 1980, is present on all three sides of the chimney breast, except for the chamfered northwest corner piece, which is original material (fig. 38). A copy of this piece was made for use on the northeast corner. The new wainscot extends from the chimney breast onto the south wall of the room, to a point 14 3/4 inches east of the chimney, and to a point 23 1/4 inches west of the chimney. New wainscot also is found on all of the west wall, and on the east wall, except for a section 41 1/2 inches from the south end. A metal thimble (painted olive green) for a stovepipe connection is embedded in the north face of the chimney wainscot (see figure 38).

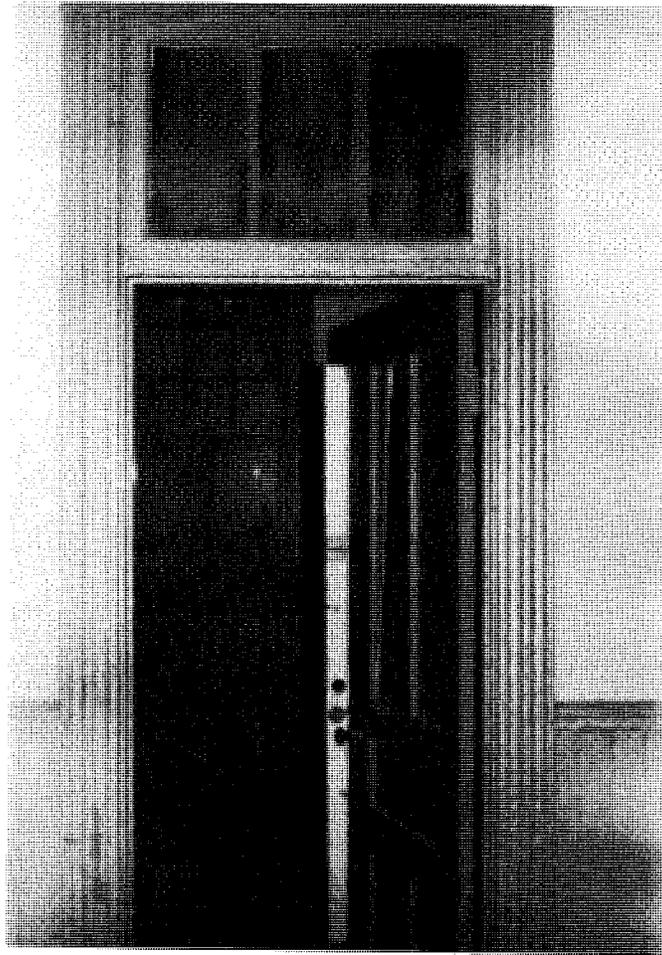
Illustration 40. Doorway 103: Looking
From the Kitchen Into the Mess Room.

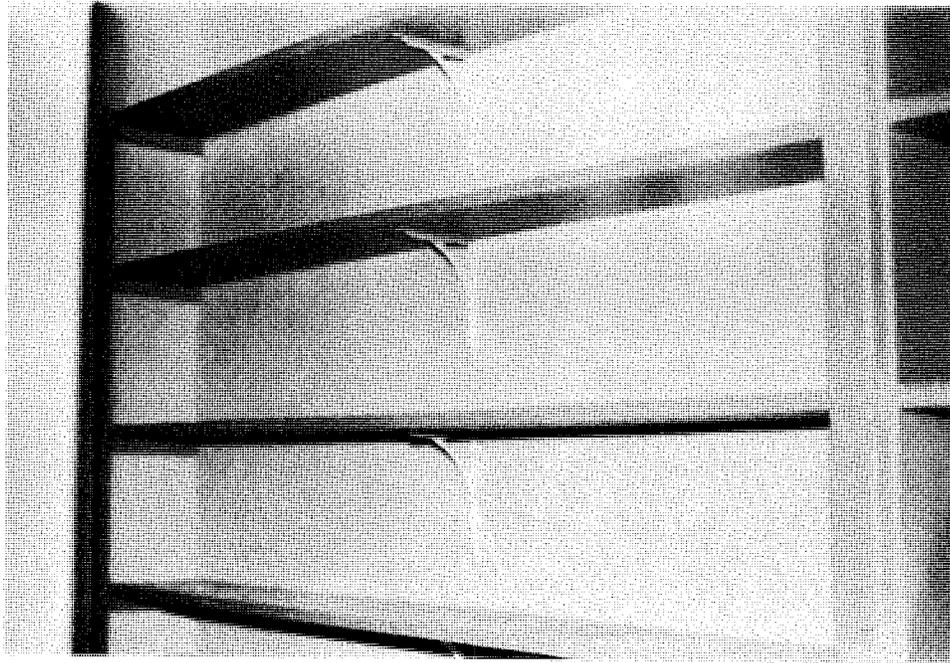
Illustration 41. Pantry: East Section of South-Wall Shelves.

The south wall above the counter top is covered with open shelving. The shelving is divided by a vertical wooden support into two sections, a larger east one and a smaller west one. (The vertical support is actually two boards installed side-by-side.) The east section extends all the way up to the ceiling; it contains four long shelves with molded edges (fig. 41). The east ends of these shelves are supported by wooden ledgers on the east wall, and are edged by a vertical molding running up the wall. The middle of the shelves rest on painted metal angle brackets. The bottom shelf is also supported by one metal angle bracket at its west end. This bracket seems to postdate the other brackets: the bottom end of the vertical divider was sawn off at the level of the bottom shelf at some point, and the west end of the bottom shelf would have needed an alternative means of support.
