**OLD HARBOR LIFE-SAVING STATION
Provincetown, Massachusetts**

HISTORIC STRUCTURE REPORT

**Cape Cod National Seashore
South Wellfleet, Massachusetts**

June 1988

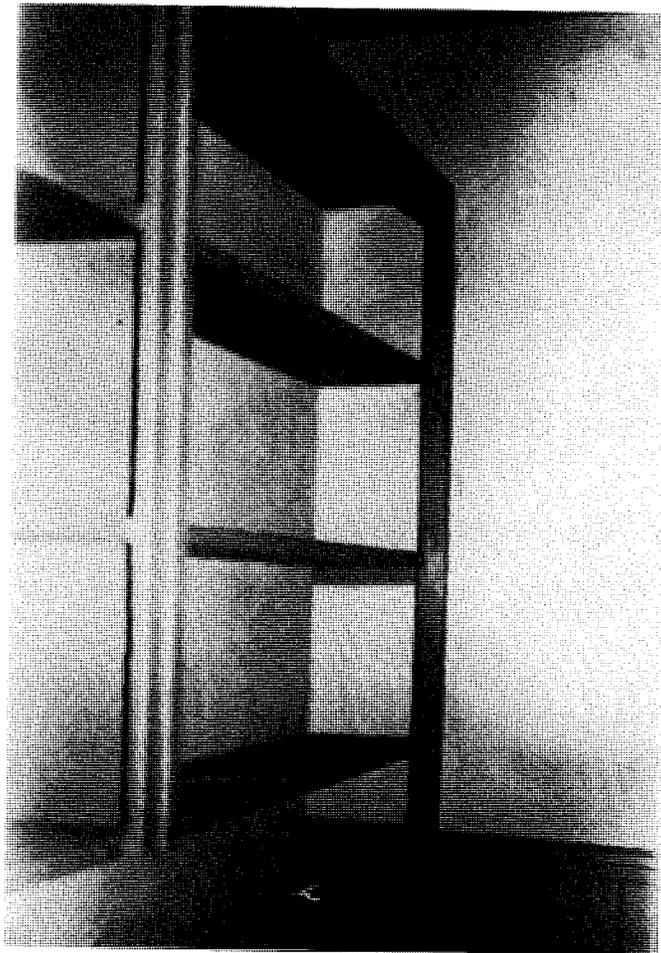
Illustration 42. Pantry: West Section of South-Wall Shelves.

The south wall above the counter top is covered with open shelving. The shelving is divided by a vertical wooden support into two sections, a larger east one and a smaller west one. (The vertical support is actually two boards installed side-by-side.) The east section extends all the way up to the ceiling; it contains four long shelves with molded edges (fig. 41). The east ends of these shelves are supported by wooden ledgers on the east wall, and are edged by a vertical molding running up the wall. The middle of the shelves rest on painted metal angle brackets. The bottom shelf is also supported by one metal angle bracket at its west end. This bracket seems to postdate the other brackets: the bottom end of the vertical divider was sawn off at the level of the bottom shelf at some point, and the west end of the bottom shelf would have needed an alternative means of support.

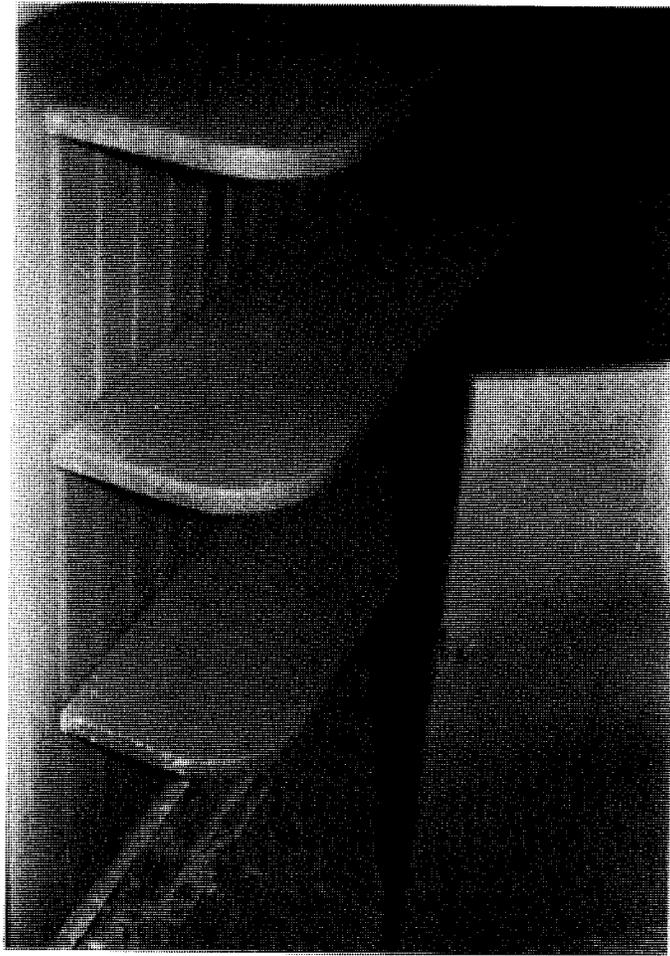
Illustration 43. Pantry: North-Wall Shelves.

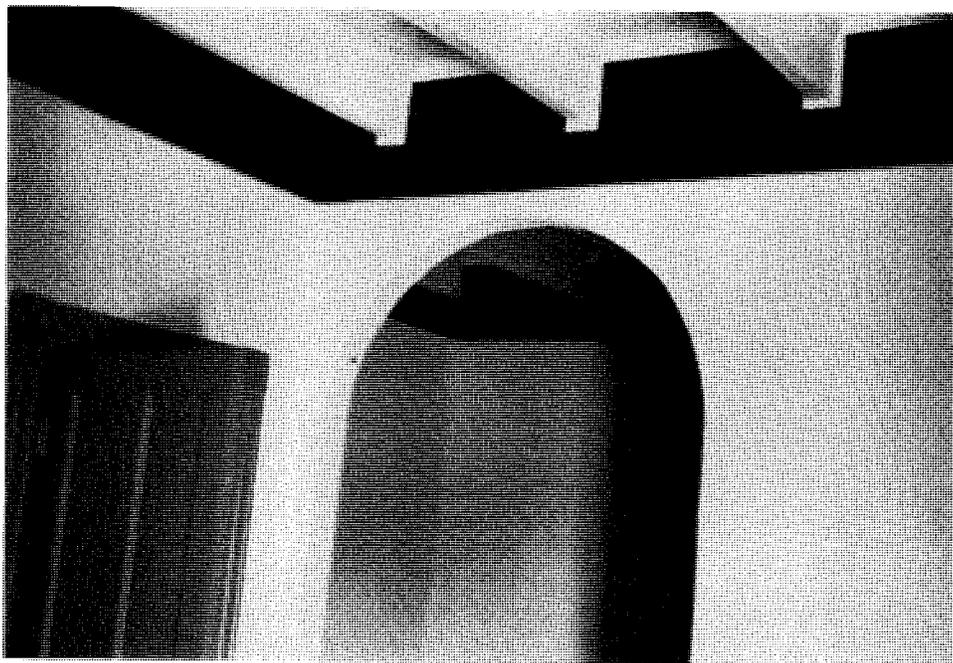
Illustration 44. Doorway 109: Looking From the Keeper's Room Into the Keeper's Office.

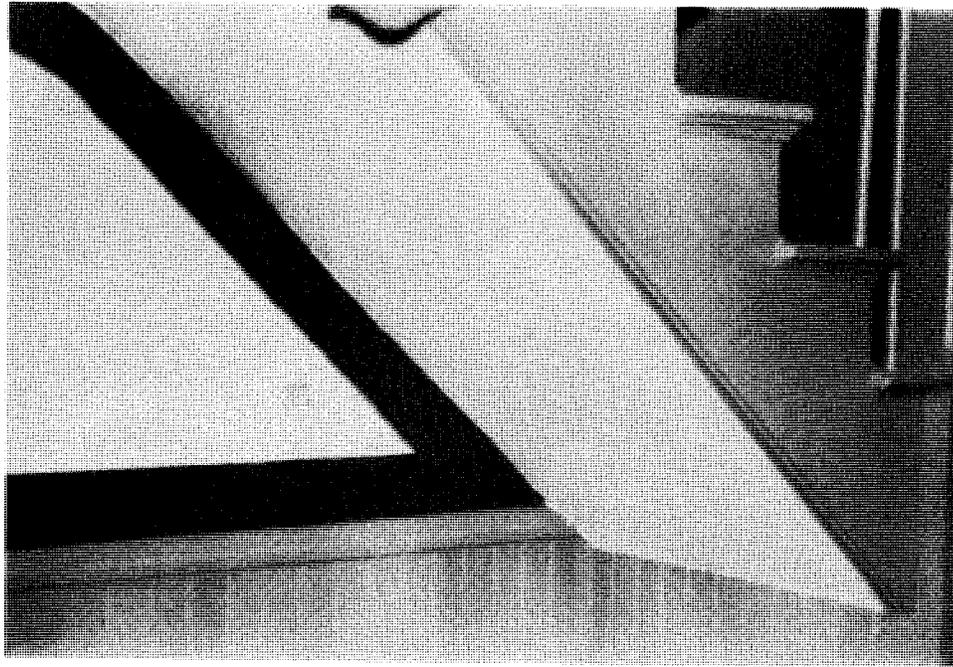
Illustration 45. First-Floor Stair Hall:
Soffit of Stair.

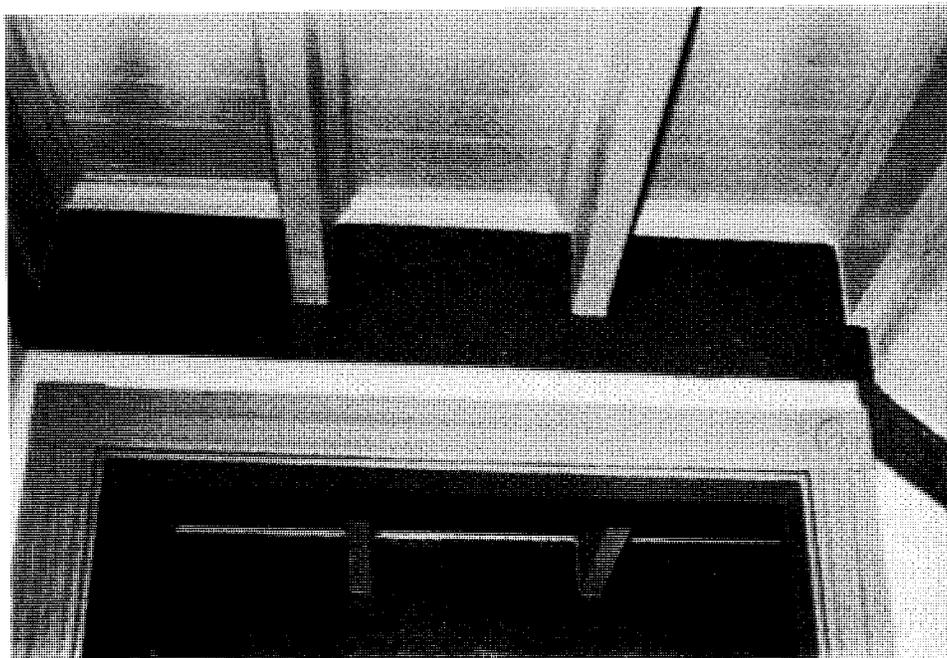
Illustration 46. First-Floor Stair Hall:
Cornice Paint on South Wall.

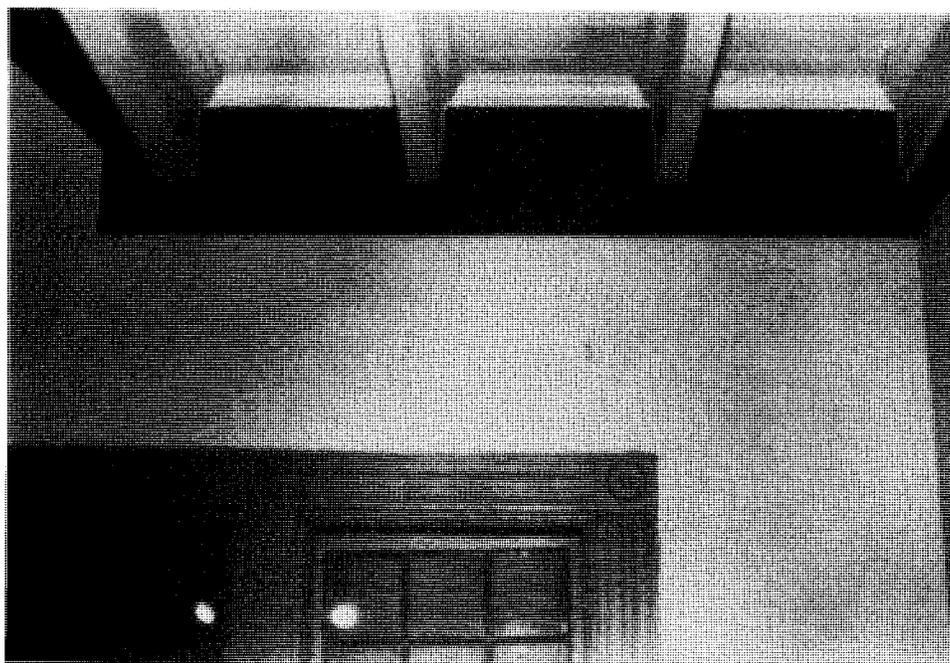
Illustration 47. First-Floor Stair Hall:
Cornice Paint on North Wall.

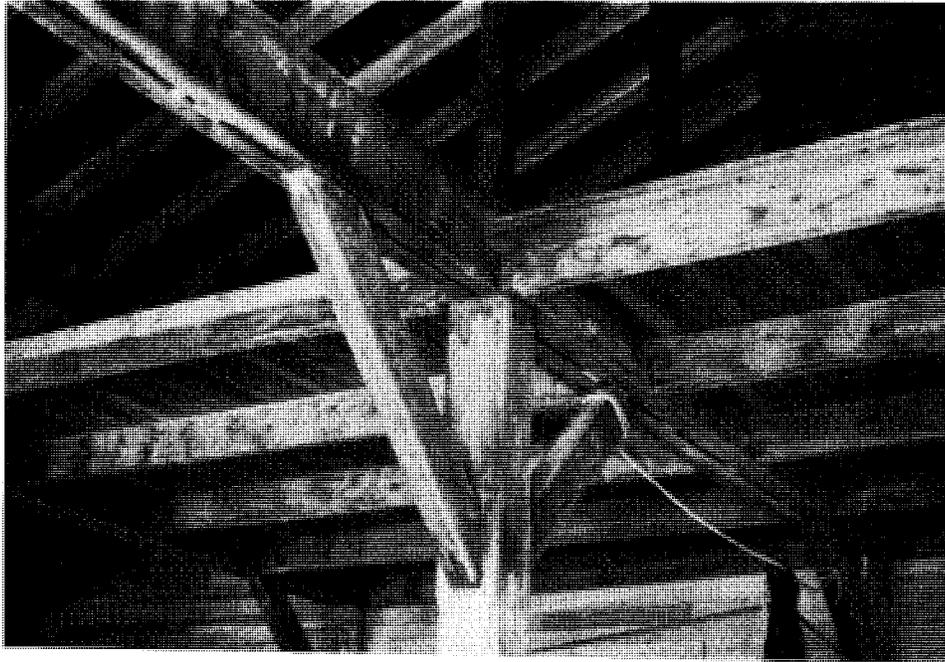
Illustration 48. Boat Room: Roof Truss
and Post.

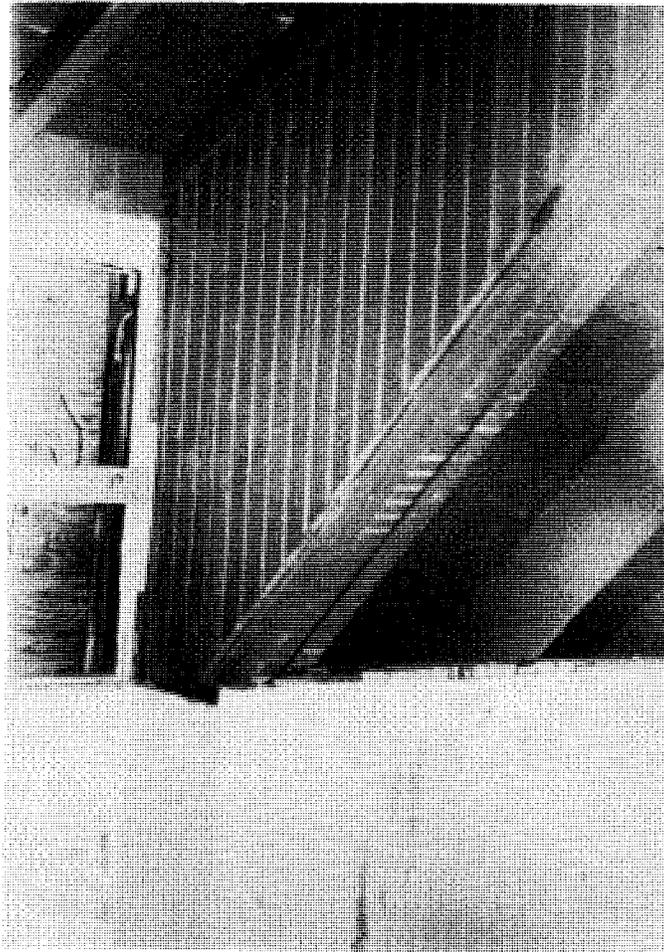
Illustration 49. Quarters: Side of
South Dormer.

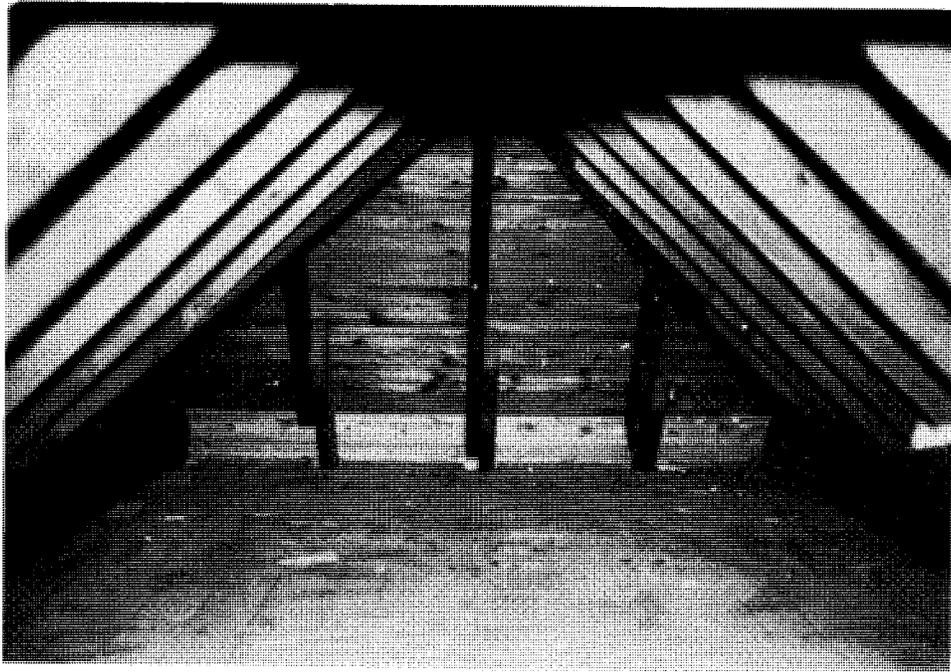
Illustration 52. Stowaway: Looking South.

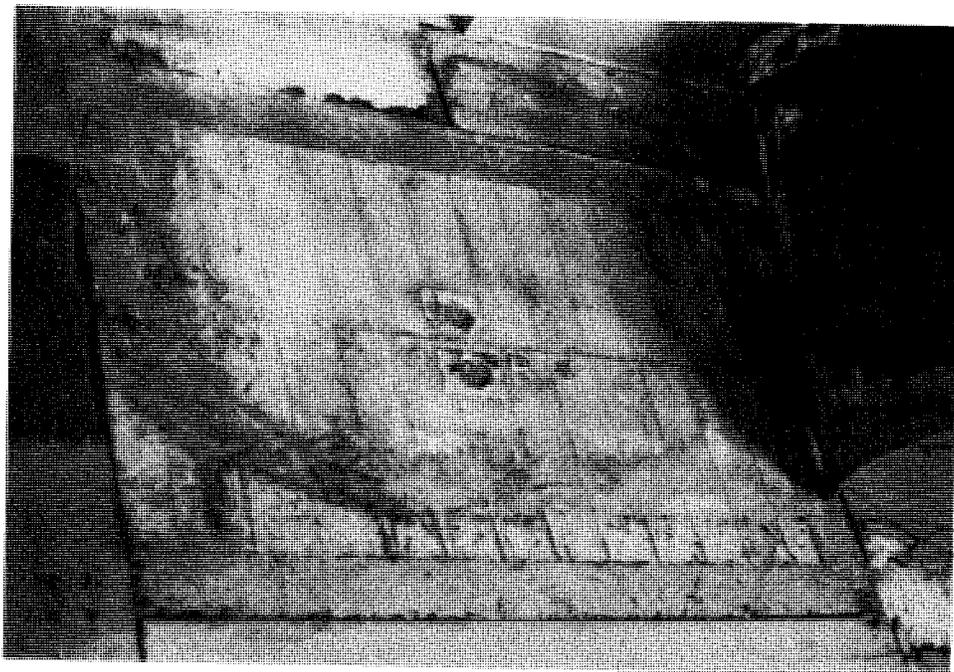
Illustration 55. Lookout: Doors of Historic Hatchway.

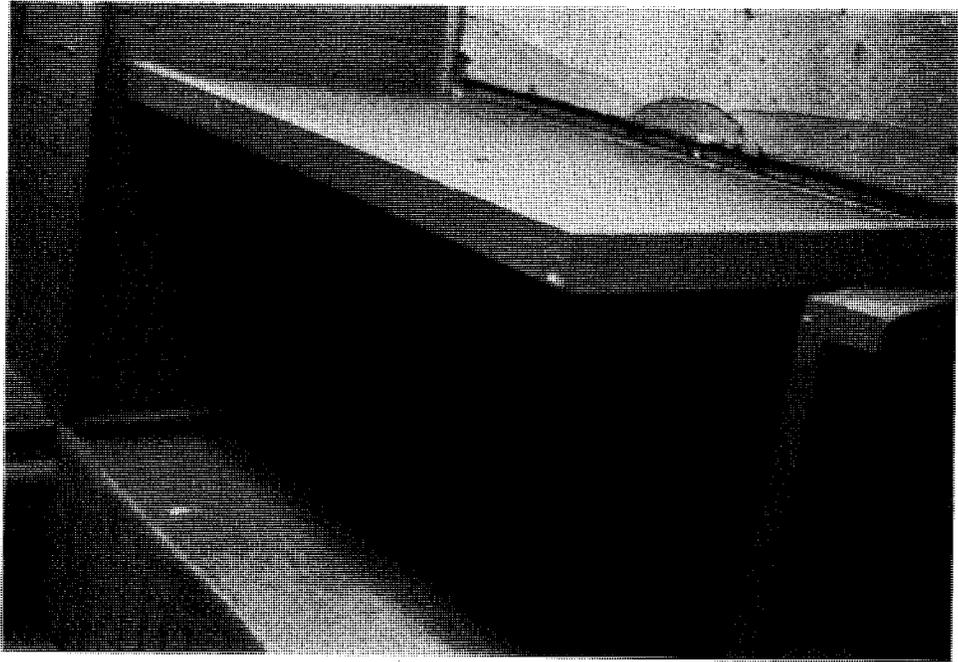
Illustration 56. Lookout:
Posthistoric Opening in Floor.

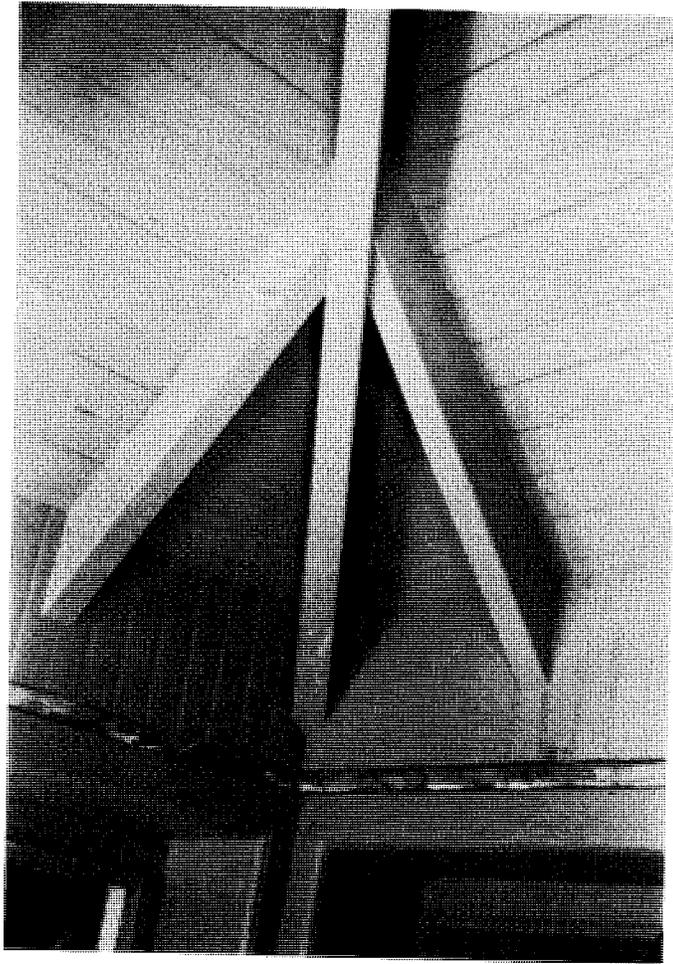
Illustration 58. Lookout: Upper Wall Tier and Hip Rafter.

The "jamb" and "soffit" of the recessed middle tier are covered with smooth lumber (fig. 58). This material appears to be original, despite the fact that the original drawings call for these areas to be covered with matchboarding. The "back" of the recessed middle tier is finished with the same type of matchboarding used on the lower tier of wall. This material is also used on the upper tier of wall.

A quarter-round shoe molding is extant around most of the base of the lower wall tier. It is missing from the southern two-thirds of the east wall, where the posthistoric opening to the third floor was created. The matchboarding here is intact, however, and paint lines on it clearly indicate the former presence of floorboards and a shoe molding. A joint near the bottom of the upper tier was formerly covered by a molding that ran around the entire perimeter of the room. This molding is now missing (see figure 58, top).

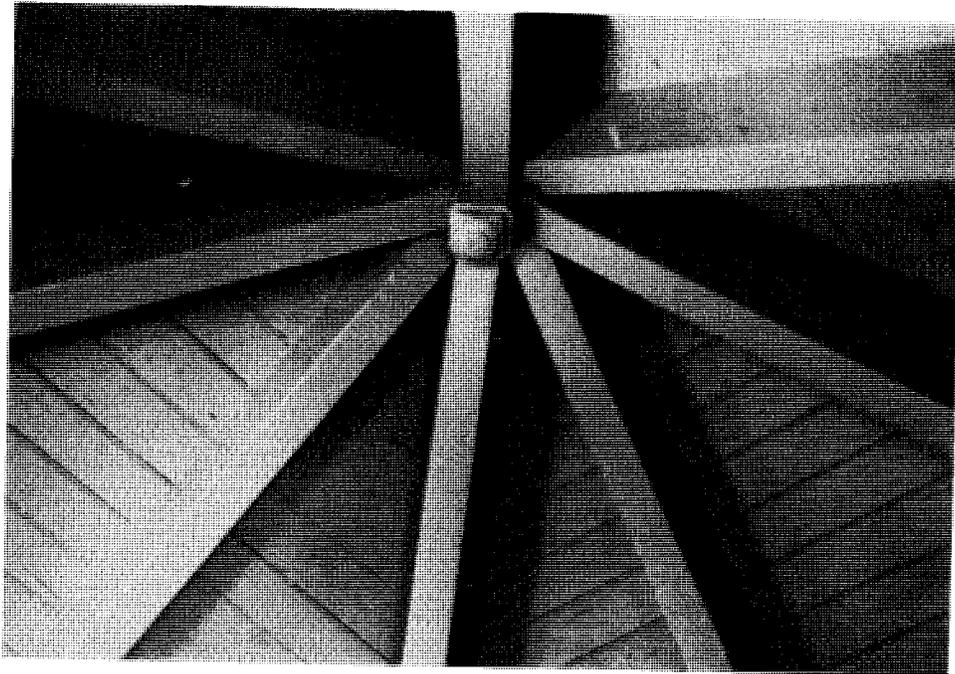
Illustration 59. Lookout: Apex of Roof Framing.
