## Historic Lighthouse Preservation:

# MASONRY

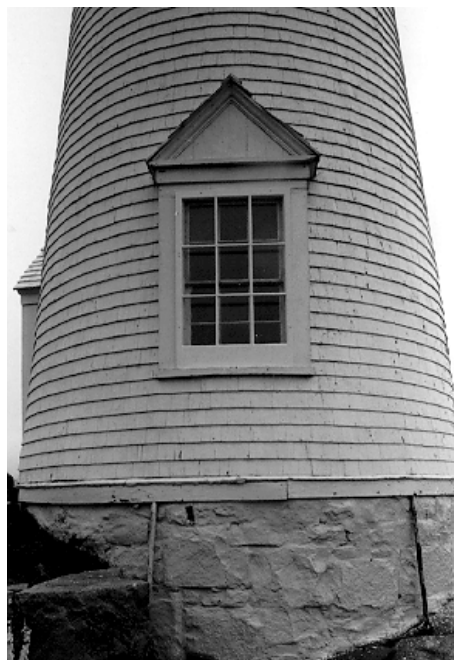
**Figure 2.** Stone masonry foundation in a 38-foot-tall wood-frame lighthouse in Maine.

Brick and stone masonry is the most commonly used building material in lighthouse construction.<sup>1</sup> Because of the harsh conditions associated with the locations of most lighthouses, brick and stone masonry was chosen for its durability. The use of masonry construction ranges from stone foundations of wood frame towers to the brick walls of tall towers (see Figures 2 and 4).

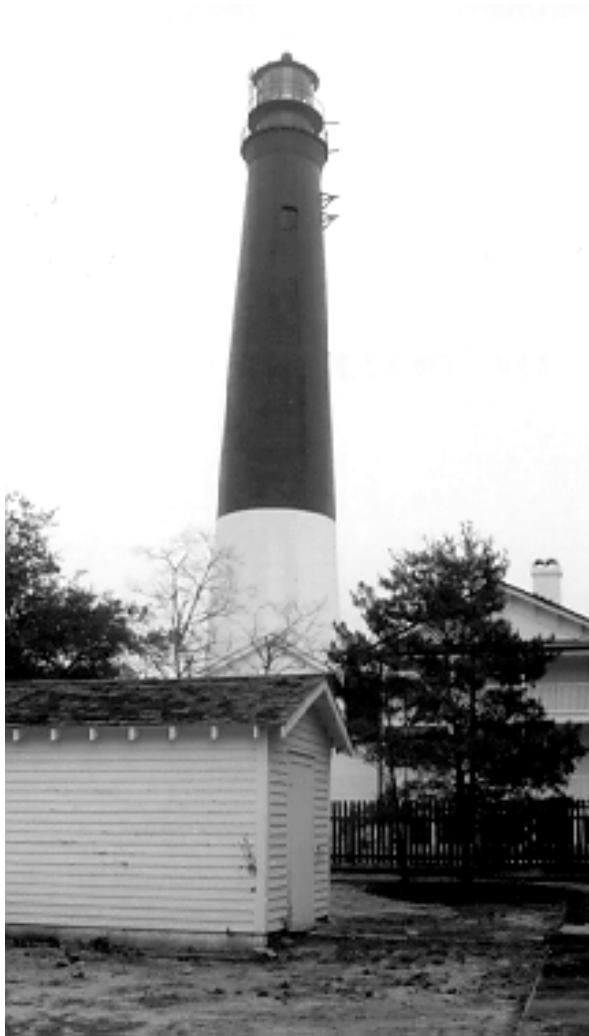
**Figure 4.** Brick masonry construction in the 171-foot-tall Pensacola Lighthouse in Florida.

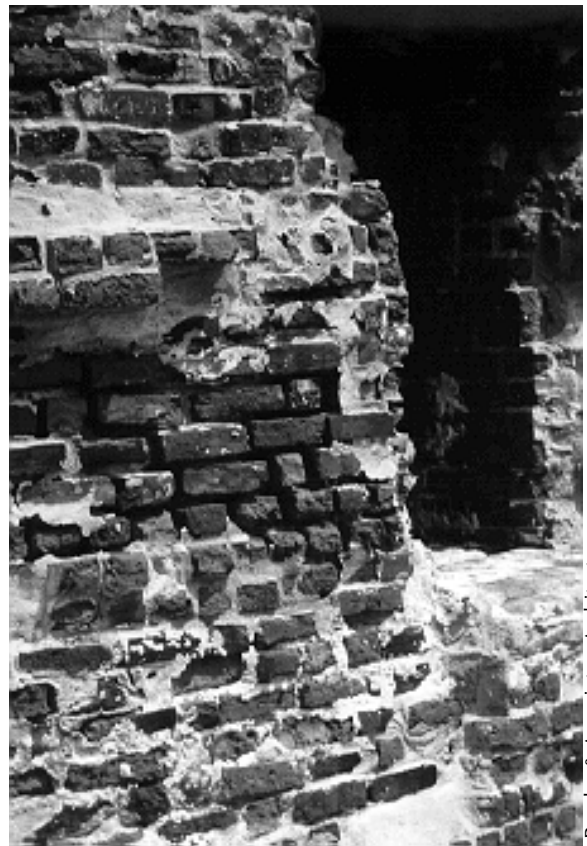
**Figure 5.** The coating that once protected the soft bricks of this lighthouse was not maintained; the severe deterioration required the replacement of nearly 25,000 bricks.
