PRESERVATION TREATMENTS

Protection and Stabilization (Mothballing)

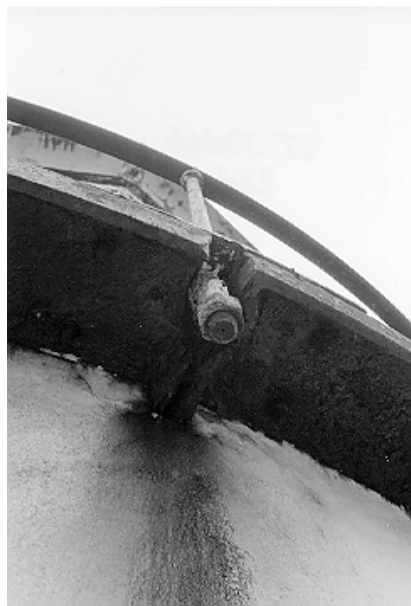
Figure 10. View of underside of gallery deck; the streaks on the stucco indicate that water is passing between the deck plates and possibly entering the masonry wall.

- **Gallery decks:** In most masonry lighthouses gallery decks are cast iron, sheet-metal-covered wood, stone, or concrete. These decks are generally laid directly on top of the masonry wall structure. The decking should be sloped away from the lighthouse to shed the water away from the structure. If the decking material is not weathertight, moisture can enter the interior cavity of the masonry wall. See Figure 10 for signs that a gallery deck is failing. Refer to the **Lantern** section of this handbook for more information concerning the weatherproofing of gallery decks.

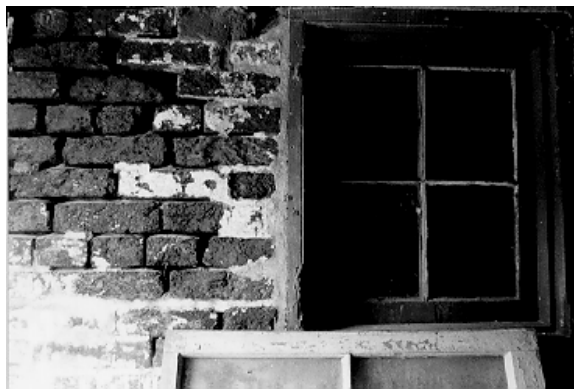
Figure 11. Detail of severely eroded brick and painting.

- **Loose or eroded mortar joints:** If pointing between masonry units is loose, cracked, eroded, or is completely missing, moisture will penetrate (see Figure 11). In order to prevent this infiltration, all pointing that is in disrepair must be removed and the affected joints repointed. For more information refer to the discussion on repointing under the **Repair** treatment in this section of the handbook.

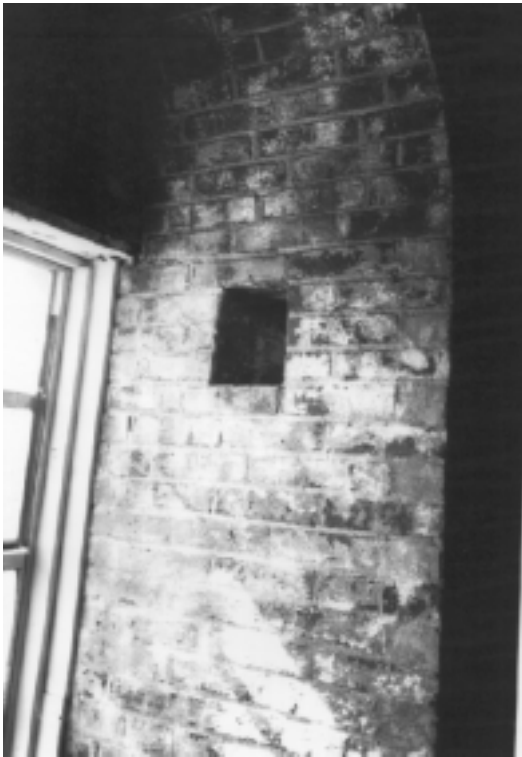
Figure 13. Vent hole located in the window well of a brick lighthouse.

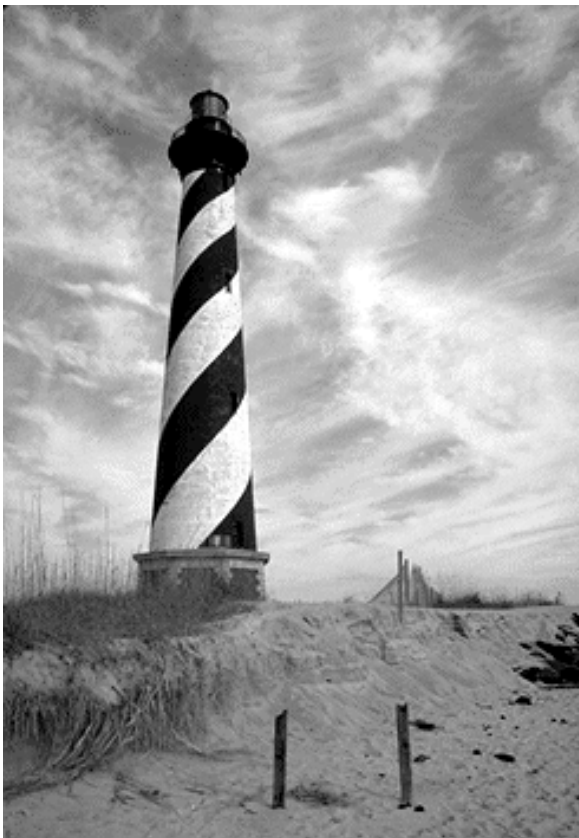
Figure 16. Daymark patterns are a character-defining feature and should be preserved.

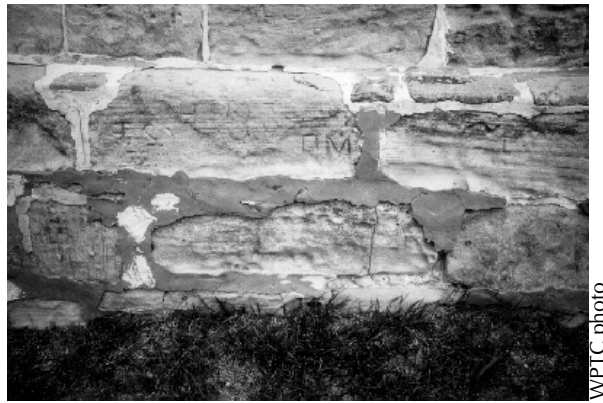
Figure 19. The use of hard portland cement mortar and sloppy pointing technique have aided in the deterioration of this soft sandstone wall.

Modern portland cement has a higher compressive strength than the lime-based mortars. This quality makes the portland-based cements less flexible than the lime-based mortars; therefore, the pointing tends to resist the expansion and contraction of the softer historic bricks. This resistance will ultimately cause the faces of the bricks to fracture and spall off the body of the brick. In some cases the exterior wythes of brick may shear from the inner core of the wall, resulting in the failure of the outer sections of the wall.

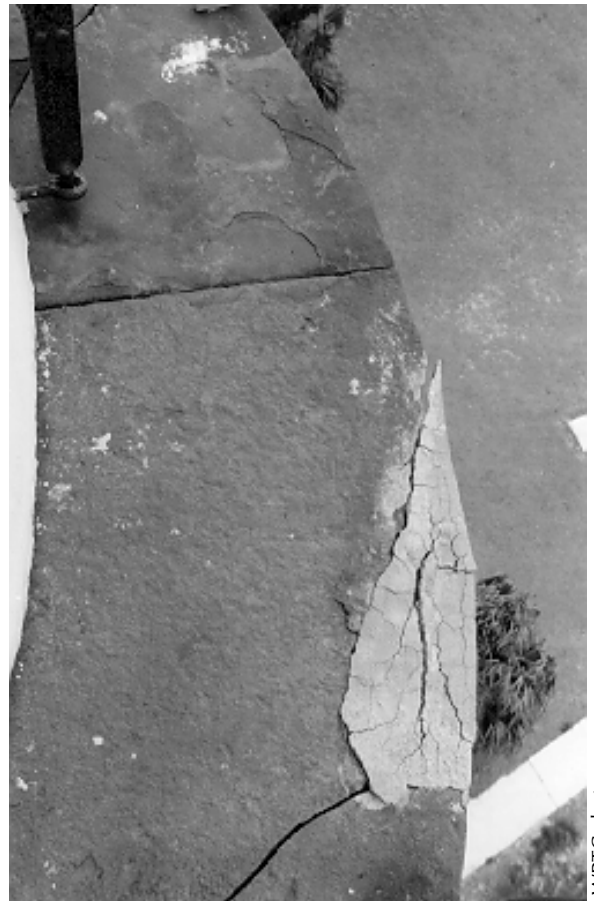
Figure 22. A failing repair made to a stone gallery deck using a simulated stone material. A stone dutchman repair should have been used.

- Repair only damaged materials. If possible, limit this type of work to replacement of damaged masonry units only, i.e., isolated removal of a single damaged brick or stone.
- When repairing stone, use traditional dutchman repair techniques as a first choice; consider substitute materials only as a last resort.
- For replacement, use only substitute materials that convey the visual appearance of the surviving parts of the masonry feature and that are physically and chemically compatible.
- Do not apply waterproof, water-repellent, or non-historic coatings such as stucco to masonry as a substitute for repainting and masonry repairs. Coatings are frequently unnecessary, expensive, and may change the appearance of historic masonry as well as accelerate its deterioration.
