PRESERVATION TREATMENTS

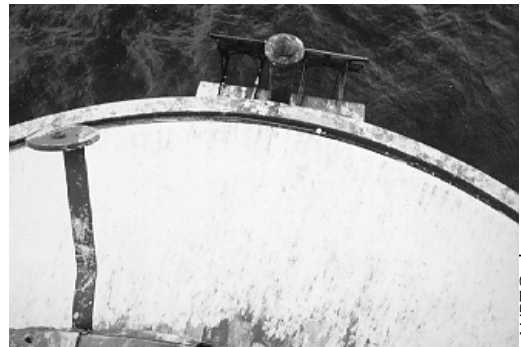
Figures 23 and 24. Two types of gutters found on iron lighthouses; the gutters must be in proper working order and checked regularly during the mothballing period.

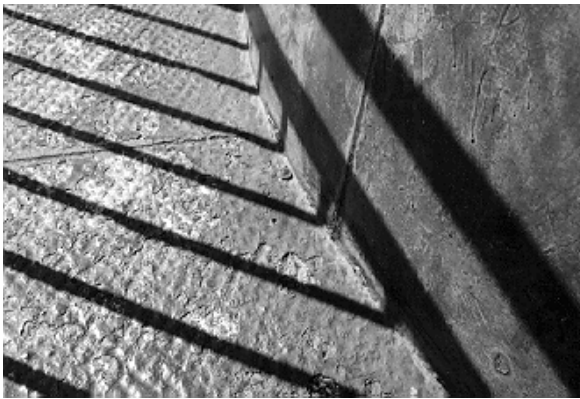
Figure 25. The seams between the deck and wall plates of this lighthouse were not properly sealed; as a result the areas collected water and began to rust.

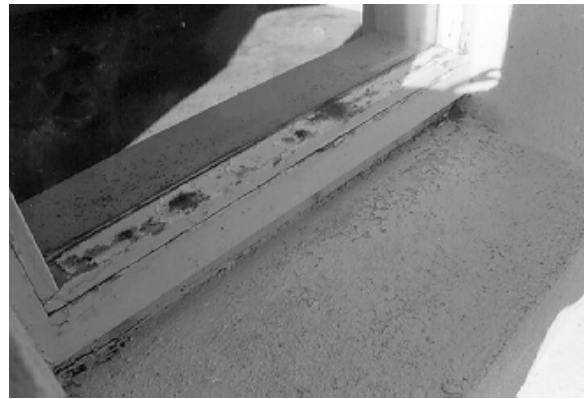
Figure 26. This steel casement window frame was not sealed properly and as a result has begun rusting from the inside out.

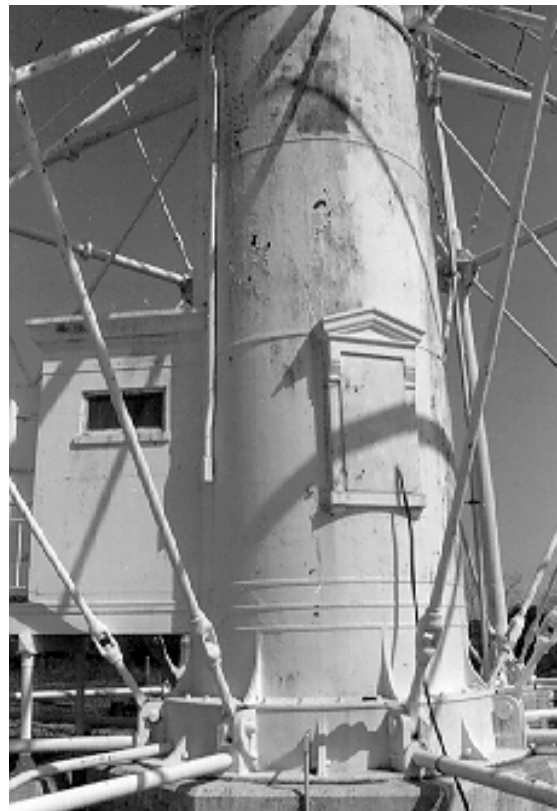
Figure 27. Blistering paint, as pictured here, should be removed and the affected areas properly primed and painted.

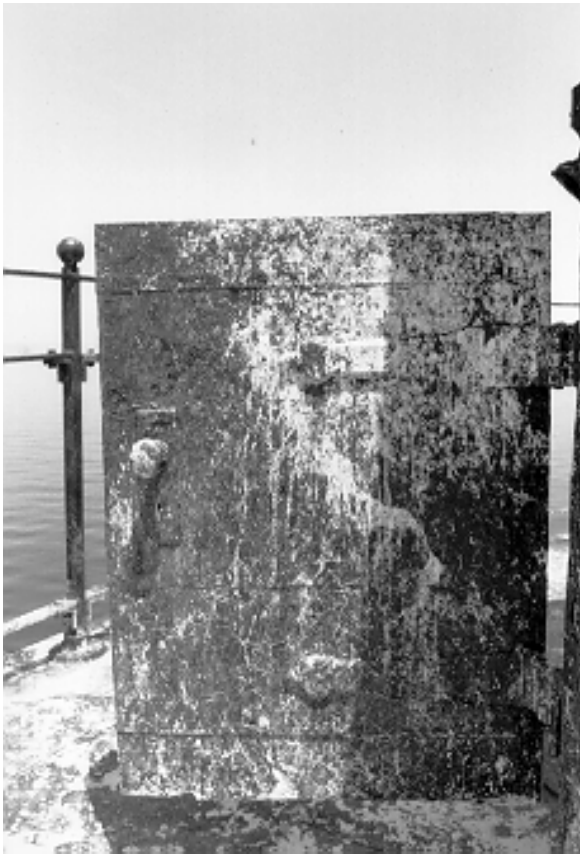
Figure 28. Surfaces such as this sheet-steel-covered parapet door that are covered with seagull guano should be thoroughly cleaned before mothballing and should be checked and cleaned once a year during the mothballing period.

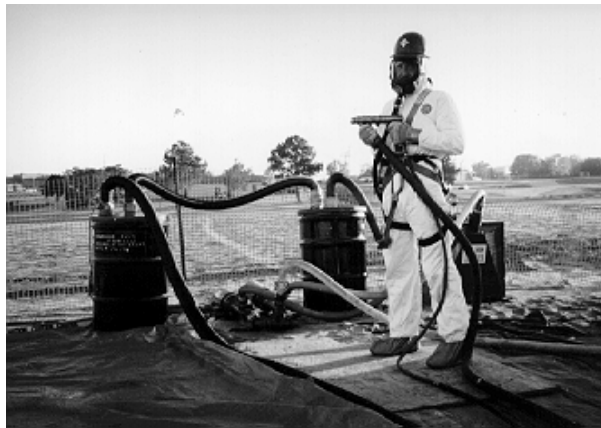
Figure 29. Worker dressed in full personal protective gear. The full-face-shield self-contained respirator provides both respiratory and eye protection. The worker is wearing protective coveralls, gloves, and boot covers to prevent lead dust contact. The harness is part of a full protection system. He is holding a pneumatic needle gun that is hooked to a two-stage HEPA (High Efficiency Particulate Air) filtered vacuum system.

outfitted with dust-collection hoods with vacuum hookup. As with any paint removal procedure, personal protective equipment required for health protection should be worn. Typical personal protective equipment includes eye/face protection, respiratory protection, gloves, coveralls, hard hat, and protection from falling if working 6 feet or higher above the ground (see Figure 29).

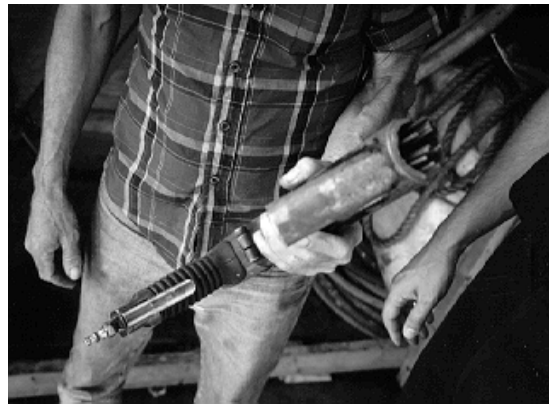
Figure 30. Close-up of a pneumatic needle gun. This tool works well for hard-to-reach and detail areas. The needle gun can be pressure-controlled to minimize impact on the iron substrate. This figure shows the vacuum-shroud connection on the right and air-hose connection on the base of the pistol-grip handle on the left.

Figures 30 through 33 are paint removal tools used during the Sand Key Lighthouse rehabilitation. Sand Key Lighthouse is located in open water off the coast of Key West. The paint being removed contained lead; therefore it was essential that all debris be contained for proper disposal.

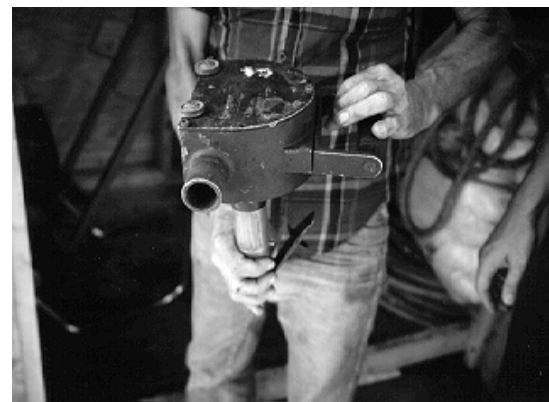
Figure 32. Close-up view of a pneumatic flush-plate tool. During the Sand Key Lighthouse rehabilitation this tool was used for all flat surfaces and for removing paint from the light-tower columns. The rollers located at the top and bottom of the shroud guide the tool over the flat and curved surfaces. The amount of air pressure controls the speed and impact of the rotating head against the iron substrate. To contain the paint dust and chips, the shroud has been outfitted with a vacuum hookup.

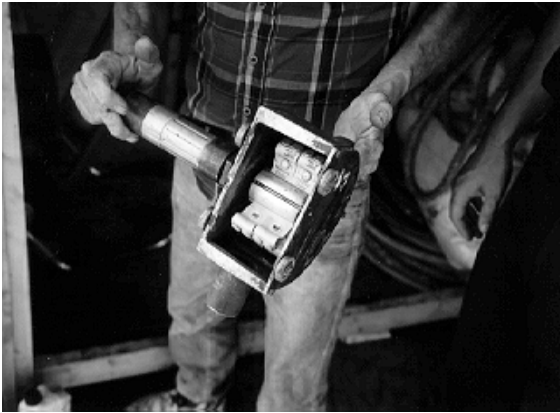
Figure 33. Close-up of the studded flaps mounted on the rotating head. To use the tool, it is held against the face of the iron member and as the studded flaps spin they “slap” the surface and “knock” the paint off the iron.

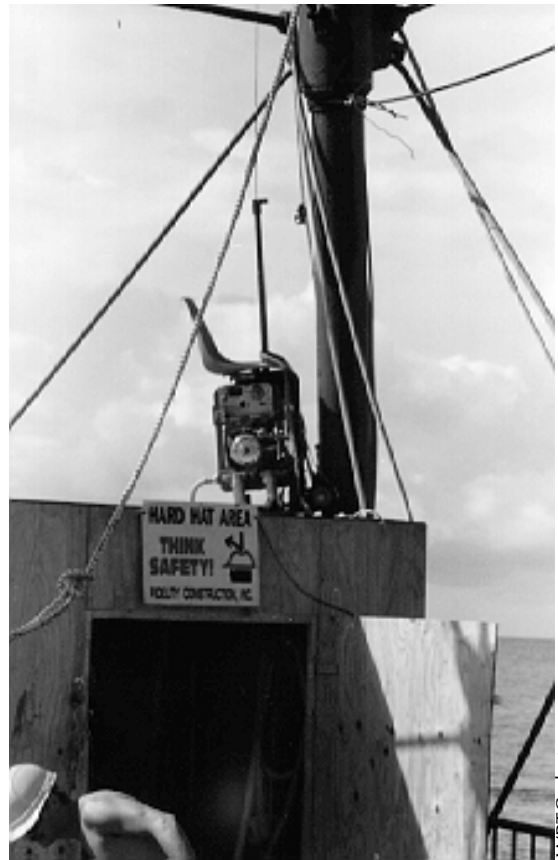
Figure 35. This motorized chair was used to hoist workers as they removed paint from the cast-iron columns at the Sand Key Lighthouse. The chair’s motor is attached to a hoist, so the chair actually climbs a cable that has been strung alongside the column.

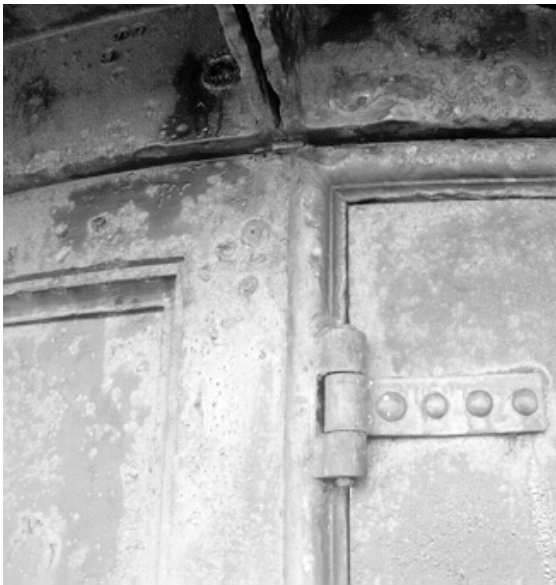
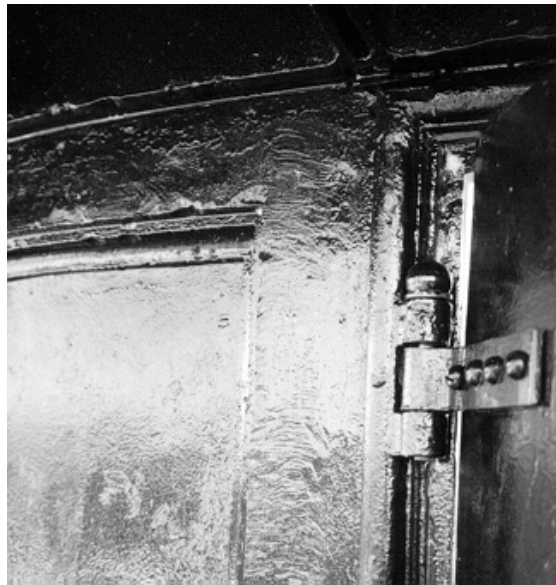
Figures 36 and 37. The left image shows the condition of the iron exterior service room wall before rehabilitation. The right image shows the same area after power hand tool cleaning and coating. The crescent shaped scars in the iron are from the arc of a grinding wheel.

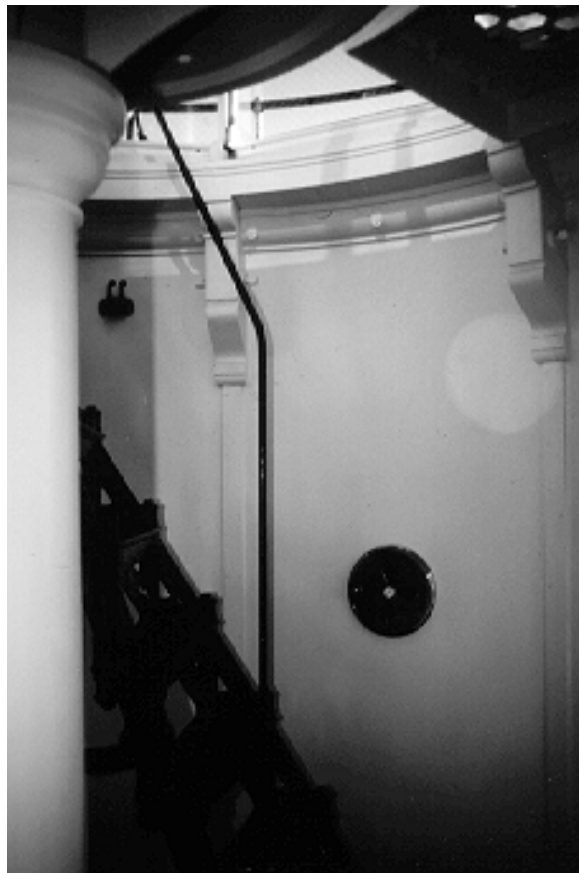
Figure 38. Service room bracket after chemical cleaning.

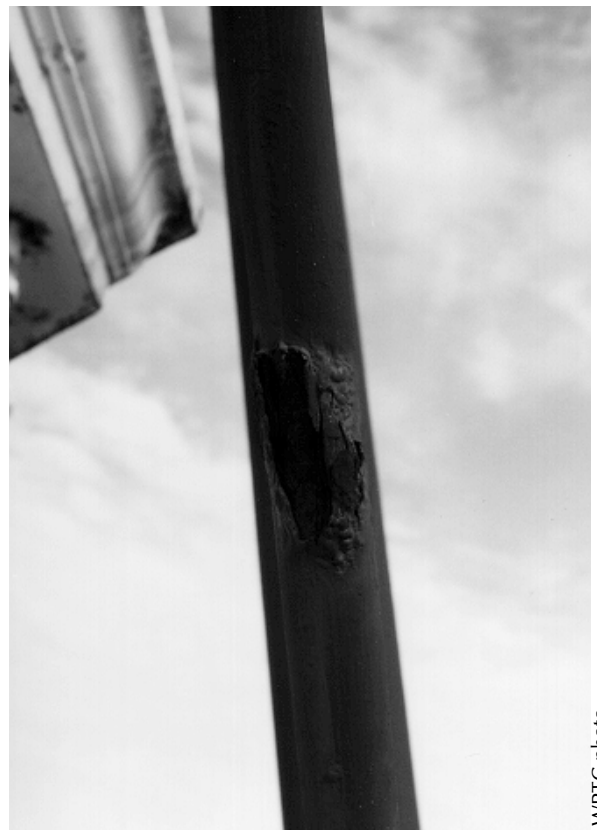
Figure 39. The finish on this tension rod failed and localized corrosion (rust) has formed. The rust is exfoliating in layers that are trapping moisture and causing corrosion to occur deeper and deeper into the tension rod. The result is pitting that will compromise the strength of the tension rod. If the area had been touched up in time, the corrosion might not have formed.

The effective protective life span of an existing paint or coating can be greatly increased by routinely touching up areas of deterioration. A small break in the protective finish can lead to accelerated corrosion of the underlying iron (see Figure 39). Areas where the paint or coating has been damaged by mechanical impact or blistering has occurred should be addressed immediately. These areas should have all loose paint and rust scale removed using one of the recommended methods

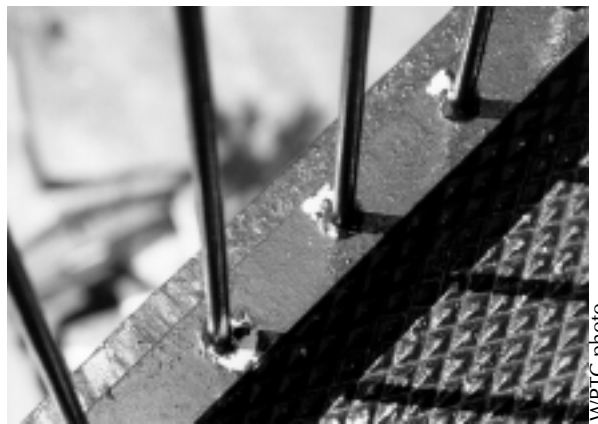
Figure 40. The paint on this stainless steel replacement gallery deck has begun to peel less than three months after it was painted. This could have been prevented if the stainless steel parts were first cleaned and then lightly glass-bead blasted.

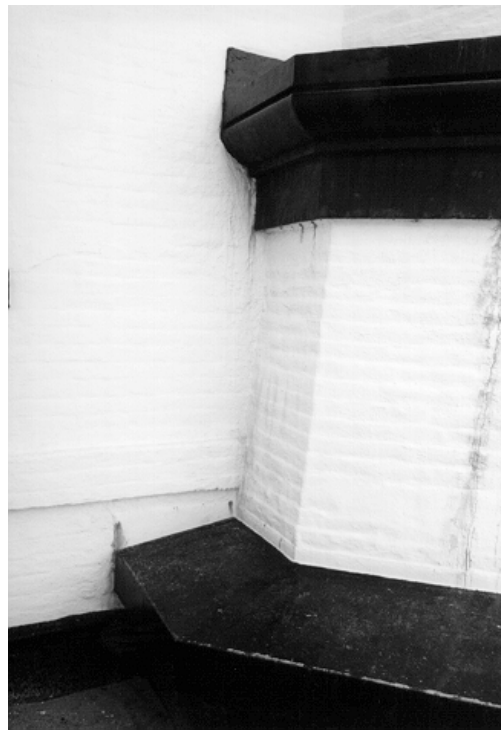
Figure 41 (left). This masonry lighthouse has been detailed with a two-tier cast-iron water table (the iron portions are painted black). Rust-bleed is occurring along lower edge of the upper tier.

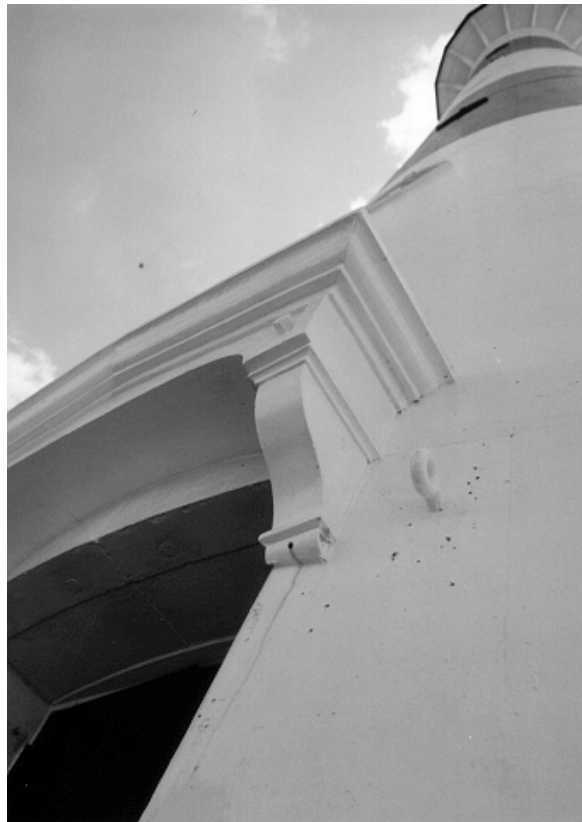
Figure 45. Within three months after painting, the rust began to bleed through this weep hole on the bottom of this pediment bracket. Two lessons are to be learned from this condition: 1) keep weep holes open to allow any water that may have entered the casting to escape, and 2) keep joints around applied castings sealed; apparently this was not done and water has entered the hollow cavity of the pediment, causing rust to form inside.
