## Historic Lighthouse Preservation:

# DOORS

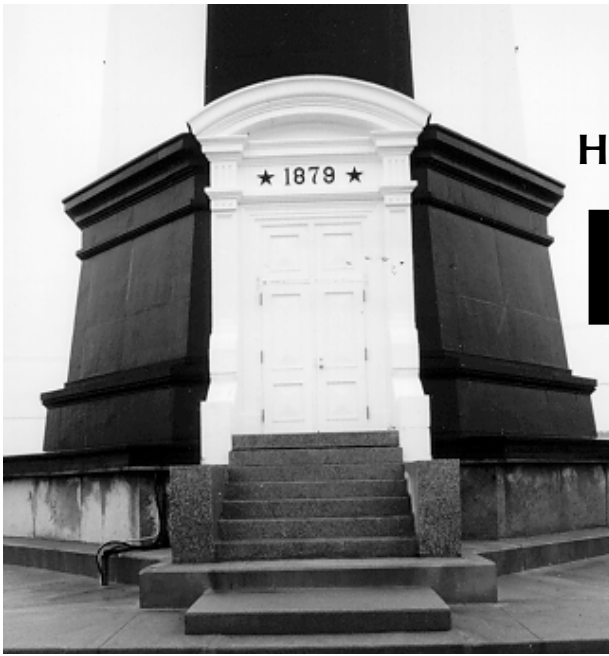
**Figure 1.** Close-up of large, double-leaf, wood-frame and panel doors at the Cape Henry Lighthouse (second tower), Fort Story, Virginia.

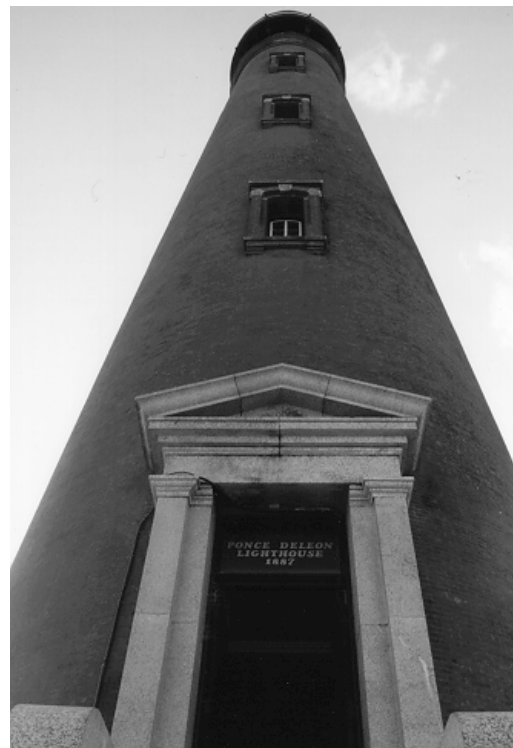
**Figure 2.** View of the neoclassical doorway at the Ponce De Leon Inlet Lighthouse, Florida.

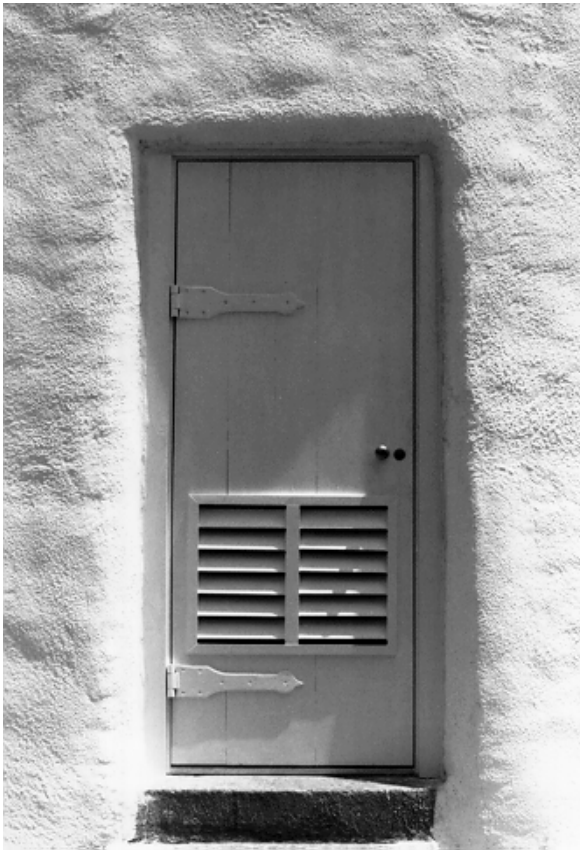
**Figure 3.** View of the simple pre-Civil-War-style replacement plank door at the Ocracoke Lighthouse, North Carolina.

- **Wood plank door:** A door of one or two leaves that is constructed of two layers of tongue and groove wood planks that run vertically on the exterior side of the door, and typically run horizontally or diagonally on the interior. The planks are typically fastened by clinch nailing (nails that are driven through the outside of the door and bent over on the inside). The door is usually reinforced with horizontal 'battens' at the hinge locations: a diagonal batten may run from the top batten to the bottom batten. Such a door is typically hung on strap hinges; however, butt hinges may have been used. This construction method is used to limit the exposure of the end grain in the boards to the top and bottom of the door.

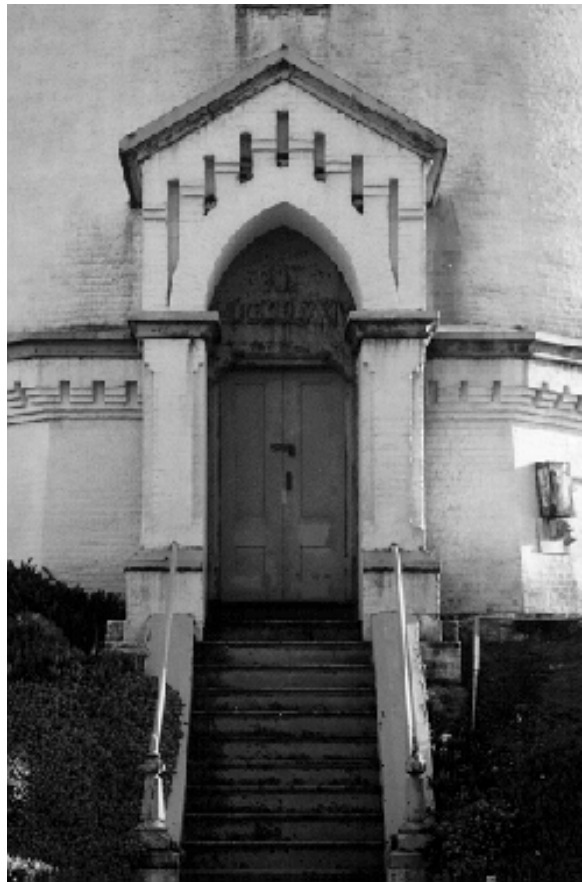
**Figure 4.** View of gothic revival style entrance at Piedras Blancas Lighthouse, California.

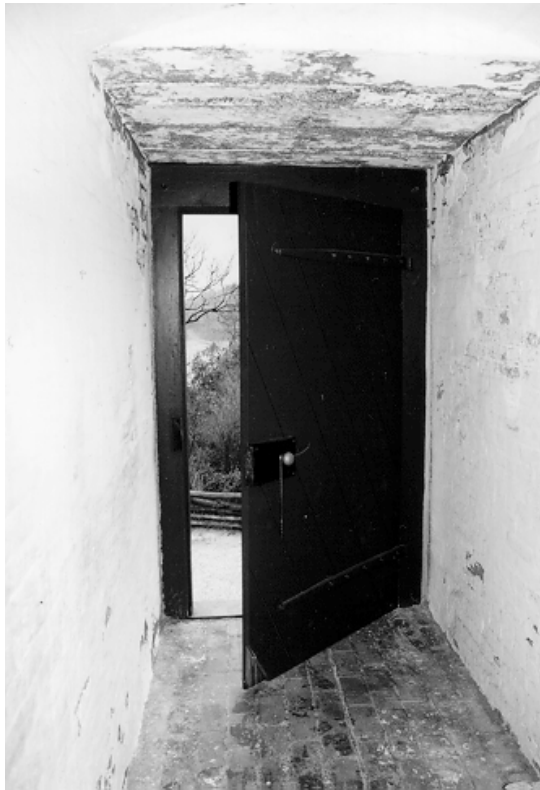
**Figure 5.** View of the large, single-leaf, wood-plank door at the Cape Henry Lighthouse (first tower), Fort Story, Virginia.

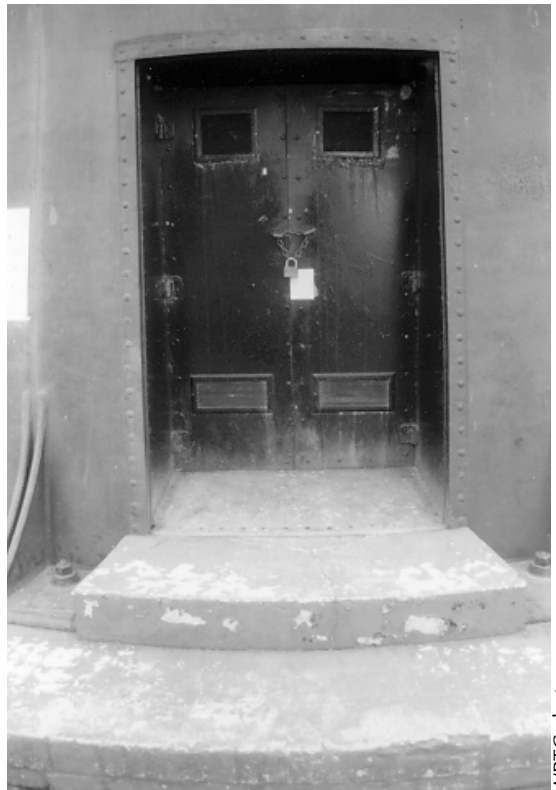
**Figure 7.** Another variation on the double-leaf, sheet-iron door configuration at the Cape Canaveral Lighthouse, Florida.

- **Sheet iron or steel door:** A door of one or two leaves, typically constructed of a single sheet of steel or iron that is reinforced along its perimeter with angle steel or iron, either riveted or welded to the sheet. The door is typically

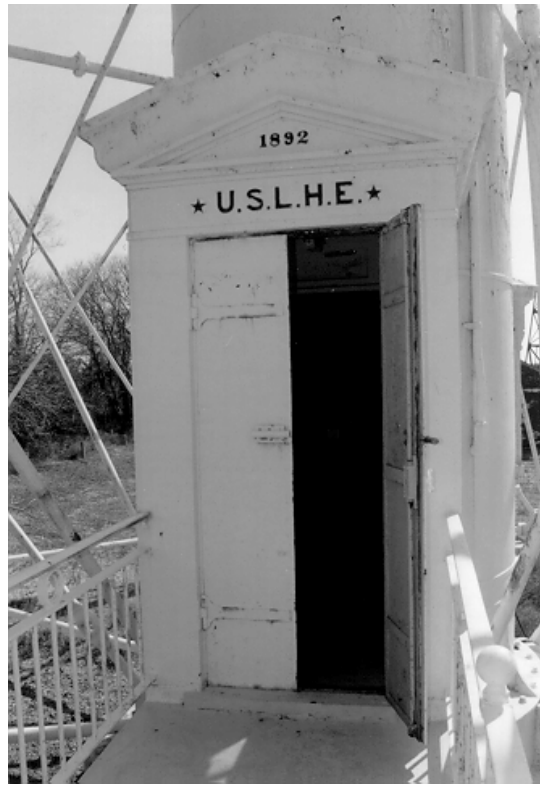
**Figure 6.** Close-up of the neoclassical, double-leaf, sheet-iron door at the Cape Charles Lighthouse, Smith Island, Virginia.

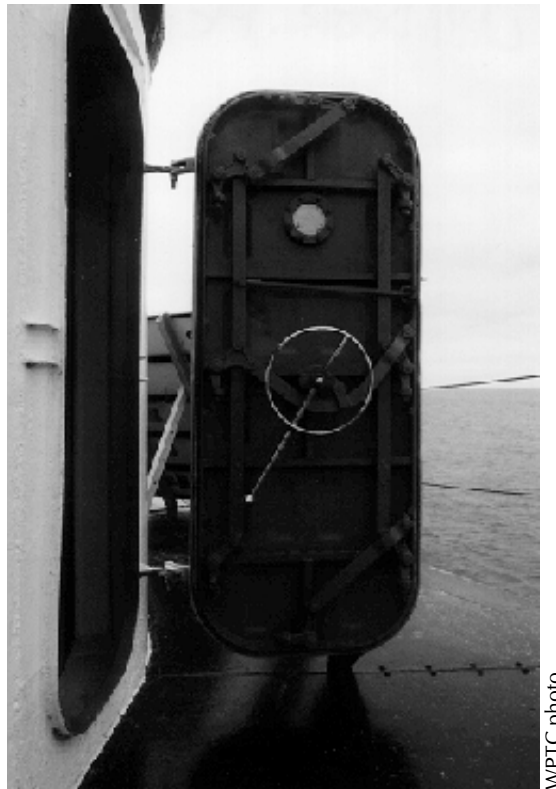
**Figure 8.** An example of a typical watertight 'ship' style door at Los Angeles Harbor Lighthouse, California.

- **Watertight steel 'ship' style door:** This door type was predominantly used in lighthouses that were located in wave-swept locations in open water and on the ends of breakwaters. The door is secured by multiple quick-action dogs that are actuated by an interior hand wheel.

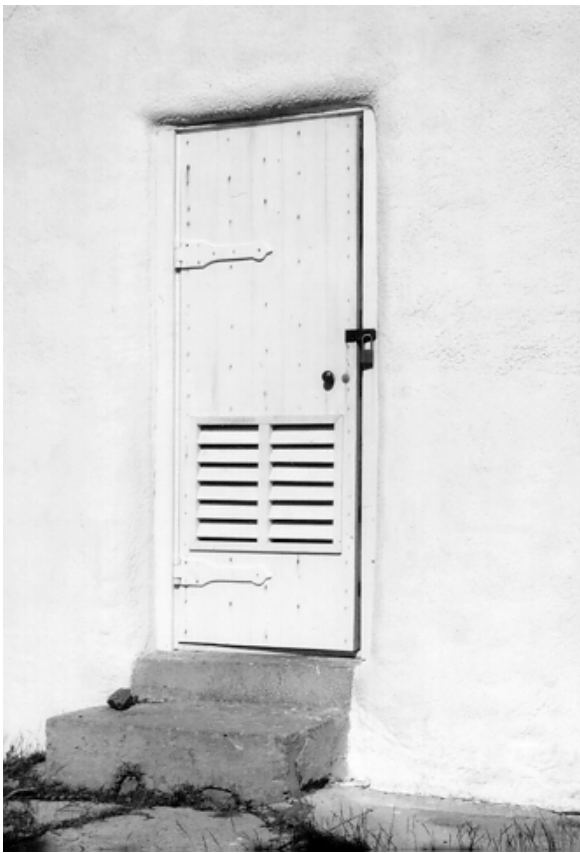
**Figure 9.** View of the Ocracoke Lighthouse five years after replacement; note rust streaks from nails. This condition indicates the paint coating has degraded to the point where moisture has permeated the surface.

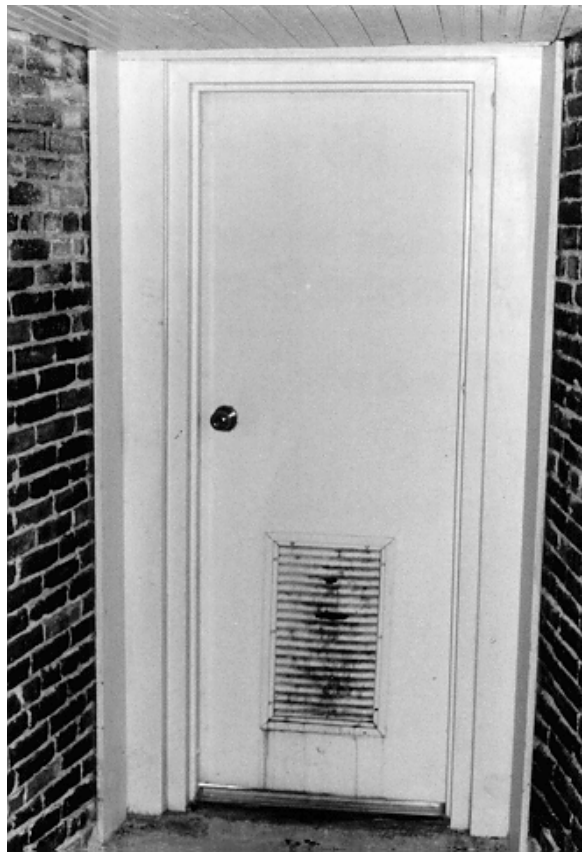
**Figure 10.** Interior view of the modern metal door at the Ocracoke Lighthouse before its replacement; corrosion like this should be removed and the affected areas treated with a rust-inhibiting coating system.

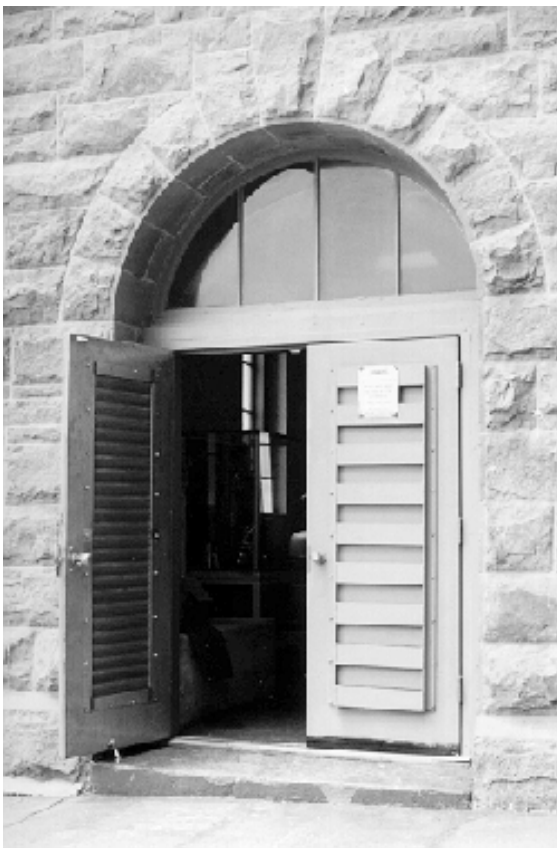
**Figure 11.** These louvered doors have been installed at Point Sur Light Station for security and ventilation. Note the baffles on the exterior and the screened louvers on the interior.

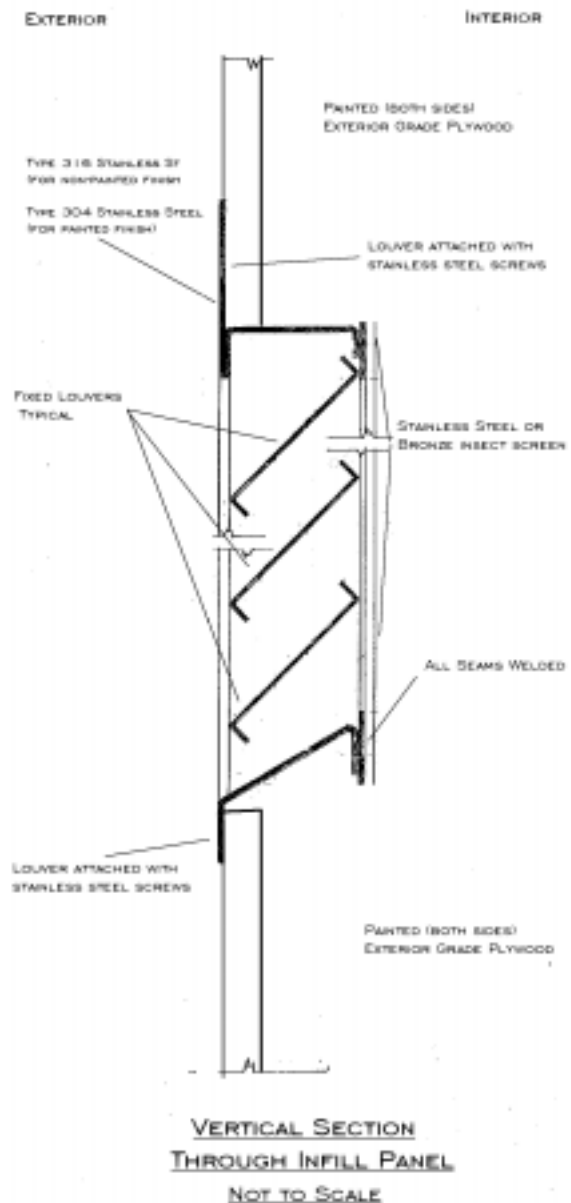
**Figure 12.** Typical detailing of a ‘storm proof’ louver for temporary lighthouse doors. (WPTC image adapted from drawing from USCG-CEU Oakland Archives)

*Site-built, fabricated steel door:* This door consists of a steel 'C' channel frame set into the existing opening that is lag-bolted to the existing door frame. On the outside of this frame, the door leaf is connected by welding the hinges to both the frame and door leaf. The door leaf should overlap the opposite door frame to facilitate the installation of an eye that will pass through a slot in the door leaf to facilitate a lock. A steel shroud big enough to facilitate lock operation with a key, but prevent bolt cutters from reaching the lock, should be welded over top of the eye slot. If the lighthouse is not in an area that is to being wave swept (i.e., if the lighthouse is located on a breakwater or pier), the door should be fitted with screened louvers that are approximately 25 percent of the total door area. The louvers

should be constructed from the same gage steel as the rest of the door.

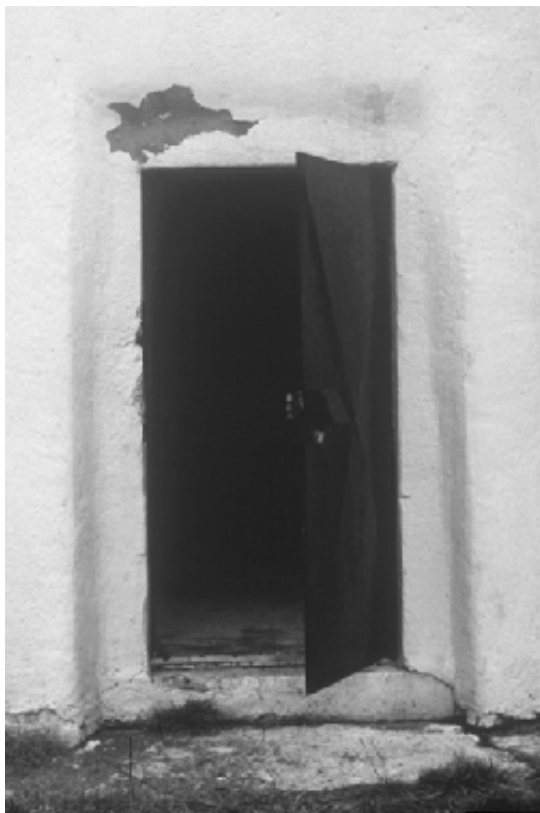
**Figure 13.** Site-built steel door at the Turkey Point Lighthouse; this solution was chosen because of the remote location and repeated break-ins. Note exterior stiffeners and shroud over the hasp and lock.

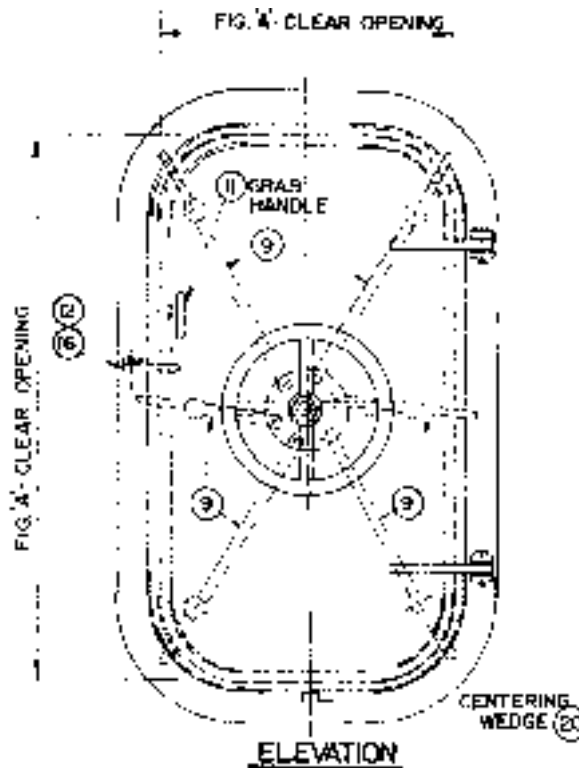
**Figure 14.** A shop drawing depicting the parts of the watertight 'ship' style door. (Drawing courtesy of Cen-Tex Marine Fabricators)

*Watertight steel 'ship' style door:* This type of door consists of a prefabricated 'ship' style door. This door system can be fitted much the same way as the site-built door. A steel 'C' channel frame should be bolted to the door opening; the prefabricated watertight door can then be welded to the frame. The prefabricated door should have six quick-action dogs, an interior hand wheel, and a flush exterior-socket-locking

mechanism that can be actuated with a mating 'T' wrench. The hinge pin caps should be welded to prevent disassembly. This door will provide a weathertight, vandal-proof access that can be removed after the mothballing period.

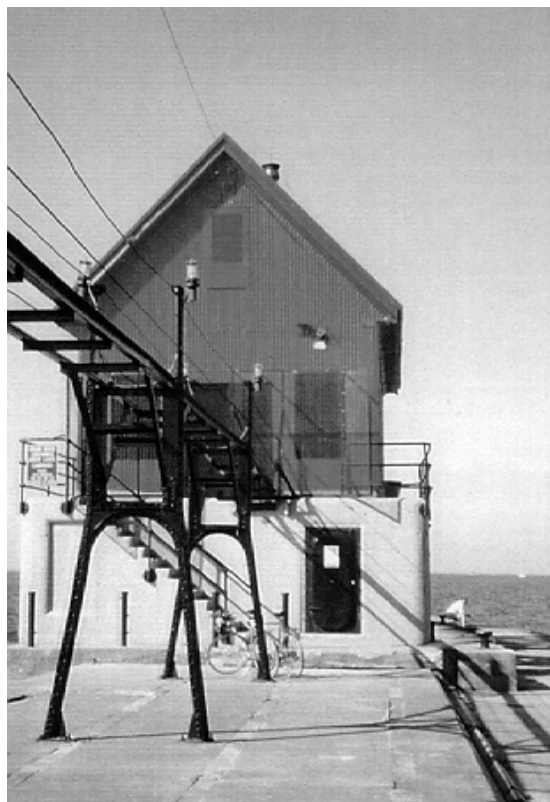
**Figure 15.** View of watertight 'ship' style door installation on the Grand Haven South Pierhead Front Range Light, Grand Haven, Michigan.

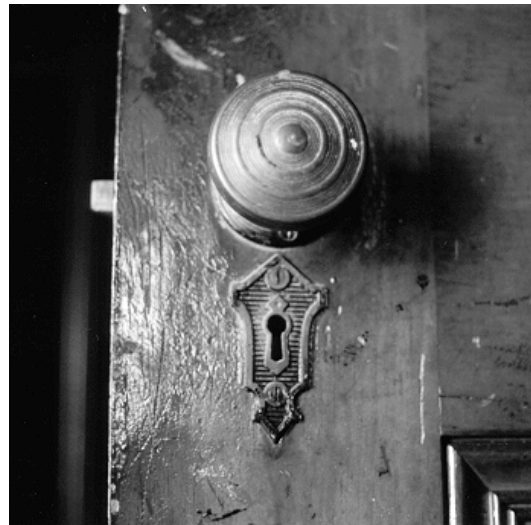
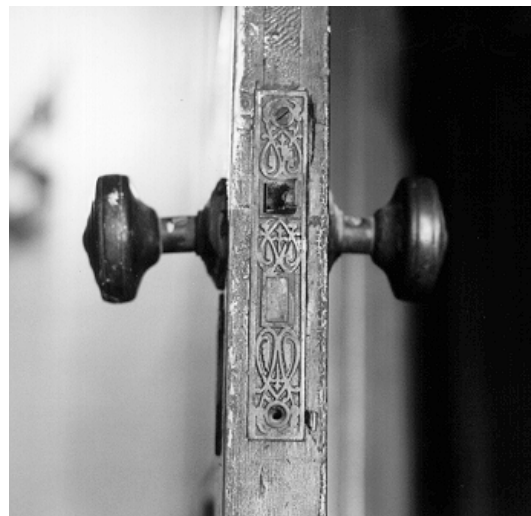
**Figures 16 and 17.** Examples of decorative door hardware found in late 19th-century lighthouses.

Historic lighthouse door hardware is not only functional but also significant in defining the character of the historic door. Lighthouse door hardware such as door knobs, hinges, keyhole escutcheons, and even strike plates were often decoratively detailed with motifs of the architectural style of the lighthouse. When preserving historic lighthouse doors, the existing hardware should be retained. When repairs are made to the door, the hardware should be removed for protection or protected in place to avoid any damage that may be incurred during the repair process. If the hardware is removed, label each piece to
