Historic Lighthouse Preservation:

LANTERN

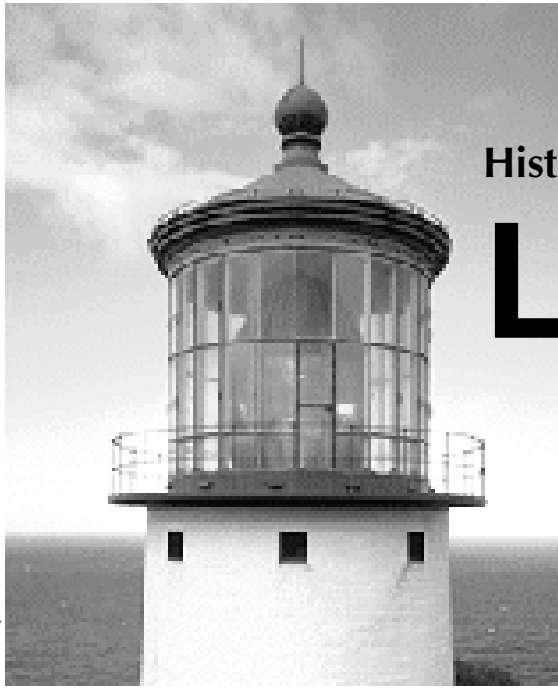
Figure 1. Lantern housing hyper-radiant lens at Makapuu Lighthouse near Waimanalo on the Island of Oahu in Hawaii.

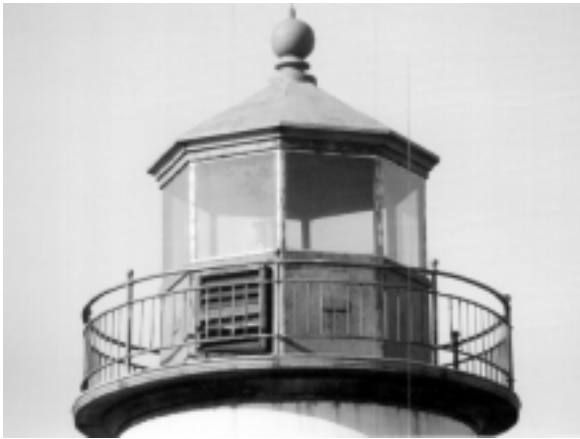
Figure 4. Close-up of the fourth-order lantern at Coquille River Lighthouse in Oregon.

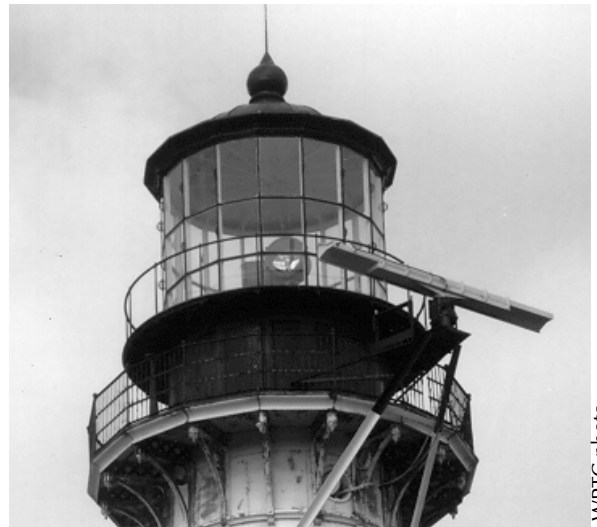
Figure 5. Close-up of the first-order lantern at Cape Canaveral in Florida.

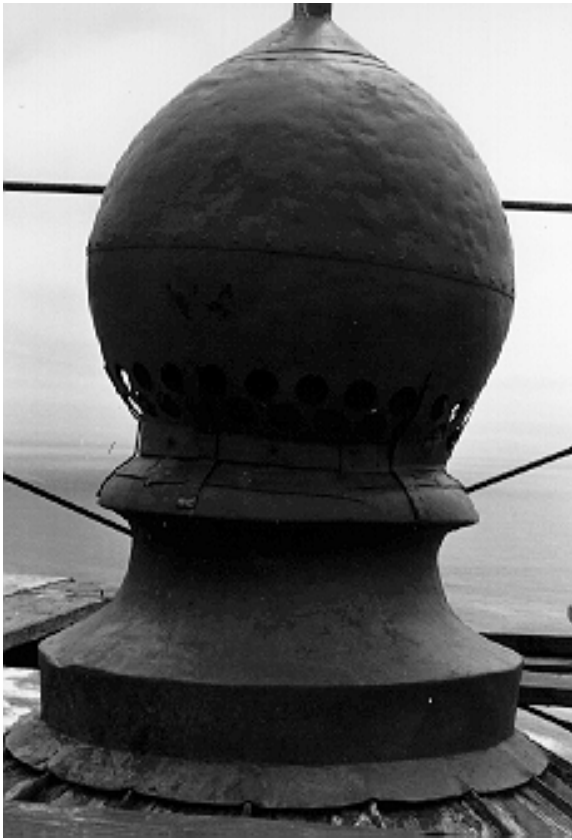
Figure 8. Despite the fact that this first-order lantern ventilation ball has been repaired several times, it still provides adequate lantern ventilation.

Nearly all, if not all, lanterns have a ventilation-ball vent located at the apex of their roofs which served as the primary vent for the fumes and smoke created by the oil-fired illuminant. Secondary vent locations varied by the size of the lantern: first- and second-order lanterns typically had vents located in the watch room area below the lantern and in the sill and head areas of the lantern glass; smaller third- through sixth-order lanterns had vents typically located in every other panel of the parapet wall.

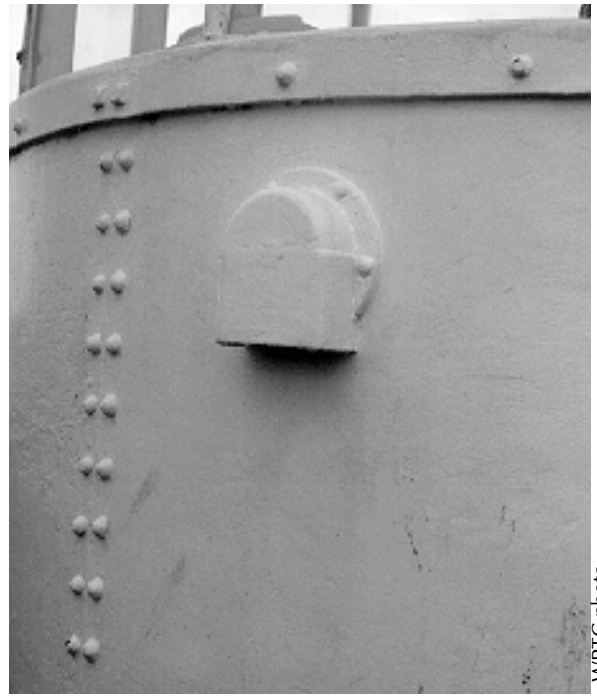
Figure 9. An example of a parapet-wall-mounted vent on a fourth-order lantern.

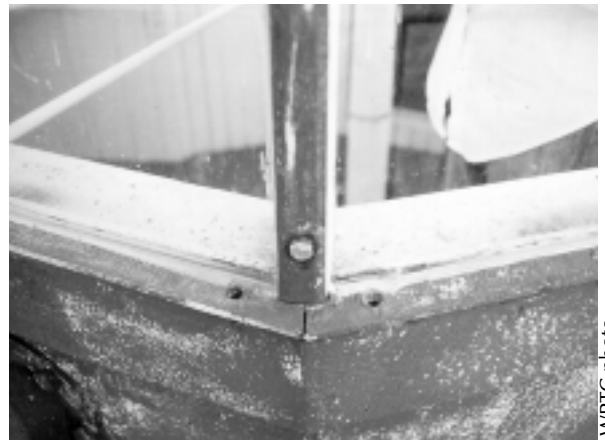
Figure 10. Close-up of missing clamp bolts; these bolts should be replaced to keep this area weather tight.

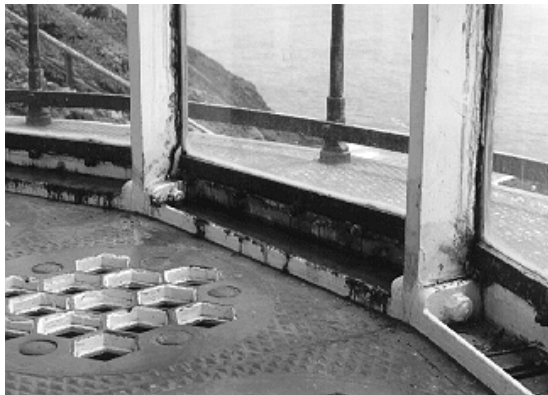
Figure 11. The water that has collected in this lantern sill is causing the iron lantern glass frame (the vertical members in the center of the photo) to rust and corrode.

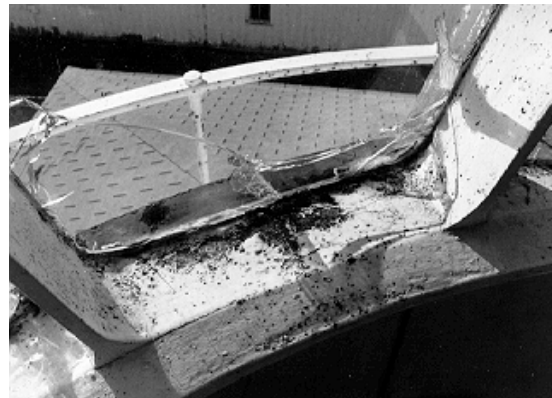
Figure 12. The glass in this lantern has been cracked by the rust-jacking that is occurring along the iron frame.

Rust-jacking threatens any iron or steel component. In lantern glass, the condition can cause severe damage. When moisture enters the channel that retains the glass, the iron frame may begin to rust. As the iron rusts, it expands and in turn cracks the glass. This phenomenon can occur anywhere a ferrous metal (iron or steel, etc.) is in direct contact with another material. The pressure created by the exfoliating rust (iron oxide) may damage the adjacent material. (For more information concerning prevention of rust-jacking refer to the repair treatment in this section of the handbook.)

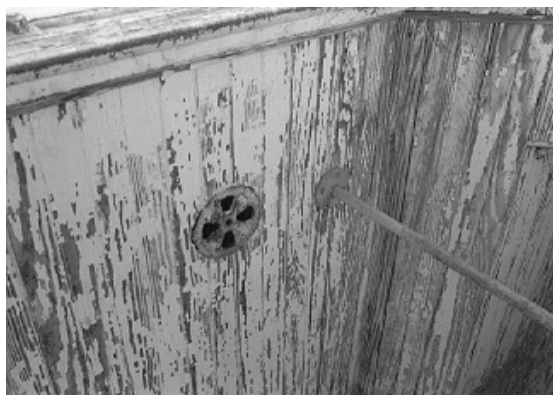
Figure 13. The paint coating that once protected this lantern parapet wall has failed.

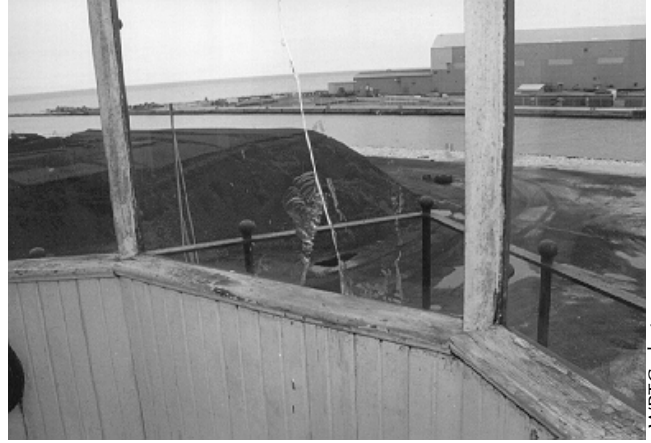
Figure 16. This lantern glass has been damaged by rock-throwing vandals. The resulting hole is allowing rain and insects to enter the lantern.
