PRESERVATION TREATMENTS

Protection and Stabilization (Mothballing)

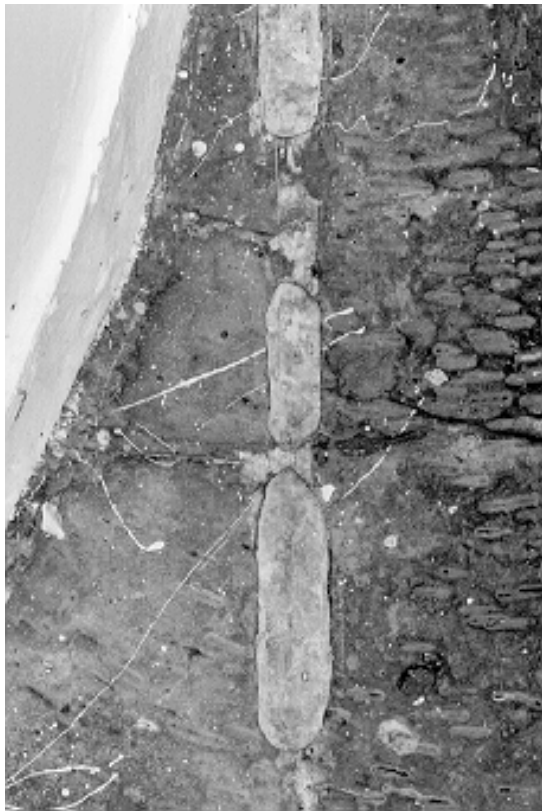
Figure 32. This sheet-copper-covered lantern gallery deck has been repaired several times by soldering sheet copper patches over the holes. This method of repair, if performed properly, greatly increases the life span of the roof covering.

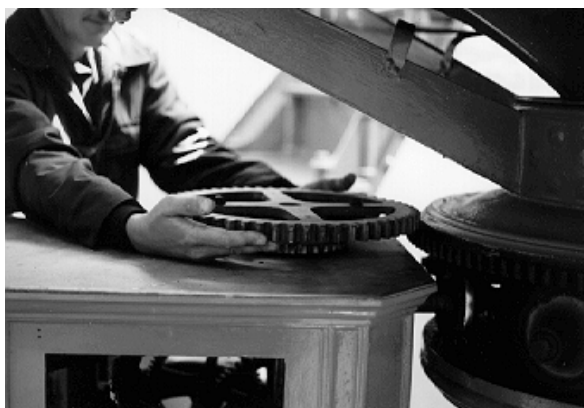
Figure 34. When this first-order classical lens was converted to AC power, the original drive gear (pictured here) was the crank used to wind the clockworks.
