National Park Service
U.S. Department of the Interior

Submerged Resources Center

Beached Shipwreck Archeology: Case Studies from Channel Islands National Park

a product of the
NATIONAL PARK SERVICE
SYSTEMWIDE ARCHEOLOGICAL INVENTORY PROGRAM

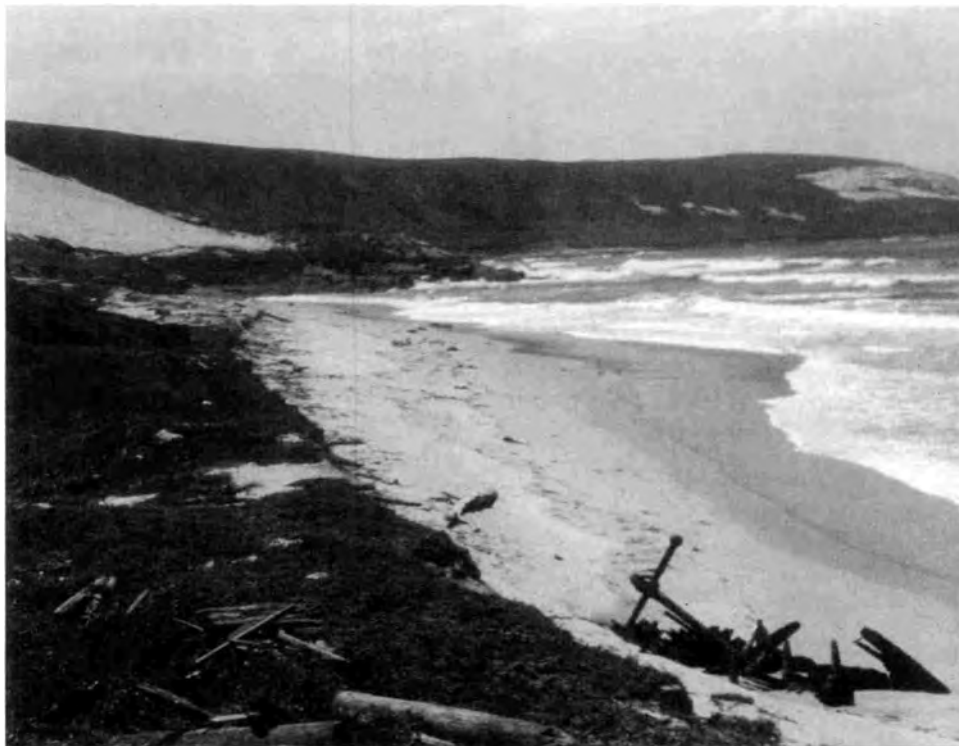
Figure 1.2. *Comet* site exposed in Simonton Cove in 1984. NPS photo by Reed McClusky.

National Park Service (NPS) personnel have known about the *Comet* site, located in Simonton Cove, San Miguel Island, since at least 1977 when the first documented site exposure occurred. The next recorded exposure was in 1984, when an NPS ranger took several photographs of *Comet's* exposed remains (Figures 1.2, 1.3 and 1.4). Although an anchor and capstan are clearly visible in the photographs, insufficient hull structure was exposed then to allow identification of specific features. Between 1984 and 1999, the site

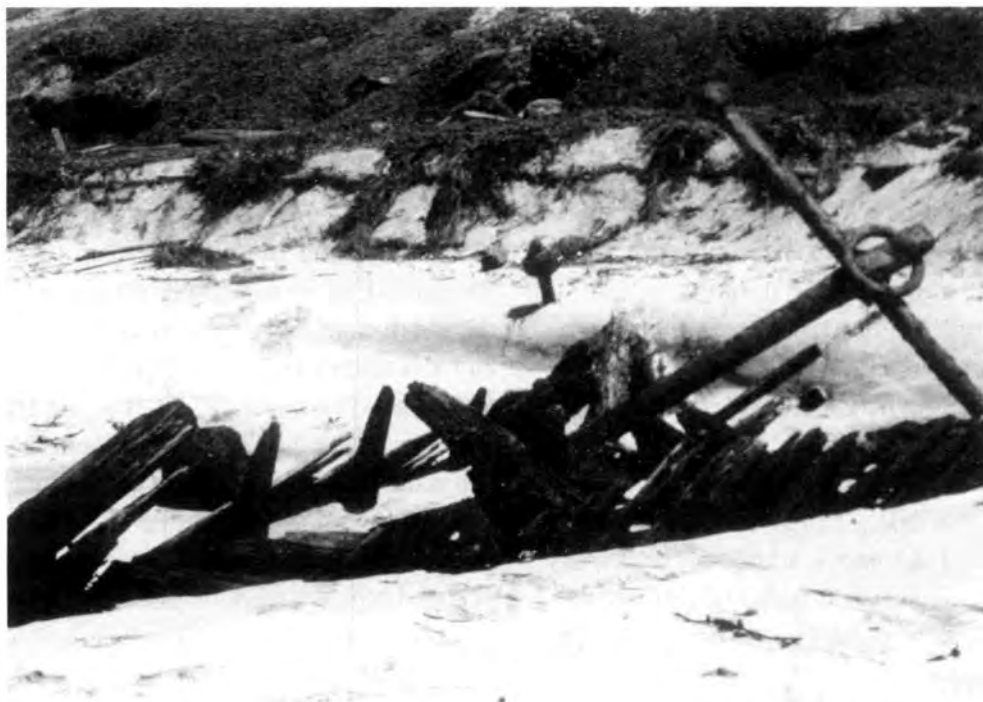
Figure 1.3. *Comet's* timbers and anchor exposed in 1984. NPS photo by Reed McClusky.

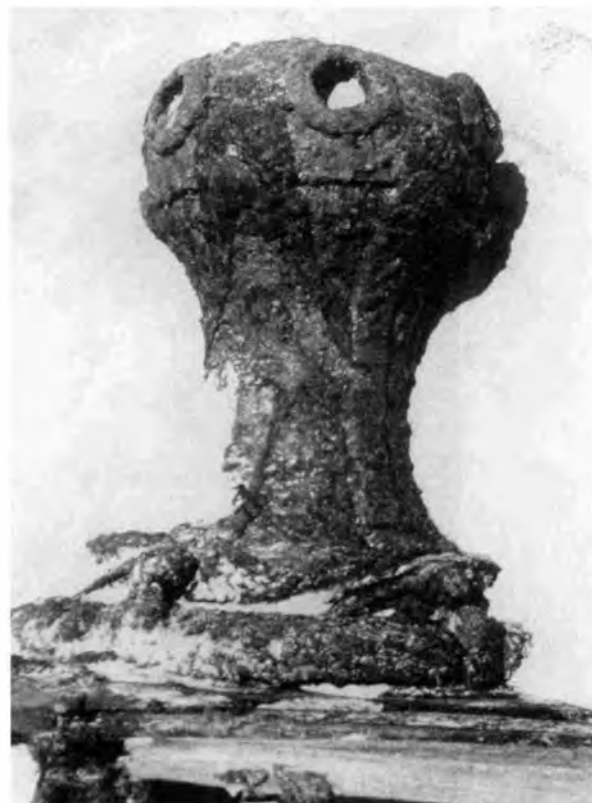
Figure 1.4. *Comet's* capstan in 1984. NPS photo by Reed McClusky.

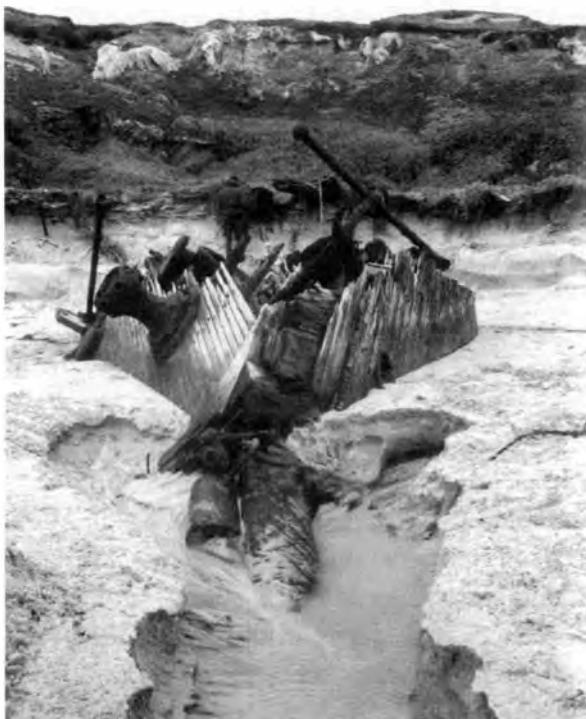
Figure 1.5. *Comet* site in April 1999, looking straight towards the bow, which is canted to the left in this photo. The forecastle deck is to the left, port side outer hull planking to the right and the bowsprit is in the bottom of the photo. NPS photo by Matt Russell.

intact bow from the break of the forecastle deck forward (Figure 1.5). The bow section is heeled to starboard; consequently, much of the port side has been exposed and is now deteriorated. But the starboard side, including the starboard half of the forecastle and main decks, is largely intact with machinery still mounted in its original location. Although only the bow section was observed during this project, this section of *Comet*'s hull is the most intact and well-preserved Pacific Coast lumber schooner documented in the archeological record. Only one other intact section of lumber schooner hull has been recorded on the West Coast, which was a small section of the side of

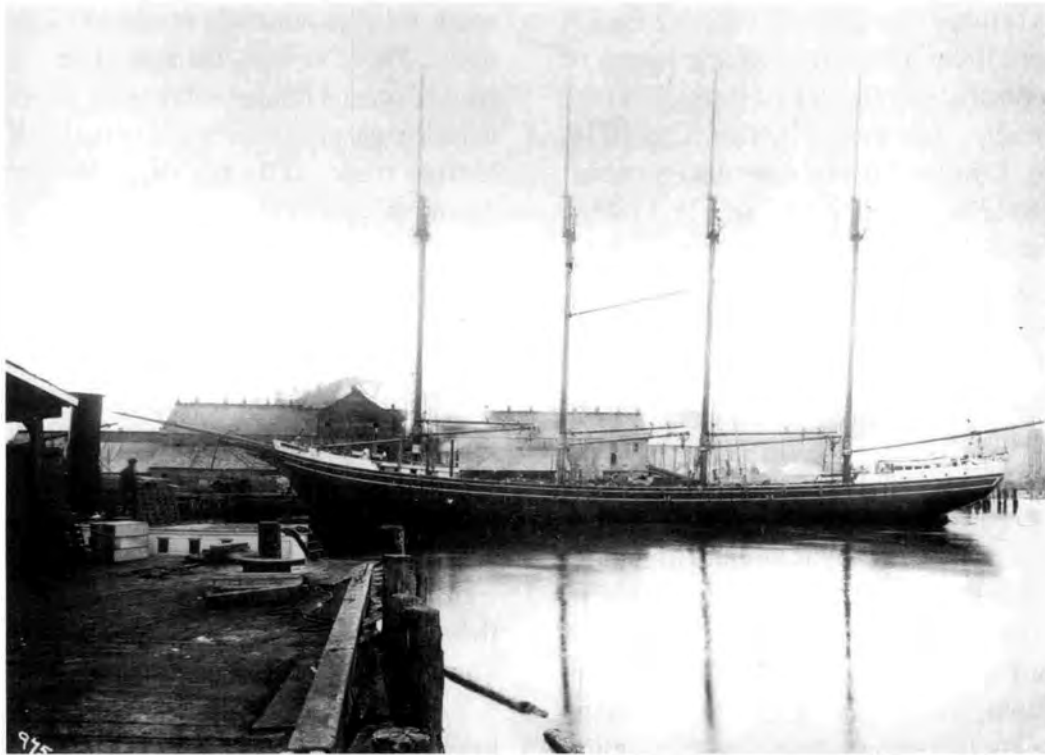
Figure 2.1. Schooner *Watson A. West* at an unknown port. *Watson A. West* was also built by the Hall Brothers. Photo courtesy of San Francisco Maritime NHP.

A distinctive vessel-type emerged for lumber transportation: the Pacific Coast lumber schooner, whose design was influenced by Pacific Coast environmental conditions and the requirement to carry an all-lumber cargo (Figure 2.1). The lumber schooner carried the raw material of California development. It delivered the basic construction material, which laid the foundation for nearly all California's metropolitan centers, making the vessel regionally significant as the primary cargo carrier.

Along with a distinct hull design, West Coast lumber schooners also had a unique schooner rig. Known as "baldheaded" schooners, they often carried only their gaff sails, preferring to run without topsails because "in the long beat to windward of the return trip there were no gafftopsails to shift when tacking" (Weinstein 1978:20). Many lumber schooners were "terns," or vessels with masts of equal height (Bauer 1988:271) (Figure 2.1). Some schooners were

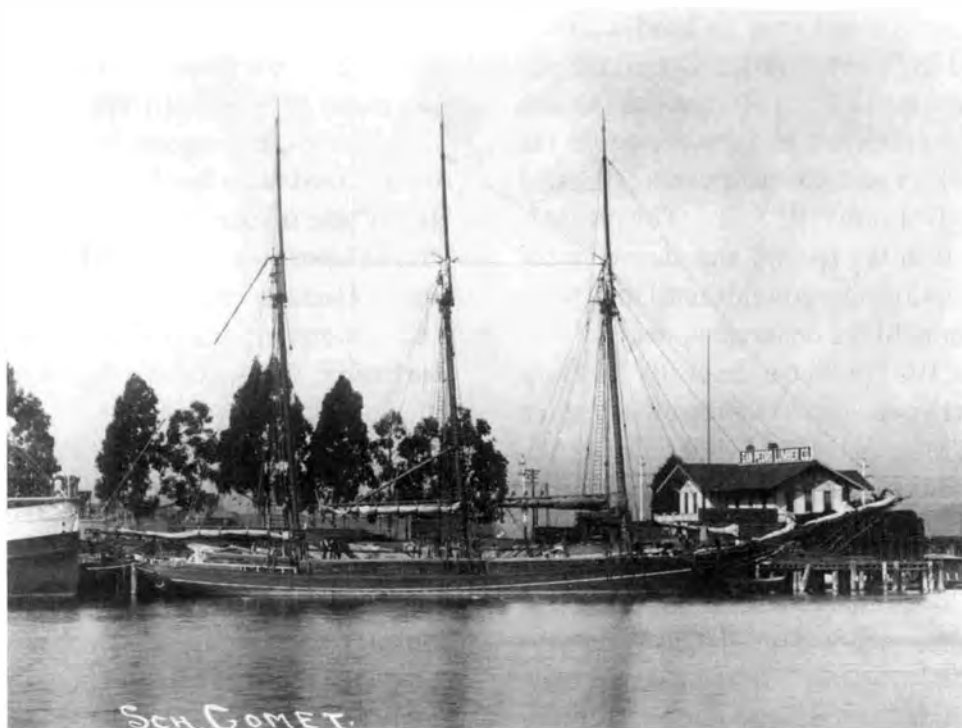
Figure 3.3. Schooner *Comet* docked at San Pedro, California. Photo by William Phelps, courtesy of San Francisco Maritime NHP.

The schooner *Comet* was launched from the Hall Brothers’ Port Blakely yard in October 1886 (Figures 3.3 and 3.4). Once again, the original contract for the vessel survives, giving a complete record of construction. *Comet* had a length of 136.0 ft. on the keel, 144.6 ft. overall, with a breadth of 35.2 ft., a depth of 11.4 ft., and registered 429.74 gross and 408.26 net tons (JPSL:Hall Brothers Shipyard Contract Number 49, 1886; NA 1886:RG 41:Registry 18). Like *Dora Bluhm*, it had one deck, three masts, a billet head and an elliptic stern (NA 1886:RG 41:Registry 18). It was constructed entirely of Douglas fir, again with the exception of the stempost and sternpost, which were “hardwood (JPSL 1886).” *Comet* was entirely iron fastened, with the addition of 1¼-in. locust treenails on the outer hull planking. The vessel was also equipped with a centerboard, and, like *Dora Bluhm*, had bow and stern ports for loading and unloading lumber. During construction, *Comet* was “salted from lower edge of wales to deck.” The rest of the fitting out and furniture was exactly the same as *Dora Bluhm*, down to the 24 in. windlass purchase and Number 3 capstan. For this vessel, the Hooper Brothers of San Francisco and C. F. S. Lass of Oakland agreed to pay \$30,000 in US Gold Coin, over four installments (JPSL 1886).

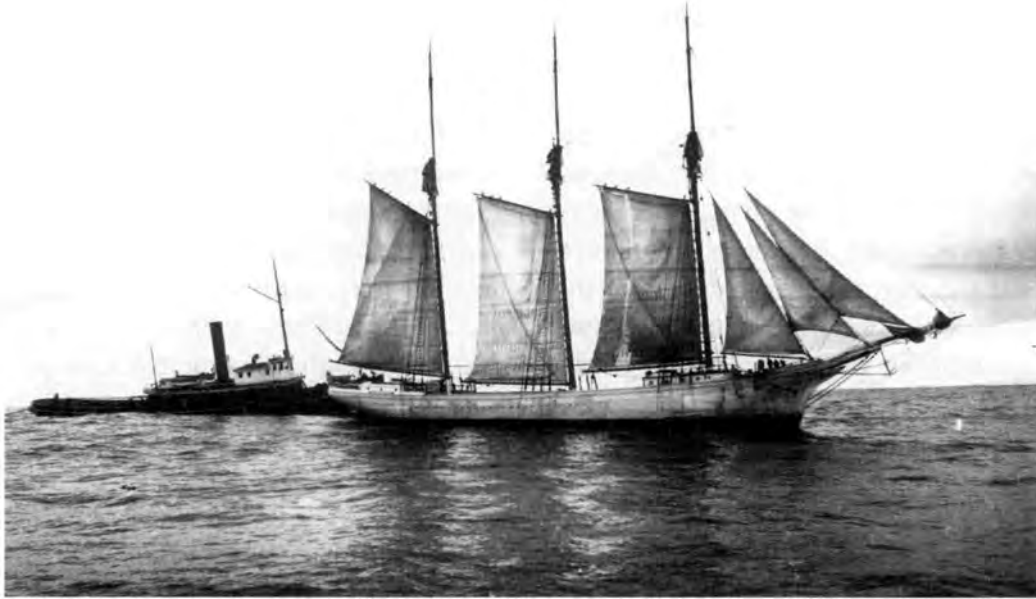
Figure 3.5. The schooner *J. M. Colman* about 1900, photographed off Cape Flattery or in the Straits of Juan de Fuca. *J. M. Colman* was built by the Hall Brothers Shipyard, who also built *Comet*. Photo by Hiram Hudson Morrison, courtesy of San Francisco Maritime NHP.

The Hall Brothers launched the schooner *J. M. Colman* in April 1888 (Figures 3.5 and 3.6). The vessel measured 157.0 ft. long, 37.0 ft. in breadth, 11.3 ft. deep, 471.95 gross tons, and 448.36 net tons. Like the other two schooners, it had one deck, three masts, a billet head and an elliptic stern (NA 1888:RG 41:Enrollment 43). It was built for J. J. McKinnon of San Francisco, who was the sole owner. Unfortunately, *J. M. Colman*'s original contract has not been located, but a hand-written ledger sheet indicates the vessel was originally known as Hull Number 56, and was built for \$33,286.84 (JPSL, Hall Brothers Shipyard Ledger Sheet Number 56, 1888). *J. M. Colman* was one of the largest three-masted schooners built on the coast, registering only 13 gross tons less than the largest, *W. F. Jewett* (Haller and Kelly 1990:22). The first master of *J. M. Colman* was C. H. Atwood (NA 1888:RG 41:Enrollment 43).

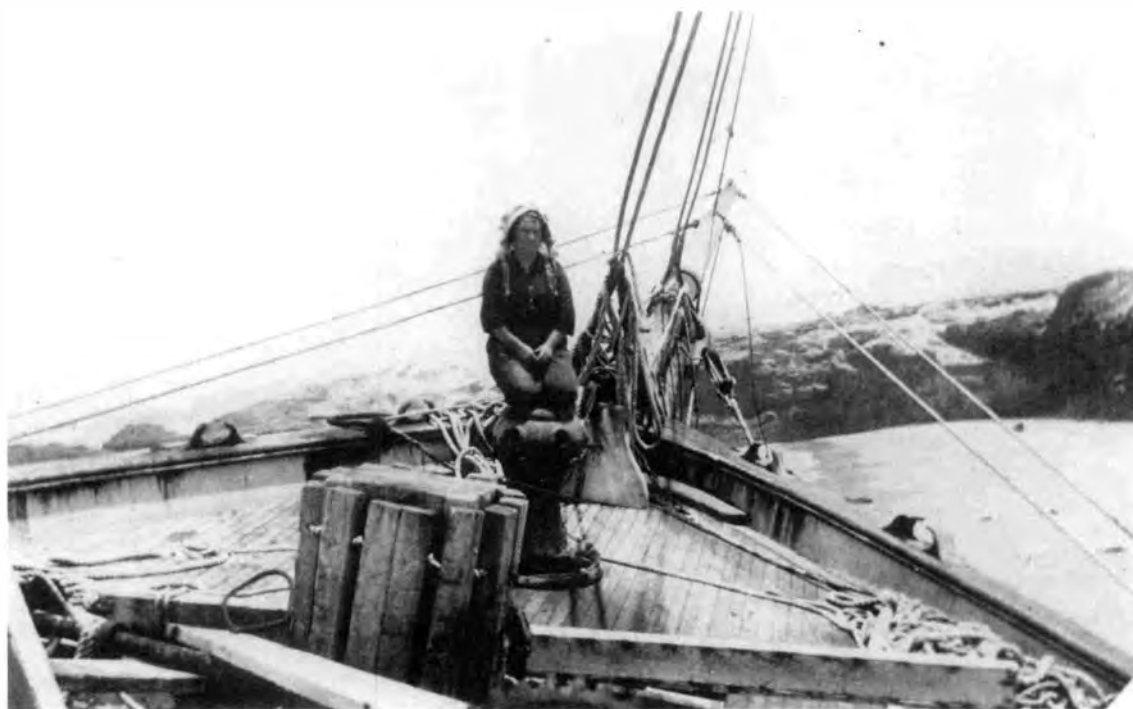
Figure 3.12. Unidentified woman on *Comet's* forecastle deck. Photo courtesy of Santa Barbara Museum of Natural History.

mean high- and low-tide lines. The foremast is still standing, but the main- and mizzenmasts are gone. Two photographs, taken from just forward of the foremast looking forward, show a man and woman standing on *Comet's* bow (Figures 3.12 and 3.13). These photographs are the key evidence in identifying wreckage in Simonton Cove as *Comet*. In the background of the photographs is an easily identifiable rock formation that is east of the wreckage in Simonton Cove today (Figure 3.14). Therefore, with the help of these historical photographs, a positive identification of the *Comet* wreck site can be made.

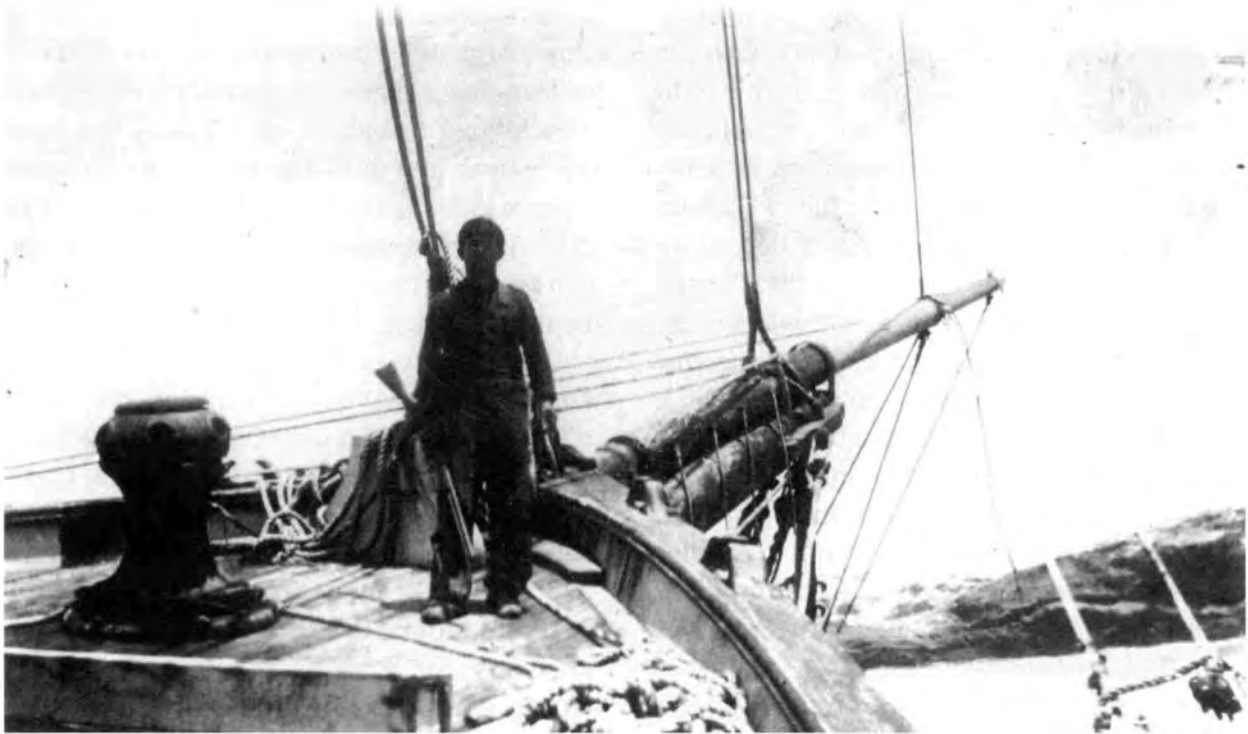
Figure 3.13. Unidentified man on *Comet's* forecastle deck. Note the capstan which is still mounted in the same location today. Also, note the rock ledge in the background which can be compared to Figure 3.14. Photo courtesy of Santa Barbara Museum of Natural History.

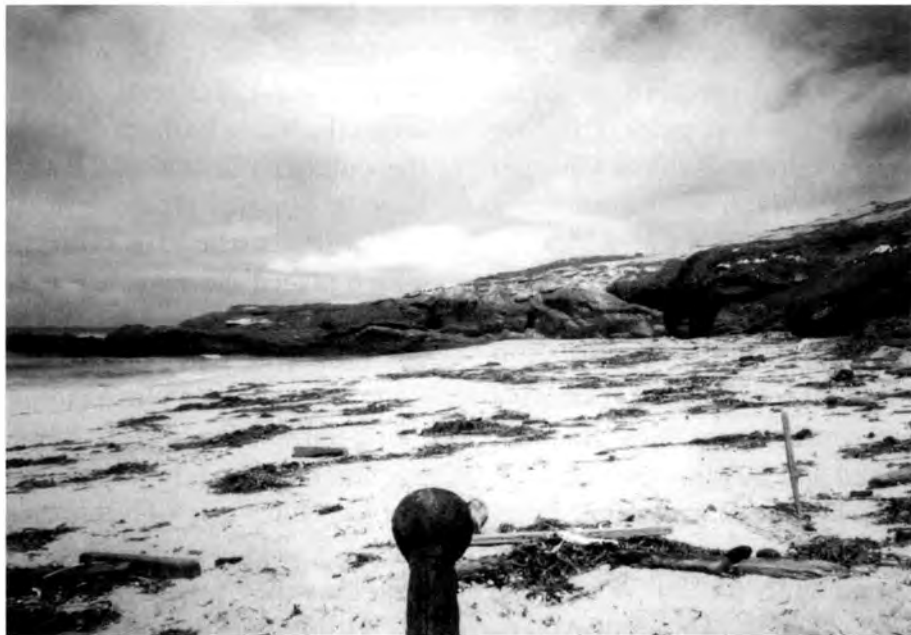
Figure 3.14. Anchor stock sticking out of the sand in Simonton Cove in the 1980s. Compare the rock ledge in the background to Figure 3.13. NPS photo by Don Morris.

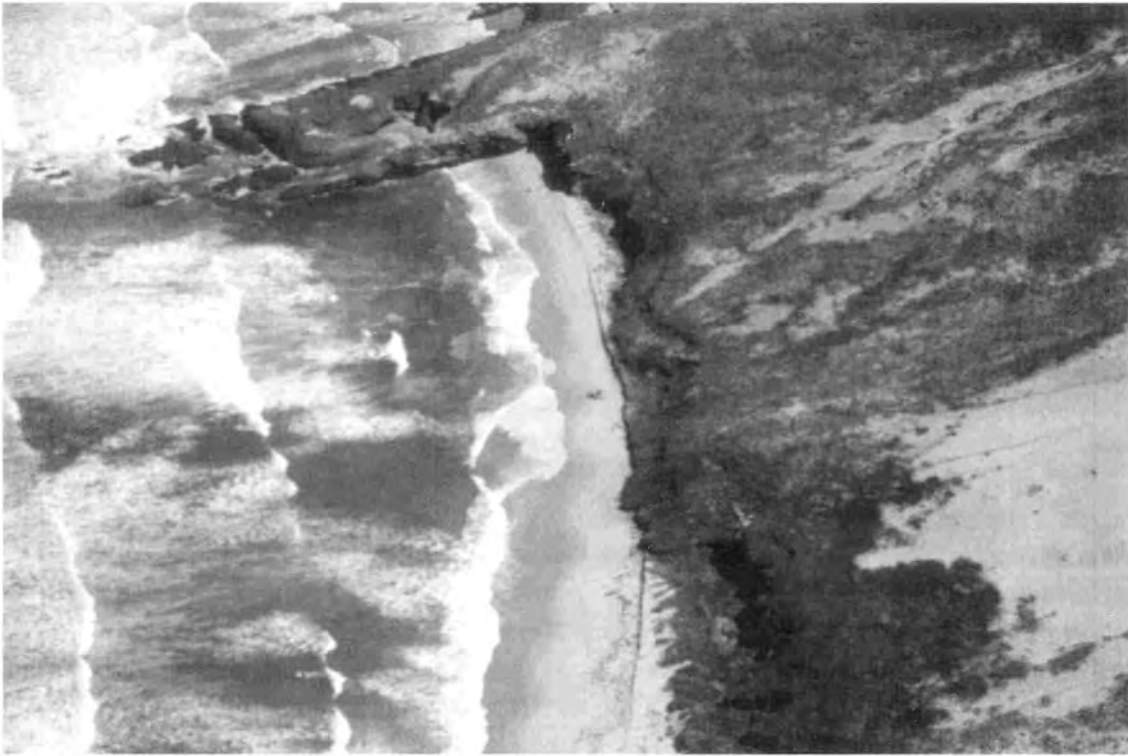
Figure 4.3. Aerial view of *Comet* site in Simonton Cove. *Comet* bow wreckage is on the beach in the center of the photograph. Photo courtesy of Robert Schwemmer.

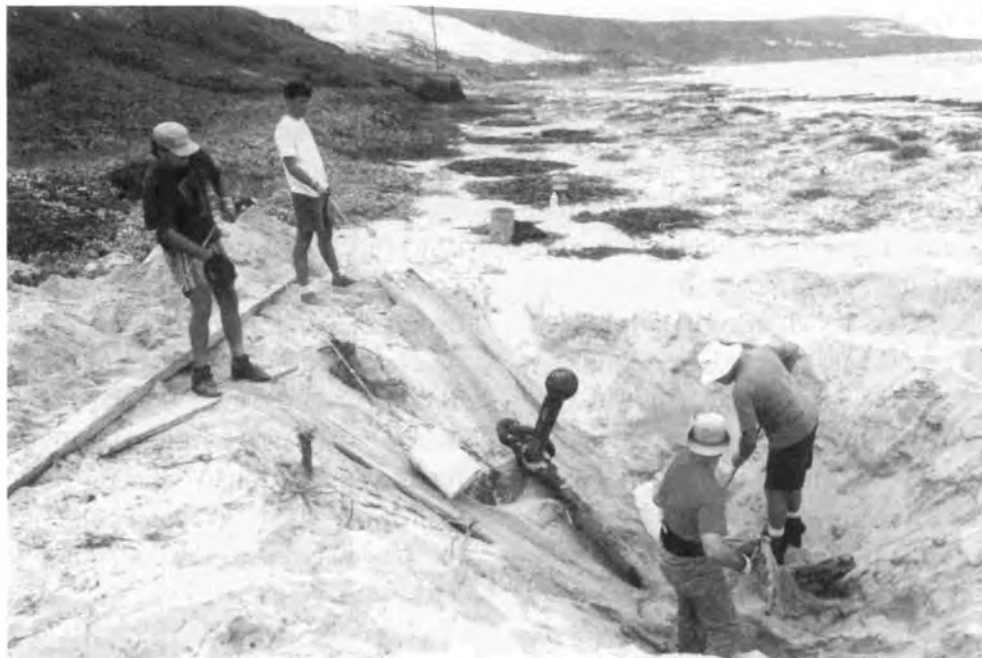
Figure 4.6. Volunteers working to expose *Comet* wreckage in October 1993. Just the tip of the anchor stock was exposed before digging began. NPS photo by Matt Russell.

Four volunteers arrived on October 19, 1993, and work began that afternoon. The tip of the anchor stock was used as a starting point for sand overburden removal. Project personnel and volunteers spent October 20–21, 1993, excavating (Figure 4.6). The anchor was

uncovered, along with a few timber ends, and nothing more. Although the timbers located are certainly from *Comet*, no details could be recorded because the unstable walls of the hole kept collapsing as the timbers were exposed. In total, about 21 cu. yds. of sand were removed from a hole 21 ft. in diameter at the top and 7 ft. deep. The few remains uncovered indicated this site could not be exposed without mechanical excavation and shoring. Barring landing a backhoe, *Comet* would have to wait for detailed recording until naturally uncovered.

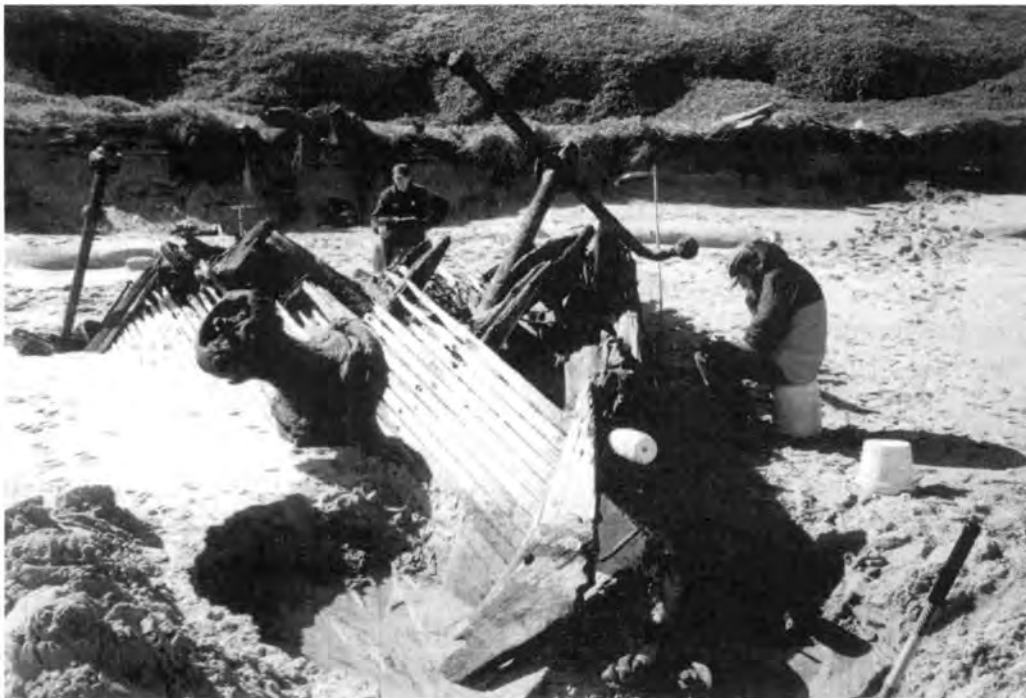
Figure 4.7. Archeologists mapping *Comet's* bow section. NPS photo by Don Morris.

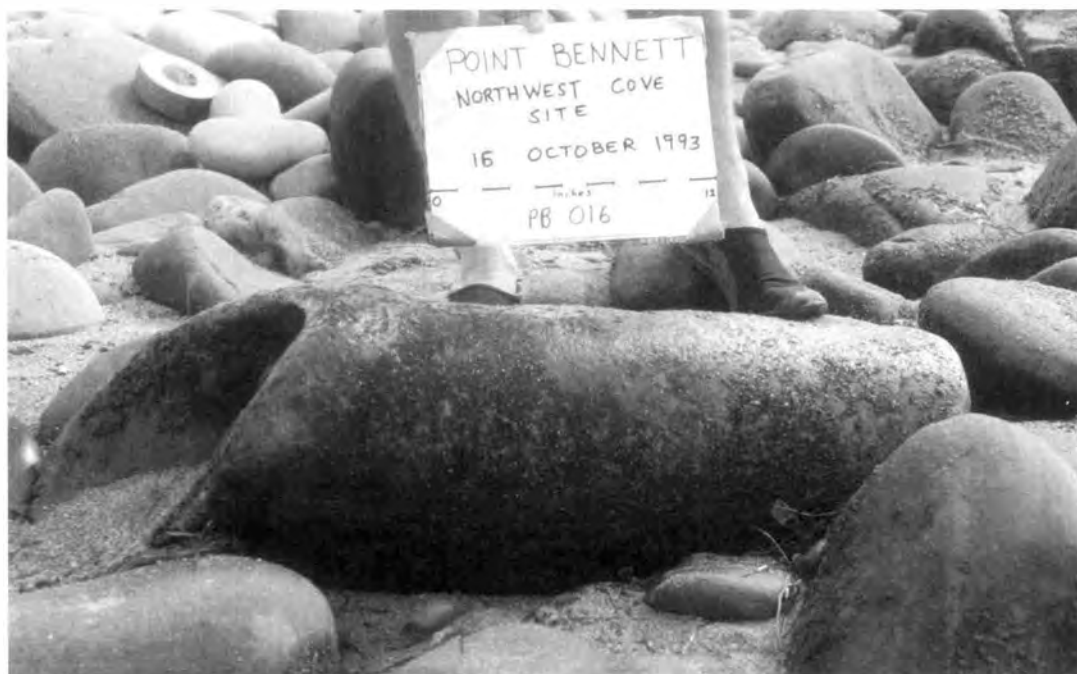
Figure 4.9. Hawse pipe (feature PB-016). NPS photo by Adriane Neidinger.

The most diagnostic objects in the intertidal zone are two hawse pipes, features PB-016 and PB-034, of identical dimensions (Figures 4.8 and 4.9). Hawse pipes were located on each side of a vessel's bow and allowed the chain cable to pass through the hull. Hawse pipes are distinguishable from mooring pipes (which allowed mooring lines to pass through the main deck bulwarks on the main deck) and chain pipes (which allowed the chain cable to pass through the main deck into the chain locker) by their

length and their sloping outer faces, which must conform to a bow's compound curves. PB-034 is located 50 ft. 6 in. northwest of PB-016. The two hawse pipes have the same dimensions, which, combined with proximity, indicate they came from the same vessel. The pipes have an overall length of 2 ft. 11 in., an outside diameter of 11 in. and an inside diameter of 9 in.

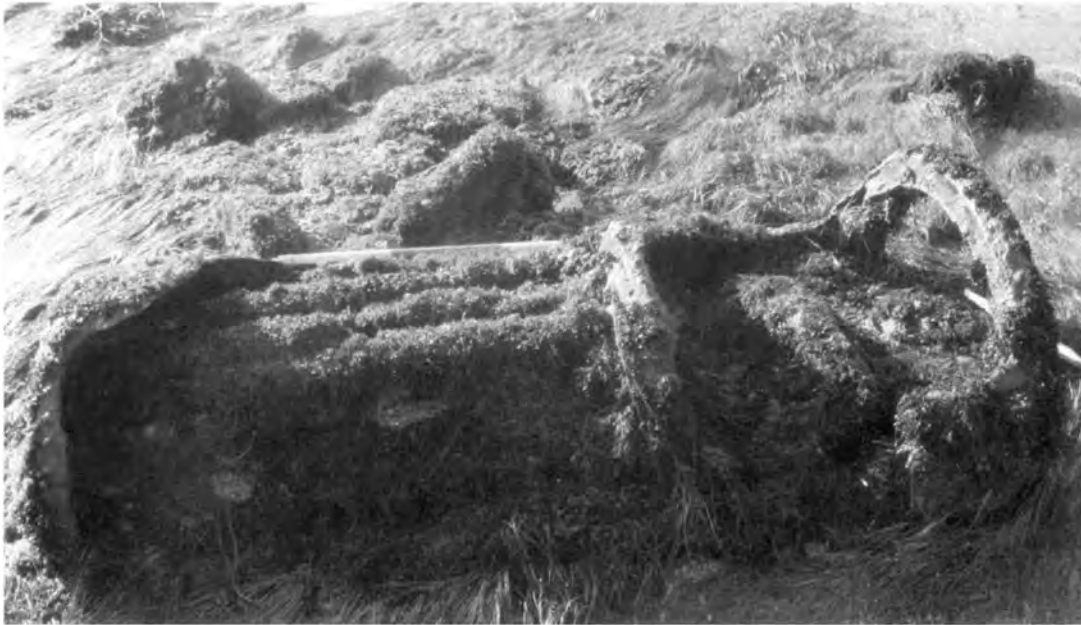
Figure 4.11. Donkey boiler (feature PB-020). NPS photo by Adriane Neidinger.

Feature PB-020 is another readily identifiable object, a steam donkey engine boiler (Figures 4.10–4.12). It is a cylinder

approximately 6 ft. 6 in. long and 3 ft. in diameter, its interior filled with 2¾-in. diameter tubes for about two-thirds of its length. Donkey engines, or “steam donkeys” as they were known, were found aboard coastal lumber schooners after the early 1880s (Cox 1974:231) and were used for a variety of purposes, including loading and unloading cargo, hoisting the sails and running the ship’s pumps. The donkey engine was usually located in the forward deckhouse, as in the coastal lumber schooner *C. A. Thayer*, built in 1895 by Hans D. Bendixsen and now on display at San Francisco Maritime National Historical Park. Like *J. M. Colman*, *Comet* and *Dora Bluhm*, *C. A. Thayer* is a three-masted lumber schooner and very similar in size and configuration to the Hall-built schooners.

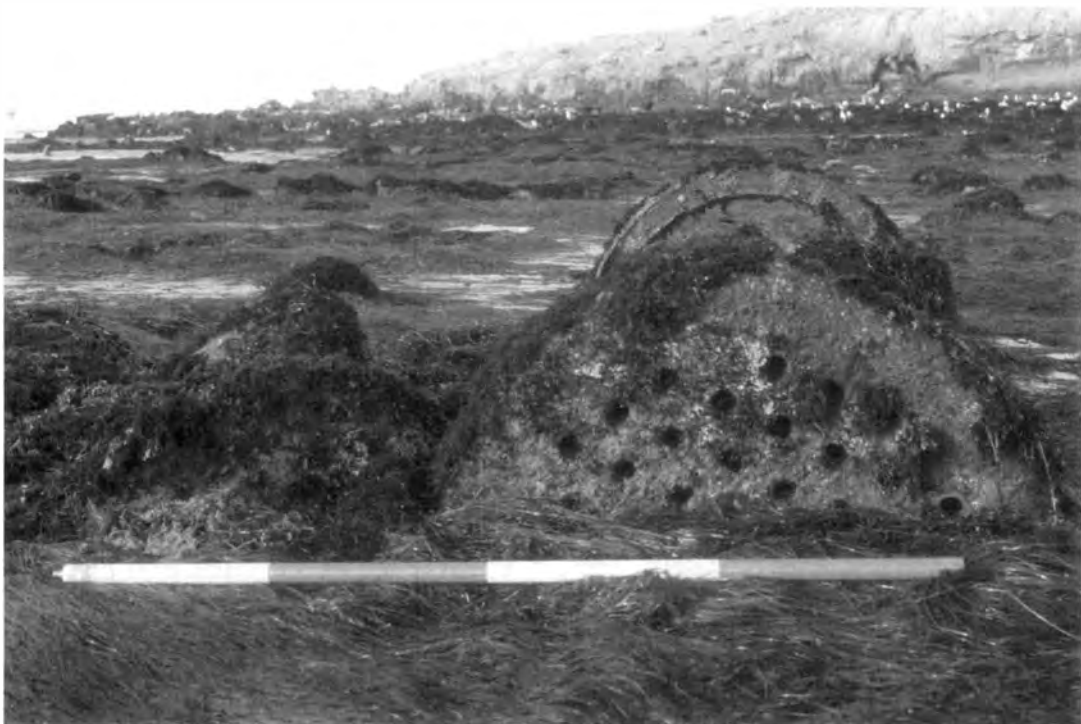
Figure 4.12. End view of the donkey boiler. NPS photo by Adriane Neidinger.

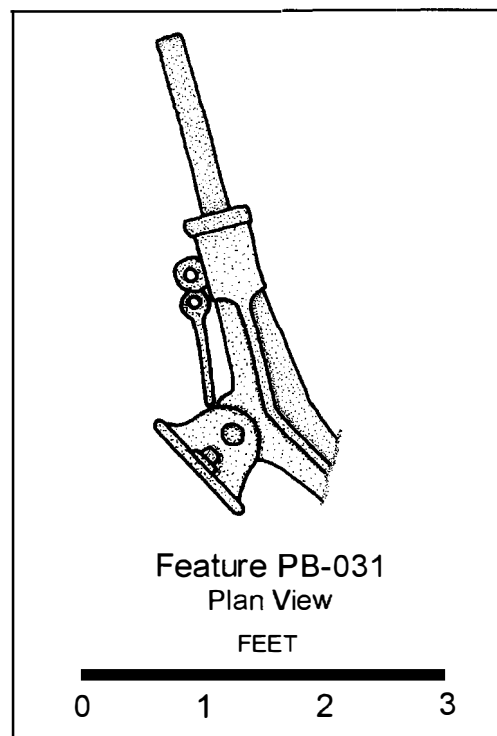
Figure 4.13. Crosshead mechanism from a pump-brake windlass (feature PB-031). Drawing by Matt Russell.

Another intertidal-zone object identified is PB-031, which is the crosshead mechanism of a hand-operated, pump-brake windlass (Figures 4.13 and 4.14). An example of this mechanism can also be seen on board *C. A. Thayer*, where it is mounted on the forecastle deck, directly forward the sampson post above the windlass. The crosshead was attached to the windlass by connecting rods that passed through the forecastle deck and were connected to the windlass purchase rims (de Kerchove 1961:614). Removable handles were inserted into the crosshead and the up-and-down motion supplied by two seamen rotated the purchase rims, which turned the windlass. This is the same type of windlass and mechanism recorded on *Comet* (see below). Feature PB-031 is partially obscured by encrustation and marine growth, but a portion of one of the removable handles is present. The overall length of the piece is 4 ft. The base of the crosshead mechanism was secured to the forecastle deck with two 1-in. diameter iron fasteners. The base is about 10 in. square and 6½ in. tall, which is similar to the crosshead mechanism found on *C. A. Thayer*.

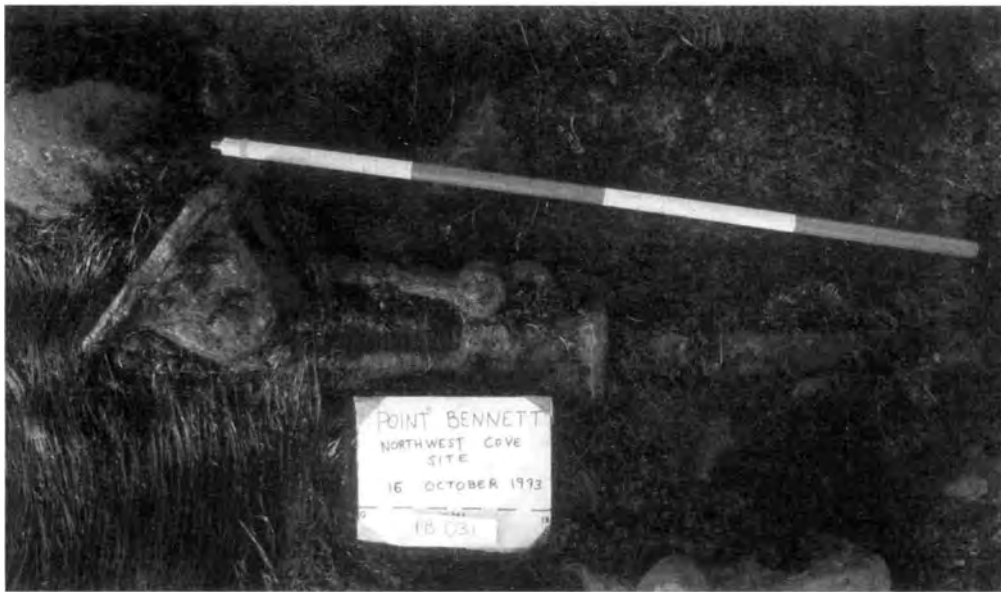
Figure 4.14. Crosshead mechanism from a pump-brake windlass. See Figure 4.96 for a similar mechanism. NPS photo by Adriane Neidinger.

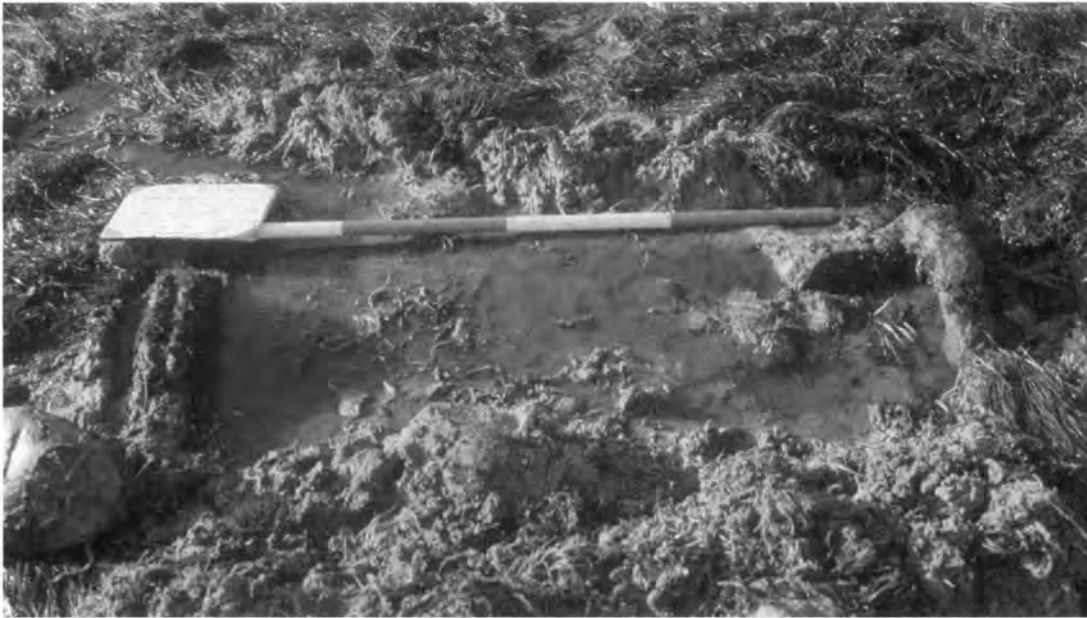
Figure 4.16. The two upright circular features are connected by a buried drive shaft. NPS photo by Adriane Neidinger.

At least seven of the remaining intertidal zone features are either from a windlass, a donkey engine, or a messenger chain system that linked the two. A messenger chain used a series of chains, gears and shafts to connect a steam donkey engine to the windlass, pumps, auxiliary warping heads and other hoisting gear. *Comet* was equipped with a messenger chain system to drive its windlass (see below). Feature PB-021/022 (actually a single object) is likely part of a donkey engine (Figures 4.15 and 4.16). PB-021/022 are two circular iron pieces sticking upright out of the bottom, 4 ft. apart, and connected by a shaft that could not be exposed (which is why they were given separate feature numbers). The circular iron pieces are 1 ft. 6 in. in diameter. One of them (PB-021) is featureless, while the other (PB-022) is grooved

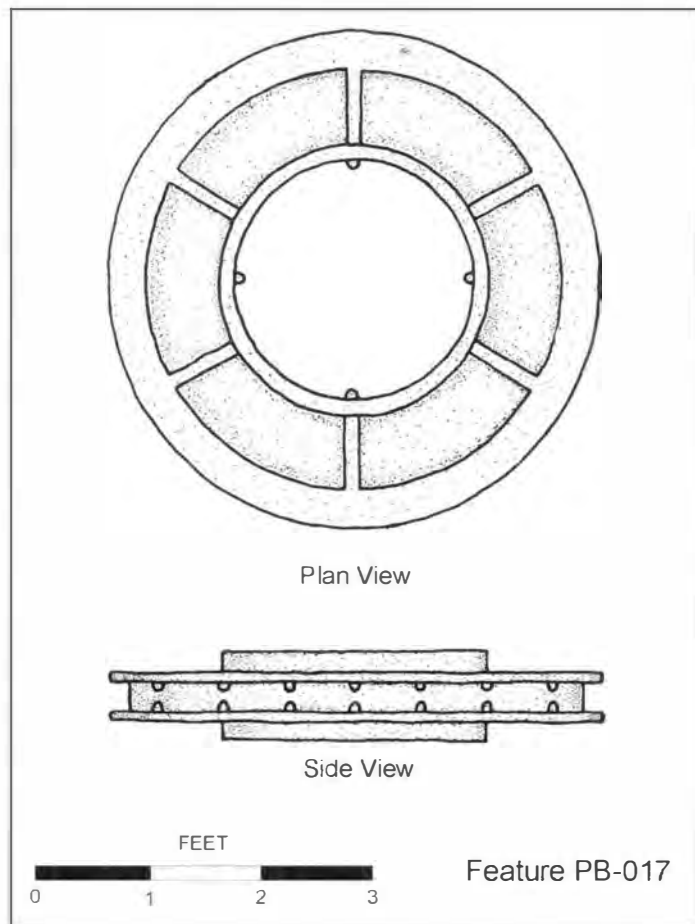
Figure 4.18. The widely-spaced teeth on this feature's outer edge indicate it is part of a messenger chain system that ran the windlass from a donkey engine. Drawing by Matt Russell.

Features PB-017, 018 and 023 are all similar objects and part of a vessel's windlass or messenger chain system. PB-017 is an iron ring with an outside diameter of 4 ft. 4 in., an inside diameter of 2 ft. 1 in., with a thickness of the main part of the ring 5 in. An inner flange adds 2 in. in thickness to either side (Figures 4.18 and 4.19). PB-018, also an iron ring, has an outside diameter of 3 ft., an inside diameter of 2 ft. 2 in., and is 4 in. thick (Figures 4.20 and 4.21). PB-023 is a solid circular iron object 2 ft. 1½ in. in diameter and 4 in. thick (Figure 4.22). All three features have edges notched for gears. Edges of PB-018 and PB-023 have closely spaced gears, while the edge of PB-017 has teeth spaced about every 7 in. Feature PB-018 is likely the purchase rim of a windlass (Figure 4.23). The 7-in.-spaced teeth of PB-017 are from the messenger chain system that ran this machinery.

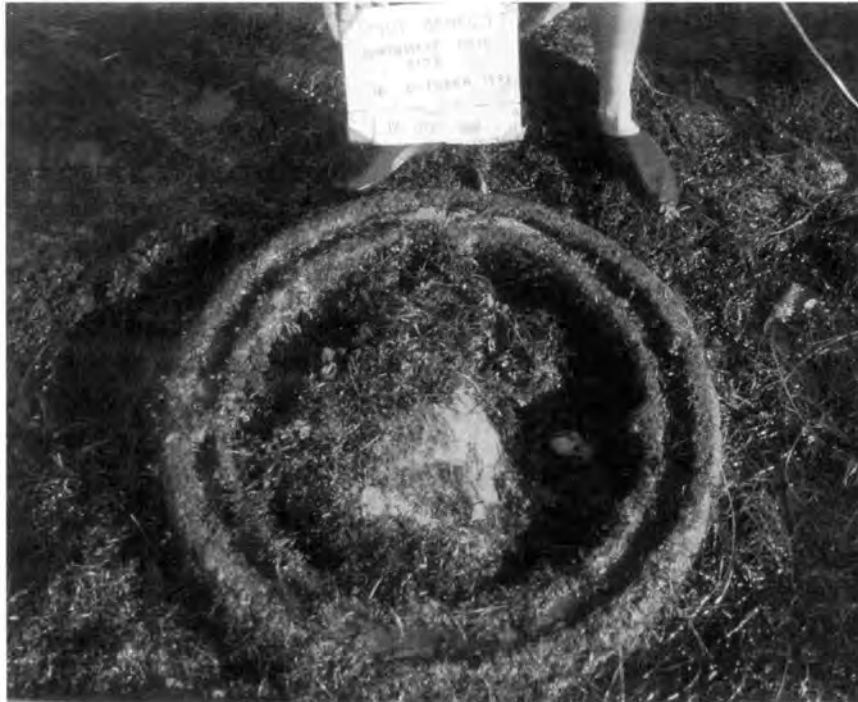
Figure 4.21. Purchase rim (feature PB-018). NPS photo by Adriane Neidinger.

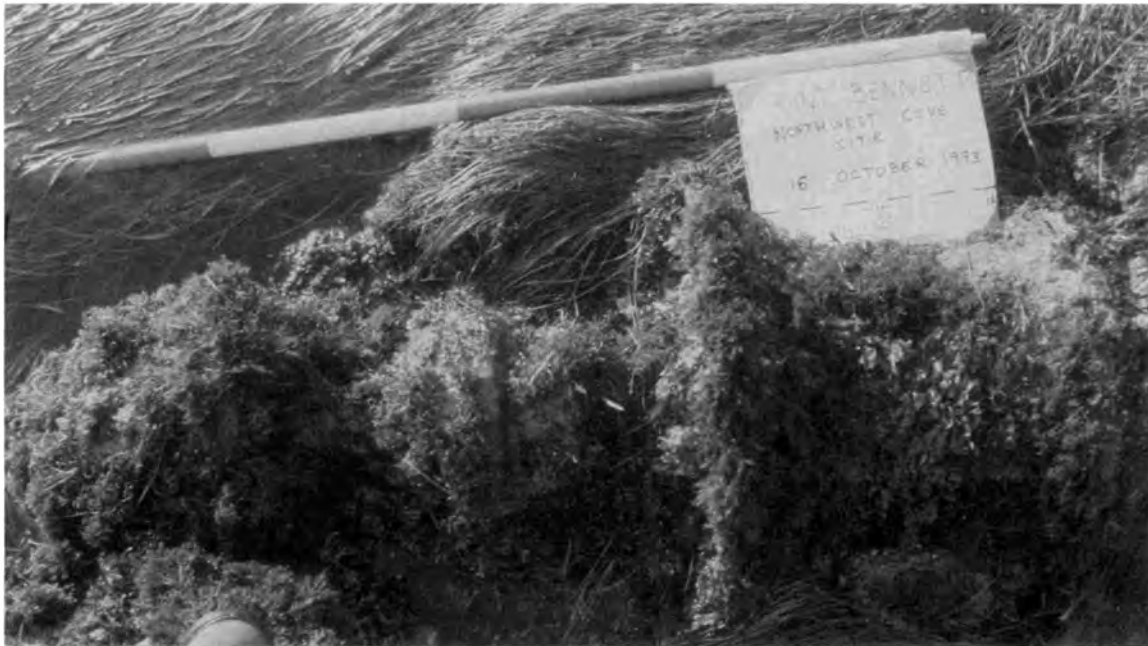
Figure 4.25. Feature PB-027. NPS photo by Adriane Neidinger.

Features PB-026, 027 and 029 are also likely parts to either a windlass or a donkey engine. Both PB-027 and PB-029 contain warping hubs and geared mechanisms on shafts, likely parts from the windlass, a deck winch or the donkey engine (Figures 4.24–4.27). PB-027 is 3 ft. 9 in. long, and PB-029 is 2 ft. long. The warping hubs on each are identical, 1 ft. 4 in. long and 1 ft. in diameter at their narrowest point. Feature PB-026 has a large, circular geared mechanism 1 ft. 10 in. in diameter, and a smaller circular object 1 ft. 5 in. in diameter (Figures 4.28 and 4.29). The teeth on the latter's edge are spaced on 7-in. centers, same as PB-017, which is also from the messenger chain system (Figure 4.30).

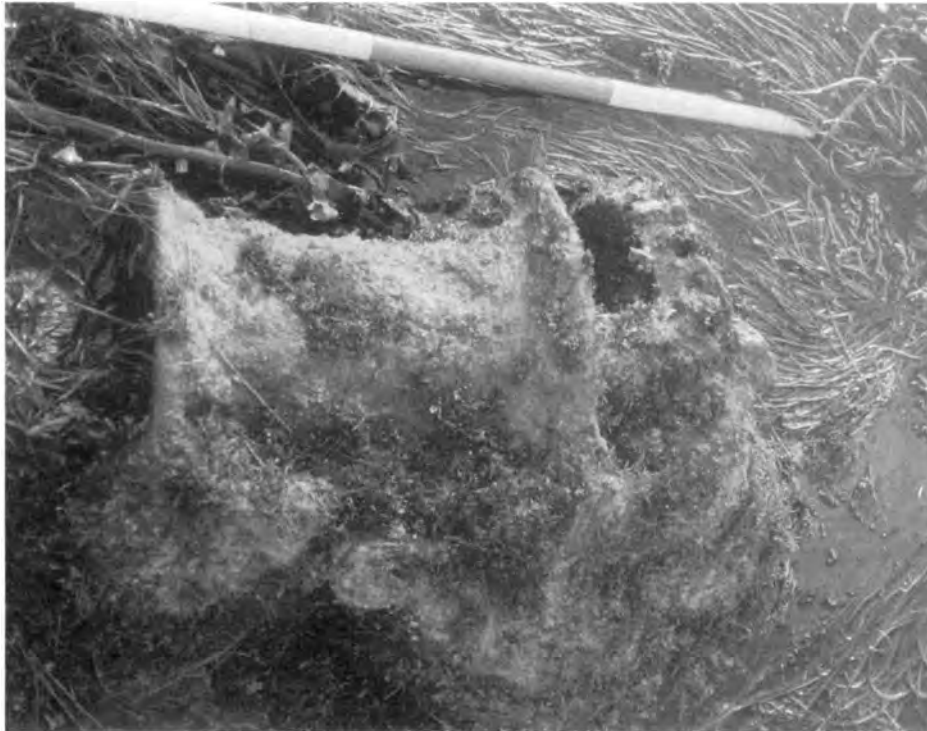
Figure 4.27. Feature PB-029. NPS photo by Adriane Neidinger.

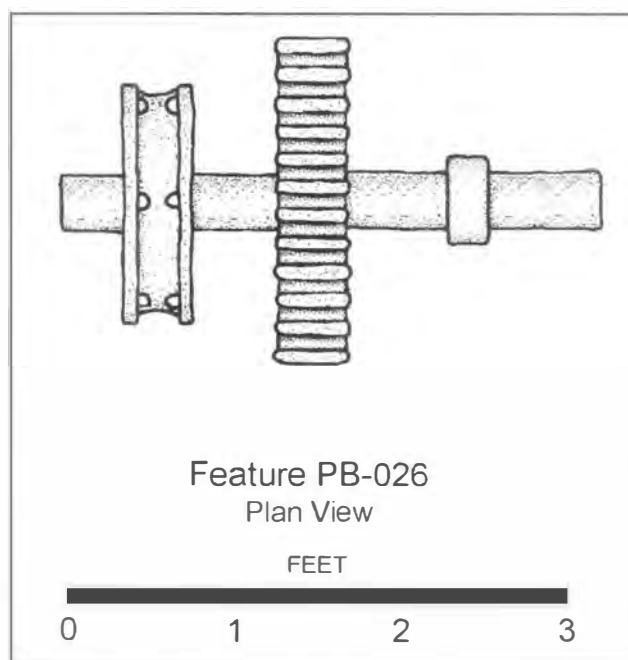
Figure 4.28. Unidentified windlass element with widely-spaced teeth for the messenger chain on the left. Drawing by Matt Russell.

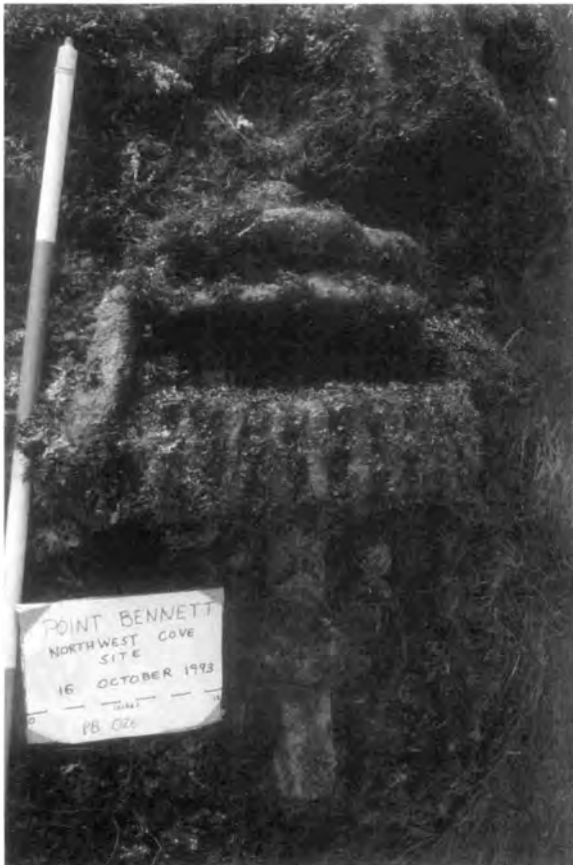
Figure 4.29. Feature PB-026 with the messenger chain gear at top. NPS photo by Adriane Neidinger.

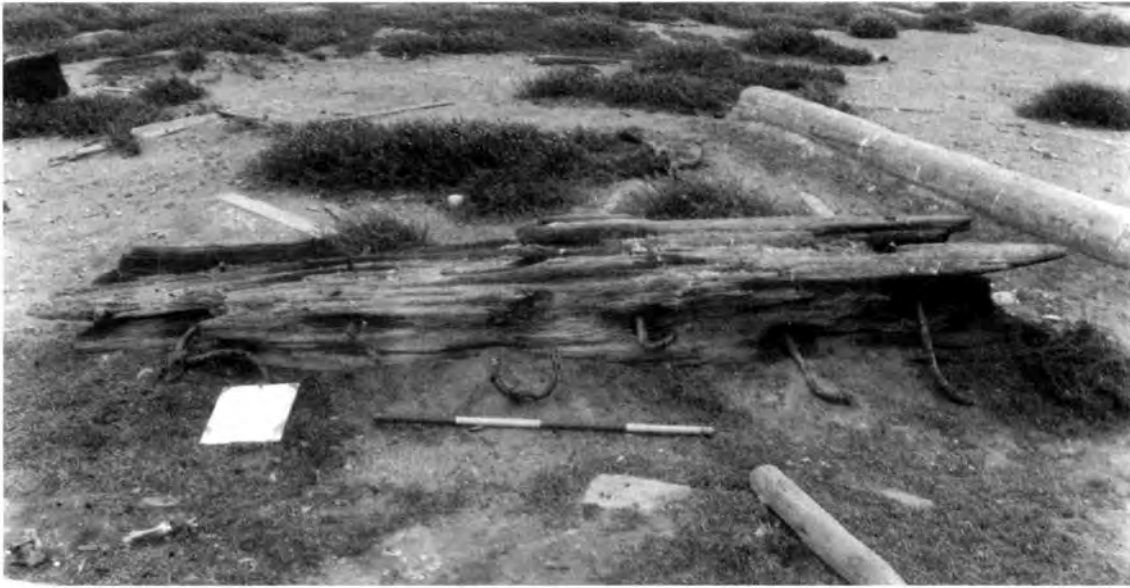
Figure 4.37. Feature PB-001. NPS photo by Matt Russell.

in. (Figures 4.36 and 4.37). Both ends are broken off, so it is impossible to determine the element's original length. All extant surfaces are badly worn and deteriorated, so sided and moulded dimensions are approximate. The element's most conspicuous characteristics are size and number of iron fasteners. There are six large, iron drift pins driven through and protruding from the side. These drifts are approximately 1½ in. in diameter (though exfoliating badly) and range in length from 2 ft. 2 in. (broken) to 4 ft. 2 in. long spaced an average of 2 ft. apart. There are also nine 1-in. diameter

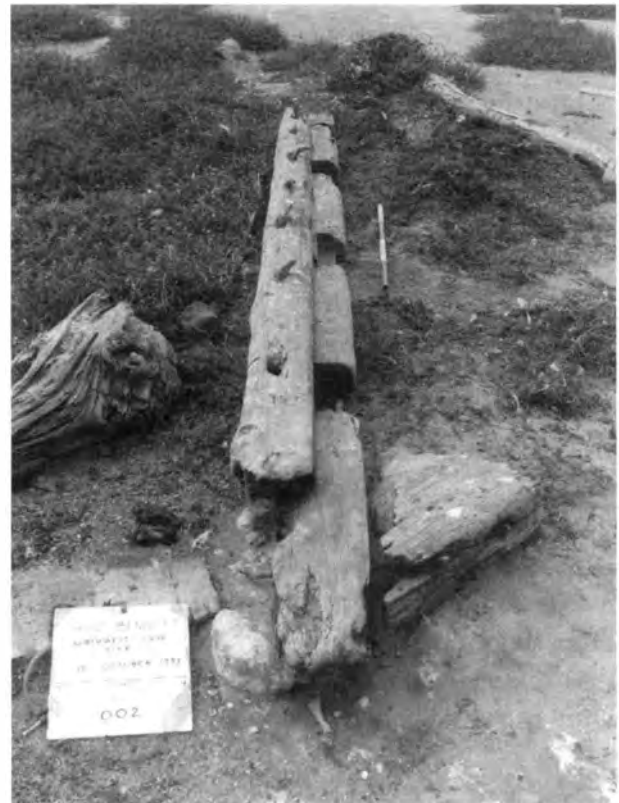
Figure 4.39. Feature PB-002. NPS photo by Matt Russell.

Another feature that is likely a scantling piece from a large, ocean-going vessel is PB-002 (Figures 4.38 and 4.39). This fragment consists of three wooden components: two long, rectangular pieces, one on top of the other, and a small trapezoidal piece fastened to the bottom timber. Also present are numerous iron fasteners. The bottom timber's total length is 19 ft. 8 in., it is 1 ft. 2 in. wide and 8 in. thick. This piece contains four mortises cut into its west side, which measure between 10 in. and 1 ft. 1 in. long, $3\frac{1}{2}$ in. high, and $5\frac{1}{2}$ in. deep. The mortises are indented about $1\frac{1}{2}$ in. from the side. The top timber, which was originally fastened to the bottom piece with eight $1\frac{1}{4}$ in. in diameter iron drift pins spaced 2 ft. on center, is 15 ft. 6 in. long, 8 in. wide, and 4 in. thick. On the feature's north end, a trapezoidal piece 2 ft. 2 in. long, 1 ft. $7\frac{3}{4}$ in. wide, and 8 in. thick is fastened to the lower timber with five iron, 1-in. diameter drift pins. In addition to these fasteners, the fragment also has two pairs of additional $\frac{1}{2}$ -in. diameter drifts in its west face.
