National Park Service
U.S. Department of the Interior

Submerged Resources Center

Beached Shipwreck Archeology: Case Studies from Channel Islands National Park

a product of the
NATIONAL PARK SERVICE
SYSTEMWIDE ARCHEOLOGICAL INVENTORY PROGRAM

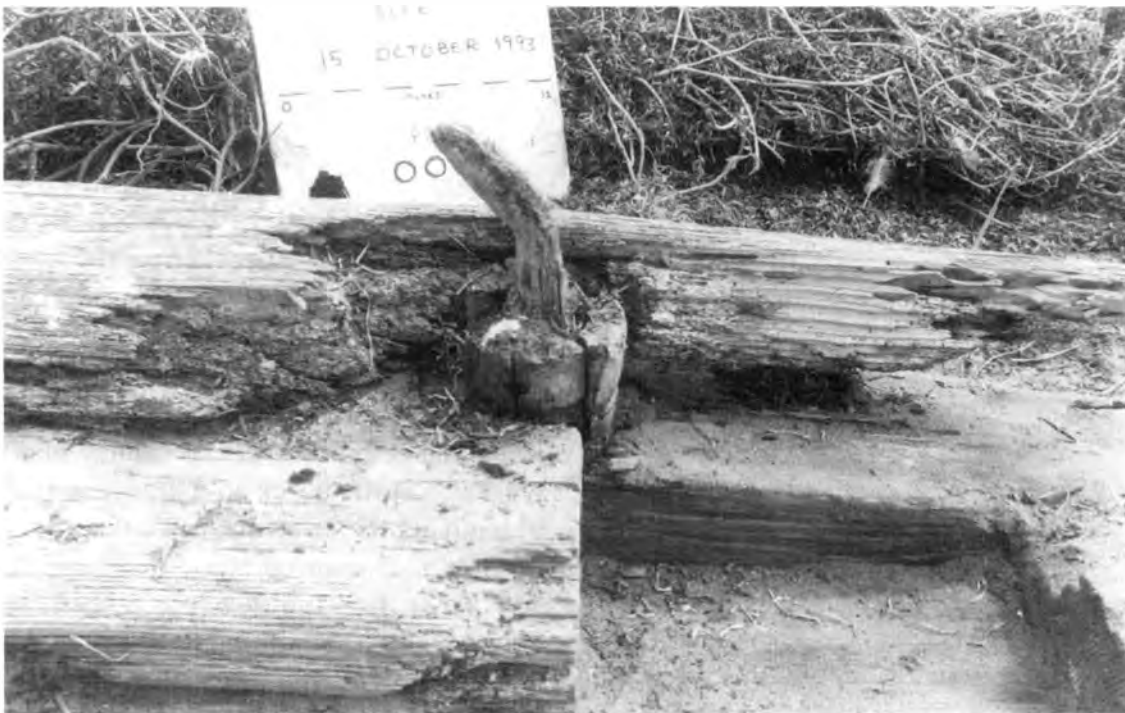
Finally, one of the most puzzling aspects of this fragment is that at least two of the vertical 1¼-in. fasteners joining the top timber to the bottom timber are driven through oak plugs (Figure 4.40). Only two could be examined, so it is possible that the remaining fasteners were also driven through plugs. Research into this practice has been inconclusive. It is unknown if this represents an effort to strengthen the bonding of these two timbers, or if this is evidence of a repair meant to replace a corroded fastener or possibly to augment wood that had deteriorated around the fastener. This may represent a peculiar and undocumented practice of the Hall Brothers. Identification as a portion of a deck clamp or shelf should be viewed as tenuous, especially when considering association with *J. M. Colman*.

Figure 4.40. Iron fastener driven through an oak plug on feature PB-002. NPS photo by Matt Russell.

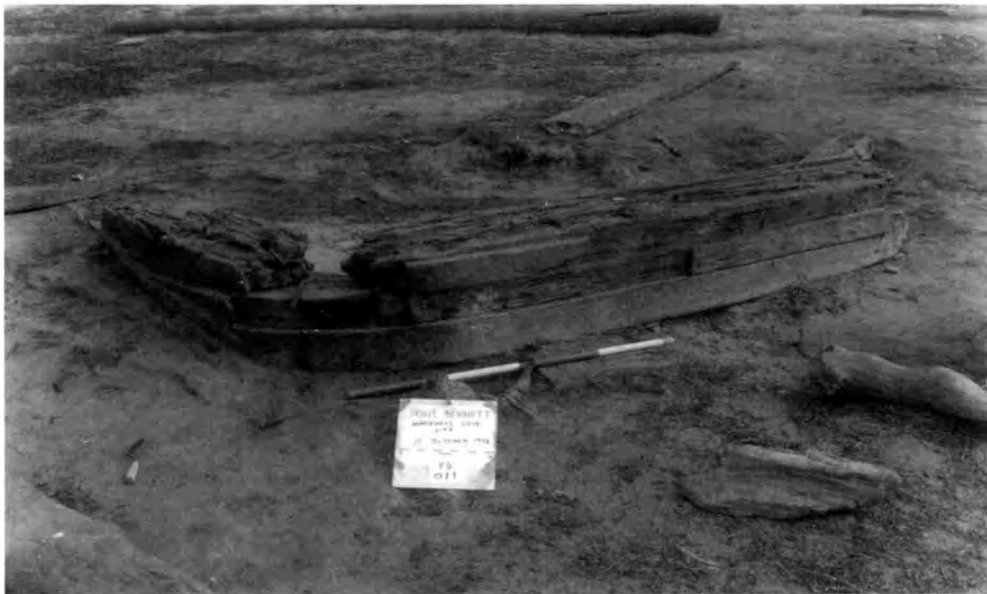
Figure 4.42. Oblique view of feature PB-011. NPS photo by Matt Russell.

Features PB-011 and PB-014, constructed in the same manner, likely represent pieces of a wooden hatch coaming (Figures 4.41–4.44). The two fragments each have three layers of timbers, fastened together with ½-in. diameter, round iron fasteners. Originally, the structure was either U-shaped or, more likely, rectangular with rounded corners. PB-011 is sitting upright, with the three layers stacked, while PB-014 is laying face-down with the three layers side by side.

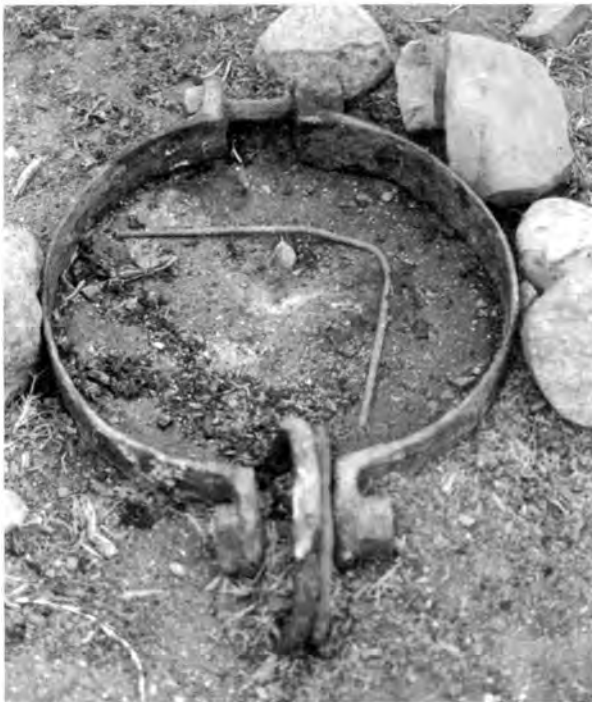
Figure 4.47. Iron mast-band used as a fire ring at Cluster Point. This object has since disappeared. NPS photo by Don Morris.

just south of Cluster Point. At that time it was being used as a fire ring, and it has since disappeared (Figure 4.47).

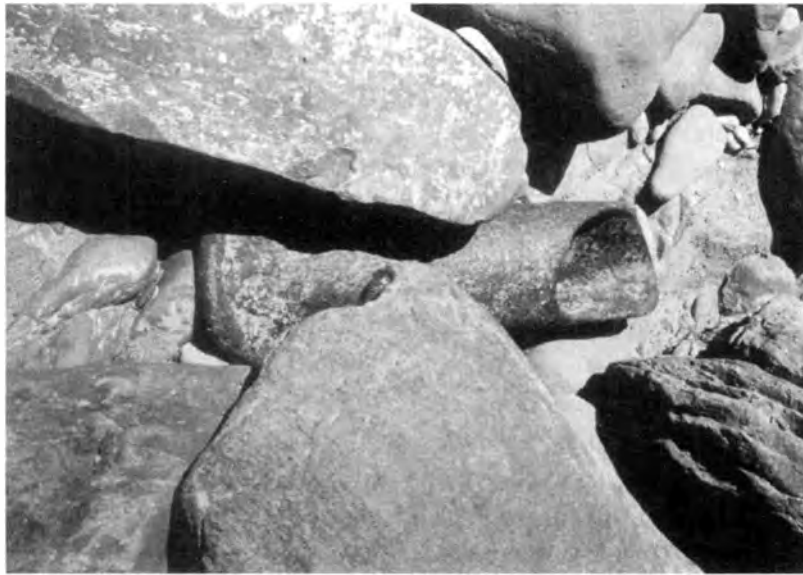
The second feature reported by Morris is an iron hawse pipe measuring 3 ft. 5 in. long, with an external diameter of 9½ in. Originally located in the rocks to the south of Cluster Point, it could not be relocated during the present study (Figure 4.48). According to the tables found in Desmond (1919[1984]), a vessel of 300 tons (*Dora Bluhm* registered 330 gross and 315 net tons) required a hawse pipe measuring 11½ in. in diameter. This hawse pipe appears to be more appropriate for a vessel of approximately 150 tons (Desmond 1919[1984]: 157), but this does not discount association with *Dora Bluhm*. It has already been demonstrated that dimensions were sometimes altered from published rules, as long as overall strength was not compromised.

Figure 4.48. Hawse pipe located near Cluster Point. NPS photo by Don Morris.

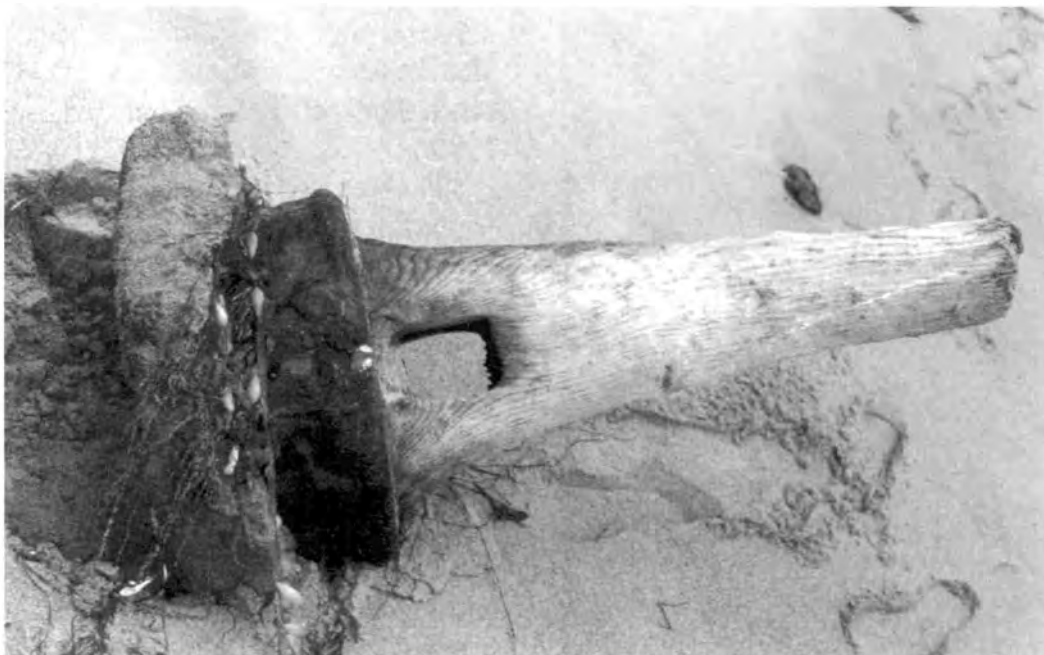
The third feature has been identified as the top of a rudder stock, which bears the yoke that attached it to a diamond-cut-screw steering gear (Don Morris, personal communication 1993; Figures 4.49–4.51). It consists of a worn wooden piece 12 in. in diameter clamped into an iron yoke, which is 10 in. wide. The iron yoke is composed of halves, connected by two iron fasteners on each side. Although there is no size comparison available, there are two pieces of evidence that support a *Dora Bluhm* association. First, the original contract for this schooner states that it was equipped with a diamond-cut-screw steering gear (JPSL 1883). Second, although not sampled for species identification, field observations by Morris indicate that the wooden portion of the feature, the top of the rudder stock, was hardwood, possibly oak. These two clues make this feature's association with *Dora Bluhm* likely. Unfortunately, this feature disappeared from the beach shortly after Morris recorded it in October 1988.

Figure 4.49. Portion of a rudder stock with the iron yoke that attached it to diamond-cut screw steering gear. NPS photo by Don Morris.

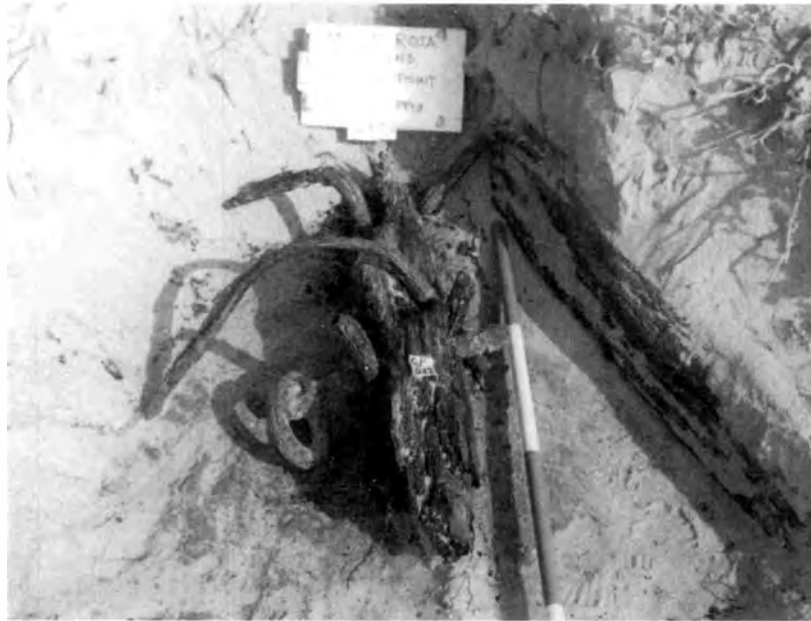
Figure 4.57. Unidentified element with large iron fasteners. NPS photo by Matt Russell.

Feature CP-017 is also a structural member from a large, wooden sailing vessel (Figure 4.57). The extremely deteriorated wood element is 3 ft. 4 in. long, 7 in. wide and 10 in. thick. It contains, however, five 1½-in. diameter iron drift pins (the longest 3 ft. long), and a 2-in. diameter iron eye-bolt with a 6½-in. outside diameter ring attached. The eye-bolt and ring represents a tie-down point, which could have been placed in many locations on the vessel. The five fastener's original measurements were considerably smaller, accounting for expansion caused by iron corrosion. The largest fasteners required in the *Dora Bluhm* contract were 1 1/8-in. drifts for the keel, keelson, stempost and sternpost. Feature CP-017 likely represents a small portion of any of these components.

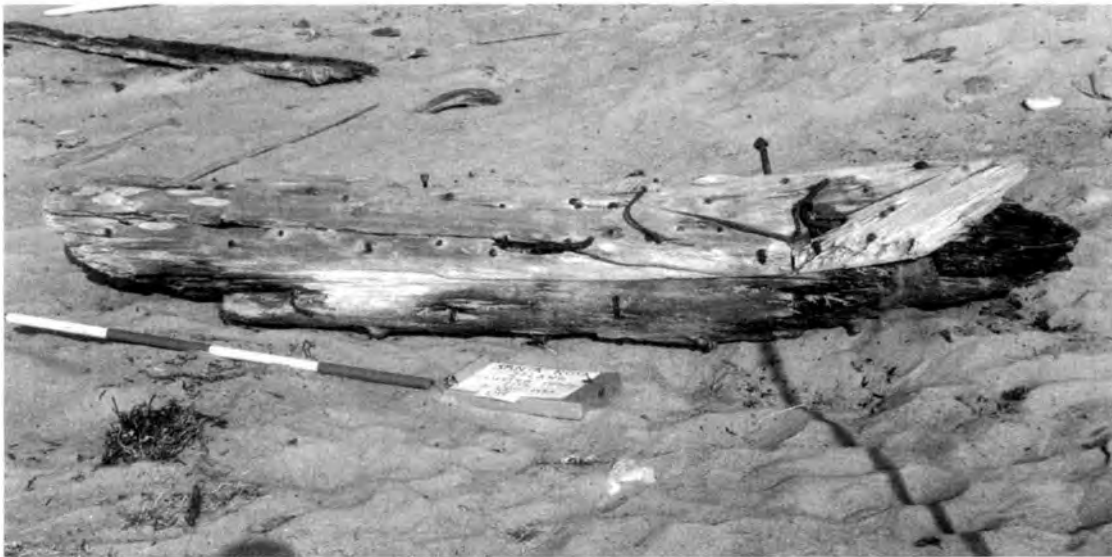
Figure 4.60. Feature CP-019. NPS photo by Matt Russell.

Feature CP-019 is an oddly shaped fragment that exhibits characteristics that are clearly from a large, wooden vessel (Figure 4.59–4.60). The feature is sizable and contains 47 iron fasteners,

all of which are $\frac{3}{4}$ -in. diameter round drifts. The fragment is composed of two pieces: a large, lower timber with three mortises along one edge, and a top portion made up of three different sections. These segments include a long element joined to a smaller element by a triangular chock. These three sections are fastened to the lower timber by 33 fasteners. The bottom part of the feature is 9 ft. long, 18 in. wide and 12 in. thick. The top timbers are 10½ in. wide and 3 in. thick. Like most of the other features, both ends are broken, so original length and configuration is unknown.

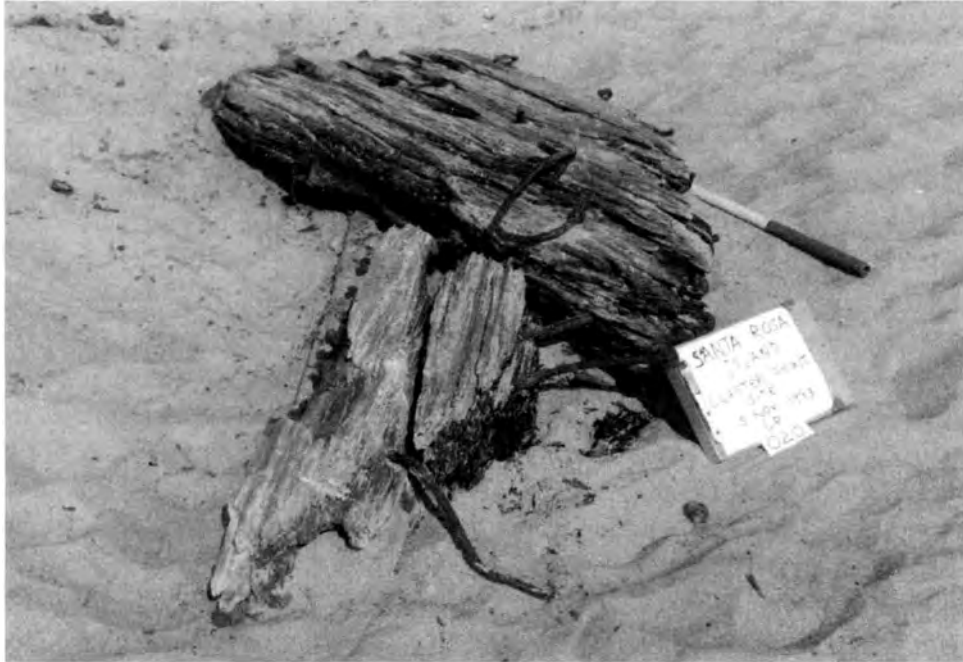
Figure 4.62. Feature CP-020. NPS photo by Matt Russell.

The last structural member discussed is feature CP-020 (Figure 4.61–4.62). It is a relatively flat fragment with a uniform thickness of 8½ in. The main timber is 7 ft. 3 in. long (though broken at the ends) and 1 ft. 9 in. wide; a smaller 4-ft. x 1-ft. 4-in. fragment is fastened to it at an angle. The feature contains nineteen 3/8-in. square spikes and seventeen 7/8-in. diameter drifts. Timber and fastener configuration suggest this piece represents a portion of the “rim” of a large, wooden vessel, while the smaller fragment attached to it is a component known as the anchor stock (Curtis 1919: 66). The rim circled the stern of the vessel

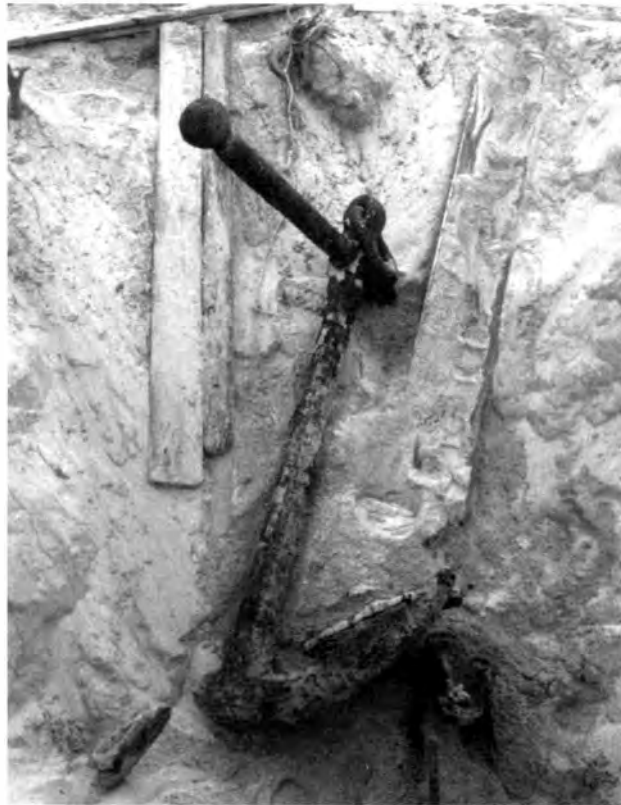
Figure 4.63. *Comet's* anchor after exposure in 1993. NPS photo by Matt Russell.

Although 1993 fieldwork exposed little of *Comet's* remains, it was possible to completely expose and record the anchor. *Comet's* anchor is iron with a collapsible iron stock (Figures 4.63–4.65). The anchor is fitted with a ring, but no cable is present. Overall length is 7 ft. 11 in.; stock length is 7 ft. 9½ in. Anchor arms are 3 ft. long, with 5 ft. 6 in. between palm tips. The palms measure 1 ft. 3¾ in. wide x 1 ft. 6 in. long, and 1¼ in. thick.

tonnage (Paasch 1890:151). Calculating an anchor's weight can determine what role it played on a vessel. The *Cyclopaedia of Useful Arts* (1854) provides a formula for estimating anchor weight (in hundredweights [cwt] = 110 pounds): $cwt = \text{overall length}^3 \times .0114$ (Murphy 1993:288). Using this formula, *Comet's* anchor weighs approximately 5.6 cwt or 616 lbs. A table of minimum anchor weights for sailing vessels found in Desmond (1919[1984]) shows a 400-ton vessel (*Comet* registered 429 gross and 368 net tons) was required to carry two 1,850-lb. bower anchors, a 600-lb. stream anchor and a 300-lb. kedge anchor. The anchor found on *Comet* most likely represents its stream anchor.

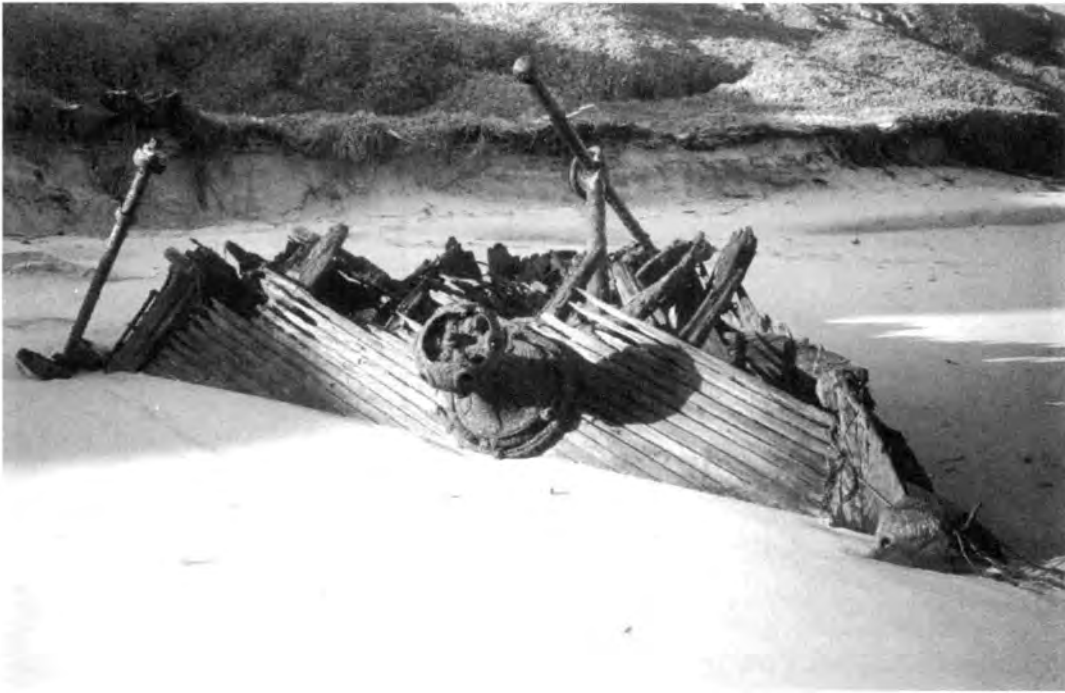
Figure 4.66. *Comet's* bow section looking down at forecastle deck. NPS photo by Matt Russell.

approximately 10 m x 8 m. The nearly intact bow section points out to sea on a heading of 317° magnetic, and the bow is heeled 55° to starboard and tilted down 20°. Much of the bow's port side has been worn away by natural deterioration (Figures 4.66–4.69).

The starboard side of the forecastle deck is intact from the bow to the deck's aft end above the windlass (Figure 4.80; also Figures 4.66 and 4.69). Forecastle deck remains are supported by five deck beams; the three forward-most beams are 5½ in. sided, and the two aft beams,

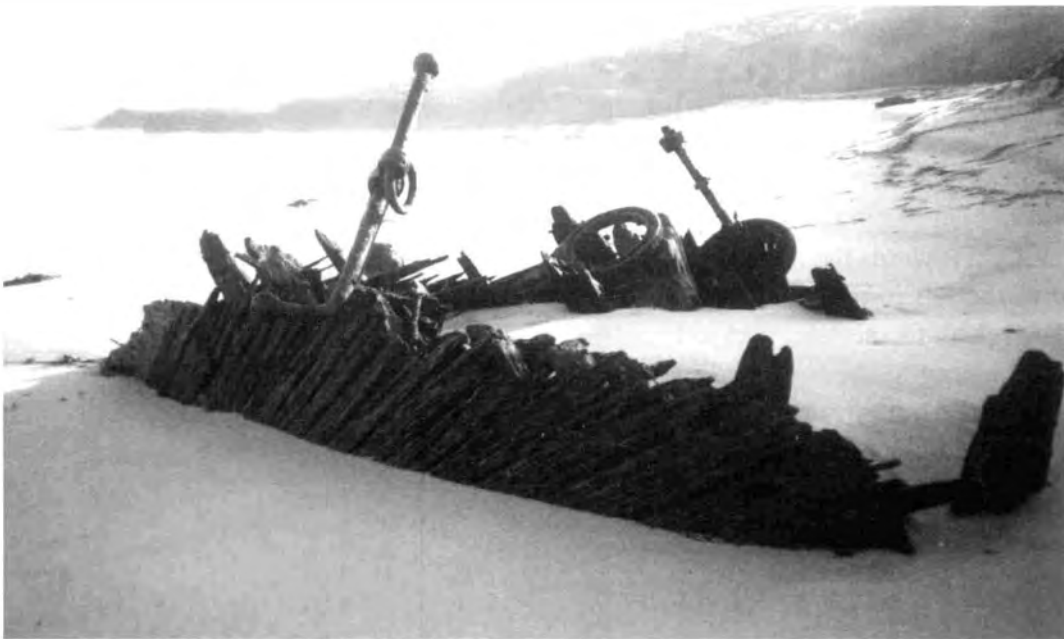
Figure 4.67. *Comet* site in April 1999, looking at the port side outer hull timbers. NPS photo by Matt Russell.

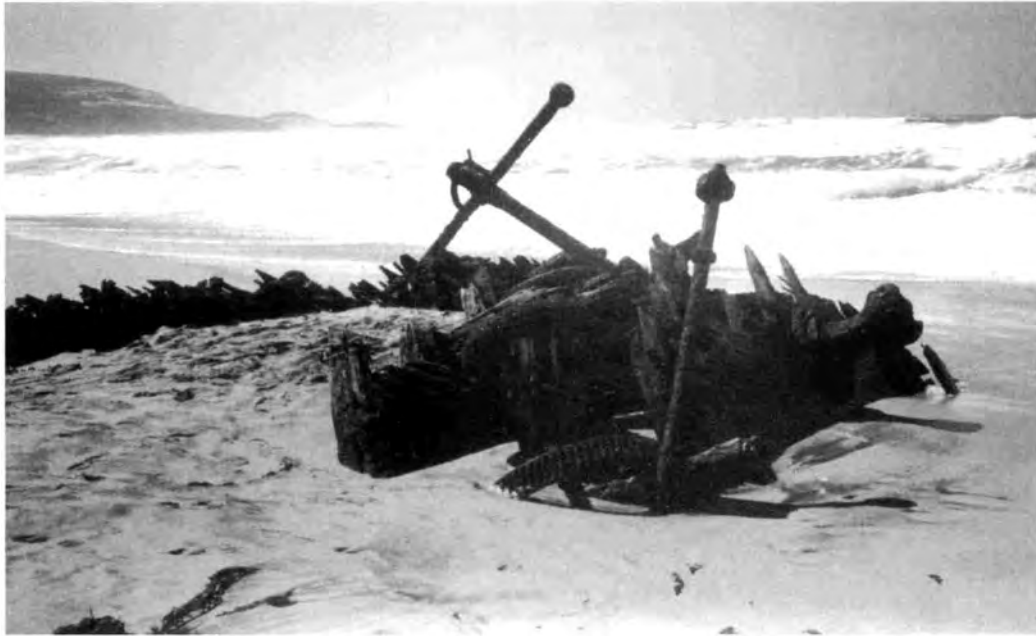
Figure 4.68. *Comet* site in 1999, looking towards the windlass (mounted on the main deck) in the center of the photo, with the capstan (mounted on the forecastle deck) to the right. NPS photo by Don Morris.

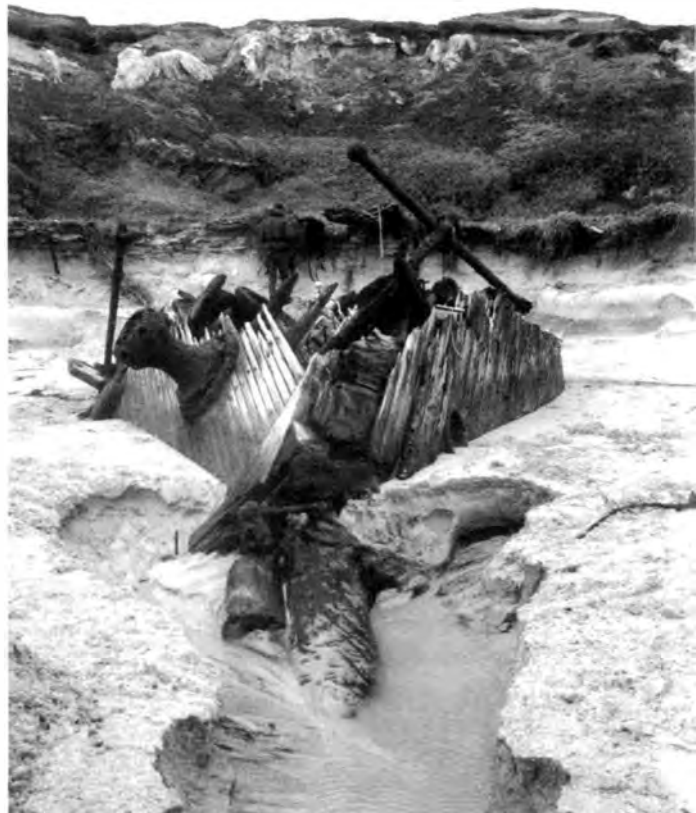
Figure 4.69. *Comet* site in April 1999, looking straight towards the bow, which is canted to the left in this photo. The forecastle deck is to the left, port side outer hull planking to the right and the bowsprit is in the bottom of the photo. NPS photo by Matt Russell.

As noted above, *Comet*'s bowsprit is intact and in its original position (Figures 4.69, 4.70 and 4.75–4.77). On a wooden sailing vessel, the bowsprit, a spar that projects forward from

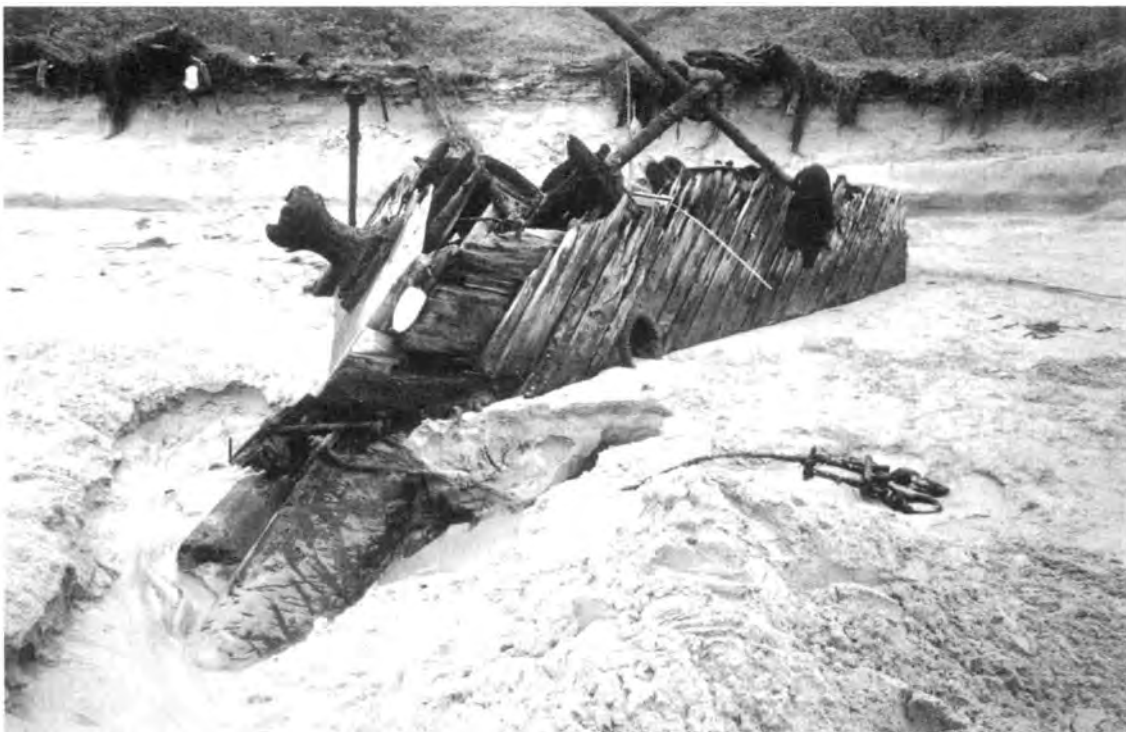
Figure 4.75. *Comet's* bow. The hawse timbers are in the center with the white float on them. The hawse pipe is visible at the sand-line, to the right of the hawse timbers. In the right foreground is an unattached rigging element. NPS photo by Matt Russell.

Forward of the frame pairs are two hawse timbers, or hawse pieces (Figure 4.75; see Figure 4.74). These timbers “. . . close the openings between forward cant frames from the knighthead aft as far as necessary to give good solid fastening for hawse-pipe flanges. The lower ends of hawse timbers are bolted to the apron and the several hawse timbers are edge-bolted together . . .” (Desmond 1919[1984]:55). The hawse pieces are 6 in. molded and 2 ft. sided, though their sided dimension appears to narrow over their length, and the aft hawse piece is eroded on its aft side, making an accurate original sided dimension difficult to measure. The top edge of the hawse pipe is located 5 ft. 5 in. below the upper surface of the hawse timbers.

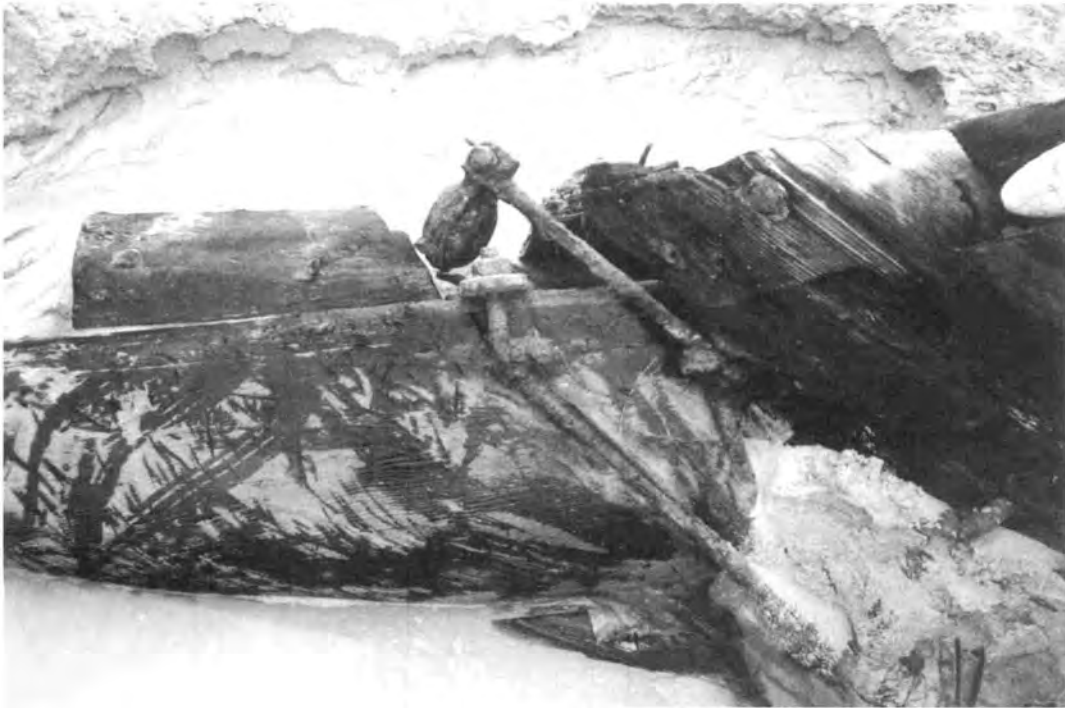
Figure 4.76. The port knighthead is the large timber on the right side of the photograph. The bowsprit extends horizontally to the left in the photo with the jibboom heel chock on top; also visible are the gammon iron and a single bull's-eye that held the foremast stay.

Forward of the hawse timbers is the port-side knighthead (Figures 4.76 and 4.77; see Figure 4.74). The knightheads strengthen the bowsprit and support the hooding ends, which are the forward ends of the outer hull planks (Desmond 1919[1984]:50). The knighthead is rhomboid in shape, with each side varying slightly between 1 ft. 2 in. and 1 ft. 3 in., and its shape narrows and curves over its length. Neither hawse timbers nor knightheads are mentioned in *Comet's* contract, but the *Rules for the Construction of Wooden Vessels* states that knightheads and hawse timbers should have double the sided dimension of the frames (American Shipmasters' Association 1879:xxi). *Comet's* hawse timbers are sided more than double the frames' sided dimensions, and the port knighthead, if measured on the diagonal, also follows this specification. The starboard knighthead and stempost were buried in the sand beneath the bowsprit and neither was observed.

Just forward of the knighthead, set up around the bowsprit, is the gammoning or gammon iron (Figures 4.76 and 4.77). The gammoning secures the bowsprit to the stempost and counters the upward lift of the foremast stays. Before the late-nineteenth century, gammoning consisted of rope or chain lashed over the bowsprit; later it was replaced by an iron band, which could be tightened with nuts and bolts (de Kerchove 1961:323). Chapelle (1973:479) depicts gammon iron consisting of iron straps for both the horizontal (across the bowsprit's upper surface) and vertical (down the bowsprit's sides and bolted to the stempost) components (Figure 4.87; see Figure 4.84). *Comet* has 5-in. wide x 1-in. thick iron strap across the bowsprit's upper face secured by 1½-in. diameter, round iron bar stock on either side of the bowsprit to the stempost. The top of the bar stock is threaded and tightened to the strap with 2¾-in. hex nuts. The point where the bar stock attaches to the stempost was buried and could not be documented.

Located on the bowsprit's upper surface, just forward of the gammon iron, is the jibboom heel chock or block, also called the jibboom saddle (Figures 4.76 and 4.77) (Chapelle 1973:359, 368, 503; de Kerchove 1961:408; Underhill 1958:33). This is a small wood block that supported the jibboom heel. The jibboom is a spar located on top of and attached to the bowsprit that extends forward of it (Figures 4.84 and 4.87)(de Kerchove 1961:408).

Another single bull's eye attached to a 1½-in. diameter iron rod is bent over on top of the bowsprit (Figures 4.76 and 4.77). The bottom of the iron rod is buried in the sand below the bowsprit, so its attachment point could not be recorded. The bull's eye itself has the same dimensions as the bull's eyes described above.

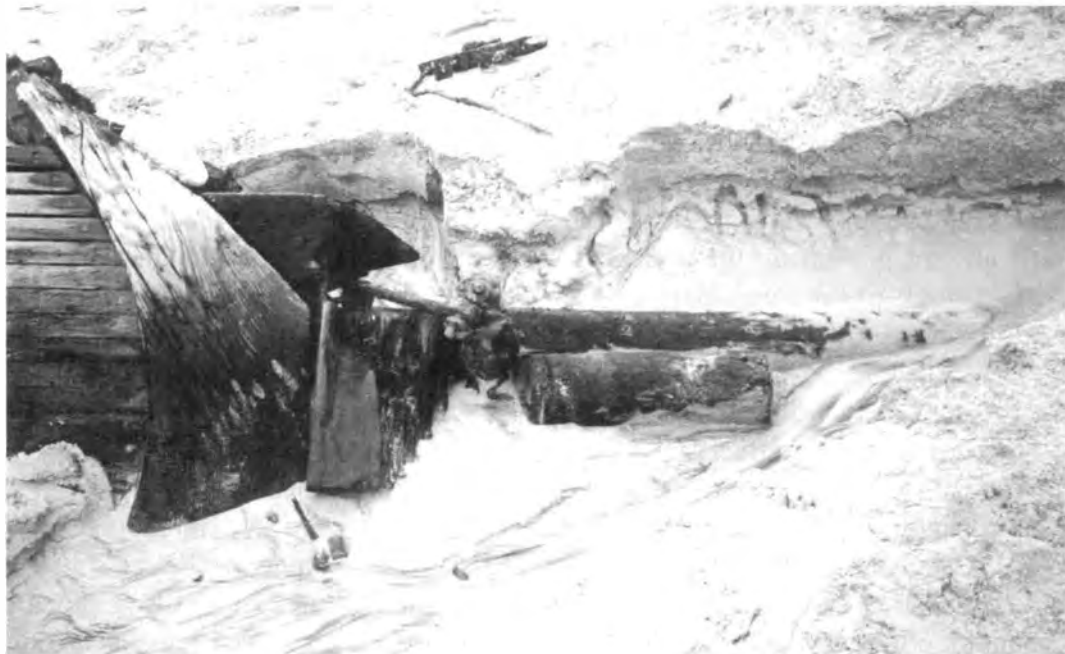
Figure 4.77. Top view of *Comer's* knighthead (to the lower right of the white float), bowsprit and jibboom heel chock. NPS photo by Matt Russell.

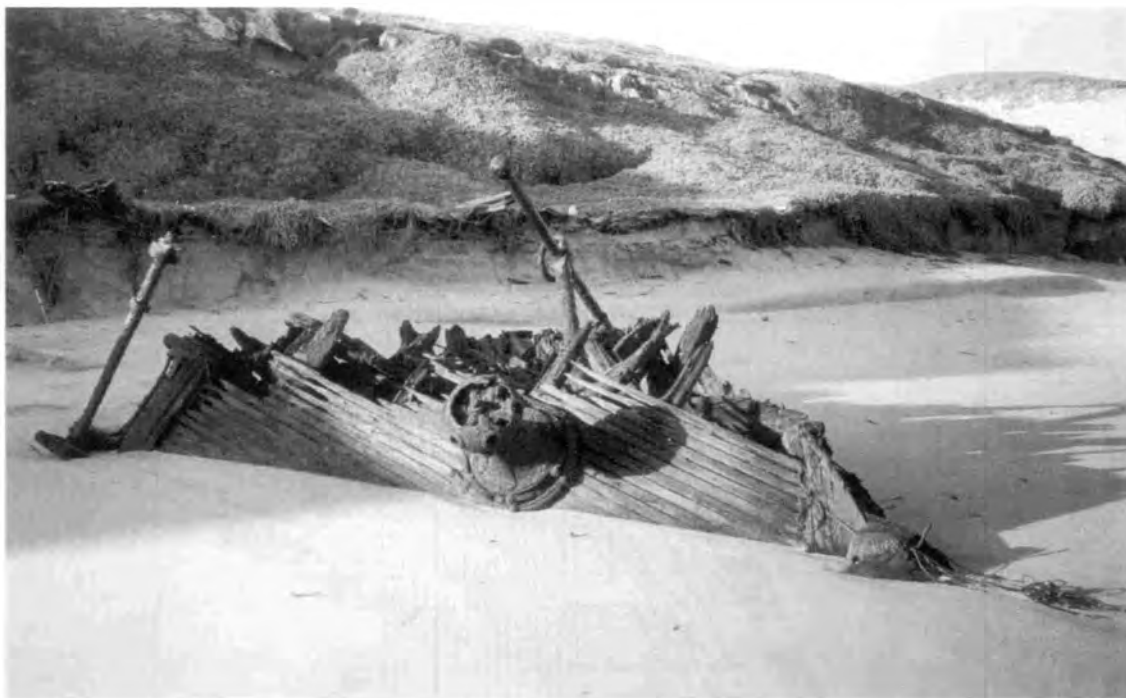
Figure 4.80. *Comet* site in April 1999, looking down on the fore-castle deck with the capstan mounted to it. The bow is to the right. NPS photo by Matt Russell.

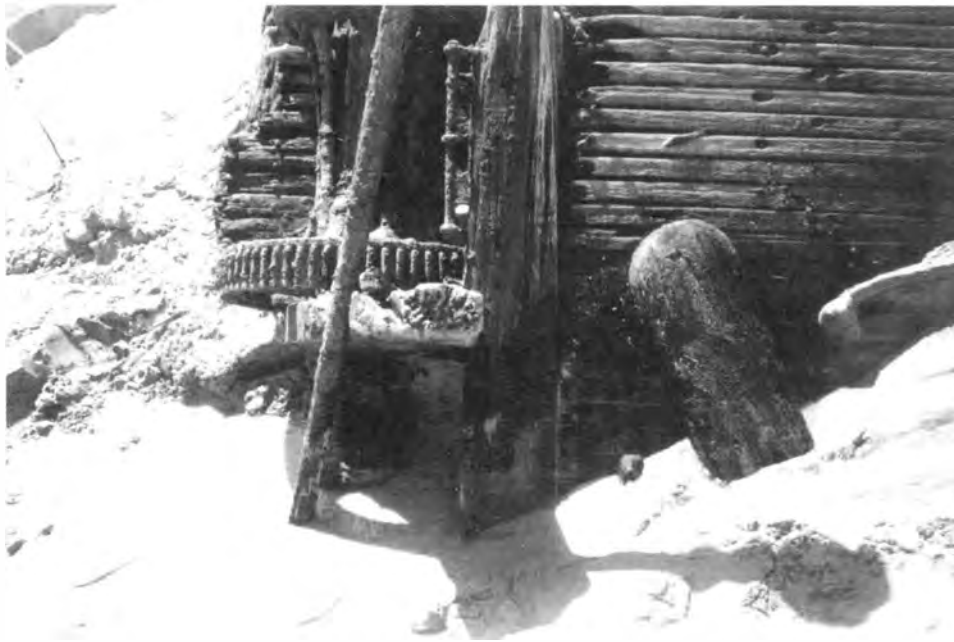
Figure 4.81. Top view of the aft end of the forecastle deck. The aft-most forecastle deck beam is the vertical timber in the center of the photo. The winlass is to the left, mounted on the main deck below; the starboard cathead is the angled timber to the right. NPS photo by Matt Russell.

fore- and aft- the pawl post, are sided between $9\frac{1}{2}$ and $10\frac{1}{2}$ in. Like on the main deck, port clamps are absent. Thirty fore-castle-deck planks are exposed: all 3 in. sided x $2\frac{1}{2}$ in. molded. Each plank is fastened with a single boat spike at its forward end, a single boat spike at its aft end (for complete planks), and a single boat spike in each deck beam. Fore-castle-deck spikes are $5\frac{1}{4}$ in. long with $5/16$ -in. square shanks and $1\frac{1}{16}$ in., four-faceted heads and are countersunk and plugged with 1-in. diameter wooden plugs. Deck plank forward ends are resting on and fastened to the fore-castle-deck hook and are butted against the fore-castle-deck waterway hook (Figure 4.77). Again, like the main deck, waterway strakes are gone. Complete deck plank aft ends are resting on and fastened to a recessed shelf notched into the forward edge of the aft-most fore-castle-deck beam (Figure 4.81). Fore-castle deck beam and

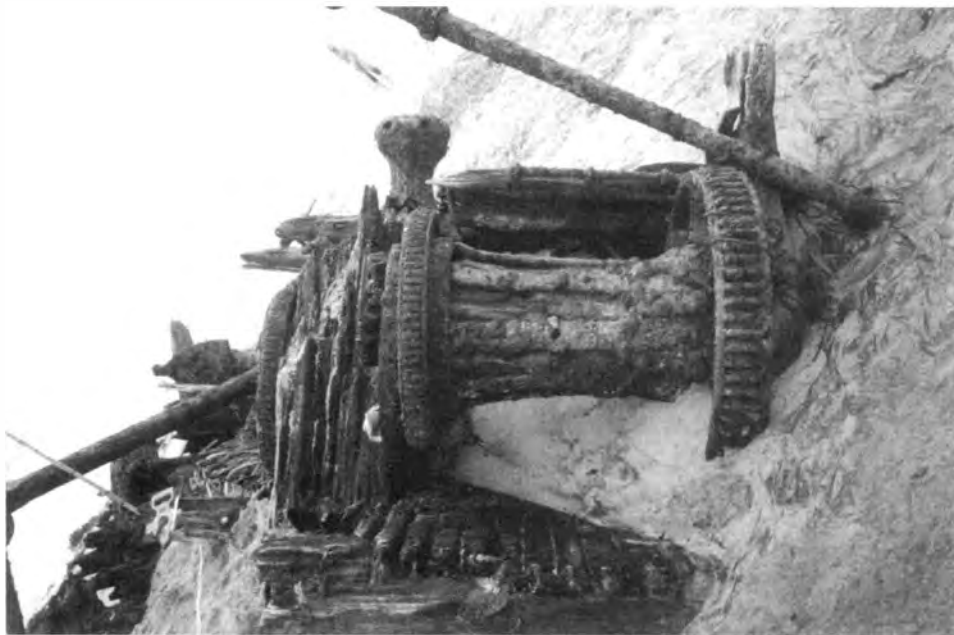
Figure 4.82. Photograph taken from the perspective as if the viewer were standing on the main deck looking forward. The pawl post is to the left of the winlass. NPS photo by Matt Russell.

The pawl post, sometimes called the pawl bitt, Samson post or heel bitt when the bowsprit is stepped into it, is present from fore-castle-deck level to the main-deck level, where it is buried in the sand (Figures 4.82–4.84). The pawl post is a solid timber, usually stepped into the keelson or bow deadwood, which extends upward and ends above fore-castle-deck level (Chapelle 1973:368–370; de Kerchove 1961:91; Underhill 1958:88). In *Comet*, the pawl post served two purposes: 1) the bowsprit's inboard end, called the heel, is stepped into the pawl post's forward face; so the pawl post serves as a major reinforcing member for the bow rigging; and 2) the windlass pawl was mounted on the pawl post's aft face, though neither the windlass pawl nor pawl rim are present on site. The pawl post

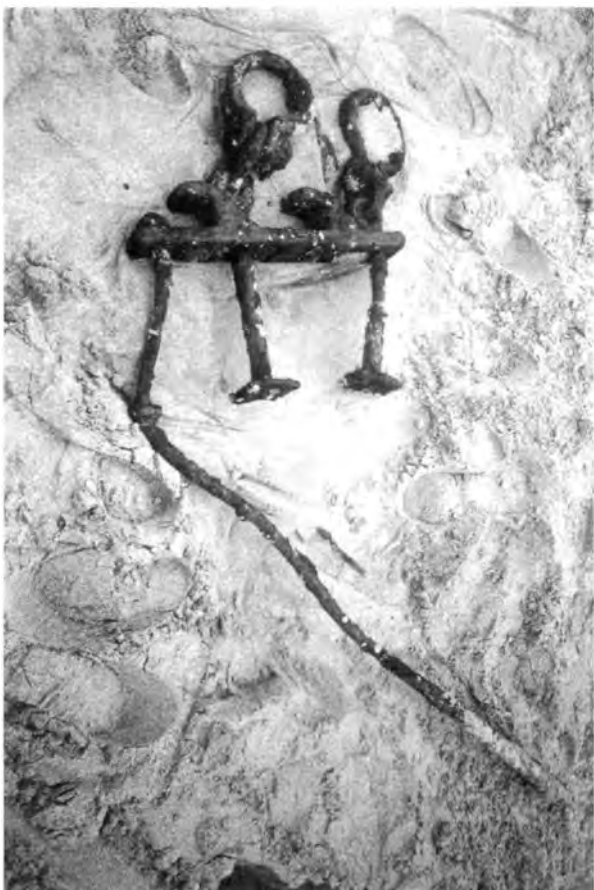
Figure 4.90. Rigging element off *Comet*'s port bow. NPS photo by Matt Russell.

Located off *Comet's* port bow is an unattached iron rigging element (Figure 4.90 and 4.91; also Figure 4.75). It consists of a 4 ft. 3 in.-long iron rod with a 5 in. long x 2½ in. wide x ½ in. thick plate on one end, attached to an 11½-in. long x ¾ in. diameter iron fastener that is attached to a 1 ft. 6½-in. long x 1-in. thick iron plate. The plate is pierced by two 1 ft. 3-in. long x 1-in. diameter eyebolts, each of which has an iron ring attached to an iron strop from a bull's eye or deadeye (the wooden block is no longer present), similar to those described above. In addition, the iron plate has two iron hooks cast as part of its upper surface. Although documentary research could not identify the element's proper name, its function was identified. This object was originally fastened to the foreside of the port cathead and provided

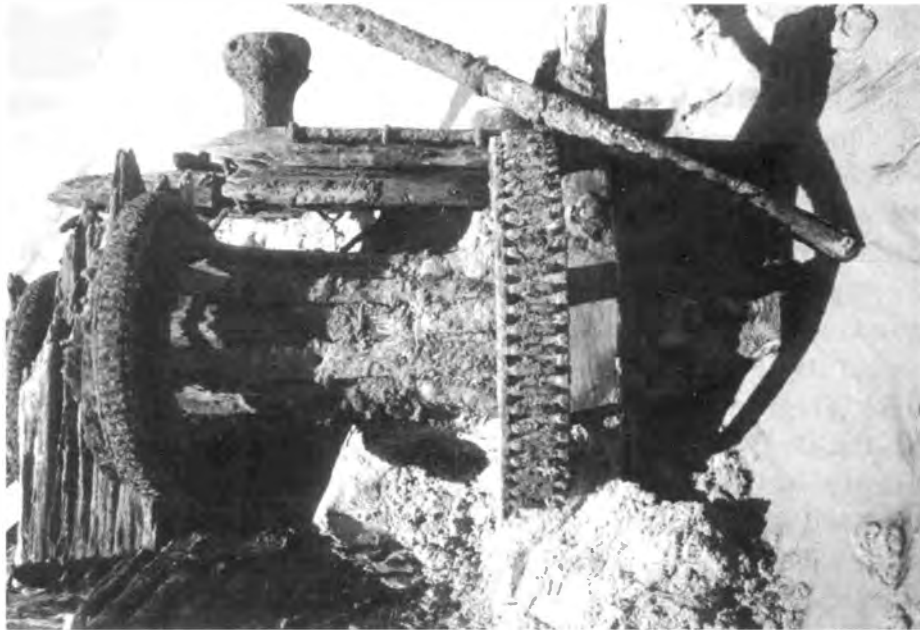
Figure 4.94. *Comet's* windlass mounted on the main deck. NPS photo by Matt Russell.

Comet's windlass is mounted on the schooner's main deck, just aft of the pawl post (Figure 4.94 and 4.95). The windlass has a wooden barrel with iron whelps supported by hardwood carrick bitts. It was worked with two iron purchase rims (with 1 ft. 11½ in., or 23½ in., inside diameter) and purchase arms connected by iron purchase rods to a pivoting rocker, or crosshead, mechanism that was originally mounted above the windlass on the forecastle deck (Figure 4.96)(Chapelle 1973:669–680; Paasch 1890:Plate 70). Just forward of the pawl post at forecastle-deck level are two fasteners and the remains of a block that supported the crosshead on the forecastle deck. On either side of the pawl post are openings in the forecastle deck where the purchase rods connected the windlass purchase arms to the rocker on the forecastle above (Figure 4.80).
