## **Case Study 8: Relocating the Lighthouse, Cape Hatteras National Seashore, North Carolina**

**Contributing Author:** John Kowlok (Cape Hatteras National Seashore)

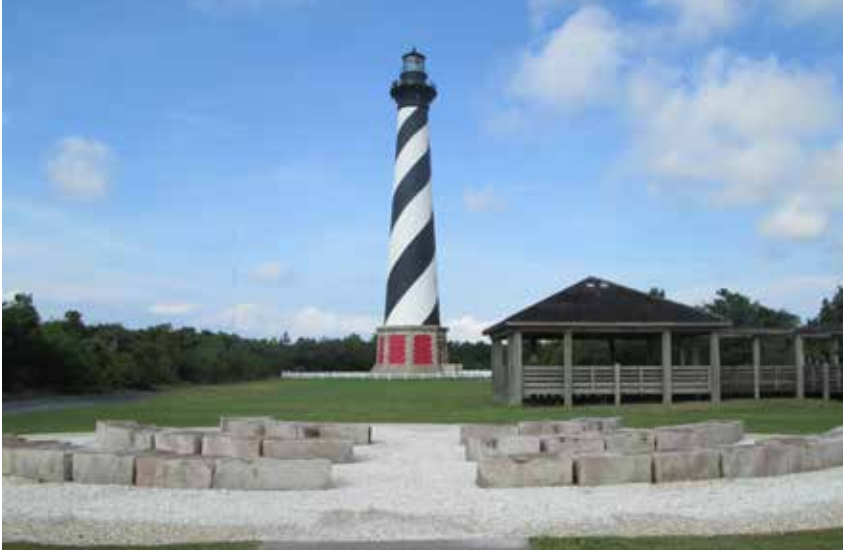
The Cape Hatteras lighthouse was moved inland using a railway in 1999. Image credit: NPS.

The lighthouse was moved in June 1999 at a cost of \$11.8 million. The new location is 0.9 km (0.55 mi) from its previous position and approximately 0.5 km (0.3 mi) from the shoreline. The Lighthouse Society placed a ring of granite stones, each engraved with the name of a lighthouse keeper, to mark the former position of the lighthouse. Although the original plan called for the stones to be left in place, continued overwash and burial of the stones led to negotiations between the Lighthouse society, a Congressional Representative, and NPS to uncover and move the stones. Cape Hatteras National Seashore funded the new Keepers of the Light Amphitheater, which was built in 2015 by placing the stones in arcs in front of the lighthouse’s new location.
