Subject: New Additions to Mid-size Historic Buildings

October 2001, ITS Number 18

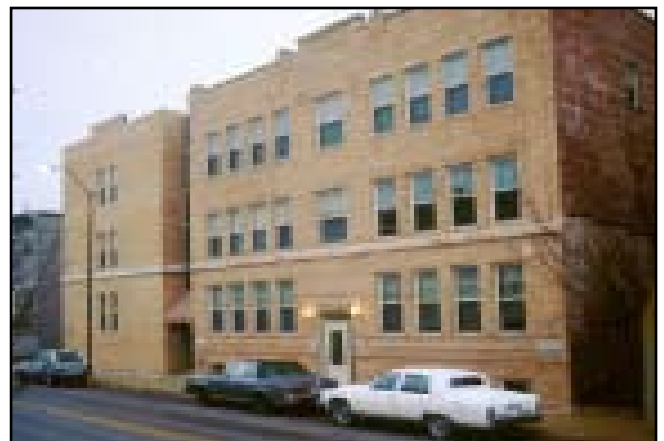
The slight recess at the intersection of the addition (left) and the historic facade (right) allows the visual mass of the original building to remain unchanged.

Application 1 (*Compatible treatment, Appropriate addition*): Constructed in 1914, this three-story apartment building was built to the front property line of its site. Architectural detailing in face brick and stone distinguish the facade from the plain side walls of common brick. The addition which is roughly half the size of the original building attaches along the full length of one of the plain, side elevations. The street elevation of the addition is in the same plane as the original facade, consistent with other buildings in the historic streetscape. Although similar in form and materials, the composition and details of the new facade are more simplified. The distinction between the old and the new is reinforced by a narrow recessed connector faced with a glass curtain wall. The size and placement of the connector prevent the glass and metal from becoming too sharp a contrast that would make the connector itself an incompatible feature.

The successful intersection of old and new continues on the interior where the character of the former exterior wall is preserved. The brick surface remains punctuated by the original window openings that have simply been infilled with painted panels. The size, and details of the addition make it distinctly subordinate to the original building, and its placement avoids obscuring any character-defining features.

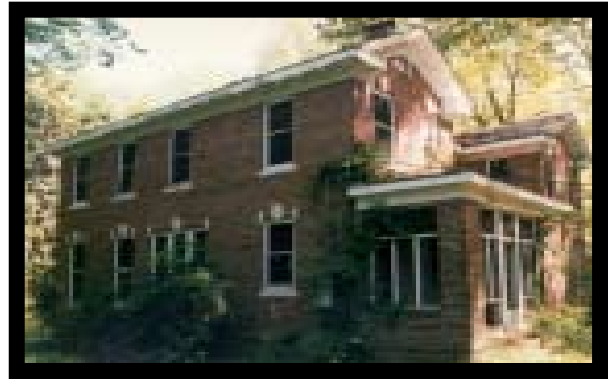
Shown is the side of the historic house illustrated in the elevation (below, left).

Application 2 (*Incompatible treatment, inappropriate addition*): This freestanding Colonial Revival style house was built in 1928 on a large site that remains somewhat wooded. The proposed addition has a footprint nearly twice the size of the original building, which is far too large to be offset even by its location at the rear of the house. There is little in terms of design or proposed materials to distinguish the new construction from the original house. In addition the architectural elaboration of the two new side entrances makes them strong elements that diminish the importance of existing character-defining features. The historic setting is also altered by so large an addition as well as the extensive paving for drives and parking lots.

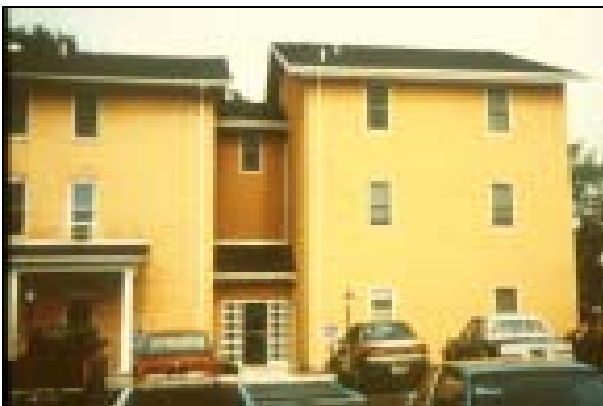
Rear of hotel showing original building (left), new addition and recessed connector.

Application 3 (*Compatible addition*): This small roadside hotel has been modified and expanded many times since its construction in 1853. The recent rehabilitation included another addition at the end of the rear wing. It is similar to the existing rear wing yet differentiated. Though the color is the same, the addition is stucco rather than brick. Windows are the same type and proportion, but the new ones have a simple lintel rather than a brick arch. The width of the addition and the slope of its roof match the rear wing but a small recessed connector separates the new from the old. The simplicity of the design and the location at the rear minimize the impact of this compatible addition.

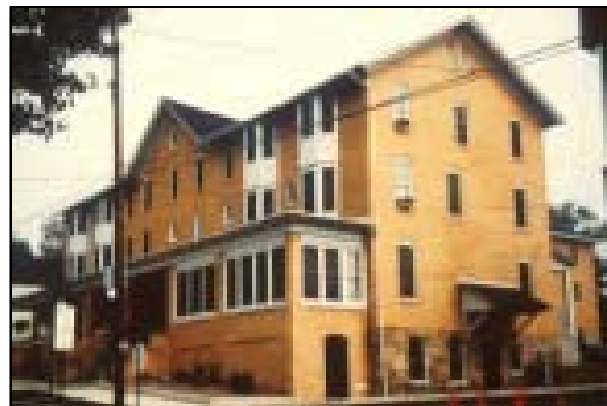
The new addition is not visible from the front of the building.
