## Subject: Adding New Openings on Secondary Elevations

- Applicable Standards:**
2. Retention of Historic Character
  9. Compatible New Additions/Alterations

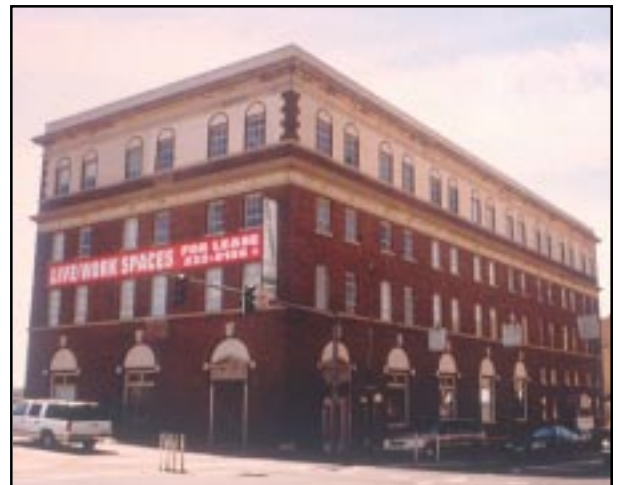
*A fourth floor was added in 1934 to this building originally constructed in 1927.*

**Application 1** (*Compatible treatment*): Originally constructed in 1927 as a manufacturer's distribution and storage facility, this building was altered in 1934 with the addition of another story. The proposal to rehabilitate the building into apartments called for windows to be inserted into a previously unfenestrated, side elevation. Even though highly visible, because the wall was not important in defining the historic character of this building, adding windows was determined to be a compatible treatment. The new windows are set back from both ends of the building, and are simply punched out openings in the wall without sills. In further contrast to the existing, historic windows in the building which are multi-paned, the new windows have a one-over-one configuration. The completed project meet the Standards.

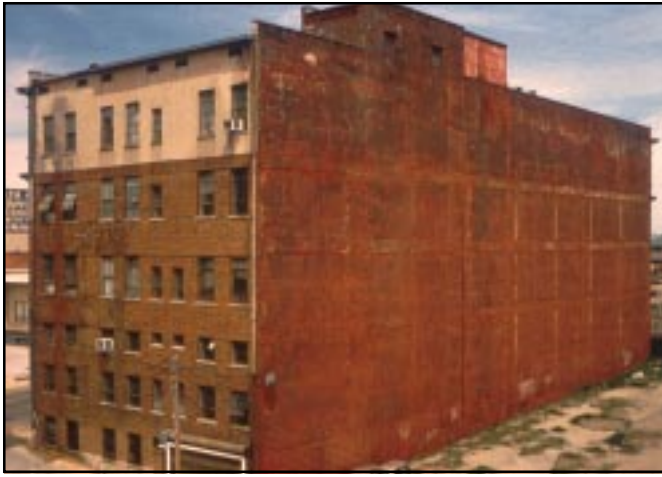
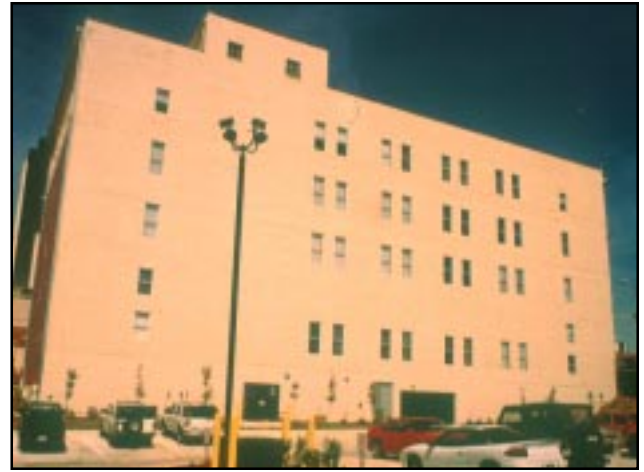
*Simple, compatible openings were cut into this blank, non-significant secondary elevation when the building was rehabilitated for apartments.*

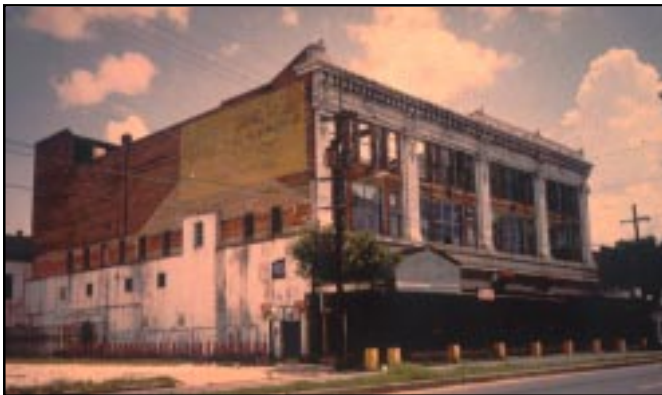
*The side elevation of a 1914 department store featured several non-historic openings which had been added over the years.*

**Application 2 (Compatible treatment):** In another example, a three-story, former department store constructed in 1914, was also converted into apartments. The front of the building featured storefront windows on the first floor, and large, equally distinctive windows on the second and third floors. The side elevation had a number of irregularly spaced openings that had been added over the years. Additional windows to provide light and air for the residential spaces were necessary for the new use. Neither the side elevation itself nor the openings in it were important to the historic character of the building. Accordingly, the existing openings were modified in order for the new apartment layout to function effectively. Three of the openings were closed up and bricked in, four were enlarged to accommodate the new windows, and several new openings were added. The new window openings are simple, unobtrusive cutouts without a sill. The pane configuration of the new windows is clearly contemporary, and it does not detract from the historic windows that dominate all three floors of the primary street elevation. This project, too, meets the Standards.

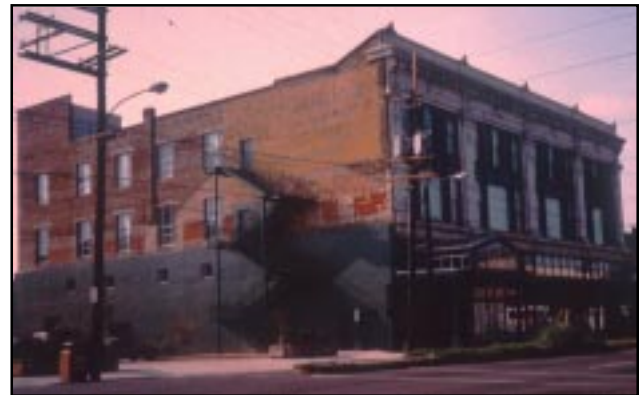
*Although highly visible, because the wall is not important in defining the historic character of the building, it was possible to change the existing openings and to add several new windows to accommodate the new use.*
