## Interpreting The Secretary of the Interior's Standards for Rehabilitation

### Subject: Changes to Shotgun Interior Plan

- Applicable Standards:
2. Retention of Historic Character
  5. Preservation of Distinctive Features, Finishes, and Craftsmanship

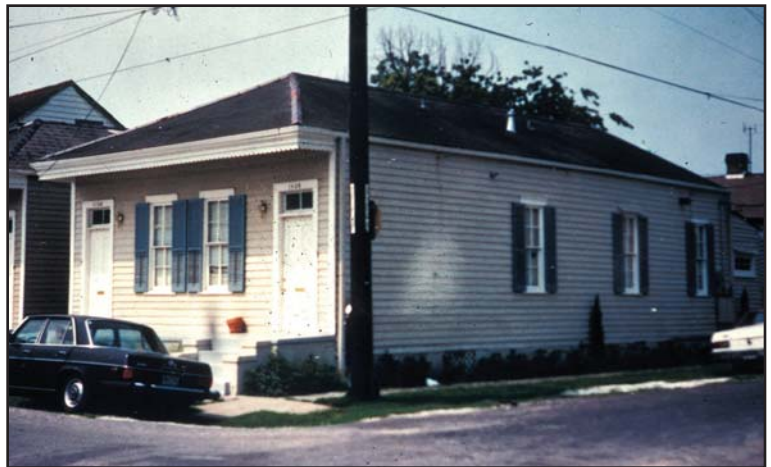
Circa 1900 double shotgun cottage prior to rehabilitation.

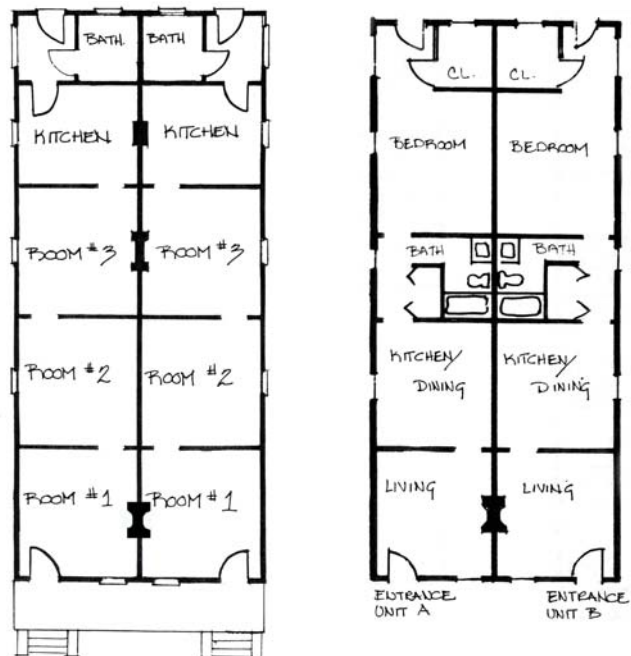
Left: Shotgun plan prior to rehabilitation. Right: Shotgun plan post rehabilitation with acceptable changes.

**Application 1 (Compatible treatment):** In the first example, the shotgun plan was generally retained in the rehabilitation with some modifications. Kitchens were inserted into the second room of each half of the duplex; a bathroom and laundry were inserted into the third room. The fourth room on each side of the building was enlarged by moving the partition forward a few feet. Despite these alterations, the historic division of the cottage into two equal units was respected in the rehabilitation. The linear arrangement of small rooms, one behind the other, was also maintained on each side. Thus, on both the exterior and interior, the building has the same appearance as it did historically, as a modest double shotgun cottage. This plan, which largely determines its historic character, remains following the rehabilitation. The project meets the Standards for Rehabilitation.

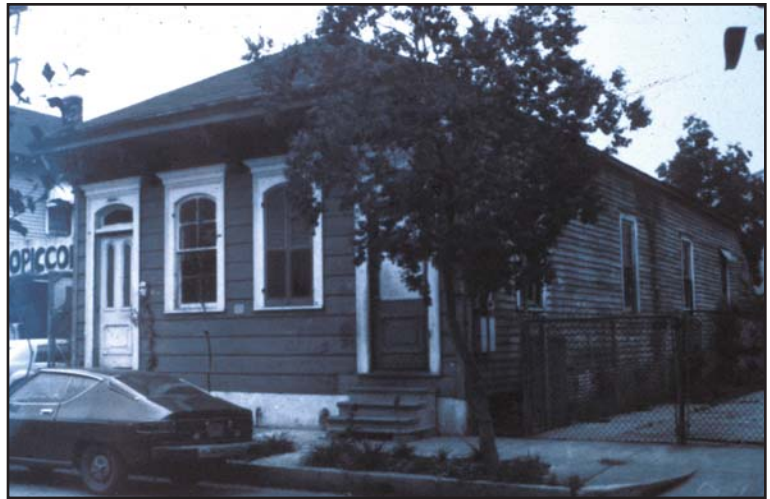
*Circa 1890 shotgun cottage prior to rehabilitation.*

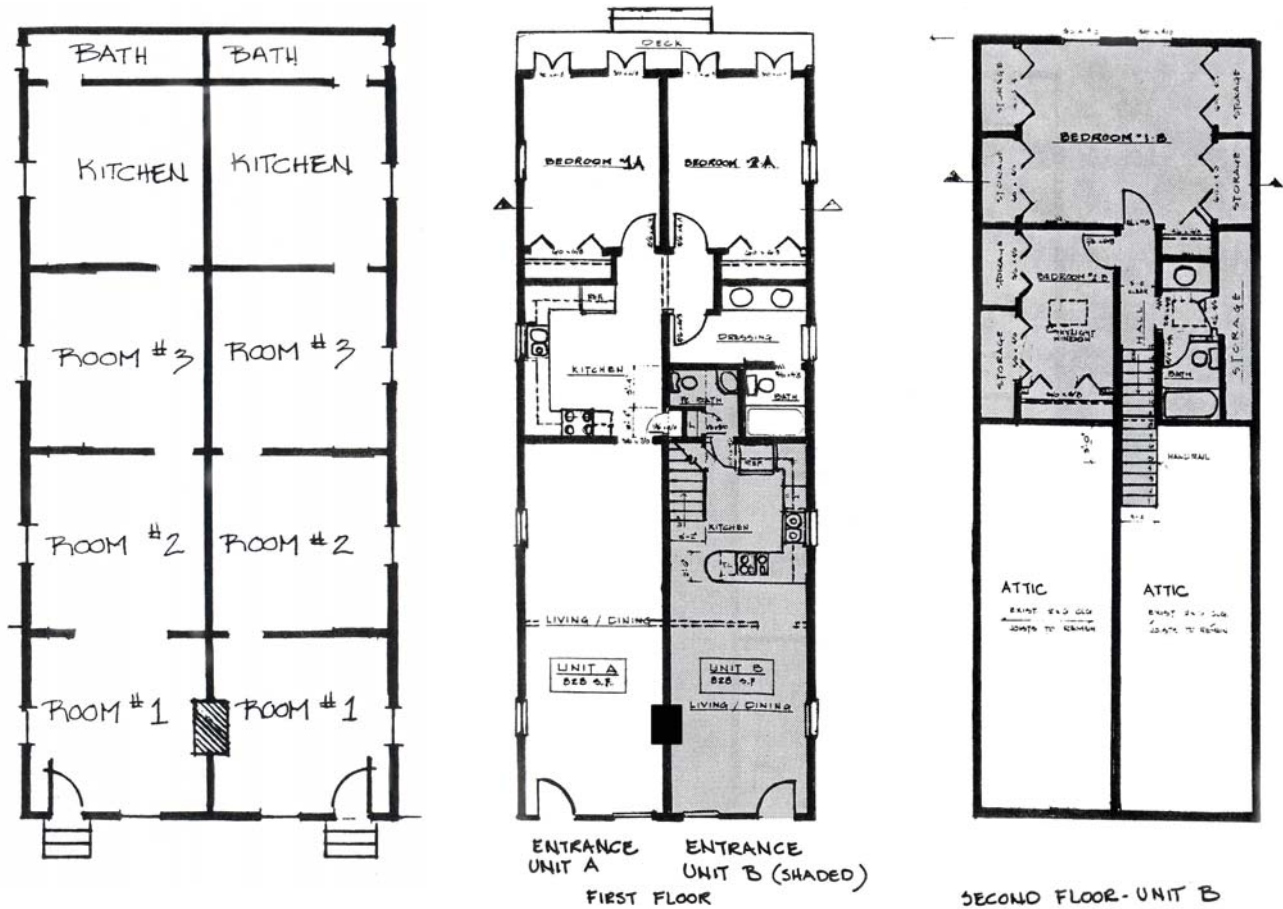
*Left: Shotgun plan prior to rehabilitation. Center and Right: After rehabilitation, extensive changes made to shotgun plan resulted in denial of project.*

**Application 2 (*Incompatible treatment*):** In the second example, radical changes made during the rehabilitation obliterated the characteristic shotgun plan. The wall between Room #1 and Room #2 in both units was removed to create one large room in each unit. Almost the entire rear half of the unit on the right side was incorporated into Unit A on the left side. This effectively destroyed most of the wall separating the two units that defined the shotgun plan. In addition, greatly truncating the length of Unit B further impacted the plan by eliminating the progression of rooms so typical of shotgun interiors. To make up for the space lost from Unit B on the right side a staircase was added to access two bedrooms that were created in the attic. Converting Unit B from a one-story unit into a two-story unit further altered the historic character of the house. The units no longer convey a sense of the original shotgun plan as a result of these changes. Accordingly, the project fails to meet the Standards for Rehabilitation.
