Case Study 3: Shell Mound Sites Threatened by Sea Level Rise and Erosion, *Canaveral National Seashore, Florida*

Contributing Author: Margo Schwadron (NPS Southeast Archeological Center)

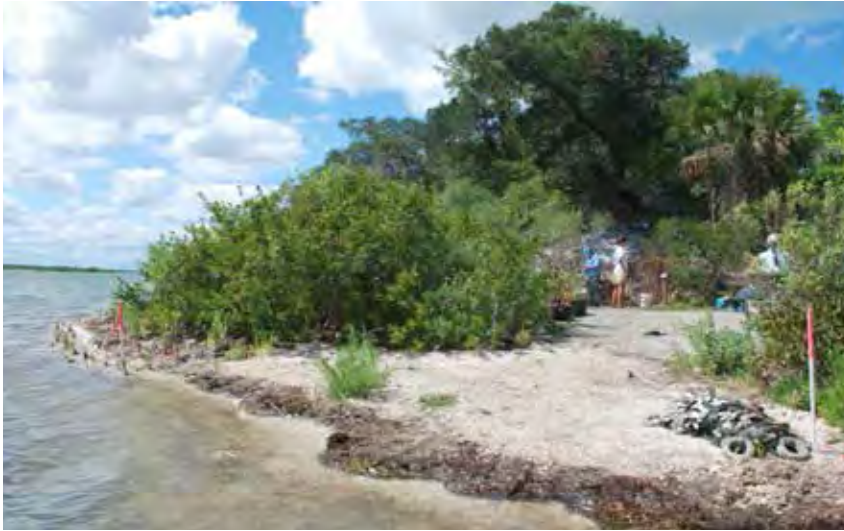
Building a living shoreline with volunteers at Castle Windy mound site, Canaveral National Seashore. Image credit: Margo Schwadron, NPS.

On-the-ground conservation and stabilization methods and techniques are being successfully employed to strengthen, protect, and stabilize eroding sites by combining soft armoring and living shoreline techniques. This hybrid approach involves planting of cordgrass (*Spartina alterniflora*) and mangroves in the intertidal zone, deploying bags of oyster shells seaward of the cordgrass, and placing oyster restoration mats seaward of the bags.
