Saved from

the

Dam

Delaware Water Gap National Recreation Area

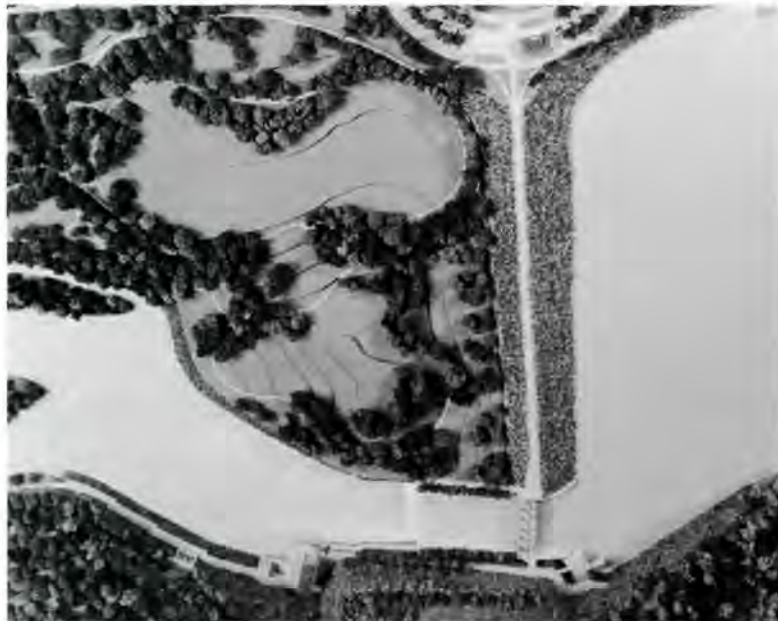
Architect's model of the unbuilt Tocks Island Dam. The spillway is on the New Jersey side of the river. Photo courtesy Delaware River Basin Commission.

Because the bearing capacity of the geology at the Tocks Island site was problematic, an earthen dam was proposed. The dam would have been 160 feet high. When the Corps found out how bad the geology at the site was, they moved the dam location downstream and greatly decreased the dam's slope in order to spread its weight over a larger area. Behind the dam was, of course, the reservoir. This would have stretched 37 or more miles upstream with the tail waters reaching above Port Jervis. The reservoir's maximum water depth was to be 140 feet and contain 250 billion gallons of water — although this would vary daily and seasonally.

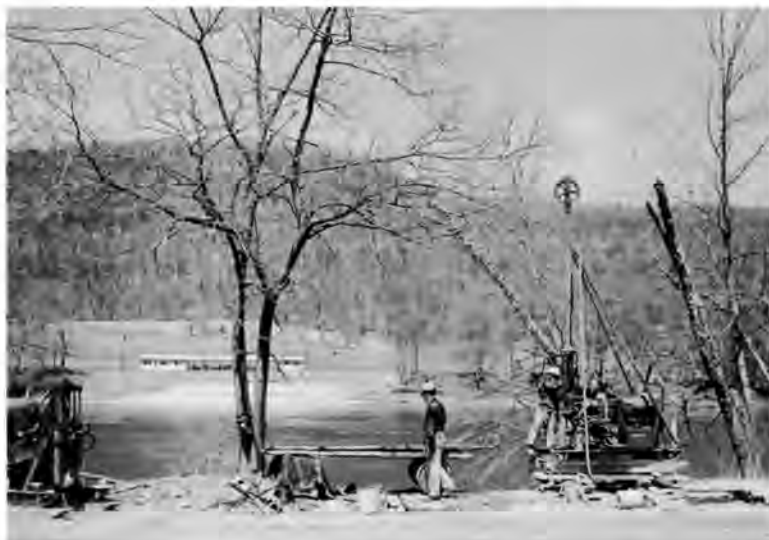
Drilling underway in 1964 near Smithfield Beach. Many miles of core samples were collected as part of the geological studies for the dam. Geological problems at the dam site resulted in major cost overruns, relocation of the dam site, and redesign of the dam structure. Photo courtesy Delaware River Basin Commission.

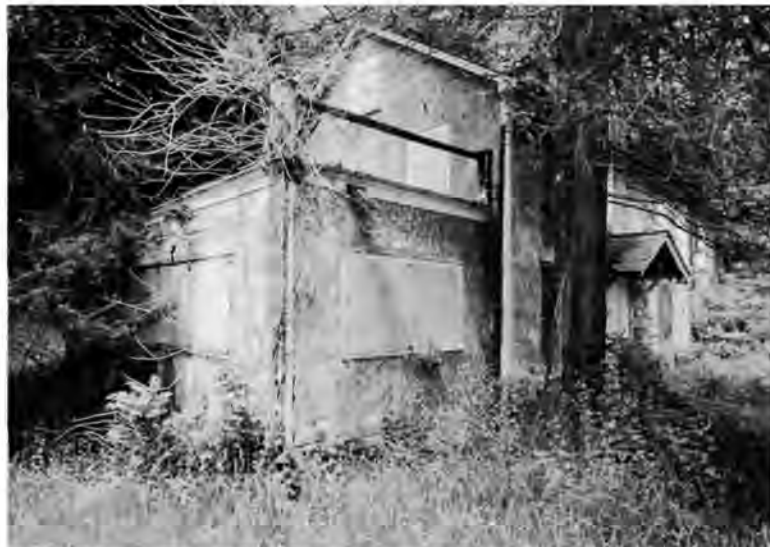
Herons Nest, built c. 1830 was converted to a summer retreat in the 1930's. Forest succession is strangling the building today. One of 31 vacant "target properties", it ranked in the lowest priority (Category C). NPS photo.

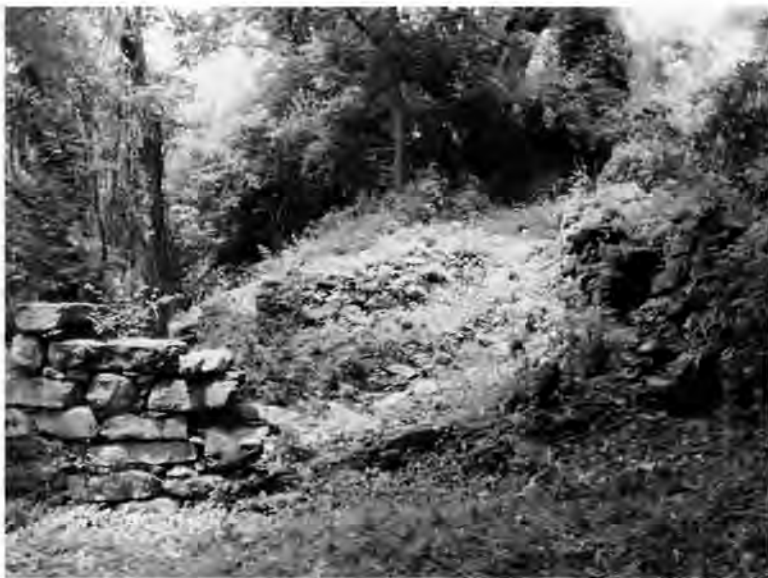
Foundation ruins of the possible block-house. NPS photo.

work. Professor Kraft's initial excavations had identified several structures, including a line of postholes and a rectangular stone structure, which may have been associated with the fort. Local oral traditions suggested that the stone structure, which served as a cowshed in the 20th century, was built on the foundations of the 18th-century block-house shown in the Hampton plan. In 1999, we excavated a section of the stone structure.

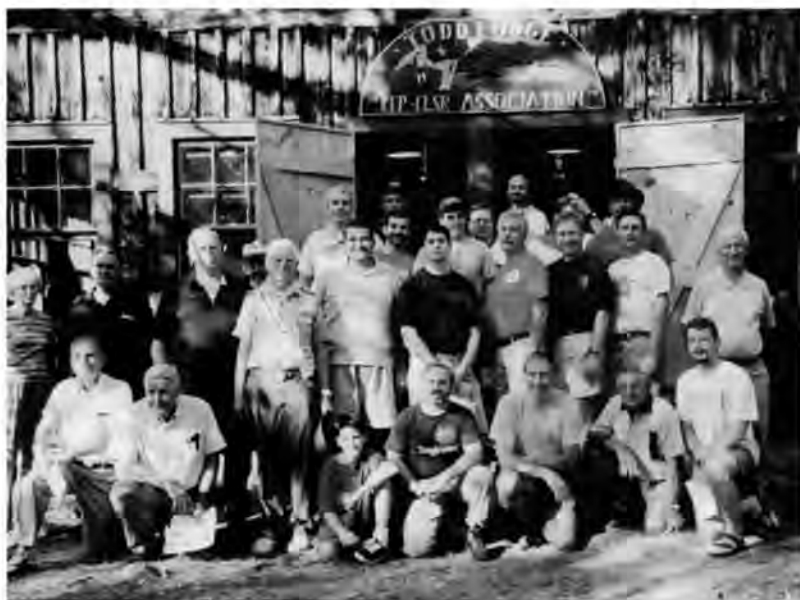
The scope of the project was enormous because Todd Lodge had been closed up for so long. Structurally, the lodge was intact; however its appearance was disheartening. A great deal of time was spent cleaning out years of accumulated debris. Once that was accomplished, windows were replaced, new doors were built, the building

was rewired and replumbed, the entire ceiling was replaced, the walls were scrubbed and refinished, and the floor was sanded and refinished.

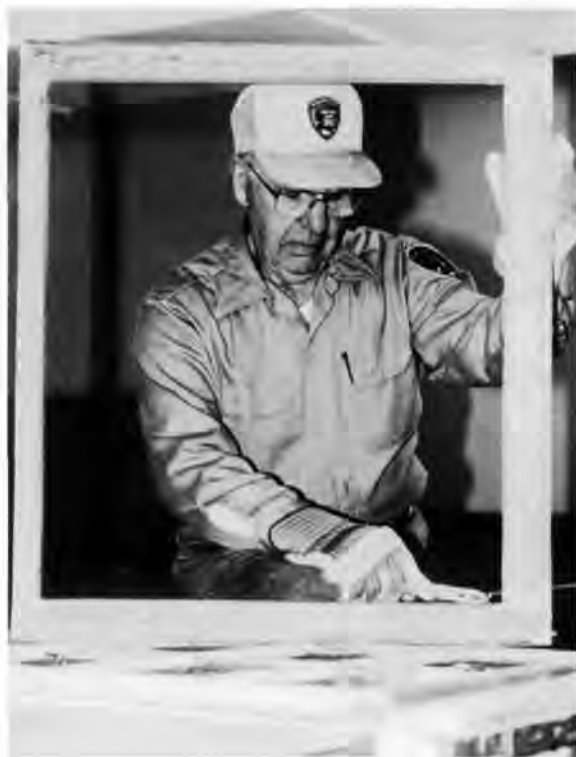
Walking the talk, the author, a VIP, has personally participated in refurbishing countless window sash and built ventilated security panels to protect them. NPS photo.

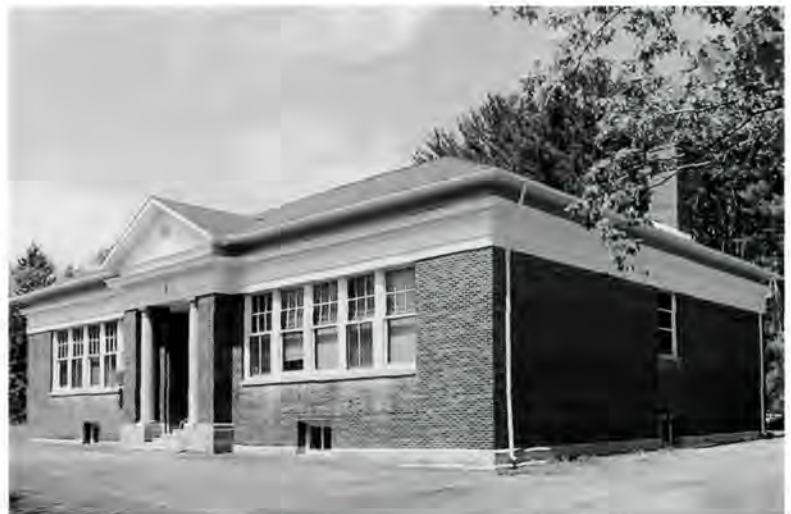
Bushkill School collection storage facility following installation of new hip roof. Work will begin on the new HVAC system later this summer. NPS photo.

multi-year approach, focusing on smaller projects and components in order of priority. Phase 1 studied the total needs of the building with a team of architects and engineers. The flat roof of the building leaked, especially under the stress of accumulating snow, so installation of a new sloping roof and structural repairs was Phase 2. In Phase 3, an HVAC system will be installed to provide a museum environment for objects in storage. The three phases of the project were funded over four years. The plans allow for the eventual expansion of the storage facility, including the mechanical system. Although storage conditions for park collections are vastly improved, there is still much more to be done. The next priority is security — including fire detection and suppression and intrusion alarms. To complete the upgrade of the Bushkill School collection storage facility, some smaller projects remain—including blocking and securing windows and doors, interior plastering, painting, and installing storage equipment.

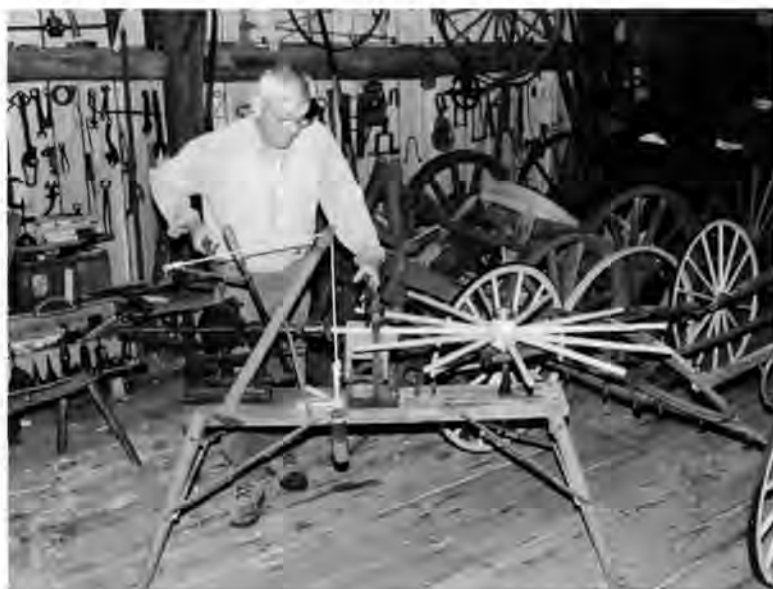
Interior of wagon shop in museum village of Millbrook, N.J. Park interpreter Jim Morris operates a horizontal boring machine patented in 1883. A hollow auger bit is being used to make wheel spoke tenons, "bit by bit." In the background are just a few of Millbrook's vast collections. NPS photo.

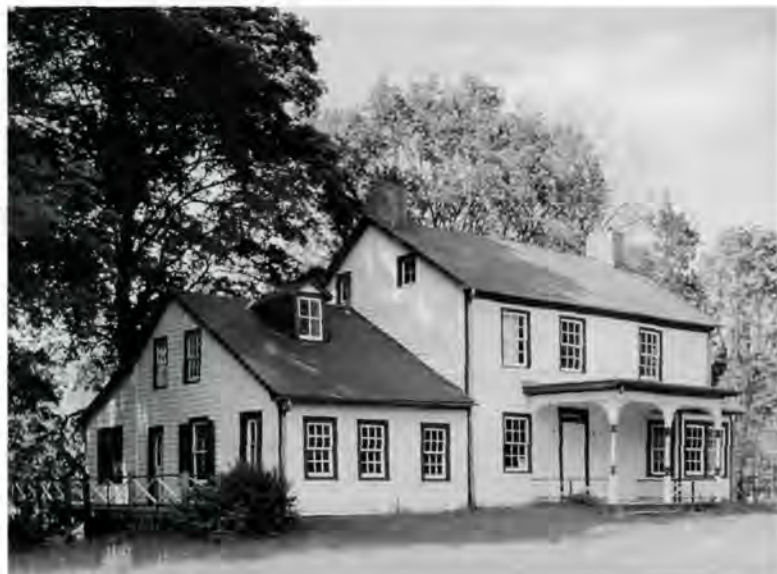
B. B. Van Campen House, built c. 1810, shown after completion of exterior rehabilitation. Work performed included the replacement of foundation sill beams, general carpentry repairs, and exterior painting. NPS photo.

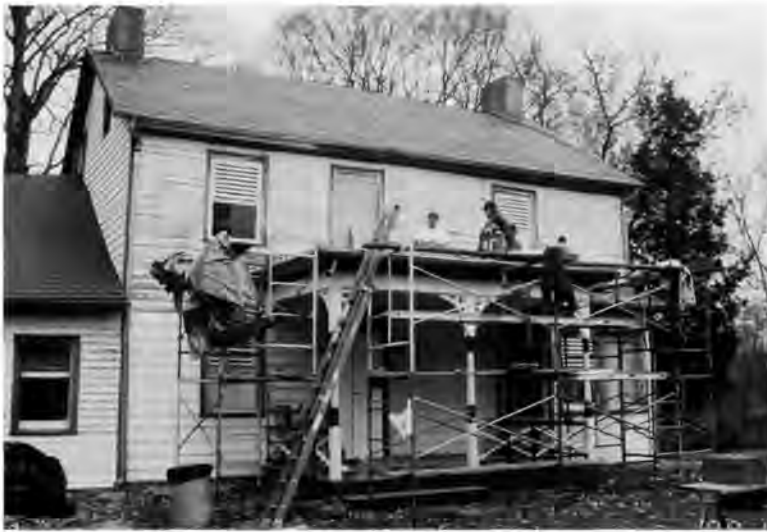
Park construction crew led by preservation carpenter Doug Townsend rehabilitates the covered porch. A new flat seam metal roof was installed with assistance from the NPS Historic Preservation Training Center in Frederick, MD. NPS photo.

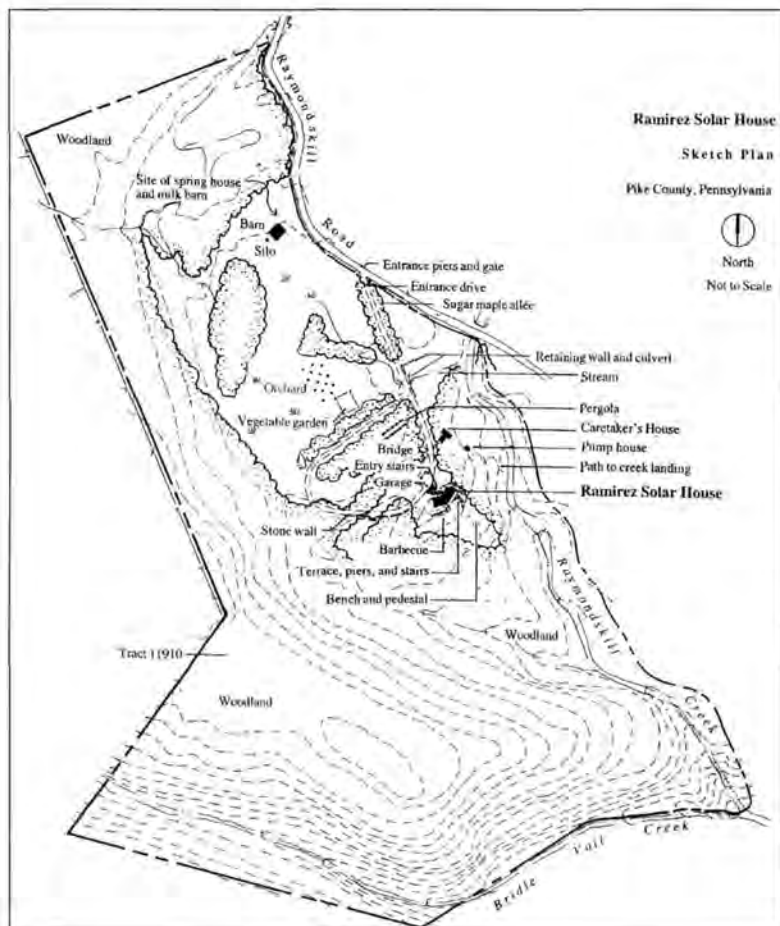
Ramirez Solar House sketch plan showing topography and landscape elements. Illustration by Liz Sargent, OCULUS.

In documenting the cultural landscape of the property, landscape architect Liz Sargent of OCULUS followed the procedures outlined in National Register Bulletin 30, "Guidelines for Evaluating and Documenting Rural Historic Landscapes." In its landscape features, the Ramirez Solar House property clearly exemplifies the recreational context of the area. The siting of the main house atop a prominent knoll with views to the surrounding landscape, an extensive use of native materials, particularly stone, and deliberate connects to picturesque landscape features are representative of response to the area's natural beauty.

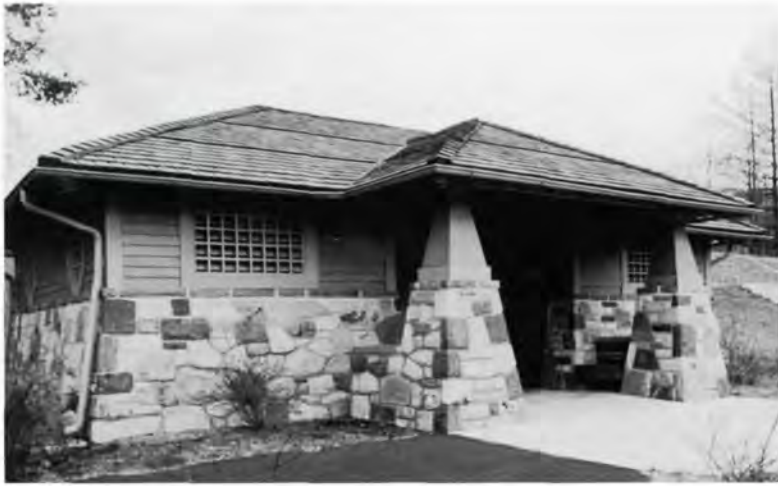
Restroom at Watergate Recreation Site, near Millbrook, NJ. The stone pattern of the foundation recalls the 1950s stone pillars of the adjacent dam that forms multi-level ponds. NPS photo.
