# BULLETIN

Volume 12: No. 5

Cultural Resources Management • National Park Service

## The Value of Photographic Documentation in Archeological Research: A Case Study

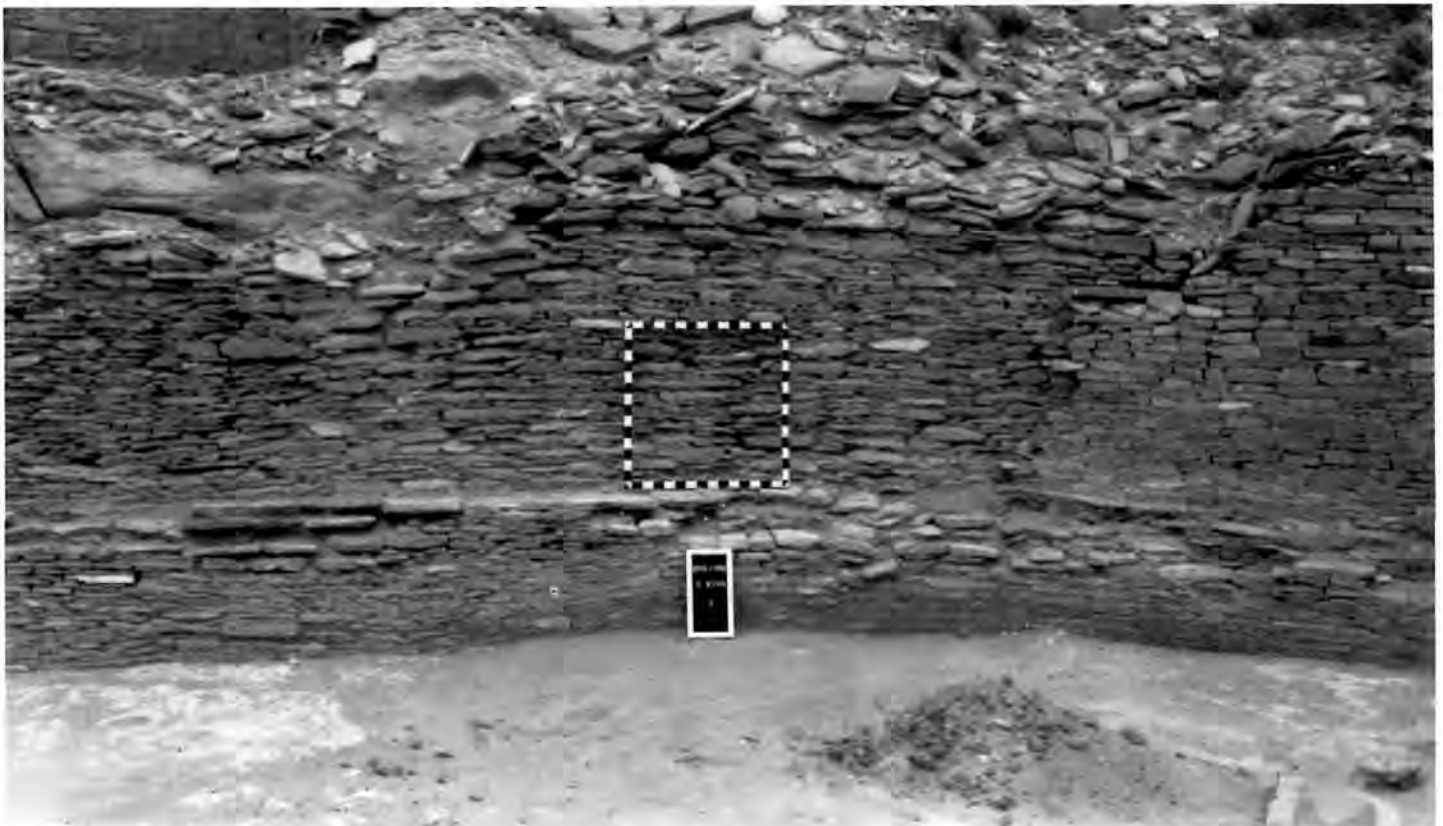
Figure 1. Kin Nahasbas, great kiva, wall section 3, after clearing in 1983.

the great kiva using a 4 x 5 inch camera. A 70-cm-square frame (internal dimensions, marked in 5 cm intervals) and a small photoboard designating the site number and wall section were included in each photograph. To start the initial series, the frame was placed on the bench of the great kiva on the northern side (beneath the east wall of the antechamber) and was centered in the photograph. The remaining photographs in the initial series were taken in a clockwise direction and with a 50% overlap in coverage until all sections of the wall had been photographed. Figure 1 is an example of one of these photographs.

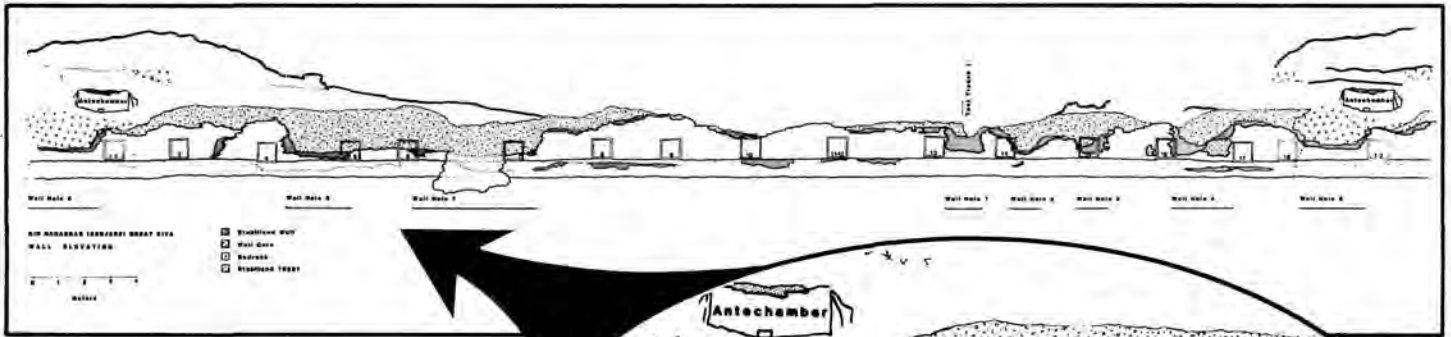
Figure 2. Great kiva wall elevation at Kin Nahasbas.

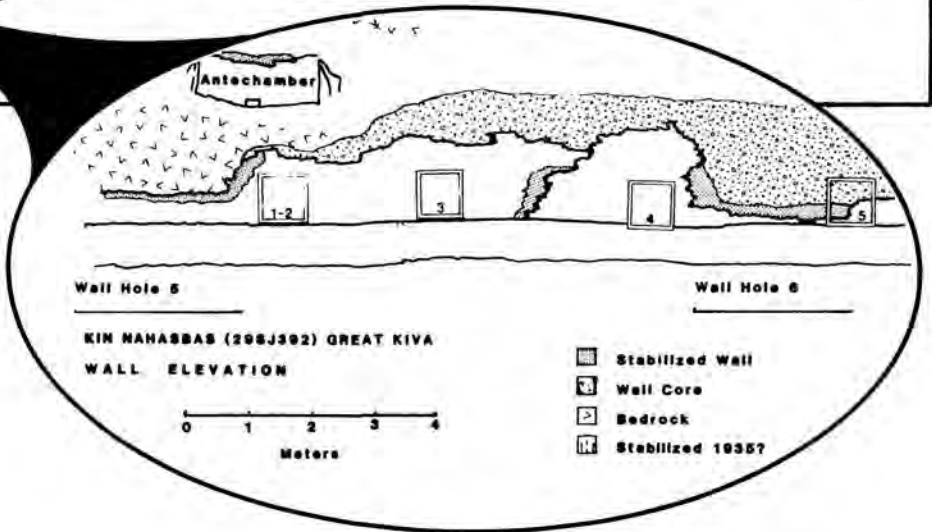
Figure 3. Kin Nahasbas, great kiva. Photograph of man facing the bench on the east side of the great kiva. There is darker mortar between the stones in front of him, and two stones to his right have a dark mixture on top of them. View looks north. Taken from Luhrs (1935:45, Figure B).

One photograph by Luhrs shows a workman facing the bench on the east side of the great kiva in a position suggesting he may have been repointing sections of the bench top (Figure 3). While no tools or pails of mortar can be seen, the dark color between the rocks directly in front of this individual suggests fresh mortar. The two stones with a dark mixture on top of them and to the man's right in this photograph may be his source of mortar. One additional photograph Luhrs 1935:25, Figure A) indicated some stabilization of part of the wall on the northwestern side

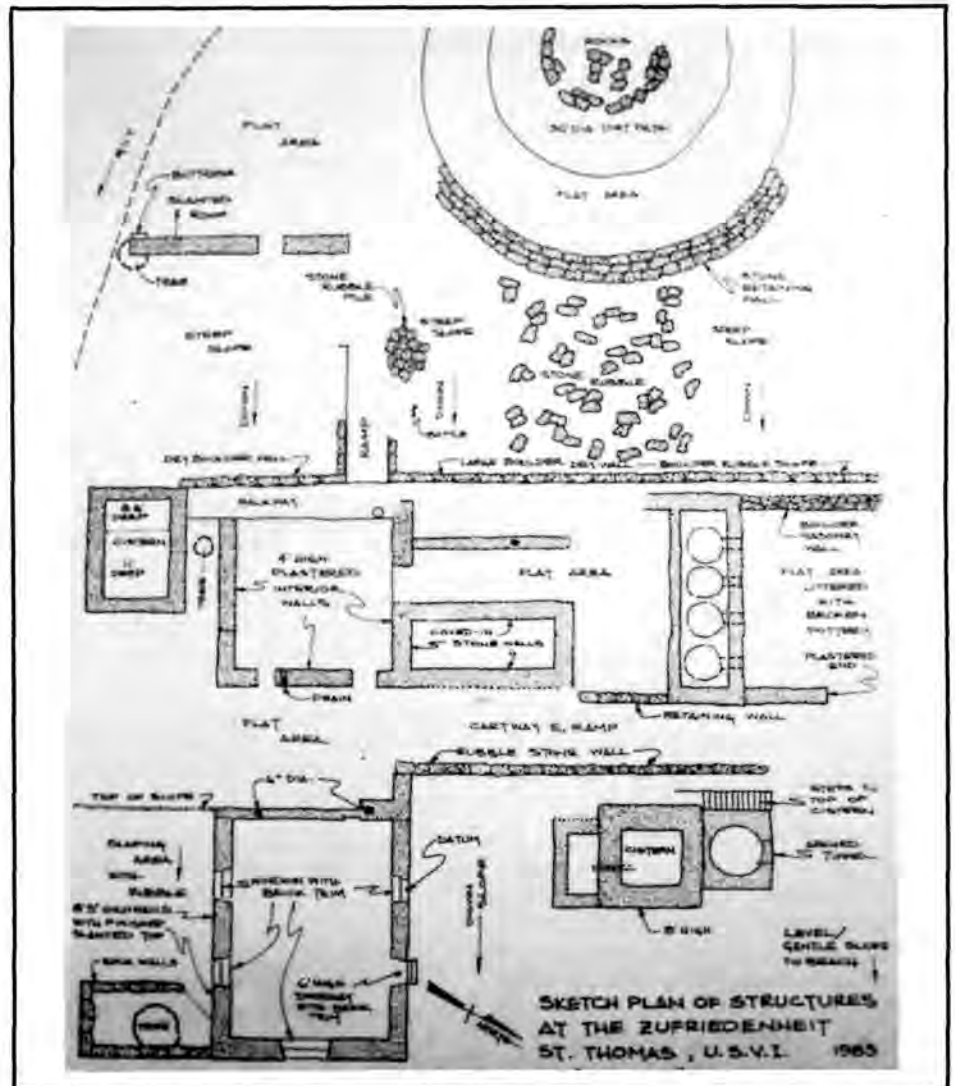
Sketch plan of structures at the Zufriedenheit, St., Thomas, U.S.V.I. 1983

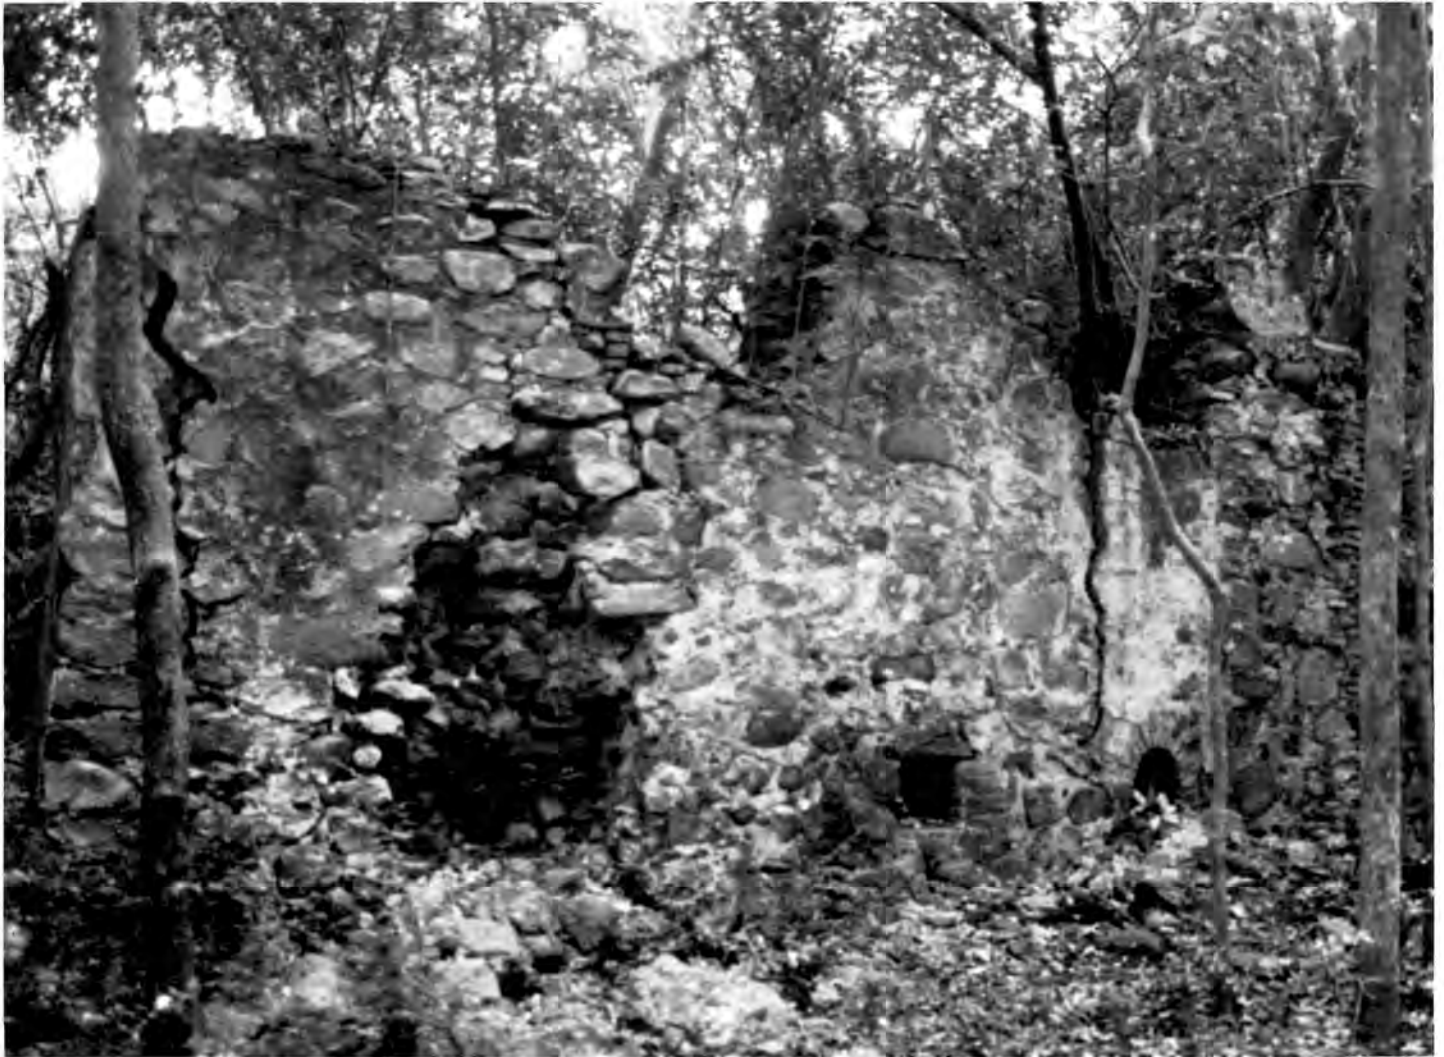
Exterior wall of the sugar boiling house at Plantation Zufriedenheit. The firebox for the Jamaica train is on the left end and vent openings are along the bottom of the wall. At the far right end of the wall are yellow brick traces of the former chimney for the boiling house.

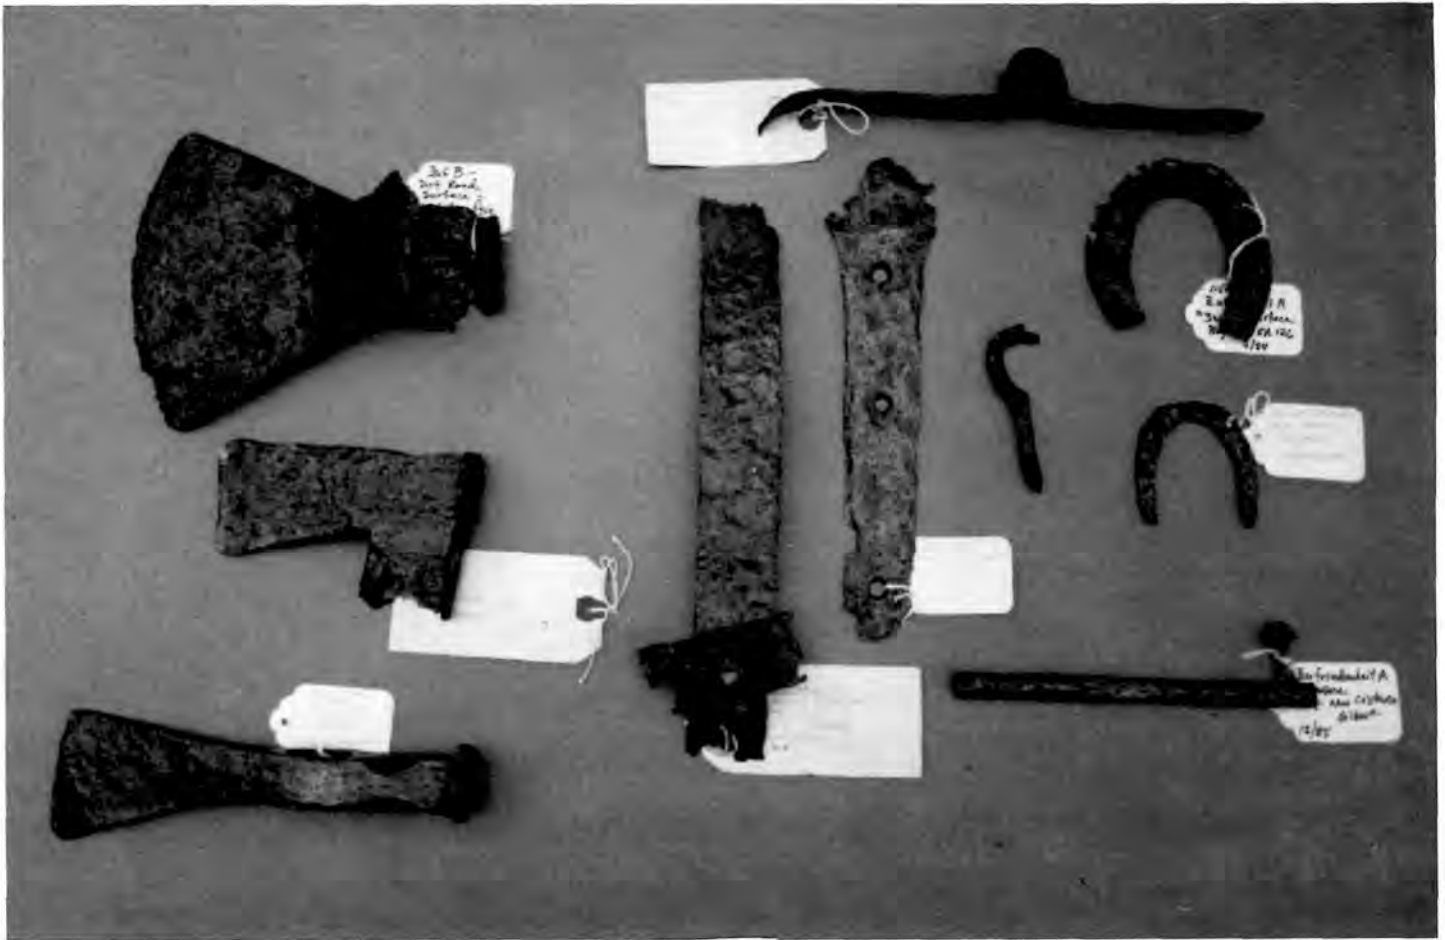
Handwrought iron tools indicative of land uses on the Zufriedenheit Plantation site. Left row, top to bottom — wood cutting tools; middle — iron strap, door hinge and hook. Top right — wheel barrow wheel support; right center — horse shoes; right bottom — door bolt.

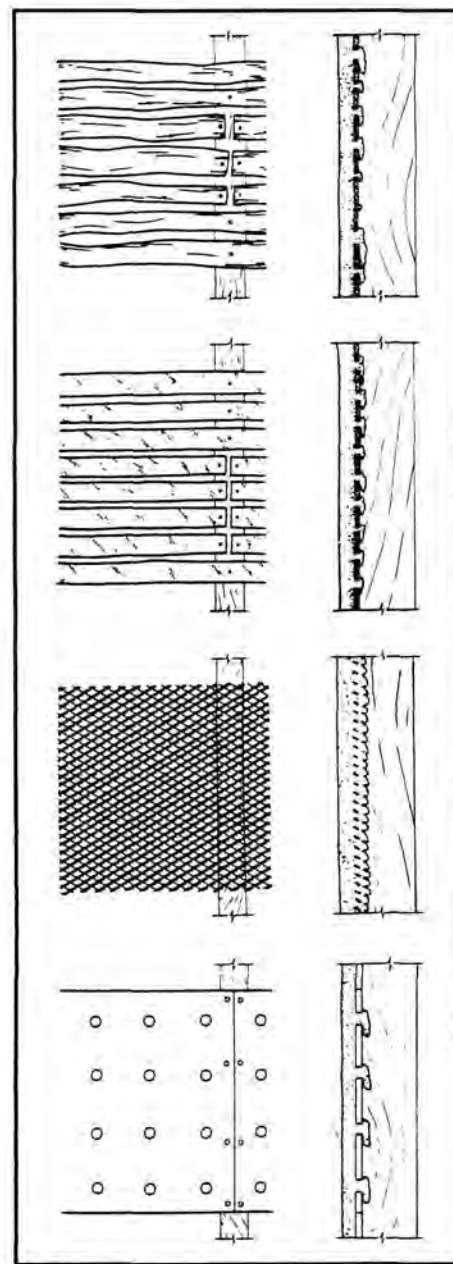
Top to bottom: Hand-riven lath, machine-sawn wood lath, diamond mesh (metal) lath, and perforated gypsum board lath. Profile views of their keying characteristics are shown to the right. For plaster repairs or for new work, galvanized metal lath is the most reliable in terms of longevity, stability and proper keying. Drawing: Kaye Ellen Simonson.

began to be replaced by machine-cut lath. Lath cut by a reciprocating saw exhibited vertical marks, whereas the circular saw left distinctive rounded marks. Compared to hand-made lath, machine-sawing resulted in faster, cheaper lath production and in a uniformity of the wood strips. Machine-sawing left a rough, “hairy” surface, which provided a better adhesive bond for the scratch coat (this was most likely an unintentional by-product of the machine rather than a planned technological advancement).

Whether hand-riven, split, or machine-cut, one may automatically think of wood as the *true* lath, with metal and gypsum board later and somehow inferior substitutes—at least esthetically. Wood was indeed the traditional lath for plaster walls and ceilings for many years and, from a contemporary viewpoint, the hand work involved in making the earliest lath is particularly compelling. But it was wood’s problems as a stable base for plaster that spurred development of other lath systems—first metal, then gypsum board.<sup>1</sup> Wood lath expands and contracts with changes in the humidity, causing the plaster to crack. Wood lath can rot. And the mechanical bond (keys formed by the plaster curling around the back of the closely placed wood slats) was often incomplete to begin with. Sometimes early lath was too closely spaced so that no plaster or very little plaster squeezed through the gaps. Or, over time, structural problems cause plaster to separate from wood lath. When plaster loses its key, walls can bulge, ceilings can sag, and chunks of plaster can even fall to the floor.

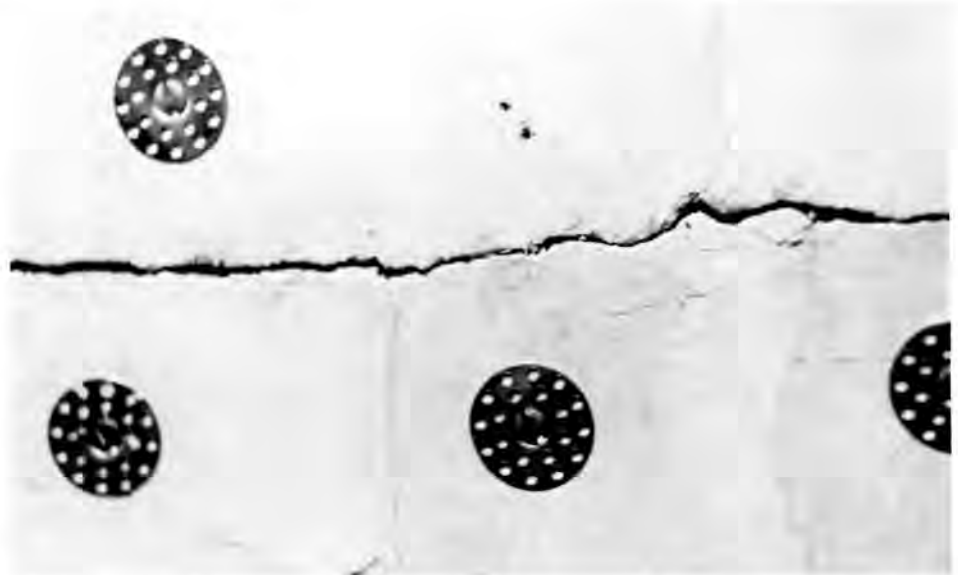
Plaster washers are being used to reattach loose ceiling plaster to wood lath when the keys have broken off. Photo: John Obed Curtis

When some of the plaster keys on a ceiling have broken and the plaster is loose or sagging, one common repair technique is to re-attach the sound plaster mechanically to the lath with flat-head wood screws and plaster washers. After the old plaster is secure around a hole, patching can take place. Plasterers always moisten the old wood lath thoroughly before re-plastering or it will twist and buckle when the wet plaster is applied. Another way to re-attach plaster to wood lath involves injecting liquid adhesives behind the wood lath, or into the plaster wall surface itself, then applying pressure by means of a brace until the bonding process is complete. (Using water-based adhesives, as opposed to solvent-based formulations, avoids problems with flammability and toxic fumes.)

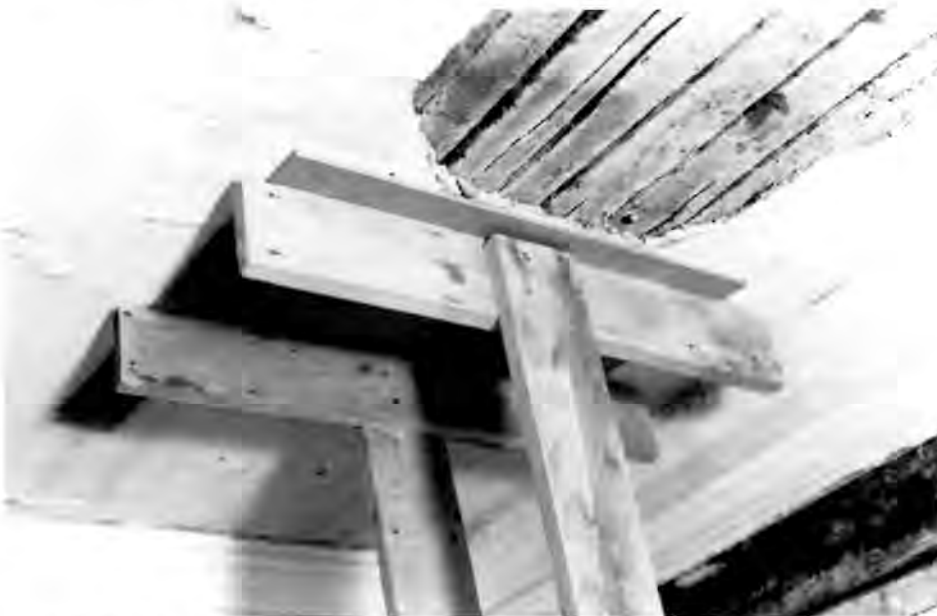
After applying an adhesive to reattach sagging ceiling plaster to the wood lath, a brace is used until bonding is complete. Photo: John Leeke

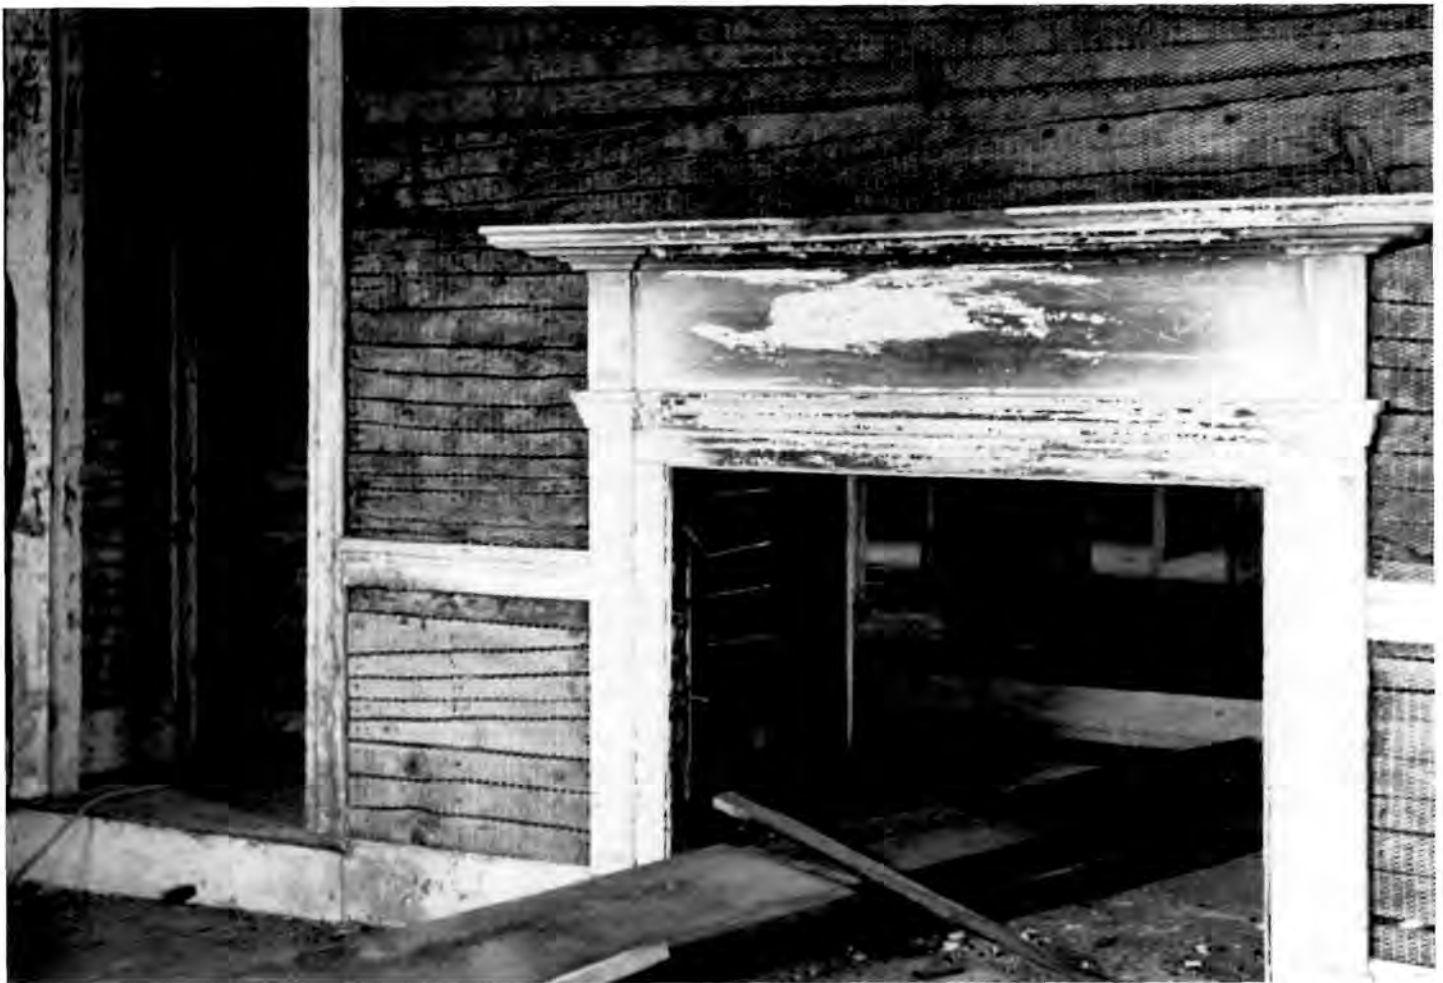
In this project, the split-board lath has been covered with diamond mesh lath in preparation for new coats of plaster. This method permits the early lath to be saved while the metal lath, with its superior keying, serves as reinforcement. Photo: National Park Service files.

If saving the plaster means forgiving the wood lath, there is a compromise approach followed by professional plasterers and increasingly recommended for homeowner repairs. Both for small patch plastering and larger repairs, the wood lath is retained in place, then covered with metal lath as a base for new plaster. Plasterers like this method because the double lathing technique makes a stronger patch. (The keys using metal lath are top-rated.) Preservationists like it because a maximum amount of the historic plaster wall is saved; the vestigial

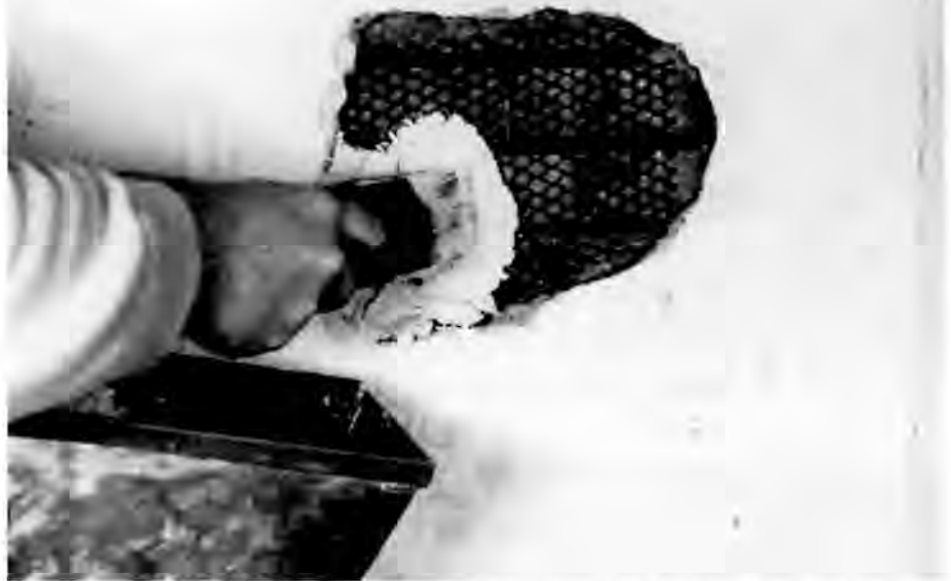
The wood lath has been covered with a small piece of diamond mesh lath (attached to the wood lath with a tie-wire). The plasterer will apply one or two ready-mix gypsum basecoats. After they dry, the gauged lime finish coat will be applied. Photo: Walter Jowers.

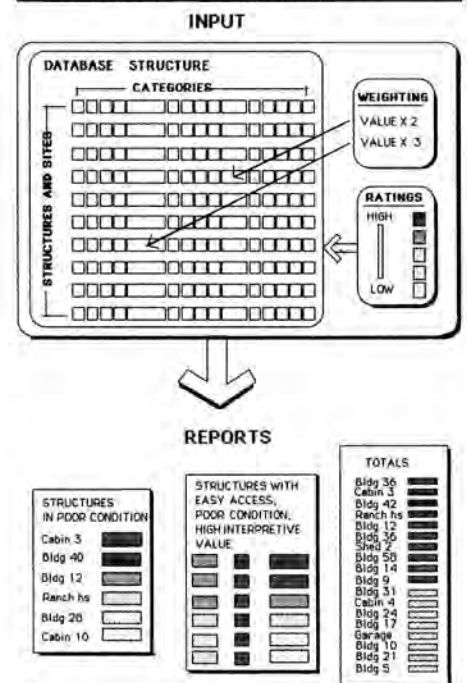
## PRESERVATION PRIORITY MATRIX DIAGRAM

Graphic representation of data base process: Inputting data and generating reports.
