Calumet Unit Historic Landscape

Cultural Landscape Report and Environmental Assessment

FINAL 2013

**Keweenaw National Historical Park**

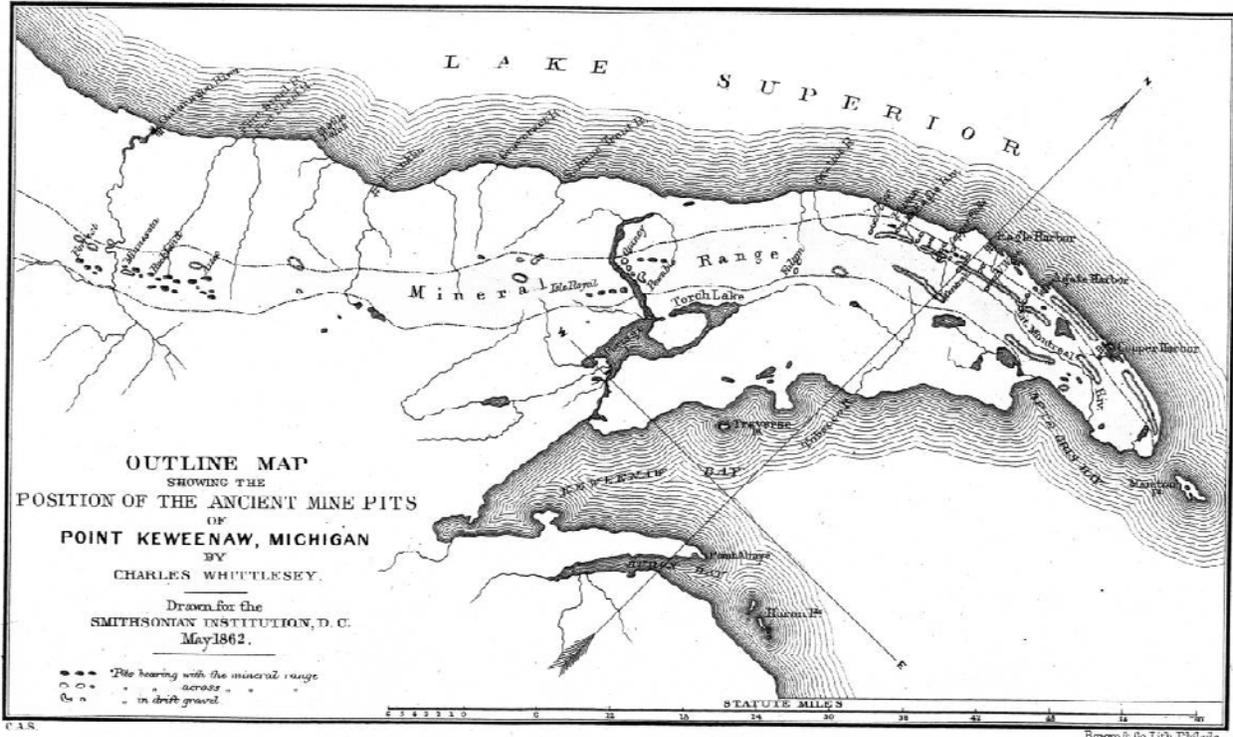
**Figure II - 2: Locations of indigenous mines in the Keweenaw, mapped by Charles Whittlesey, 1862** (source: Whittlesey, 1863)

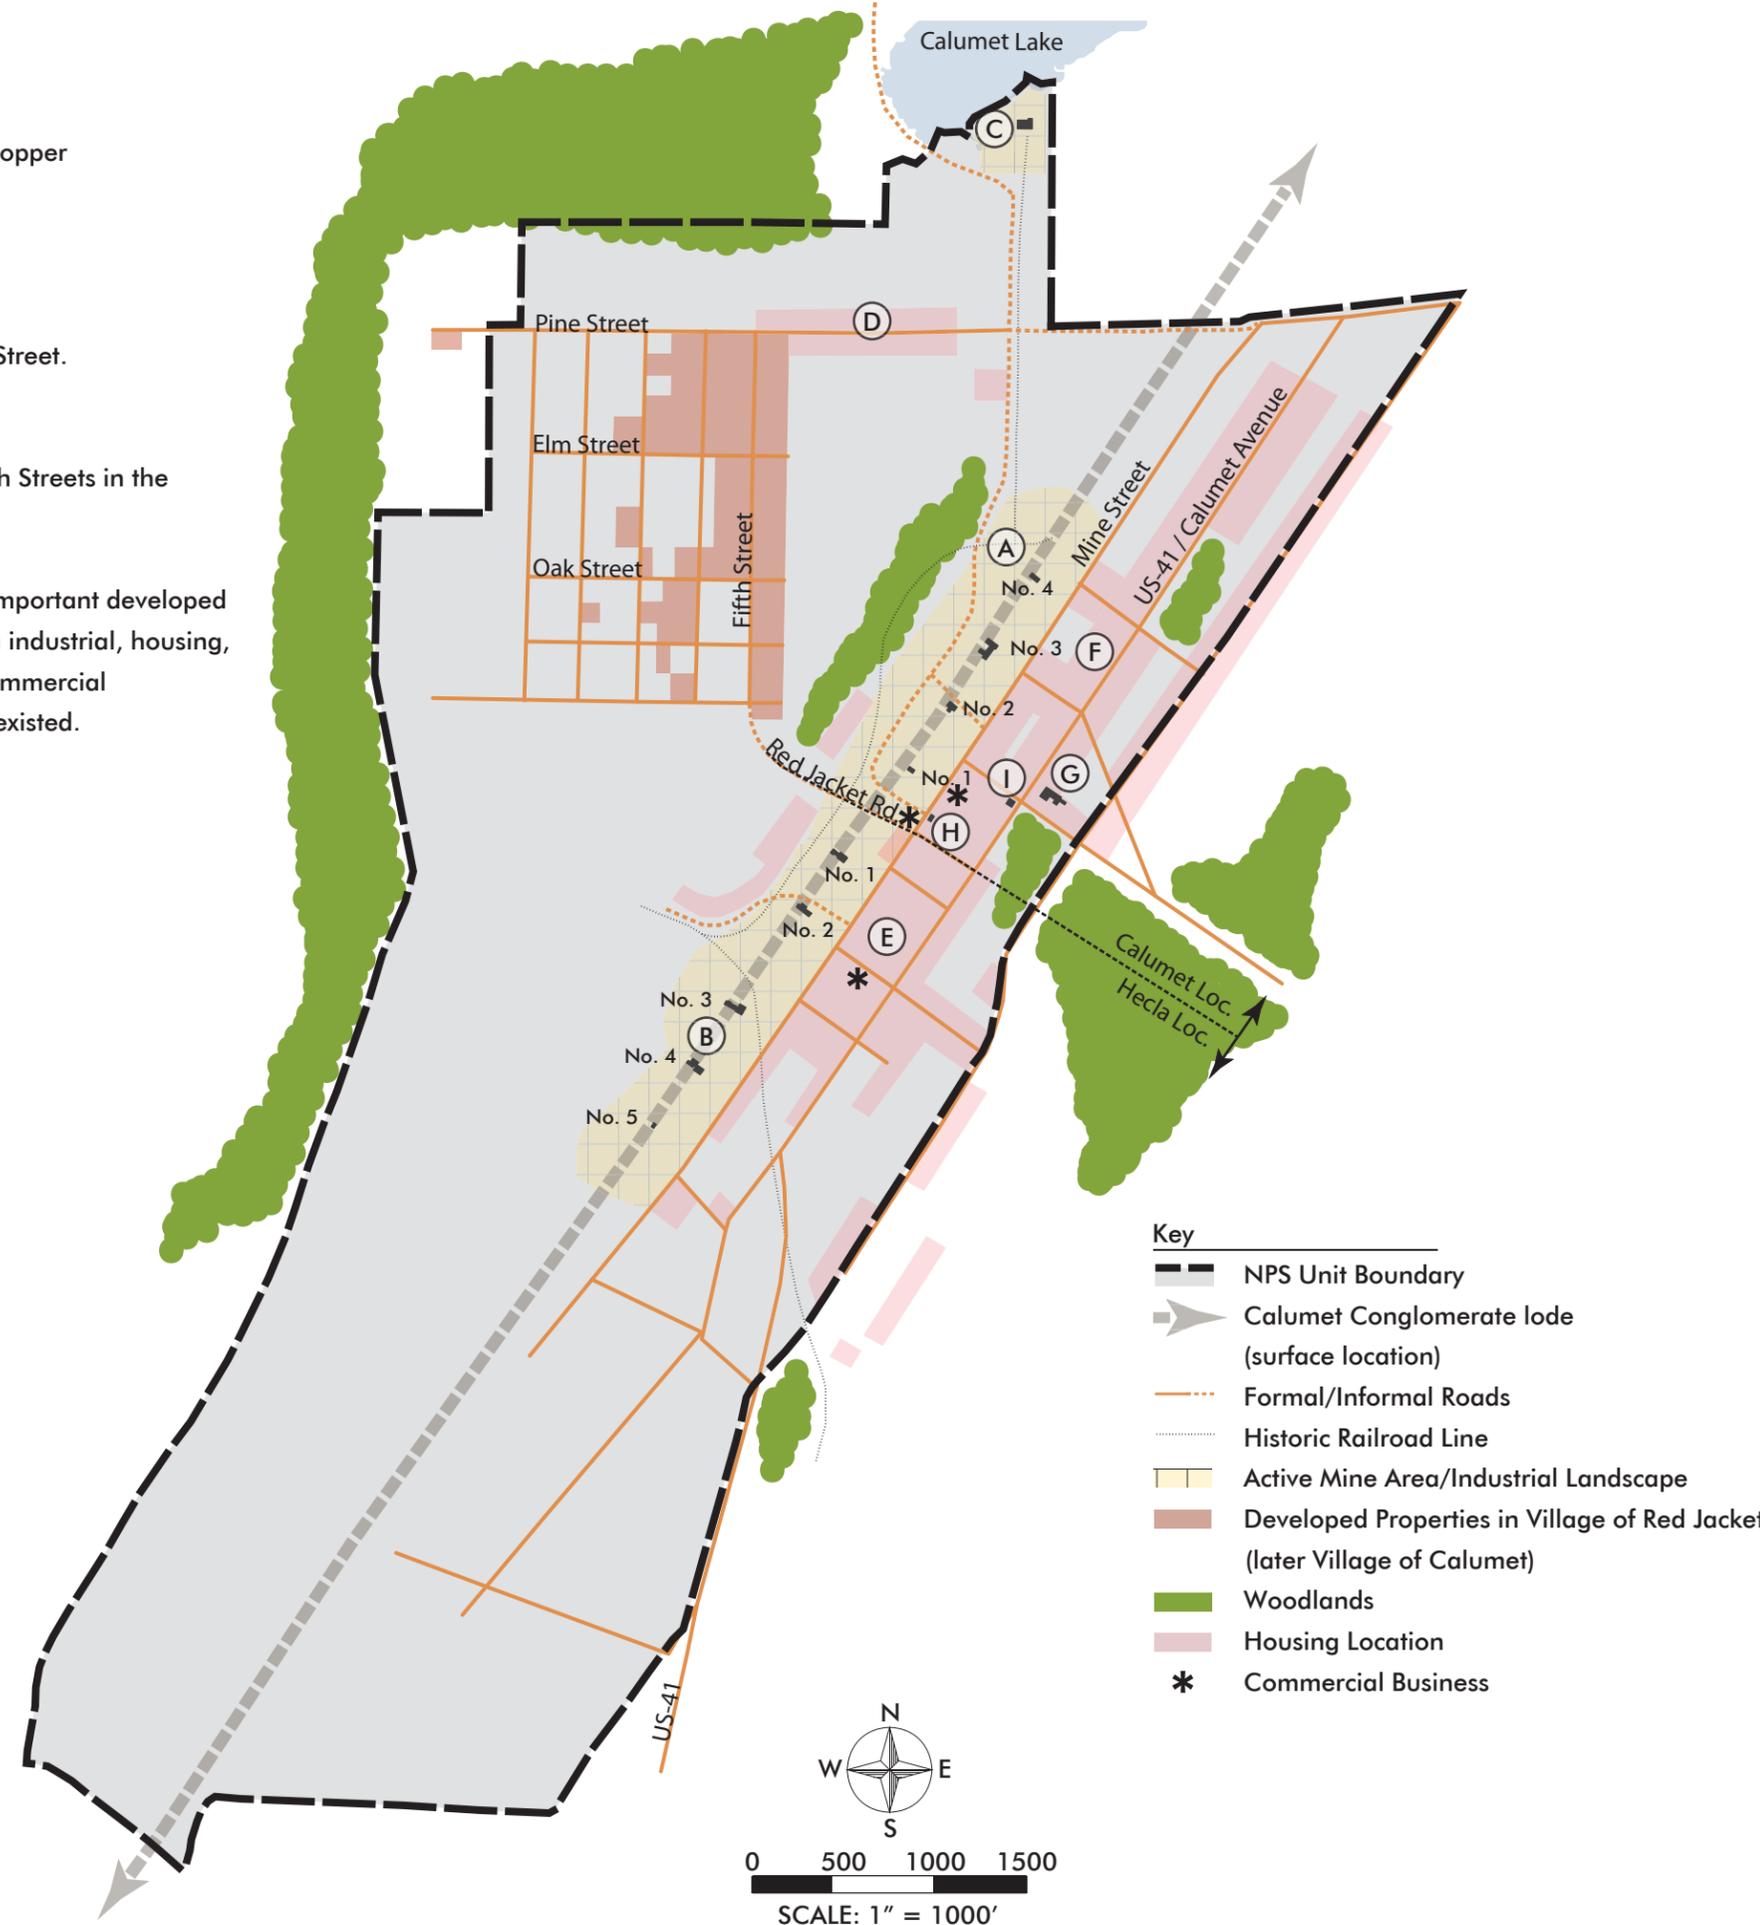
Figure II-7

During this period, Mine Street was the most important developed corridor including a wide mix of uses including industrial, housing, and commercial. Locations of a few known commercial establishments are indicated, but many more existed.

1. Locations of elements on plan are approximate based on best available sources. Plan sources are provided in the adjacent CLR narrative.
2. Mineral lodes are indicated on diagrams only for periods during which they were actively mined.

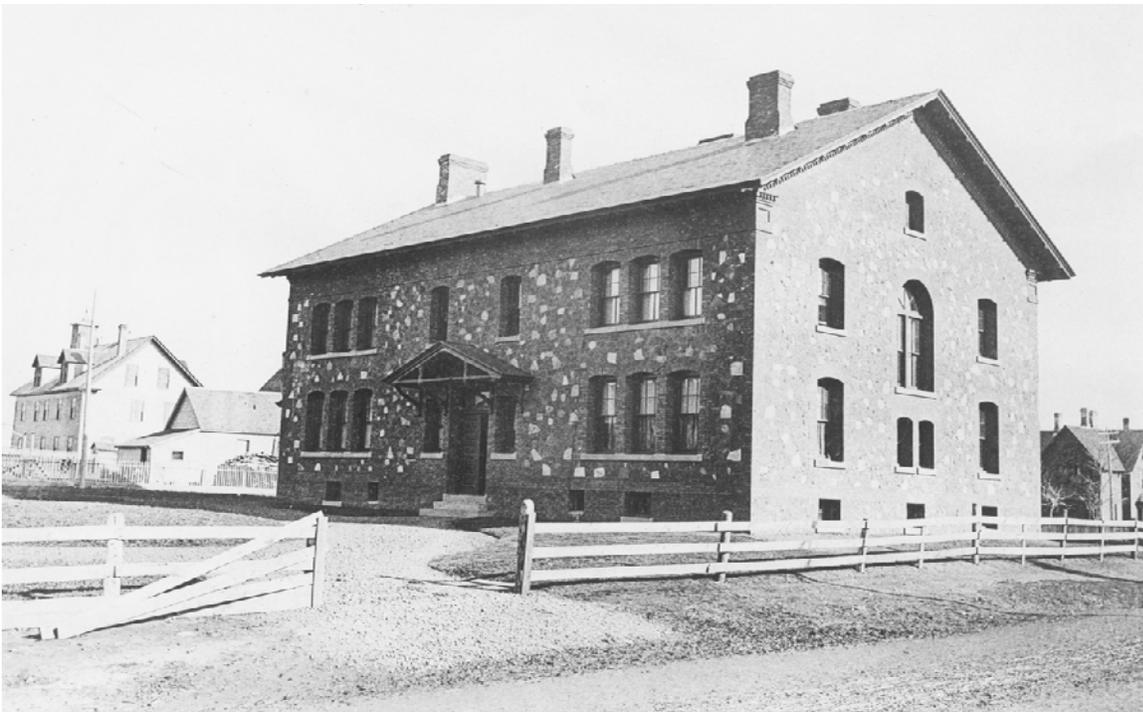
**Figure II - 14: The general office of the C&H Mining Company was constructed using poor rock from the mines. Note the lawn and fence, ca. 1885.** (source: NPS, Keweenaw NHP, Jack Foster Collection, Series II Assembled Albums (002), Album 28, [C&H General Offices] R. Acton)

By 1880, the majority of the non-industrial activities had moved from Mine Street to the Village of Red Jacket. Mine Street was highly developed and functioned as the primary circulation spine of the industrial core of the C&H mining activities (see Figures II-9 through II-10). The route paralleled the Calumet Conglomerate lode, running in a southwest to northeast direction. This alignment was initially established on the surface by the alignment of the shafts along the angle of the lode. Mine Street and the other streets on C&H property were aligned with this common angle, running either parallel or perpendicular to it. Tramroads were constructed at the same angle and tramcars transported rock from the shafthouses to the rockhouses. The two rockhouses were adjacent to railroad lines allowing trains to load material to be conveyed to the stamp mills at Lake Linden. Other industrial structures present included two large engine houses, dry houses, a railroad roundhouse, pumphouses, a compressor building, blacksmith shops, a machine shop, warehouses, man-engine houses, a carpenter shop, and several smokestacks. The earliest versions of many of these buildings were constructed of wood. These were eventually followed by structures built of poor rock from the mine (see Figure II-14). The company's most important structures utilized poor rock and brick (see Figure II-15).<sup>65</sup>

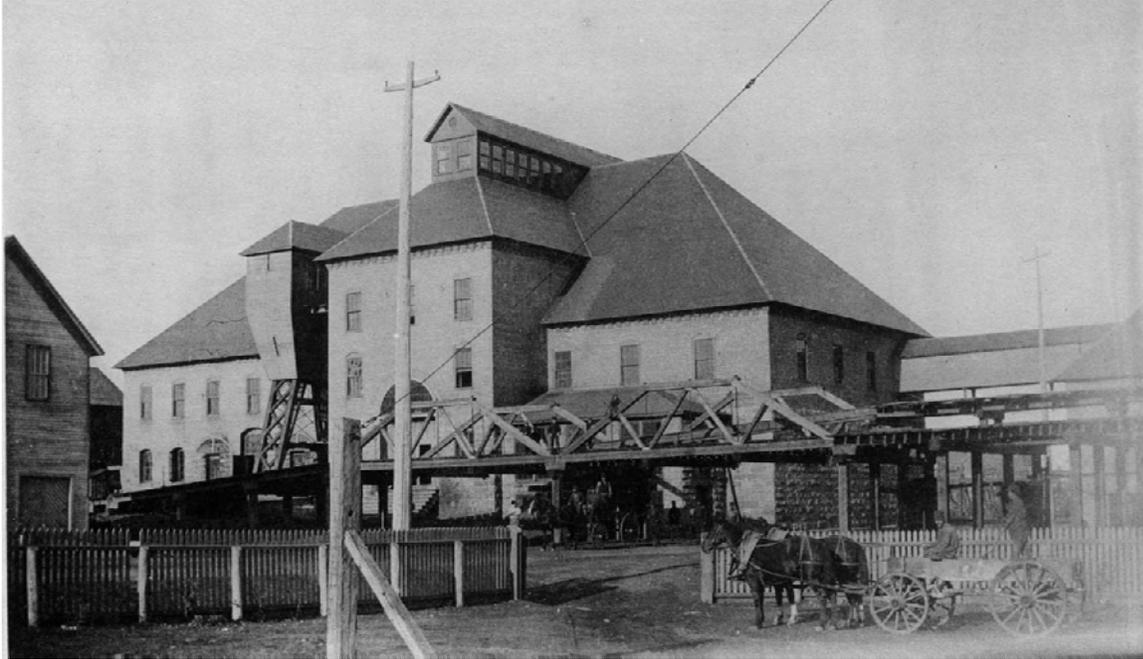
**Figure II - 15: Calumet engine house, containing the celebrated Superior Engine, ca. 1880** (source: NPS, Keweenaw NHP, Jack Foster Collection, Series II Assembled Albums (002), Book 22, #131)

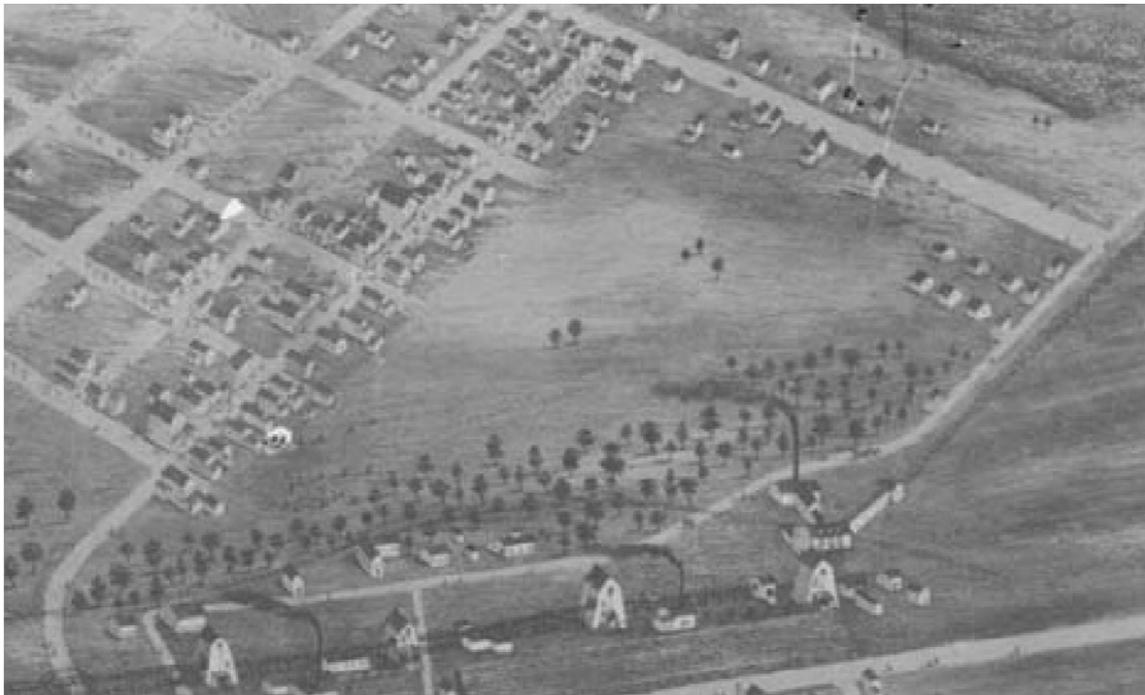
**Figure II - 19: Calumet Commons (later Agassiz Park) excerpt from Birds eye view of Calumet, Hecla and Red Jacket, 1871.** (source: NPS, Keweenaw NHP, Jack Foster Collection, Series I (001), Sub-series A (C and H), Sub-series (01) Library, #016)

An 1871 view of the Calumet Commons illustrates a roughly triangular shaped open area located between the village and the mine location (see Figure II-19). There is a grove of trees at the southeastern portion of the property, and a few scattered canopy trees in the center of the space. No fence or other structures are apparent within the common space. The western and northern boundaries of the Commons were bounded by residences. By 1881 (see Figure II-20) a fence enclosed the Commons and there appears to be newly planted vegetation at the northwestern portion of the property. In 1885 (see Figure II-21) a fenced baseball field is present in the northern section of the Commons and a barn has been constructed to the east of the ball field. A view of the park in the winter of 1888 illustrates a stark landscape utilized for pedestrian circulation (see Figure II-22).

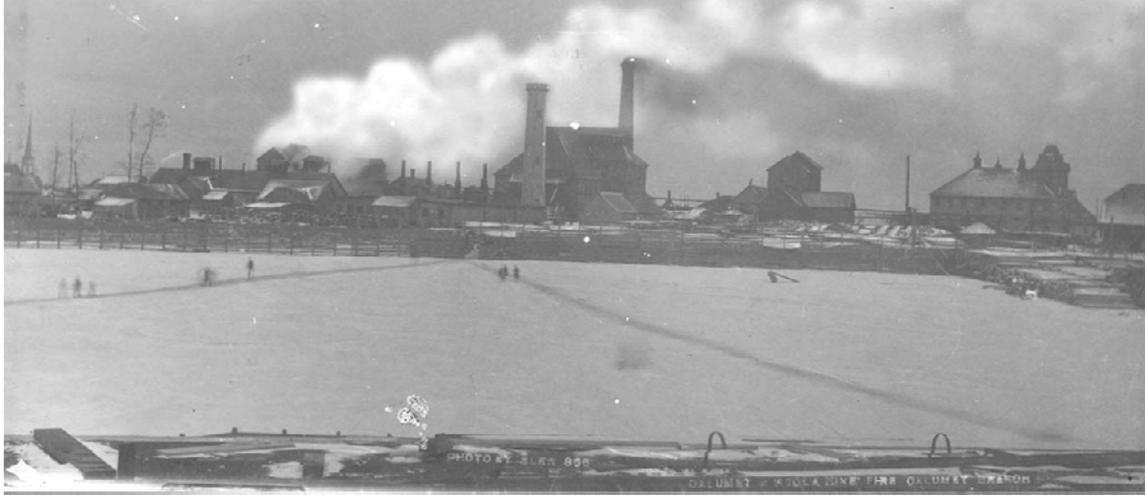
**Figure II - 22: Calumet Commons (later Agassiz Park) facing east, viewed during the Calumet No.3 Shaft Fire, 1888.** (source: NPS, Keweenaw NHP, Jack Foster Collection, Series I (001), Sub-series A (C and H), Sub-series (01) Library, #084(1~1))

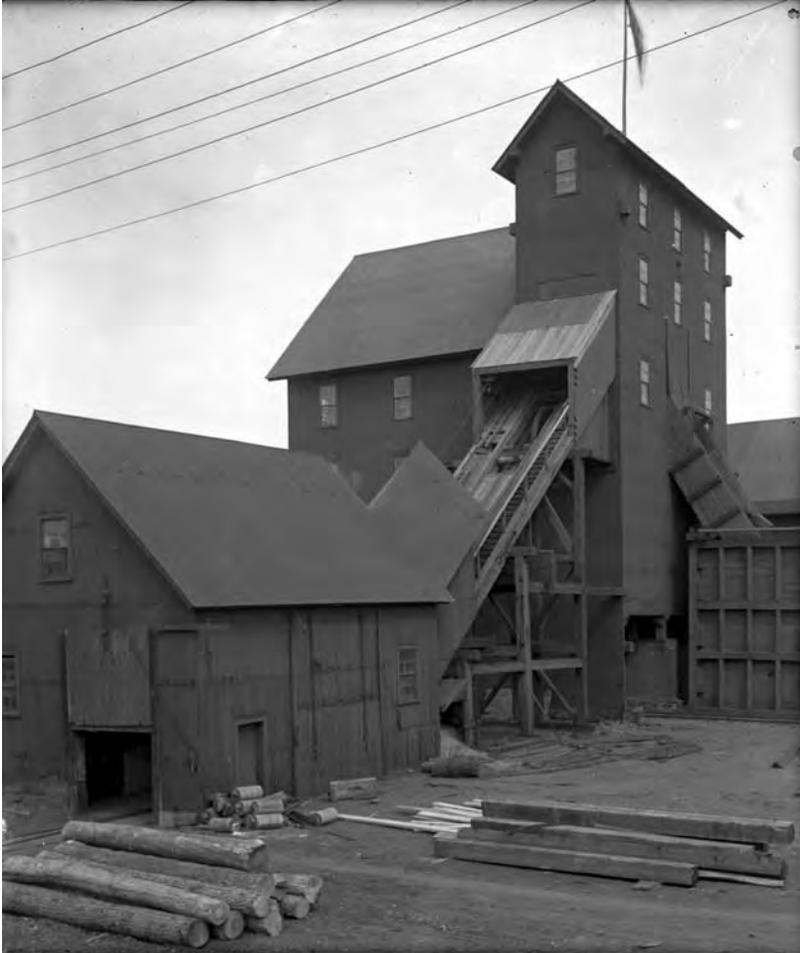
**Figure II - 24: Hecla Shaft-rockhouse, date unknown** (source: courtesy of Scott See)

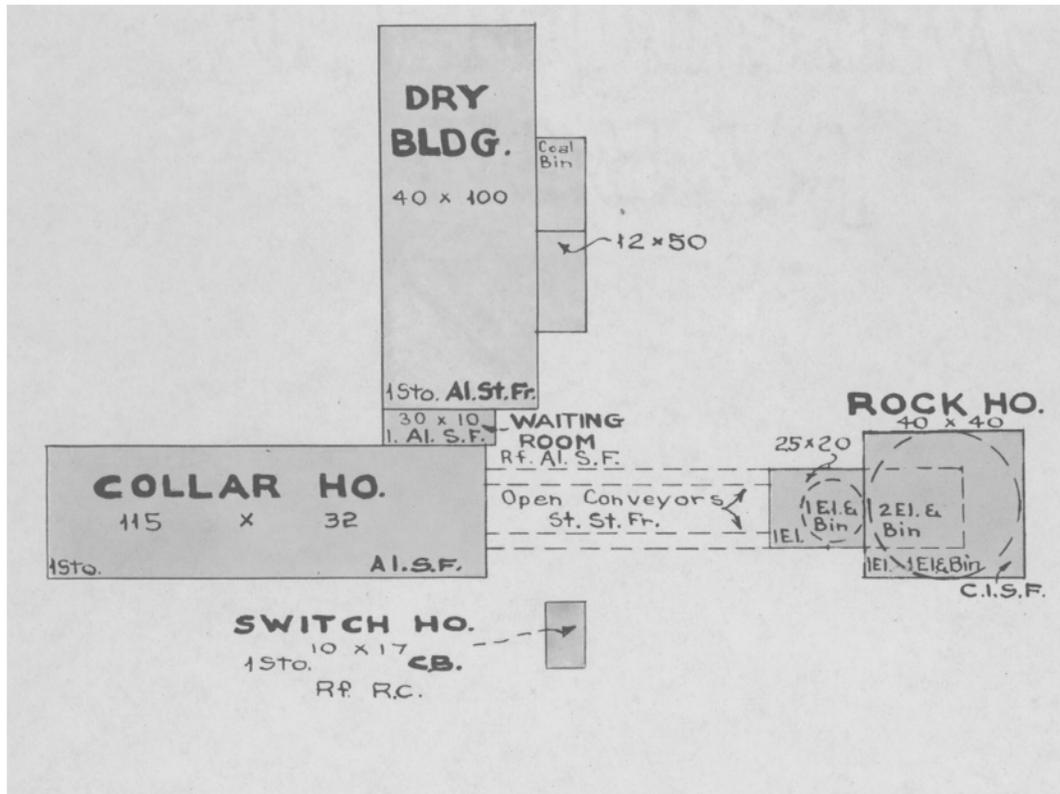
**Figure II - 25: Osceola No. 13 Shaft-rockhouse plan, 1955** (source: courtesy of Scott See)

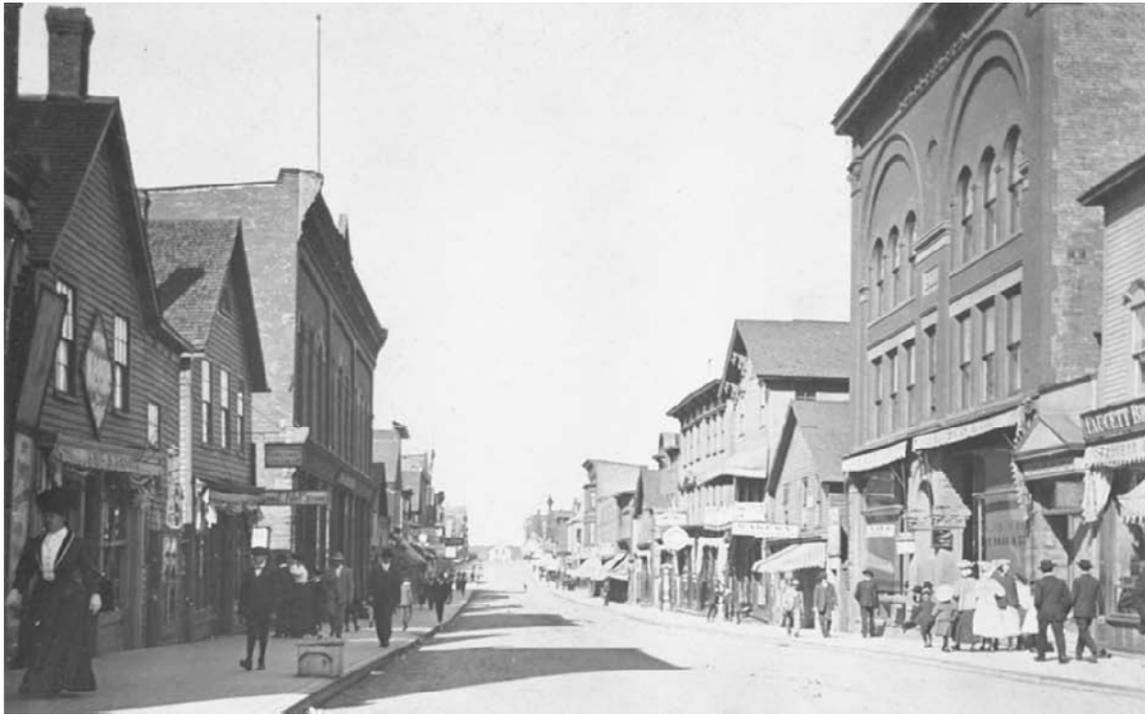
**Figure II - 32: Fifth Street, facing north at Oak Street, Red Jacket, ca. 1910. Note the concrete sidewalk and curb.** (source: image courtesy of Dave Sprenger)

In 1900 the population of the Village of Red Jacket was approximately 4,500. The village served the wider settlement area, which housed approximately 30,000 people.<sup>103</sup> By 1910, sidewalks were added along the commercial streets in the village (see Figures II-32 and II-33). The dirt streets were paved with wooden pavers, brick, asphalt and concrete and automobiles became more prevalent on the village streets.<sup>104</sup> In 1912 Fifth and Sixth streets were illuminated with electric lights, giving the village a new appearance.<sup>105</sup> The overhead streetcar lines ran between poles apparent in Figure II-33.

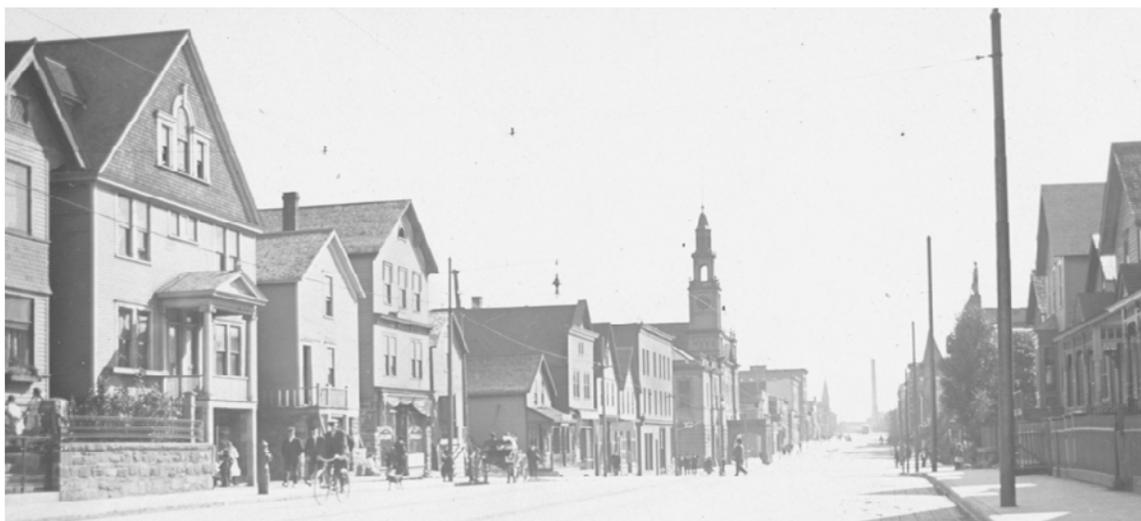
**Figure II - 33: Sixth Street, Village of Red Jacket, ca. 1910** (source: courtesy of Dave Sprenger)

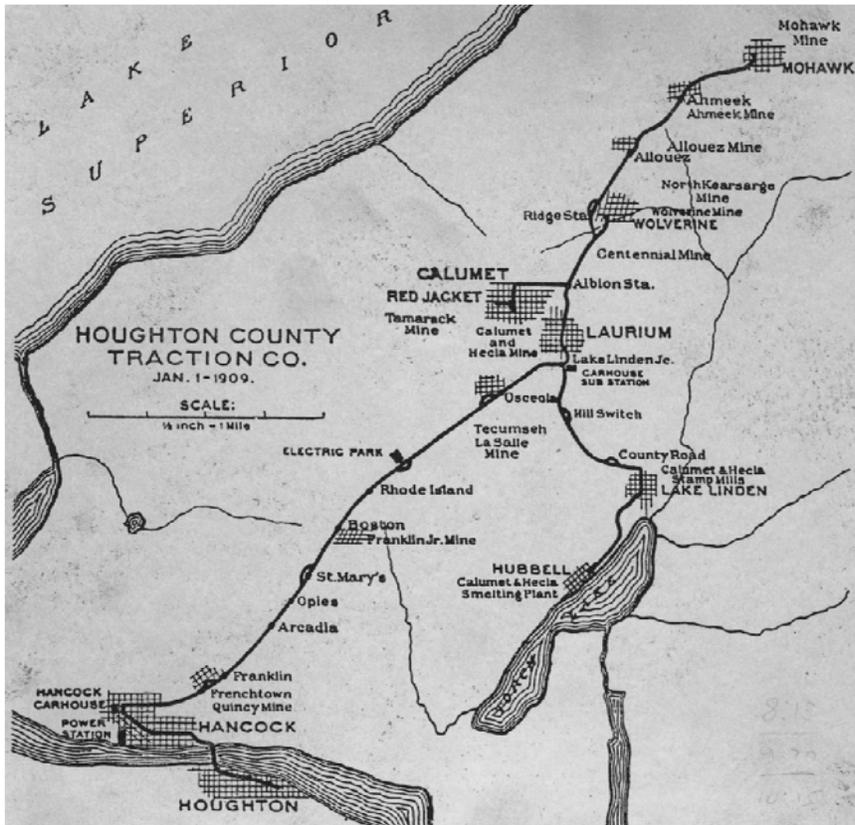
**Figure II - 34: Houghton County Traction Company routes, 1909** (source: Copper Range Railroad website, [www.copperrange.org/traction.htm](http://www.copperrange.org/traction.htm), accessed 28 January 2012)

route utilized a private right of way in the countryside, and ran on streets in towns. Tracks in Red Jacket ran along Sixth Street from Scott to Pine, with a spur along Oak Street. Other tracks connected Laurium to Red Jacket and the mines, making it easier for Laurium residents to get to work and leading to more growth for that village. The presence of the streetcar increased commercial growth along the corridor. The streetcar operated until May 1932.<sup>106</sup>

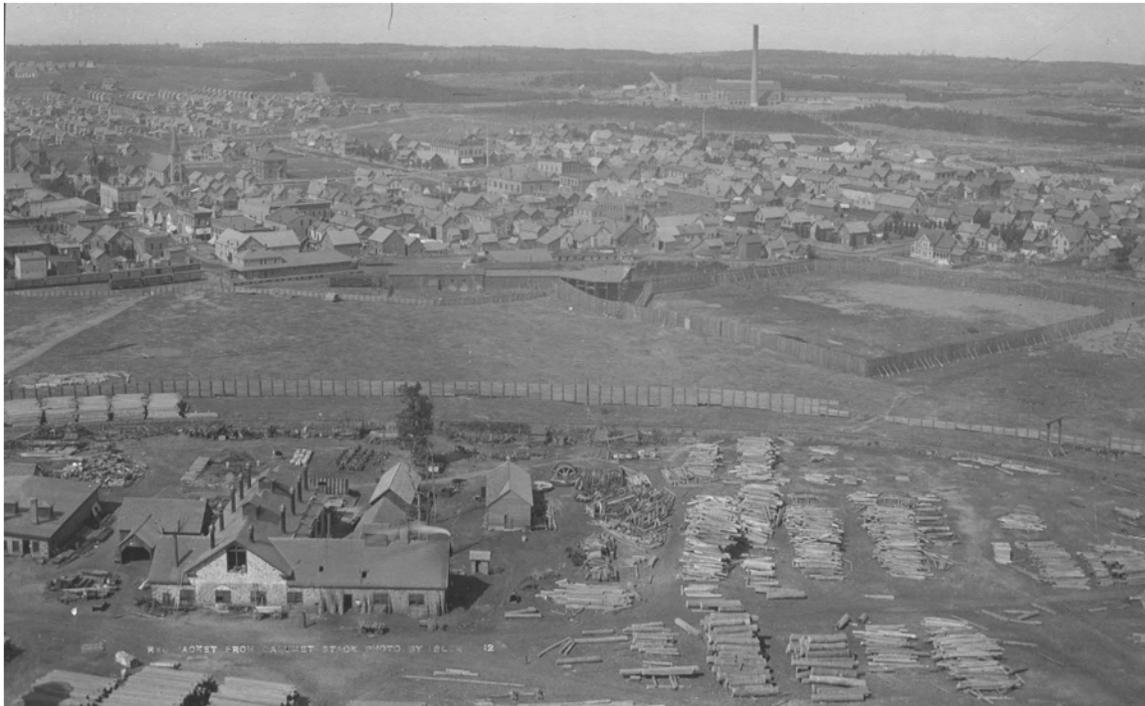
**Figure II - 35: Calumet Commons (later Agassiz Park) looking northwest, 1893.**  
(source NPS, Keweenaw NHP, Jack Foster Collection, Series I (001), Sub-series A (C and H), Sub-series (01) Library, #006)

The Commons continued to be used for recreation and the baseball field was fenced and included a covered grandstand by 1893 (see Figure II-35). The ball field was worn bare and the remainder of the commons had rough turf and bare patches. Additional fences extended around the perimeter of the Commons, although there must have been gates or openings since paths from the village to the mine location were present. An area south of the baseball field was fenced. All of the fences were built of wood board construction. The southeastern portion of the property was utilized to stockpile a large quantity of lumber and two pedestrian paths cut through the site, connecting the industrial area to the village of Red Jacket (see Figure II-36).

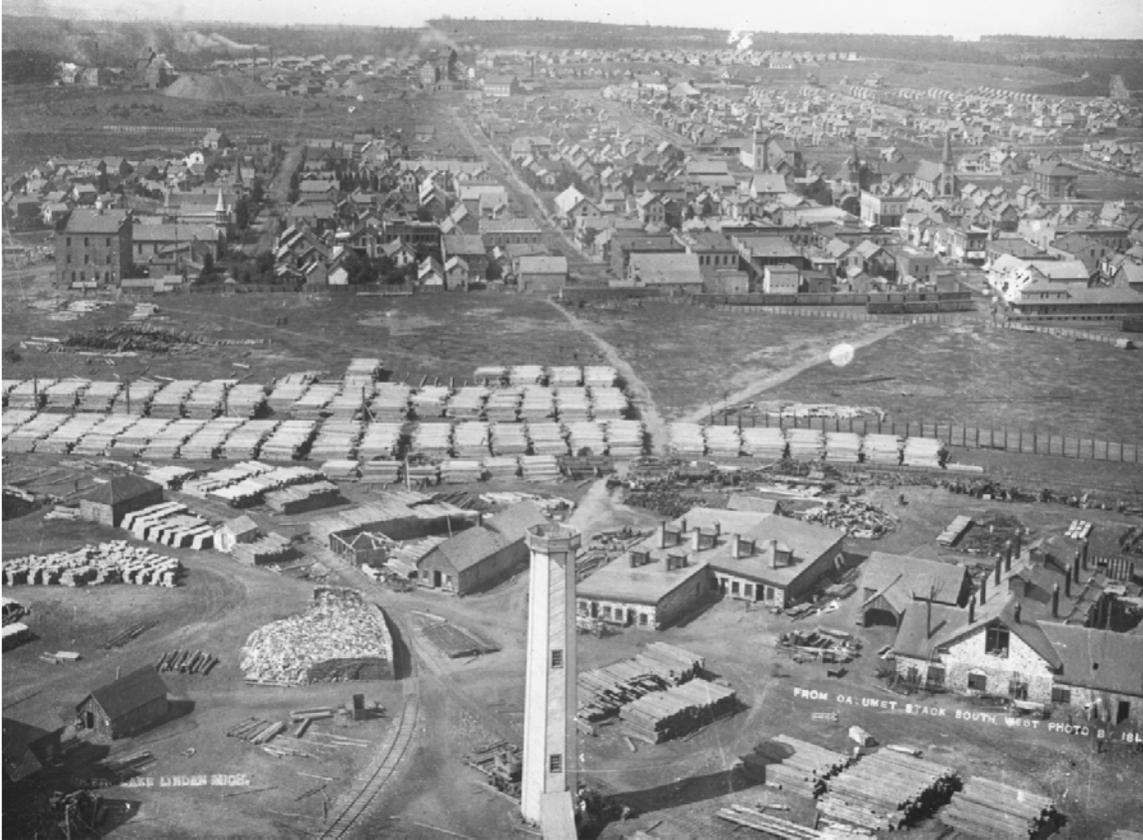
**Figure II - 36: Southern portion of Calumet Commons (later Agassiz Park), facing west, ca.1895.** (source: NPS, Keweenaw NHP, Andrew C. Curto Collection, Album 12, #006)

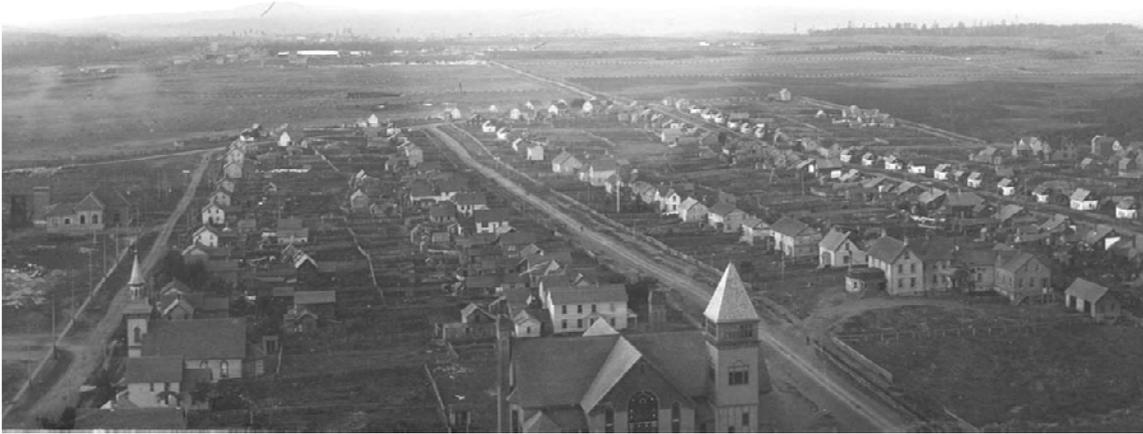
**Figure II - 46: Calumet looking north, 1893. Note the residential fences, outbuildings and lack of shared barns in this location.** (source: NPS, Keweenaw NHP, Jack Foster Collection, Series I (001), Sub-series A (C and H), Sub-series (01) Library, #023)

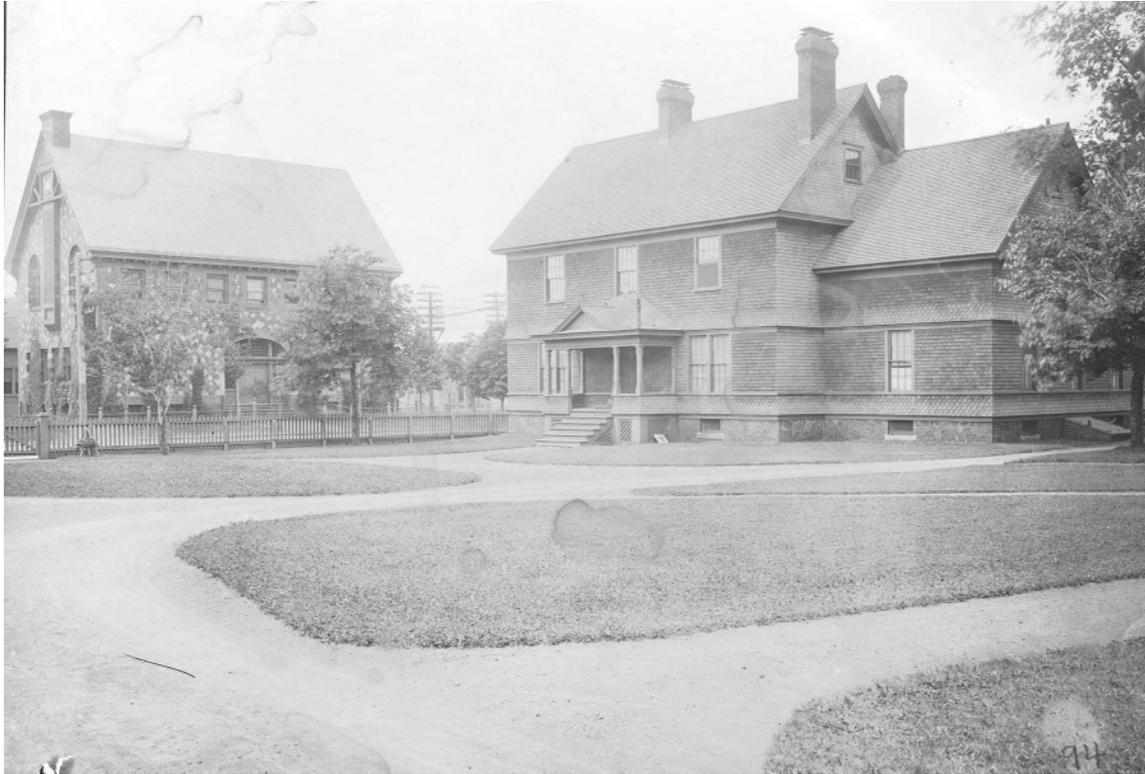
**Figure II - 48: Agassiz House and C&H Public Library, facing southwest, 1909, note the manicured lawns, paths, fences, and street trees. (source: NPS, Keweenaw NHP, Jack Foster Collection, Series I (001), Sub-series A (C and H), Sub-series (01) Library, #237)**

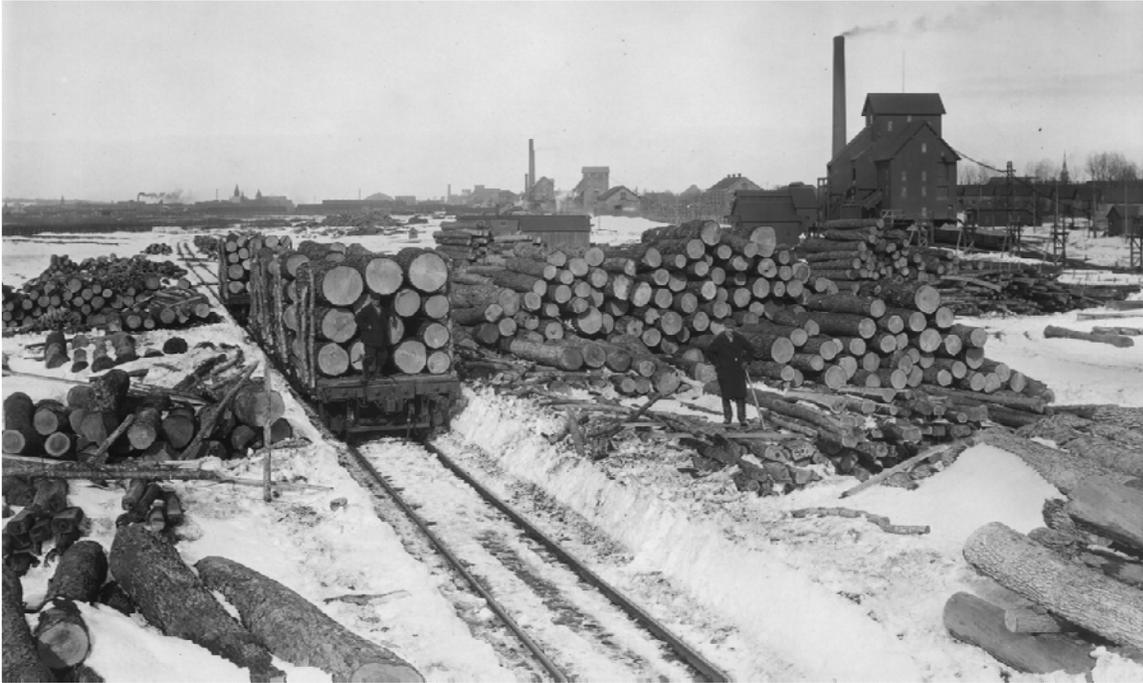
**Figure II - 50: South Hecla, ca. 1925** (source: NPS, Keweenaw NHP, Jack Foster Collection, Series II Assembled Albums (002), Album 3, #005)

The broad patterns of land use remained essentially stable during this period. Comparison of the Period of Change plan for 1890-1915 and the plan for 1916-1930, shows relatively little change in overall land use (see Figures II-31 and II-51). The landscape of the industrial core continued to be a vast industrial presence, but changes were apparent. Most noticeably, the level of activity upon the landscape was greatly reduced as fewer trains, trucks, people, and materials were circulating through the area. Many large areas previously crowded with stockpiles of materials and circulating vehicles were transformed into cleared open areas of dirt and gravel (see Figure II-49). Several large surfaceworks, previously bustling with activity, were idle. Others continued to operate with reduced staff and production (see Figure II- 50).

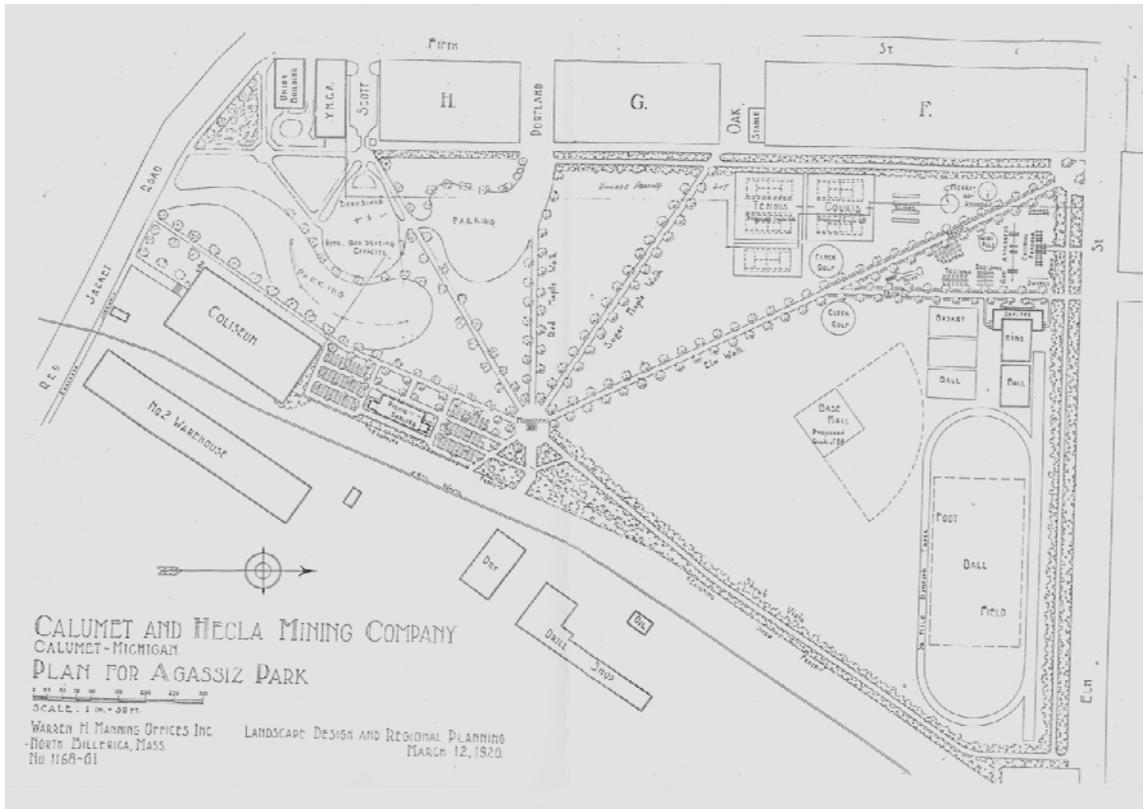
**Figure II - 57: Manning Design for Agassiz Park, March 1920** (source: NPS, Keweenaw NHP, Structures and Cultural Landscapes Vertical File, Agassiz Park)

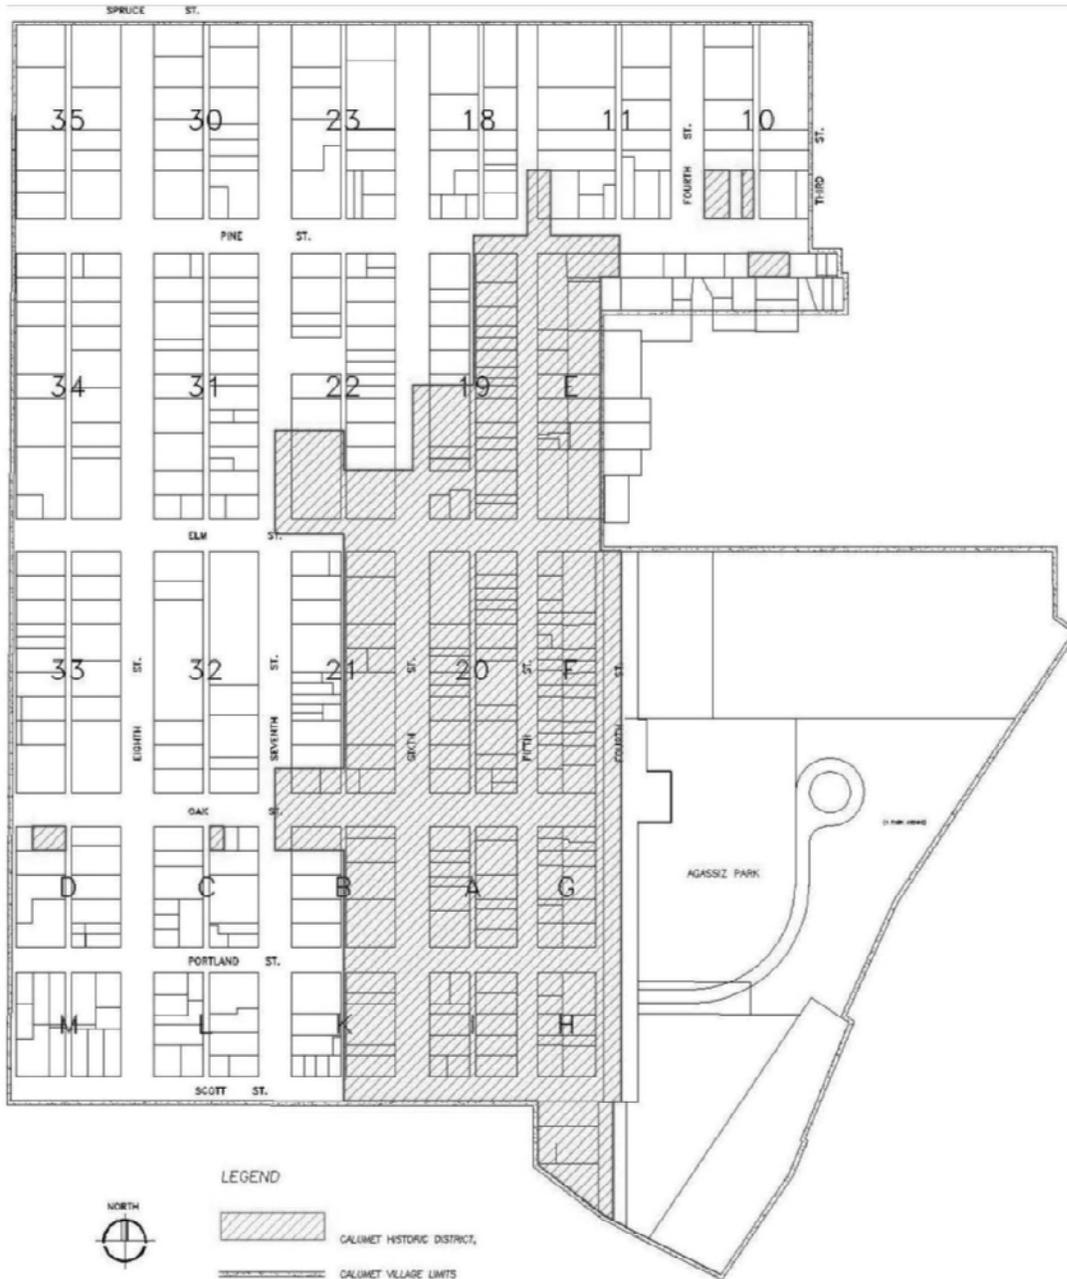
**Figure II - 73: Calumet Civic and Commercial District Boundary, est. 2002**  
(source: Village of Calumet Civic and Commercial Historic District Design Guidelines, 2006)

Plans for the Civic & Commercial Historic District were prepared in 1979 and 1981, solidifying goals focused on preserving and rehabilitating historic resources in the Village. The Calumet Civic and Commercial District was established in 2002 (figure II-73) and design guidelines for properties within the district were published in 2006.<sup>151</sup> These plans set forth recommendations for private property owners and the Village to implement to improve the conditions within the historic district. The Village secured grants to help implement numerous projects including: sidewalk replacement and lighting restoration on Oak and Sixth Streets; brick street restoration and lighting on Fifth Street; reconfiguration of Fourth Street, creating additional off-street parking; repaving of Sixth Street; and brick street restoration on Pine Street. Private investors have rehabilitated downtown buildings and established numerous commercial businesses and residential units.<sup>152</sup>

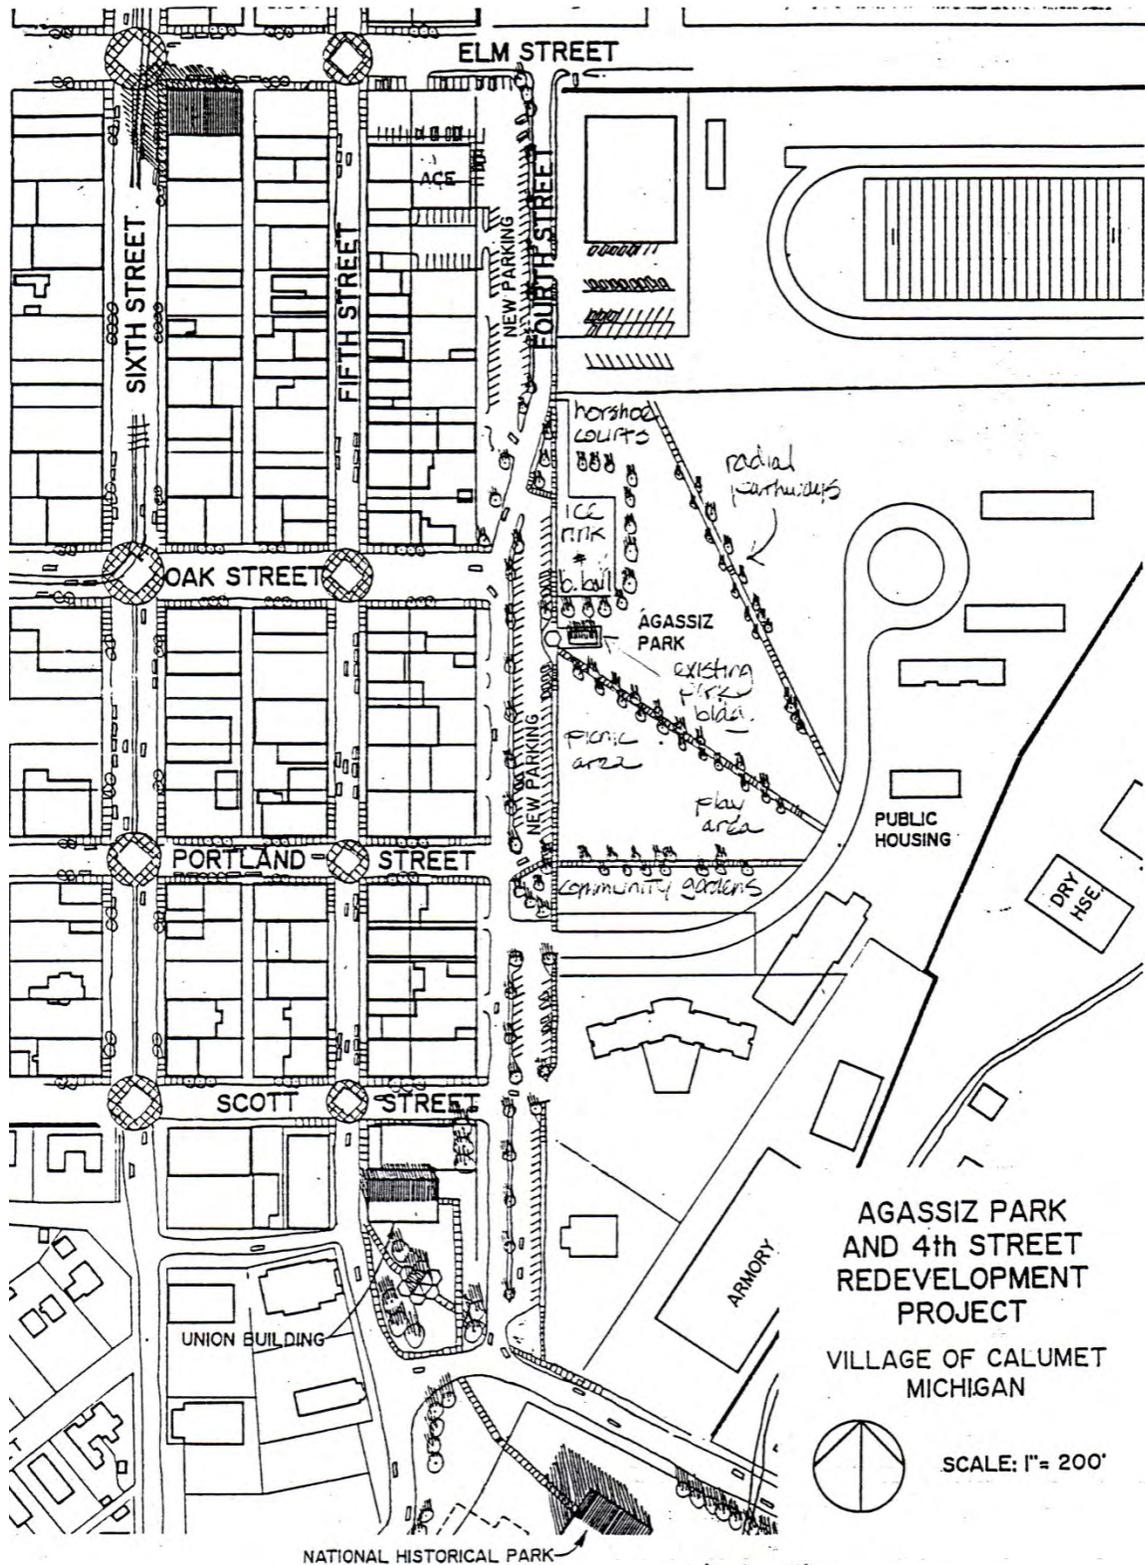
**Figure II - 74: Agassiz Park and Fourth Street Redevelopment Project, 1995**  
(source: attached to *Agassiz Park Master Plan*, prepared by U.P. Engineers & Architects, Inc., and cited in the *Village of Calumet Recreation Plan*, 1998 )

In 1991, a park building including restrooms and an activity area was constructed on the western side of the park. Improvements to Fourth Street included construction of parking lots along the west side of Agassiz Park from Oak Street to the South. The proposed medians with trees were planted with ground cover, as the Village Council was concerned that trees would inhibit snow plowing, but the plants died and were not replaced. The ice rink and parking/street alignment at the northern block of Fourth Street were not implemented. The parking on Fourth Street is used by downtown businesses and for overnight parking by residents. It is considered a vital element in the rehabilitation of downtown Calumet.

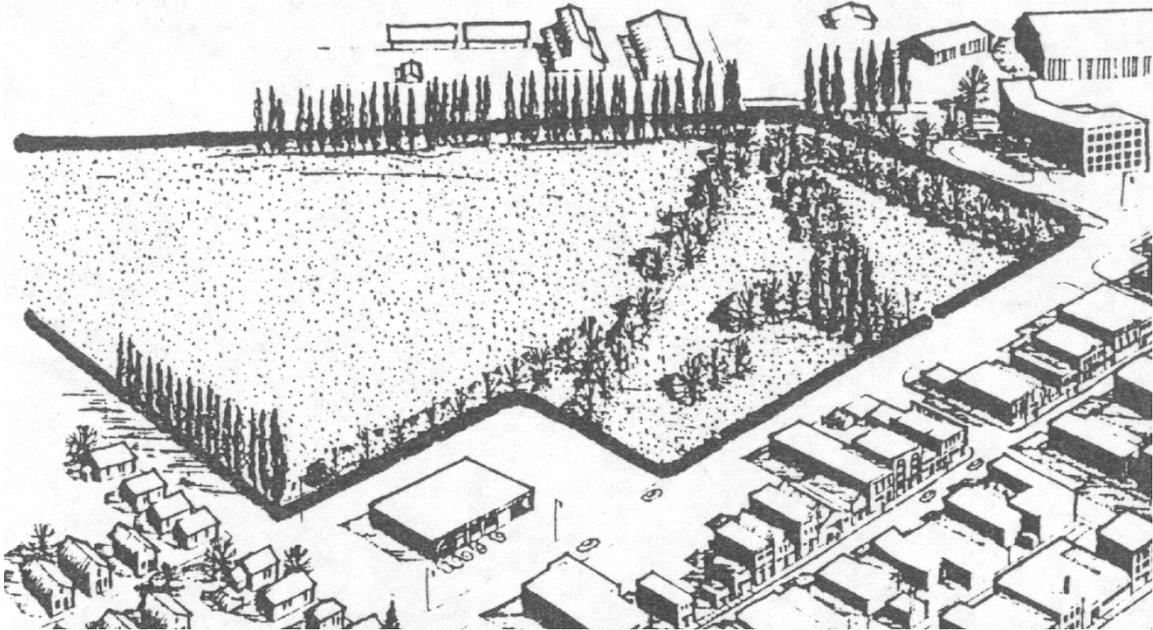
**Figure II - 75: 1979 Conditions at Agassiz Park** (source: Calumet Civic & Commercial Historic District Plan prepared by Preservation Urban Design, excerpt from plan titled “Public Open Space Improvements” 1979)

valuable community amenity and recommended that it be “defended vigorously against any further development.”<sup>156</sup> Three years later, in 1982, a second apartment building for elderly residents and four townhouse structures, a street with a cul-de-sac, and three parking lots were constructed on park land. The project provided much needed housing for elderly residents, as well as units for families. Undertaken by the Calumet Housing Commission, funding was provided by the Department of Housing and Urban Development (HUD). An office building was constructed, to the south of the original elderly apartment complex, by Farmers Mutual Fire Insurance Company. All of these structures remain and are being utilized for their original purpose.
