Calumet Unit Historic Landscape

Cultural Landscape Report and Environmental Assessment

FINAL 2013

**Keweenaw National Historical Park**

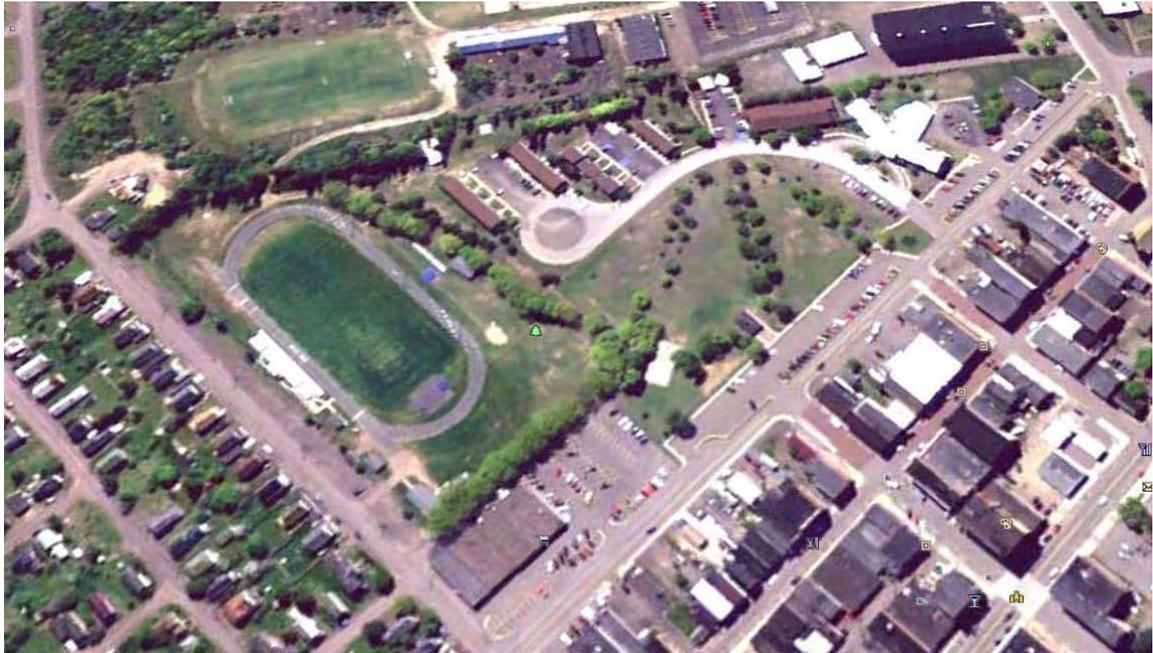
**Figure II - 76: 2012 Conditions at Agassiz Park** (source: GoogleEarth accessed February 2012)

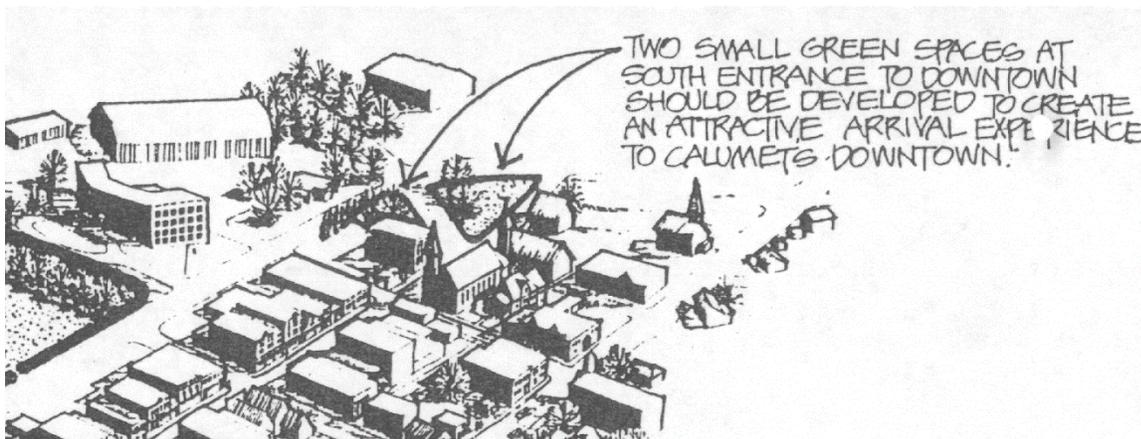
**Figure II - 77: Recommendations for Red Jacket Road Park, 1979**

(source: Calumet Civic & Commercial Historic District Plan prepared by Preservation Urban Design, excerpt from plan titled “Public Open Space Improvements” 1979)

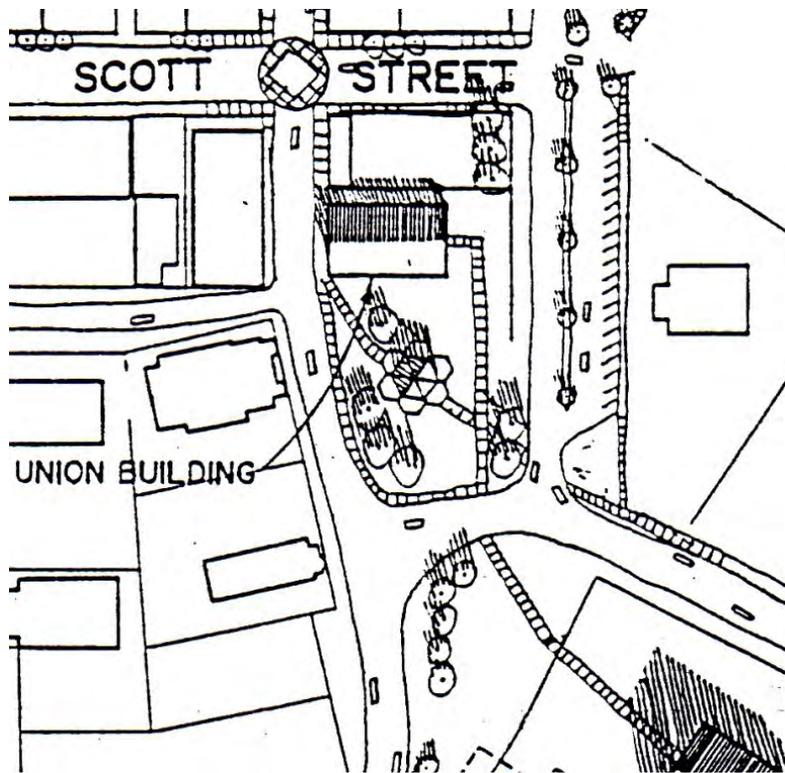
**Figure II - 78: Red Jacket Road Park Plan, 1995**

(source: attached to *Agassiz Park Master Plan*, prepared by U.P. Engineers & Architects, Inc., and cited in the *Village of Calumet Recreation Plan*, 1998)

A 1995 plan entitled “Agassiz Park and Fourth Street Redevelopment Project” provided a conceptual landscape plan for the Red Jacket Road Park (figure II-78). The plan was not adopted by the Village, and the concept for this area has not been pursued. The plan included the development of a path, gazebo, and ornamental plantings in the small park. The plan also indicates that Red Jacket Road be re-aligned in this area, making the park larger and eliminating Armory Street.<sup>158</sup>

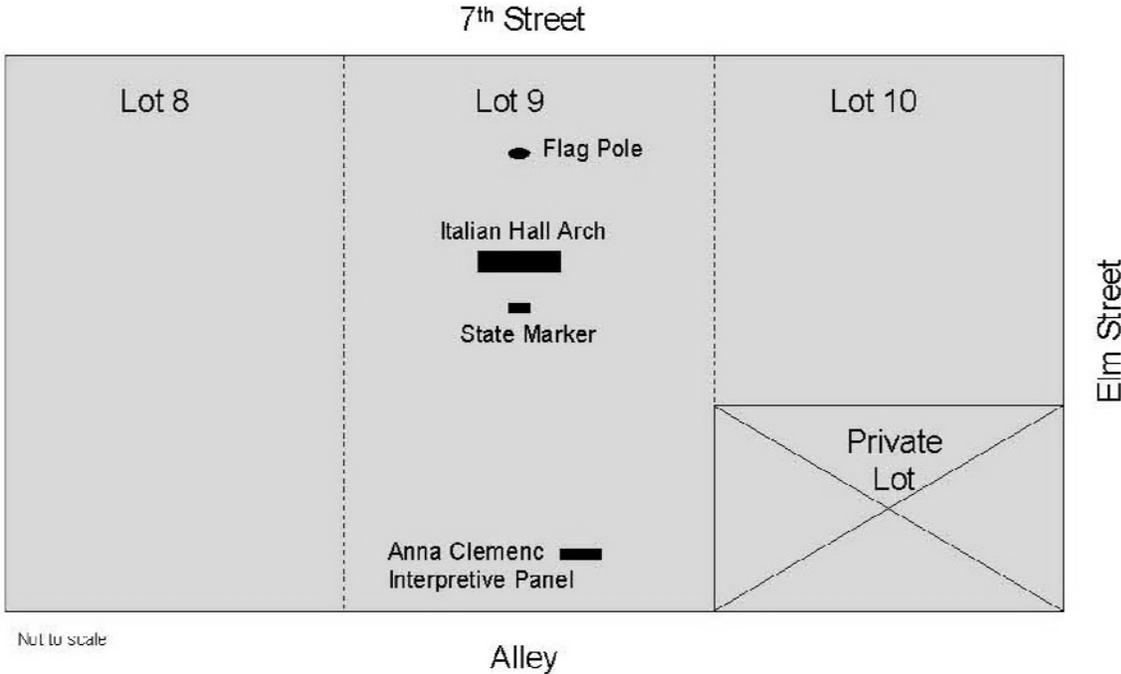
**Figure II - 79: Italian Hall Memorial Site Lots**  
(source: Wells Resources, Inc., *Front-end Planning Report, Italian Hall Memorial Park, Calumet, Michigan, 2011, 3*)

In January 2011, a *Front-end Planning Report for Italian Hall Memorial Park* was completed. Preparation of the report included a series of pre-planning exercises with historians and local citizens to inform an “enhanced re-design of the Italian Hall site.” The report provides recommendations for design approaches and content for the development of a plan for the memorial site.<sup>161</sup>

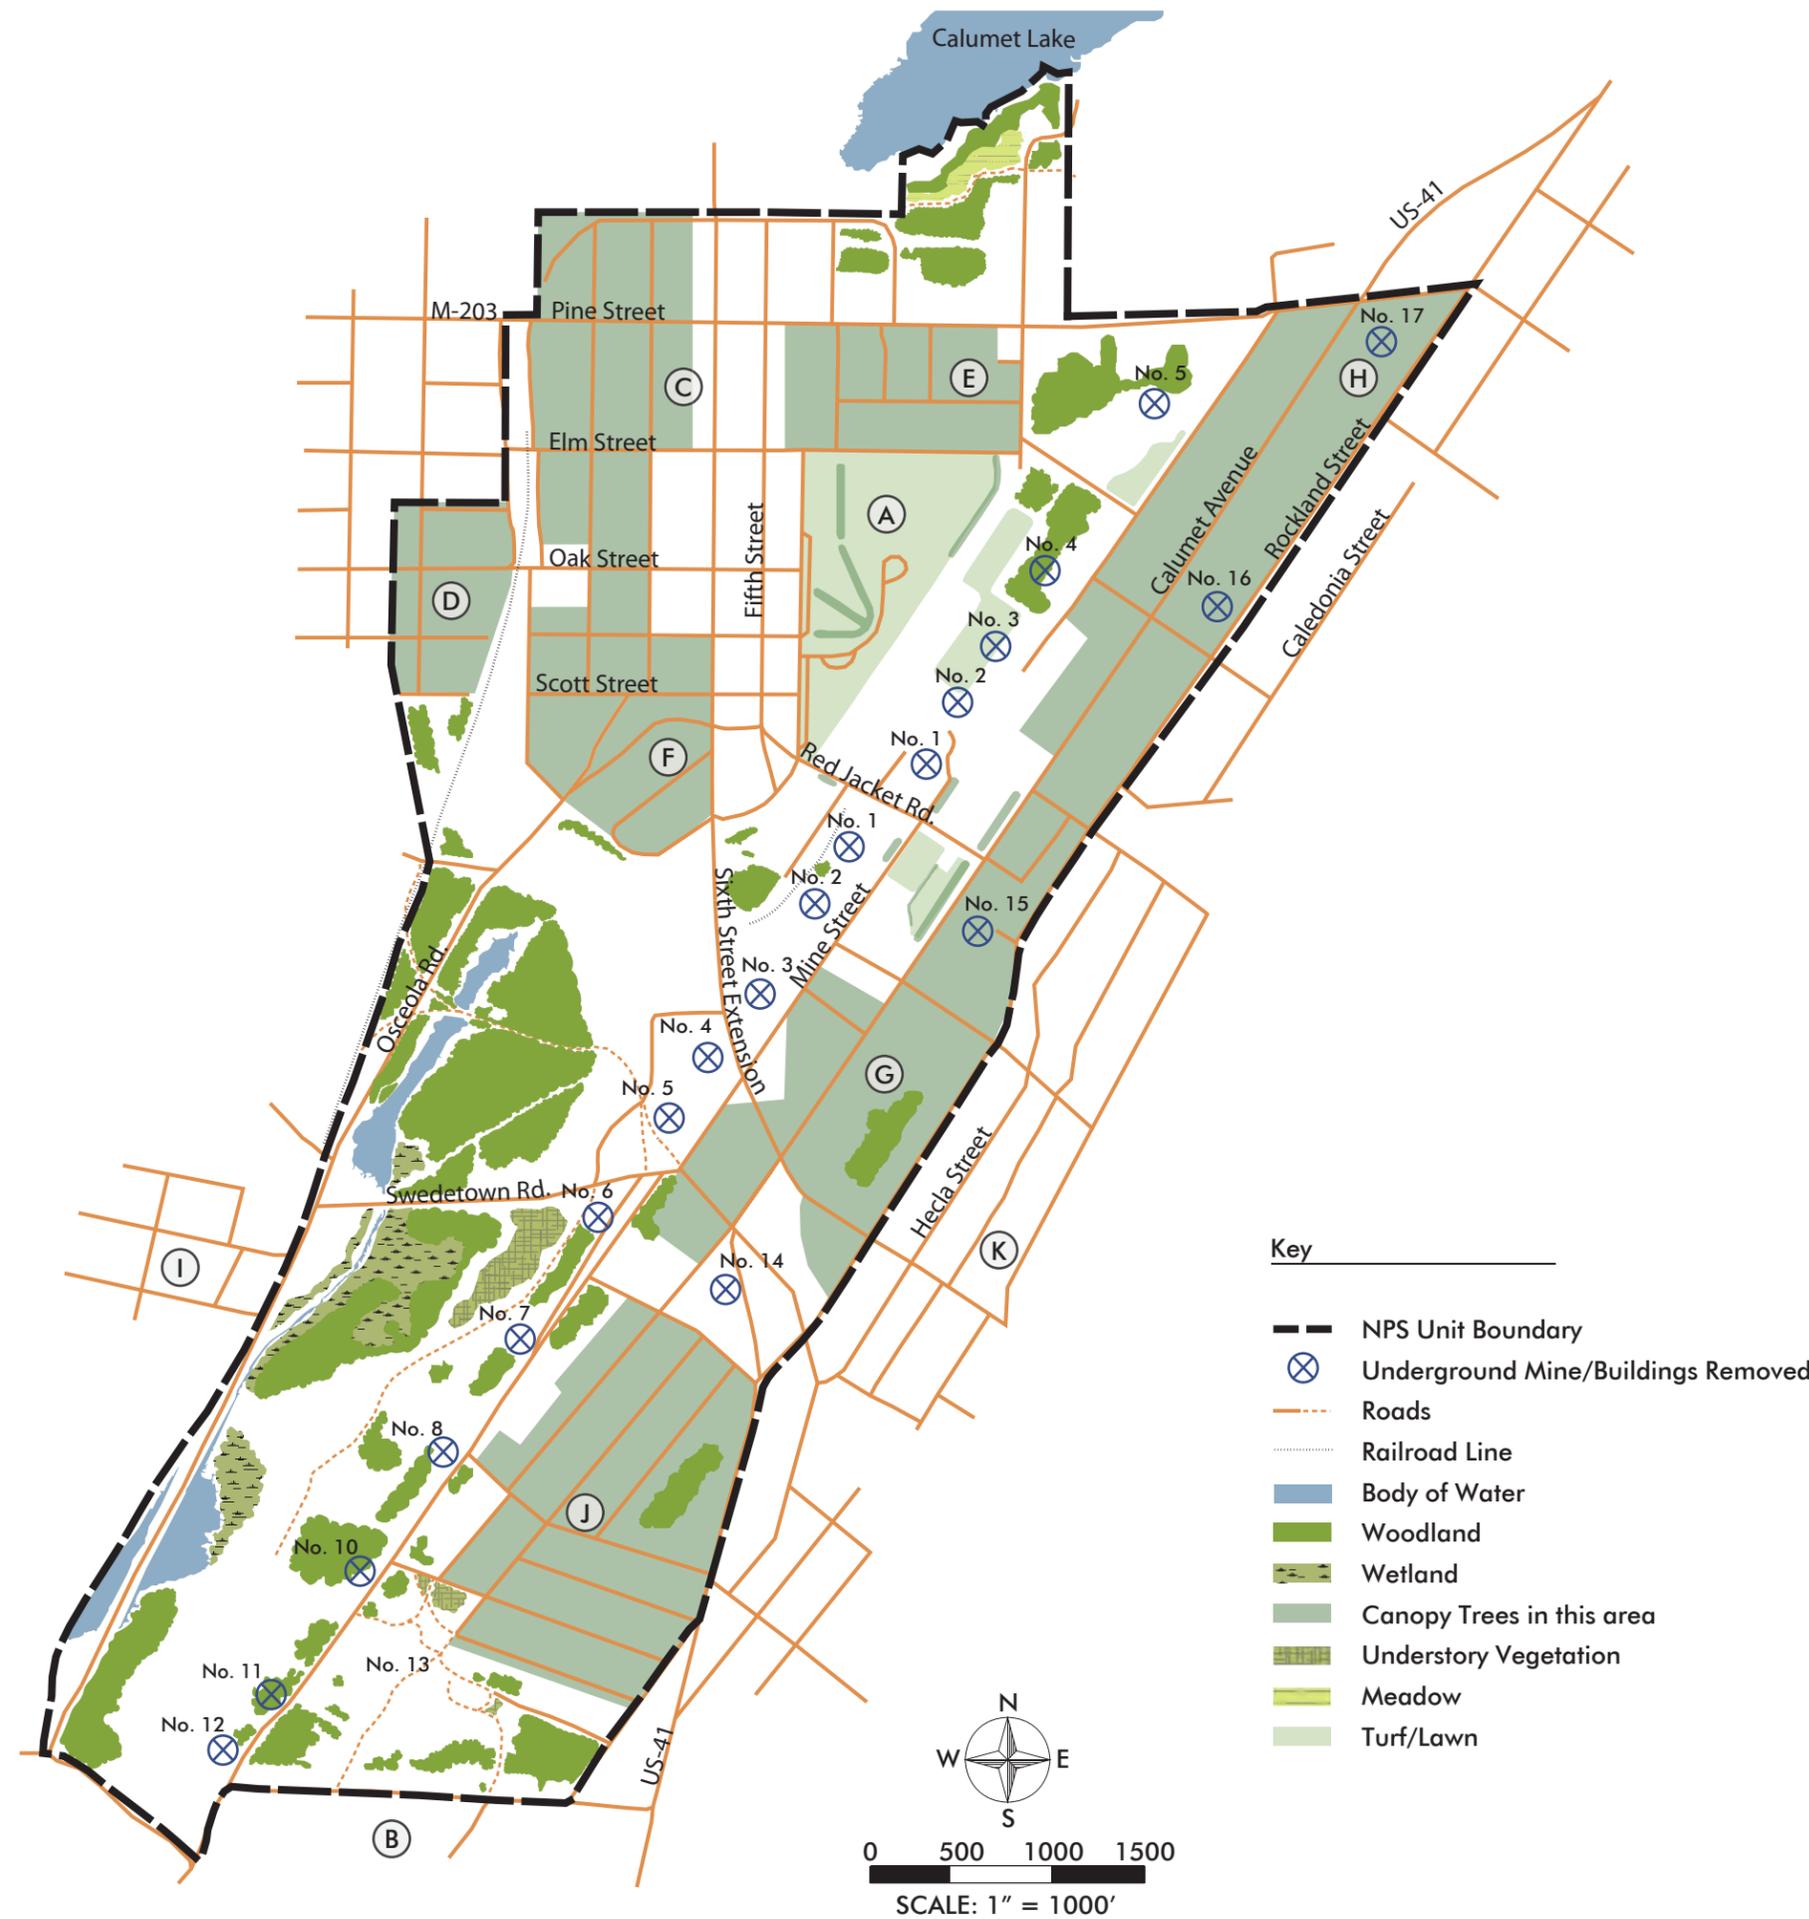
- NPS Unit Boundary
- ⊗ Underground Mine/Buildings Removed
- Roads
- ⋯ Railroad Line
- Body of Water
- Woodland
- Wetland
- Canopy Trees in this area
- Understory Vegetation
- Meadow
- Turf/Lawn

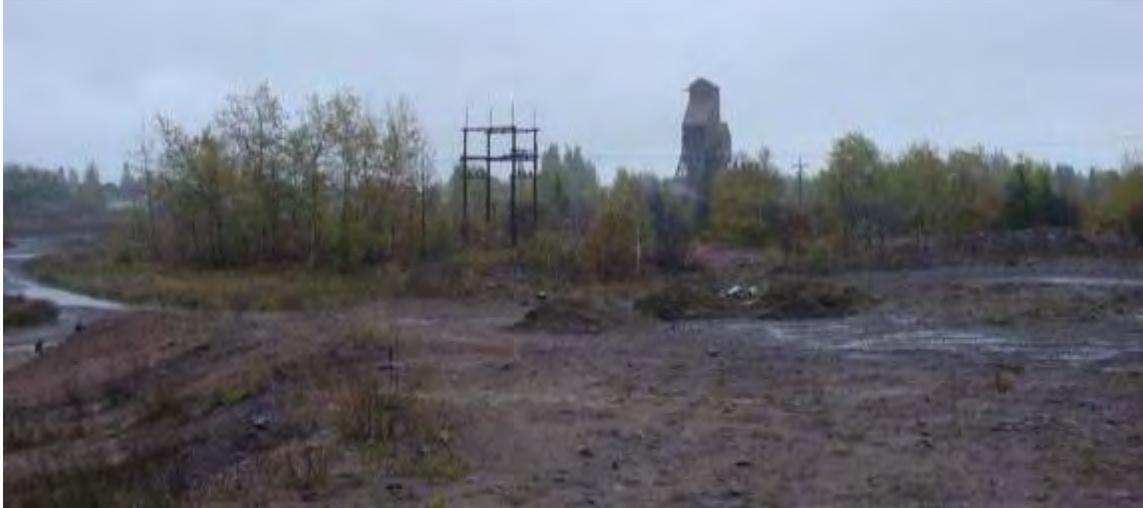
**Figure III- 12: EV.1 / Existing View 1, Osceola No. 13, shaft-rockhouse, 2010**  
(source: QEA 7345)

View facing east from near Mine Street illustrates the Osceola shaft/rockhouse number 13 and surrounding landscape. The area includes uneven ground with stockpiles of rock and dirt, areas where volunteer vegetation has grown, an unimproved road, and overhead utility lines.

Both of the views above are somewhat similar to the character of views within the industrial corridor during the historic periods. The main difference is the lack of industrial equipment and activities as well as the addition of vegetation that would not have been present historically. The rugged character of the area represents the historic character that is difficult to capture with manicured landscapes.

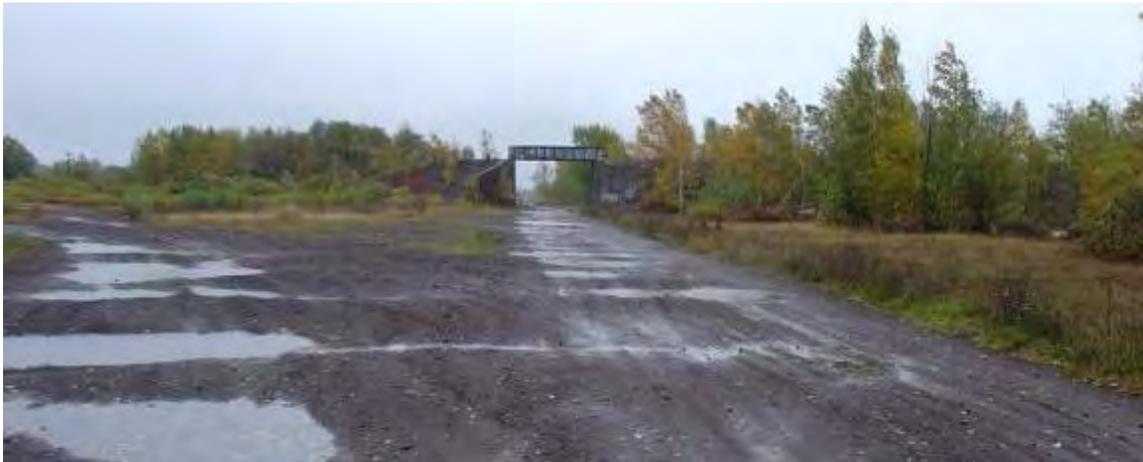
**Figure III- 13: EV.3 / Existing View 3, Railroad Corridor facing north, 2010**  
(source: QEA 7384)

The railroad corridor includes a roughly graded atv/snowmobile route surfaced in gravel and dirt. There are many large potholes and irregularities in the route. The railroad overpass is a remnant of a historic industrial feature related to the movement of mine materials. The edges of the corridor include volunteer vegetation and industrial artifacts.

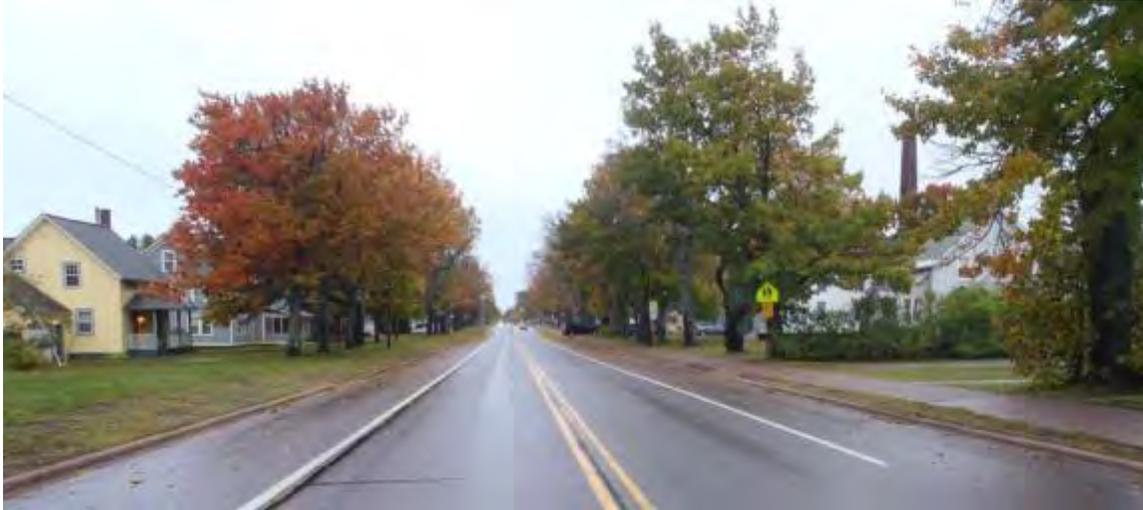
**Figure III- 14: EV.5 / Existing View 5, Calumet Avenue facing south, 2010**  
(source: QEA 9240001)

Calumet Avenue/U.S. 41 is a primary transportation route through the region. Entering the Calumet unit from the north (heading south) on this road, the residential character of Calumet is apparent. While this character is also apparent when heading in a northerly direction, the view is pronounced when heading south, due to the slope of the landscape. The consistent set back of the houses, presence of lawns, sidewalks, and street trees, all contribute to the character of this corridor. This portion of U.S. 41 presents a unique character compared to the highway north and south of Calumet. In other areas, views from the highway alternate between dense woodland and commercial strip development.

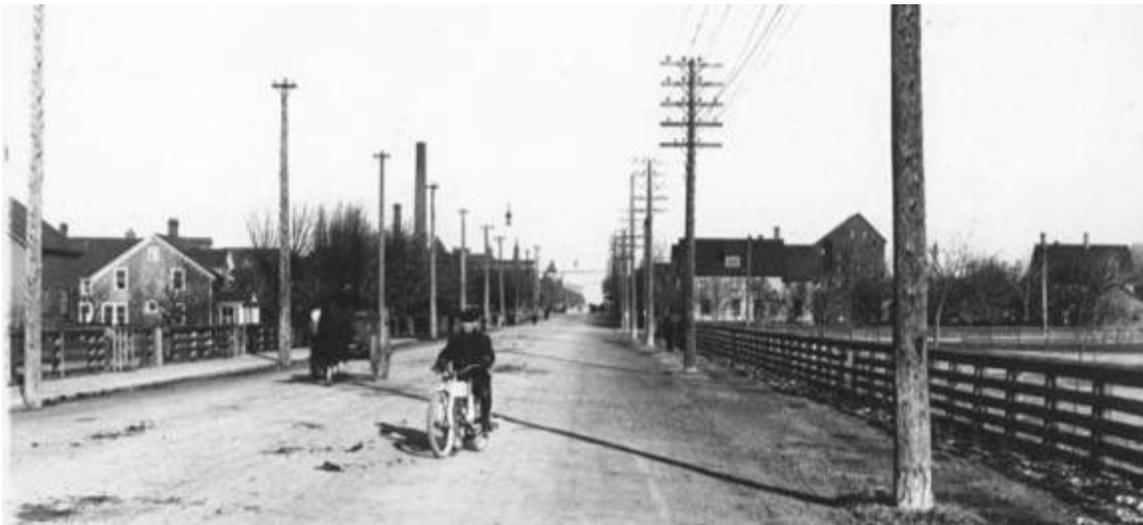
**Figure III- 15: HV.6 / Historic View 6, Calumet Avenue facing North, 1910** (source: Keweenaw NHP archives)

Calumet Avenue during the historic period was already a major regional transportation route. Fences were likely used to keep livestock from wandering into the road.

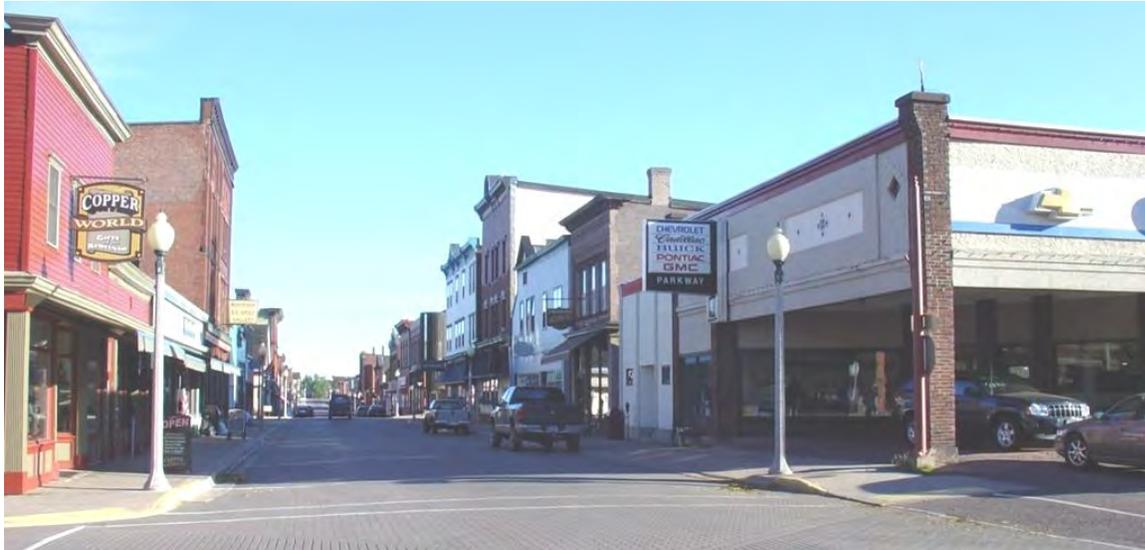
**Figure III- 16: EV.8 / Existing View 8, Fifth Street at Scott Street facing north, November 2010** (source: QEA 6456)

Upon turning the corner from Red Jacket Road to Fifth Street, views include the historic downtown scene. Although the car dealership at the corner of Scott and Fifth is incongruent with the historic character, the historic storefronts, brick paving, historic style light fixtures and consistent building massing establish a strong historic setting.

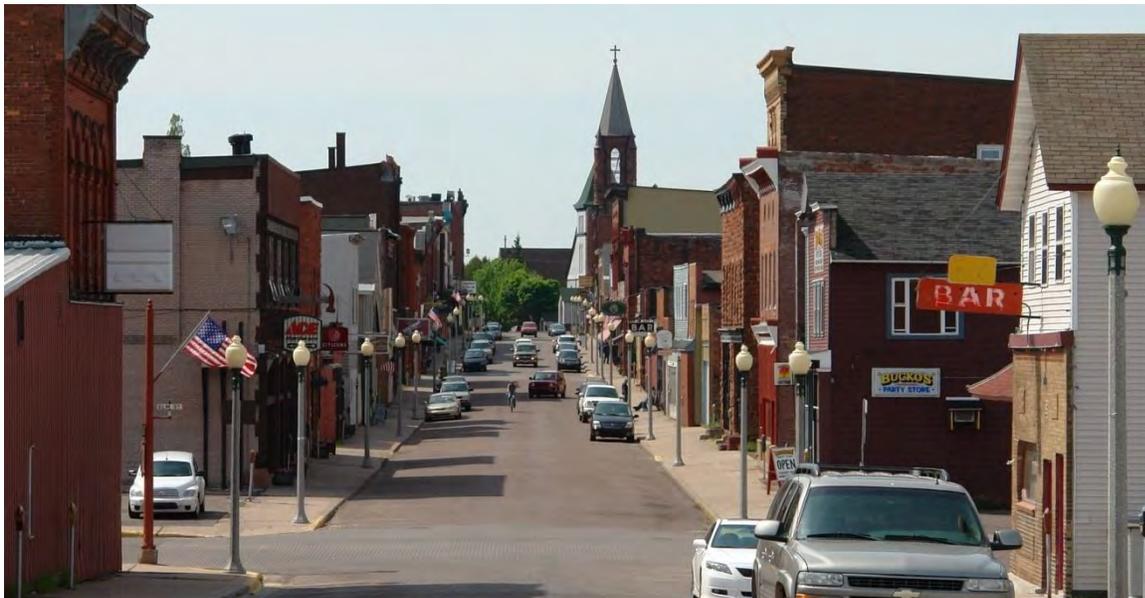
**Figure III- 17: EV.9 / Existing View 9, Fifth Street facing south, June 2011** (source: QEA 9062)

The view of the Fifth Street facing south is enhanced by the rise in topography toward Elm Street. The historic storefronts, brick paving, historic style light fixtures and consistent building massing establish a strong historic setting. Non-historic building materials, signs and other elements detract from the historic character but the overall impact is not substantial.

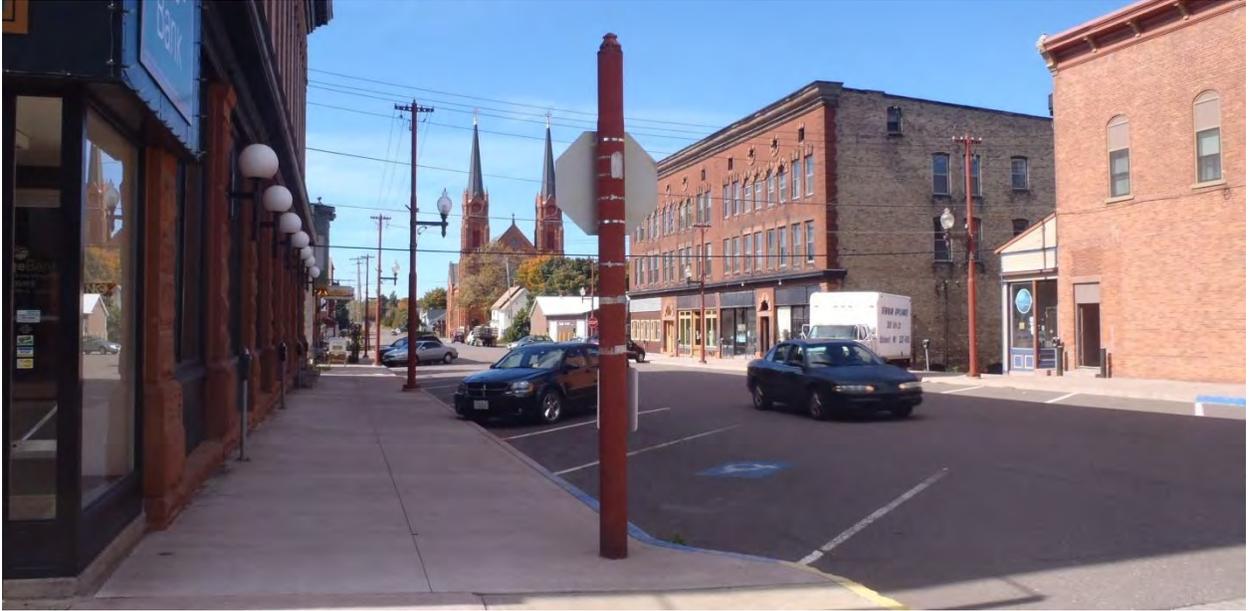
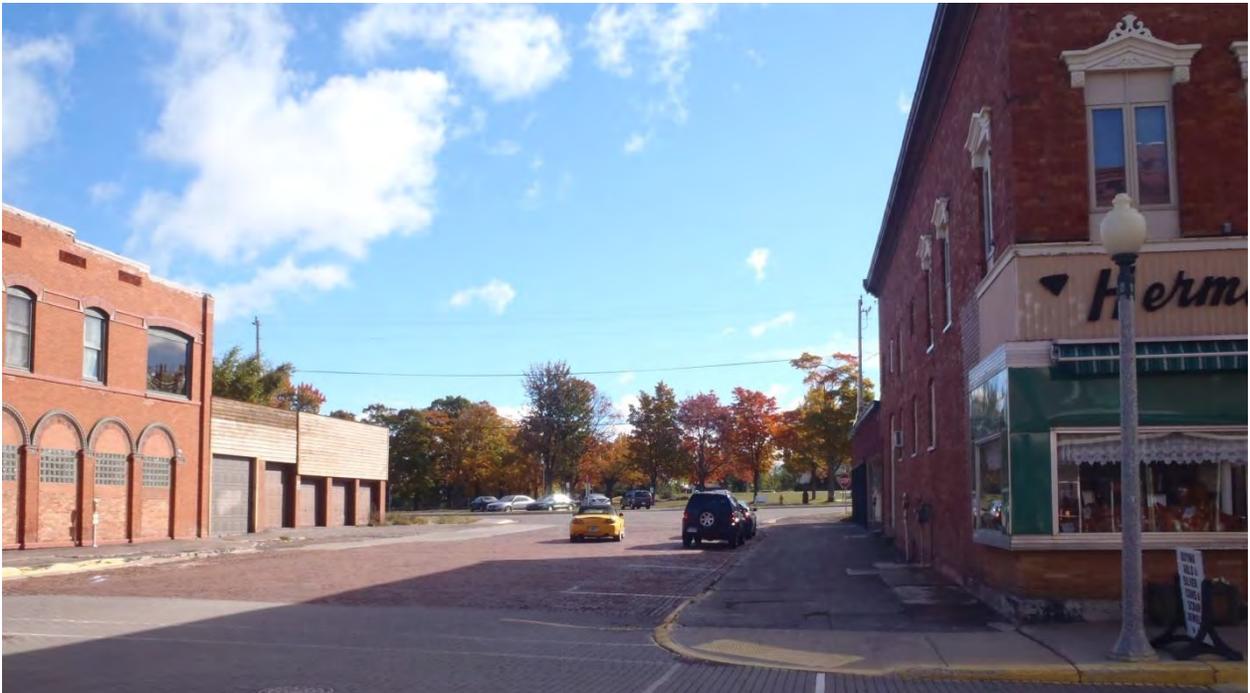
**Figure III- 18: EV.10a / Existing View 10a, Oak Street facing west, September 2010**  
(source: QEA P9220148)

**Figure III- 19: EV.10b / Existing View 10b, Oak Street at Fifth Street facing east, September 2010**  
(source: QEA P9220147)

The Oak Street corridor between the Mineral Range Depot and Agassiz Park includes important visual connections for the community. The majority of the corridor is flanked by extant historic buildings including commercial properties in the blocks between Fourth Street and Seventh Street, and historic residences from Seventh Street to Ninth Street. St. Paul's church is clearly viewed from both directions and provides a strong anchor for views.

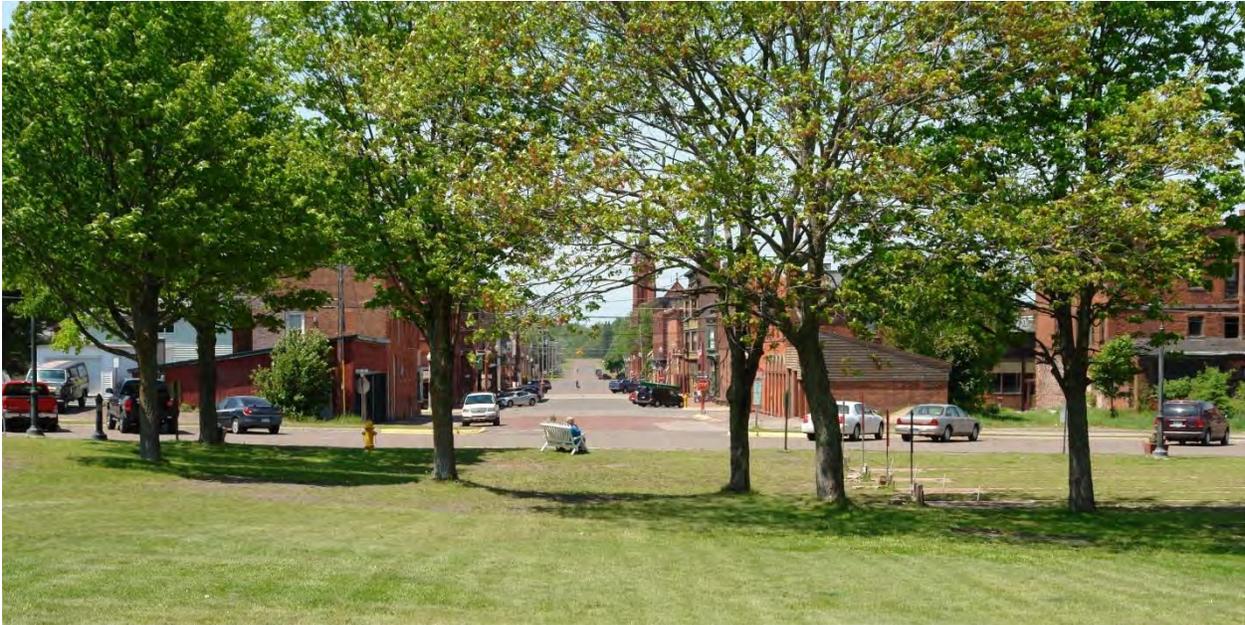
**Figure III- 20: EV.2a / Existing View 2a, View of Oak Street from within Agassiz Park facing west, June 2011** (source: QEA 9121)

From Agassiz Park, the long-range view along Oak Street includes the commercial buildings along the street and the steeples at St. Paul’s Church. This important connection between Agassiz Park and downtown Calumet is not clearly addressed at the park, Fourth Street or Oak Street.

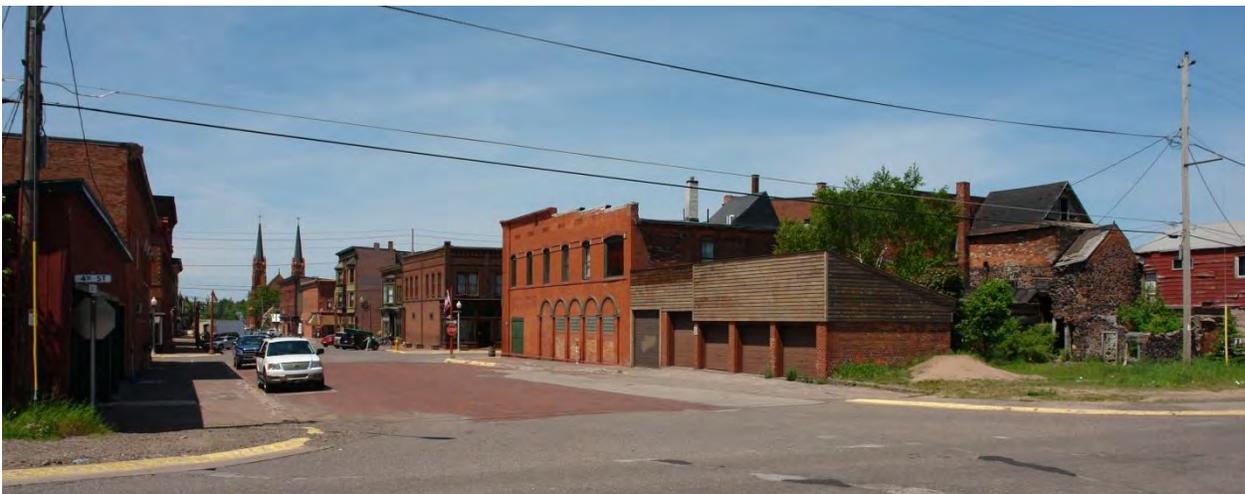
**Figure III- 21: EV.2b / Existing View 2b, View of Oak Street from Agassiz Park at Fourth Street facing west, June 2011** (source: QEA 9110)

The current conditions along Fourth Street and Oak Street do not encourage pedestrian oriented activities. The street is wide and does not include crosswalks, the parking area at the park does not include clearly defined pedestrian zones. The buildings do not include welcoming facades along Fourth or Oak in this block.

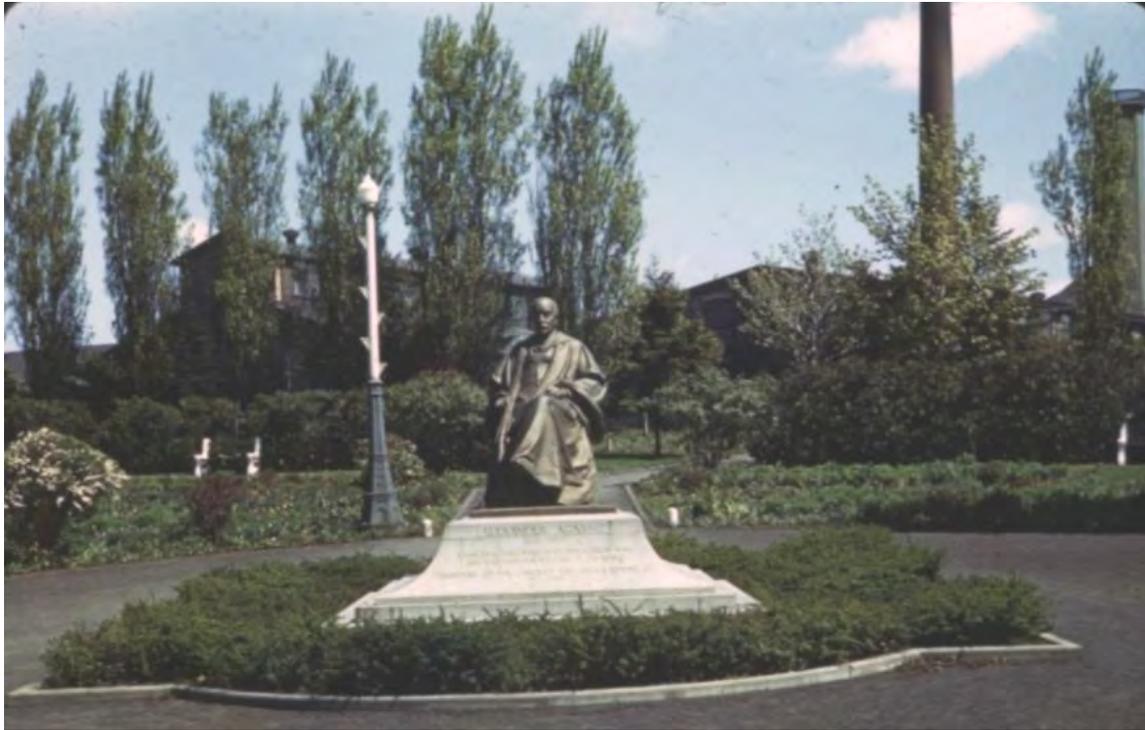
**Figure III- 22: HV.1 / Historic View 1, View of Agassiz Memorial statue and surrounding plaza in Agassiz Park, facing northeast, ca. 1940** (source: NPS, Keweenaw NHP, LaMuth Collection, Kodachrome Slides)

The statue and plaza provided a focal point for the park and a pivotal pedestrian link between the industrial core and downtown Calumet. The vegetation was well maintained and provided a pleasant environment for community members.

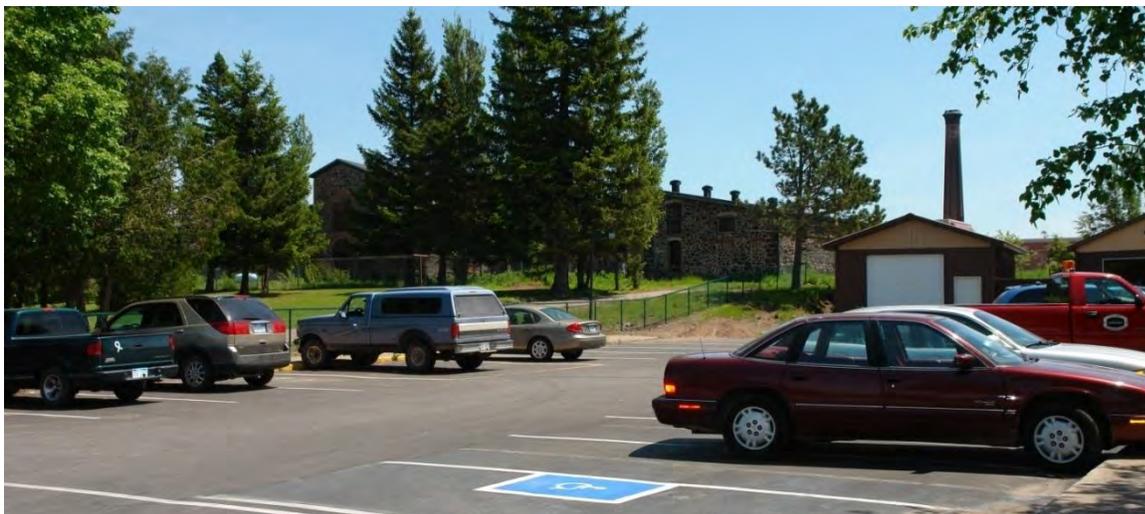
**Figure III- 23: EV.12/ Existing View 12, Parking lot at former site of Agassiz Memorial plaza, June 2011 (similar view point as HV.1)** (source: QEA 9151)

A parking lot and maintenance sheds are currently situated on the former site of the Agassiz Memorial statue and plaza.

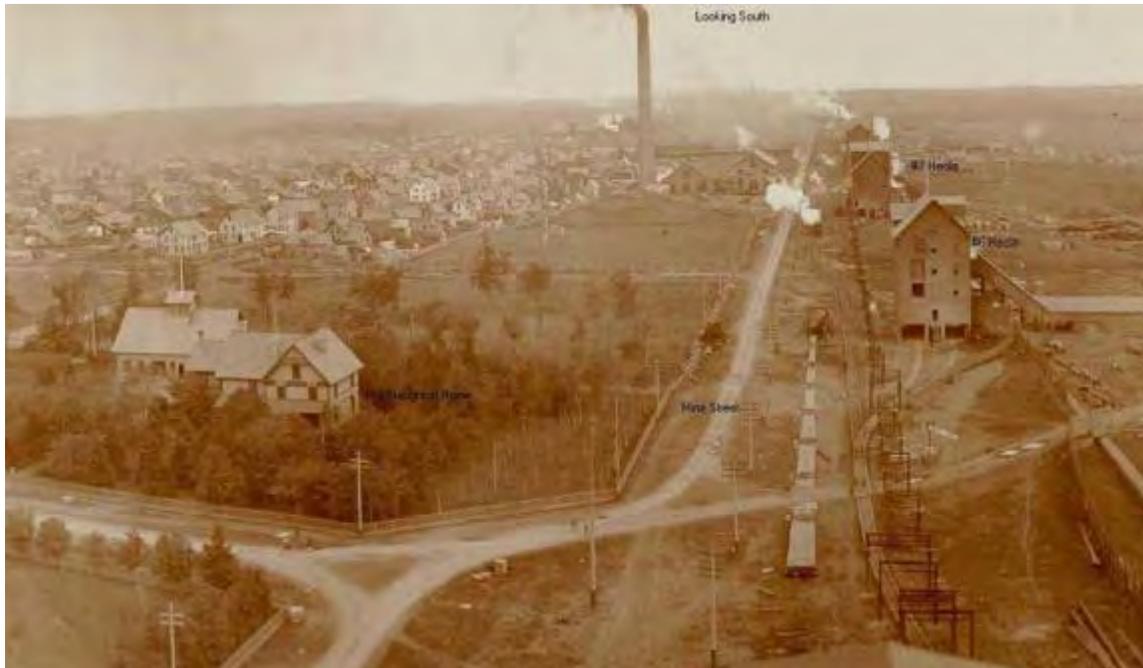
**Figure III- 24: HV.2 / Historic View 2, Hecla/Mine Street looking South, 1893**  
(source: Chuck Voelker Collection, Copper Country Reflections, [www.pasty.com/reflections](http://www.pasty.com/reflections))

Mine Street in 1893 included the Hecla shafthouses, a tram route, work areas, stockpiles of materials, and the street itself. Note the fence on the east (left) side of the street. It appears that the area to the east (left) of Mine Street was not yet being used for industrial activities.

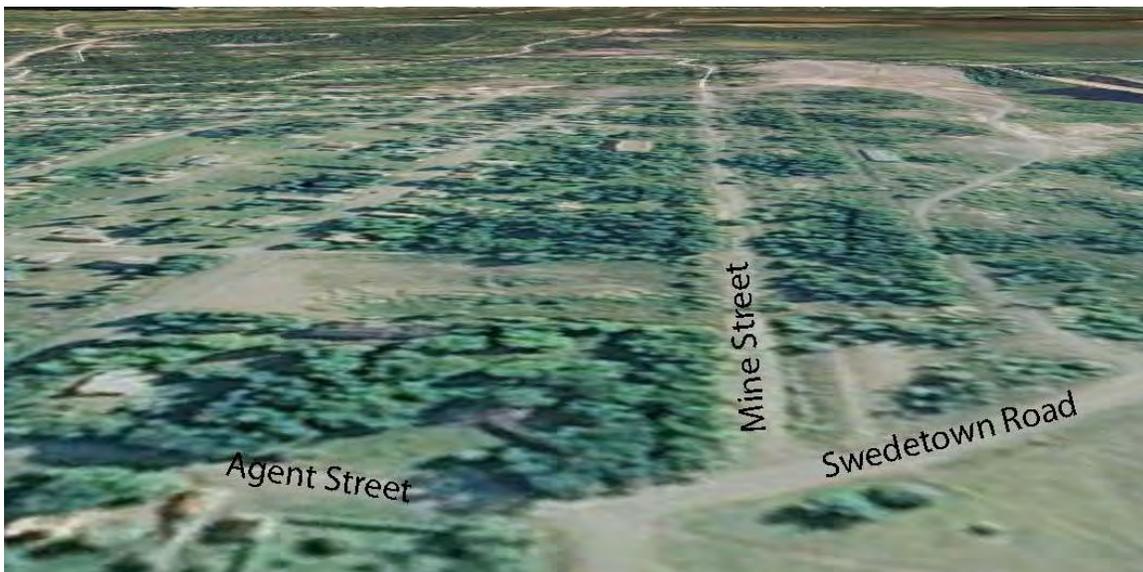
**Figure III- 25: EV.13 / Existing View 13, Mine Street looking South, 2012 (similar view as HV.2)** (source: QEA, base image from Google earth)

The street alignments have not changed and traces of the industrial buildings exist in the form of foundations on the north (right) side of Mine Street. The corridor provides an opportunity to interpret historic use and provide recreational activities.

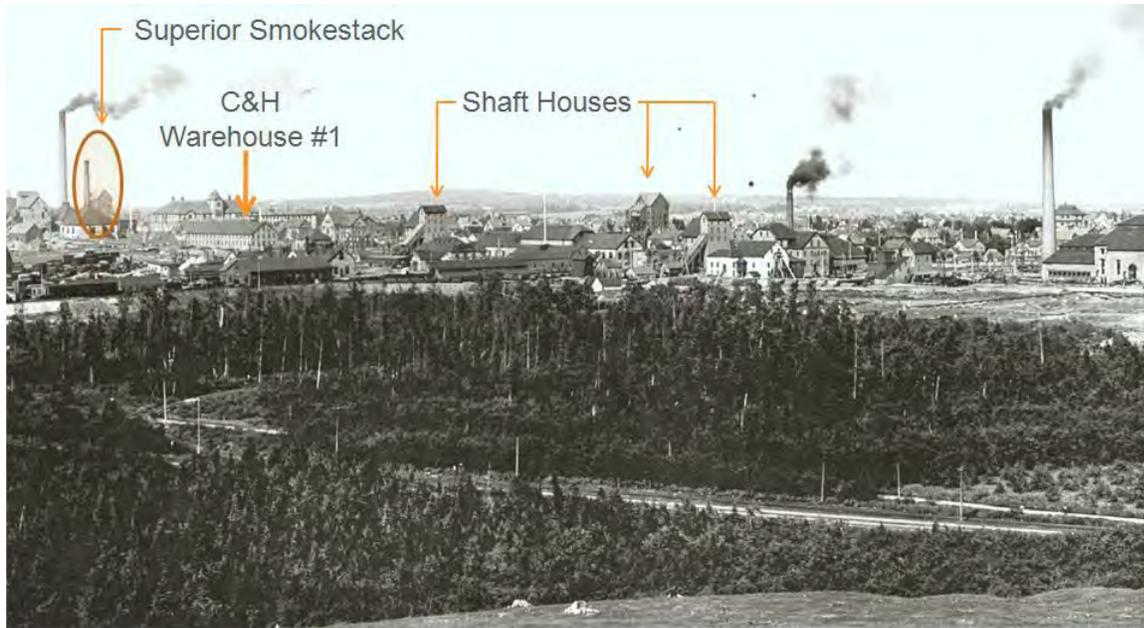
**Figure III- 26: HV.3 / Historic View 3, Calumet and Hecla from Swedetown**  
(source: Keweenaw NHP archives)

Viewed from the highpoint of Swedetown, Calumet was highly developed during the historic period. Vertical elements within the landscape added to long-distance views and gave visual cues related to the industrial and community activities. Smokestacks, shaft houses, and church steeples were especially prominent during the historic periods.

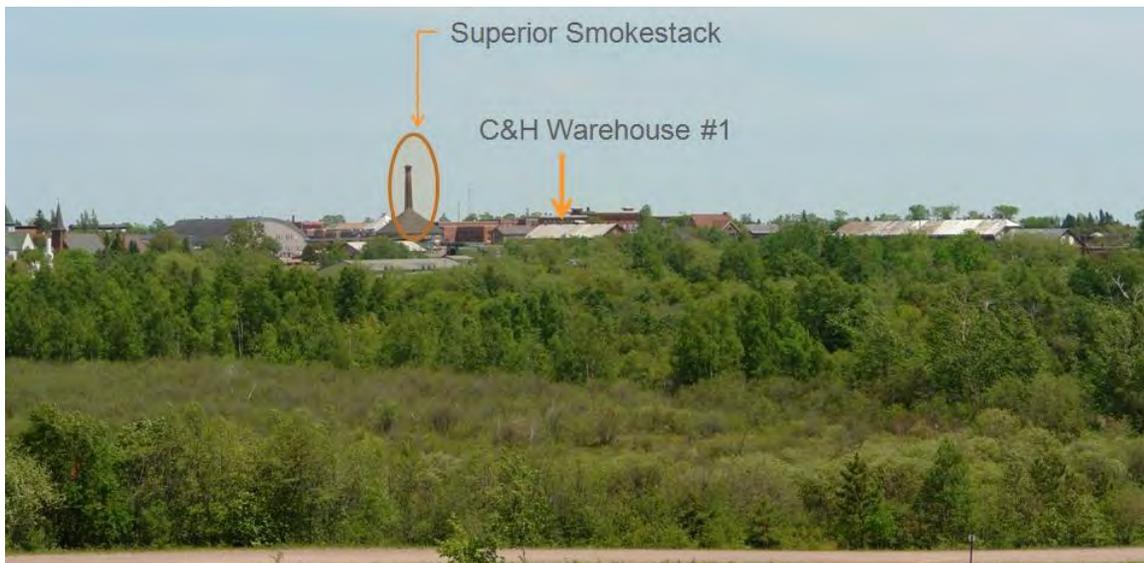
**Figure III- 27: EV.11: Existing View 11, Overview of Calumet skyline from Swedetown, facing northeast, June 2011** (source: QEA 9171)

Today, many of the vertical elements, including shaft houses and smokestacks, are no longer extant. The Superior Smokestack and several churches in the Village of Calumet continue to provide visual reference points.

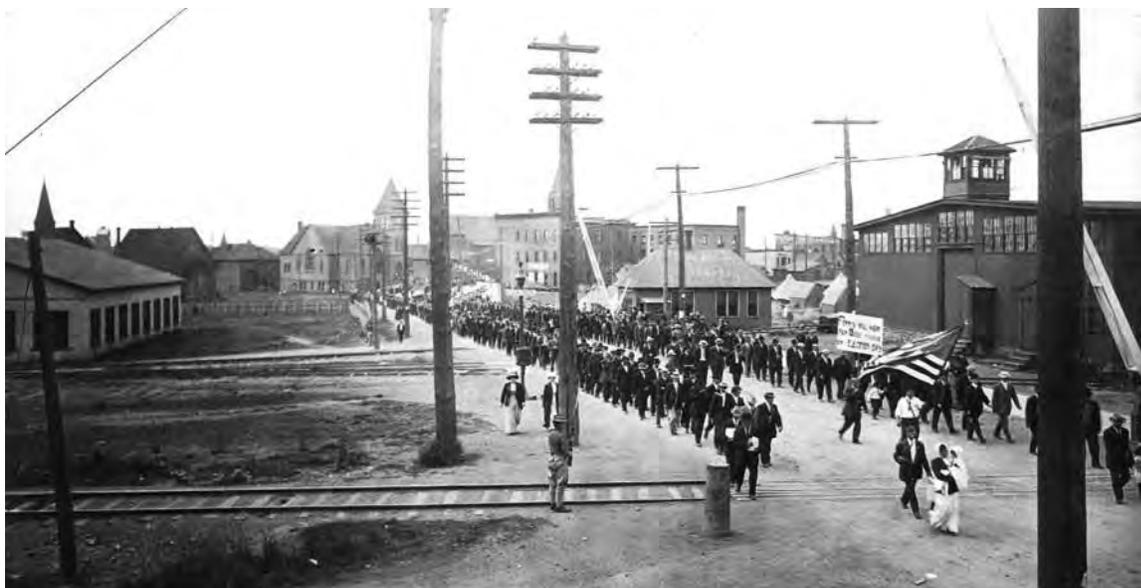
**Figure III- 28: HV.5a / Historic View 5a, Red Jacket Road facing northwest, 1913**  
(source: NPS, Keweenaw NHP)

Red Jacket Road was an important corridor linking the company property to private development in Calumet. It served as the main east-west vehicular and pedestrian corridor from the Village to Calumet Avenue. Since it cut across the industrial corridor, Red Jacket Road was crossed by many railroad tracks, roads, and utility facilities during the historic period. These north-south oriented linear features accentuated the importance of movement along the industrial core.

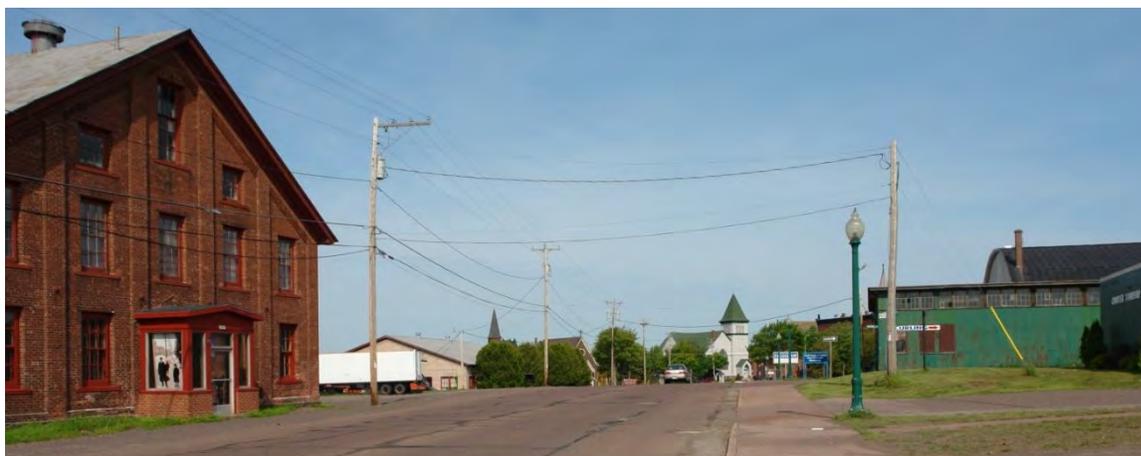
**Figure III- 29: EV.7a Existing View 7, Red Jacket Road facing northwest, June 2011**  
Current View near HV.5 (source: QEA 8970)

Red Jacket Road is the primary entrance corridor for park visitors. Heading northwest along the corridor Temple Square and the First Presbyterian Church draw the eye to the end of the corridor. The north-south features present historically are no longer apparent. The road is very wide and there are large areas that have no curbs or sidewalks. Sidewalks that do exist are interrupted by multiple curb cuts for driveways.

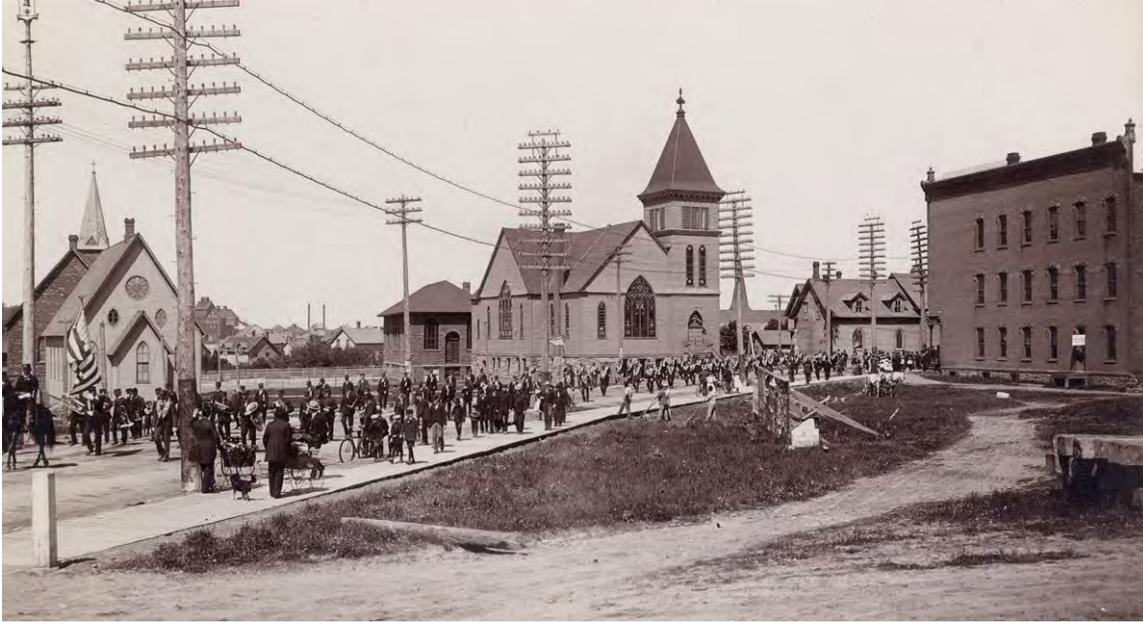
**Figure III- 30: HV.5b / Historic View 5b, Temple Square from Red Jacket Road, ca. 1895**  
(source: Houghton County Historical Society)

Red Jacket Road was an important corridor linking the company property to private development in Calumet. The intersection of Red Jacket Road and Fifth Street was a key connector made visually distinct by the numerous churches in Temple Square. A board walkway was located on the north side of Red Jacket Road for pedestrians. The triangular area in the foreground was unfinished and some images show it used for parking during events.

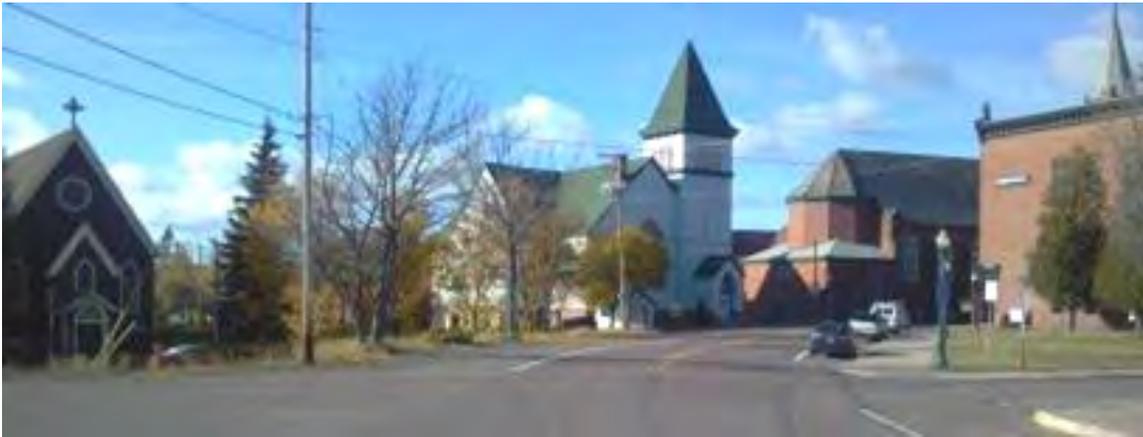
**Figure III- 31: EV.7b Existing View 7b, Temple Square from Red Jacket Road facing northwest, June 2011, Current View near HV.5b** (source: QEA 1320347406820)

Heading northwest along the corridor, Temple Square and the First Presbyterian Church continue to draw the eye to the end of the corridor. There is more vegetation present today in the area. The vegetation partially screens views of the buildings. The alignment of the road is similar to its historic condition, and a concrete sidewalk is located on the north side of the street in the location of the historic boardwalk. Red Jacket Road park (at the corner of Fifth and Red Jacket and adjacent to the Calumet Visitor Center) is more level and includes lawn and mature cedars.
