Calumet Unit Historic Landscape

Cultural Landscape Report and Environmental Assessment

FINAL 2013

**Keweenaw National Historical Park**

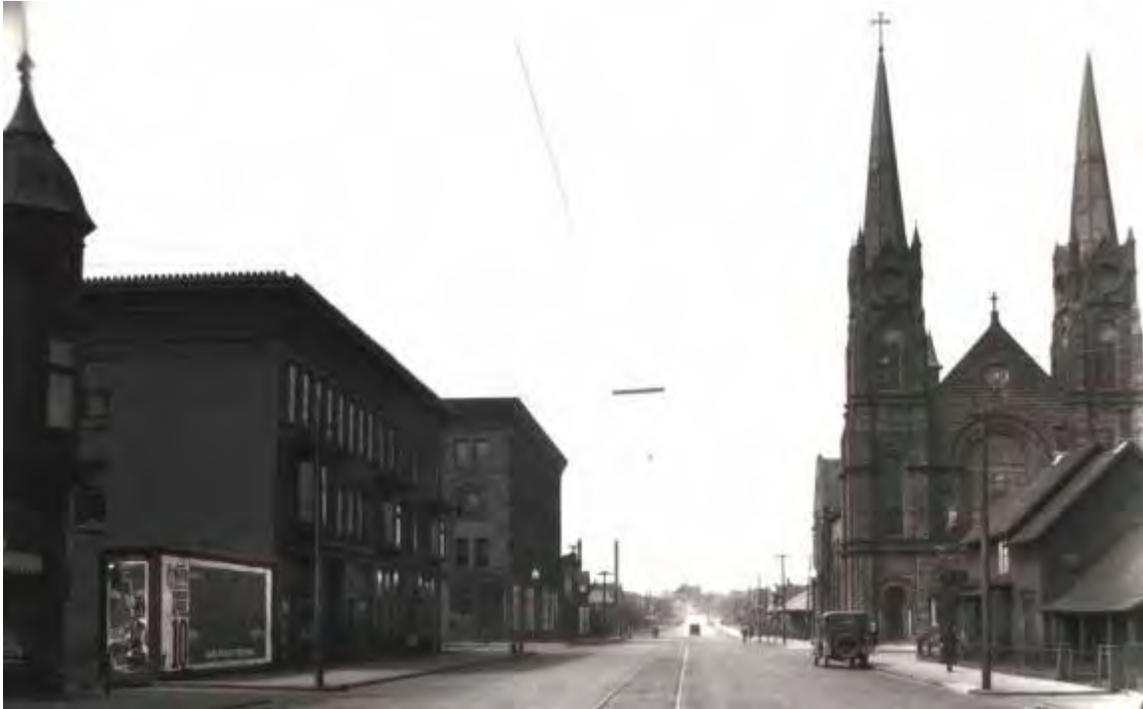
**Figure III- 32: HV.7 / Historic View 7, Corner of Oak Street and Eighth Street, facing west** (source: NPS, Keweenaw NHP, Curto Collection, Album 8, #028)

The Village of Calumet was a well developed metropolis during the period of significance. St. Paul's church is on the right side of the image, the street car tracks are in the center of Oak Street, and three-story commercial buildings line the left side of the street.

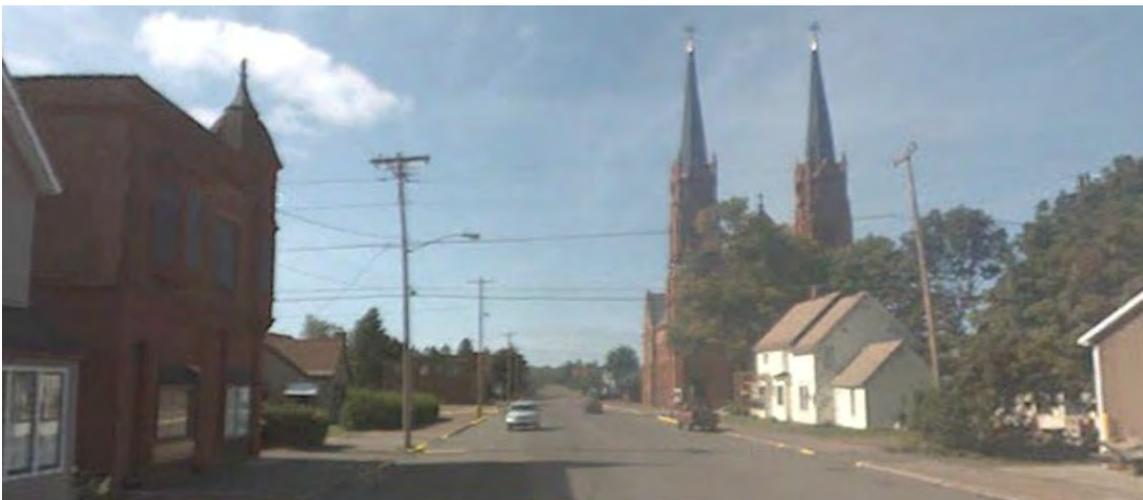
**Figure III- 33: EV.10c / Existing View 10c, Corner of Oak Street and Eighth Street, facing west (Current View at HV.7)** (source: QEA Oak Street St.Pauls)

St.Paul's church remains an iconic figure on Oak Street. Remaining commercial buildings help to retain form and scale along the corridor, however the replacement of several commercial buildings with smaller residences has changed the feeling of the street somewhat.

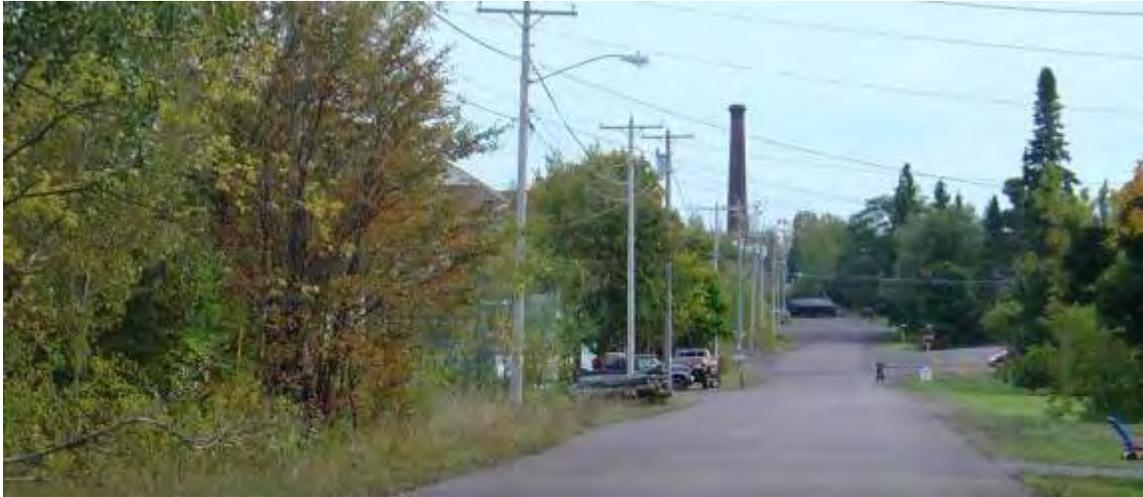
**Figure III- 34: EV.4 / Existing View 4, Waterworks Road facing south, 2010**  
(source: QEA 6935)

From this vantage point just south of Calumet Lake, the remaining C&H smokestack is visible beyond the vegetation and residential street in the foreground.

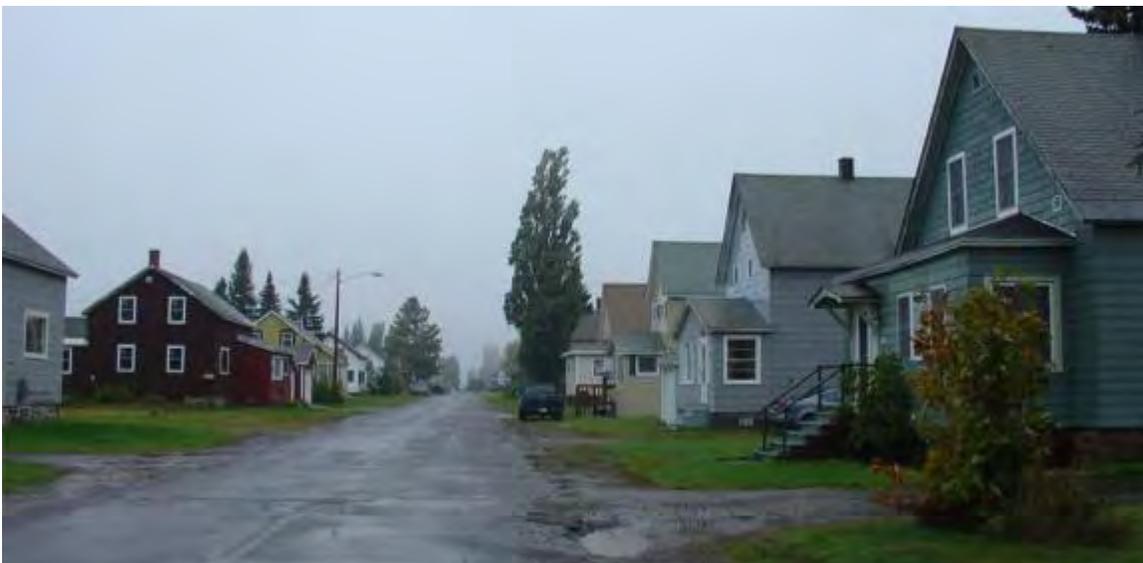
**Figure III- 35: EV.6 / Existing View 6, Raymbaultown-Log Street facing south toward Osceola No. 13 Area, 2010** (source: QEA 7277)

Log Street in Raymbaultown presents a typical housing location. The road edges are irregular and no curbs are present. Houses are situated close to the road edge and the spaces between houses and the road are often used for parking. Very little vegetation is present in this area. The houses are modest one and one-half and two story structures; several of the same model are located adjacent to each other.

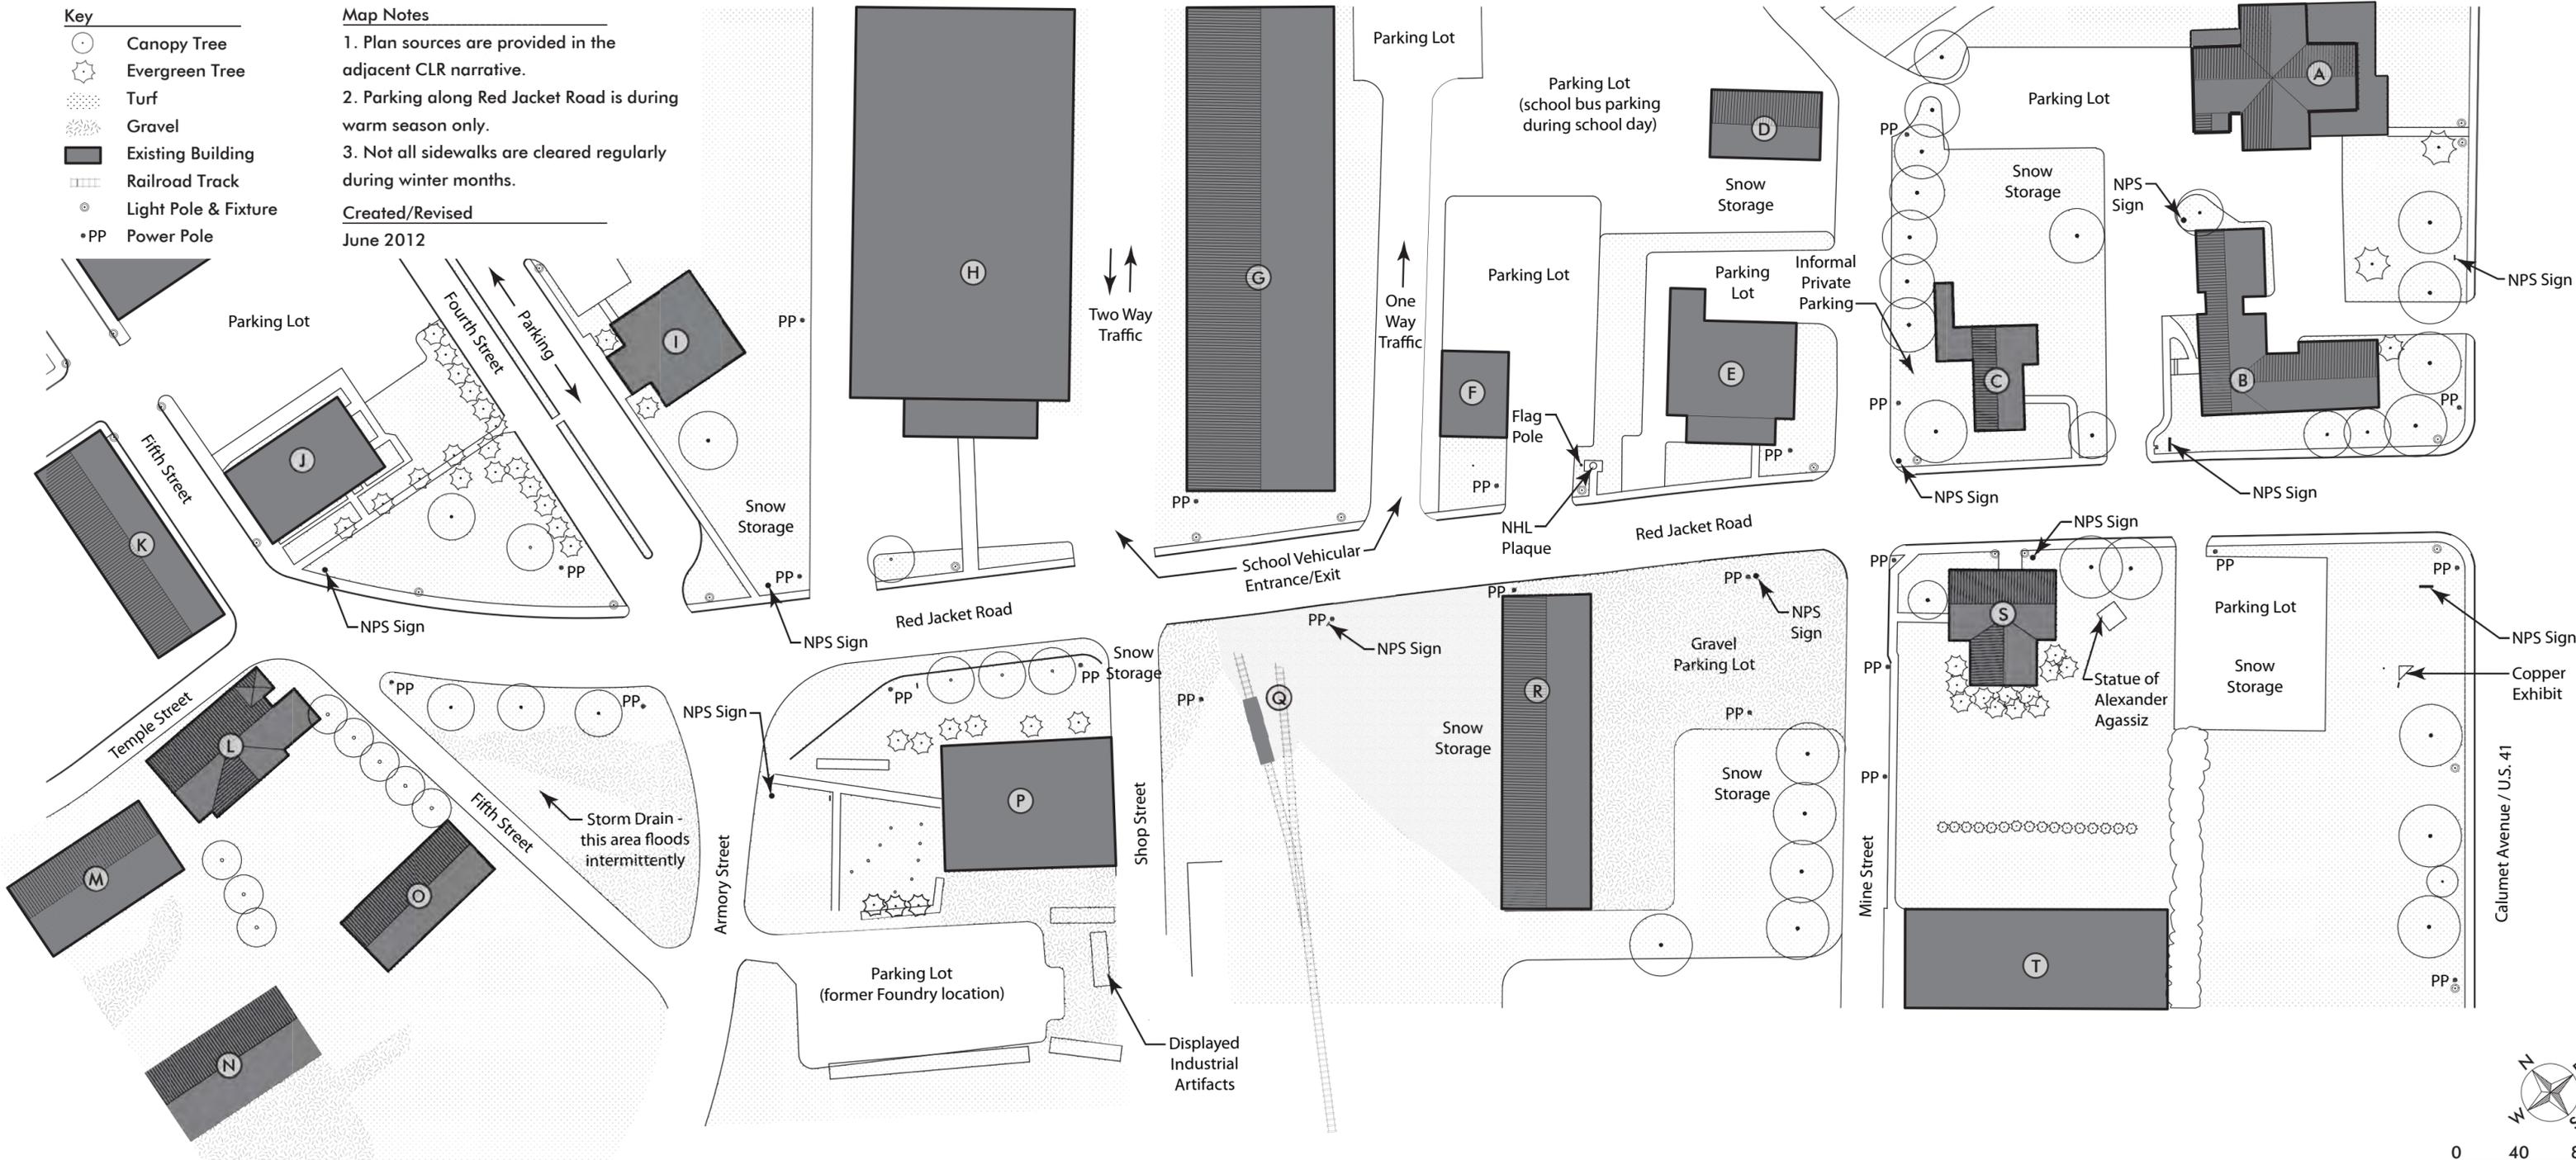
Figure III-38

**Figure III- 38: Red Jacket Road Corridor, Existing Conditions** (source: QEA)

- Map Notes**
1. Plan sources are provided in the adjacent CLR narrative.
  2. Parking along Red Jacket Road is during warm season only.
  3. Not all sidewalks are cleared regularly during winter months.

The Red Jacket Road corridor has the ability to convey its historical significance, therefore it retains integrity. The corridor includes several primary significant buildings in their historic locations oriented along the historic street alignment resulting in integrity of location, setting and design. The historic materials and workmanship of these buildings are also intact and clearly reflect historic conditions; however, changes to the surrounding landscape including the removal of railroad tracks, utility corridors, and stockpiles of materials have diminished the overall integrity of materials and workmanship. Feeling is a property's expression of the aesthetic or historic sense of a particular period of time. Despite the absence of the active mining operations and additions of non-contributing structures, the scale, materials, and architectural style of the remaining historic industrial structures clearly convey a feeling of historic character within the corridor. Association is the direct link between an important historic activity and the historic property. The loss of active mining operations and small-scale landscape features within the Calumet unit has resulted in the loss of integrity of association in the Red Jacket Road Corridor.

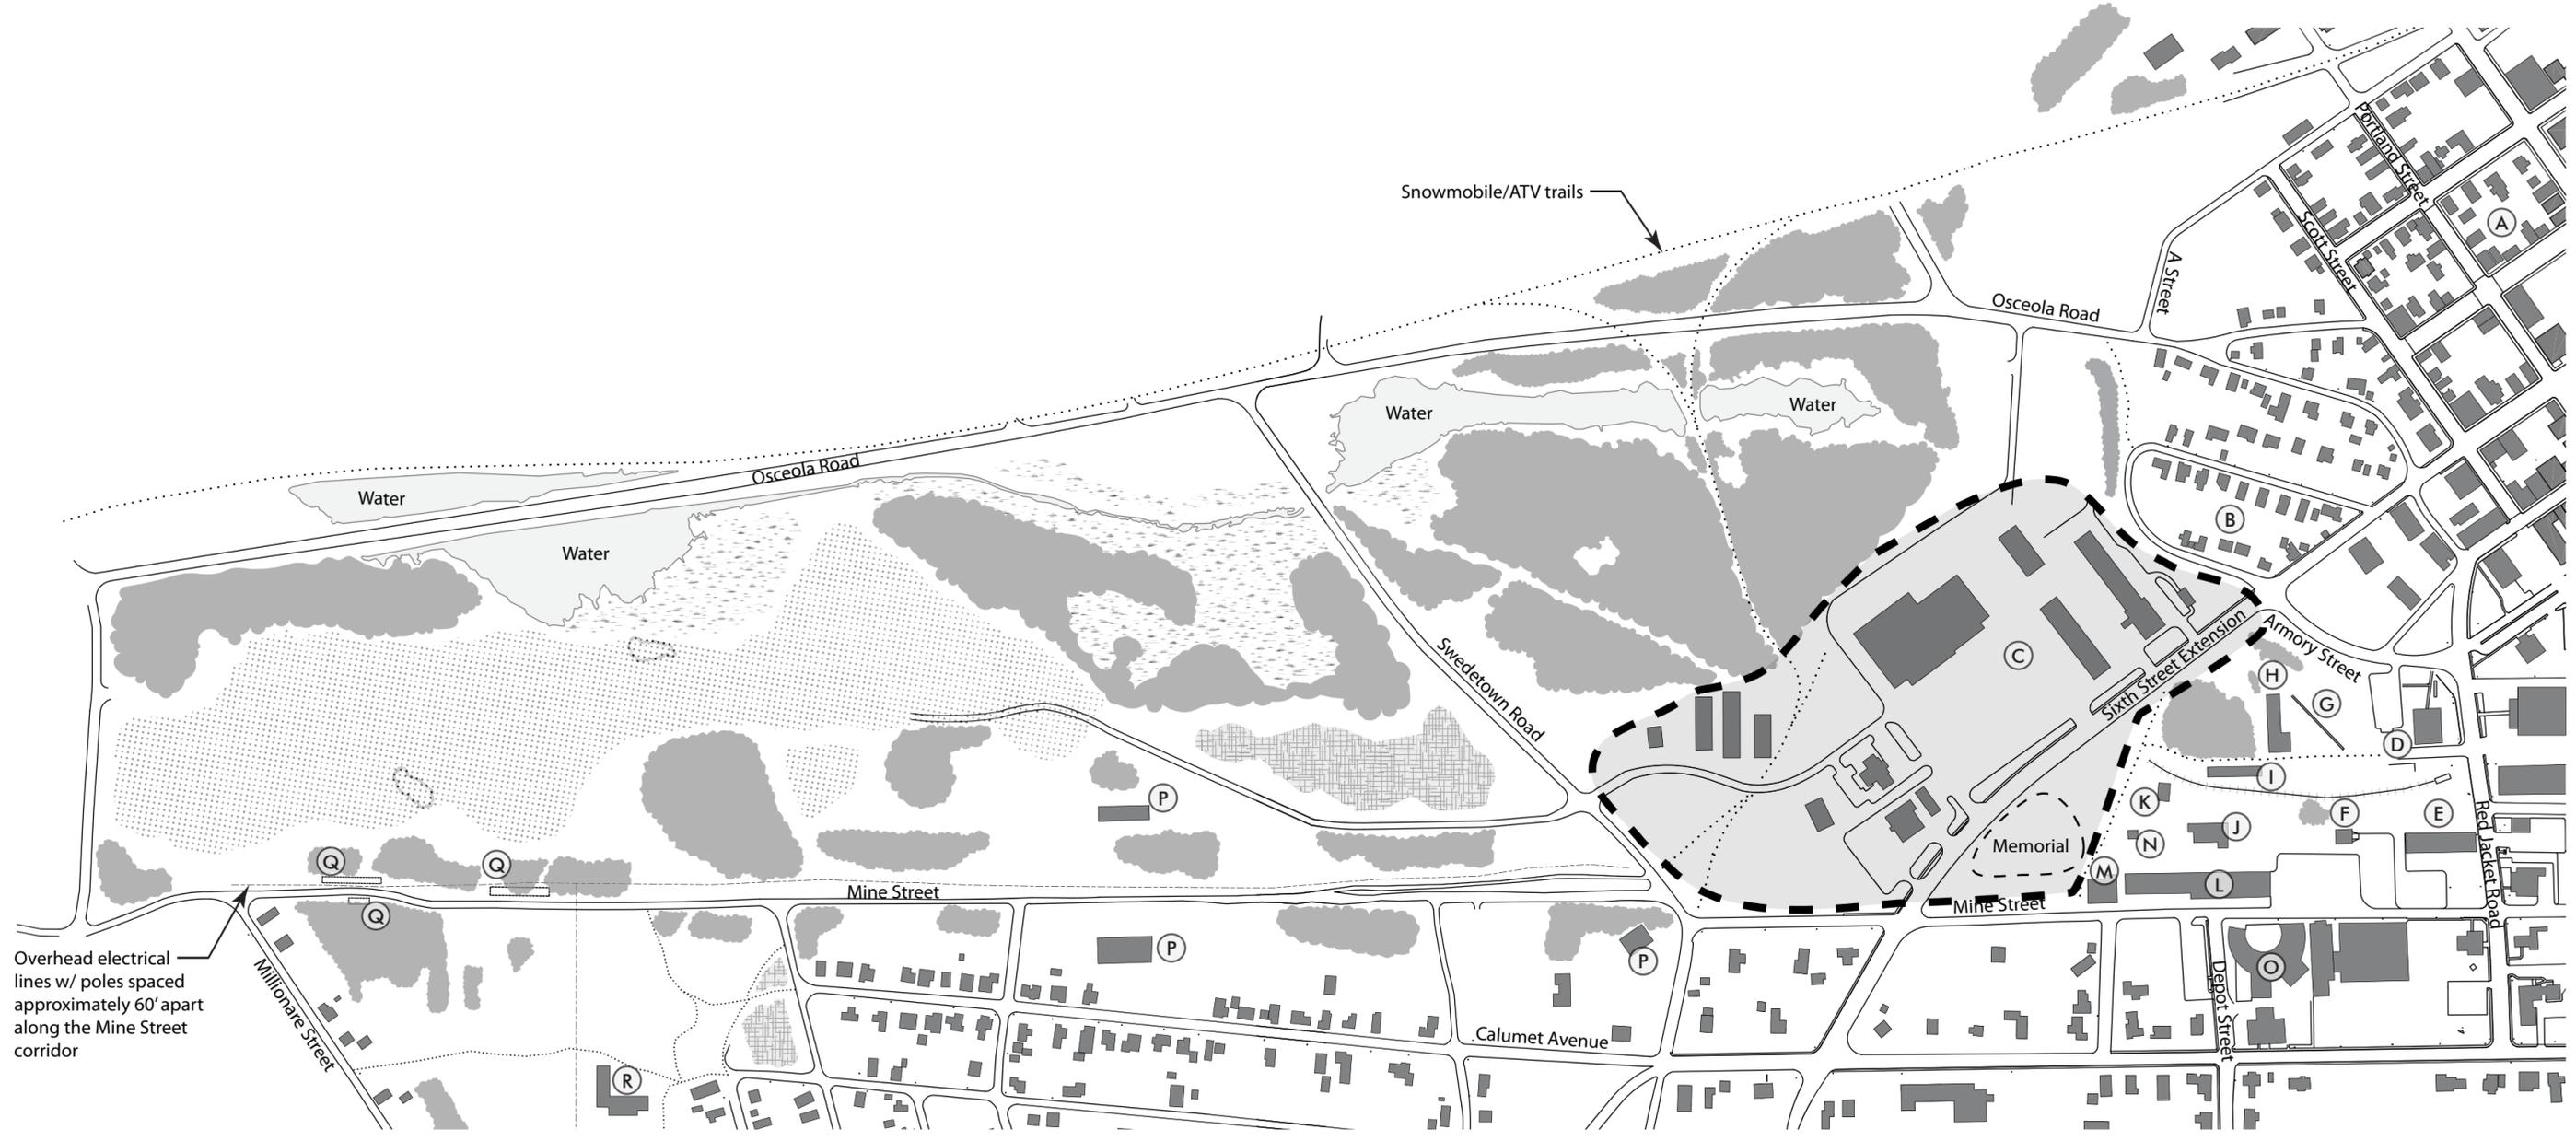
**Figure III- 59: South Mine Street Corridor, Existing Conditions** (source: QEA)

- Legend**
- (A) Village of Red Jacket (Now Calumet)
  - (B) Newtown Housing Location
  - (C) Mine Street Station
  - (D) Coppertown Museum
  - (E) C&H Warehouse No. 1
  - (F) Man Engine House
  - (G) C&H Stone Retaining Wall
  - (H) C&H Pattern Storage Warehouse
  - (I) Sand Storage
  - (J) C&H Blacksmith Shop
  - (K) Hecla Mine Captain's Office
  - (L) C&H Machine Shop
  - (M) Calumet Township Volunteer Fire Dept.
  - (N) C&H Railroad Shack
  - (O) Calumet Electronics
  - (P) Remnant of Industrial Building
  - (Q) Foundation of Industrial Building
  - (R) Osceola No.13 Dryhouse & Warehouse
- Key**
- Buildings
  - Railroad Tracks
  - Industrial Materials/Foundations
  - Informal Unpaved Roads
  - Woodland
  - Understory Vegetation
  - Wetlands
  - Rock Piles
  - Overhead Power Lines
  - Resource Extraction Area
  - New Development

Overhead electrical lines w/ poles spaced approximately 60' apart along the Mine Street corridor

Map Key	Building	Figure #	Contributing/ Non-contributing	Rationale
D	C&H Pattern Shop / Coppertown Mining Museum	III-54	Contributing	Built as part of C&H Mining Company operations.
E	C&H Warehouse No. 1	III-56	Contributing	Built as part of C&H Mining Company operations.
F	C&H Man Engine House / Warehouse No.3	III-60	Contributing	Part of C&H mining operations.
G	C&H Stone Retaining Wall	III-61	Contributing	1909, part of C&H mining operations.
H	C&H Pattern Storage Warehouse	III-62	Contributing	1909, part of C&H mining operations.
I	C&H Sand Storage	III-63	contributing	Part of C&H mining operations.
J	C&H Locomotive Shop	III-64	Contributing	Part of C&H mining operations.
K	C&H Mine Captain's Office	III-68	Contributing	C&H Mine Captain's Office during period of significance.
L	C&H Machine Shop	III-66	Contributing	Original built ca. 1882, altered 1907 and 1911. Used to repair large equipment, including mining skips and trams.

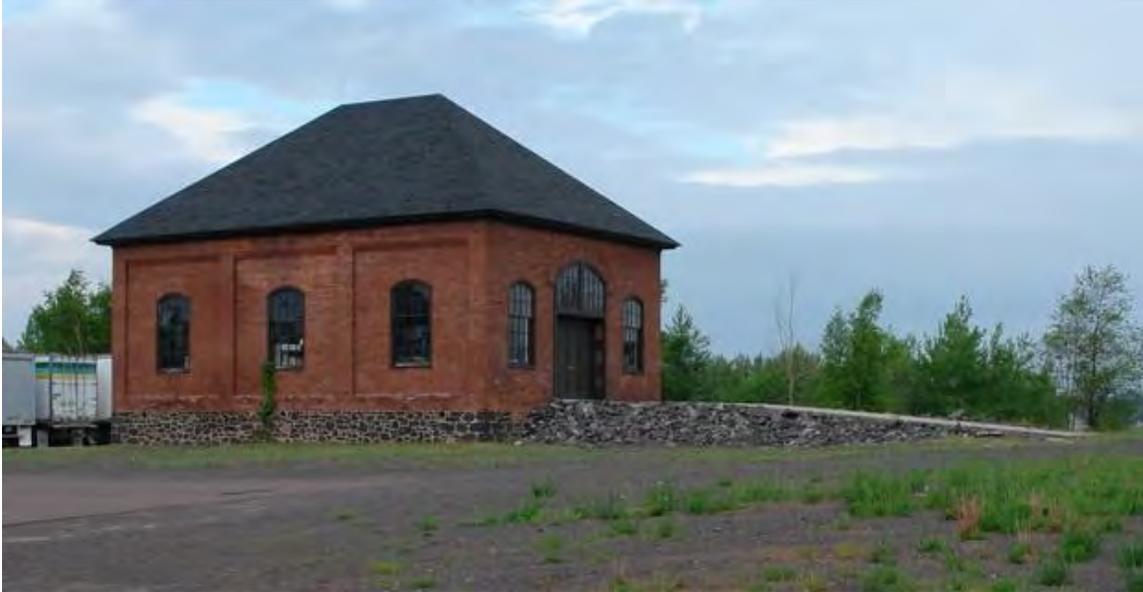
**Figure III- 60: C&H Man Engine House/Warehouse No. 3, 2011 (source: QEA 08453)**

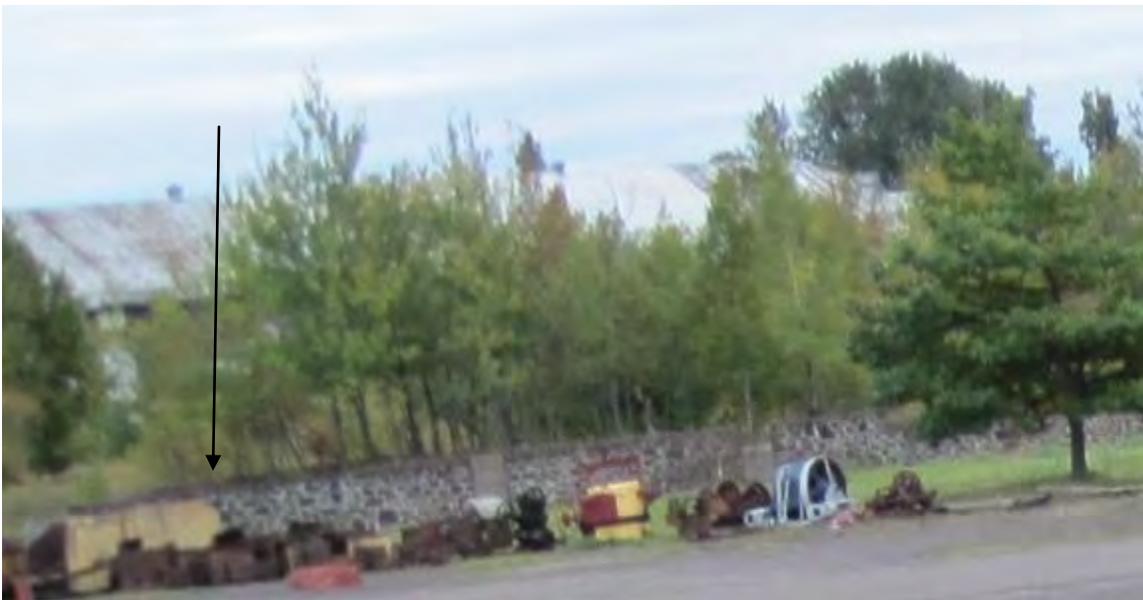
**Figure III- 61: C&H Stone retaining wall, facing southeast. The parking lot in the foreground is the site where the Foundry stood, 2010 (source: QEA 0545)**

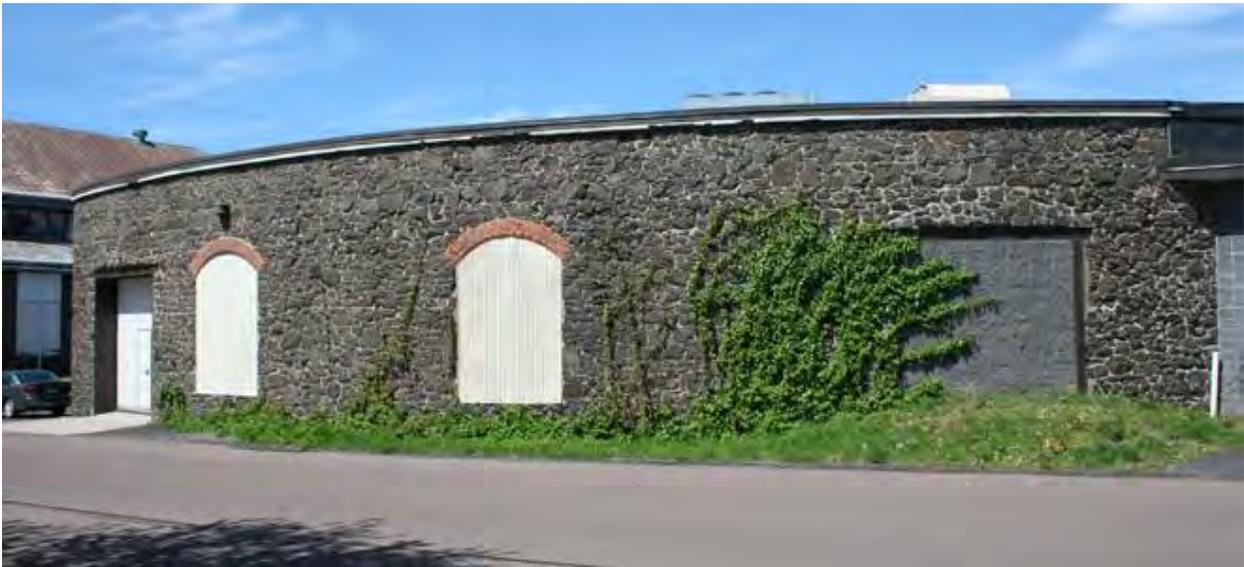
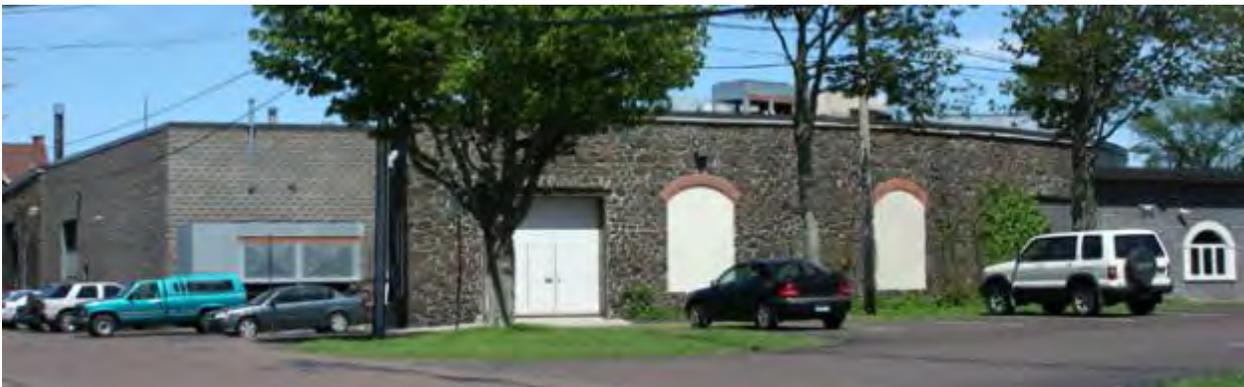
**Figure III- 69: C&H Round House** (source: <http://keweenawfreeguide.com/ch-roundhouse/>, accessed 25 March 2011)

M	Hecla Fire Station	III-67	contributing	Part of C&H mining operations.
N	C&H Railroad Shack	III-65	Contributing	Part of C&H mining operations.
O	C&H Round House	III-69	Contributing	Built 1888 to service locomotives. Additions in 1902 and 1907. Altered ca. 2000 for Calumet Electronics Corporation headquarters.

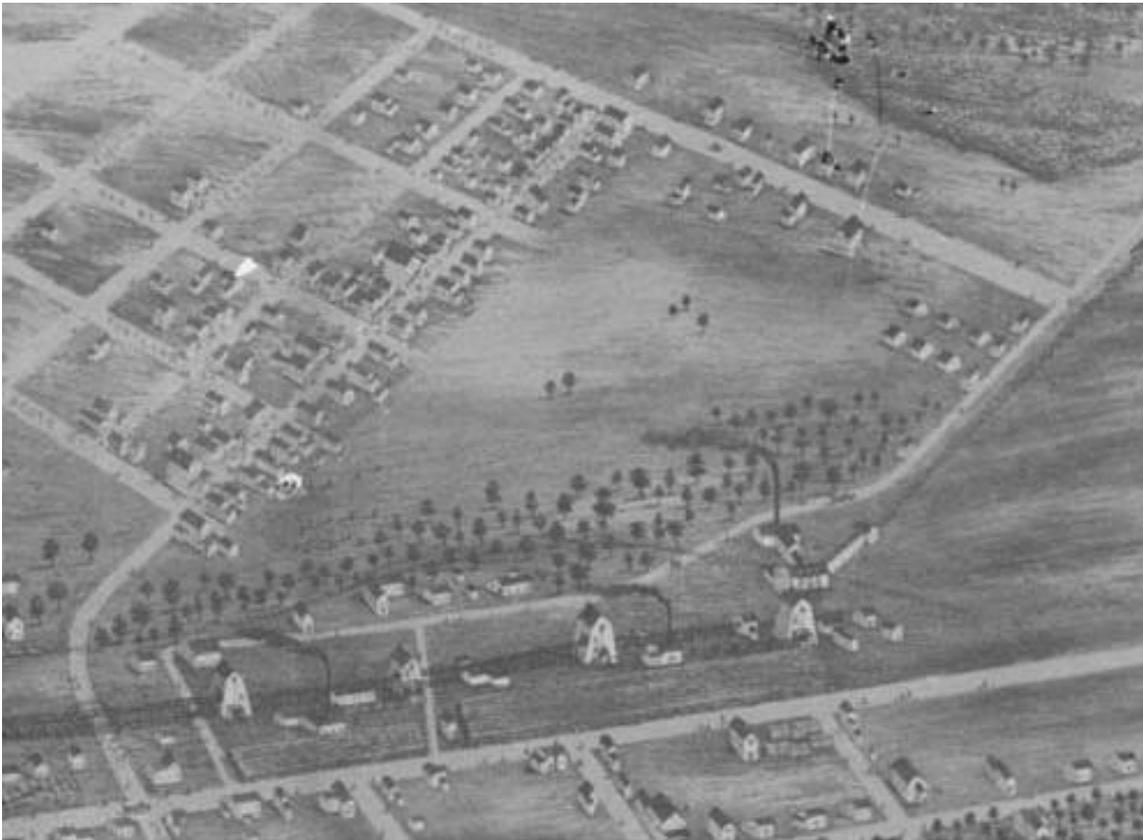
**Figure III- 70: Detail of Calumet Commons, (future site of Agassiz Park) from Birds eye view of Calumet, Hecla and Red Jacket, 1871.** (source: NPS, Keweenaw NHP, Foster Collection, C&H Photos, Library Card Photo #016).

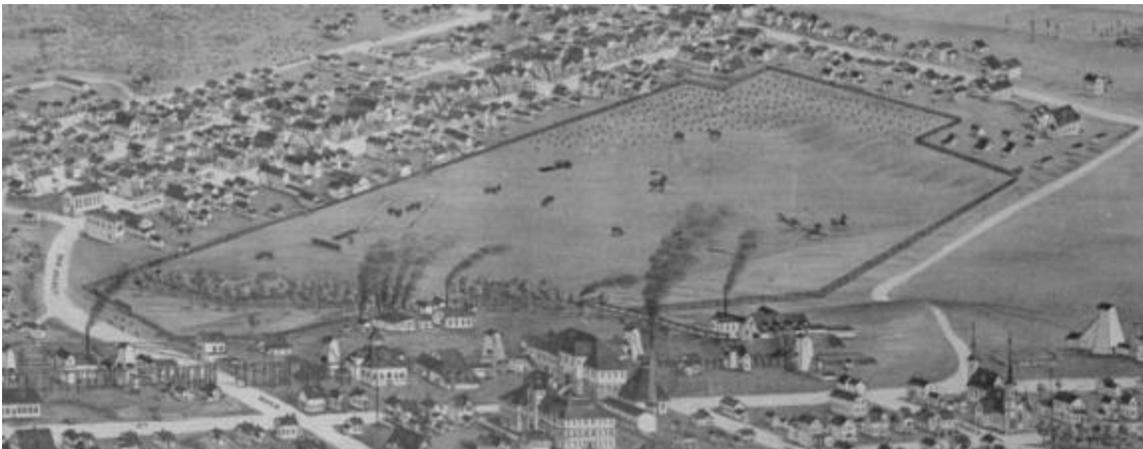
**Figure III- 71: Detail of Calumet Commons, (future site of Agassiz Park) from Birds Eye View of Calumet, Hecla and Red Jacket, 1881.** (source: NPS, Keweenaw NHP, Foster Collection, C&H Photos, Library Card Photo #015)

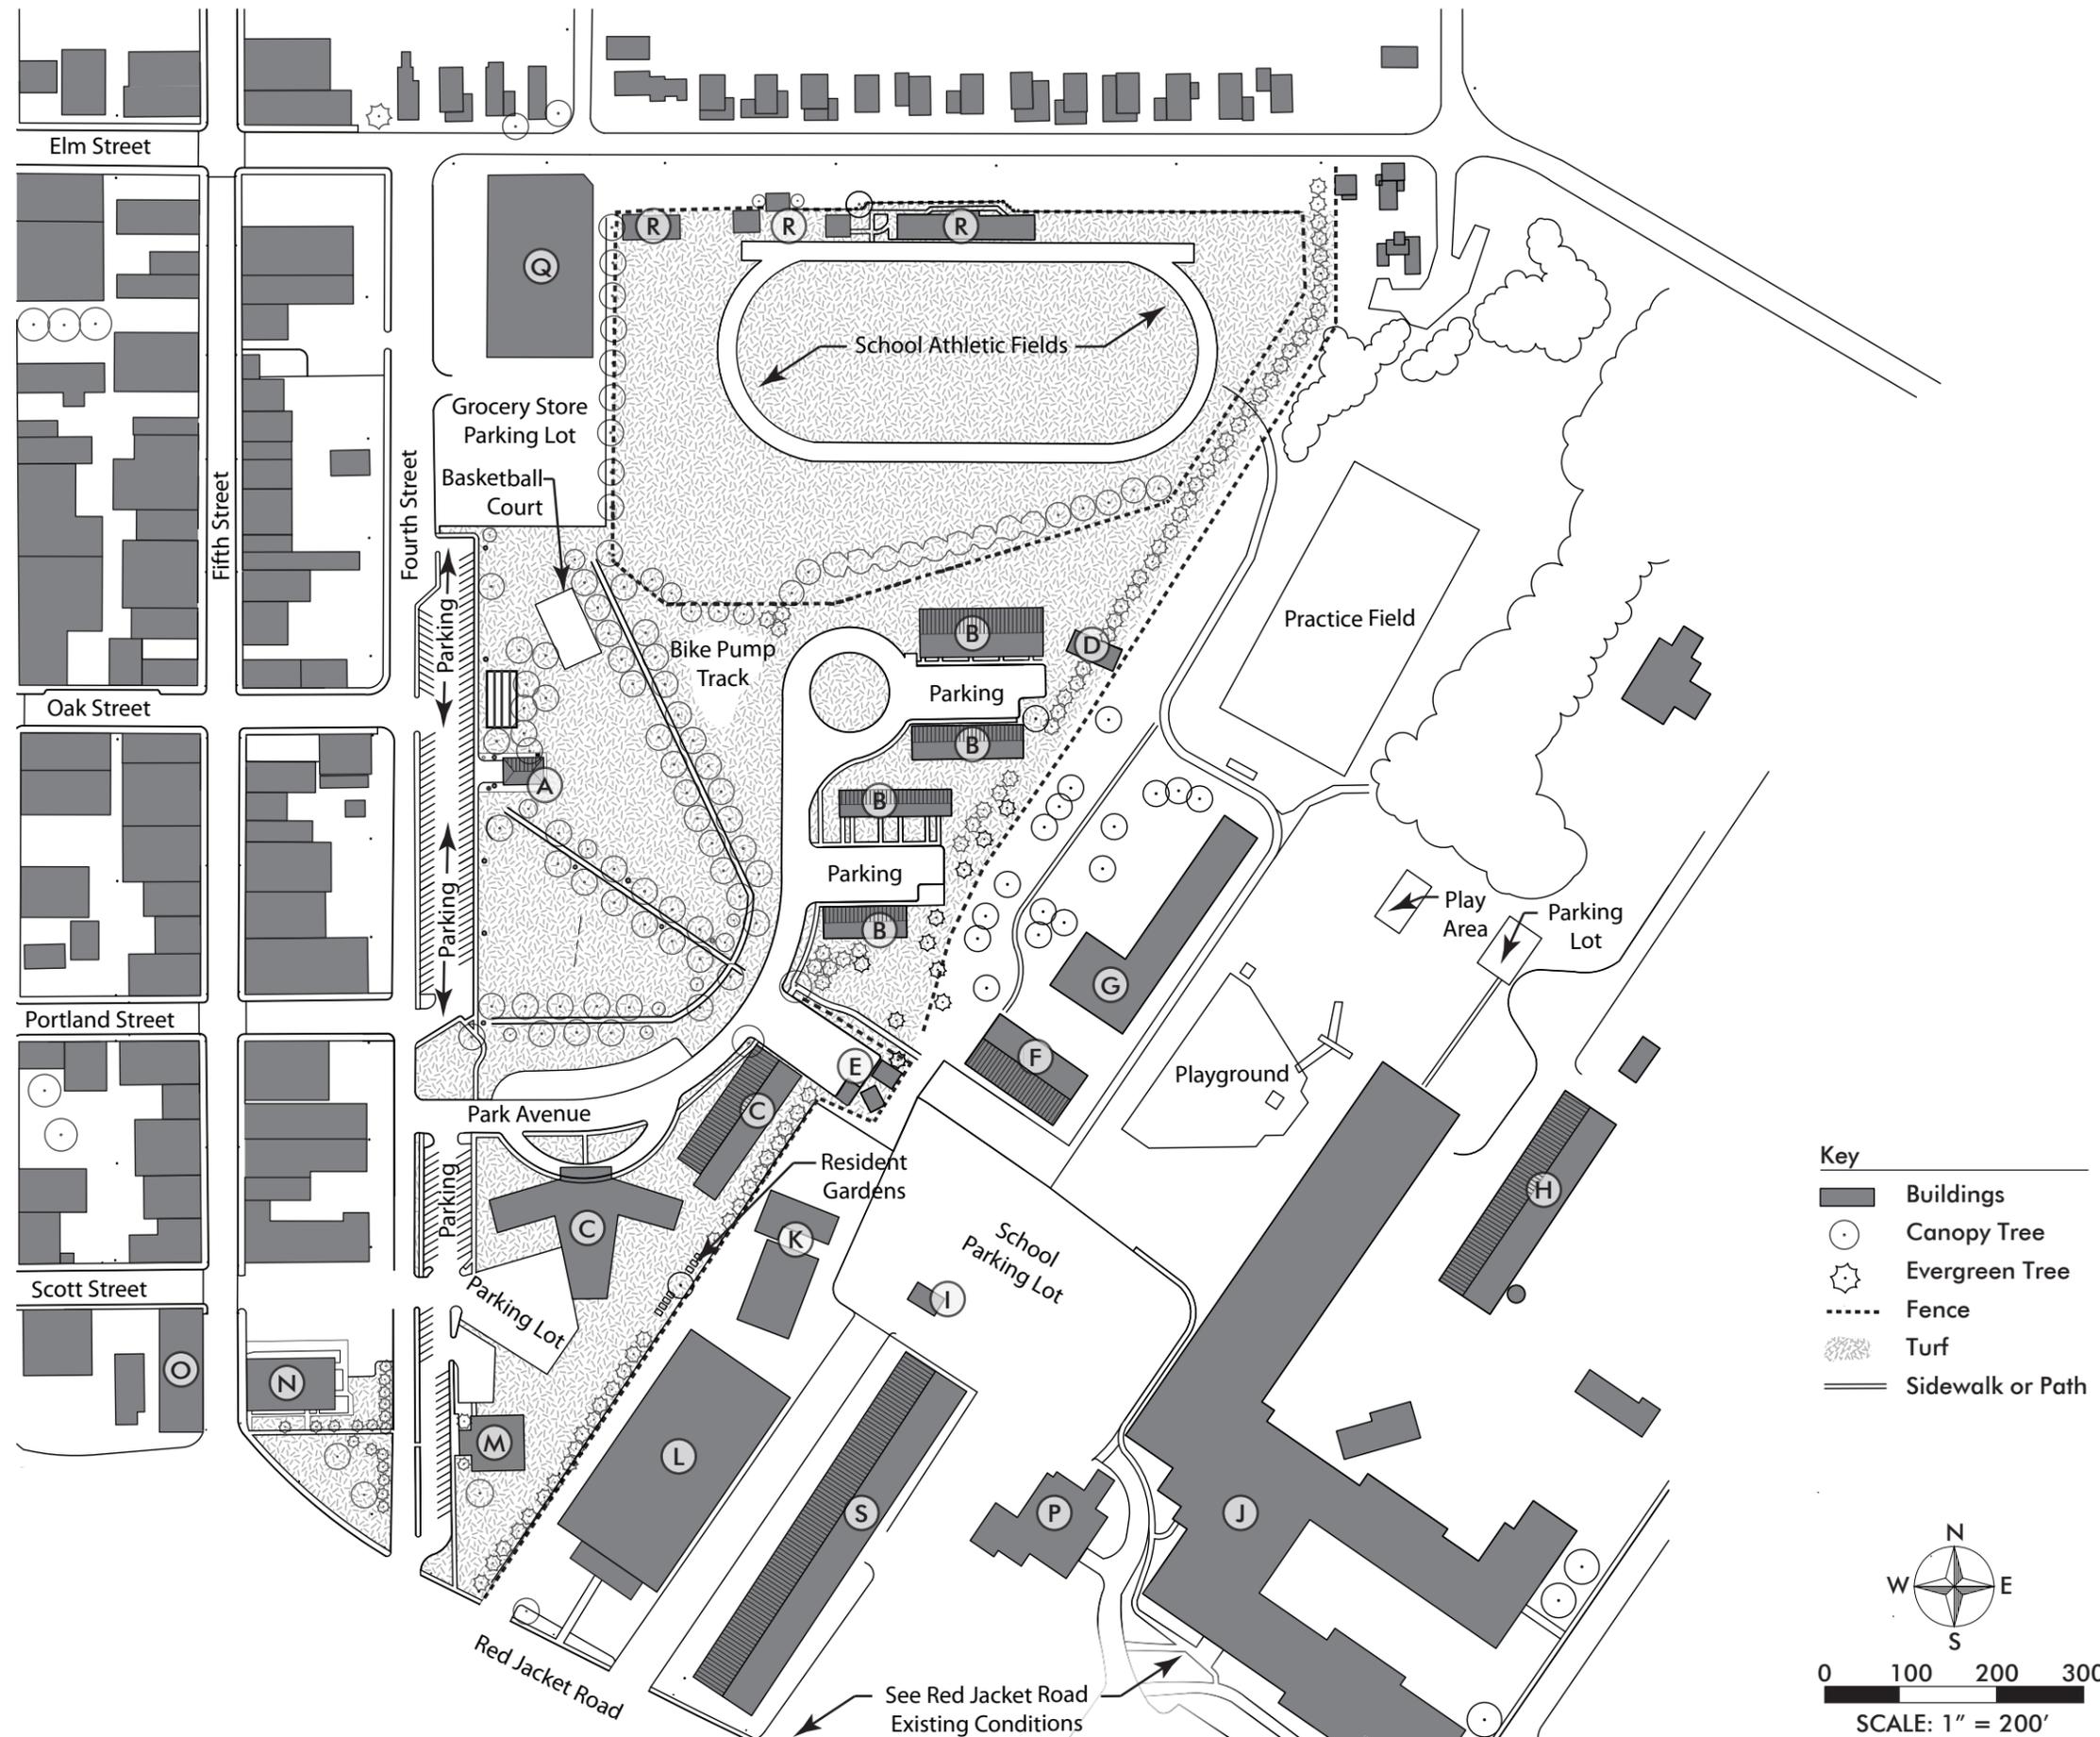
Figure III-76

**Figure III- 76: Agassiz park, Existing Conditions** (source: QEA)

Note: the map key for this table is coordinated with Figure III-76.

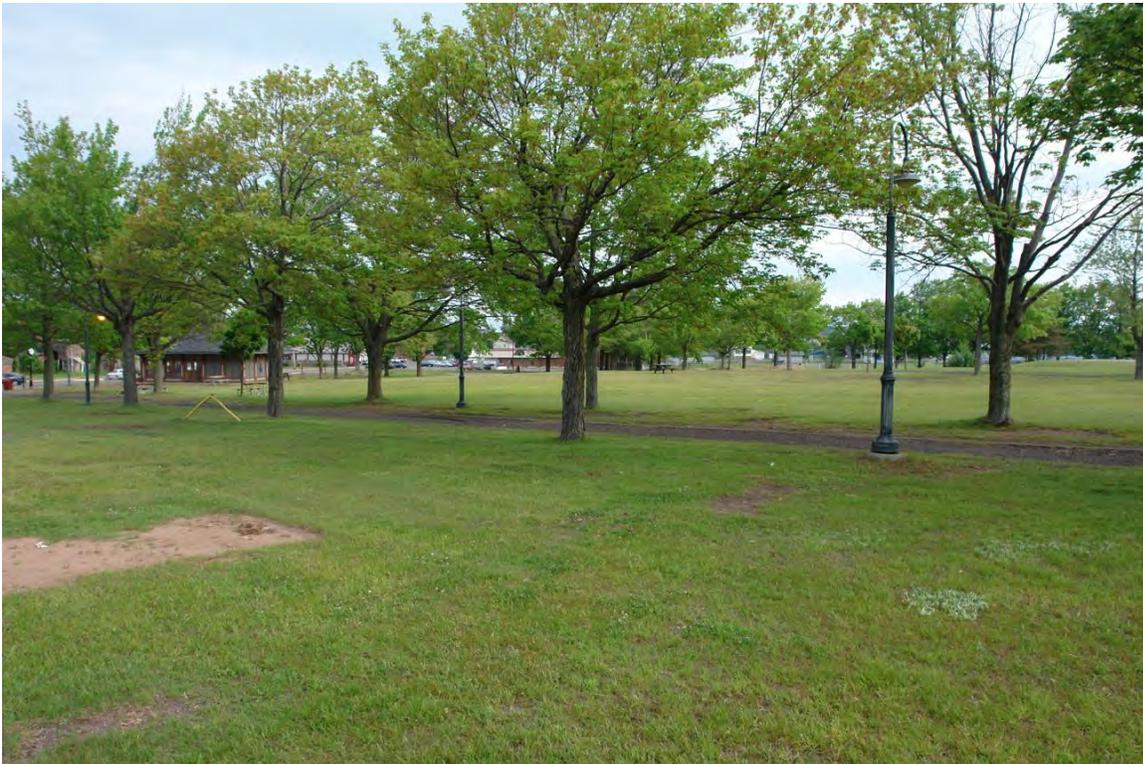
**Figure III- 81: Oak Street Path Agassiz Park, facing North, 2011 (source: QEA 9510)**

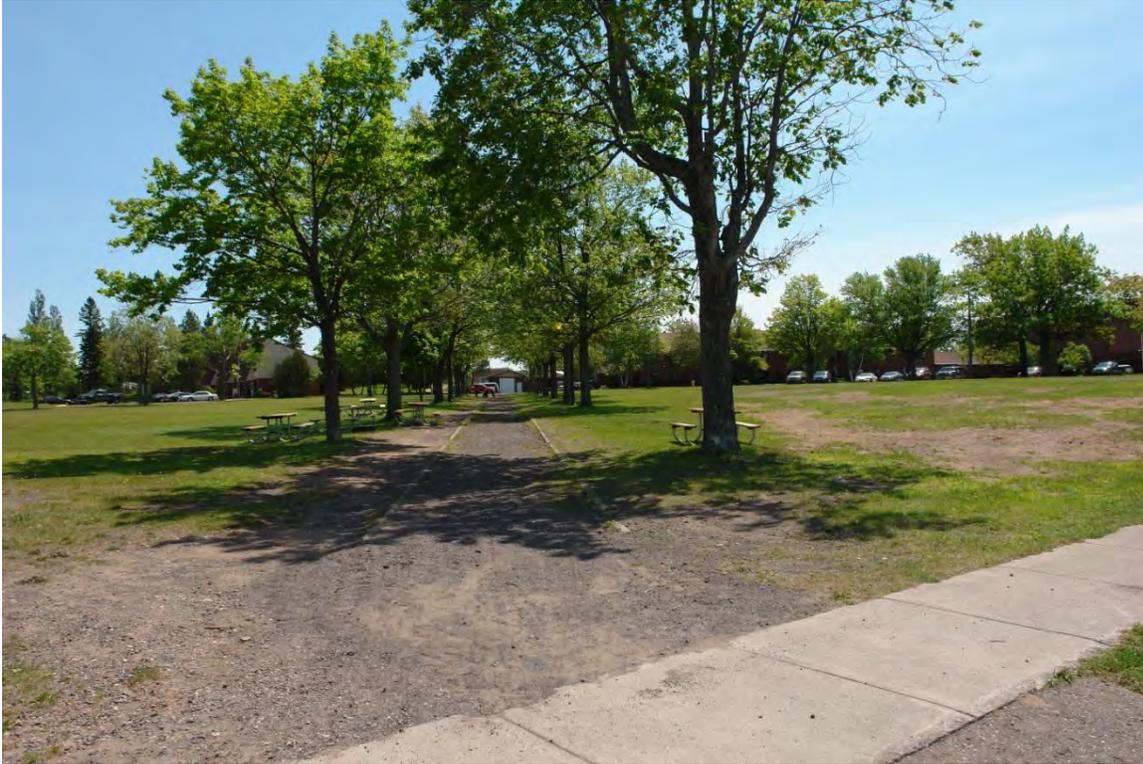
**Figure III- 82: Oak Street Path in Agassiz Park, facing southeast, 2011 (source: QEA 9117)**

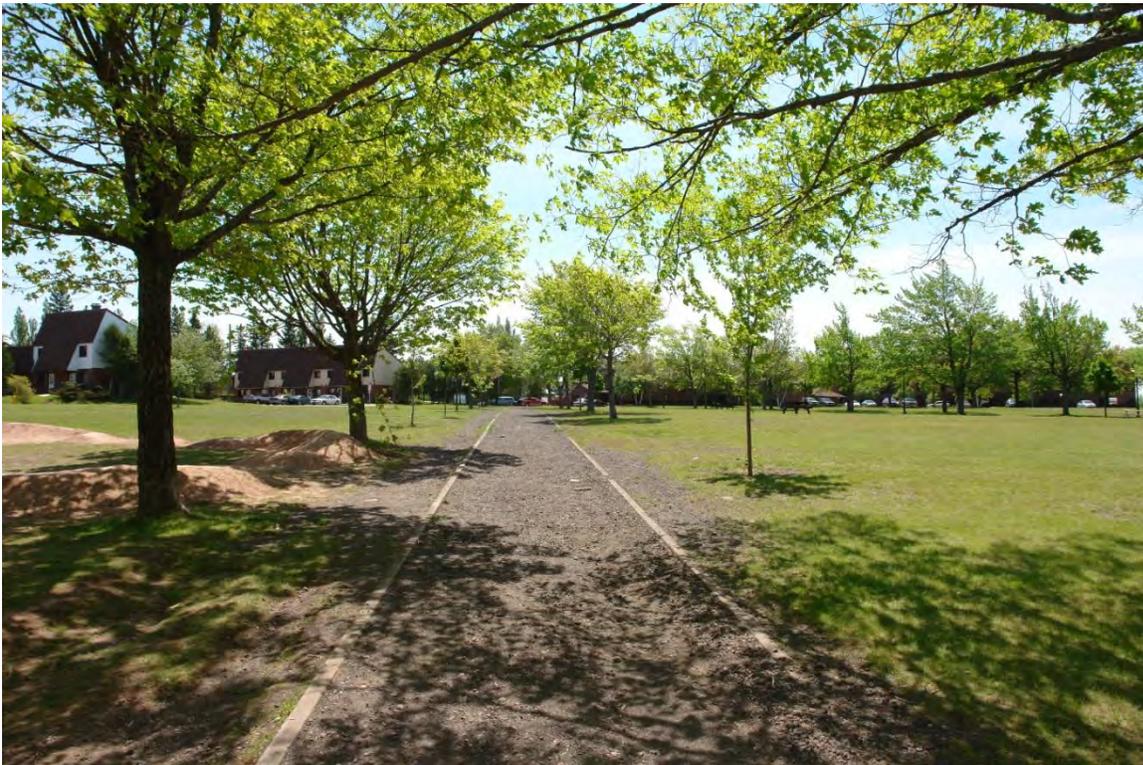
**Figure III- 83: Path from Grocery Store Parking Lot through Agassiz Park, facing southeast, 2011 (source: QEA 9120)**

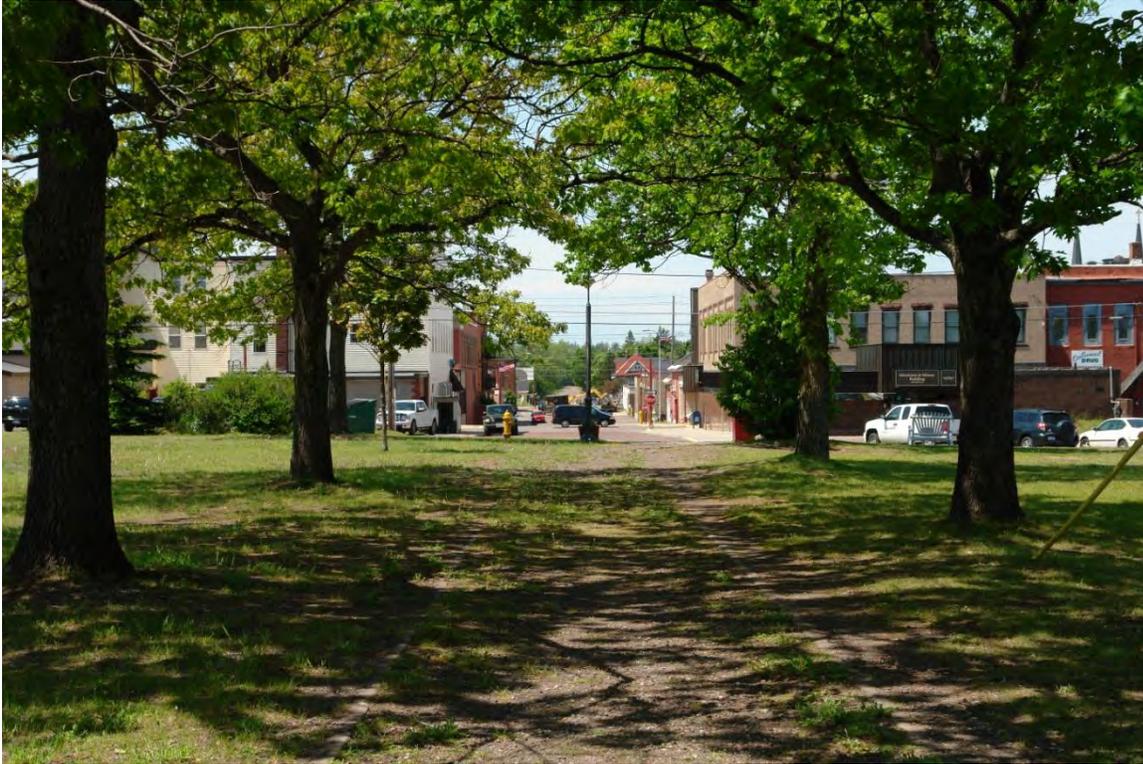
**Figure III- 84: Portland Street Path in Agassiz Park, facing west, 2011 (source: QEA 9153)**

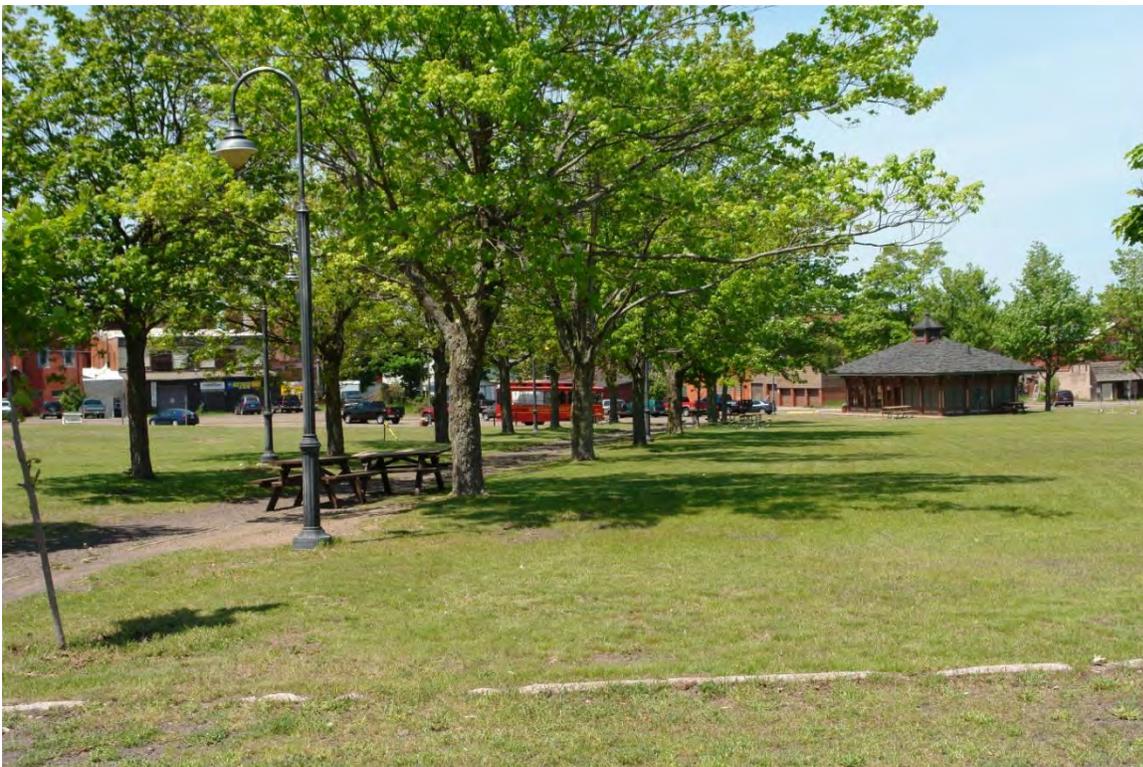
**Figure III- 85: Oak Street Path, facing northwest, 2011 (source: QEA 9145)**
