Calumet Unit Historic Landscape

Cultural Landscape Report and Environmental Assessment

FINAL 2013

**Keweenaw National Historical Park**

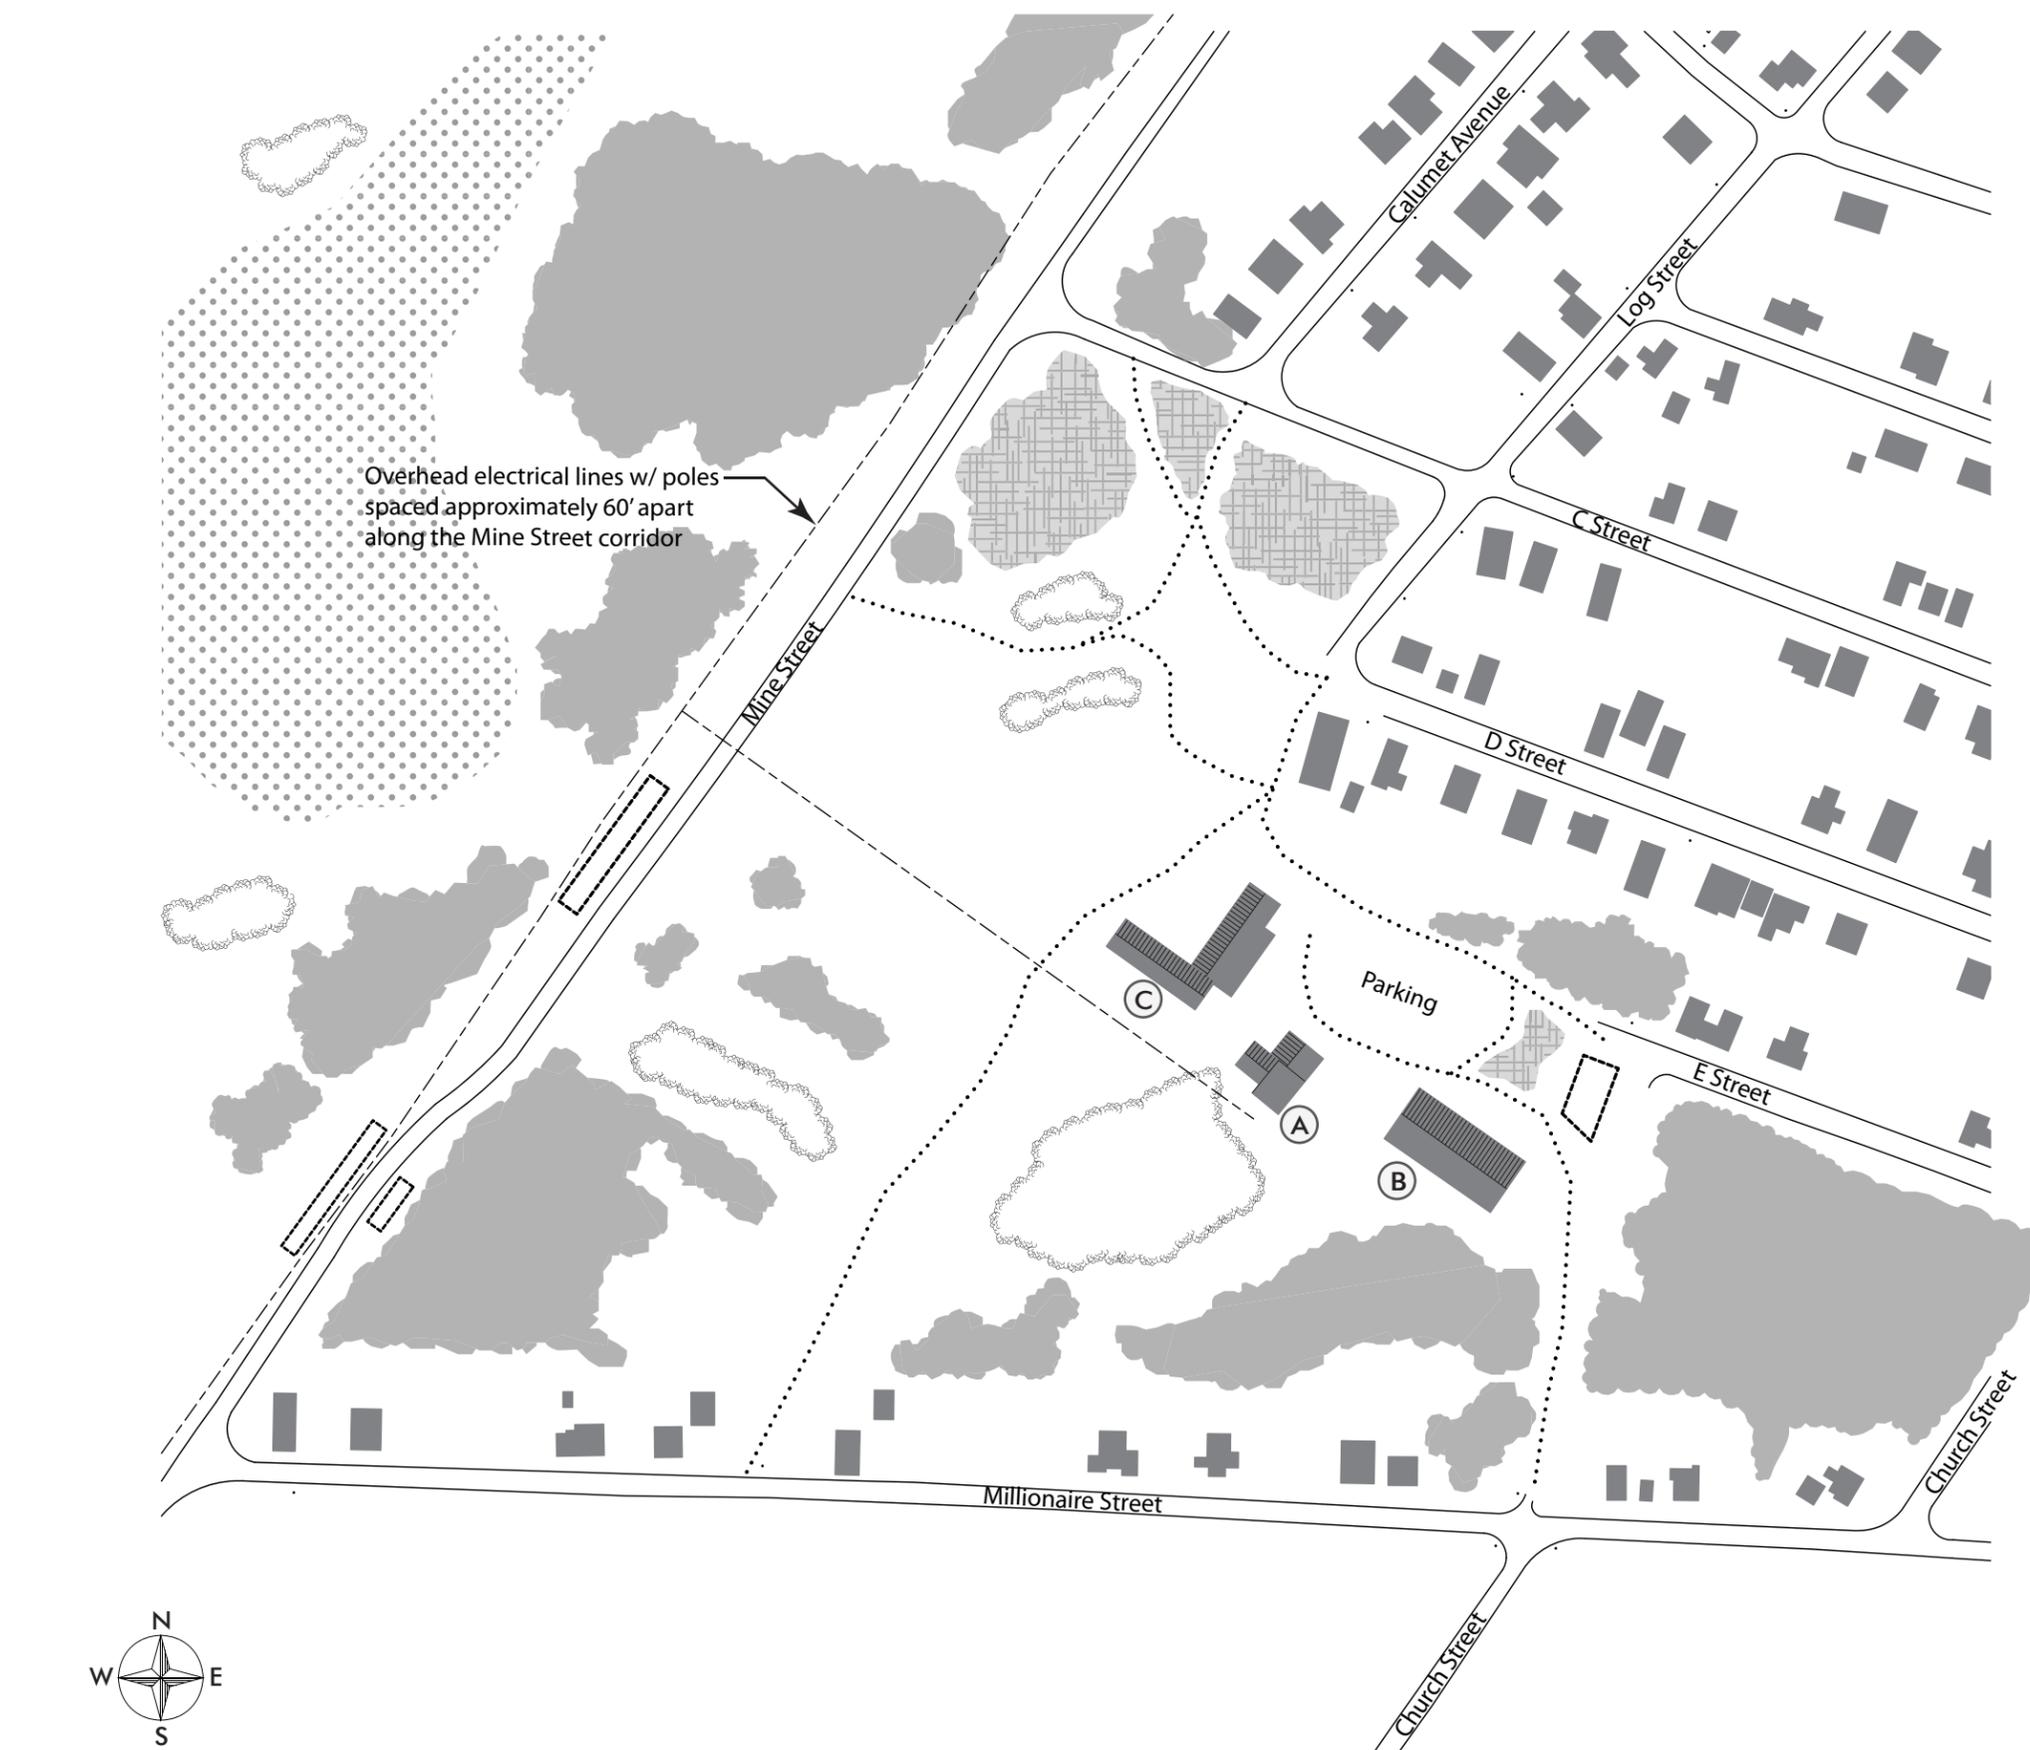
Overhead electrical lines w/ poles spaced approximately 60' apart along the Mine Street corridor

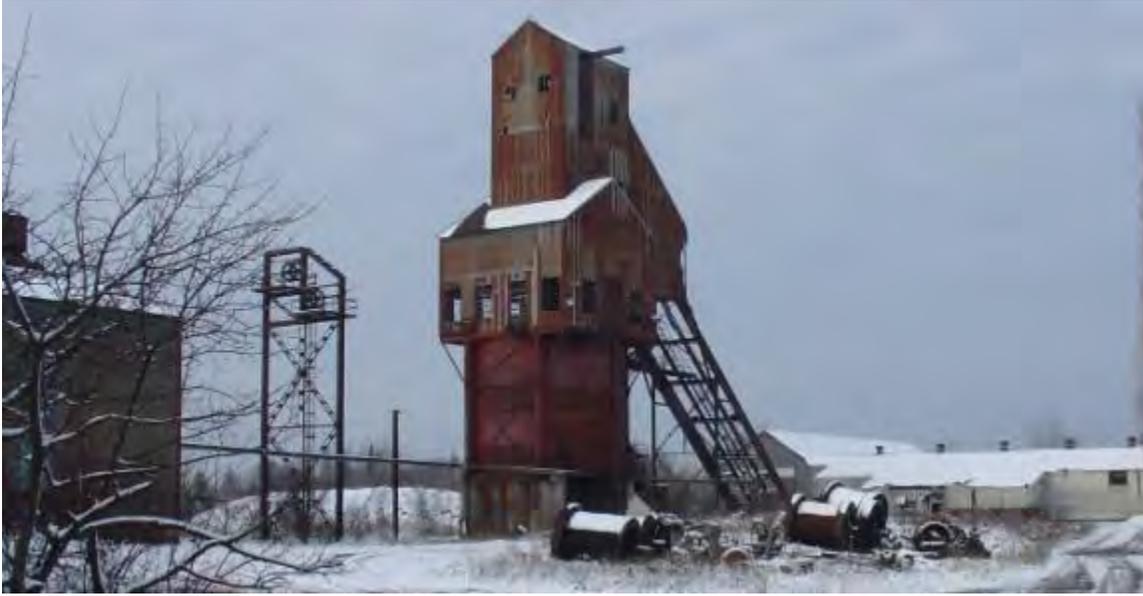
**Figure III- 87: Osceola No. 13 Shaft-rockhouse, 2010 (source: QEA 7833)**

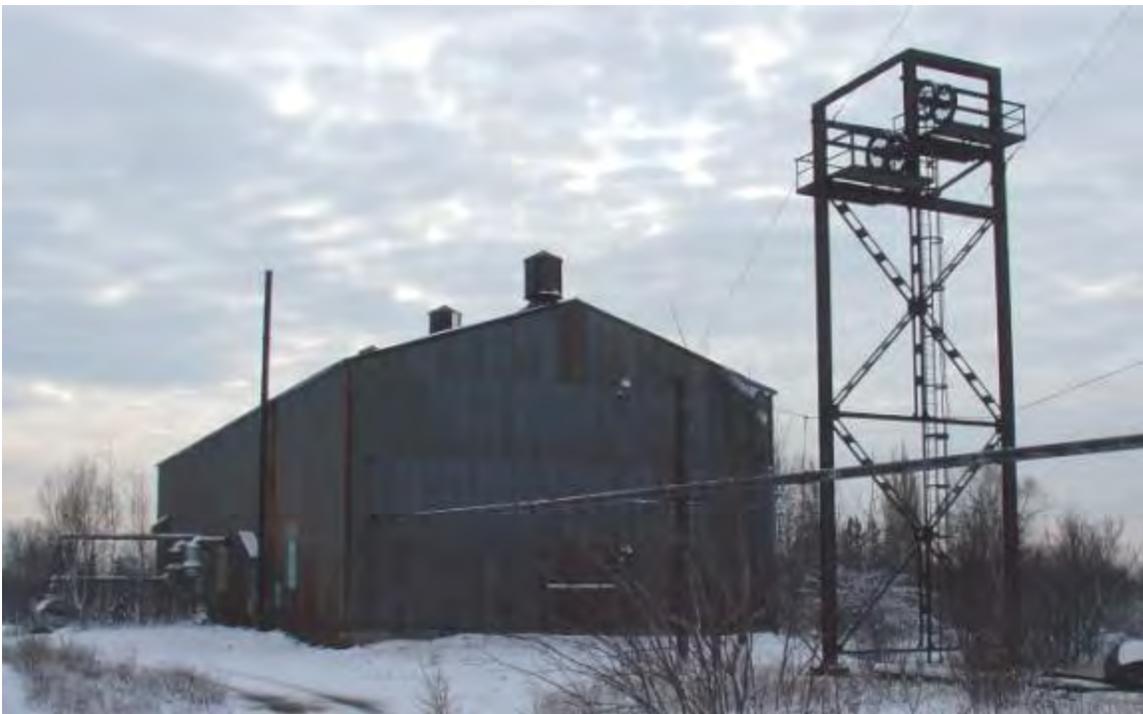
**Figure III- 88: Osceola No. 13 Hoist House and pulley stand, 2010 (source: QEA 7999)**

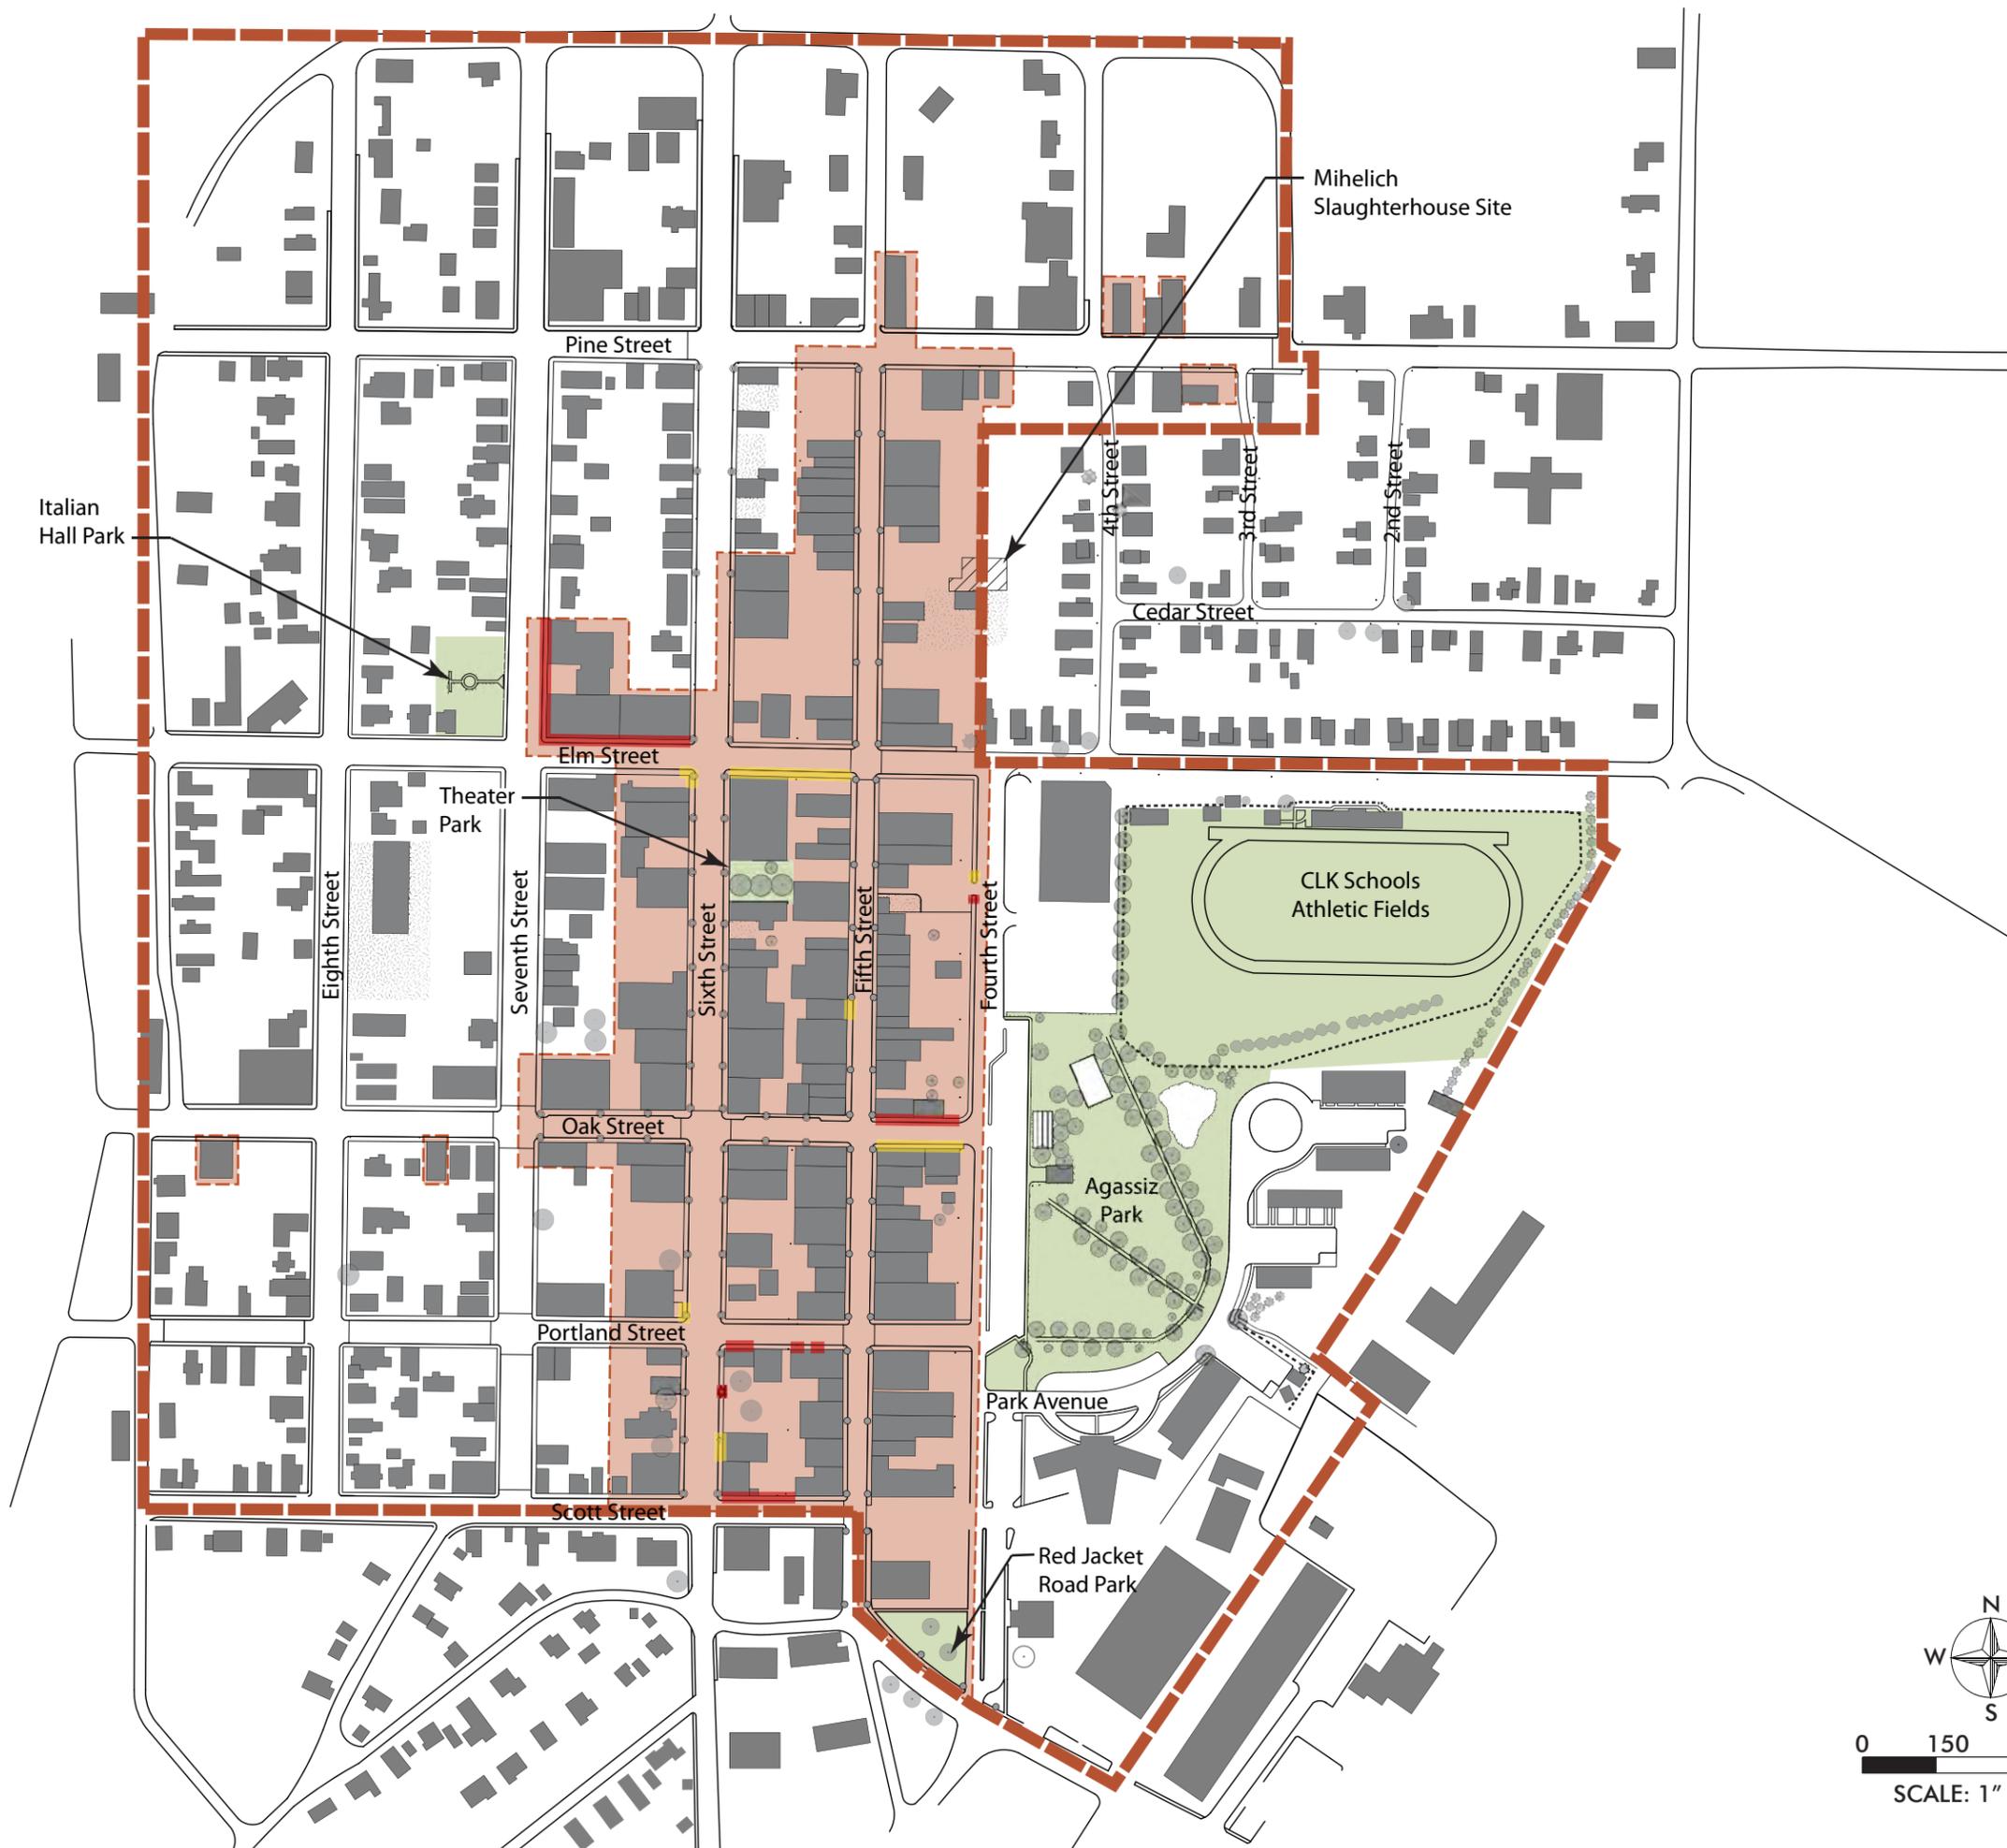
Figure III-90

**Figure III- 90: Calumet Civic & Commercial Historic District, Existing Conditions** (source: QEA)

Historic district sidewalk/curbs in poor condition. Repairs necessary.
-

Historic district sidewalk/curbs in fair condition. Some repairs necessary.
-

Historic district sidewalk/curbs in good condition. No repairs necessary.

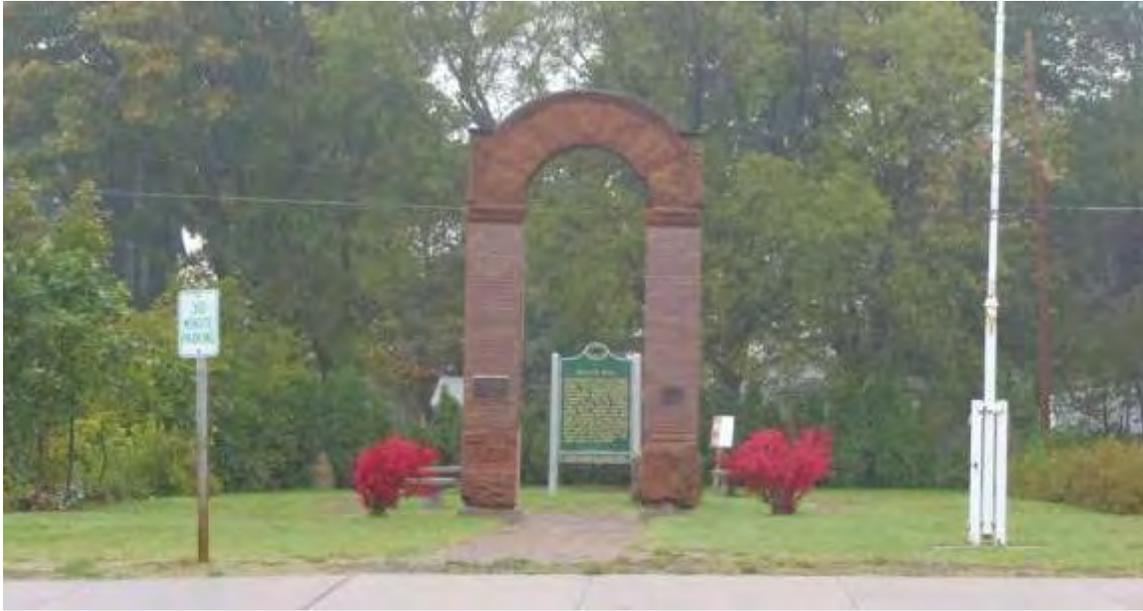
The Italian Hall Memorial Park consists of three lots at the corner of Seventh Street and Elm Street (see Figures II-79 and III-91). A concrete sidewalk extends along the three blocks on Seventh Street. Lot 10 is located at the corner of Elm and Seventh Streets and contains an asphalt parking lot that is in poor condition with volunteer vegetation growing through the cracks. The asphalt extends to Elm Street without a curb on the south side of the property. A historic light pole is situated at the corner and a pedestrian crossing sign is nearby. There are no curb cuts for pedestrian access. The concrete sidewalk adjacent to Lot 10 includes portions that are in need of repair. Lot 9 is the lot associated with the former Italian Hall building. The sidewalk adjacent to this lot is new and in good repair. The property includes a flag pole, the entrance arch from the non-extant building, a historical marker, interpretive panel, brick paving, and a couple of ornamental shrubs, all in a mown lot. The western edge of the lot is lined with mature trees and the north and south boundaries are lined with volunteer herbaceous and woody vegetation. Lot 8 is located to the north of Lot 9 and is vacant. The lot contains volunteer herbaceous vegetation and is lined with trees and shrubs on the north and west sides. The Village and National Park Service are planning to work together to address the development of an appropriate design for the park.

**Figure III- 91: Italian Hall Site, 2010** (source: QEA P9230215)

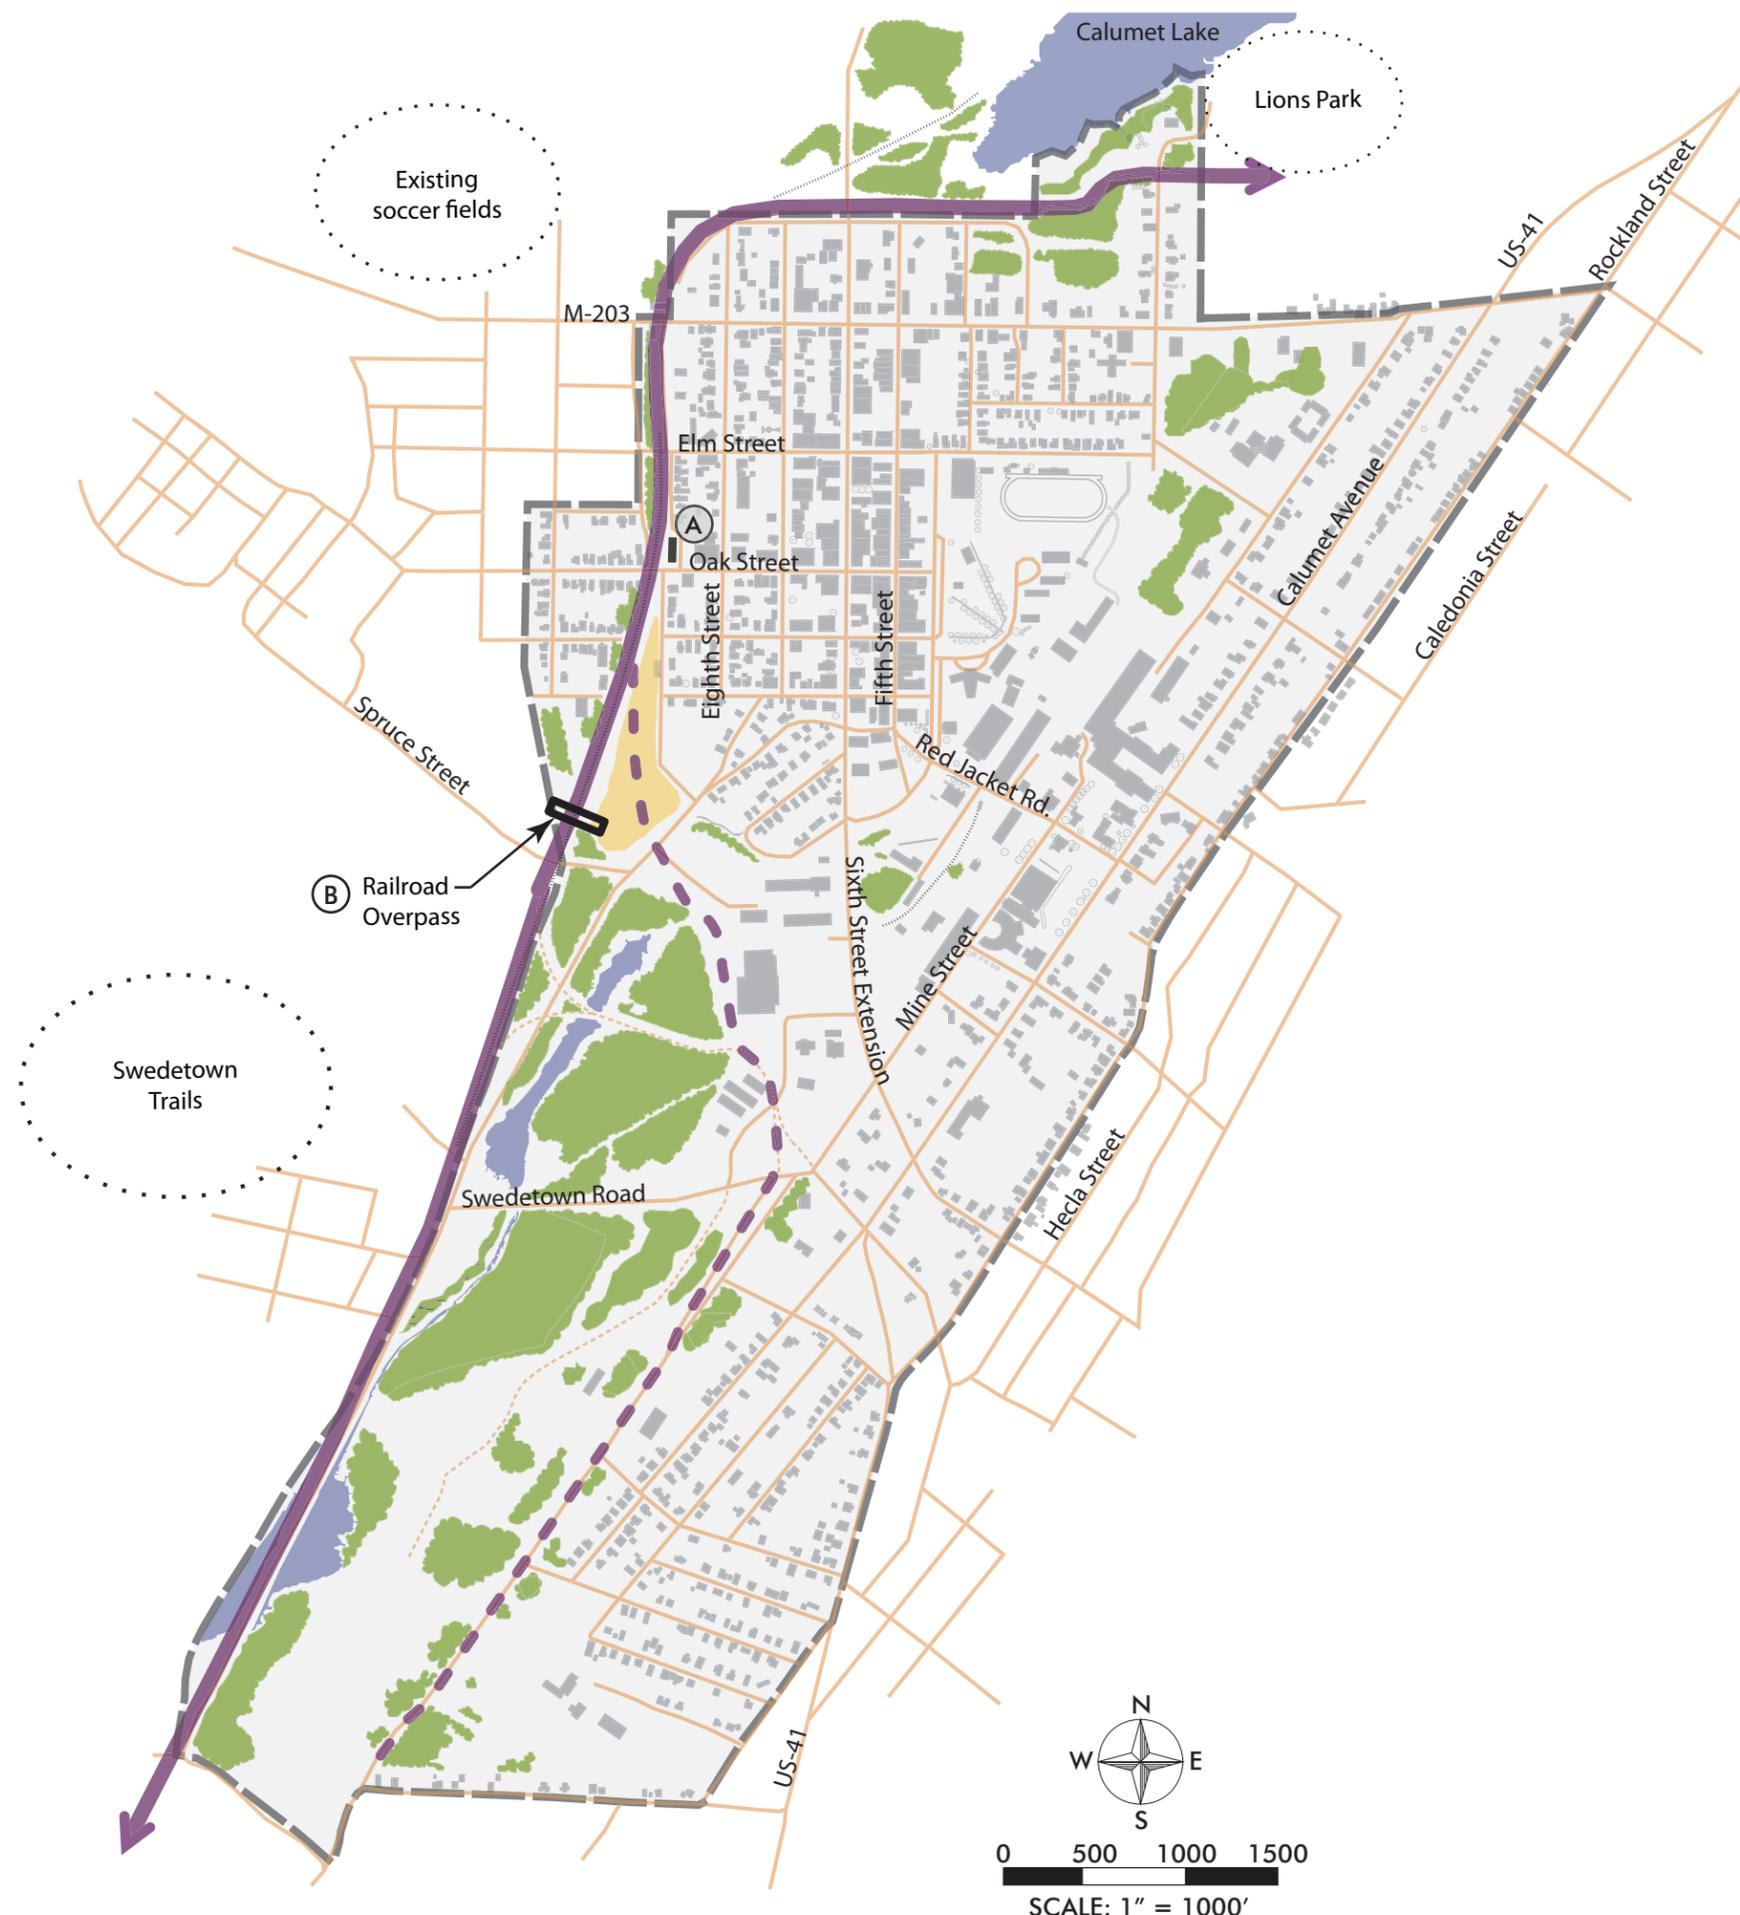
Figure III-101

**Figure III- 101: Railroad/Recreational Corridor, Existing Conditions (source: QEA)**

Map Key	Building	Figure #	Contributing/ Non-contributing	Rationale
A	Mineral Range Railroad Depot	III-102	Contributing	Important transportation hub during the period of significance.
B	Railroad overpass	III-103	Contributing	Part of industrial circulation system during period of significance.

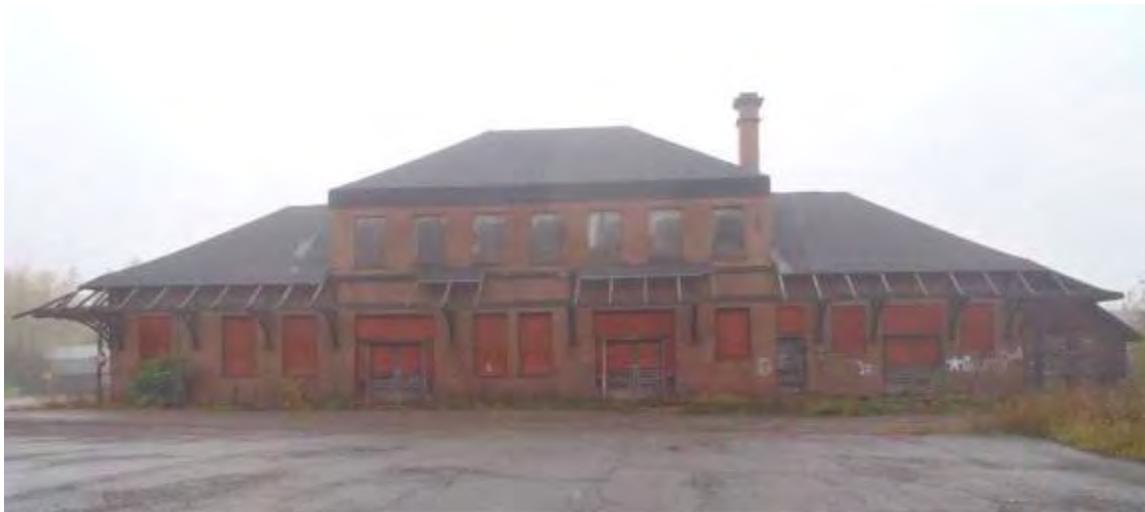
**Figure III- 102: Mineral Range Railroad Depot, East elevation, 2010** (source: QEA P92303P9230319)

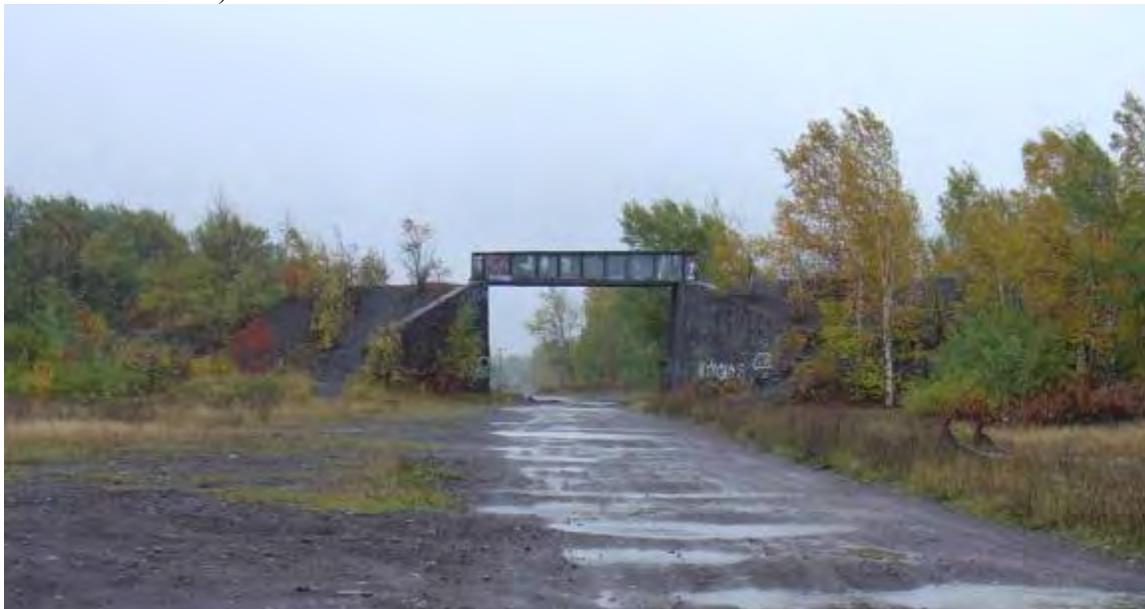
**Figure III- 103: Railroad overpass, 2010** (source: QEA 7383)

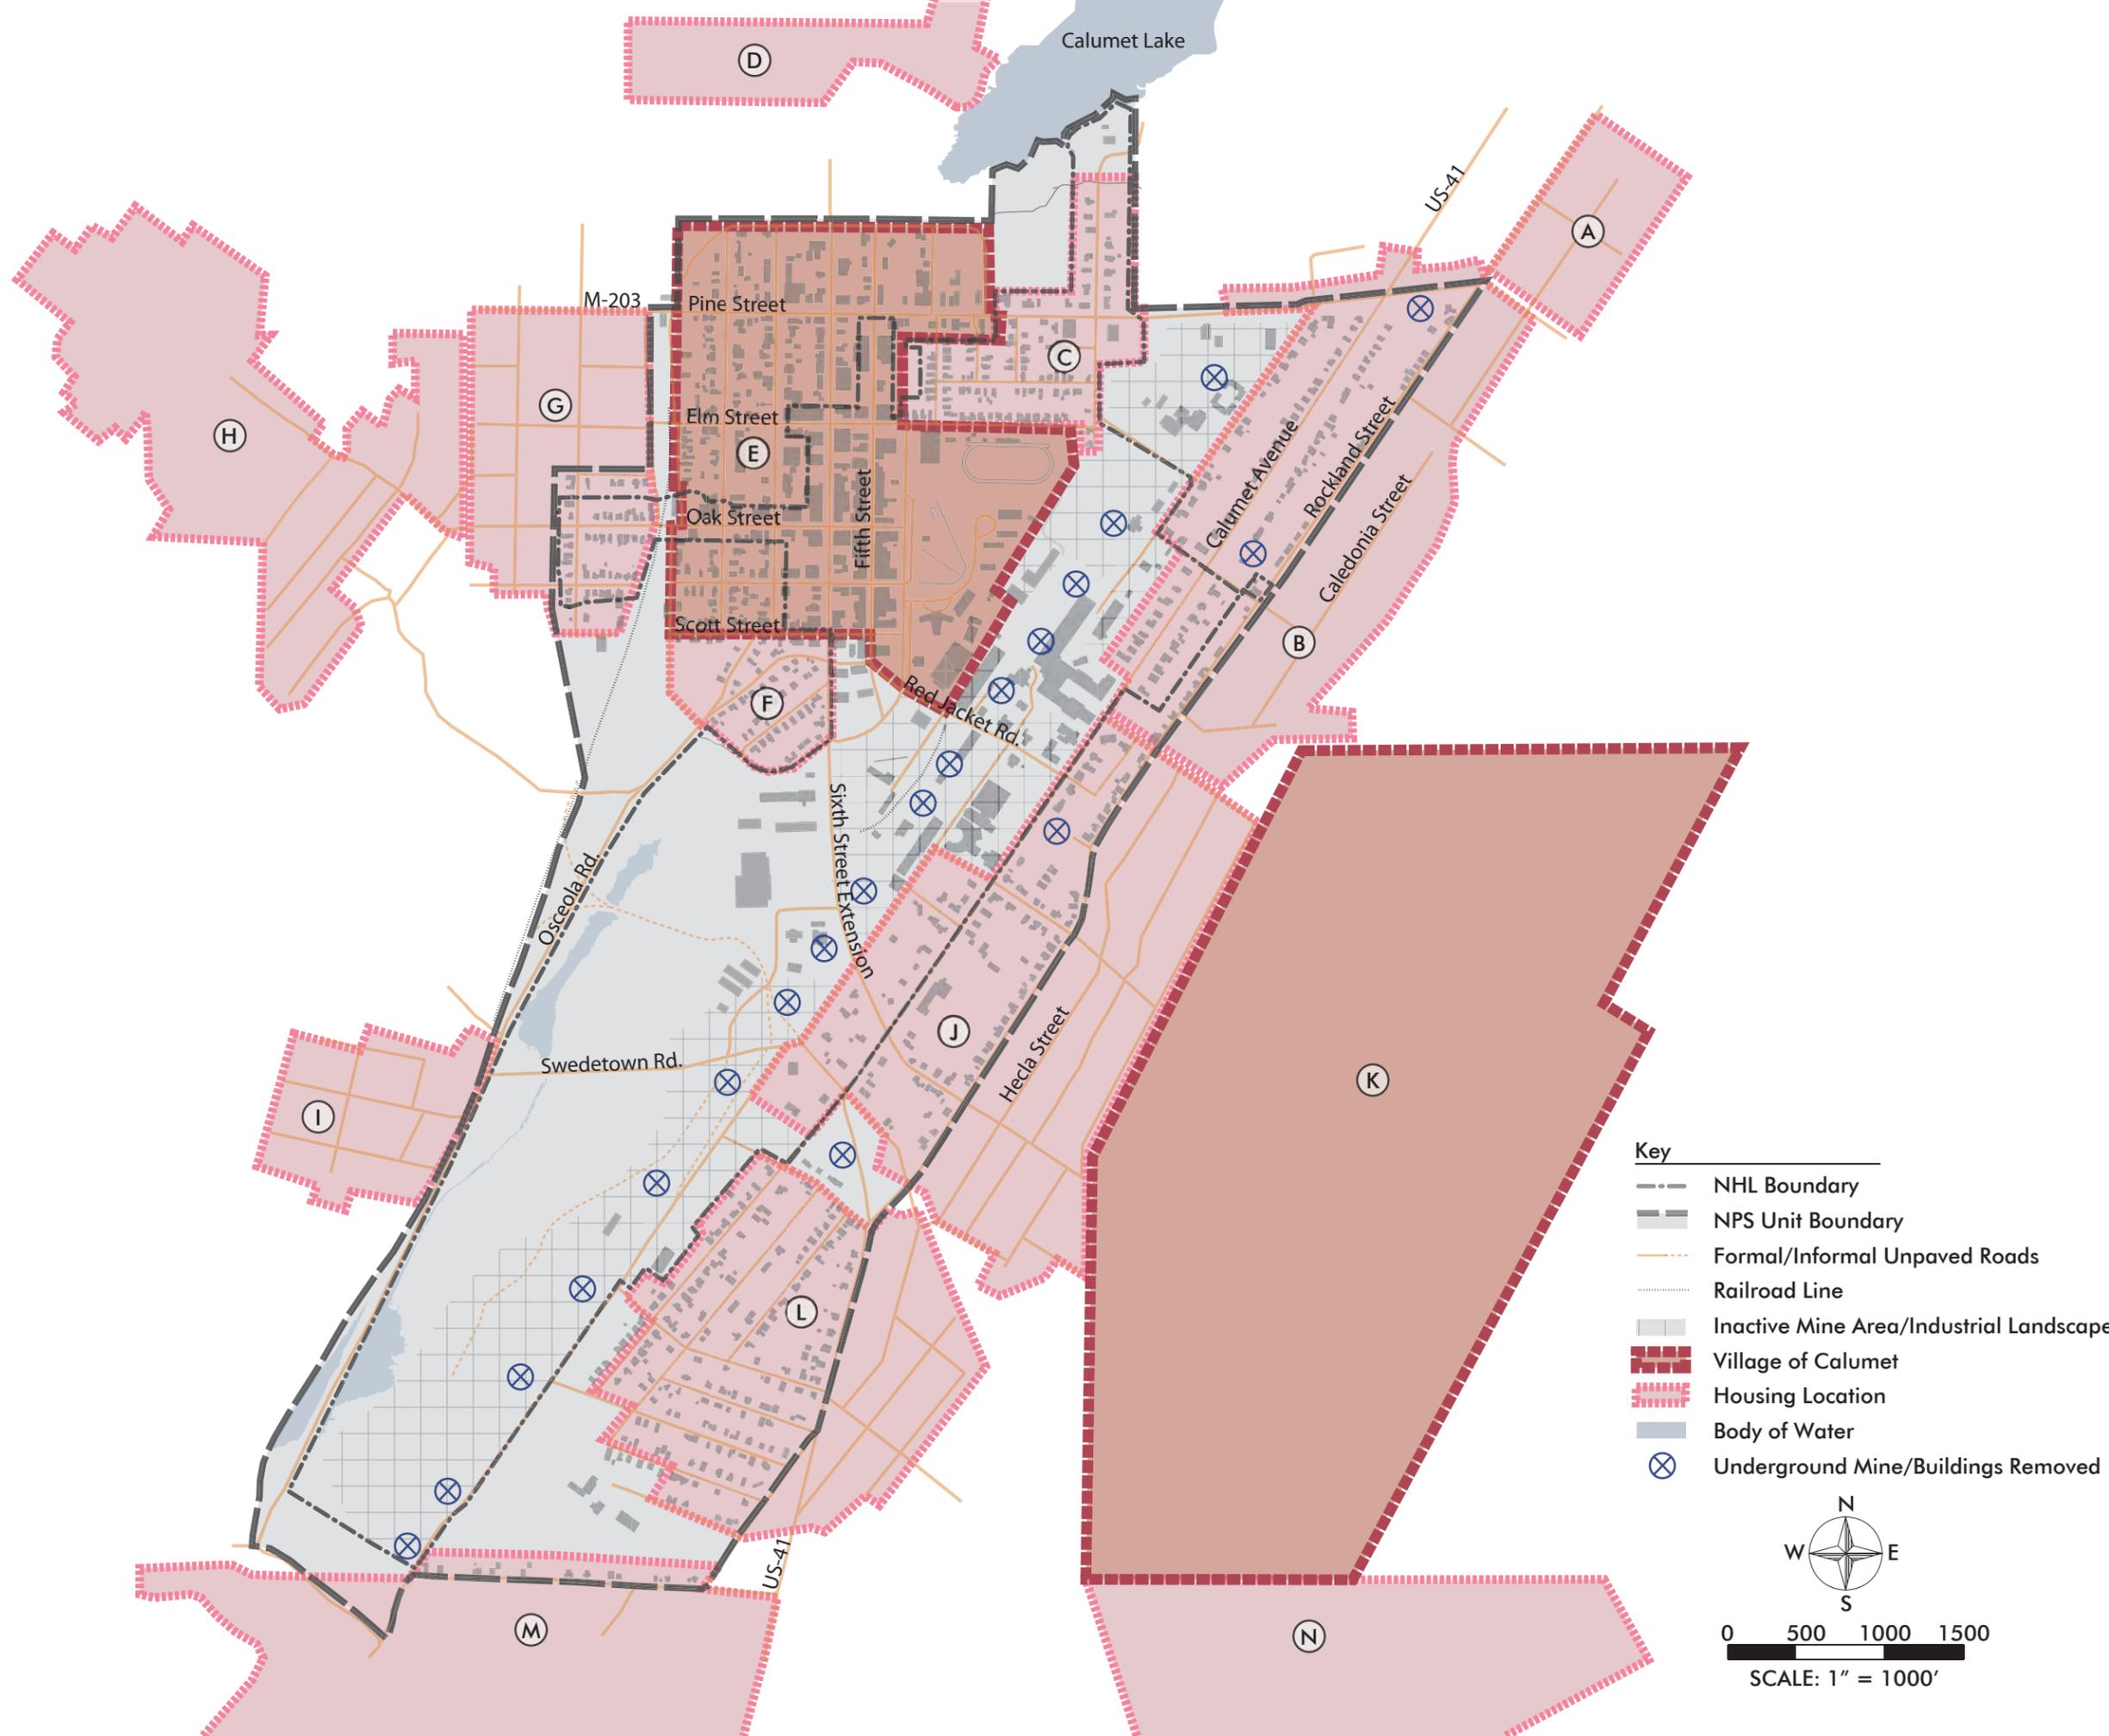
Figure III-113

The Blue Jacket housing location is located north of Agassiz Park. Its boundaries are illustrated in figure III-113. The overall character of the portion of Blue Jacket between Pine and Elm Streets is an in-tact historic housing location. In particular, the north side of Elm Street between Fourth and Waterworks Streets includes a row of two and one-half story frame houses with front end gables and consistent spacing and setbacks from the street (see Figure III-114). There have been additions and alterations made to most of the individual structures, but the overall historic character of the street is high. There is very little vegetation in the fronts of the houses, so their facades are clearly visible along the street. There is no curb or sidewalk along this portion of Elm Street, and the asphalt street is extended to provide parking at the fronts of many of the houses. The East side of Fourth Street also retains a distinct historic character with consistently sized, spaced historic buildings (see Figure III-115). Portions of several streets in Blue Jacket include vacant lots, overgrown vegetation, and additions that extend into the setback, reducing the historic character in some areas, but the impact is minor compared to the extensive historic resources present (see Figure III-116).

The Calumet housing location is located at the northeastern portion of the Calumet unit (see Figures III-113 and III-121). The portion of this housing location that is northwest of Rockland Street is included in the Calumet unit. This housing location includes a large amount of historic residences, as well as structures built more recently that do not reflect the historic character of the neighborhood (see Figures III-122 and III-123). Selected areas hold together well as historic landscapes, including sections of Calumet Avenue and Rockland Street (see Figures III-124 and III-125). These areas contain rows of historic houses and out buildings that are constructed of similar materials, with forms and sizes that are alike and that are adjacent to each other. They have consistent set backs and spacing. Other areas include vacant lots, masses of vegetation, or buildings that are out of context with the historic neighborhood.

Yellow Jacket is located to the west of the Village of Calumet (see Figure III-113). The area is bounded by Pine Street on the north, First Street on the west, Ninth Street on the east, and Scott Street on the south (see Figure III-126). About one quarter of this housing location, the southeastern portion, is located within the Calumet unit. This portion includes the blocks of Oak and Portland Streets that lie between Ninth and Tenth Streets. These blocks are highly intact historic landscapes that include historic houses of consistent form, scale, spacing, and setback. There are also good visual connections to the heart of the Calumet Civic & Commercial Historic District facing east and viewing along Portland and Oak Streets. Other portions of this housing location also include a high level of integrity. Examples include East and West Cone Streets, Ash Street and Elm Street (see Figures III-127 through III-131). Although many of the homes have been altered, their historic forms, spacing, and setbacks are still clearly apparent. This housing location has a high percentage of extant landscape elements, especially houses but also streets, outbuildings and lot arrangements.

The Hecla housing location is located at the eastern side of the Calumet unit, between the Calumet housing location and the Raymbaultown housing location (see Figure III-113). The boundaries of this location are irregular (see Figure III-132). Approximately one-half of this housing location is located within the Calumet unit. This housing location includes a large amount of historic residences, and also includes structures built more recently that do not reflect the historic character. Selected areas have integrity as historic landscapes, including sections of Rockland, Hecla, Laurium and Cemetery Streets (see Figure III-133). These areas contain rows of historic houses and out buildings that are constructed of similar materials, with forms and sizes that are alike and that are adjacent to each other. They have consistent set backs and spacing. Of particular distinction are the southern sections of Cemetery, Laurium and Hecla Streets, where intact rows of homes with gambrel roofs display a strong character and rhythm. Other areas include vacant lots, masses of vegetation, or buildings that are out of context with the historic neighborhood.

Raymbaultown is located at the southeastern edge of the Calumet unit directly north of the Osceola No. 13 mine location (see Figures III-113 and III-134). The portion of this housing location that is west of Calumet Avenue / U.S. 41 is included in the Calumet unit. This housing location includes a large amount of historic residences, as well as structures built more recently that do not reflect the historic character of the neighborhood. Selected areas have integrity as historic landscapes, including sections of A, C and D Streets and the northern portion of Middle Street (see Figures III-135 through III-137) as well as others. These areas contain rows of historic houses and out buildings that are constructed of similar materials, with forms and sizes that are alike and that are adjacent to each other. They have consistent set backs and spacing. Other areas, such as portions of A Street, B Street, and Log Street include one-story ranch style homes with larger footprints than the historic residences as well as vacant lots, masses of vegetation, or buildings that are out of context with the historic neighborhood.

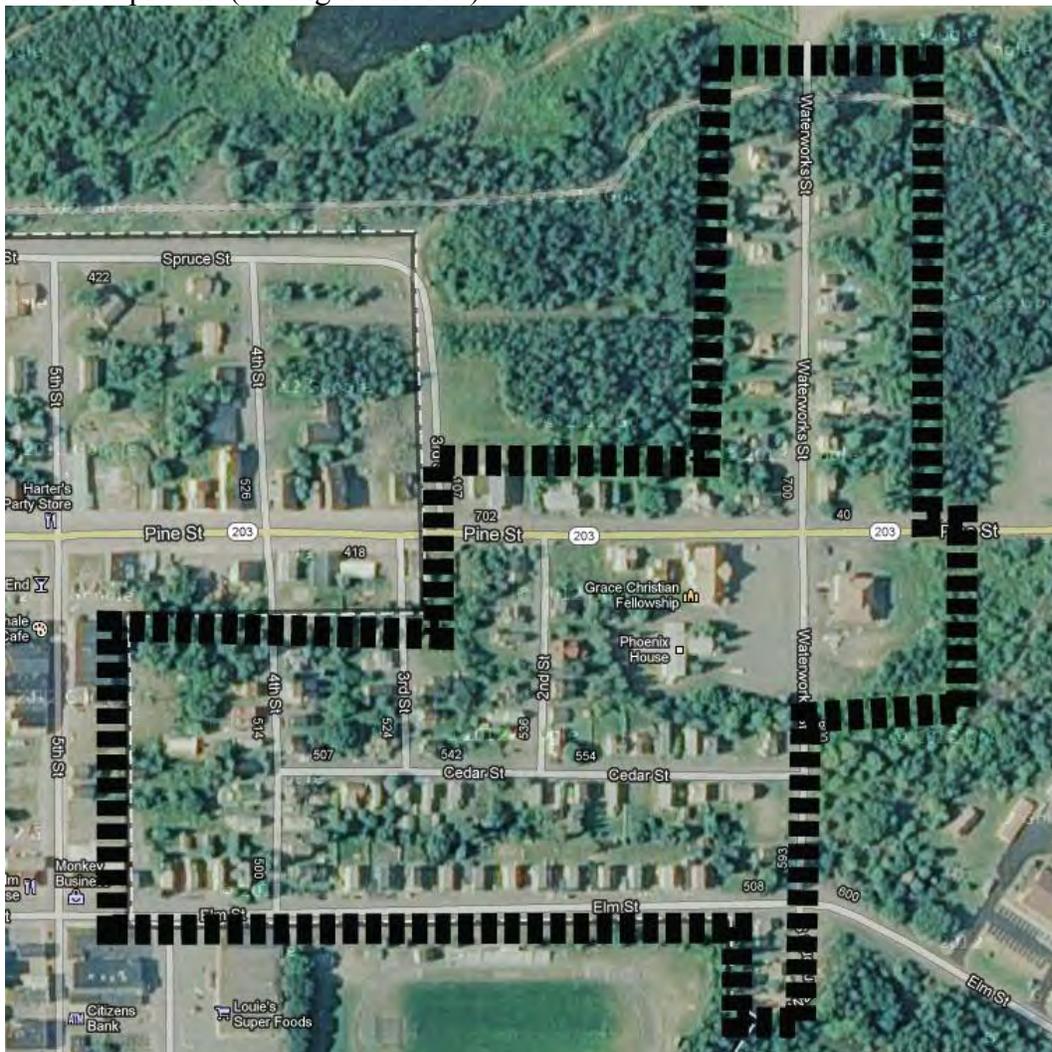
**Figure III- 114: Blue Jacket Housing Location, 2012** (source: 2012 DigitalGlobe, GeoEye, USDA Farm Service Agency, Mapdata @ 2012 Google, adapted by QEA)

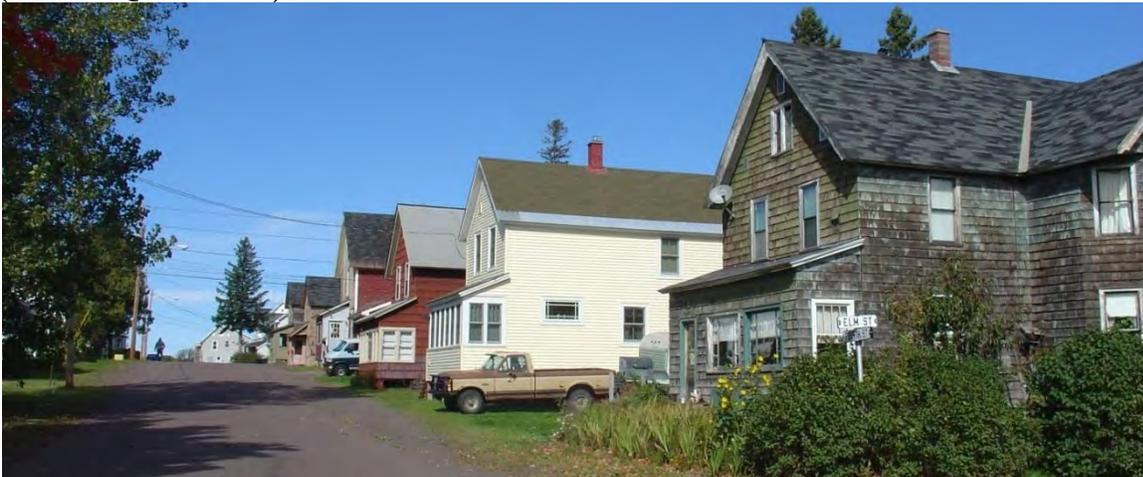
**Figure III- 116: Blue Jacket Housing Location, East side of Fourth Street, facing north, 2010 (source: QEA 06764)**
