Calumet Unit Historic Landscape

Cultural Landscape Report and Environmental Assessment

FINAL 2013

**Keweenaw National Historical Park**

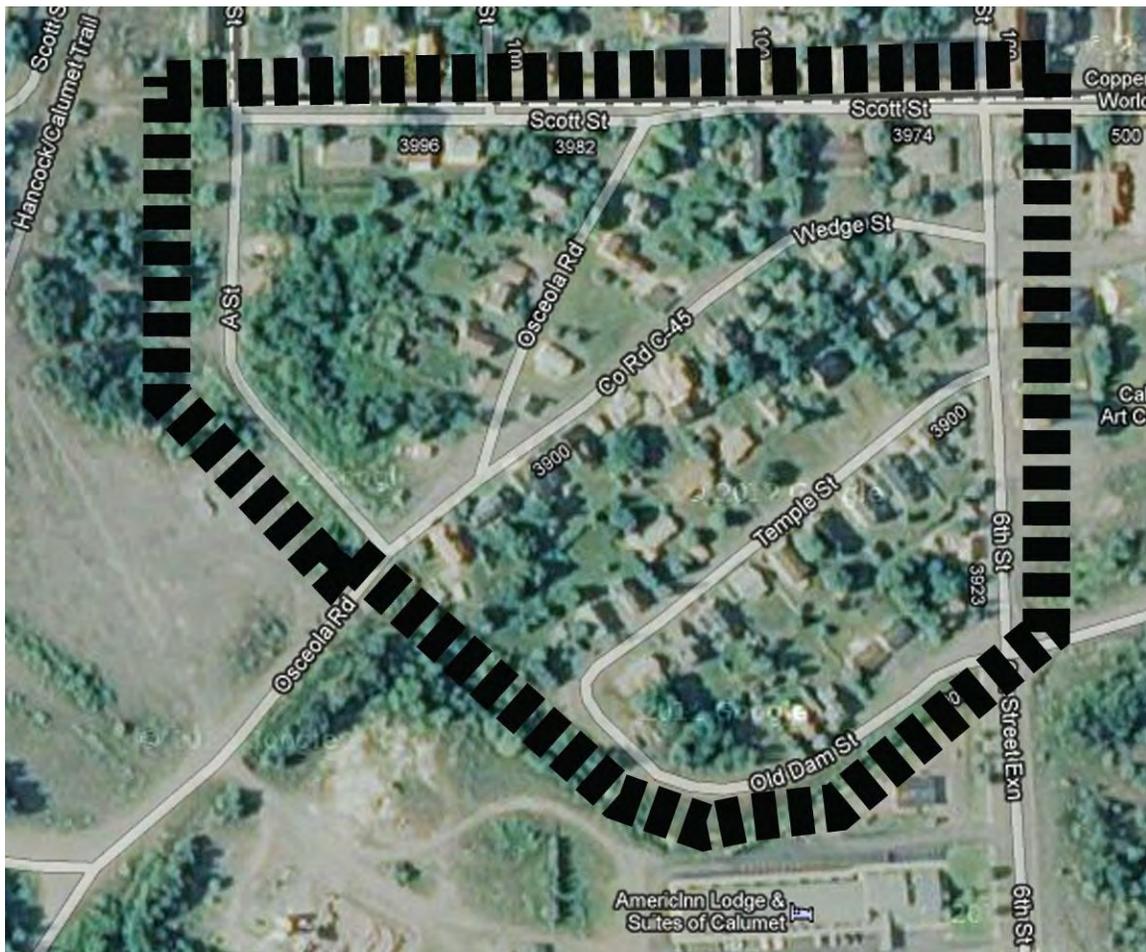
**Figure III- 118: Newtown Housing Location, 2012** (source: 2012 DigitalGlobe, GeoEye, USDA Farm Service Agency, Mapdata @ 2012 Google, adapted by QEA)

The Newtown housing location is located south of the Village of Calumet and directly west of Temple Square (see Figure III-118). The area includes a large number of historic houses, examples are illustrated in Figure III-119. Some portions of the Newtown housing location include landscape characteristics with high integrity, but the overall neighborhood includes numerous vacant lots, overgrown vegetation, additions and alterations to historic buildings that diminish the integrity of this housing location landscape. The neighborhood includes a mixture of historic residences with non-contributing buildings (see Figure III-120). The spacing of new buildings is not consistent with that of historic structures. The overall landscape does not retain as high a level of integrity as others in the Calumet area.

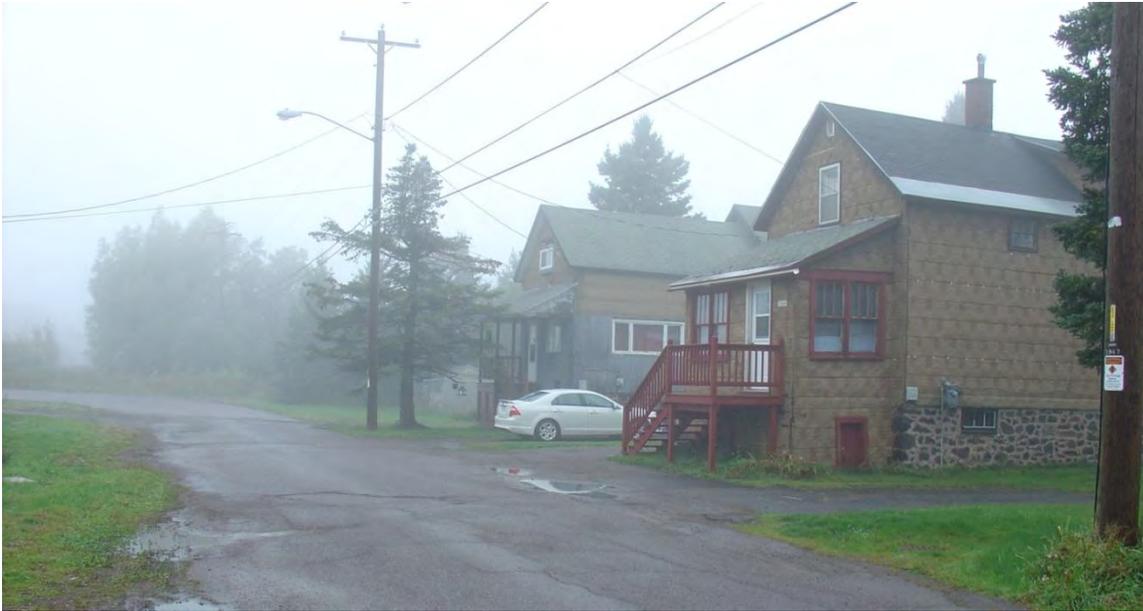
**Figure III- 119: Newtown Housing Location, Northwest side of Temple Street at southwest end of street, facing southwest, 2010 (source: QEA 7266)**

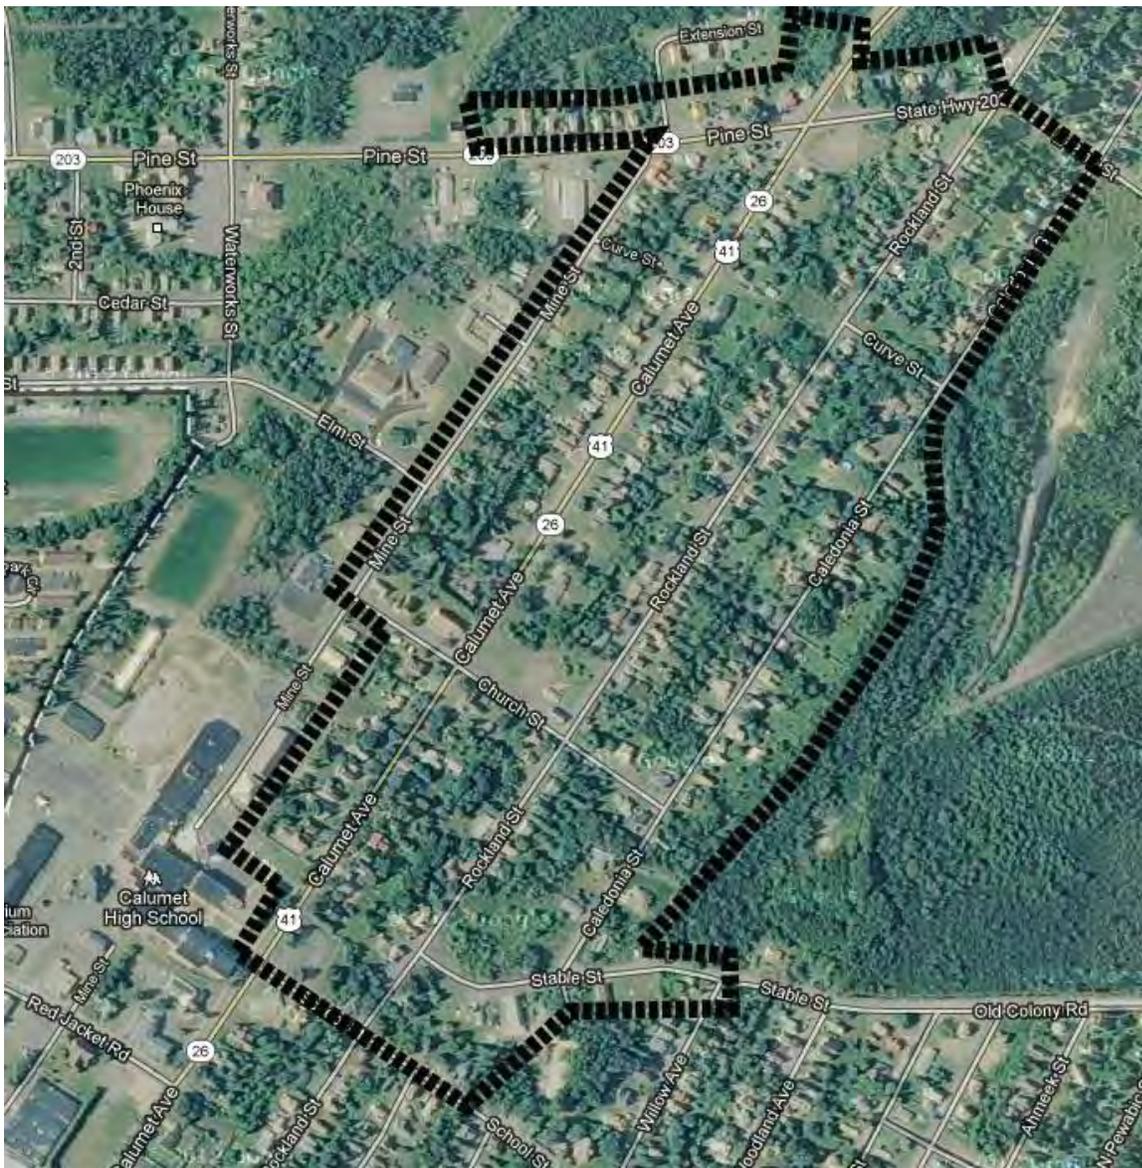
**Figure III- 121: Calumet Housing Location, 2012** (source: 2012 DigitalGlobe, GeoEye, USDA Farm Service Agency, Mapdata @ 2012 Google, adapted by QEA)

The Calumet housing location is located at the northeastern portion of the Calumet unit (see Figures III-113 and III-121). The portion of this housing location that is northwest of Rockland Street is included in the Calumet unit. This housing location includes a large amount of historic residences, as well as structures built more recently that do not reflect the historic character of the neighborhood (see Figures III-122 and III-123). Selected areas hold together well as historic landscapes, including sections of Calumet Avenue and Rockland Street (see Figures III-124 and III-125). These areas contain rows of historic houses and out buildings that are constructed of similar materials, with forms and sizes that are alike and that are adjacent to each other. They have consistent set backs and spacing. Other areas include vacant lots, masses of vegetation, or buildings that are out of context with the historic neighborhood.

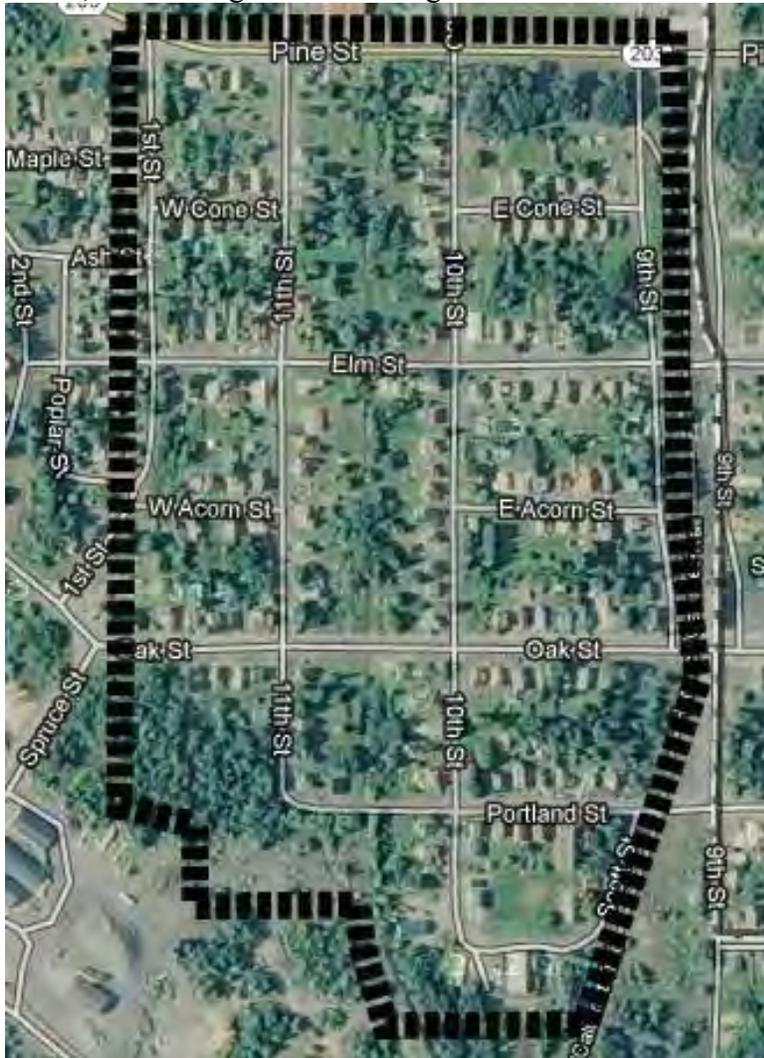
**Figure III- 126: Yellow Jacket Housing Location, 2012** (source: 2012 DigitalGlobe, GeoEye, USDA Farm Service Agency, Mapdata @ 2012 Google, adapted by QEA)

Yellow Jacket is located to the west of the Village of Calumet (see Figure III-113). The area is bounded by Pine Street on the north, First Street on the west, Ninth Street on the east, and Scott Street on the south (see Figure III-126). About one quarter of this housing location, the southeastern portion, is located within the Calumet unit. This portion includes the blocks of Oak and Portland Streets that lie between Ninth and Tenth Streets. These blocks are highly intact historic landscapes that include historic houses of consistent form, scale, spacing, and setback. There are also good visual connections to the heart of the Calumet Civic & Commercial Historic District facing east and viewing along Portland and Oak Streets. Other portions of this housing location also include a high level of integrity. Examples include East and West Cone Streets, Ash Street and Elm Street (see Figures III-127 through III-131). Although many of the homes have been altered, their historic forms, spacing, and setbacks are still clearly apparent. This housing location has a high percentage of extant landscape elements, especially houses but also streets, outbuildings and lot arrangements.

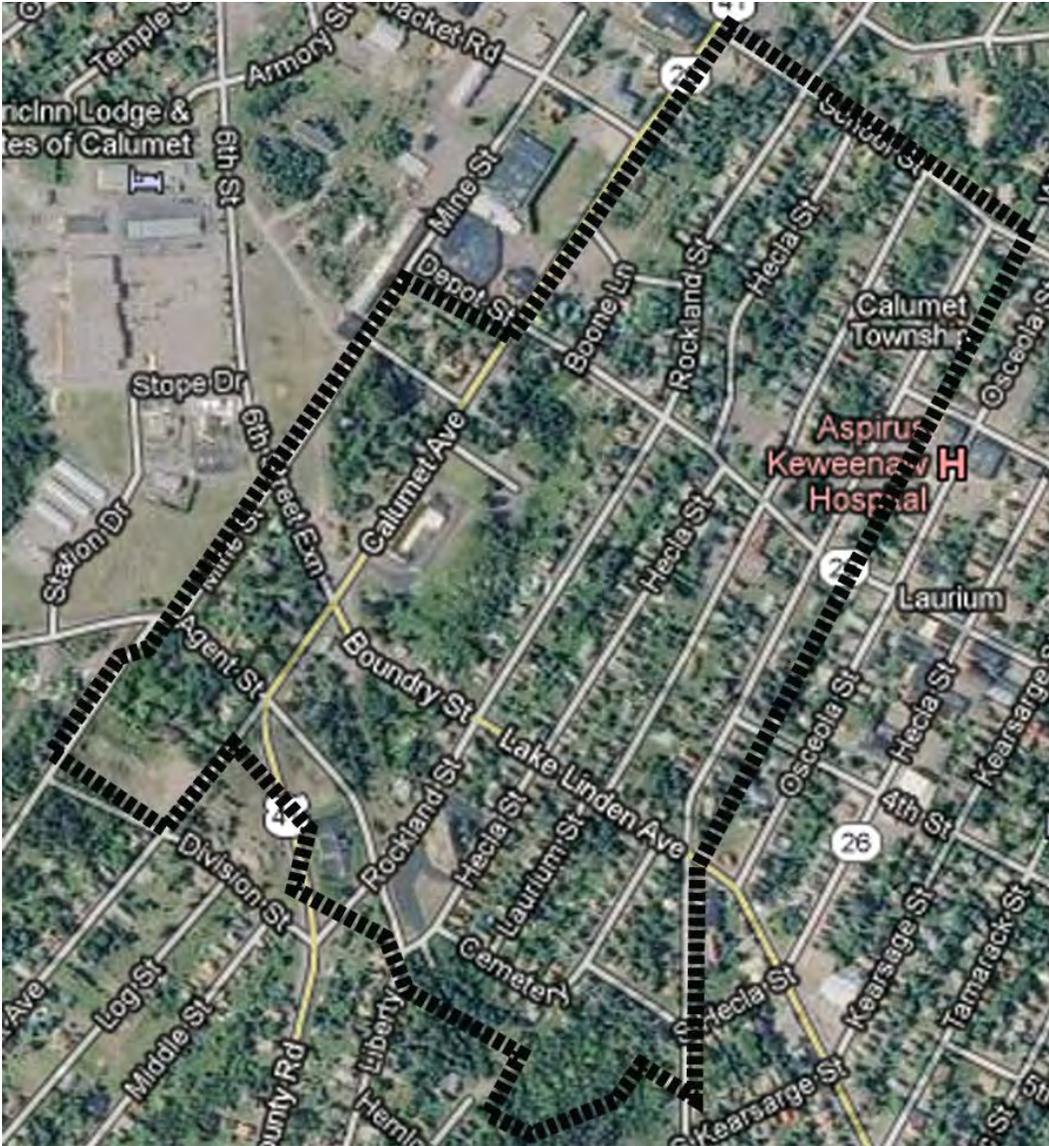
**Figure III- 132: Hecla Housing Location, 2012** (source: 2012 DigitalGlobe, GeoEye, USDA Farm Service Agency, Mapdata @ 2012 Google, adapted by QEA)

The Hecla housing location is located at the eastern side of the Calumet unit, between the Calumet housing location and the Raymbaultown housing location (see Figure III-113). The boundaries of this location are irregular (see Figure III-132). Approximately one-half of this housing location is located within the Calumet unit. This housing location includes a large amount of historic residences, and also includes structures built more recently that do not reflect the historic character. Selected areas have integrity as historic landscapes, including sections of Rockland, Hecla, Laurium and Cemetery Streets (see Figure III-133). These areas contain rows of historic houses and out buildings that are constructed of similar materials, with forms and sizes that are alike and that are adjacent to each other. They have consistent set backs and spacing. Of particular distinction are the southern sections of Cemetery, Laurium and Hecla Streets, where intact rows of homes with gambrel roofs display a strong character and rhythm. Other areas include vacant lots, masses of vegetation, or buildings that are out of context with the historic neighborhood.

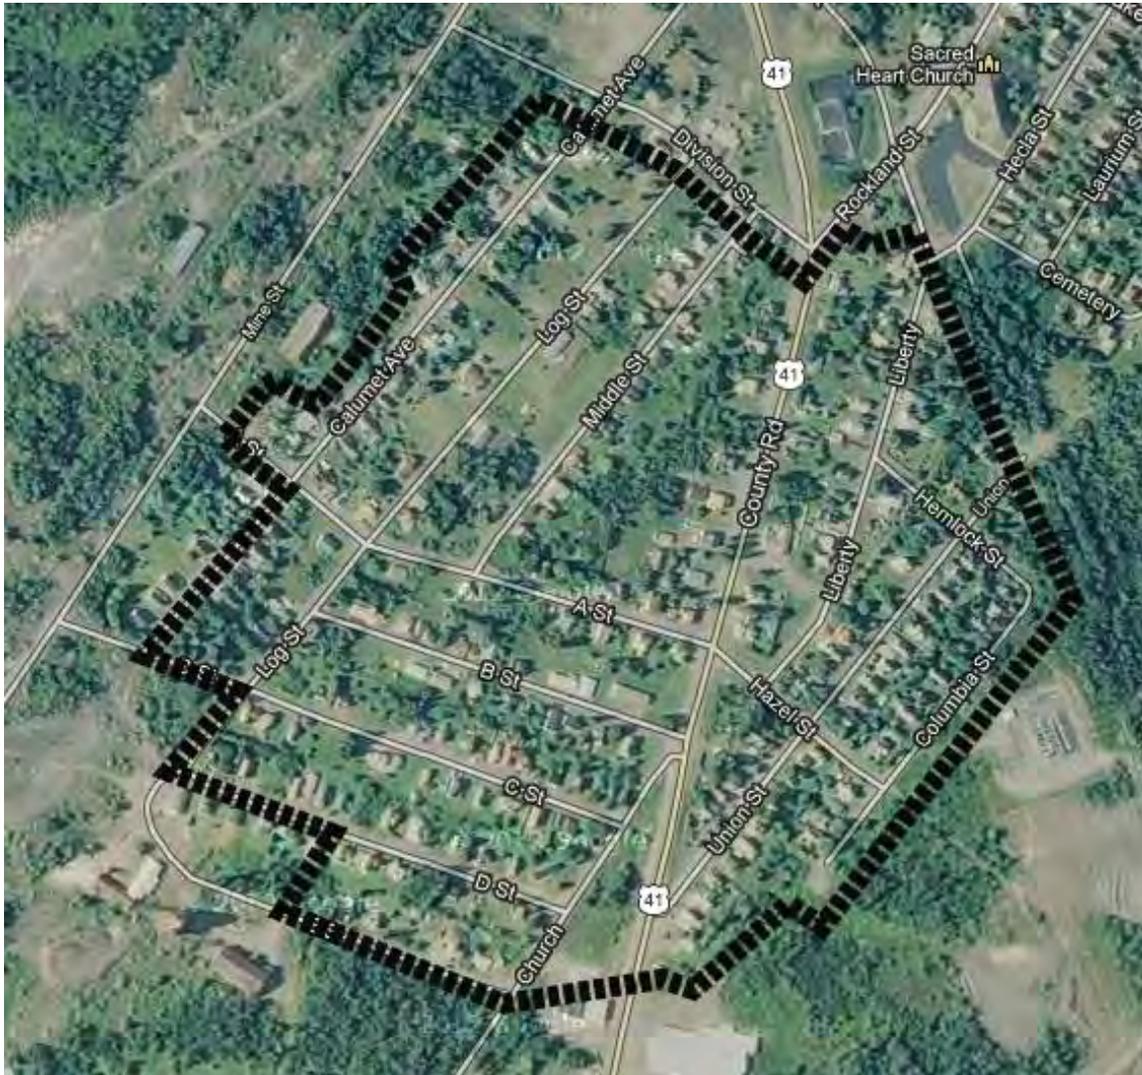
**Figure III- 134: Raymbaultown Housing Location, 2012** (source: 2012 DigitalGlobe, GeoEye, USDA Farm Service Agency, Mapdata @ 2012 Google, adapted by QEA)

Raymbaultown is located at the southeastern edge of the Calumet unit directly north of the Osceola No. 13 mine location (see Figures III-113 and III-134). The portion of this housing location that is west of Calumet Avenue / U.S. 41 is included in the Calumet unit. This housing location includes a large amount of historic residences, as well as structures built more recently that do not reflect the historic character of the neighborhood. Selected areas have integrity as historic landscapes, including sections of A, C and D Streets and the northern portion of Middle Street (see Figures III-135 through III-137) as well as others. These areas contain rows of historic houses and out buildings that are constructed of similar materials, with forms and sizes that are alike and that are adjacent to each other. They have consistent set backs and spacing. Other areas, such as portions of A Street, B Street, and Log Street include one-story ranch style homes with larger footprints than the historic residences as well as vacant lots, masses of vegetation, or buildings that are out of context with the historic neighborhood.

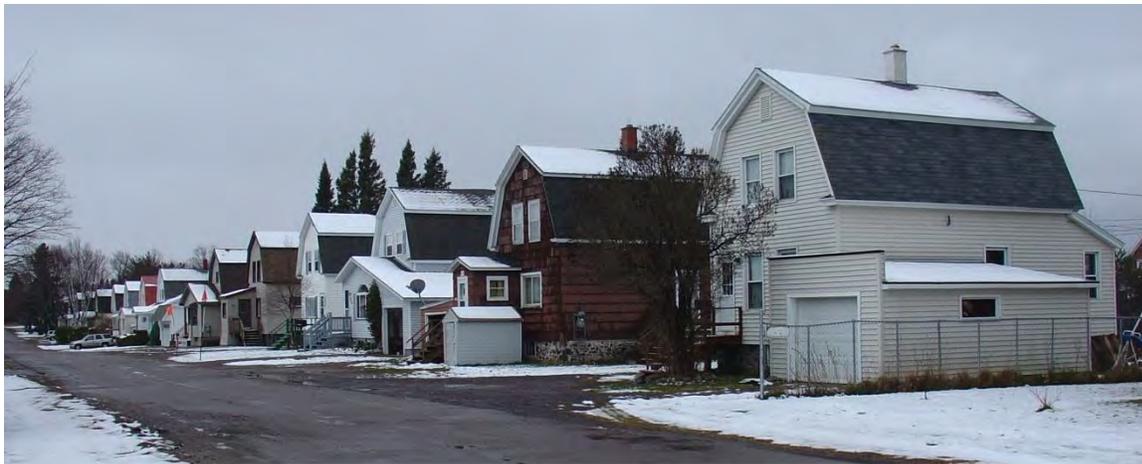
**Figure III- 138: Albion Housing Location, west side of Caledonia Street, facing south, 2010**  
(source: QEA 08570)

In addition to the housing locations that are located within the Calumet unit, there are several housing locations in the Calumet area that are directly related to the historical significance of the unit. These include Albion, Red Jacket Shaft, Tamarack, Tamarack Heights, Swedetown, Florida, and the Village of Laurium. Although not within the unit, these neighborhoods were developed to provide housing for mine workers and other residents during the period of significance. The housing locations surround the industrial core of the unit and contain extensive historic residences and associated landscape features including streets, yards, out buildings, and vegetation. They include historic landscapes that have integrity and their preservation should be considered within the context of an overall approach to housing preservation in the region. An example is Caledonia Street in Albion, which includes an excellent grouping of two-story homes with gambrel roofs (see Figure III-138).

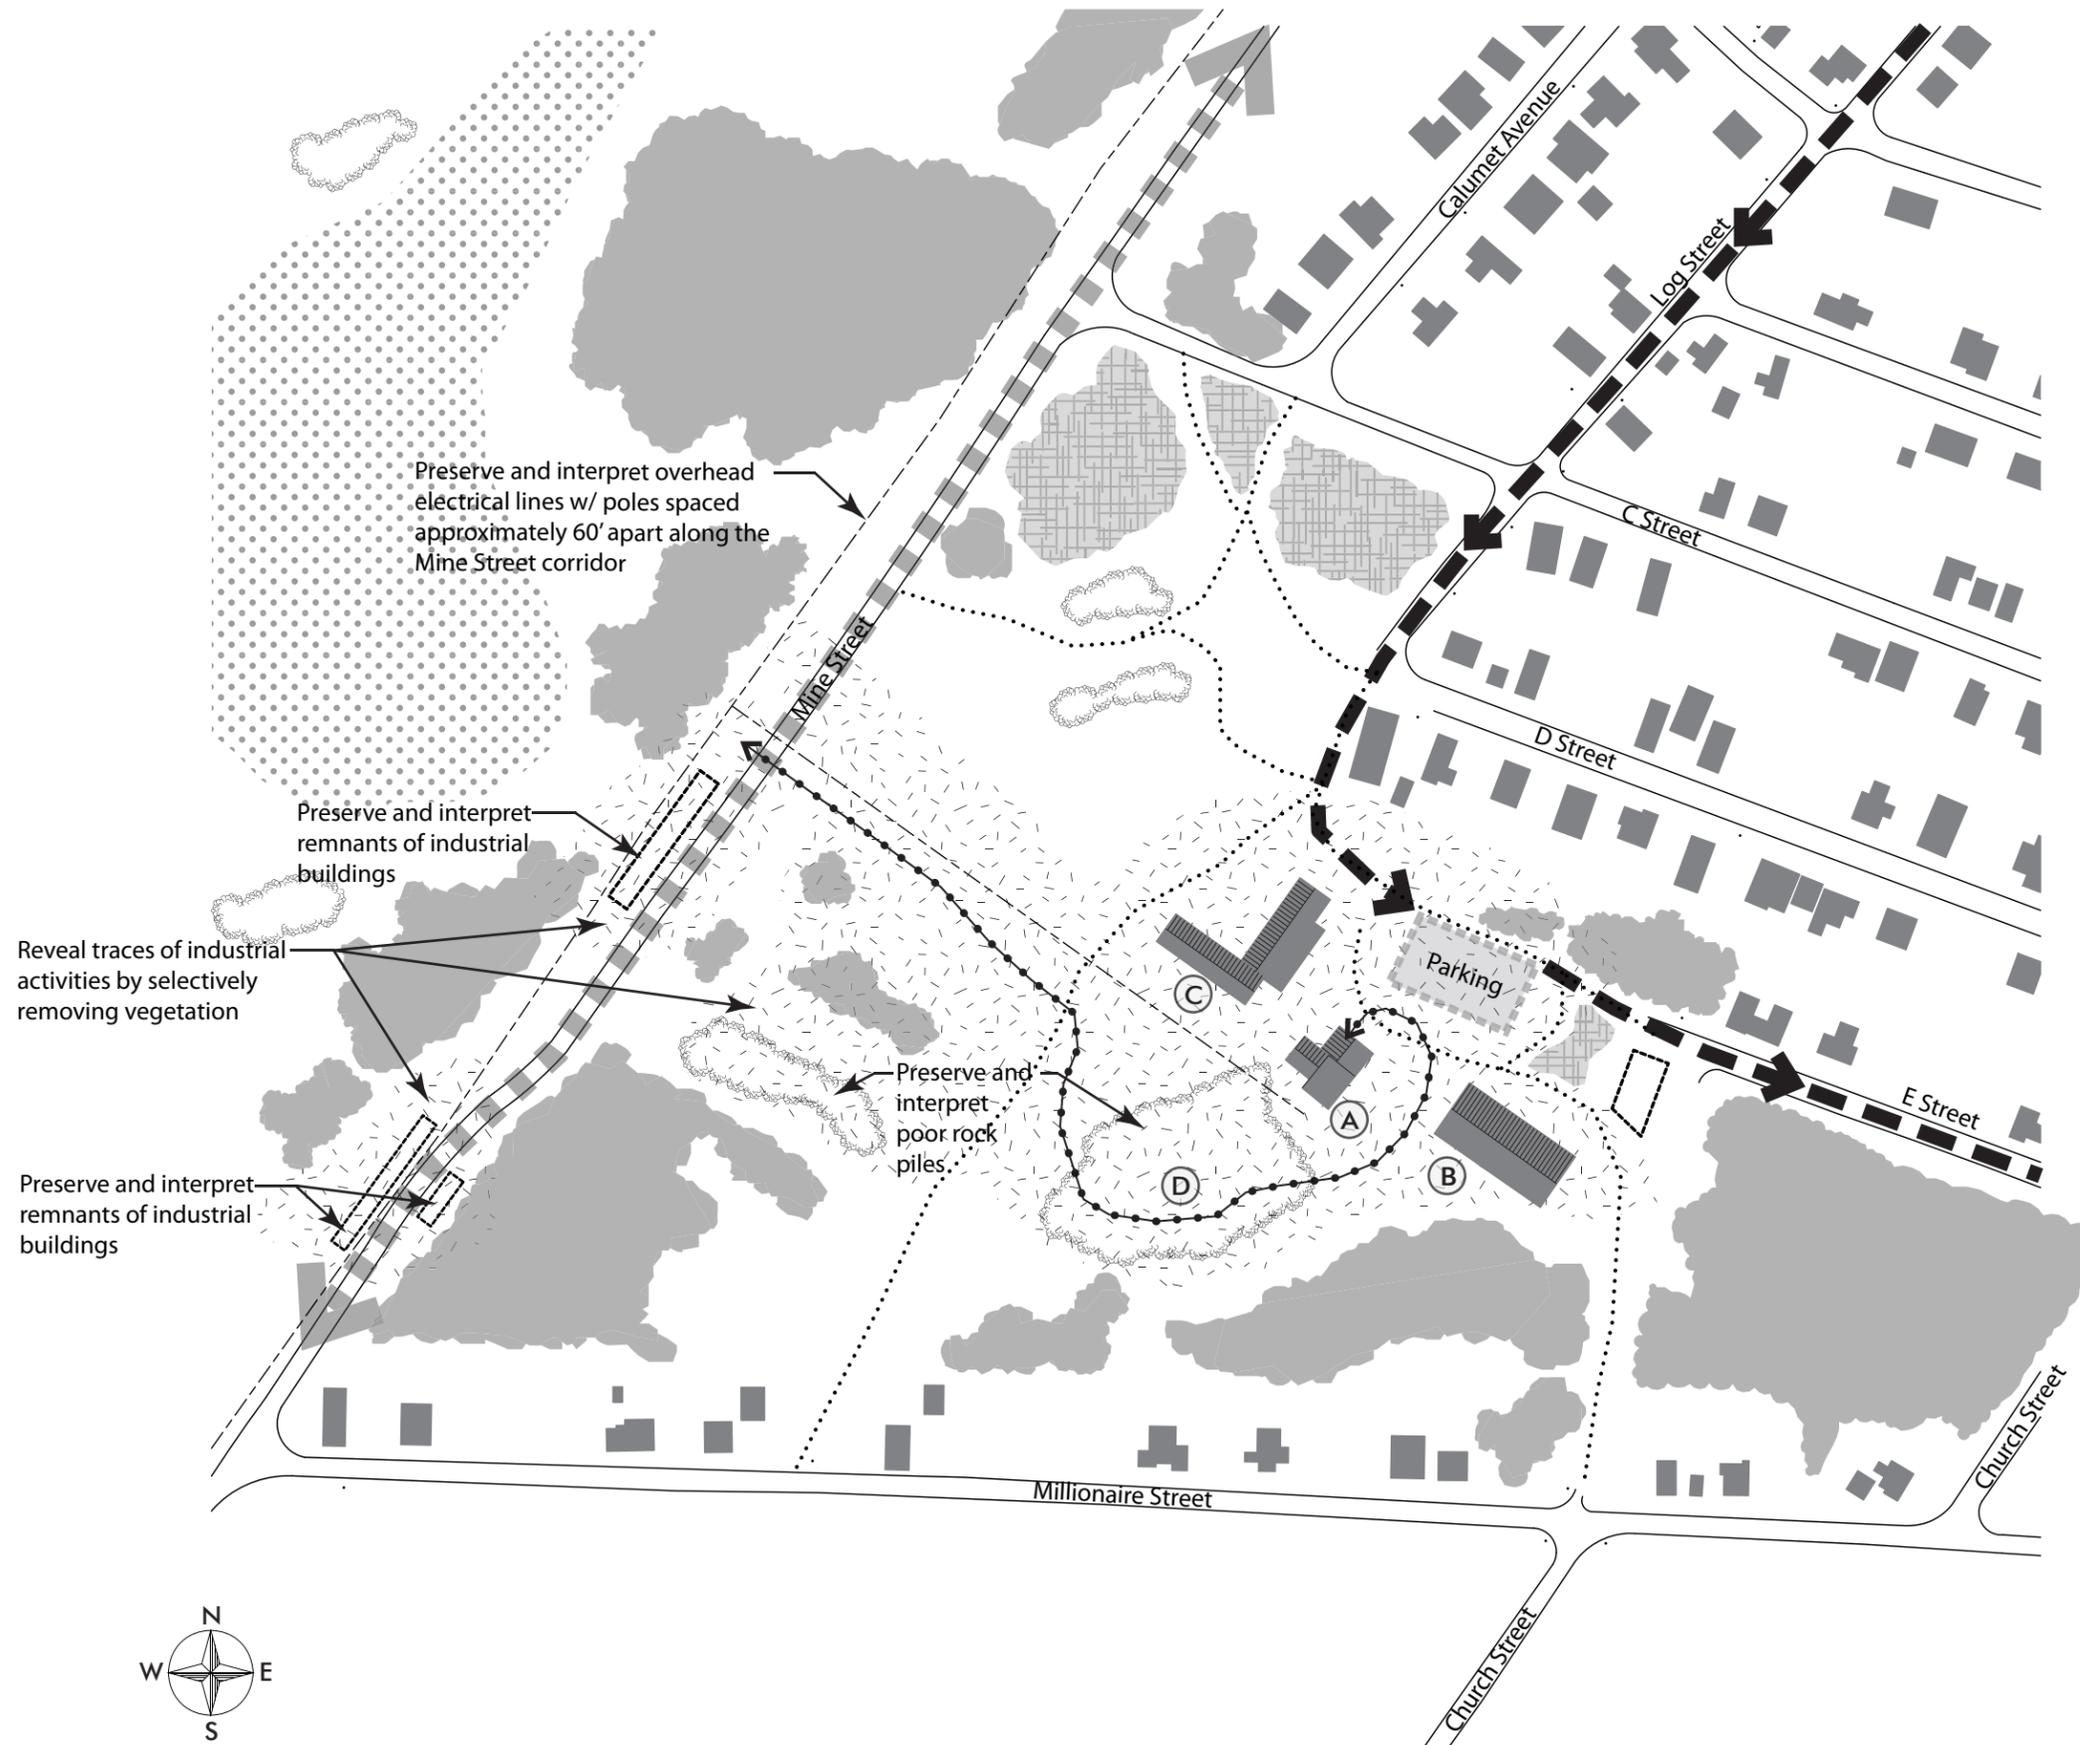
Figure V-2

Of the treatment alternatives considered for Osceola No. 13, Treatment Alternative B is the recommended approach. Treatment guidelines for this area focus on preserving the extant historic features related to the mining activities, and providing opportunities for visitors to explore and learn about the history of the site. The guidelines are outlined below and illustrated in Figure V-2.

- h. Preserve the mining equipment located on the property. Inventory the equipment and provide interpretive information regarding the role of the equipment in the mining process. Consider rearranging the equipment to create a display that is authentic to the site operations. Assess the condition of the equipment and develop a plan for preserving these resources.

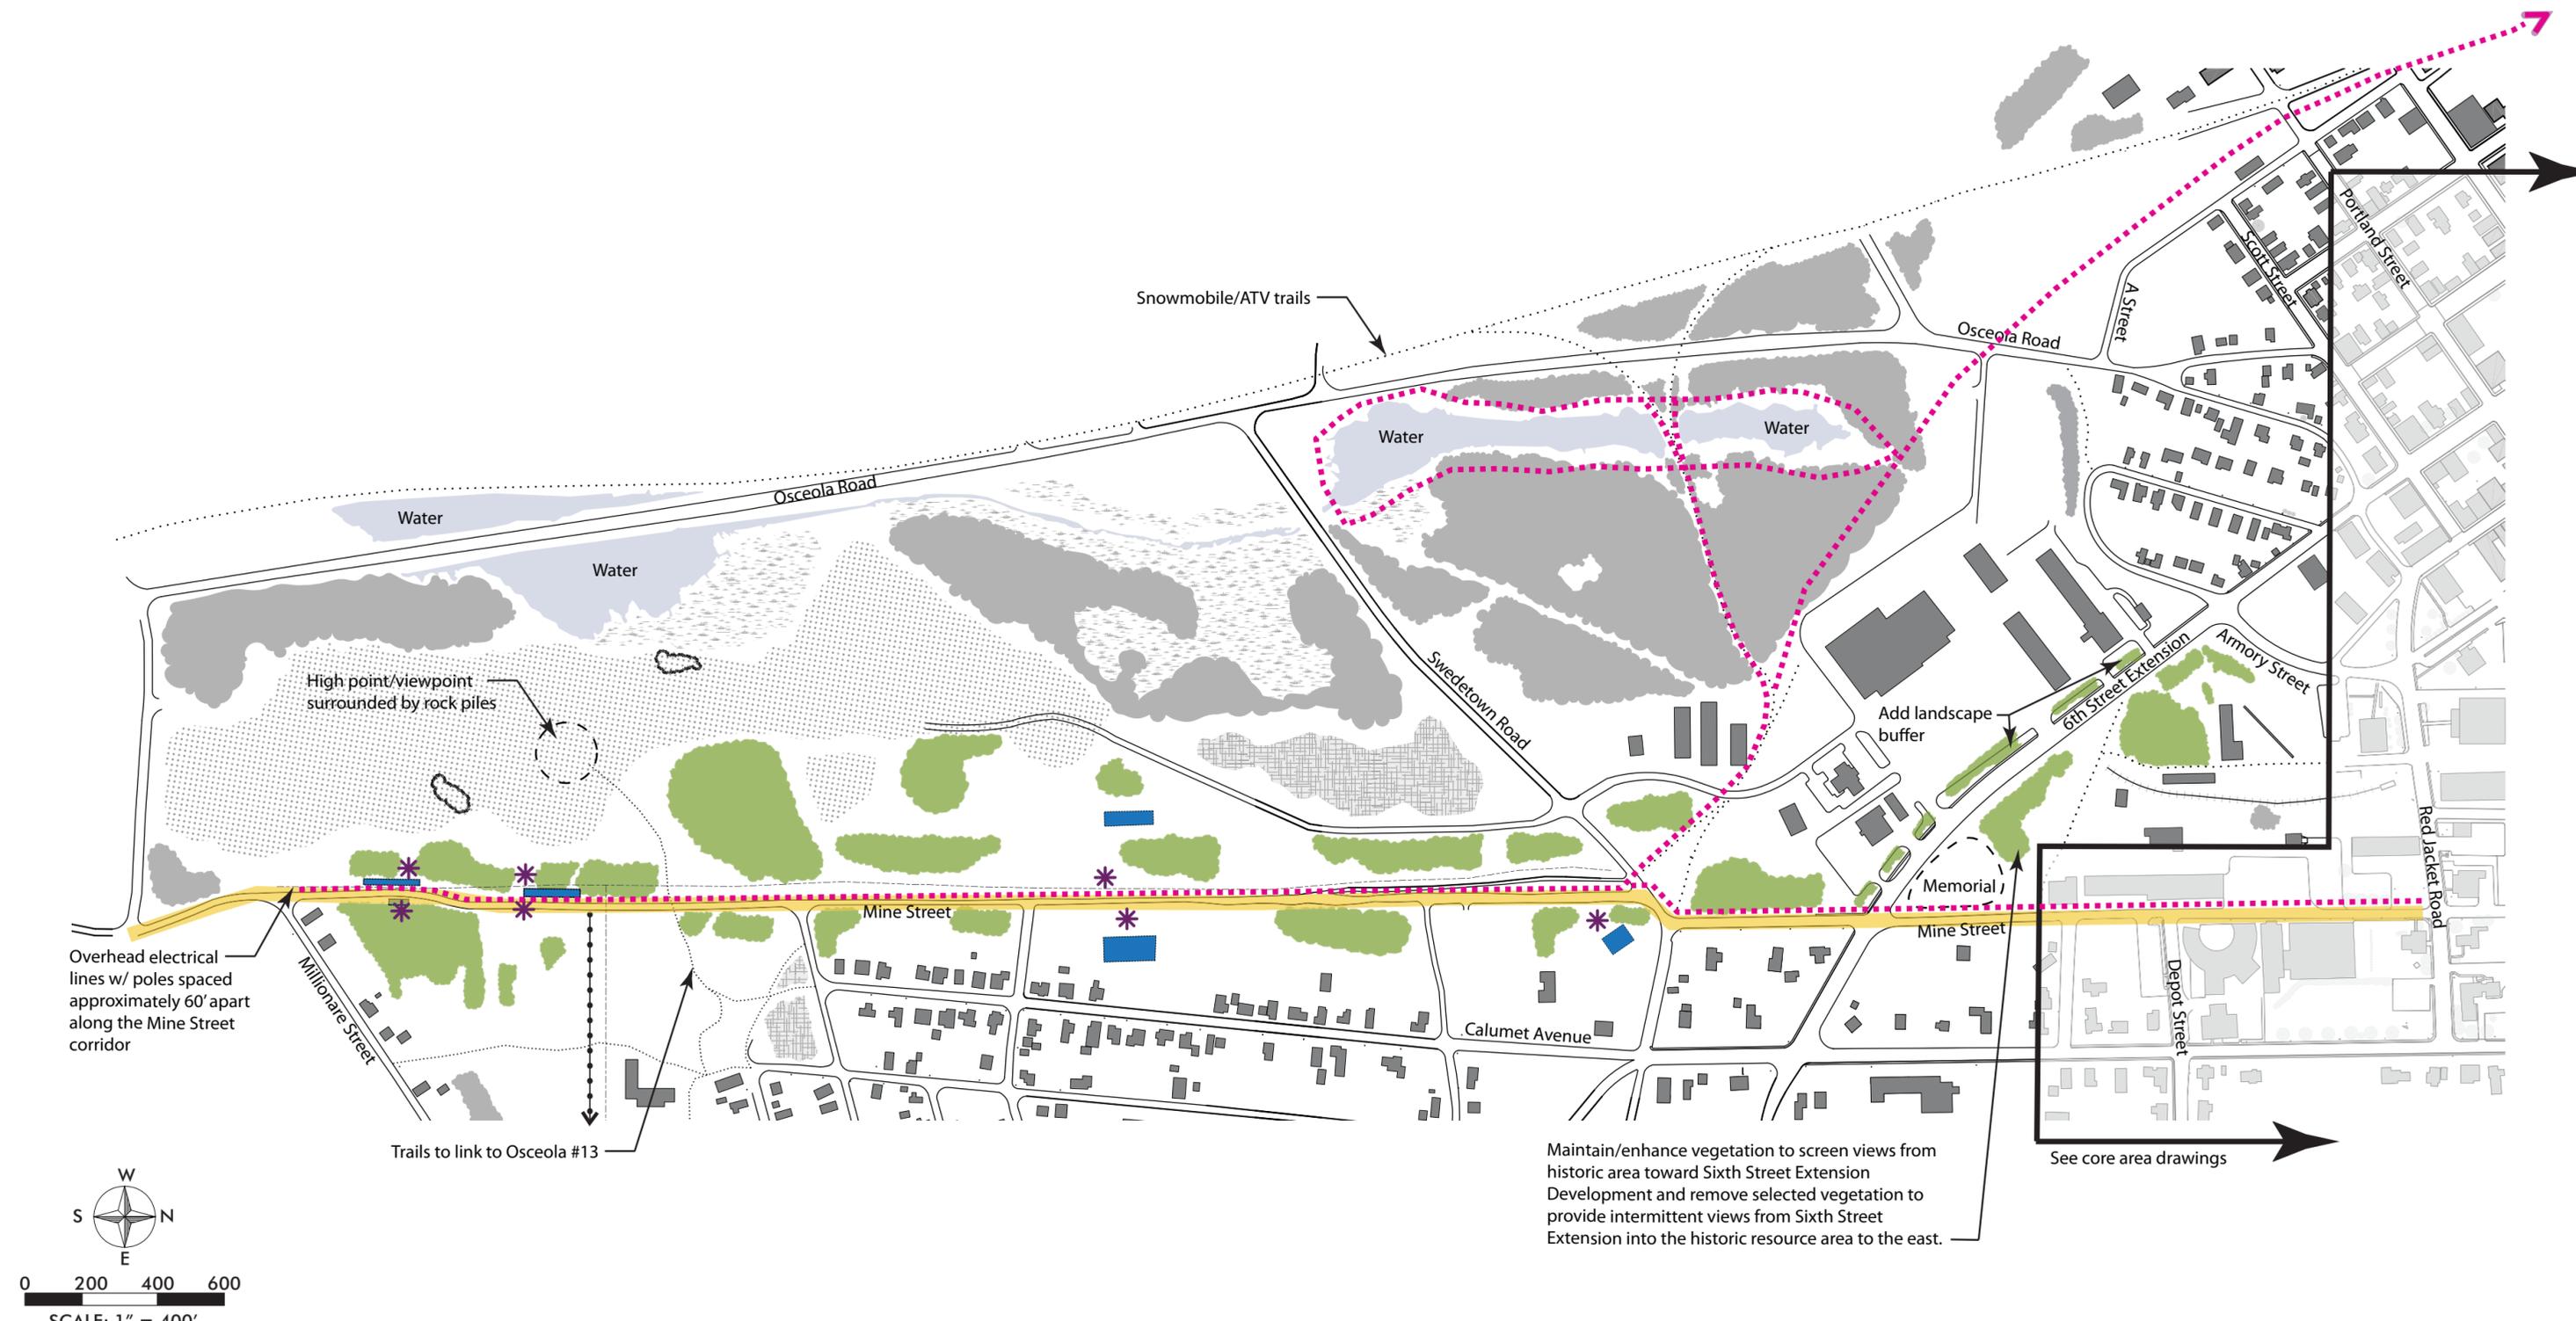
Figure V-3

**Figure V- 3: South Mine Street Corridor, Treatment Alternative B, Recommended Treatment**

Of the treatment alternatives considered for the South Mine Street Corridor, Treatment Alternative B is the recommended approach. Treatment guidelines for this area focus on preserving the extant historic features related to the mining activities, and providing opportunities for visitors to explore and learn about the history of the site, while providing recreational opportunities and pedestrian and bike links within the Calumet Unit. In addition, recommendations for vegetation management along the Sixth Street Extension are aimed at increasing views of historic features and screening views of non-historic structures to improve the overall character of this route. The guidelines are outlined below and illustrated in Figure V-3.

3. Buildings:
  - a. Assess the condition of the buildings and remnants within the corridor.
  - b. Advocate for the stabilization of the historic resources within the corridor.

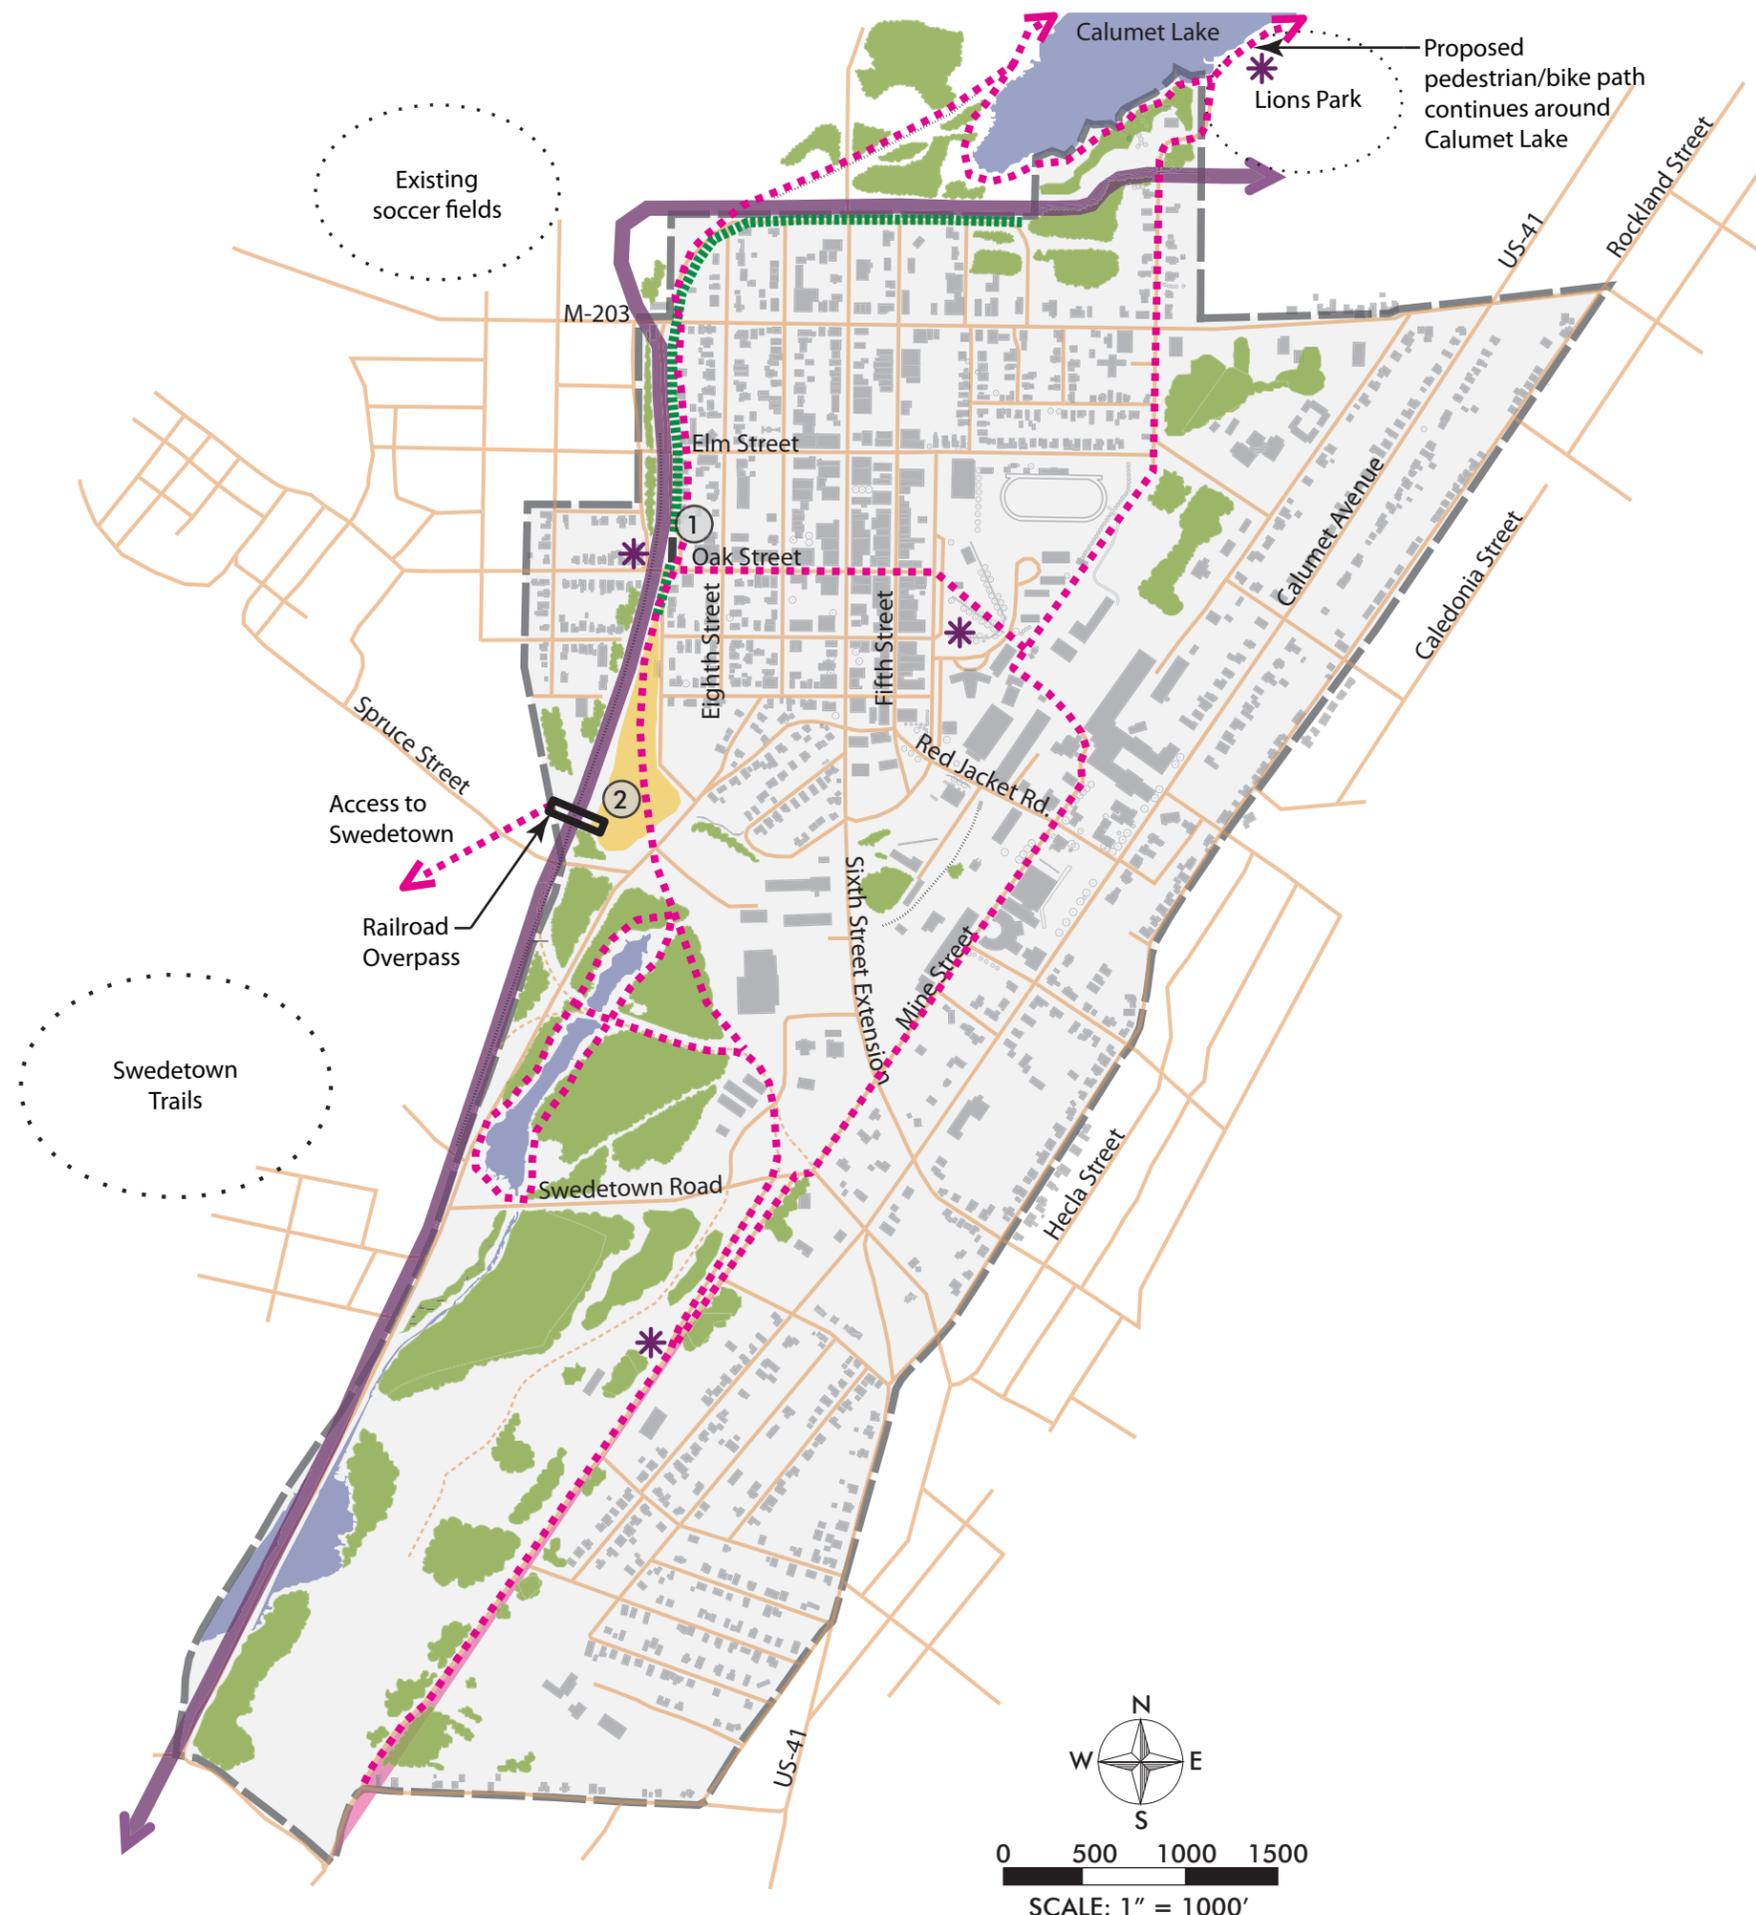
Figure V-4

15. Although a transportation study is beyond the scope of this CLR, recommendations for recreational corridors are provided. These include:
  - a. A pedestrian / bike path throughout the Calumet Unit, as indicated in Figures V-1 and V-4.

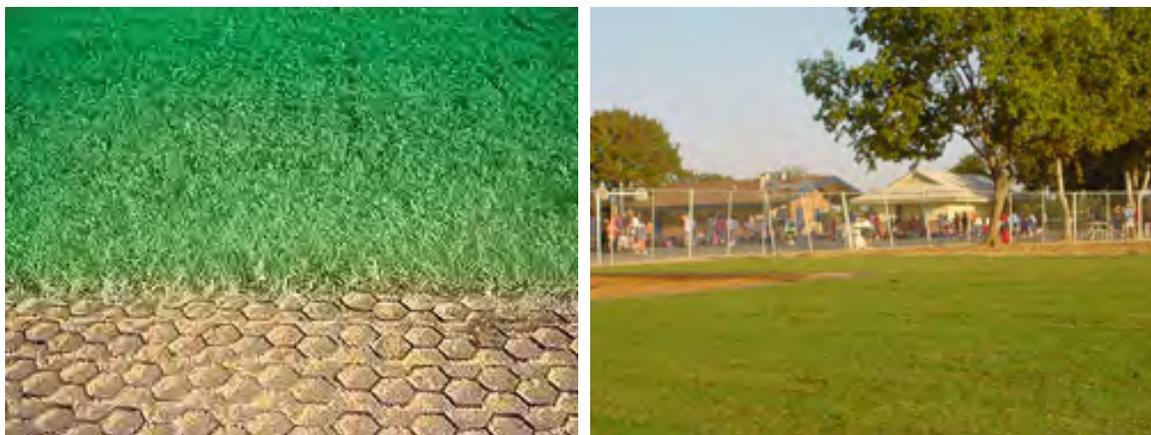
**Figure V-6: EZ Roll Grass Pavers, detail (left) and overflow parking area at play field (right).**

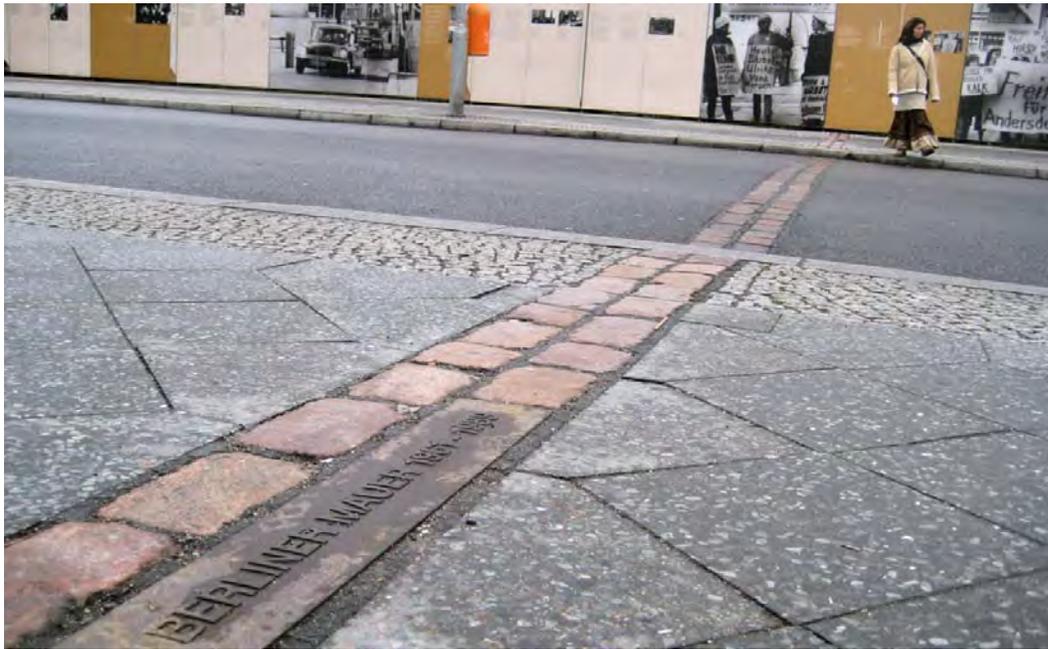
**Figure V-7: Example of interpretive paving pattern in Berlin. A similar approach could be used in Calumet using poor rock to illustrate the underground locations of shafts and the line between the shafts. A different paving pattern is used to indicate the footprints of non-extant historic buildings. (source: <http://thejetpacker.com/wp-content/uploads/2010/01/Berlin-Wall-Path.jpg>, accessed 7/14/2012)**

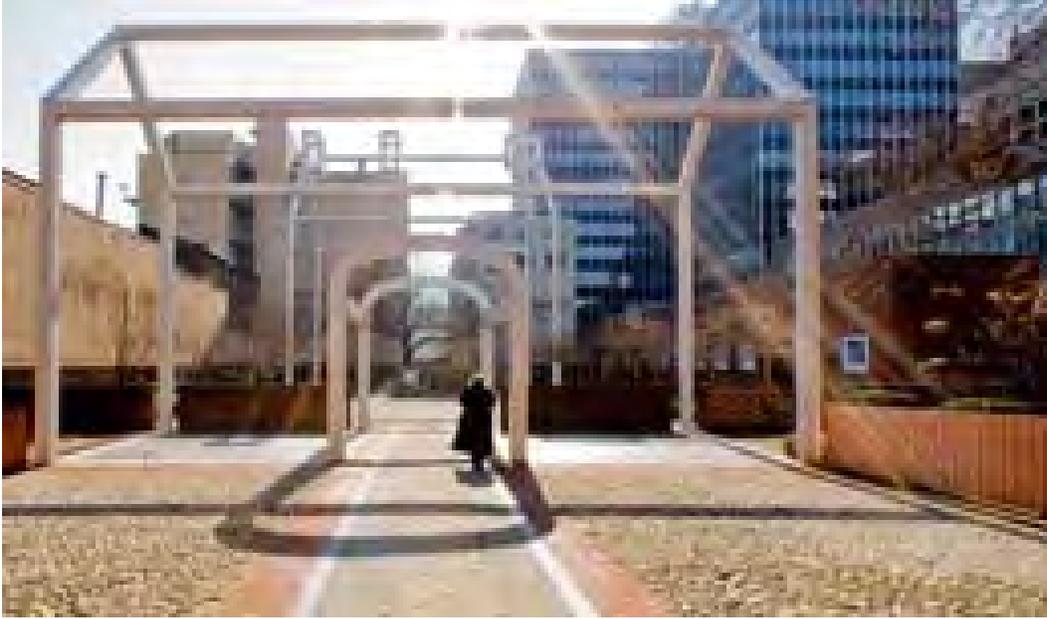
**Figure V- 8: Franklin Court paving illustrates building foundations and former landscape features.** (source: <https://www.google.com/search?q=Franklin+Court&hl=en&client=firefox-a&hs=lim&rls=org.mozilla:en-US:official&prmd=imvns&tbm=isch&tbo=u&source=univ&sa=X&ei=Z-E6T-KLEMOBgAeoltmYCw&ved=0CEoQsAQ&biw=1920&bih=951>, accessed 2/14/2012)

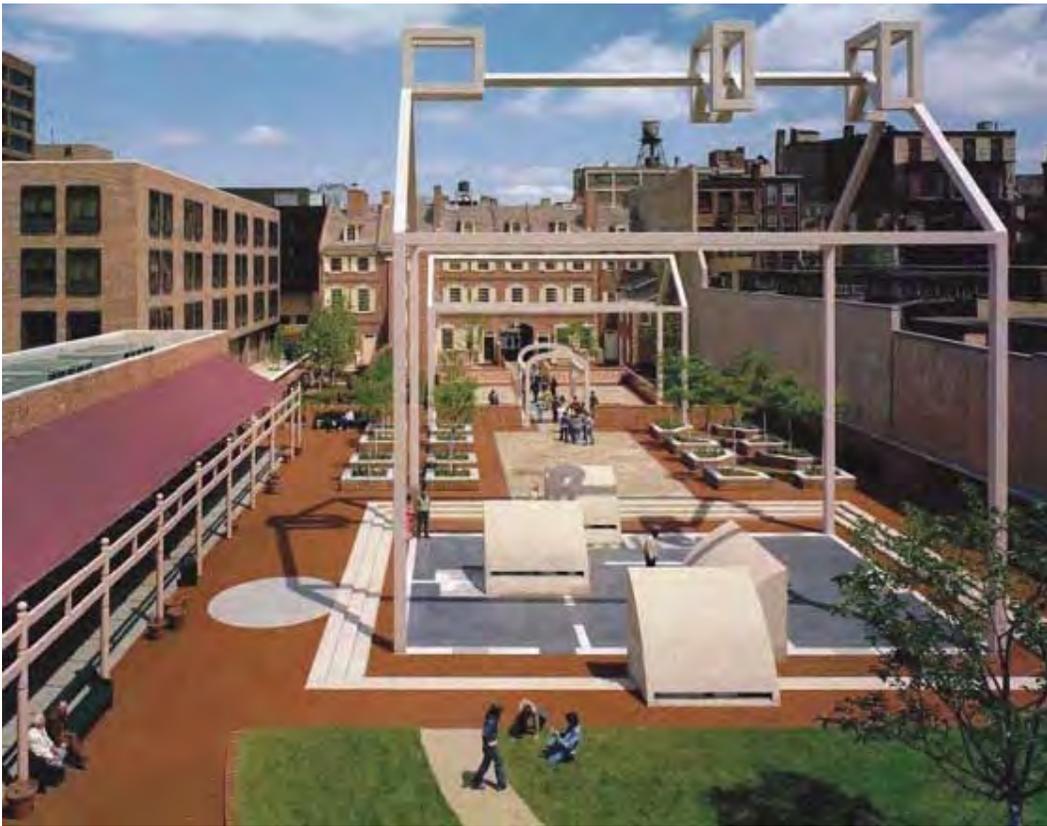
**Figure V- 9: Franklin Court, Philadelphia. Paving patterns, grade changes, and skeleton structures are used to represent non-extant historic features.** (source: <http://www.phillyarchaeology.org/news/aia051111.htm>, accessed 2/14/2012).
