Calumet Unit Historic Landscape

Cultural Landscape Report and Environmental Assessment

FINAL 2013

**Keweenaw National Historical Park**

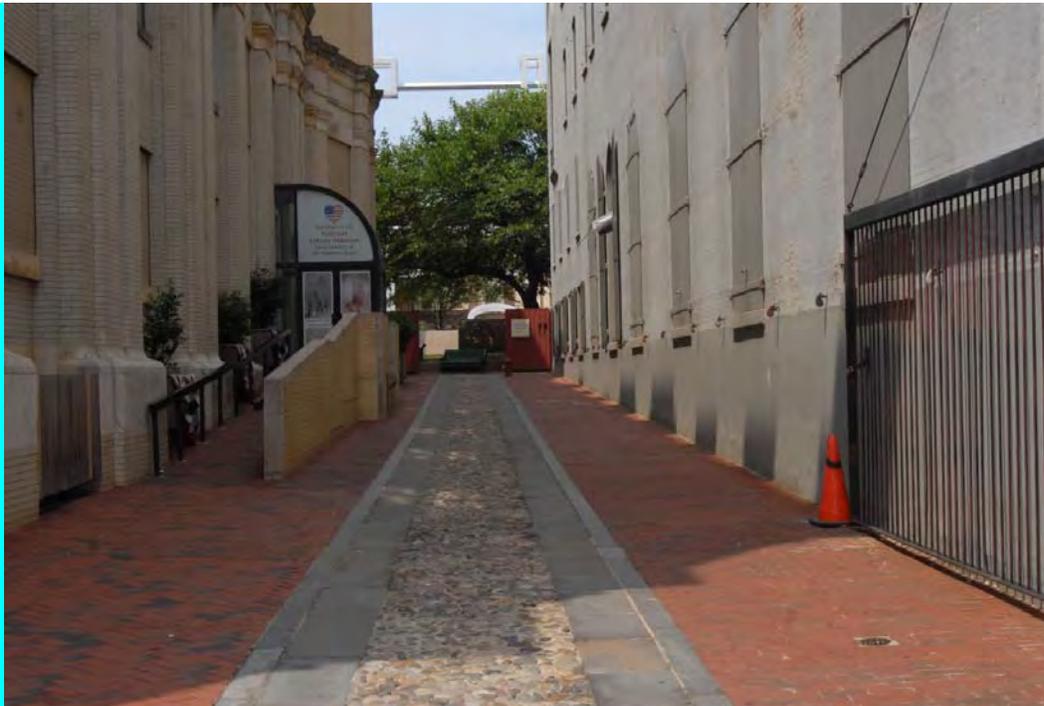
**Figure V- 10: Interpretive paving at Franklin Court in Philadelphia.** (<http://www.nps.gov/inde/Franklin-Court-Gallery.htm>, accessed 2/14/2012)

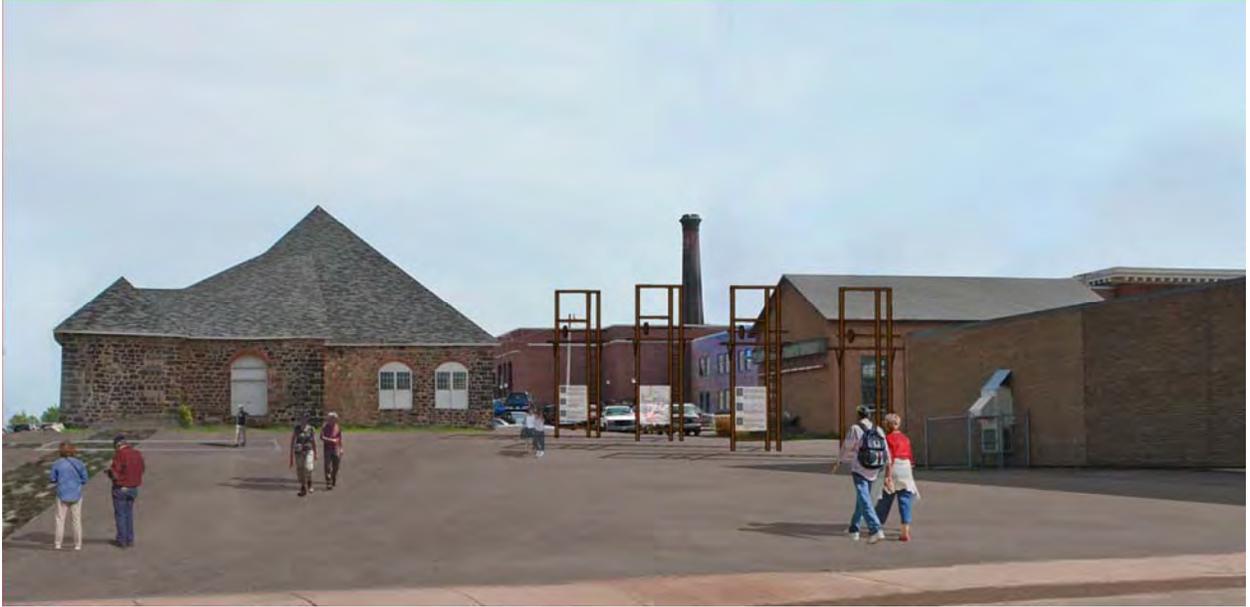
**Figure V- 12: Middle Section Red Jacket Road Corridor facing Northeast, Treatment Alternative C** (note: Sketch is for conceptual purposes only. Additional design development is necessary to address detailed issues.)

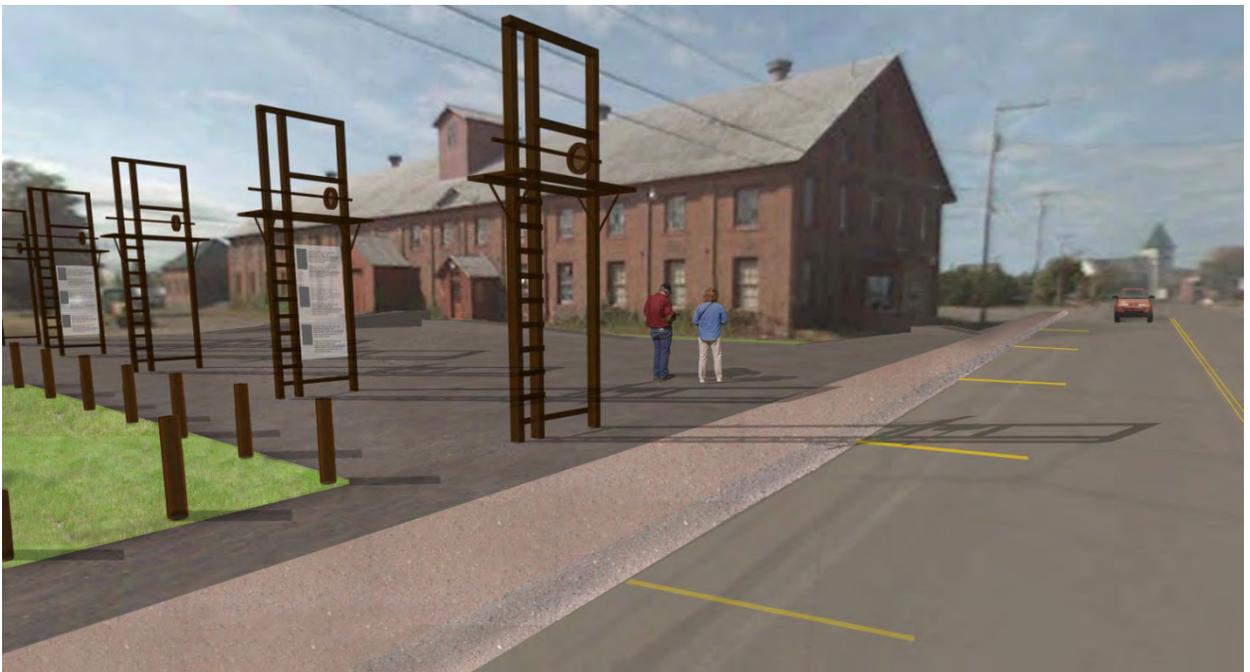
**Figure V- 13: Middle Section Red Jacket Road Corridor facing Southwest, Treatment Alternative C** (note: Sketch is for conceptual purposes only. Additional design development is necessary to address detailed issues.)
