# Submerged Cultural Resources Site Report

CHARLES H. SPENCER  
MINING OPERATION AND  
PADDLE WHEEL STEAMBOAT

GLEN CANYON NATIONAL RECREATION AREA

Southwest Cultural Resources Center Professional Papers  
Number 13

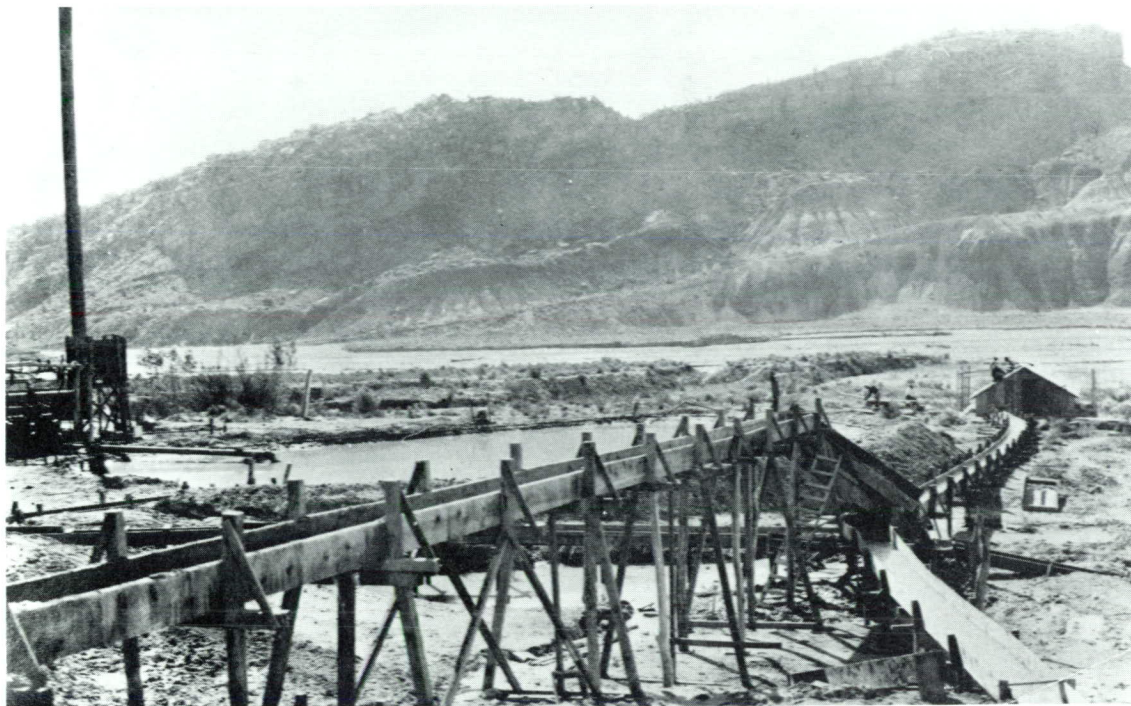
Figure 2.2. The long flume at Paria Creek, set up in late 1909 or early 1910, was used to carry the sluiced silts from the cliff to the amalgamators by the river. This arrangement was similar to the set up at Lee's Ferry. Courtesy W. L. Rusho.

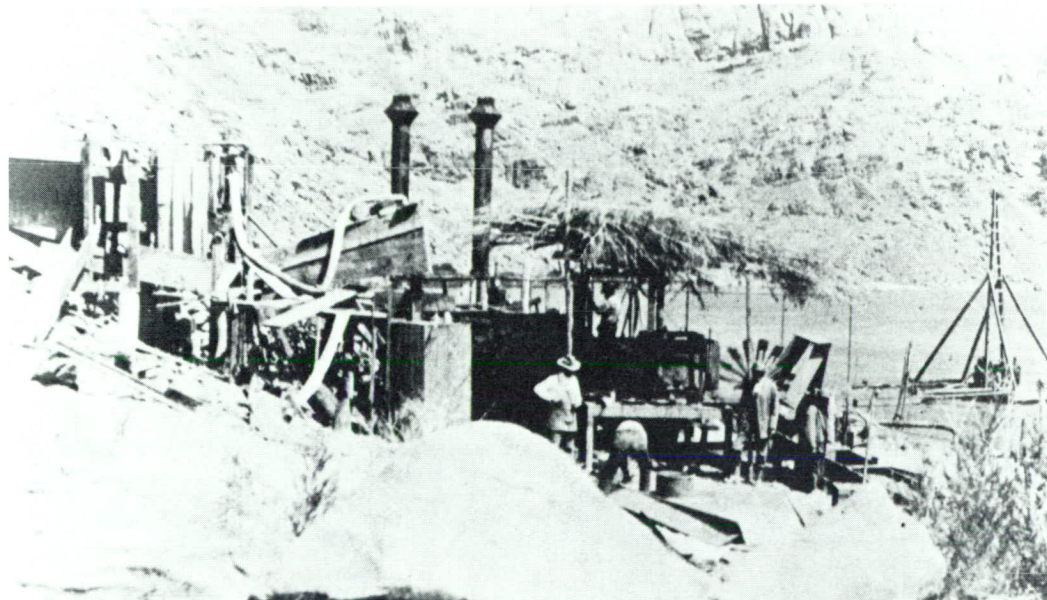
Figure 2.3. The boilers, pump, and amalgamator, set up on shore near the ramada, as well as a pipe dredge, were set up by Charles Spencer at Lee's Ferry in 1911 in an effort to extract gold from both the nearby cliffs and riverbed. National Archives Photo.

for fuel (Wilson 1961:24). A pipe dredge, a device that injected air and water under high pressure directly down into the ground forcing sand and fine particles up through a casing, was tried. The pipe dredge was set up on a gravel bed near the river bank, unfortunately just below the surface they hit coarse rock and the casing would sink no further. The experiment was given up as a failure.

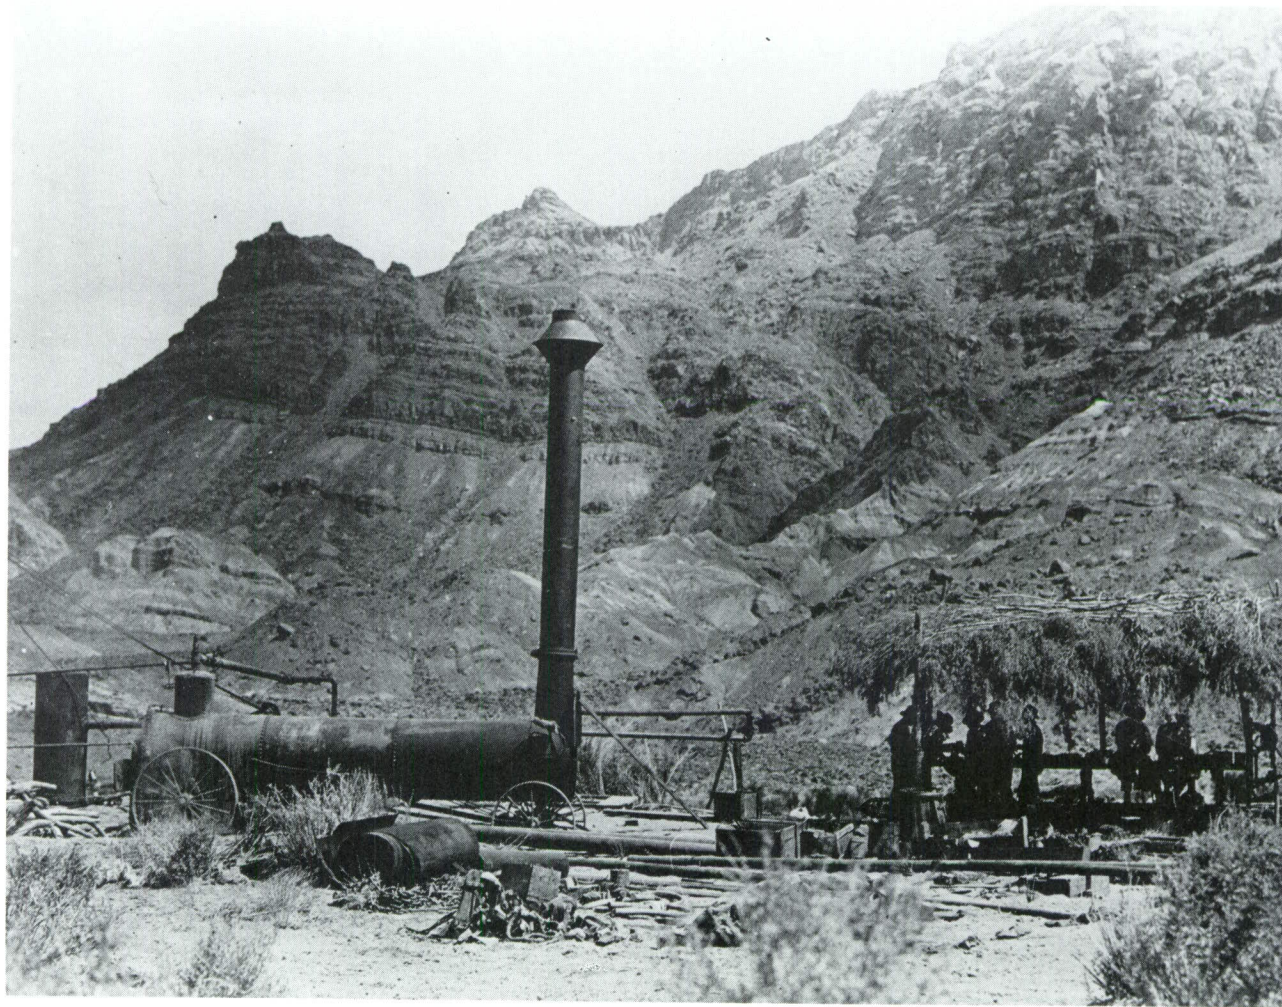
Figure 3.5. Boiler used to operate a small water pump and air compressor connected to the Lovett pipe dredge. The nozzle of the dredge can be seen extending out of the left side of the ramada. Photo by A. H. Jones, August 1910. Courtesy W. L. Rusho.

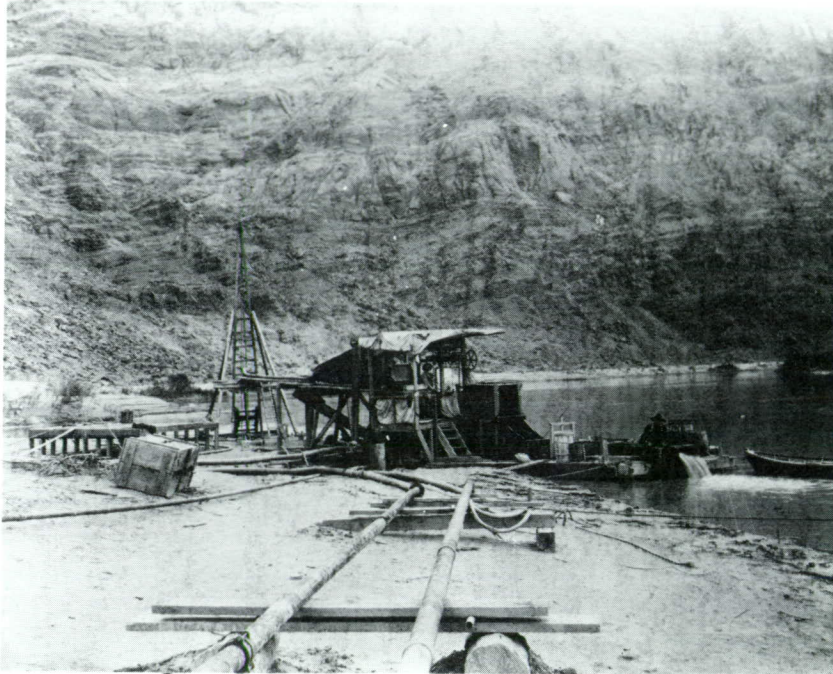
Figure 3.8. The amalgamator at Lee's Ferry. The pipes in the foreground connect the boiler/compressor to the pipe dredge in the left background. From the dredge, the discharged sand was fed to the amalgamator where efforts to extract the gold particles from the sand were carried out. Photo by Emery C. Kolb, November 1911. Special Collections Library, Northern Arizona, Northern Arizona University.

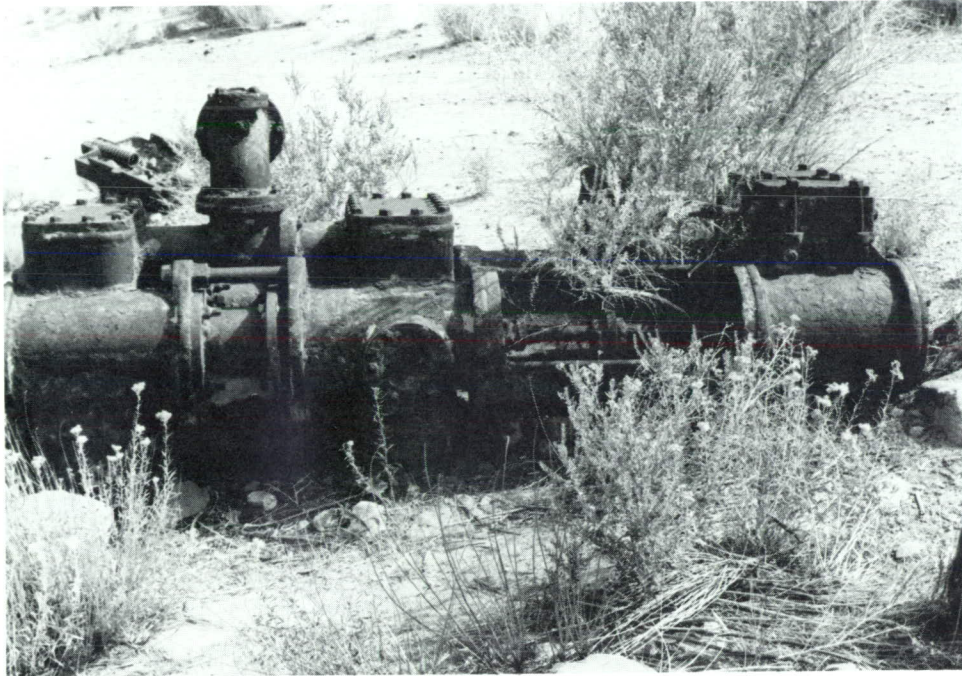
Figure 3.10. Closeup of the remains of one of Spencer's pumps used to convey water from the river to the hydraulic nozzles at the base of the cliffs. Photo by J. Bradford.

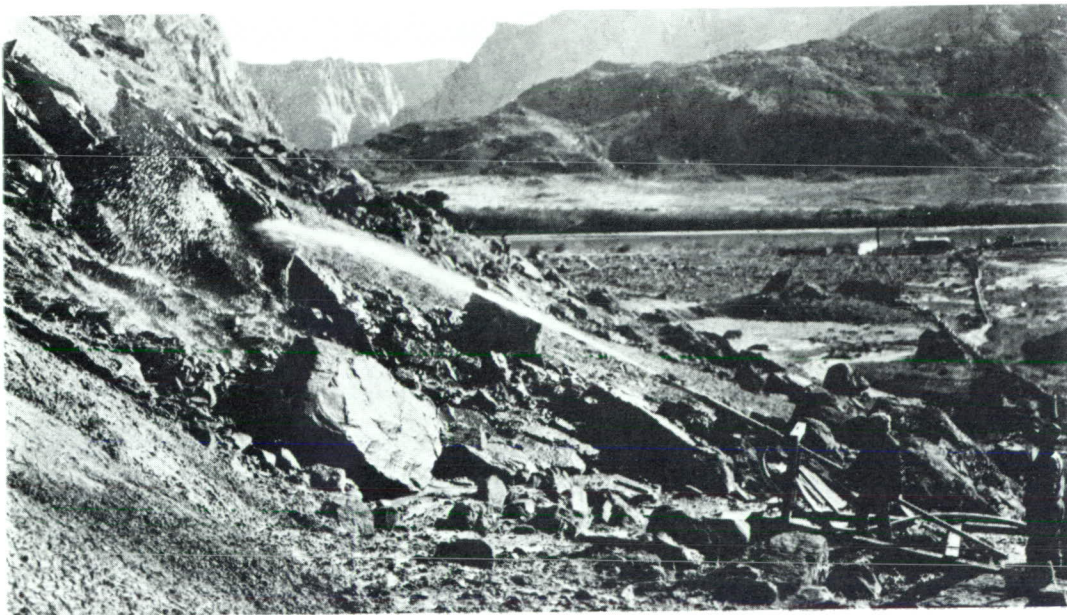
Figure 3.11. Hydraulic mining of the Chinle formation at Lee's Ferry in 1911. Water was pumped from the river, through the hose to the monitor or nozzle. The runoff was collected in a flume (right) and returned to the amalgamators at the river. Photo from Charles H. Spencer. Courtesy W. L. Rusko.

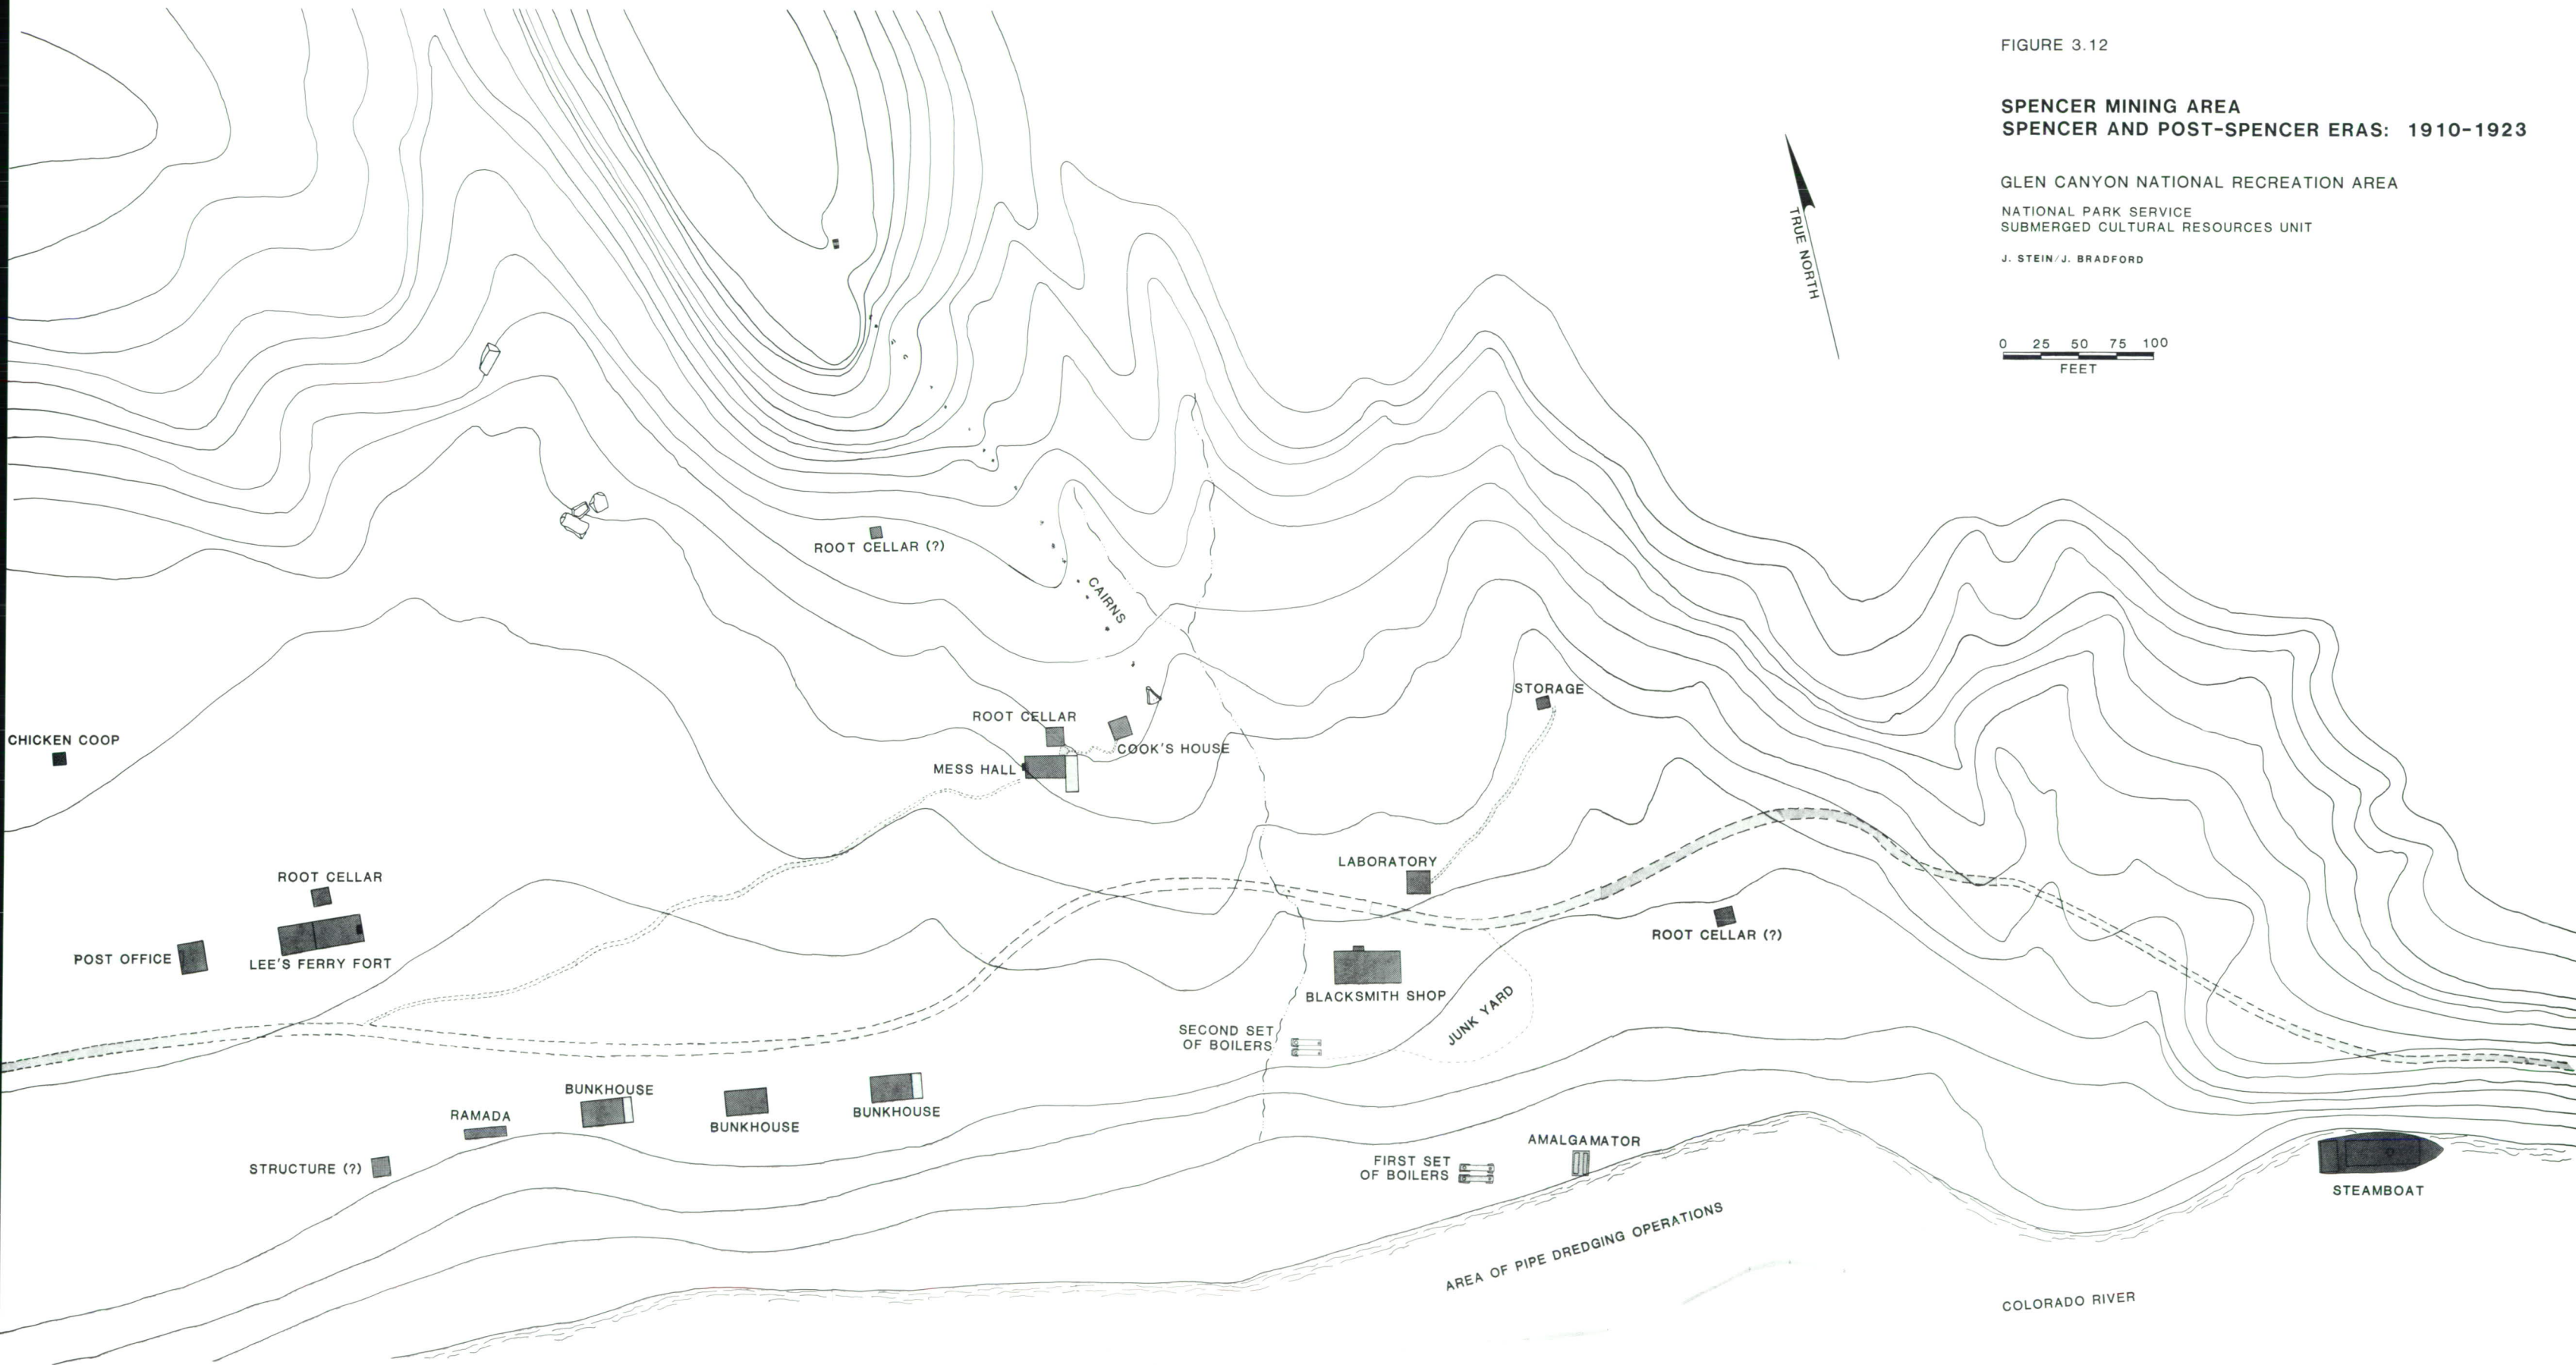
Figure 3.12. Map of the Spencer mining area depicting the location of all major features as they appeared at the end of the Spencer era and with additions from the post-Spencer decade.

The above inventory of buildings and associated features represent what still remains from Spencer's activities during the period of May 1910 to the summer of 1912 (Figure 3.12). During this time Spencer spent a considerable amount of money invested in the Chicago-based American Placer Corporation. Although the remoteness and geography of the area made mining efforts most difficult, Spencer succeeded in establishing a small community of several stone buildings and employed numerous people. As with all mining speculations in the Glen Canyon area, Spencer's was doomed to failure due to problems that the technology of the day could not overcome. Although a few men employed by Spencer stayed around Lee's Ferry and/or Paria after the operation went broke, the physical remains of the operation were, by late 1912, essentially abandoned by Spencer and left for other's use. As described by Mrs. Mary Harker who moved to Lee's Ferry in April 1913, "Spencer's mining venture had failed, and there was mining equipment all over the place, just rusting away. I remember that a steamboat was tied up along the river bank..." (Rusho 1965:1).

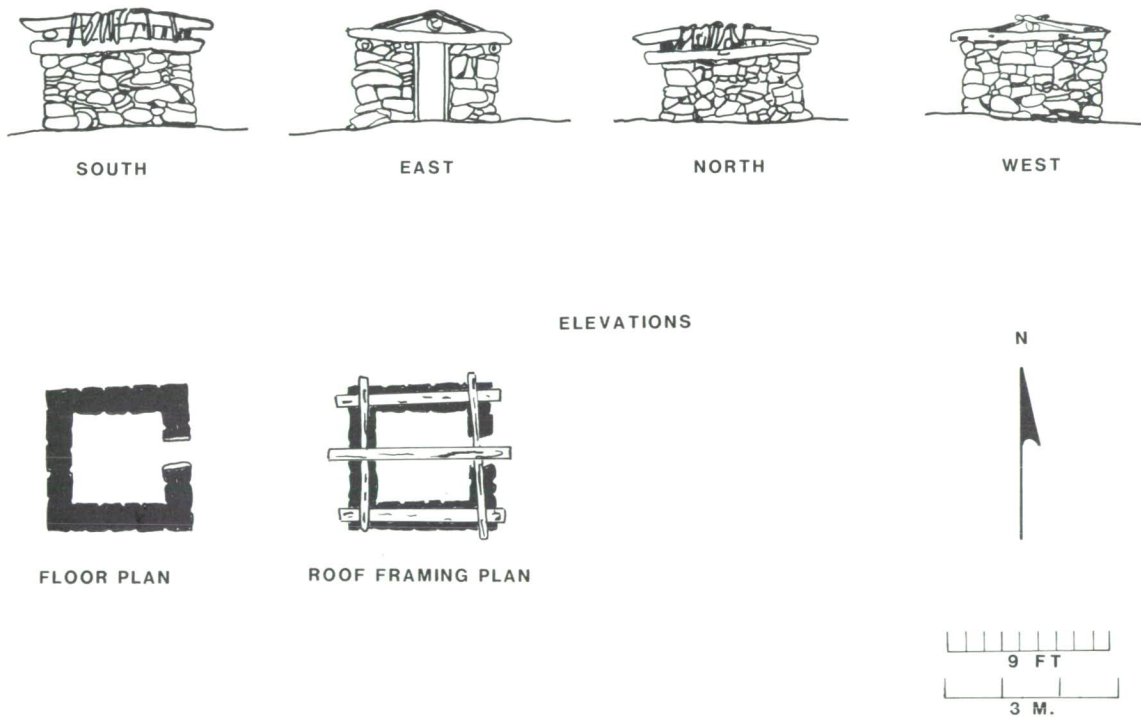
Figure 3.15. Plan and elevation drawings of the chicken coop located northwest of the fort. Adapted from Historic American Buildings Survey records.

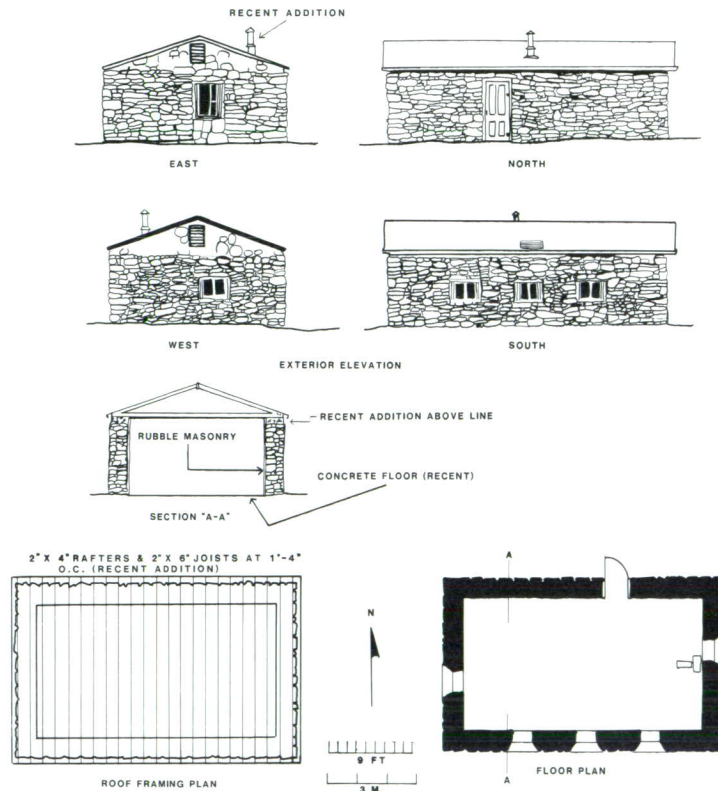
Figure 3.18. Plan and elevation drawings of Spencer's bunkhouse later remodeled into a laboratory by the USGS. Adapted from Historic American Buildings Survey records.

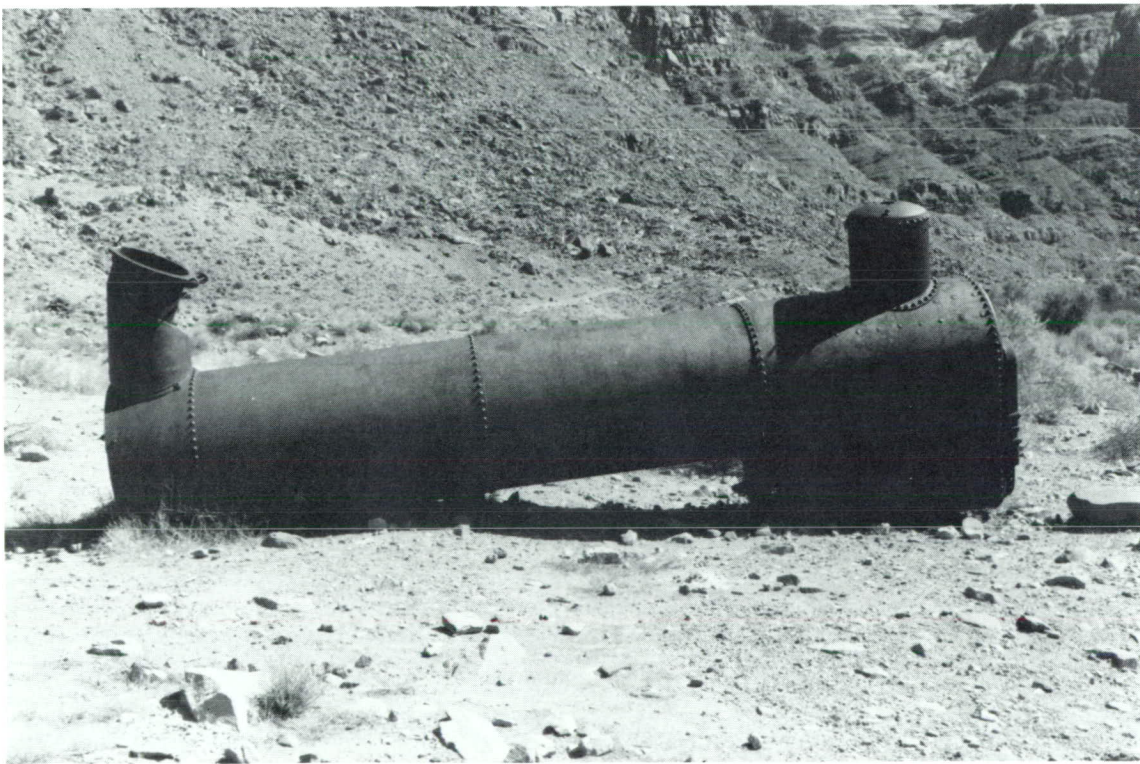
Figure 3.20. Side view of the boiler in its present condition. Photo by J. Bradford.

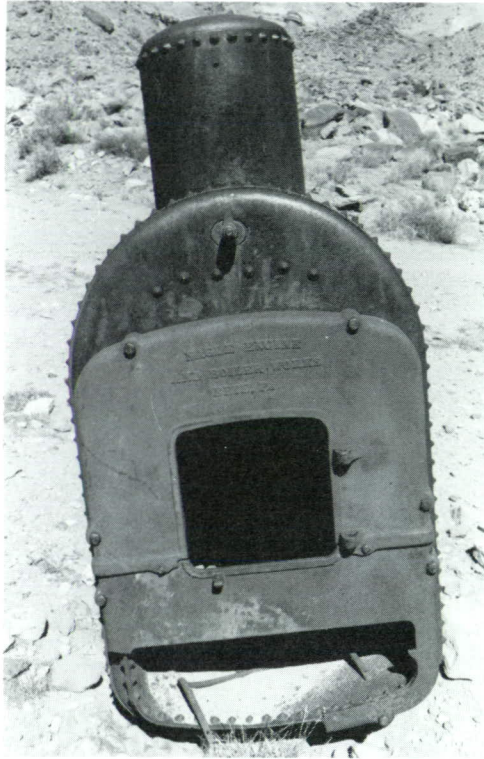
Figure 3.21. End view of the boiler showing the firebox, steam dome, and manufacturer's name. Photo by J. Bradford.

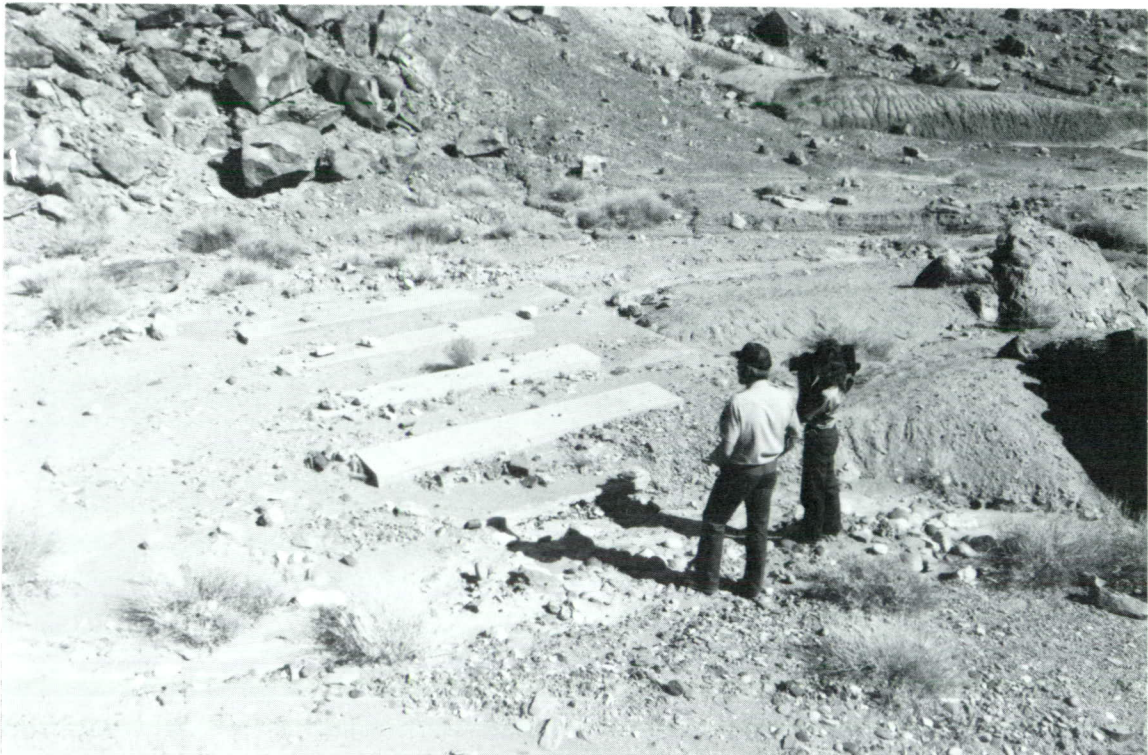
Figure 3.22. Remains of what may have been an amalgamator located northeast of the fort. The date of use of this feature is unknown. Photo by J. Bradford.

Near the head of the drainage that runs under the small wooden bridge are the remains of further mining activities. One feature is the concrete base of what may have been an amalgamator set up in the bottom of the drainage (Figure 3.22). The concrete base measures 19.3 feet north-south by 31.2 feet east-west and appears to have been built in two phases: 1) the lower section being a thick stone foundation with cement mortar, and 2) the upper portion consisting of a finished concrete platform that may have accommodated four sluice boxes. A section of a wooden flume, located just north of this feature, is constructed of 1-by-6-inch lumber, and measures 10.4 feet long by 1 foot wide. Two cuts in the hillside to the west of the cement foundation indicate that hydraulic sleds were, at one time, located on the mined slope. Just downstream from the possible amalgamator is a partially buried piece of circular steel almost 5 feet in diameter. It appears to be a guard that covered a pulley wheel or gear. All of this material is located within an area of obvious past mining activity. No record indicating that this immediate area was worked during the Spencer era has been located, but Rusho (1986: personal communication) believes that Spencer returned to mine at Lee's Ferry in the 1930s and that this particular area represents those efforts. Figure 3.23 indicates the major features at Spencer's old mining community at the close of the USGS era.

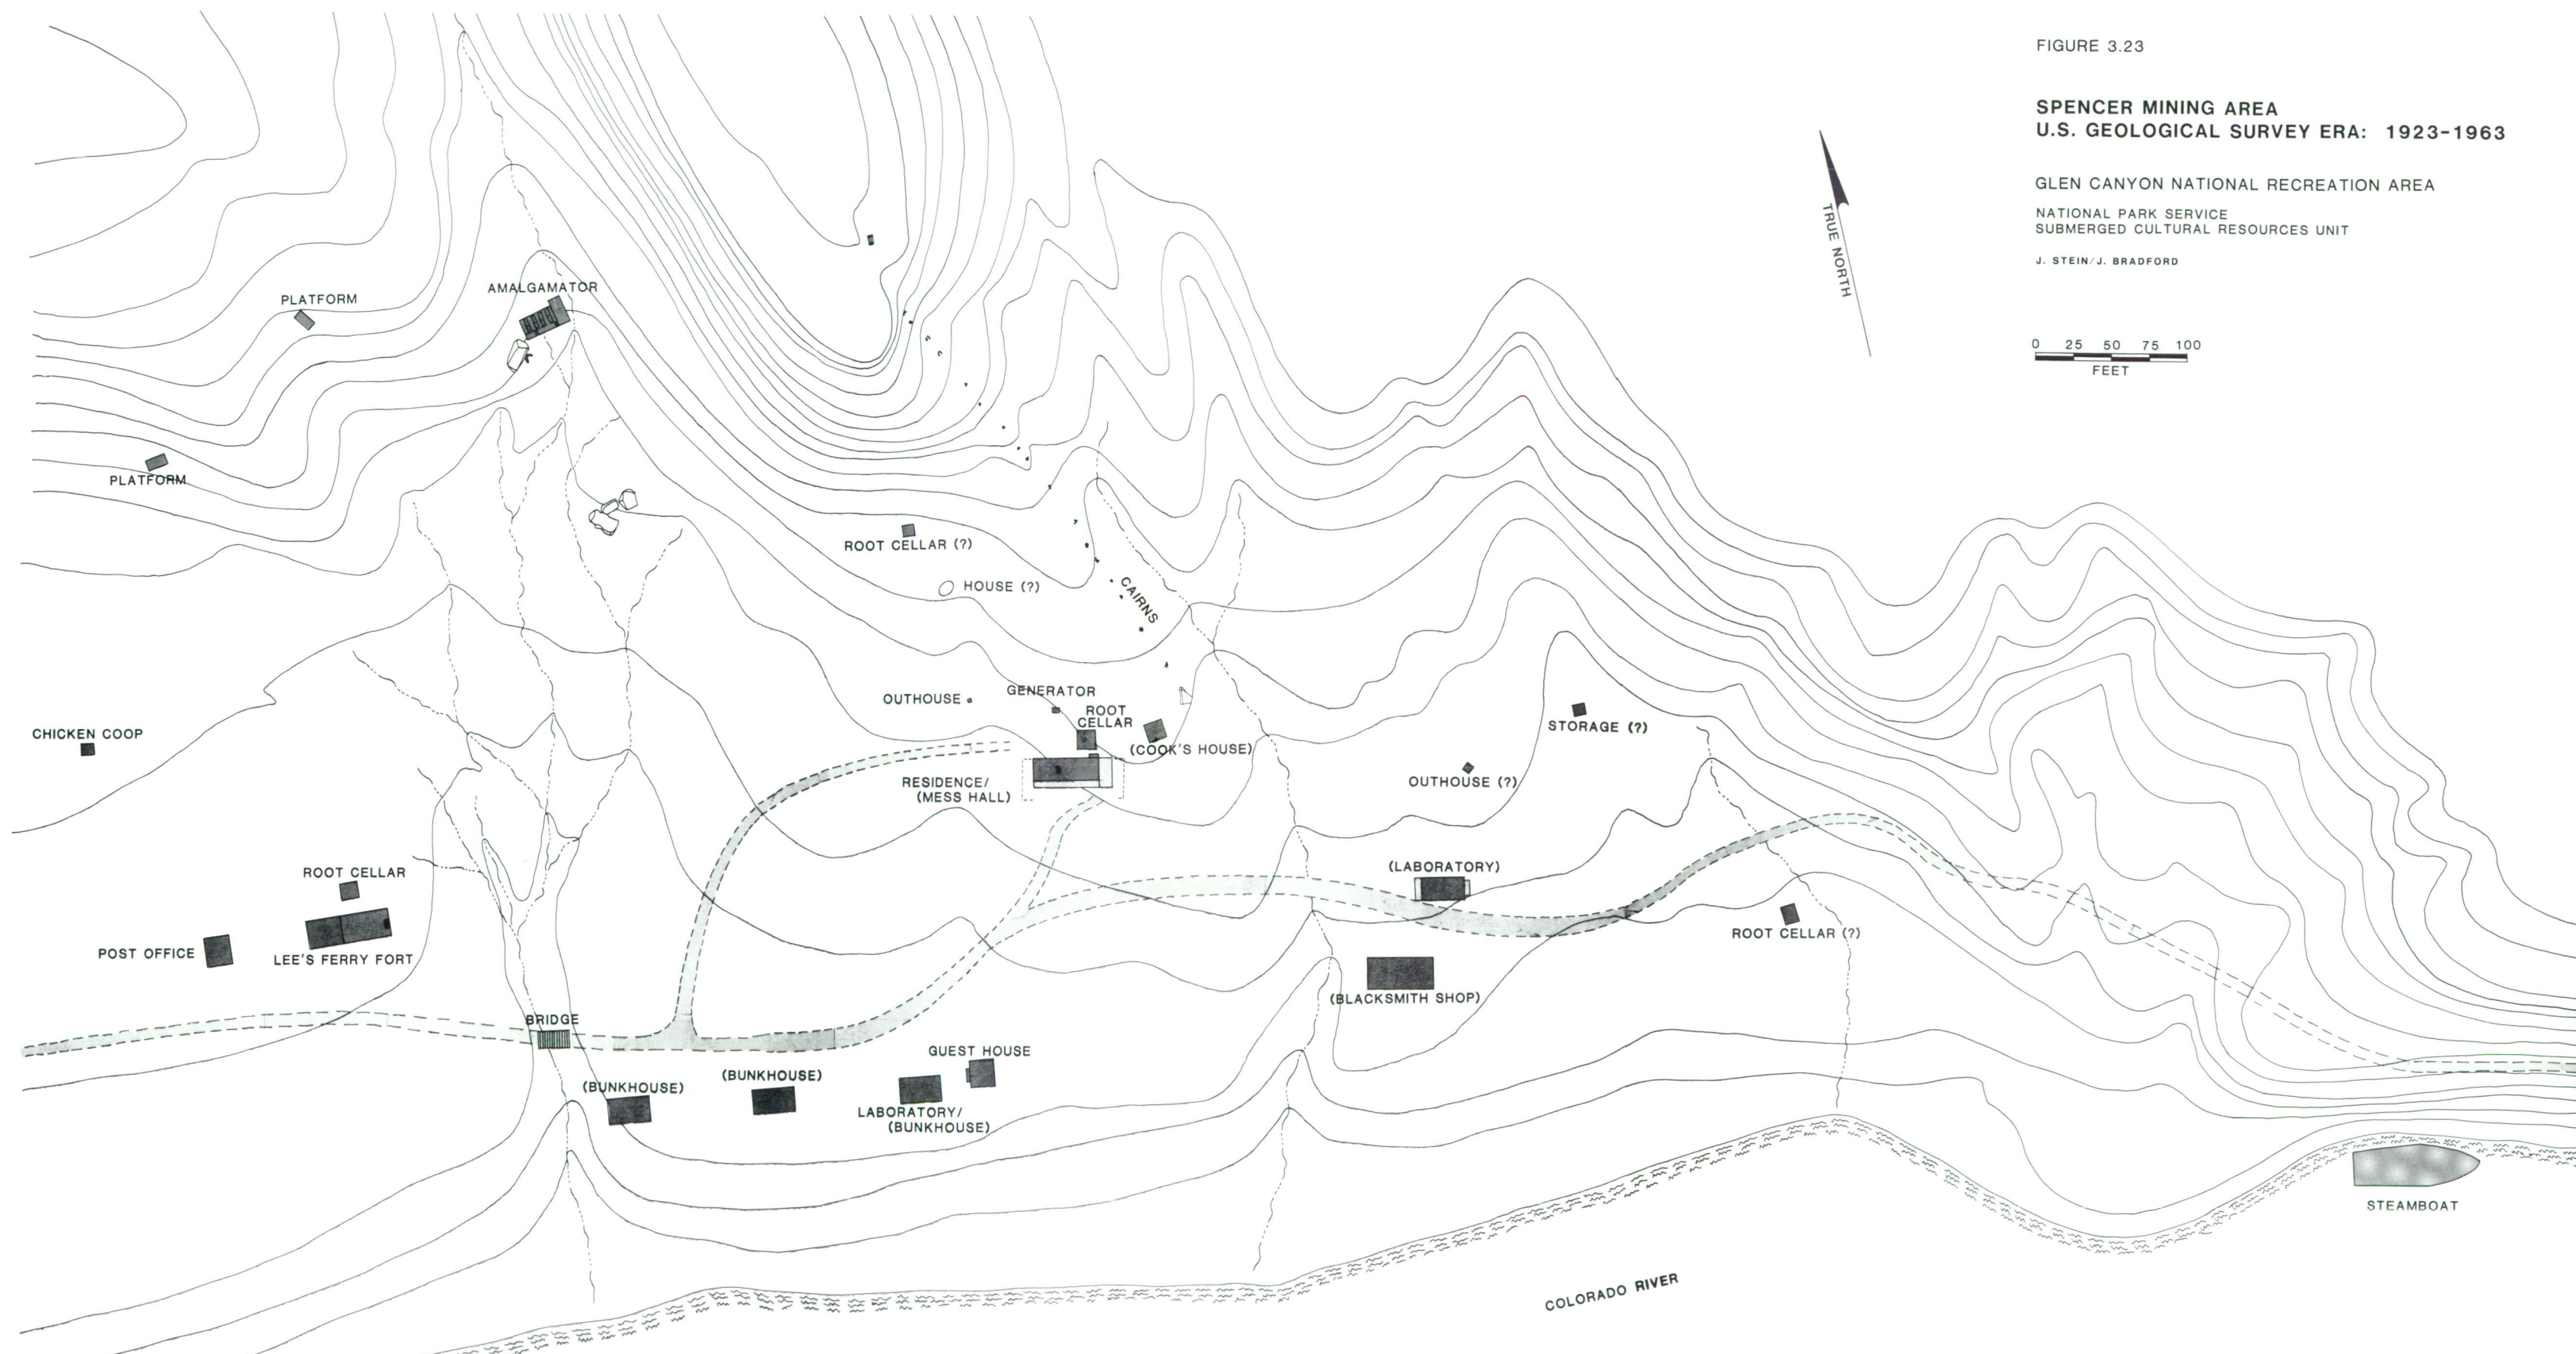
Figure 3.23. Map of the historic district as it appeared about 1963 at the end of the USGS era. Note the differences in the building configurations as compared to Figure 3.12.

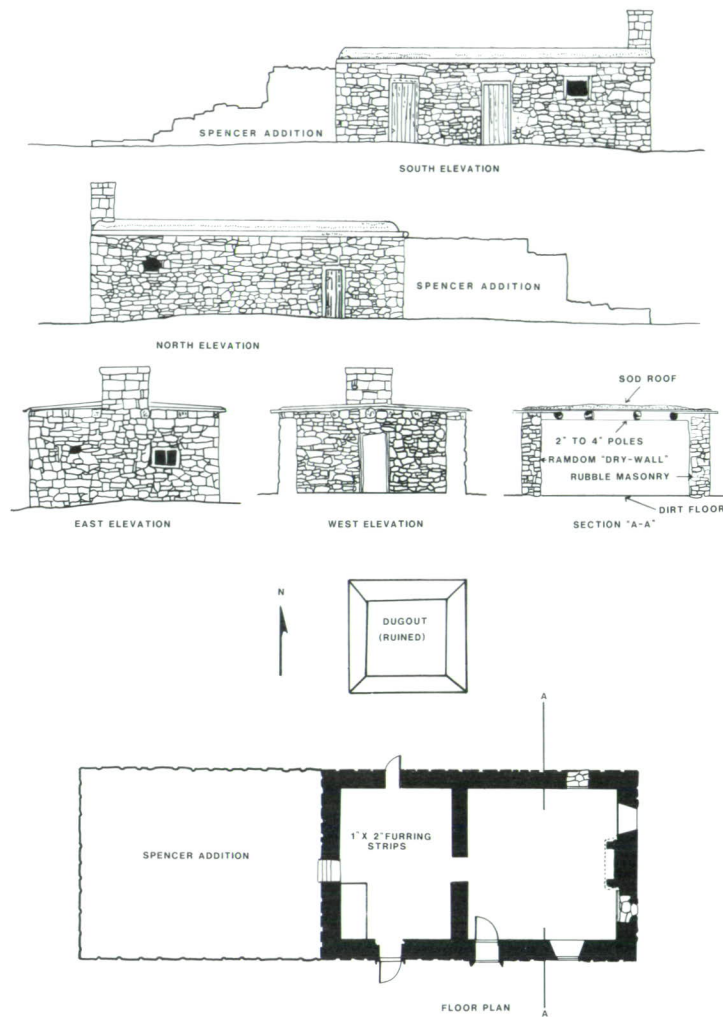
Figure 3.30. Plan and elevation drawings of Lee's Ferry Fort and the dugout immediately behind it. Adapted from Historic American Buildings Survey records.

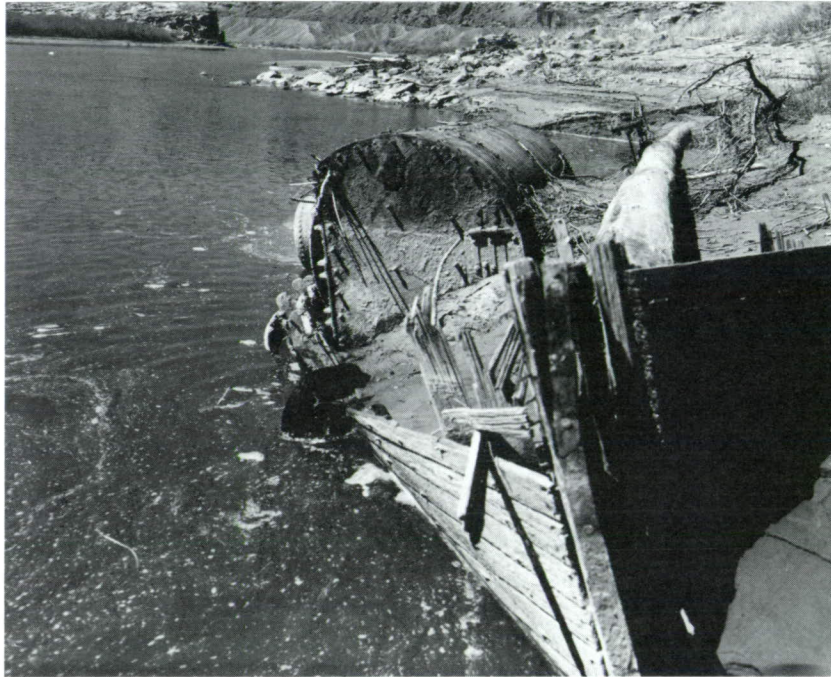
Figure 6.5 The bow of CHARLES H. SPENCER had deteriorated considerably by 1963. The small hand pump is still in place, however the boiler had rolled over onto the starboard side. Photo by W. L. Rusho.

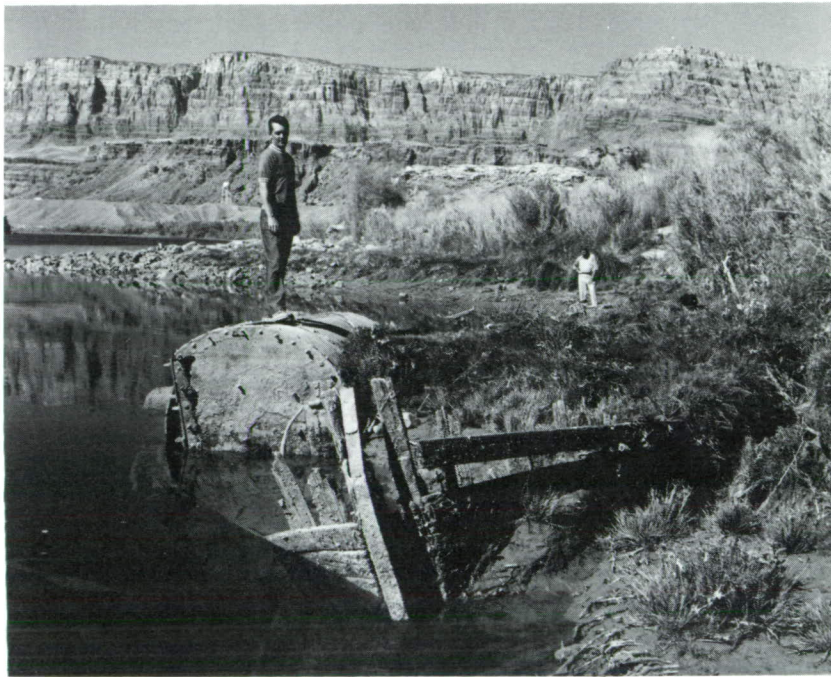
Figure 6.6 Ten years later, in 1973, the vessel was photographed from the same angle. Increased deterioration of the remains and extensive vegetative growth typified the site. Photo by W. L. Rusho

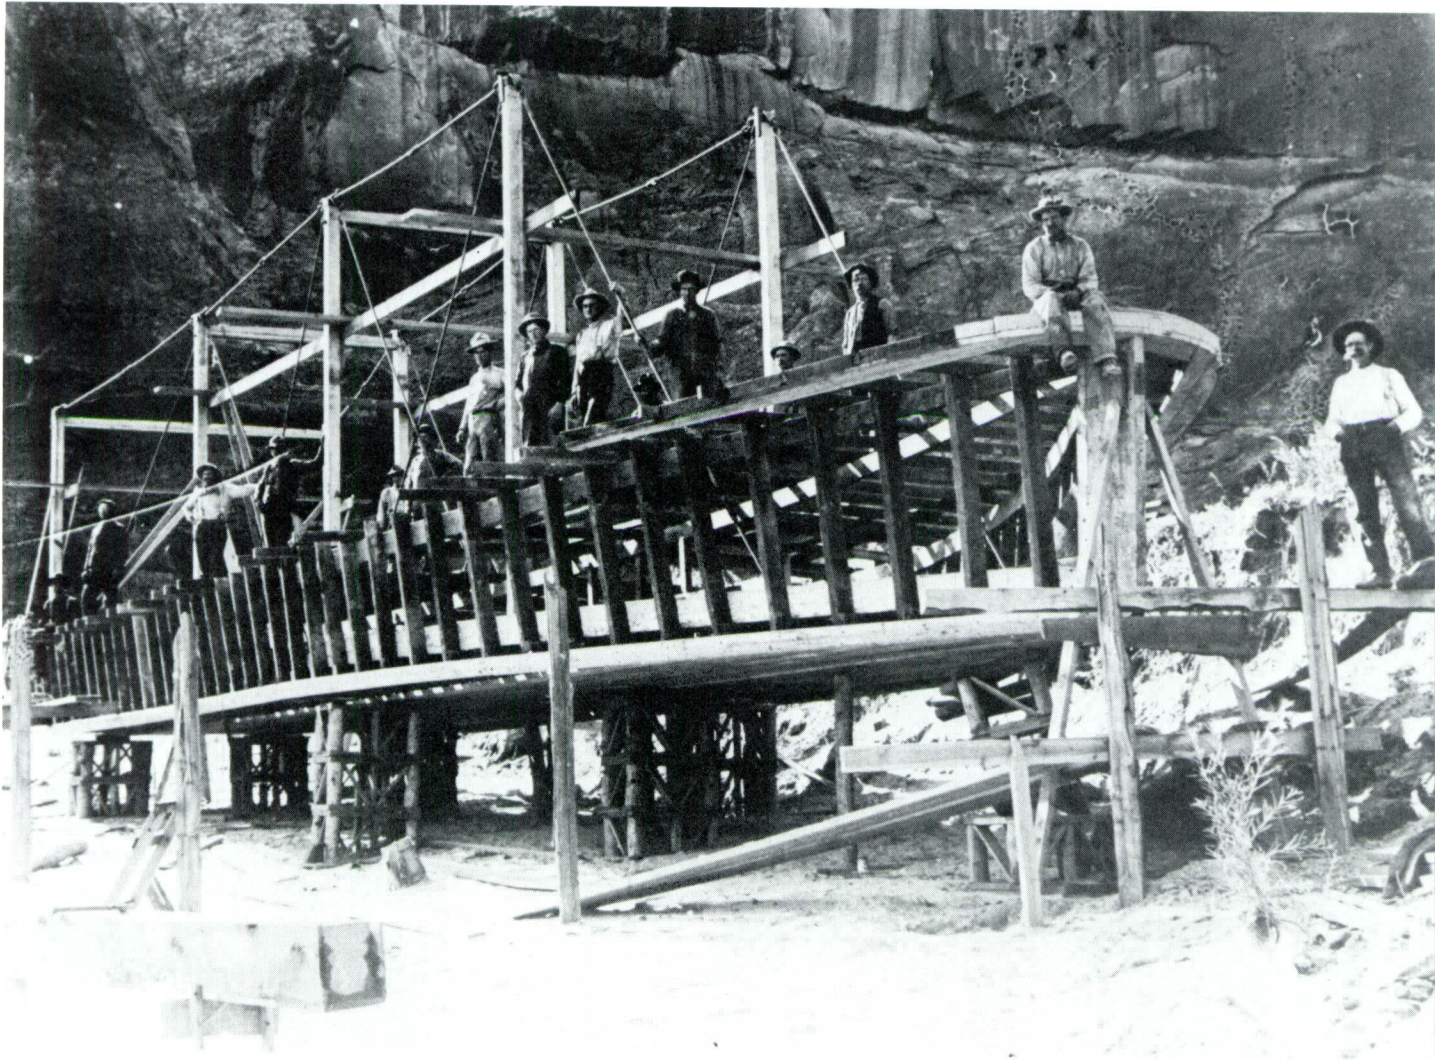
Figure 7.2 CHARLES H. SPENCER under construction at the mouth of Warm Creek, November, 1911. View from bow. Photo by C. Emery Kolb. Special Collection Library, Northern Arizona University. Courtesy of Bureau of Reclamation.

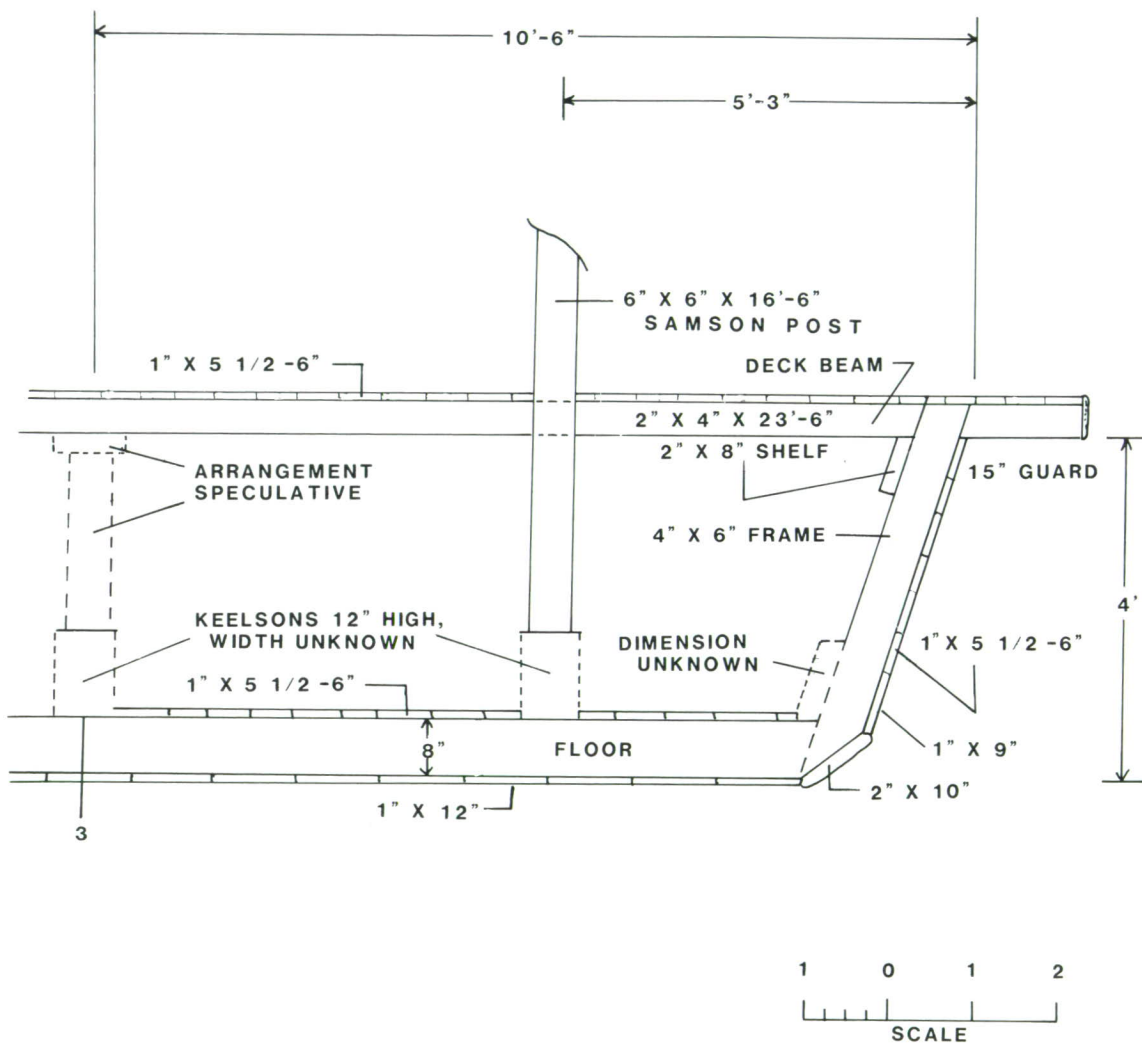
Figure 7.3 Hull cross-section, approximately amidships. View from stern.

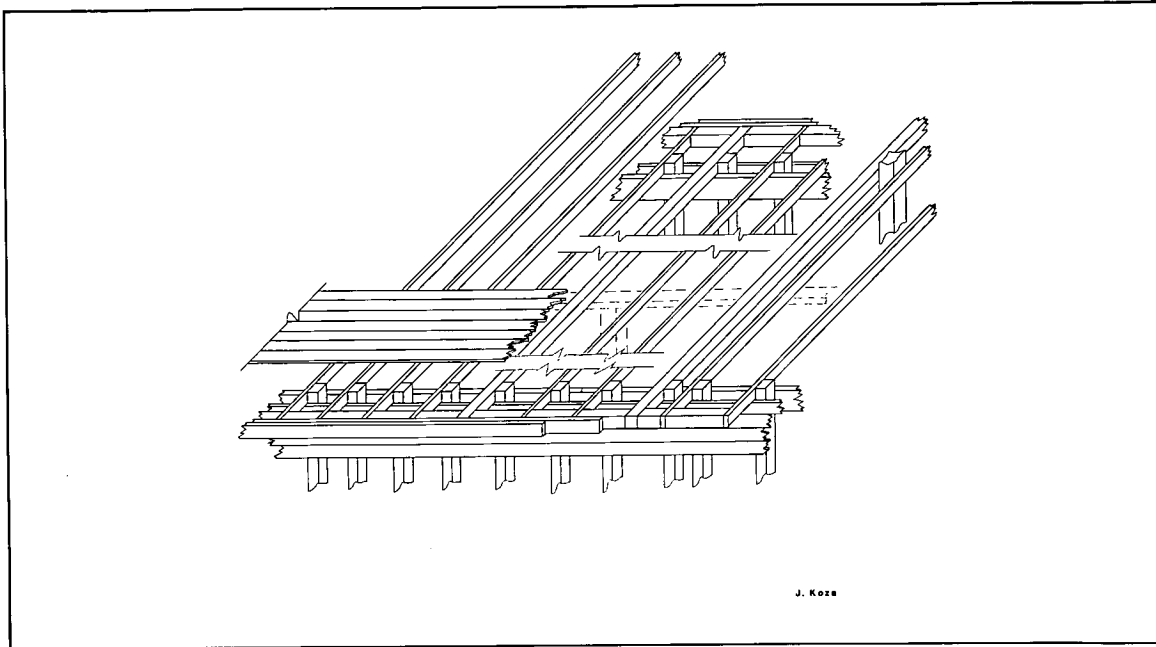
Figure 7.4 Exploded view of main deck construction.

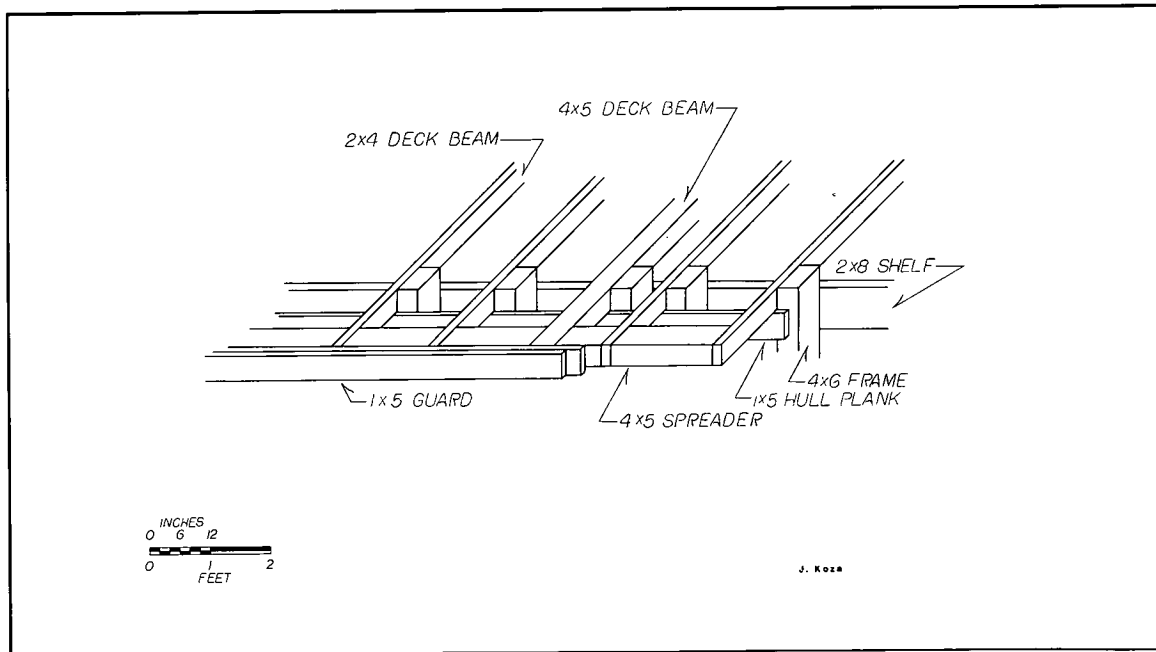
Figure 7.5 Detail of overhanging guard construction, approximately amidships.
