# Submerged Cultural Resources Site Report

CHARLES H. SPENCER  
MINING OPERATION AND  
PADDLE WHEEL STEAMBOAT

GLEN CANYON NATIONAL RECREATION AREA

Southwest Cultural Resources Center Professional Papers  
Number 13

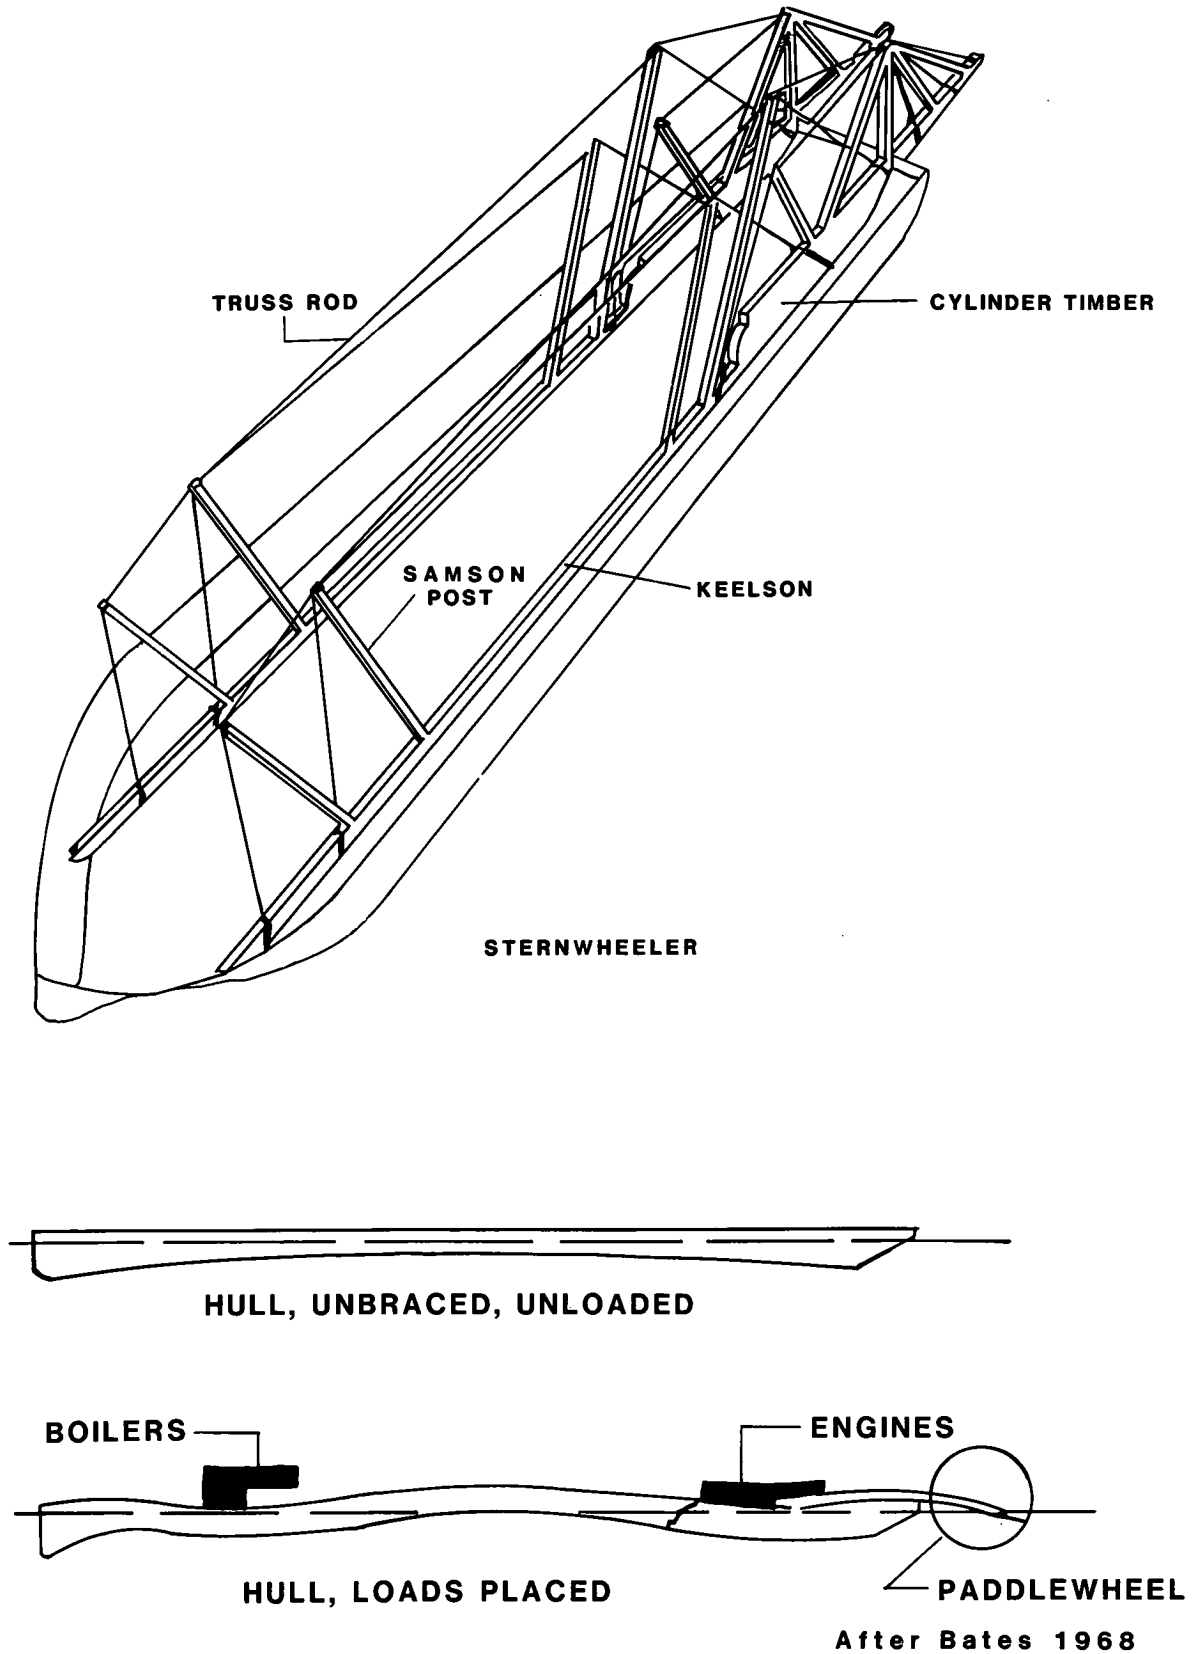
Figure 7.9 Typical arrangement of keelsons, cylinder timbers, samson posts, and truss rod on a stern paddle wheel boat and hull stresses as a result of boiler and engine loads.

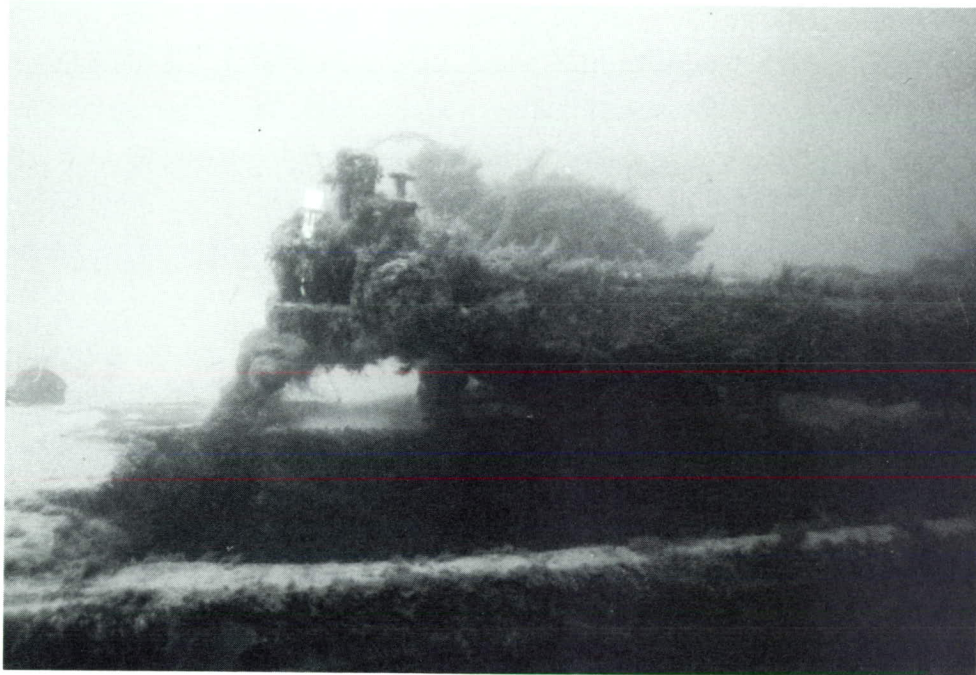
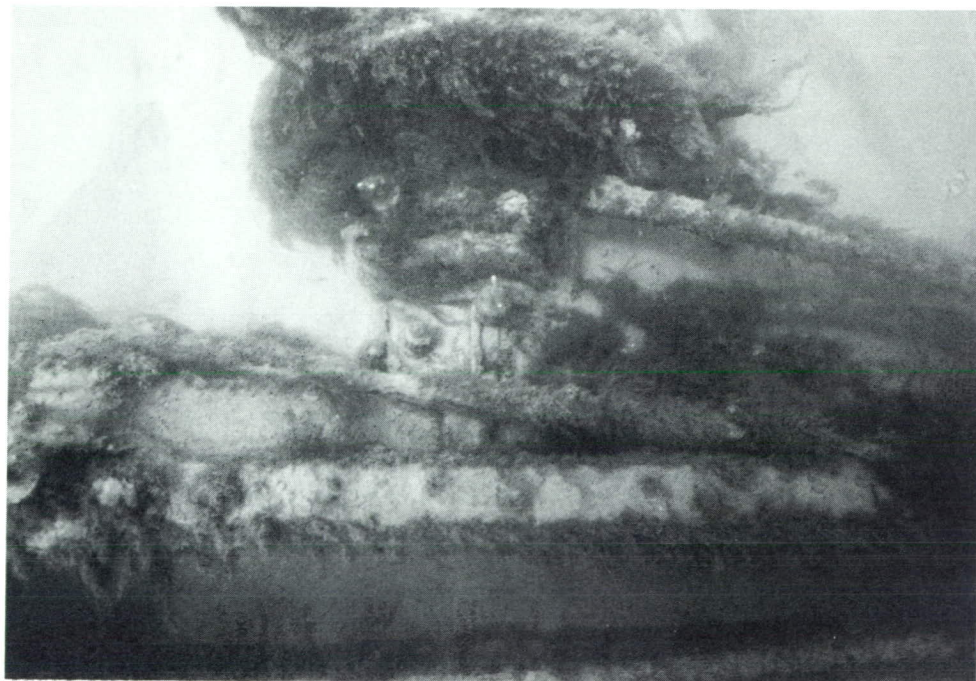
Figure 7.11 Profile view of pitman, pitman jaws, cylinder timber, and crank (top). Plan view of pitman, eccentric rods, crank, pillow block and cap, and paddle wheel hub (bottom). Photo by T. Carrell.

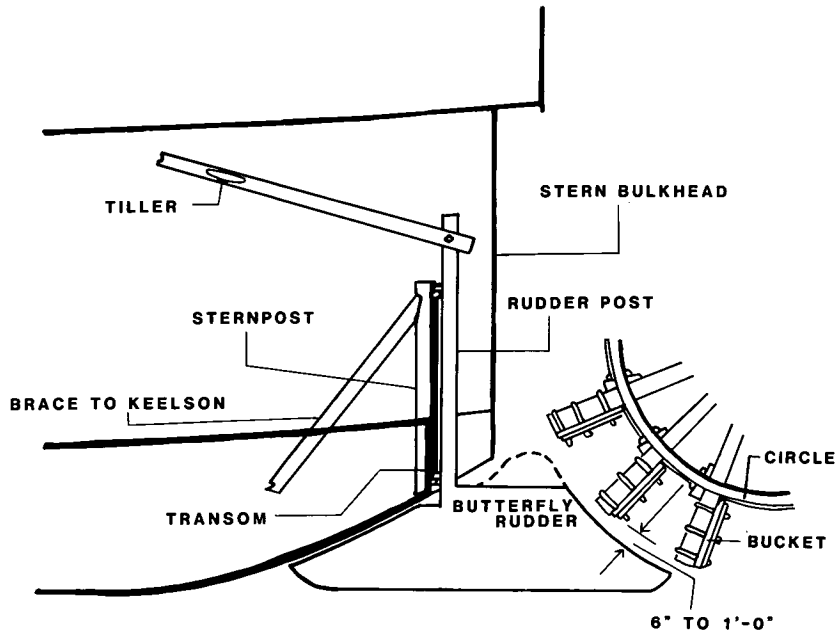
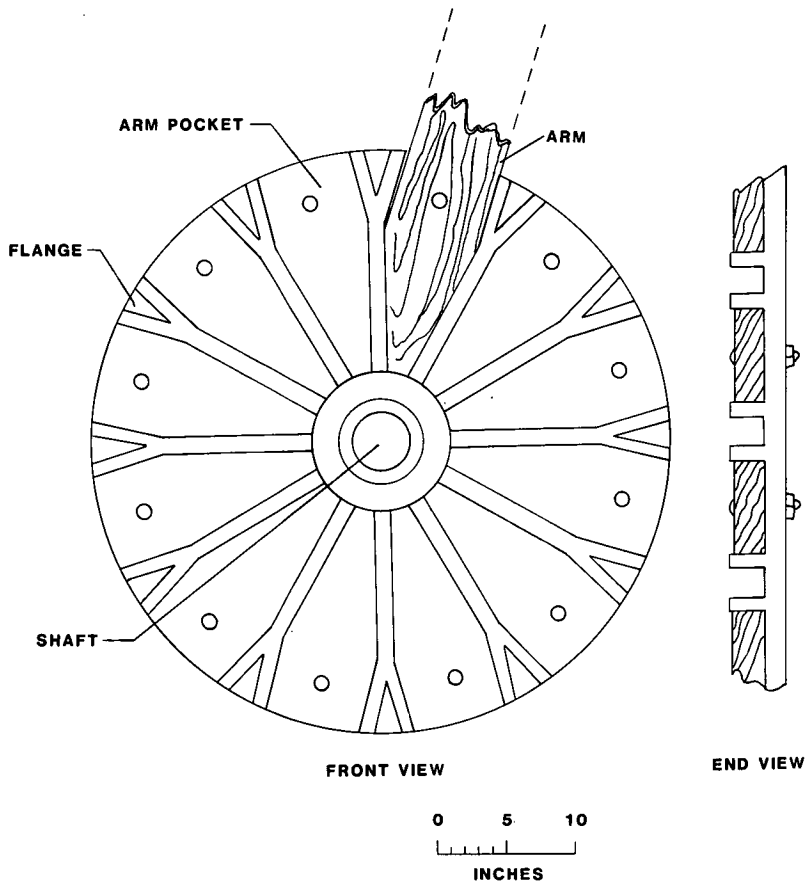
Figure 7.12 Typical arrangement of paddle wheel, rudder and transom on sternwheeler (top). The paddle wheel arms were strengthened by an iron-reinforced wooden circle. Detail drawing of CHARLES H. SPENCER's paddle wheel hub (bottom).

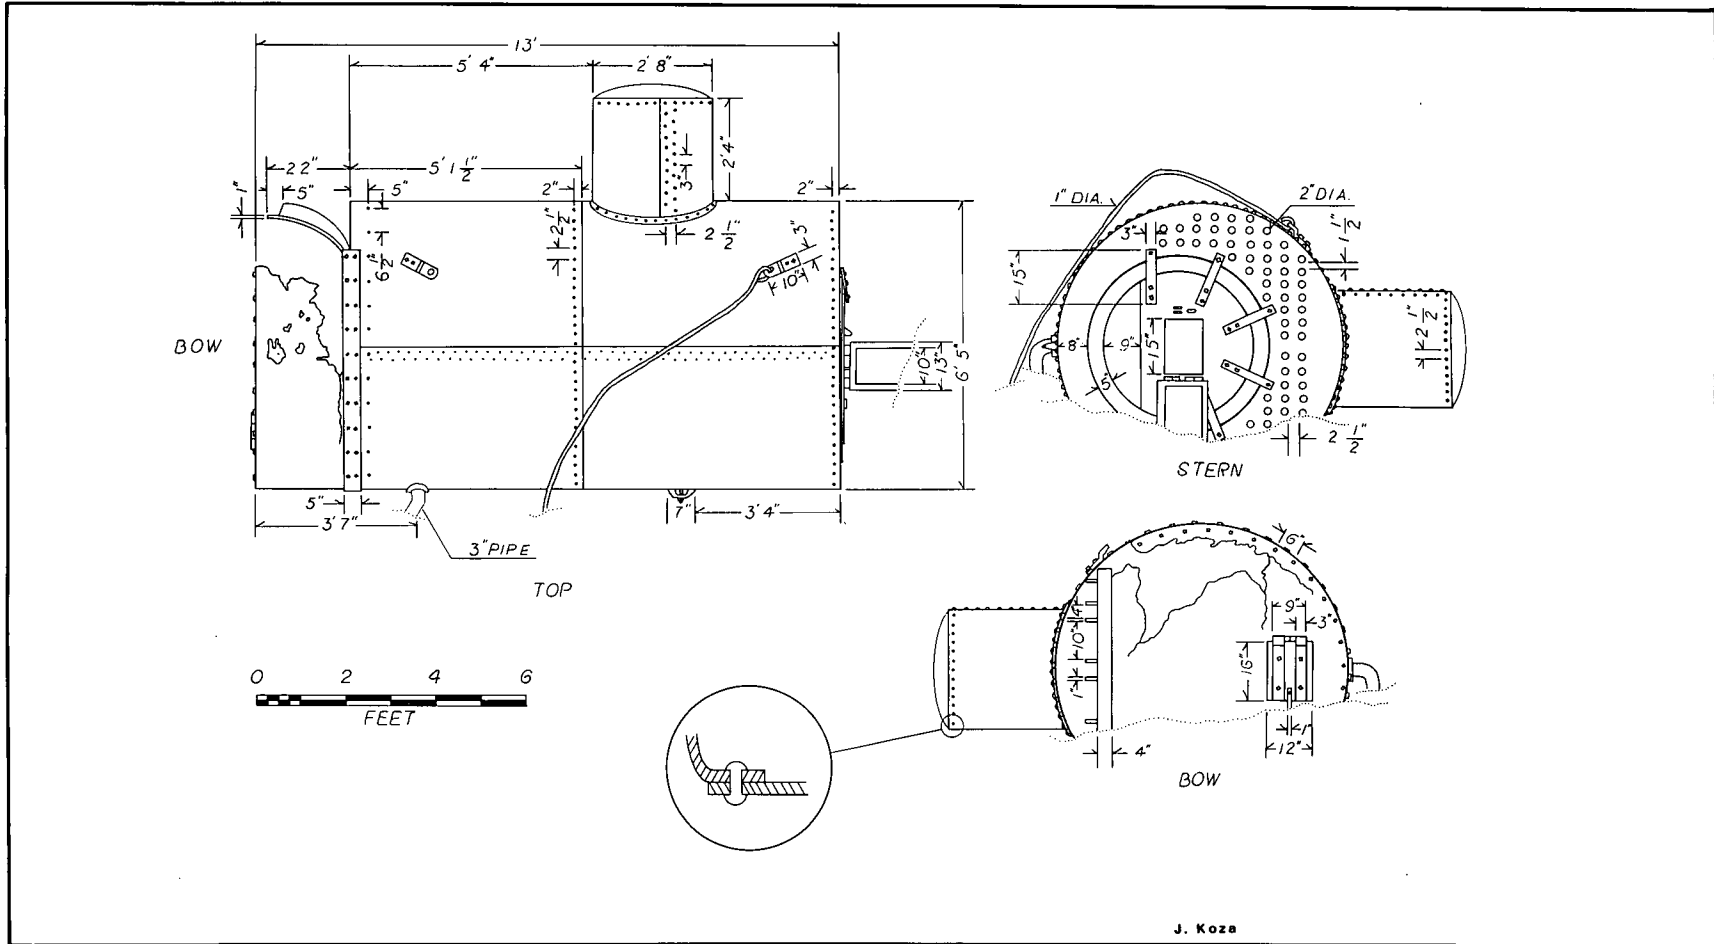
Figure 7.13 Detail drawing of boiler on CHARLES H. SPENCER.

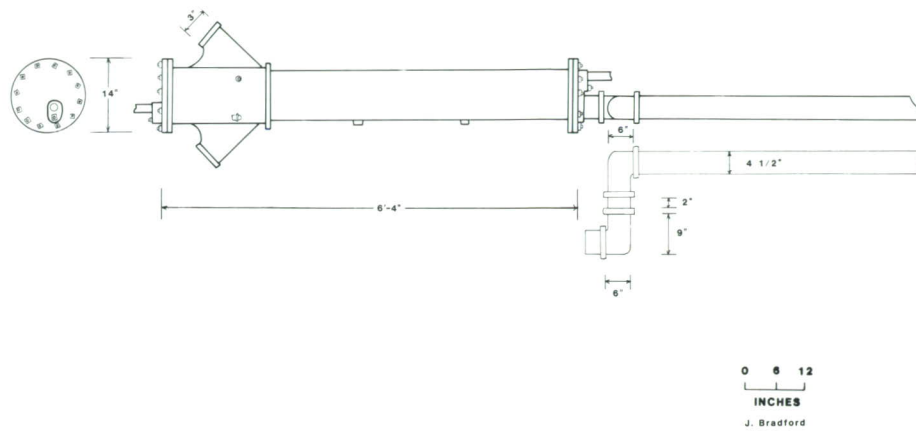
Figure 7.14 Detail drawing of heater with plan and profile views.

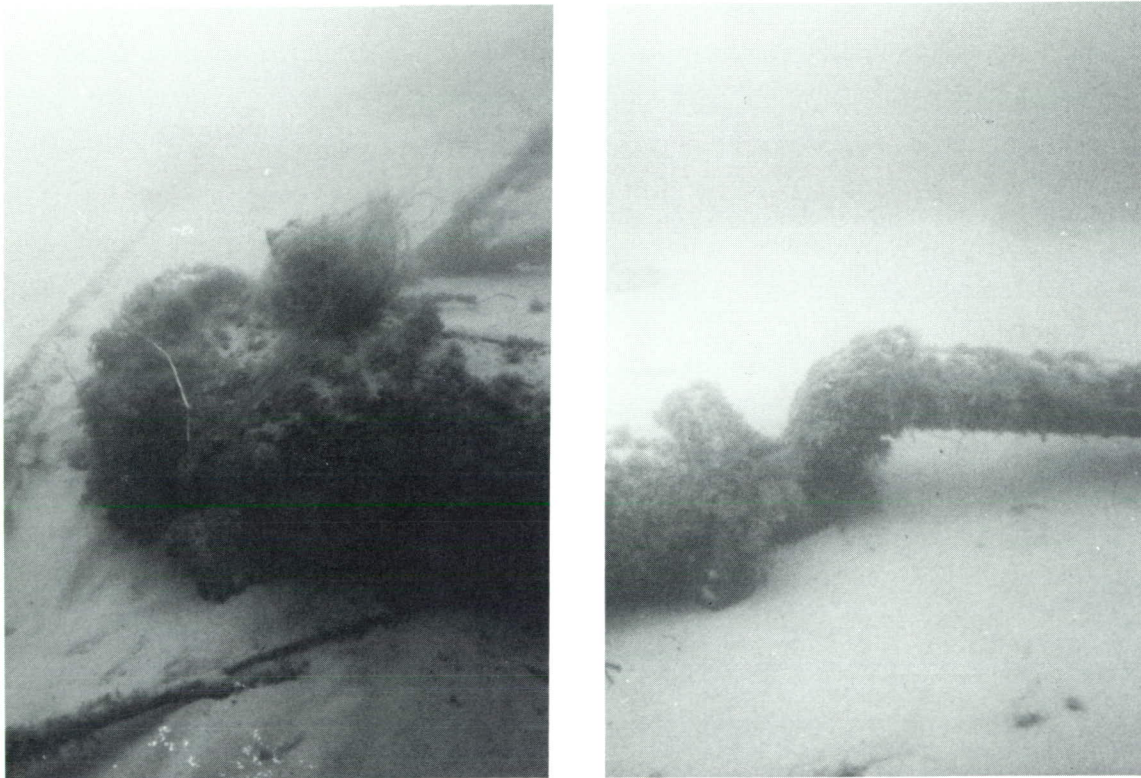
Figure 7.15 Heater head showing connections to steam pipes from engines (left). Heater exhaust with double reverse elbow attached (right). Photo by T. Carrell.

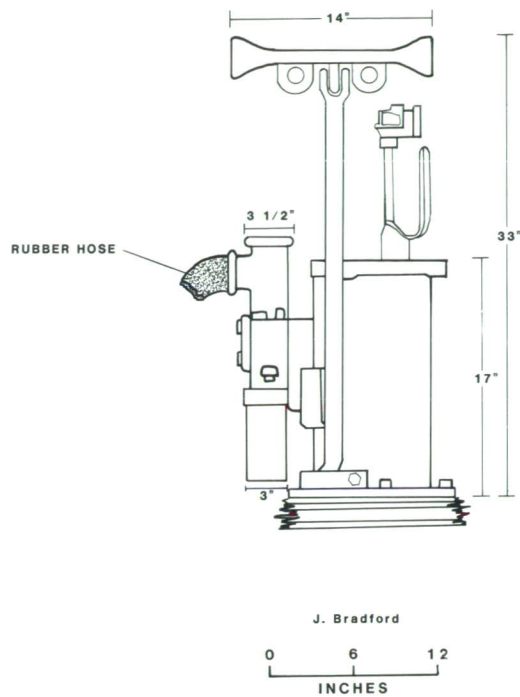
Figure 7.16 Detail drawing of hand-operated bilge pump.

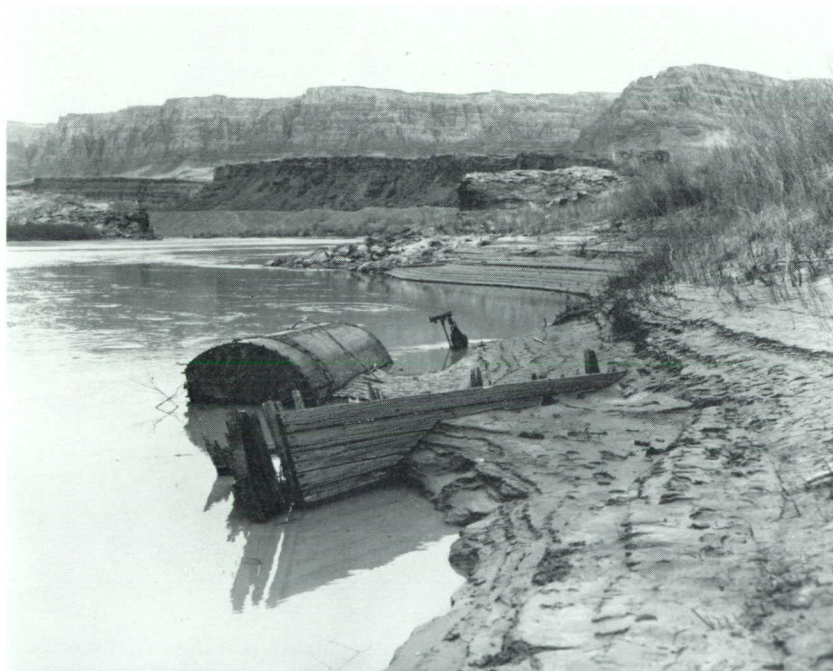
Figure 7.17 Condition of the boiler and the bilge pump in situ, March 1962. Photo by W. L. Rusho.

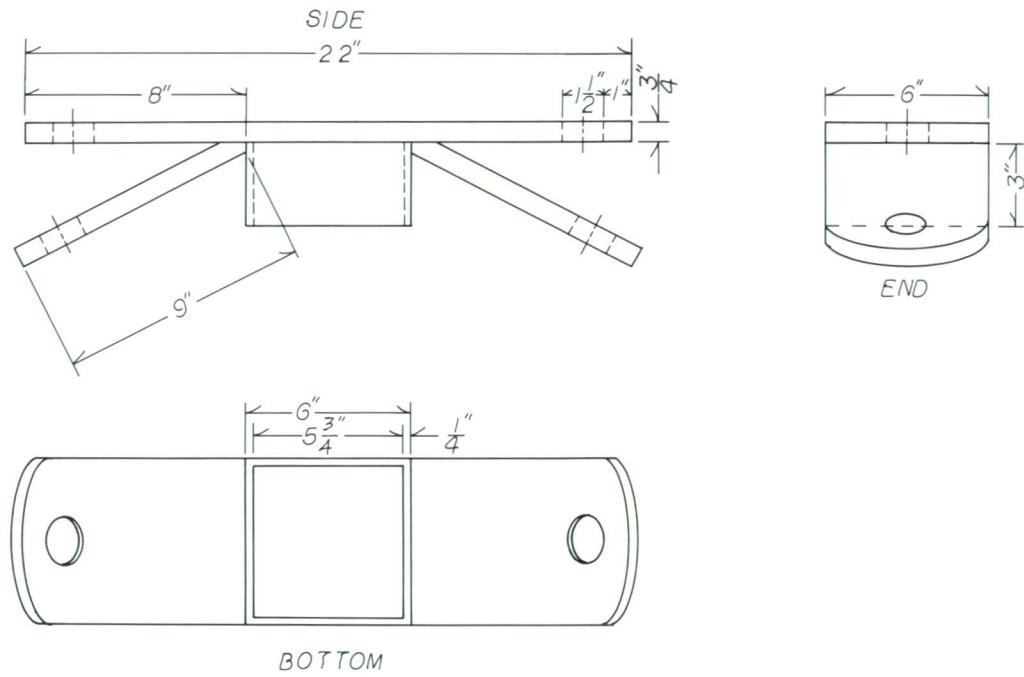
Figure 7.18 Detail drawing of samson post cap.

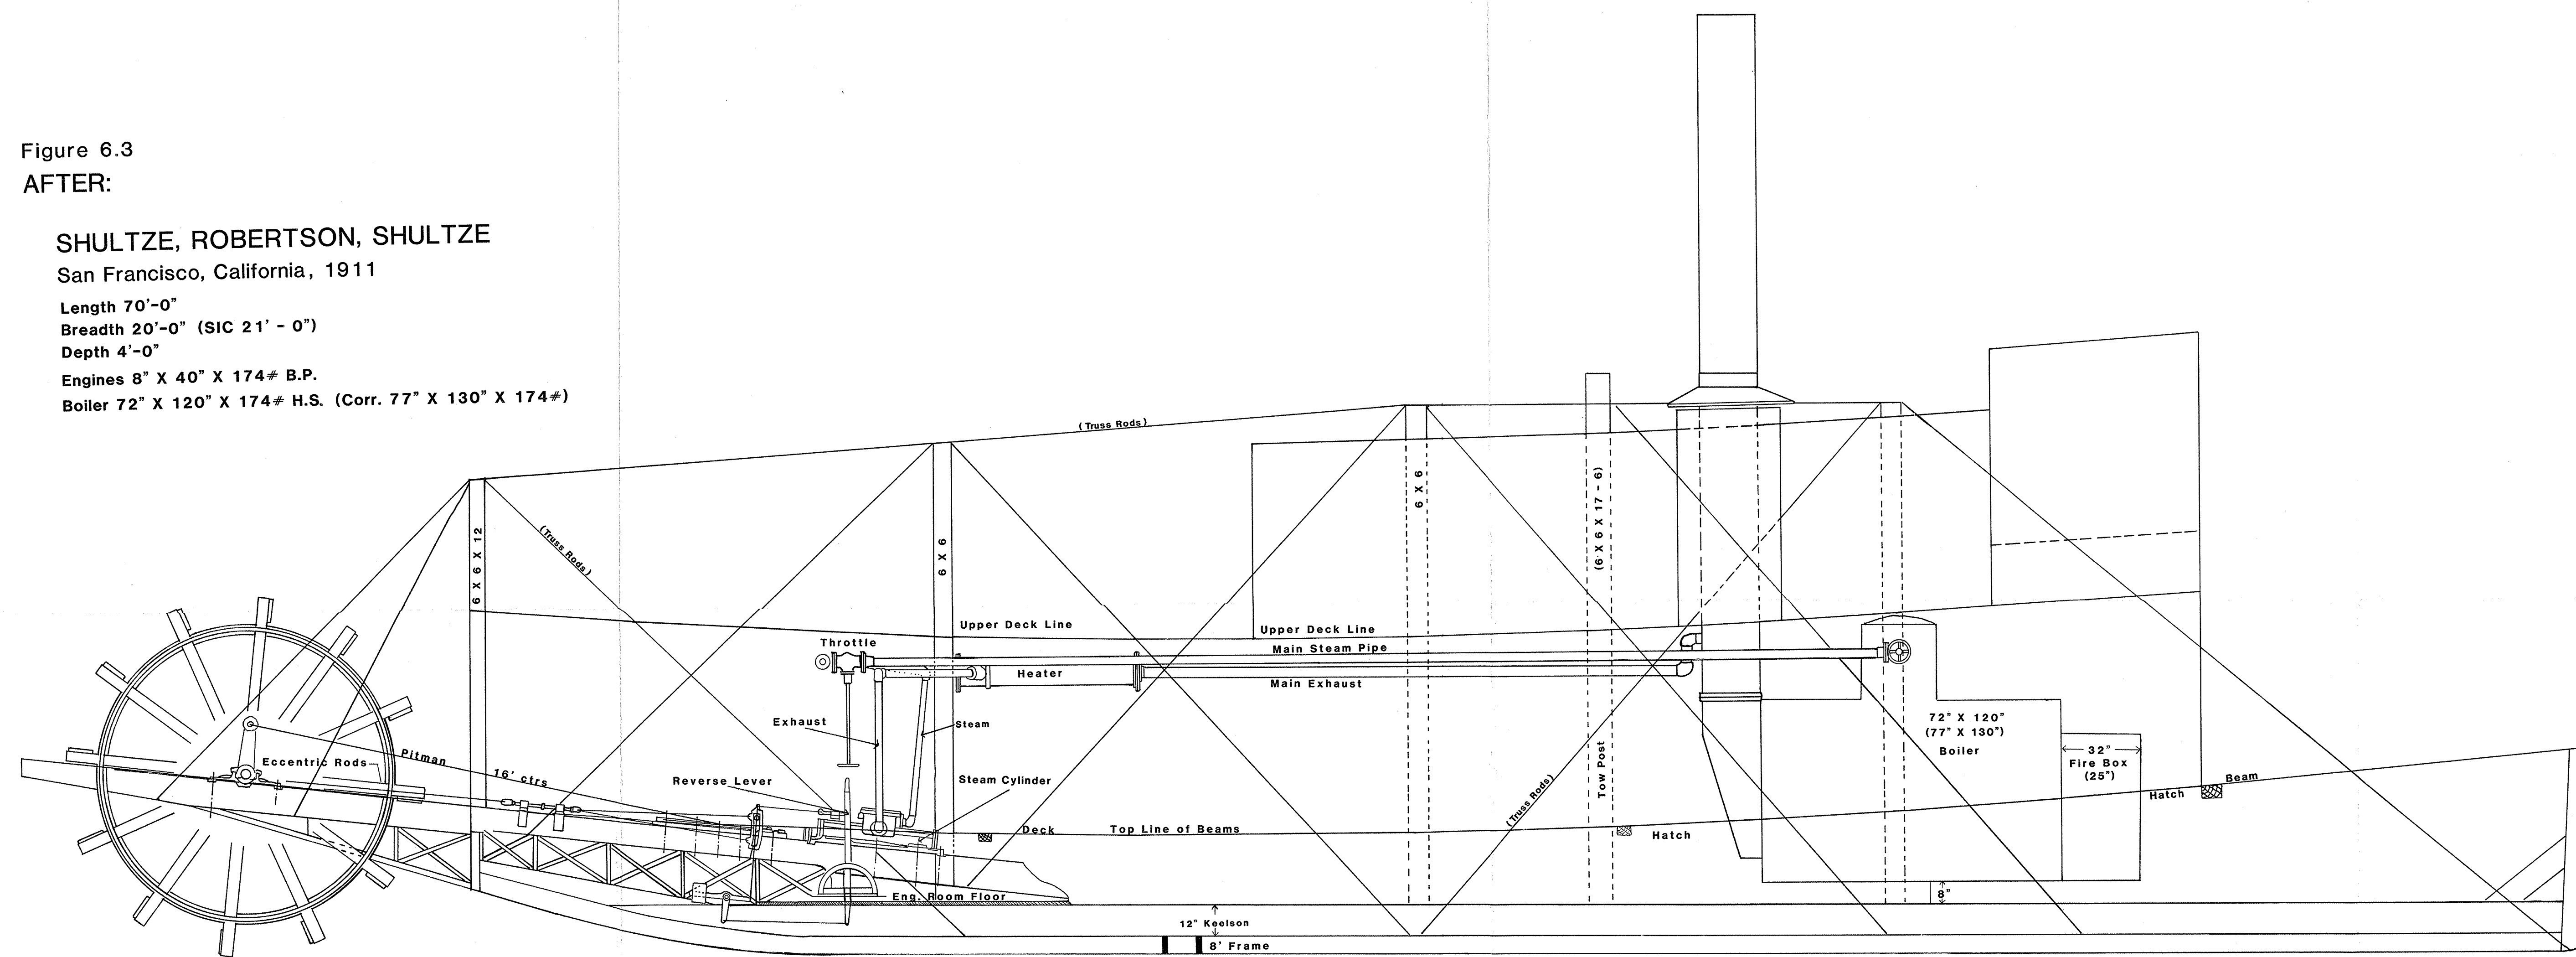
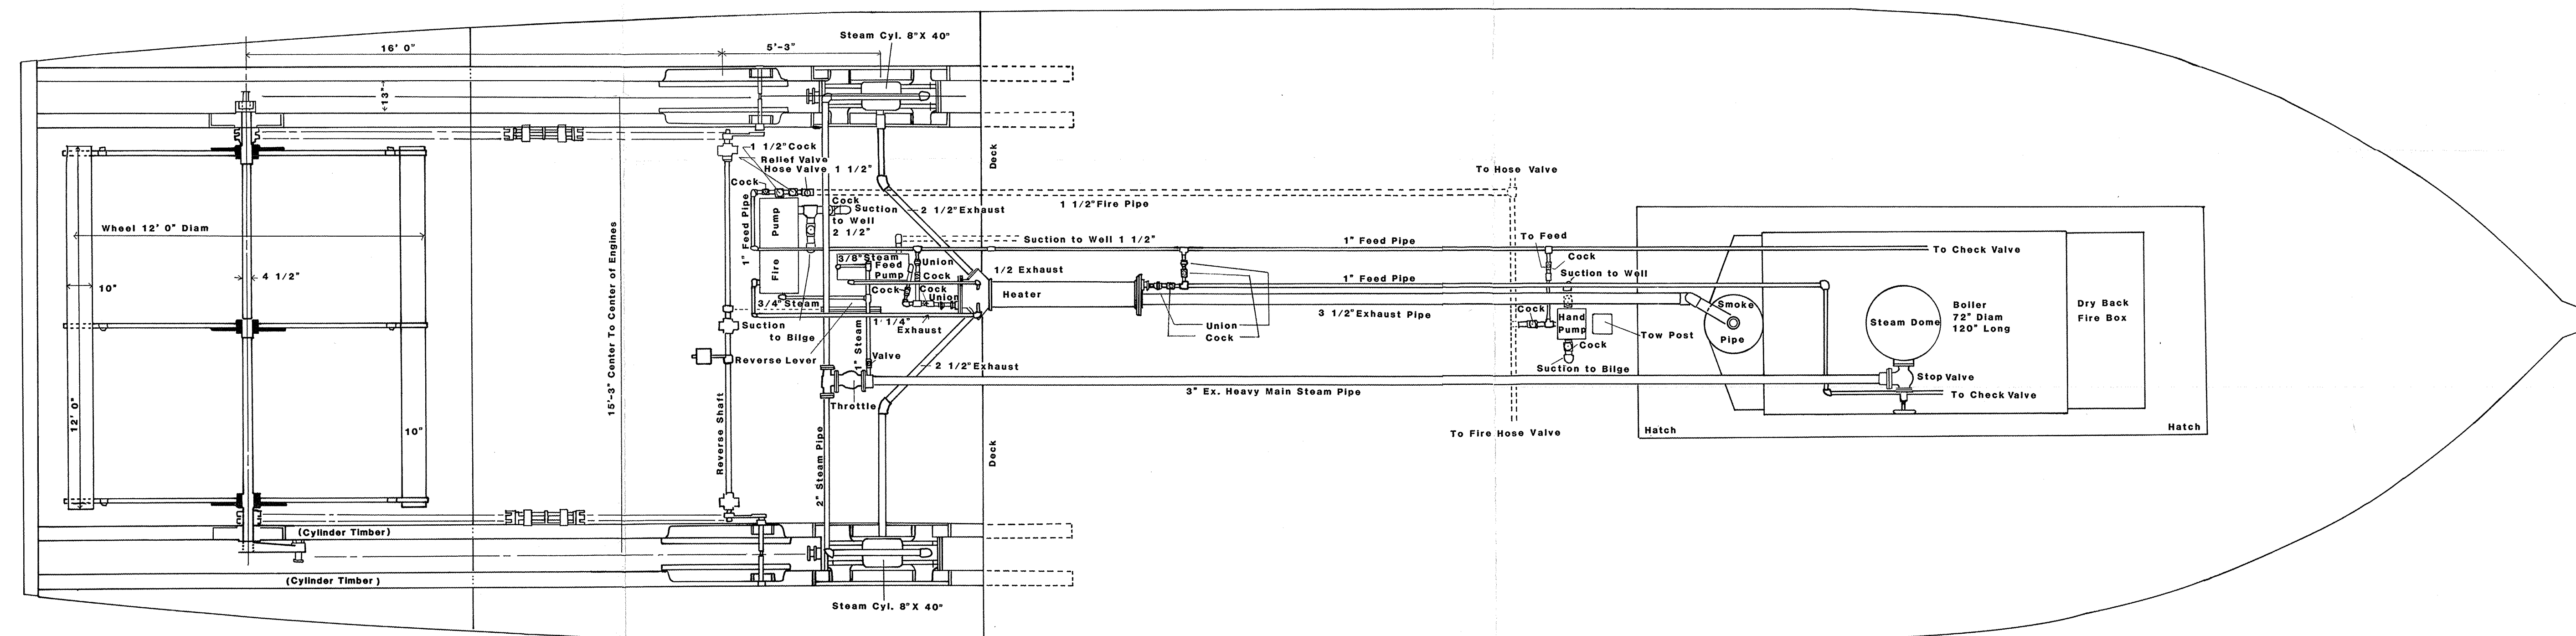
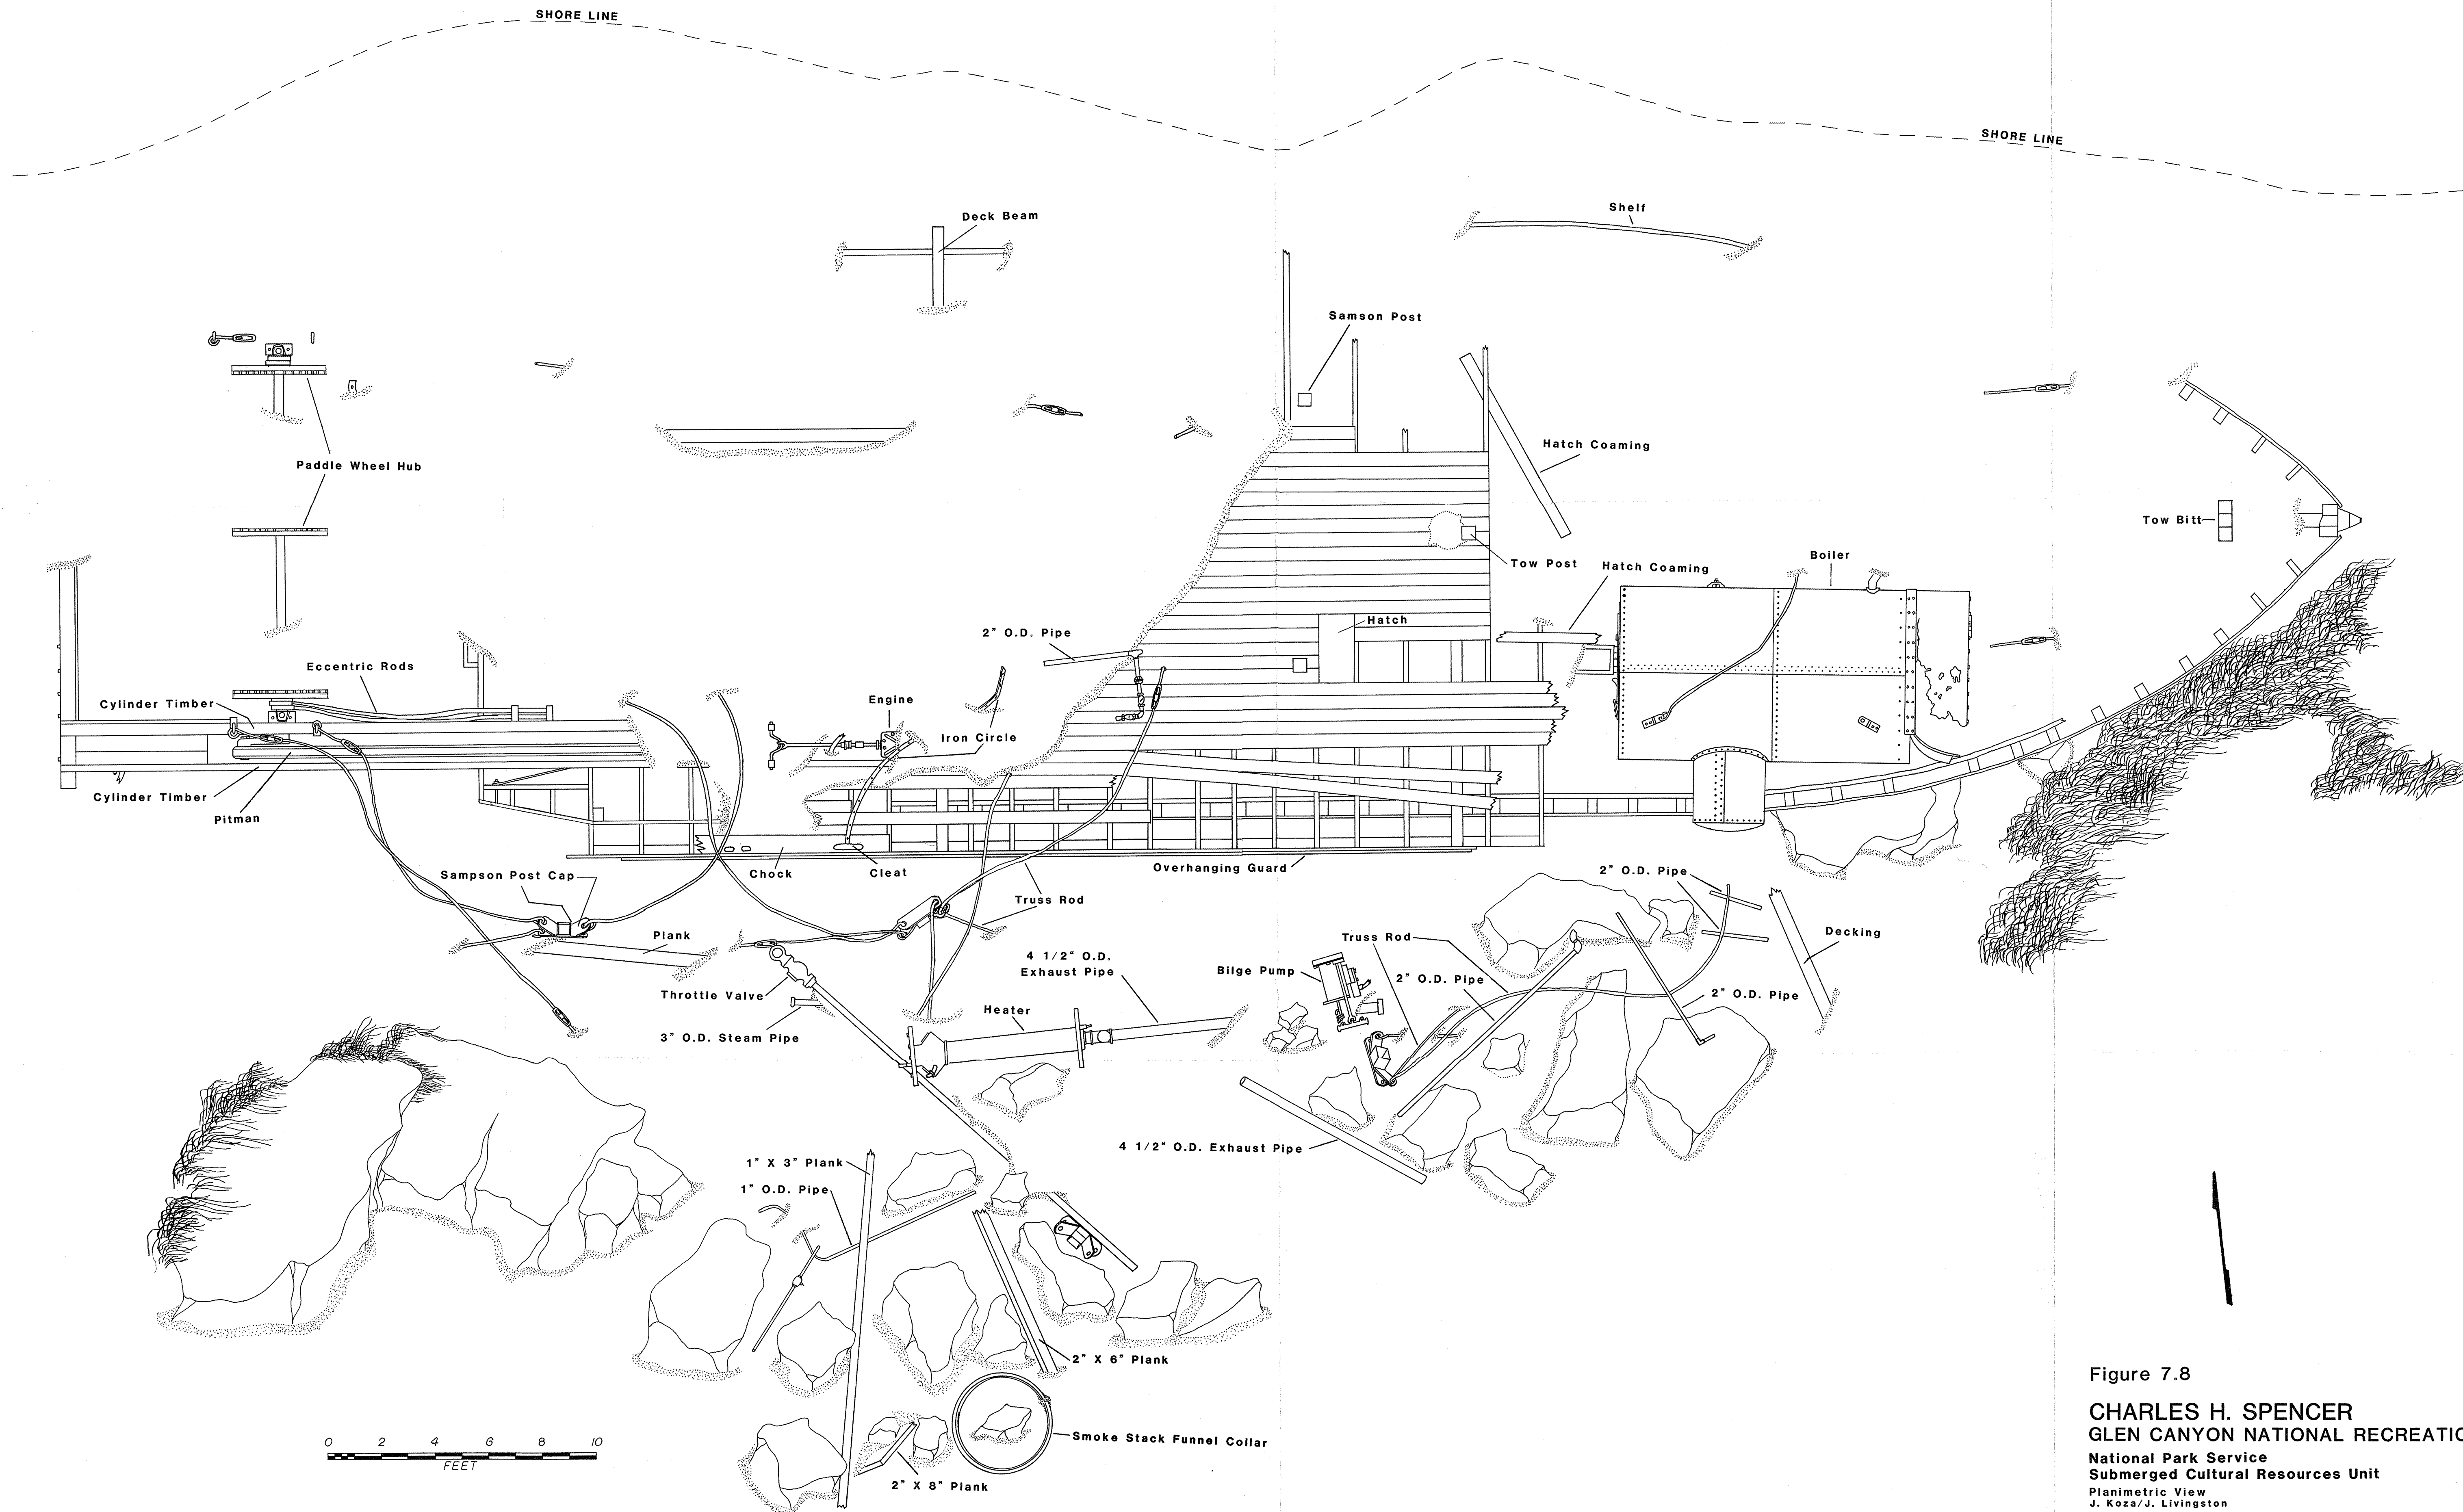
Figure 7.8  
**CHARLES H. SPENCER**  
 GLEN CANYON NATIONAL RECREATION AREA  
 National Park Service  
 Submerged Cultural Resources Unit  
 Planimetric View  
 J. Koza/J. Livingston
