Introduction to

# Federal Tax Credits for Rehabilitating Historic Buildings

## Barns

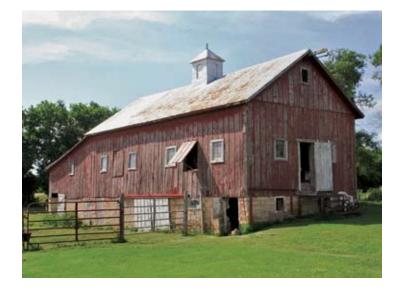
A common building type, bank barn construction allows ground entry from two levels. *Photo: Brenda Spencer, Kansas Historical Society.*

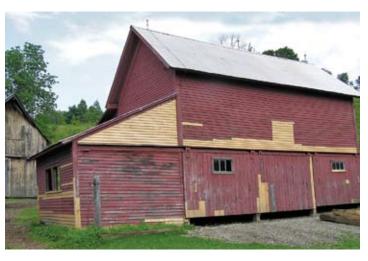
The siding on this barn was repaired with matching siding, a treatment that meets the Secretary of the Interior's Standards for Rehabilitation. *Photo: Vermont Division for Historic Preservation.*

While masonry construction is common in some regions, most historic barns were clad in either horizontal or vertical wooden boards. If portions of the wood siding are beyond repair, or missing altogether, they should be replaced in kind with boards that match the historic size and detailing. Vinyl or metal siding is not an appropriate replacement for wood siding on historic barns.
