39 PRESERVATION BRIEFS

Holding the Line: Controlling Unwanted Moisture in Historic Buildings

Sharon C. Park, AIA

U.S. Department of the Interior
National Park Service
Cultural Resources
Heritage Preservation Services

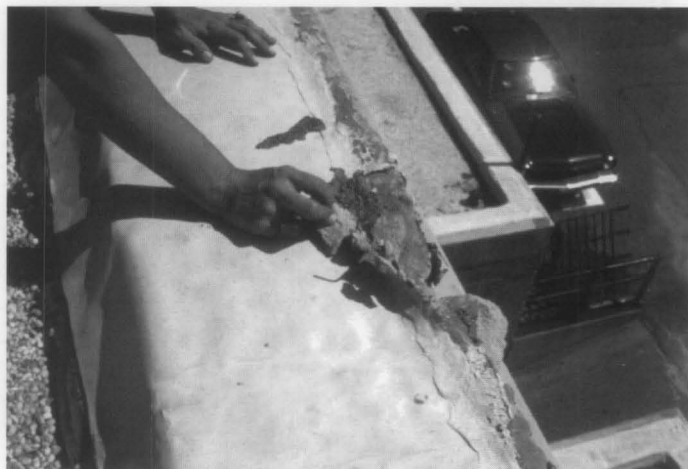
Fig. 1. Moisture problems, if not properly corrected, will increase damage to historic buildings. This waterproof coating trapped moisture from the leaking roof, causing portions of the masonry parapet to fail. Photo: NPS Files.

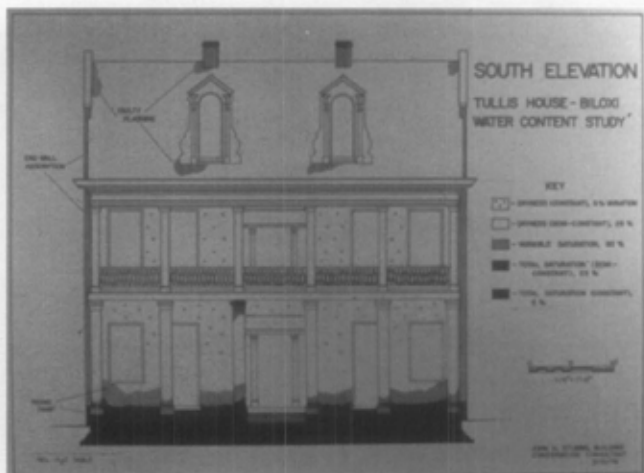
Fig. 2. Historic buildings plagued by dampness problems will benefit from systematic documentation to set a baseline against which moisture changes can be measured. Exterior areas with higher moisture levels may have algae growth or discoloration stains. Drawing: John H. Stubbs.

Identifying the type of moisture damage and discovering its source or sources usually involves the human senses of sight, smell, hearing, touch, and taste combined with intuition. Some of the more common signs of visible as well as hidden moisture damage (see fig. 2, 3) include:

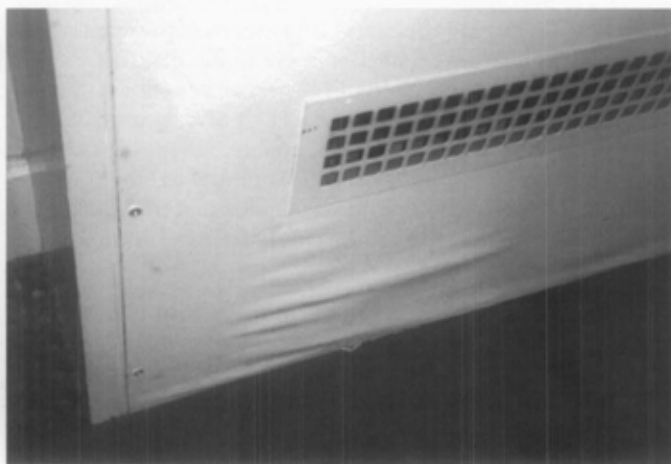
Fig. 3. The deterioration of this wooden cover was a sign that water was leaking from the fan coil unit behind. Photo: author.

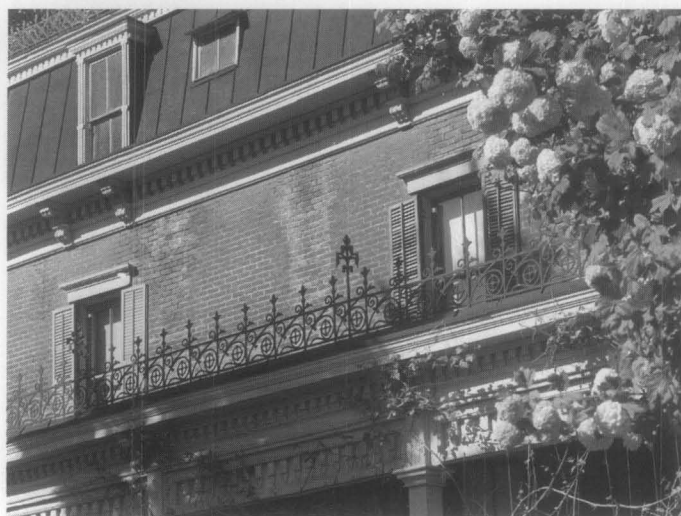
Fig. 4. Deferred maintenance often leads to blocked gutters and downspouts. This cracked gutter system allowed moisture to penetrate the upper exterior wall, erode mortar joints, and rot fascia boards. Photo: NPS files.

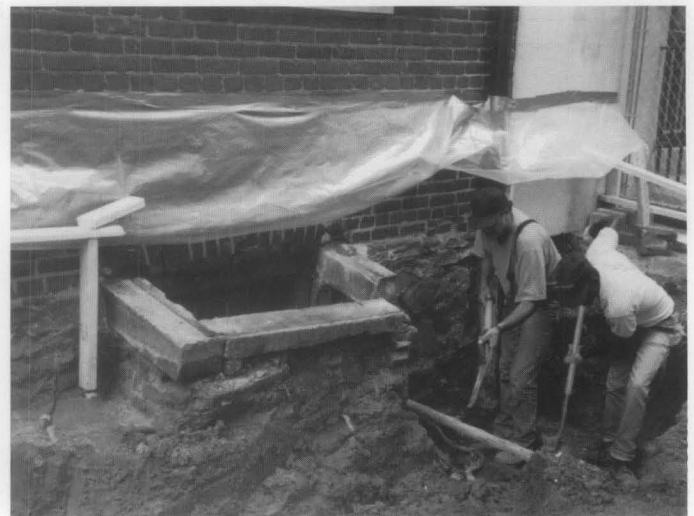
Fig. 5. Excavating this foundation revealed that the downspout pipe had corroded at the “u-trap” and was leaking moisture into the soil. Openings around the horizontal water supply line and cracks in the wall allowed moisture to penetrate the basement in multiple locations. Photo: author.

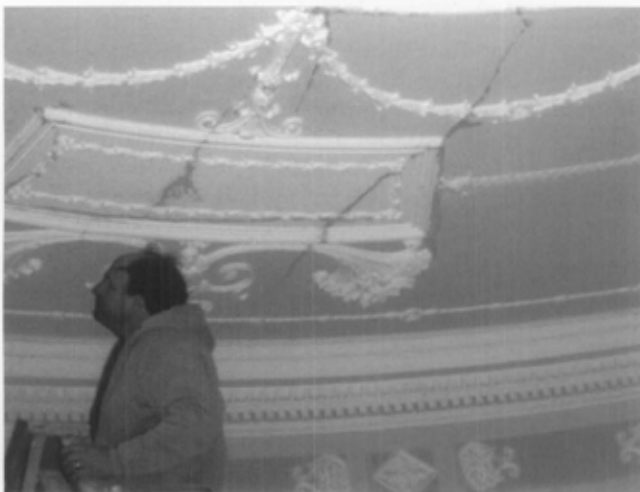
Fig. 6. Uninsulated plumbing pipes close to the exterior wall froze and cracked, wetting this ornamental plaster ceiling before the water supply line could be shut off. As a result, limited portions of the ceiling needed reattaching. Photo: author.

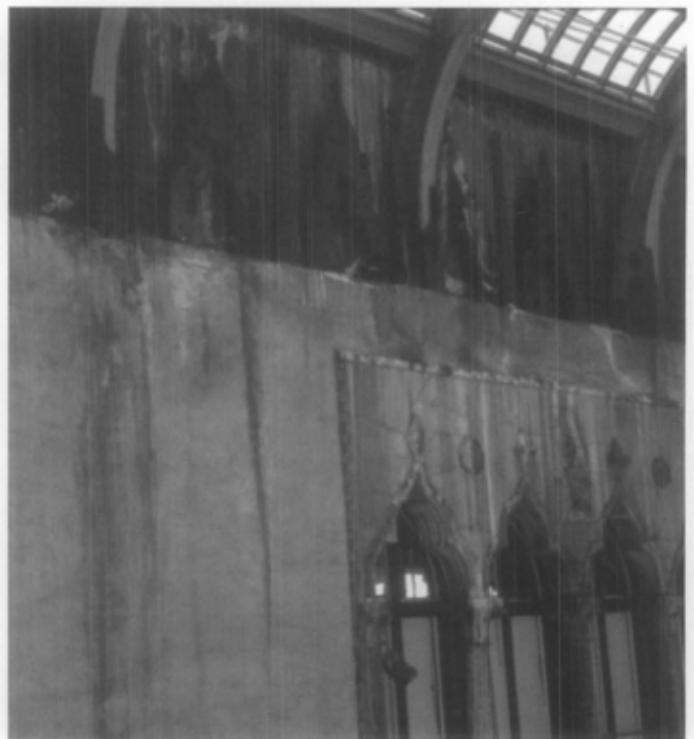
Fig. 7. Condensation dripping from the large overhead courtyard skylight was damaging the masonry in this museum. A new skylight with thermal glazing was installed, replacing the deteriorated single-glazed unit. A new climate control system monitors interior temperature and humidity. Photo: © Isabella Stewart Gardner Museum, Boston.

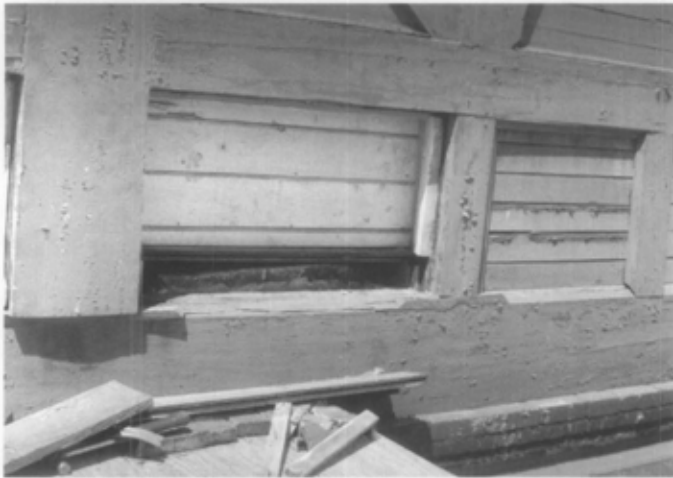
Fig. 8. Damaging moisture conditions can occur during construction. Peeling paint on this newly rehabilitated frame wall was attributed to wall insulation that had become wet during the project and was not discovered. Photo: NPS Files.

plastered interior walls or the construction of new additions attached to historic buildings may hold moisture for months; new plaster, mortar, or concrete should be fully cured before they are painted or finished. The use of materials in projects that have been damaged by moisture prior to installation or have too high a moisture content may cause concealed damage (see fig. 8).

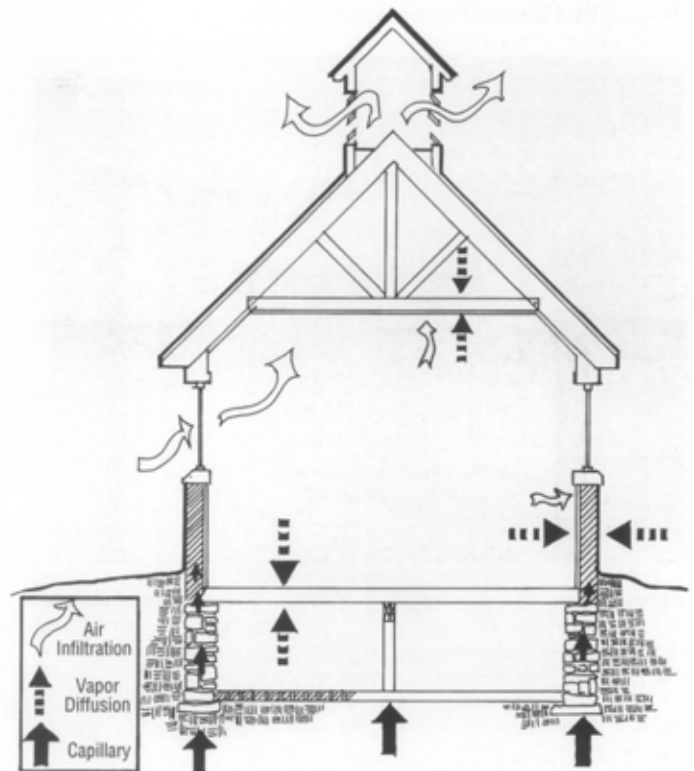
Fig. 9. The dynamic forces that move air and moisture through a building are important to understand particularly when selecting a treatment to correct a moisture problem. Air infiltration, capillary action, and vapor diffusion all affect the wetting and drying of materials. Drawing: NPS Files.

Three forms of moisture transport are particularly important to understand in regards to historic buildings — infiltration, capillary action, and vapor diffusion — remembering, at the same time, that the subject is infinitely complex and, thus, one of continuing scientific study (see

fig. 9). Buildings were traditionally designed to deal with the movement of air. For example, cupolas and roof lanterns allowed hot air to rise and provided a natural draft to pull air through buildings. Cavity walls in both frame and masonry buildings were constructed to allow moisture to dissipate in the air space between external and internal walls. Radiators were placed in front of windows to keep cold surfaces warm, thereby reducing condensation on these surfaces. Many of these features, however, have been altered over time in an effort to modernize appearances, improve energy efficiency, or accommodate changes in use. The change in use will also affect moisture movement, particularly in commercial and industrial buildings with modern mechanical systems. Therefore, the way a building handles air and moisture today may be different from that intended by the original builder or architect, and poorly conceived changes may be partially responsible for chronic moisture conditions.

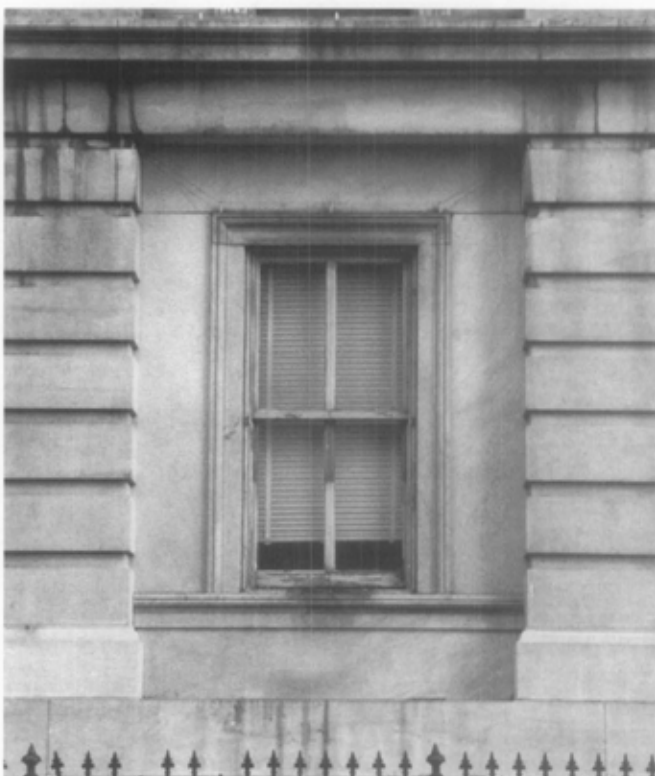
Fig. 10. Infiltration of damp air can occur around loose-fitting or deteriorated window sash and through cracks or open joints in building exteriors. Photo: Ann Brooks Prueher.

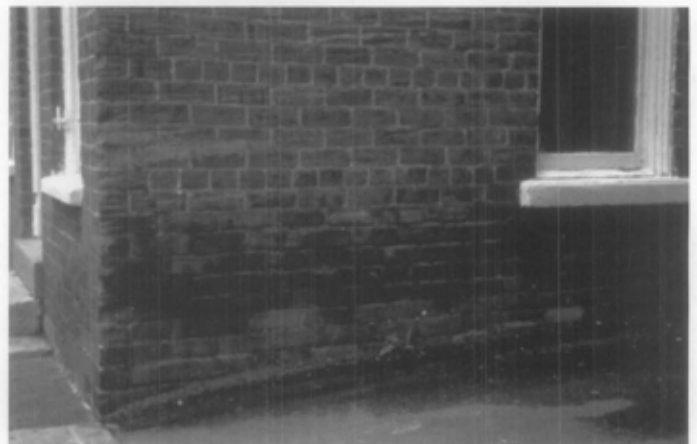
Fig. 11. Capillary rise of moisture in masonry is often accompanied with a horizontal tide-mark line several feet above the grade, as seen here. Removing or redirecting as much ground moisture as possible usually helps reduce moisture within a wall. Photo: NPS Files.

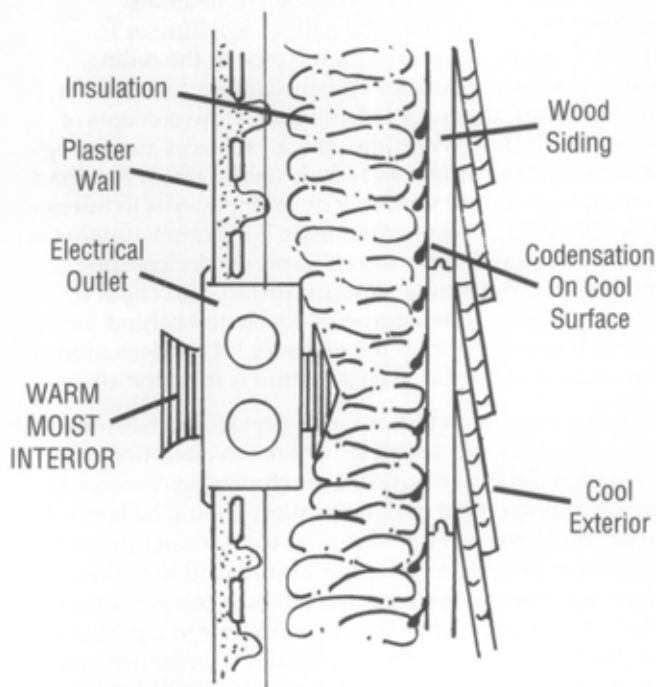
Fig. 12. Vapor diffusion can result in damp air migrating into absorbent materials and condensing on colder surfaces, thereby wetting insulation, damaging electrical conduits, and causing deterioration of the wooden framing. Drawing: NPS Files.

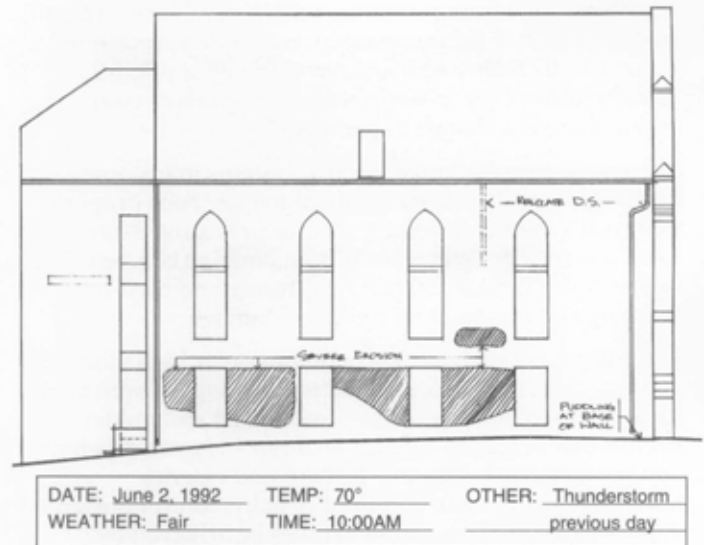
Fig. 13. Using sketch plans and elevation drawings to record the moisture damage along with the date, time, and weather conditions will show how moisture is affecting buildings over time. Drawing: Courtesy, Quinn Evans Architects.

Surveying moisture damage must be systematic so that relative changes can be noted. Tools for investigating can be as simple as a notebook, sketch plans, binoculars, camera, aluminum foil, smoke pencil, and flashlight. The systematic approach involves looking at buildings from the top down and from the outside to the inside. Photographs, floor plans, site plan, and exterior elevations — even roughly sketched — should be used to indicate all evidence of damp or damaged materials, with notations for musty or poorly ventilated areas. Information might be needed on the absorption and permeability characteristics of the building materials and soils. Exterior drainage patterns should be noted and these base plans referred to on a regular basis in different seasons and in differing types of weather (see fig. 13).

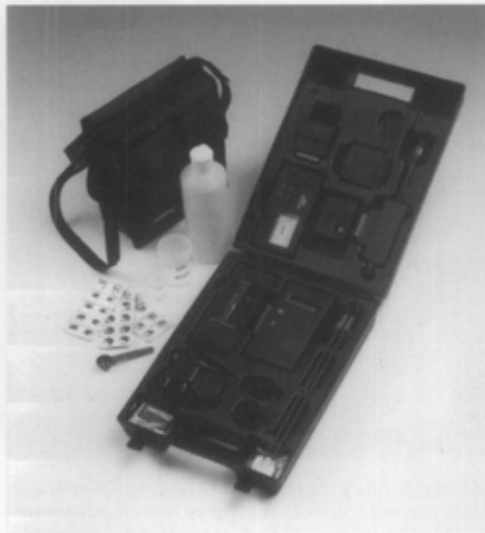
Fig. 14. Using instruments in this damp-check kit can help determine the relative change in wet conditions over time. This involves readings of air temperature, computing dewpoint temperatures, and tracking the moisture content of materials to indicate if they are drying properly. Photo: Dell Corporation.

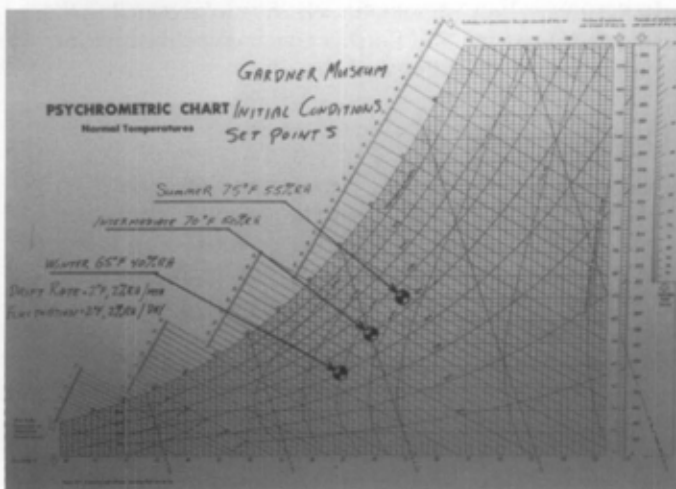
Fig. 15. Psychrometric charts quantify the amount of relative humidity a building can tolerate before dewpoint condensation occurs. This is important when the range of temperature and humidity are critical to both collections management and historic building preservation. Chart: Landmark Facilities Group.

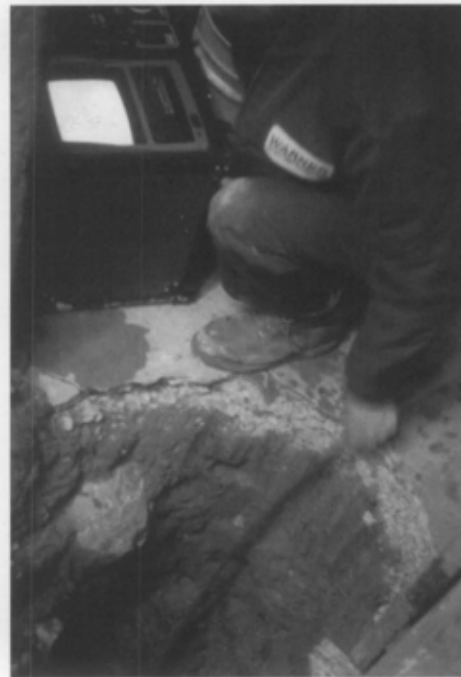
Fig. 16. Contractors specializing in building diagnostics often have video cameras or fiber optic equipment that allow the viewing of inaccessible areas. This is particularly helpful in chimney flues or subsurface drains, as shown here. In the past, these areas would need to be excavated for visual inspection. Photo: author.

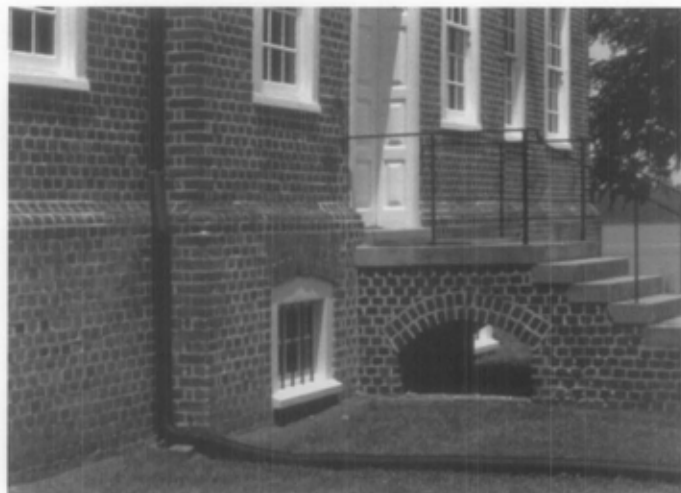
Fig. 17. In testing a theory for the cause of basement wetness, the owner used long black extender pipes to direct roof run-off away from the foundation. This test established that the owner did not need expensive waterproofing of the foundation, but a better drainage system. Photo: Baird M. Smith.

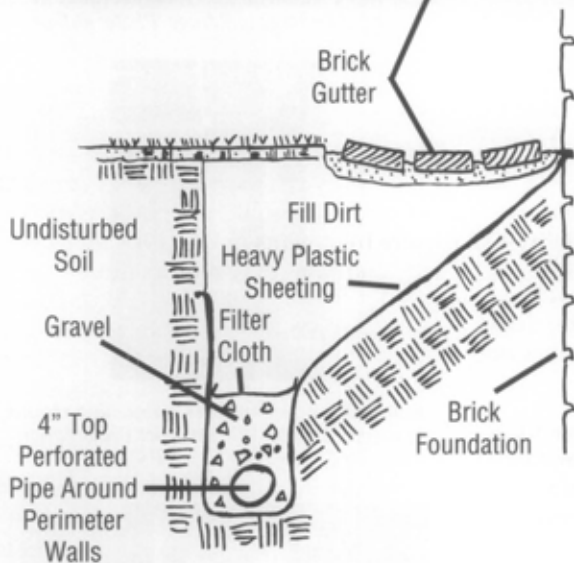
Fig. 18. This detail drawing shows a sub-surface perimeter drain in conjunction with a historic brick ground gutter system to help control roof run-off moisture from entering the historic foundation. Detail: Courtesy, Gunston Hall Plantation. Photo: Elizabeth Sasser.

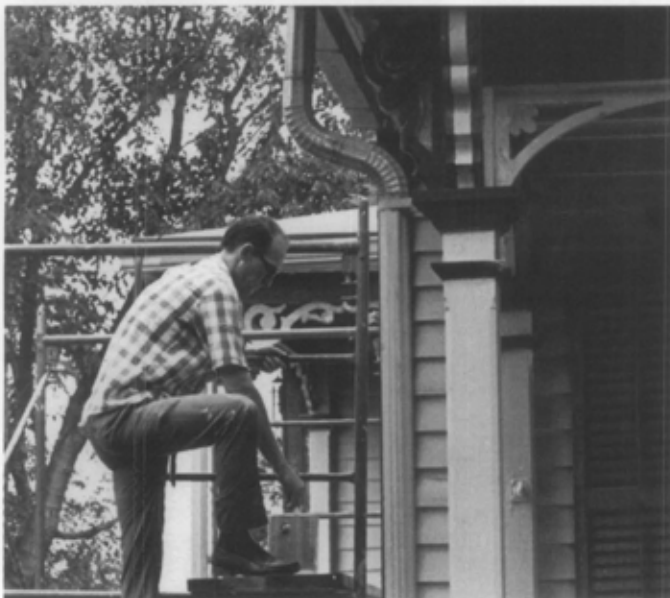
Fig. 19. Maintaining gutters and downspouts in good operable condition, repairing exteriors to keep water out, redirecting damaging moisture away from foundations and controlling interior moisture and condensation are all important when holding the line on moisture deterioration. Photo: Nebraska State Historical Society.

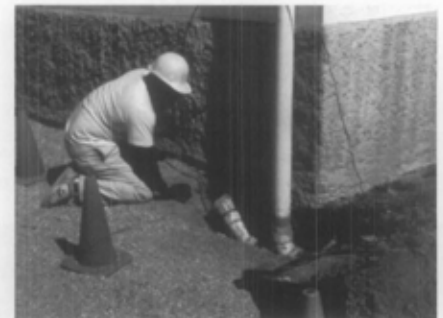
C. Cleaning out gutters and downspouts should be done at least twice a year. Photo: WPTC, NPS.

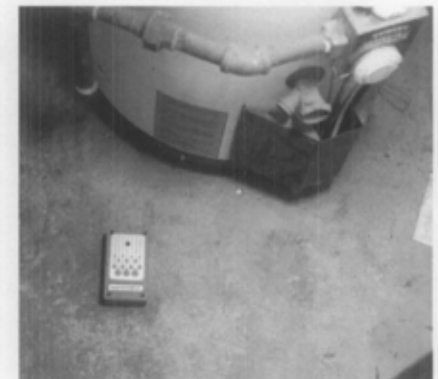
D. Protect the building from damage by maintaining equipment and using alarms, like this floor water sensor. Photo: Dell Corporation.

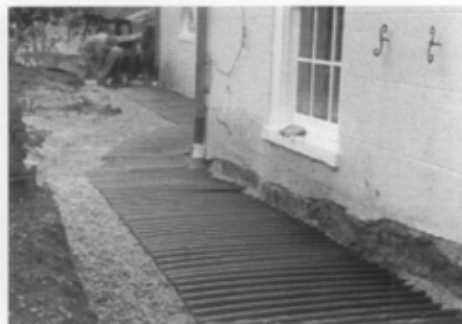
A. Mitigate poor drainage with gravel, filter cloth, or the use of subsurface drainage mats under finished paving. Photo: Larry D. Dermody.

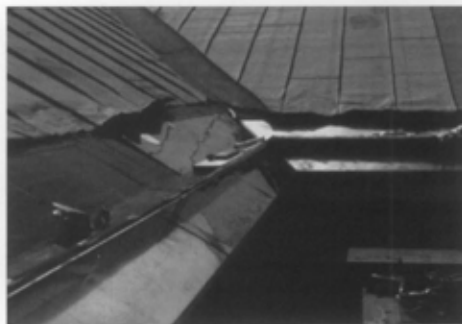
B. Repair roofs and add ice and water shields at eaves and under valleys in cold climates. Photo: Larry D. Dermody.

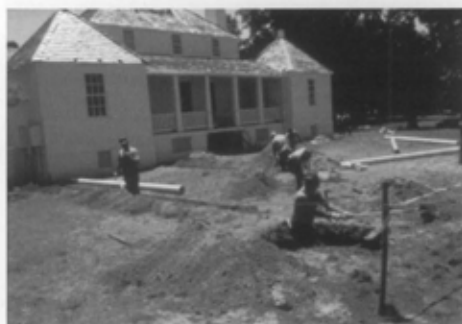
C. Develop new drainage systems for roof run-off that remove moisture from the base of the building. Photo: WPTC, NPS.

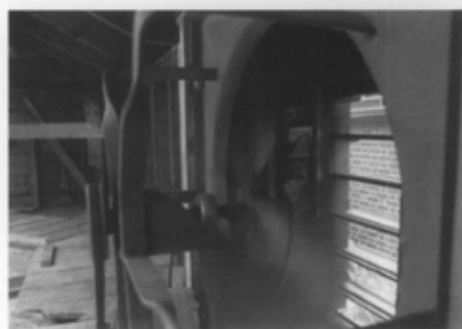
D. Install ventilating fans when additional air circulation will improve damp conditions in buildings or reduce cooling loads. Photo: Ernest A. Conrad, P. E.

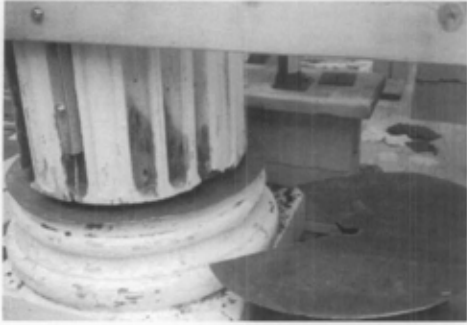
A. This lead sheet was installed at the base of the replacement column to stop rising damp. Photo: Bryan Blundell.

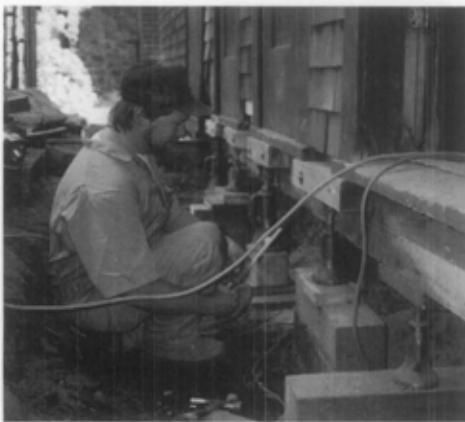
B. Wood sills set on grade were replaced with concrete pier foundation and new wooden sill plates. Changes were not visible on the exterior (see C). Photo: WPTC, NPS.

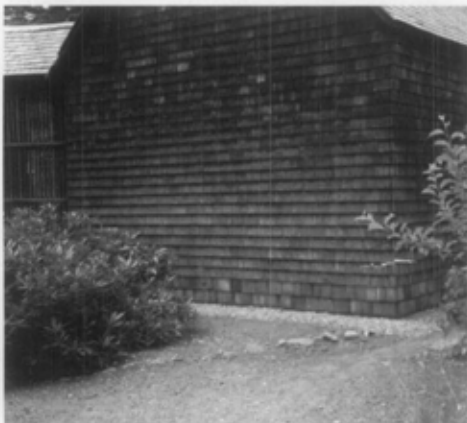
C. The new ground gutter gravel base helps drainage around the concrete foundation (see B above) which is not visible behind the replaced wooden wall shingles. Photo: WPTC, NPS.

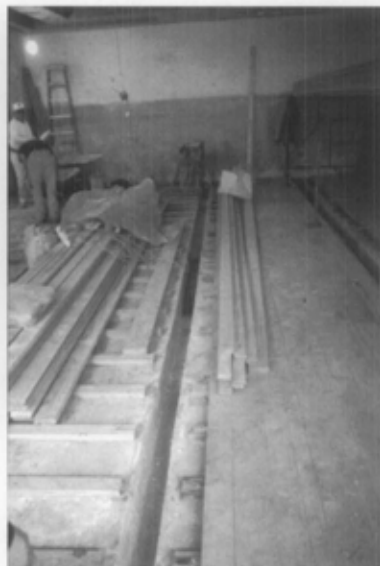
D. In a flood plain, rotted joists were replaced with a concrete slab and sleepers designed to drain water. Spaced flooring allowed drainage and room for damp wood to swell without buckling. Harper's Ferry Center, NPS.

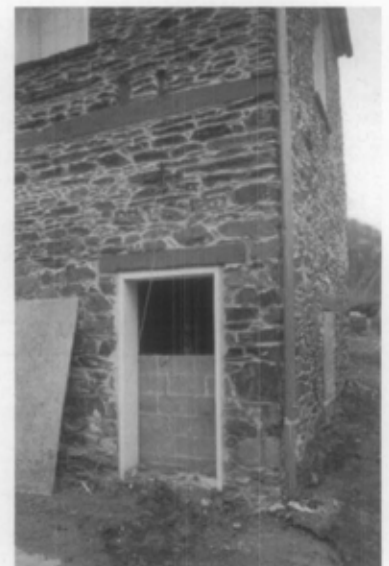
E. Mechanical systems on the lower level were placed on platforms above the flood line. Harper's Ferry Center, NPS.

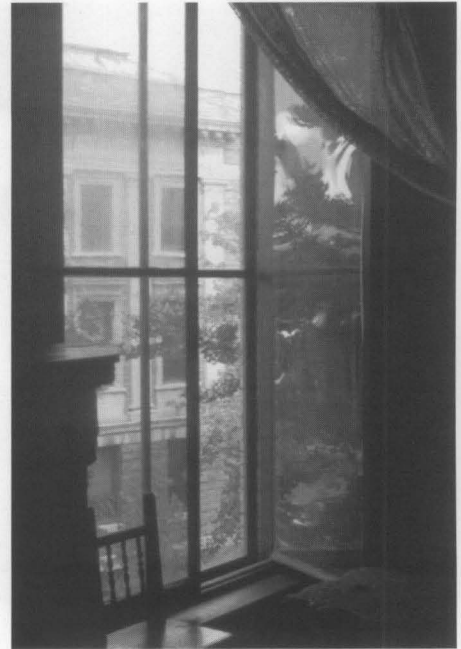
F. Triple glazed windows replaced the originals to control condensation. Photo: © Isabella Stewart Gardner Museum, Boston.

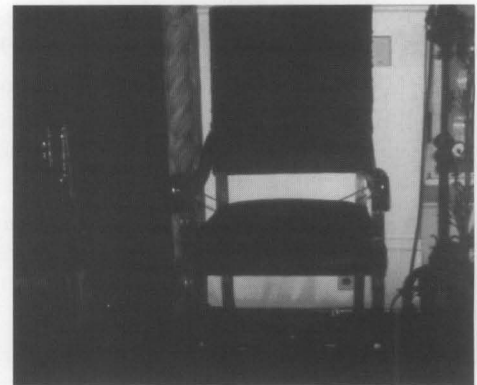
G. New sensors which monitor temperature and relative humidity are located throughout this museum and tied to a computer that controls the climate control system. Photo: © Isabella Stewart Gardner Museum, Boston.

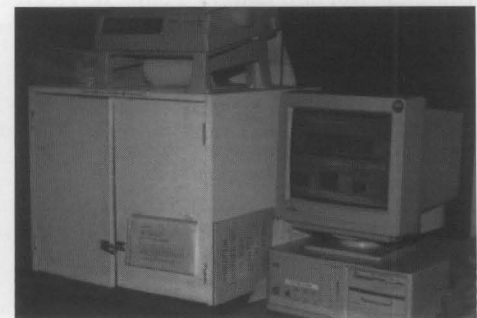
H. New computers tie a variety of monitoring and security features into a comprehensive system which provides warning and backup alerts when any of the system components are not functioning properly. Photo: © Isabella Stewart Gardner Museum, Boston.

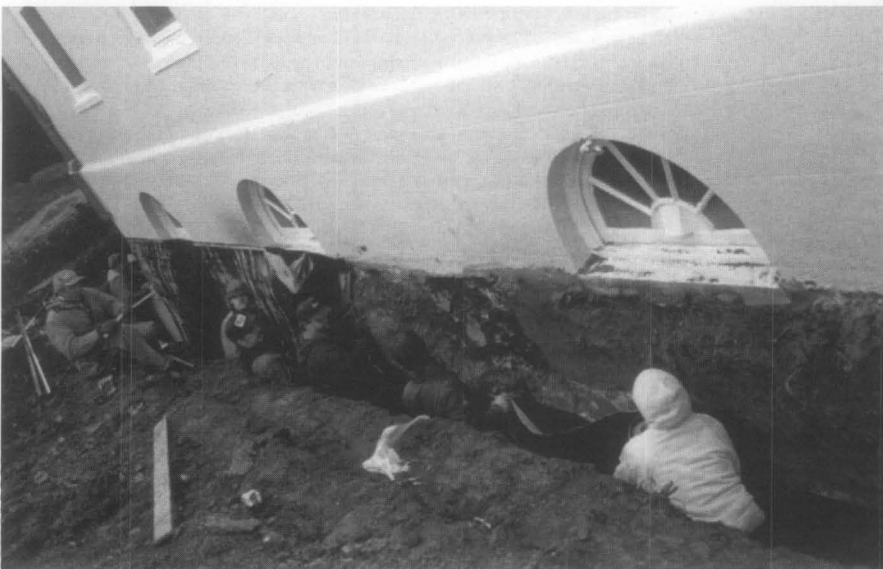
I. Critically damp foundation walls were protected with a layer of bentonite clay to reduce moisture penetration. This work was in combination with new downspouts that were connected to drainage boots that deposited captures roof run-off away from the foundation. Photo: Courtesy, Larry D. Dermody and the National Trust for Historic Preservation.
