CONSERVATION, OUTDOOR RECREATION, AND NATURAL DISASTER  
RESILIENCY STRATEGIES FOR THE ISLAND OF CULEBRA

# CONSERVA CULEBRA

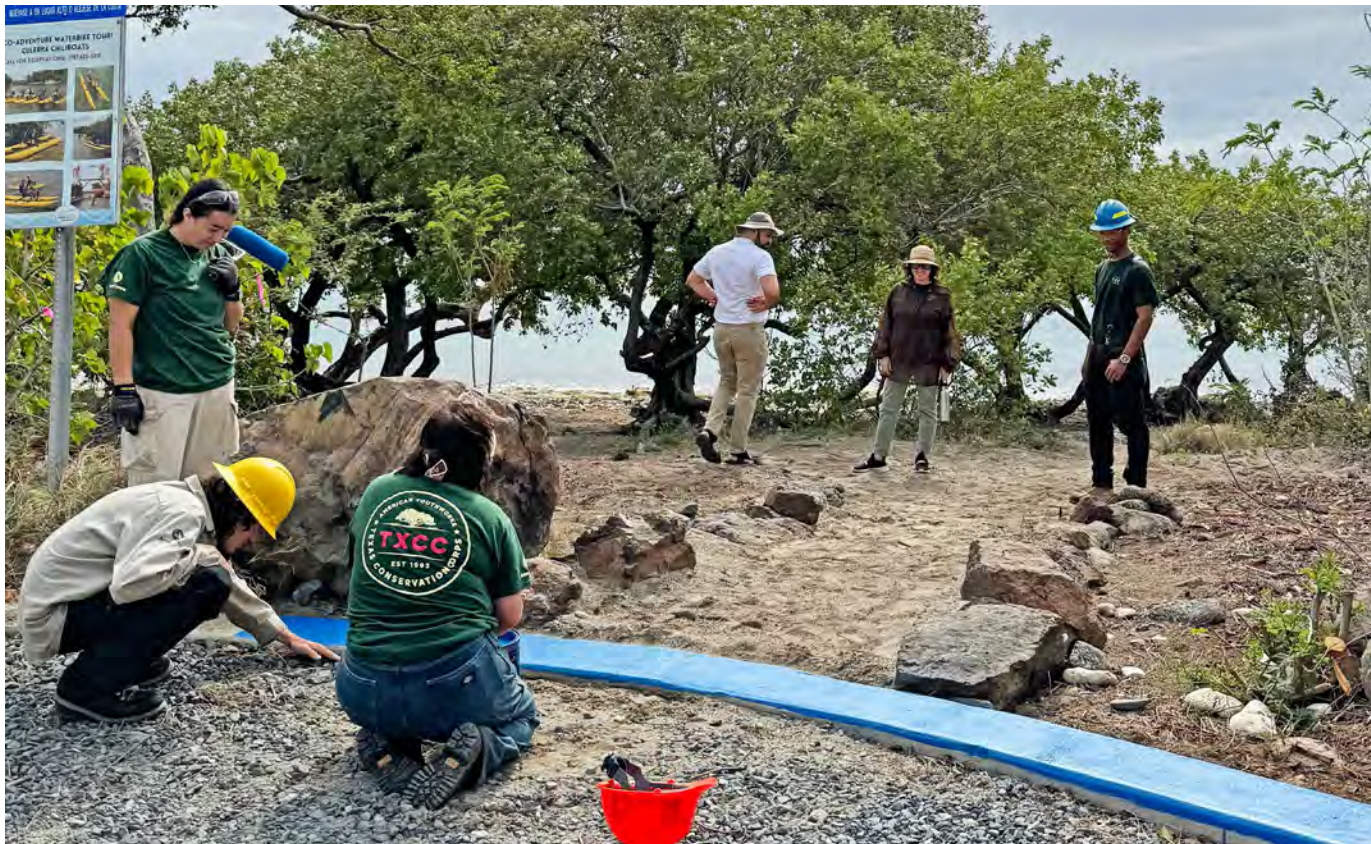
TEXAS CONSERVATION CORPS MEMBERS BUILDING AN ACCESSIBLE RAMP AT PUNTA SOLDADO

- ◆ Clear overgrown and invasive vegetation
- ◆ Build a ramp to improve accessibility to the beach
- ◆ Plant native species, provided by SEVA, along main road
- ◆ Host a trail building and maintenance workshop

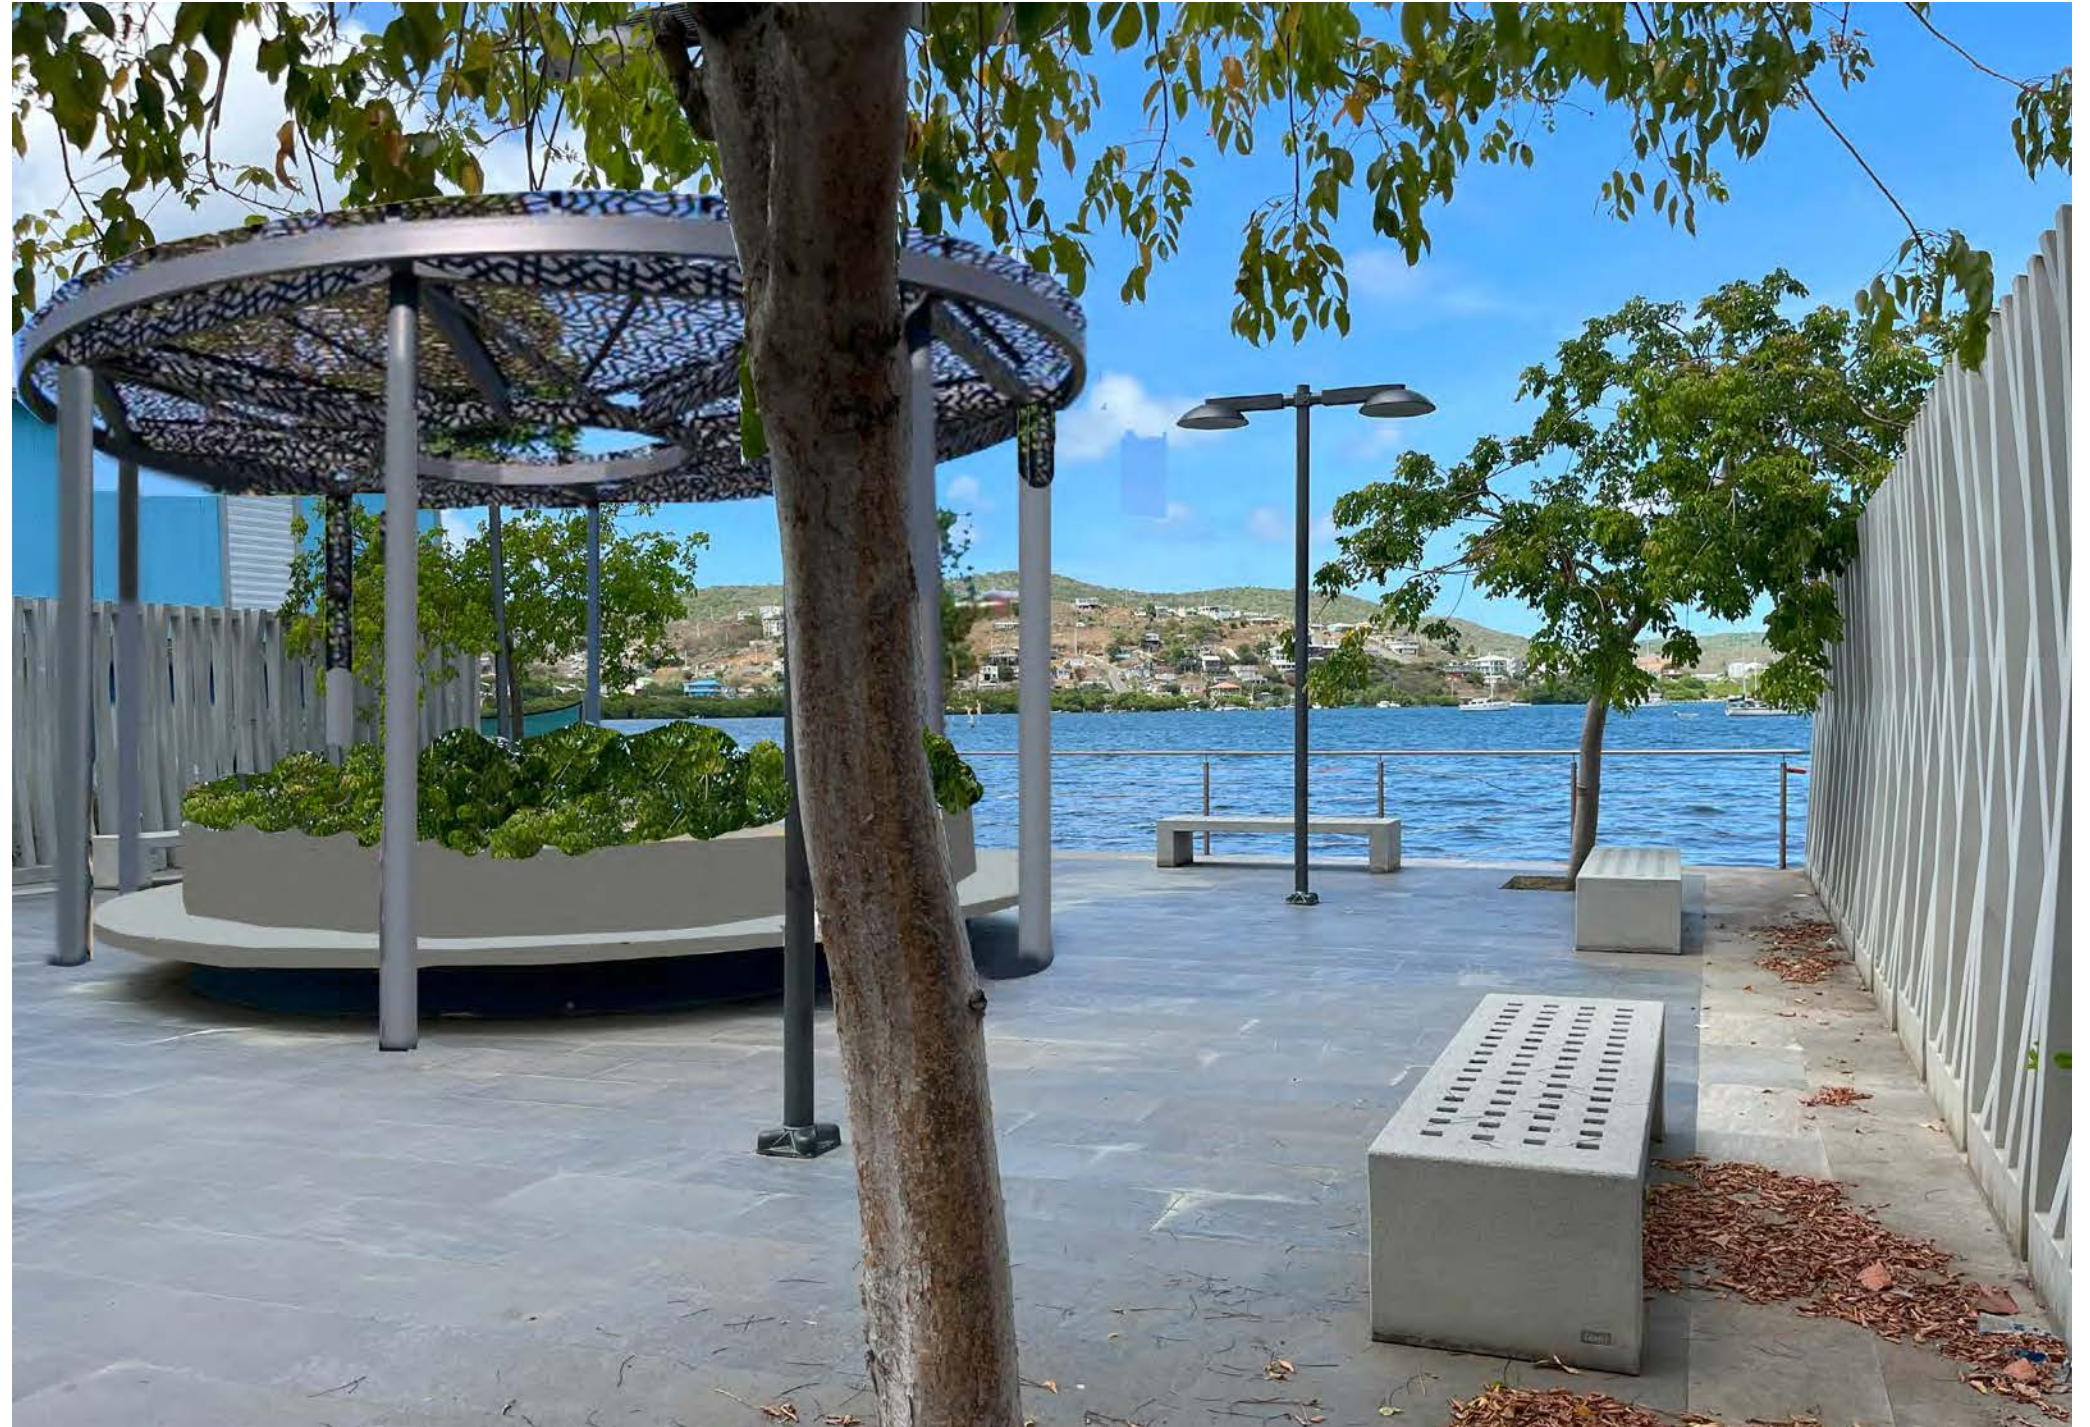
PROPOSED IMPROVEMENTS FOR THE PLAZA AT ENSENADA HONDA

- ◆ Replace the guardrail or repair the balusters using a more durable and resilient material, such as cable railing.
- ◆ Replant the missing tree with one of similar size. Expand the pavement openings around the trees to improve access to air and water, ensuring healthier growth and better shade in the future.
- ◆ Rehabilitate the steel feature in the circular sitting area. If the structure beneath the damaged steel cover is hollow, consider converting it into a raised planter to reduce the heat-absorbing impact of the pavement. Install a pergola over the area to provide reliable shade. The pergola could be designed with an opening to allow sunlight and rain to reach the plantings.
- ◆ Collaborate with local artists to incorporate public art into the pergola design to add a unique and culturally significant element to the plaza.

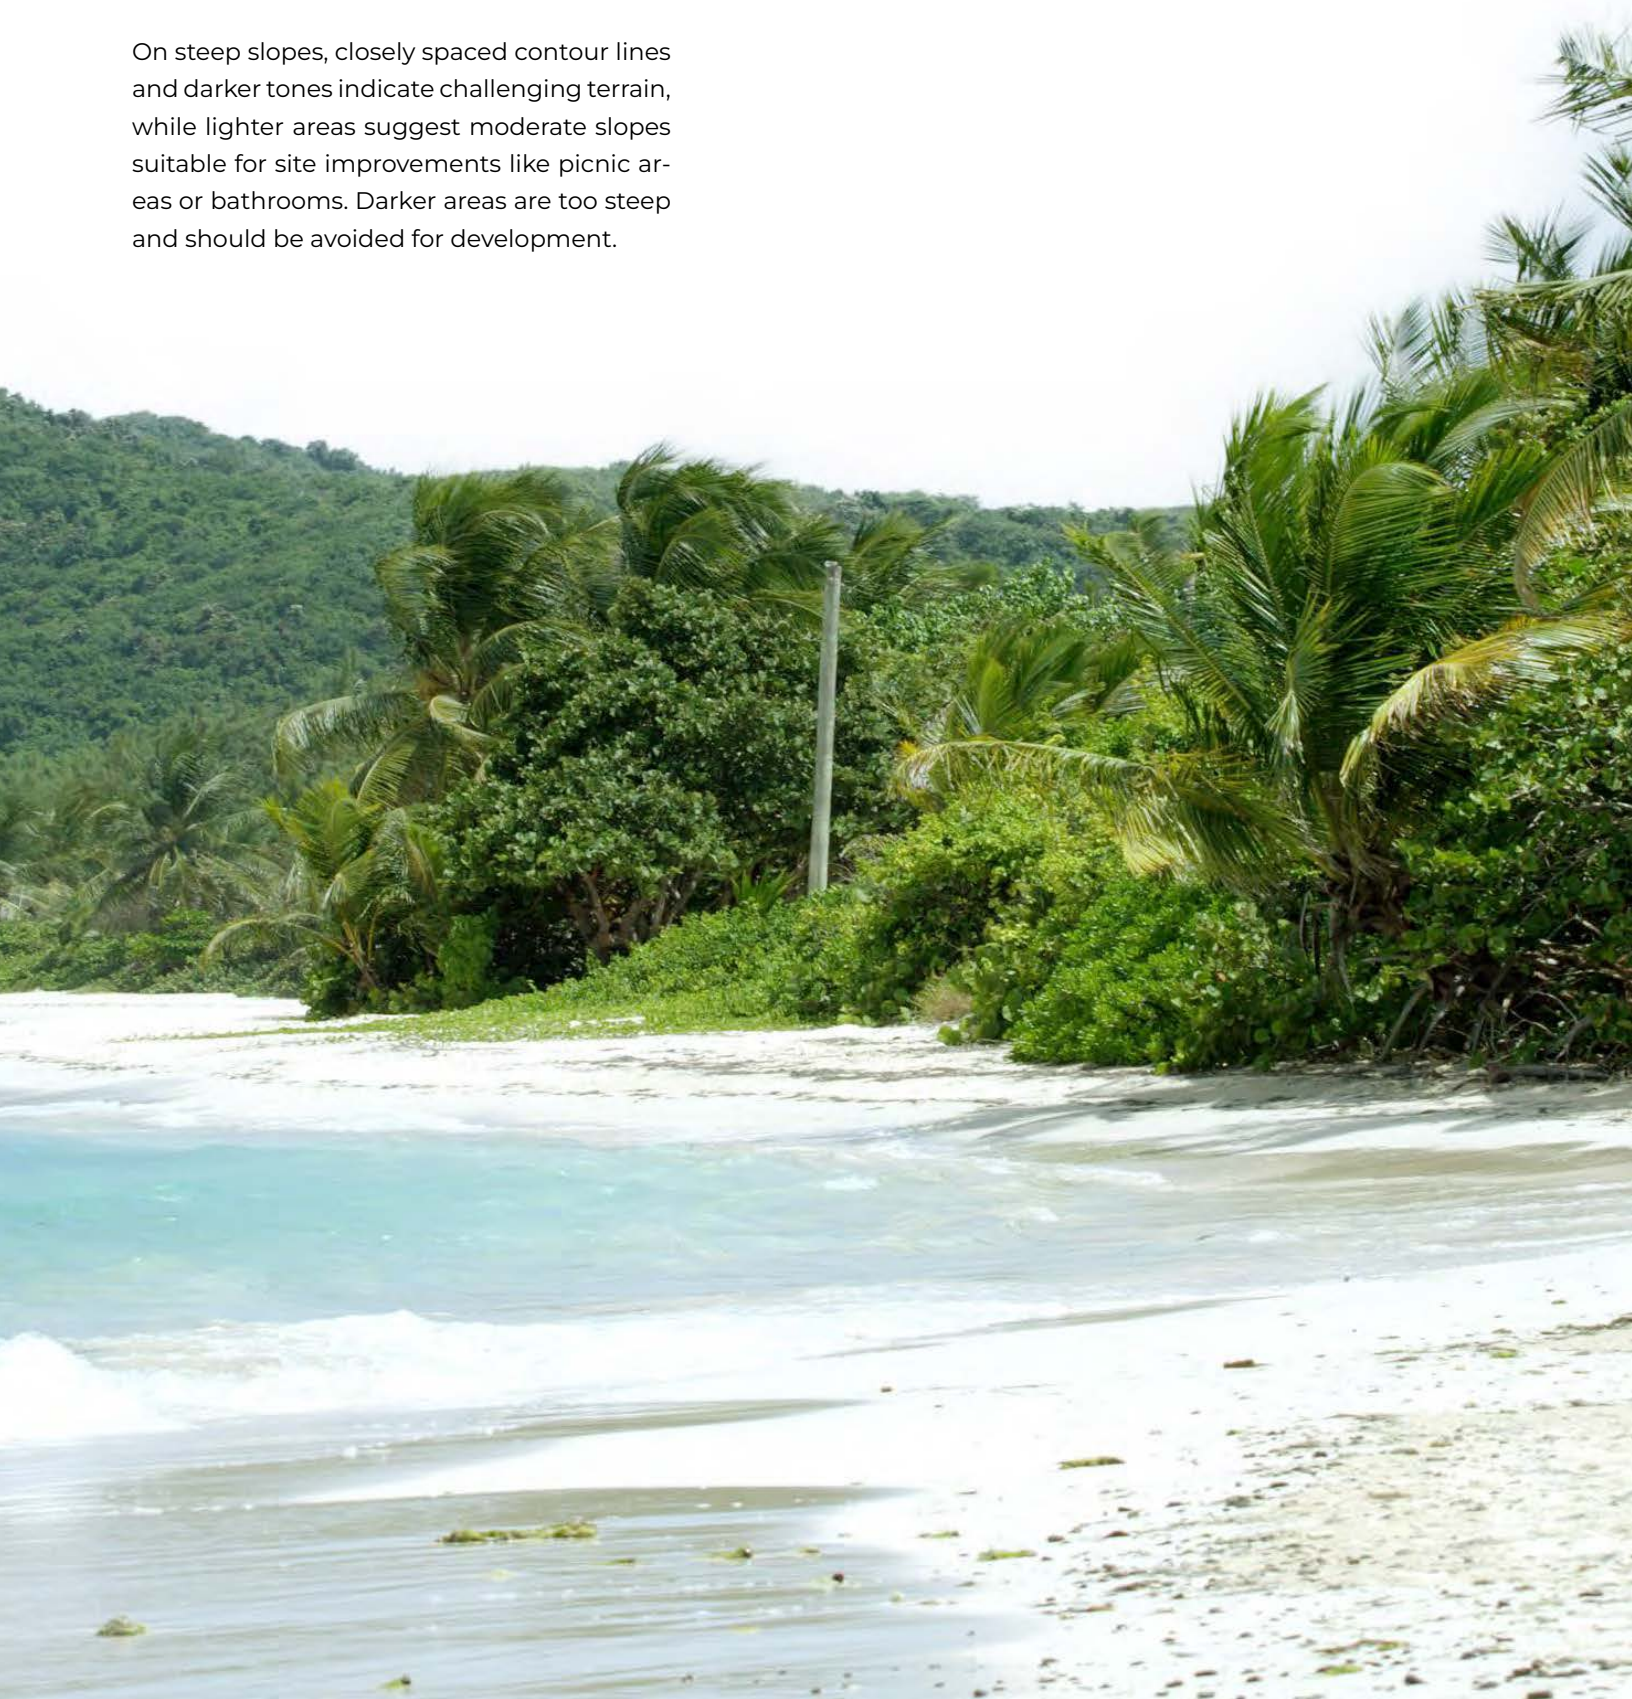
CULEBRITA ISLAND MAP

On steep slopes, closely spaced contour lines and darker tones indicate challenging terrain, while lighter areas suggest moderate slopes suitable for site improvements like picnic areas or bathrooms. Darker areas are too steep and should be avoided for development.

Photos on the following pages show the existing conditions on Cayo Culebrita. The locations of the photos are shown on the topography map.

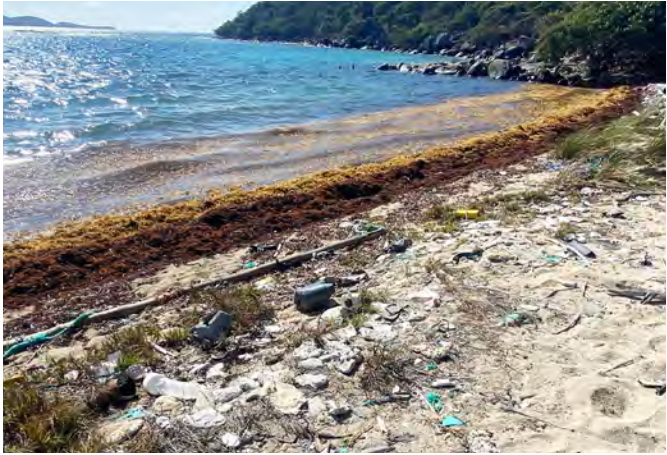
TRASH ON PUNTA SOLDADO

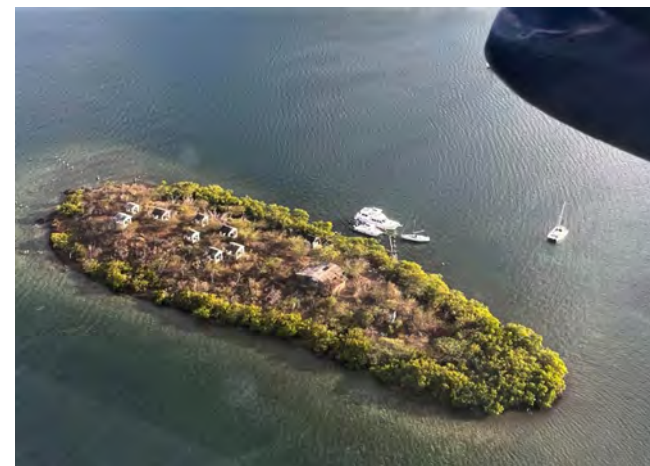
AN AERIAL VIEW OF CAYO PIRATA WHERE GAZEBOES AND OTHER STRUCTURES CAN BE SEEN.

- ◆ The first step should be to reconstruct at least a portion of the dock to make the island accessible.
- ◆ Organize a series of community clean-up efforts to remove hurricane debris, unsafe structures, and invasive vegetation.
- ◆ Once cleared, the municipality could build trails and plant native trees and shrubs to open the island for public use.
- ◆ Reuse existing picnic shelters until funding is secured for removal and replacement.
- ◆ Plan future additions (e.g., camping platforms, play structures) through annual budgets or grants.
- ◆ Fund larger projects (e.g., community hall, light-house) via a capital improvement campaign.
