NATIONAL PARK SERVICE
Point Reyes National Seashore
Point Reyes, California 94956

This letter and Pre-Construction Notification (PCN) is submitted for the proposed project to restore natural conditions to Drakes Estero through removal of 95 oyster racks extending approximately 5 miles over subtidal lands within Drakes Estero. This project will remove the remaining non-historic and non-essential facilities associated with the Johnson Oyster Company and Drakes Bay Oyster Company (DBOC) and restore wilderness conditions to the marine waters within Drakes Estero.

The Drakes Estero Restoration Project is intended to remove all oyster racks and aquacultural debris and to restore conditions supporting natural ecological and hydrologic process within Drakes Estero within Point Reyes National Seashore (Figure 1). The restoration actions include removal of wooden racks, aquacultural debris (including tubes, bags and strings), oyster mats, anchors and lines, as well as development and implementation of long-term monitoring programs to document the ecological response and transition of Drakes Estero to the cessation of aquaculture activities and restoration. The project involves the followin

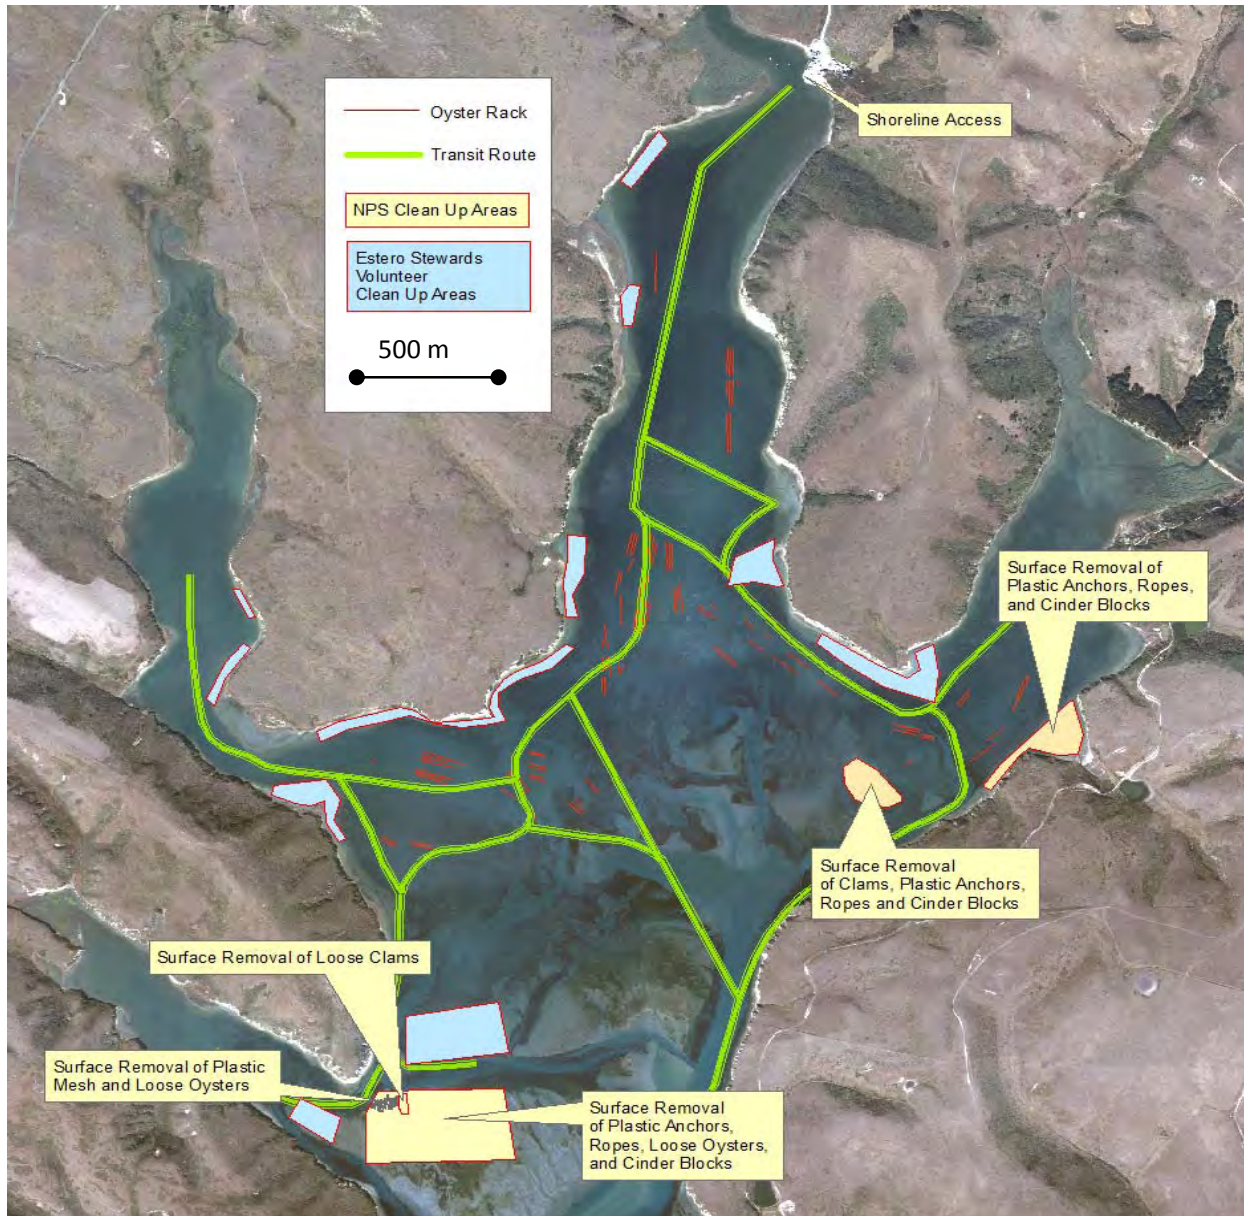
Figure 2: Project Treatment Areas, and primary vessel transit routes within Drakes Estero

The Project Area is represented by the offshore and onshore areas of the former commercial oyster operation within Drakes Estero. There are a number of specific areas within the restoration project area where the NPS plans to implement removal and restoration activities (Figure 2). Barge and boat traffic associated with the demolition and restoration activities will primarily follow established vessel transit corridors.

The 95 oyster racks comprise approximately 7.07 acres of area (308,000 square feet), and if lined up end to end are more than 5 miles long. The Project will result in removal of between 200,000 and 250,000 total board feet (approximately 477 tons) of lumber from Drakes Estero. In the long-term, the project will enhance and restore conditions within the entire 7.07 acre footprint through the removal of infrastructure and restoration of more natural conditions. The NPS estimates that approximately 2,234 vertical structures (bents) are installed in the bed of the estero holding the racks in place. It is estimated that approximately 40% of the posts and 41% of the length of bottom cross-member (deadman) are adjacent to and could affect existing eelgrass habitat. Table 1, below identifies the overall project area footprint and impact area within areas where eelgrass is documented.

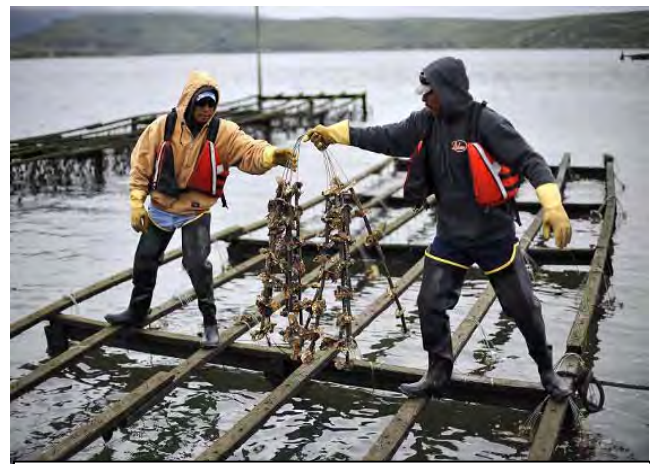
Figure 3: Typical Oyster Rack in Drakes Estero (Photo Source: www.sfweekly.com)

It is estimated that the 95 oyster racks contain between 200,000 and 250,000 linear feet of dimensional lumber. Materials used to construct the racks typically consisted of 2 in. x 4 in. and/or 2 in. x 6 in. milled lumber (see Figure 3 and Figure 4 for typical condition). Some oyster racks were constructed using pressure treated lumber. Drakes Bay Oyster Company (DBOC) was not permitted to construct or add new lumber to the oyster racks for the last ten years. Therefore, it is assumed that all lumber in the Estero has been in-place for at least 10 years, with much of it present in the estero for 3-4 decades.

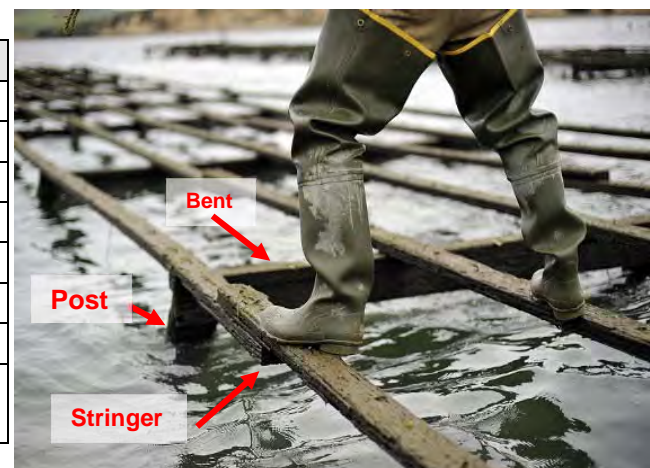
Figure 4: Typical Oyster Rack in Drakes Estero (Photo Source: www.sfweekly.com)

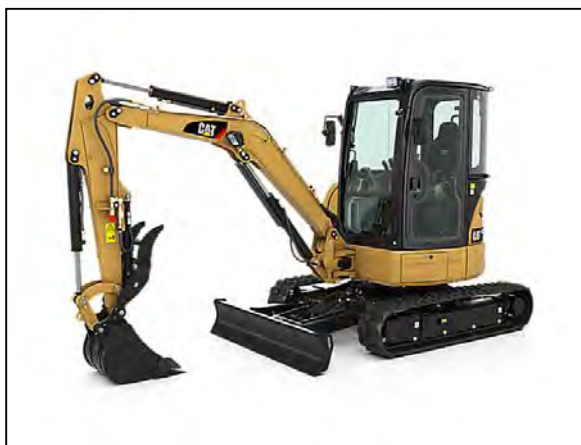
Figure 5: Typical Mini-Excavator
Photo: www.cat.com

excavators, which have been described for use in debris removal and in-situ treatment, could also be highly effective for rack removal activities because they could allow operators to have a longer reach and therefore require less anchoring. Additionally, the NPS is evaluating how the

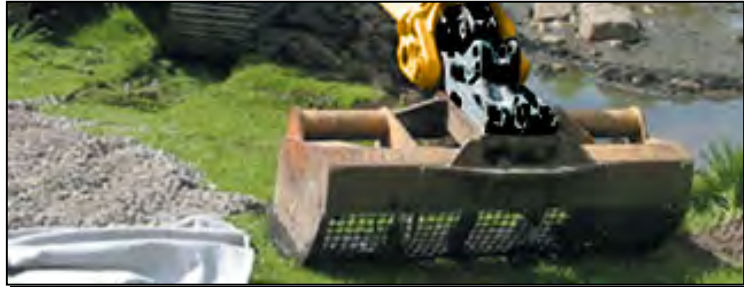
Figure 6: Dredge Bucket (Photo:<http://www.gradall.com>)

The NPS documented approximately 1 acre of aquaculture debris (tubes, strings, bags and lines) within the footprint of the racks. An excavator using a clamshell or equivalent dredge bucket type was originally identified as the equipment that would access and remove accumulated aquaculture debris (bags, strings, and tubes) from the bottom surface (See Figure 6).

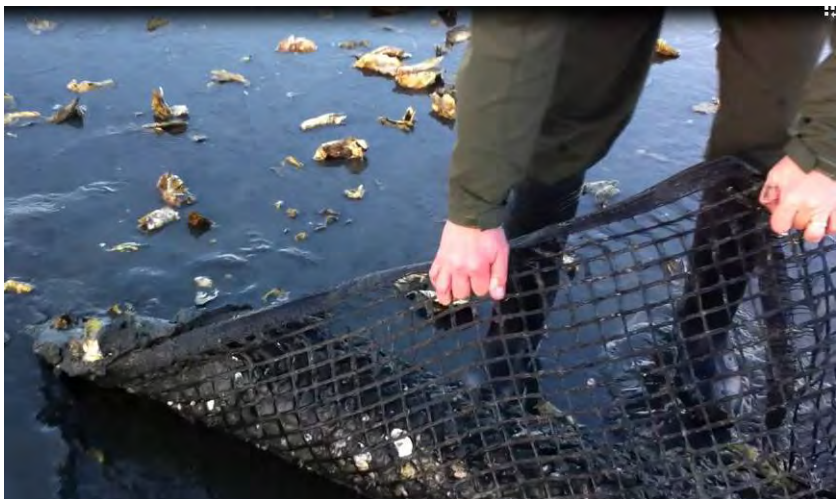
Figure 7: Plastic Mesh Fabric Oyster Mat

It appears that sometime between 2009 and 2014 DBOC rolled out plastic mesh mats that were used to grow oysters outside of bags or containment (Figure 7).

The NPS has documented, through review of recent aerial photos and field inspection, the presence of approximately 15 sections of this 12 foot wide mat, ranging in length from 50 to 100 feet on the western portions of the sandbar near bed 17 (see Figure 8). The total area covered by these mats is approximately 16,900 SF (0.39 acres). These mats are covered by 2-6 inches of sand and a large number of uncontained live large pacific oysters (see left portion of Figure 7).

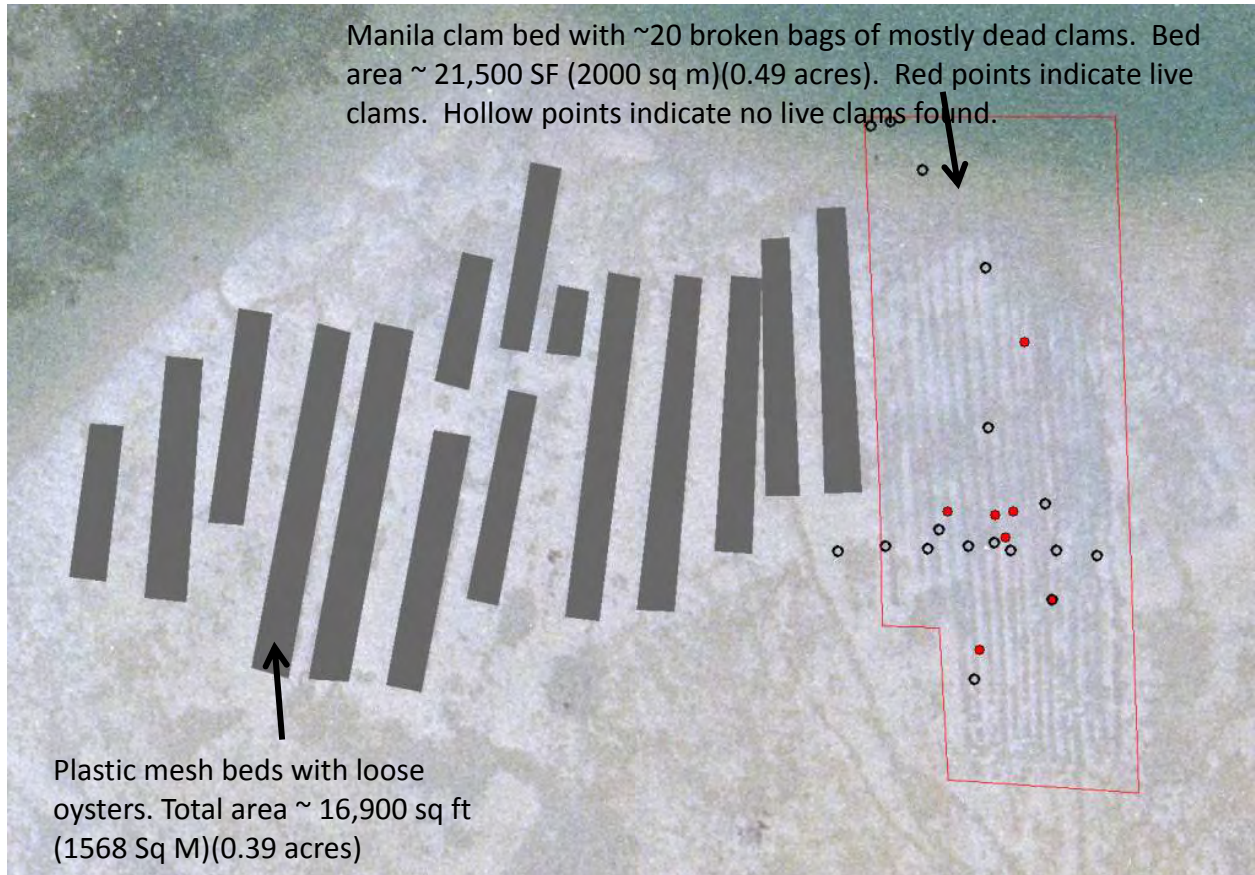
Figure 8: Locations of mesh mats (n = 15) and former Manila clam bed with broken bags and live clams in the sediment near bed 17. See Figure 2 (Project Map) for location with project area.

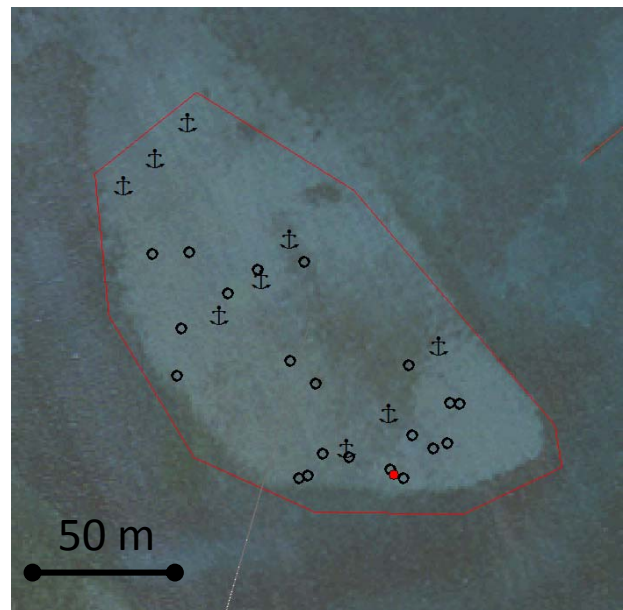
Figure 9: Former manila clam bed (Bed 7) with ~10 broken bags of dead clams. Bed area = approx. 20,000 sq m. (4.94 acres). Red points indicate live clams. Hollow points indicate no live clams found. Anchor symbols are plastic anchors.

DBOC provided GPS locations of more than 30 plastic anchors that would be left at the close of their operations in areas of Bed 17 (Figure 10), Bed 7 (Figure 9), and Bed 39 (Figure 11). The NPS has observed that these anchors still include a network of connected lines. Additional infrastructure, including cinder block anchors

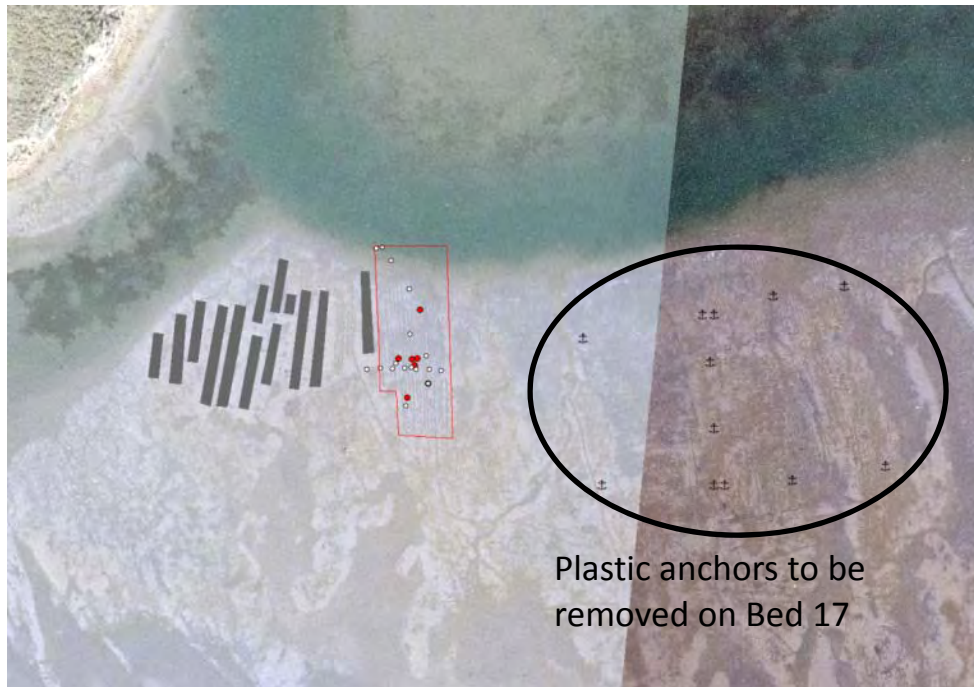
Figure 10: Plastic anchors to be removed on Bed 17.

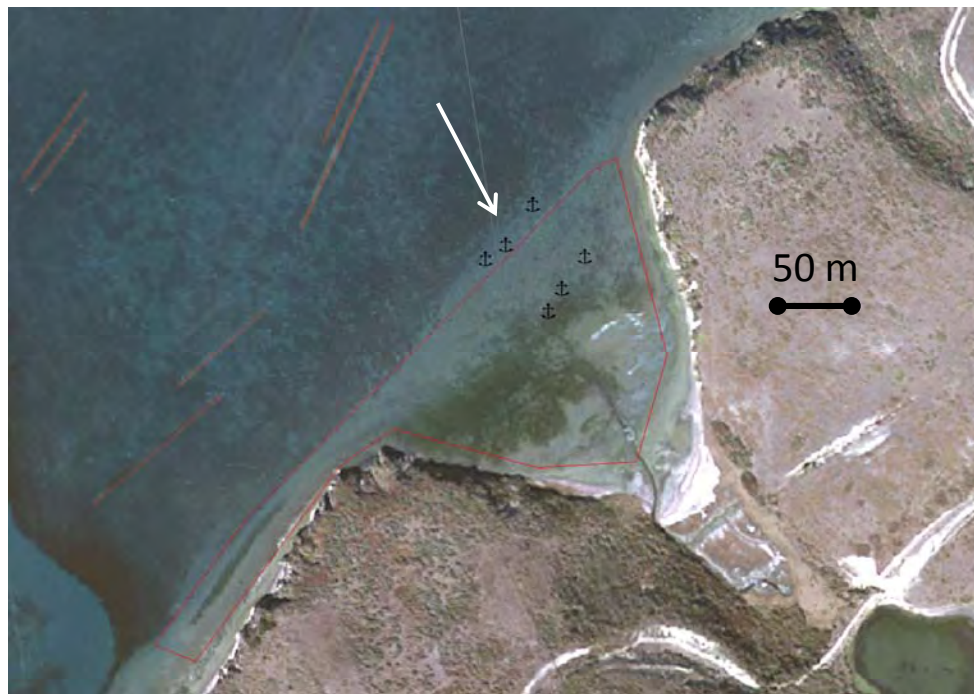
Figure 11: Plastic anchors to be removed on Bed 39.

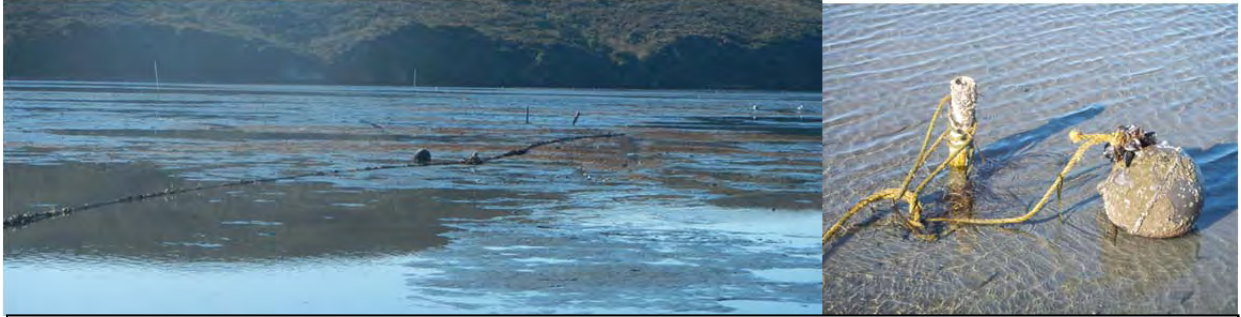
Figure 12: Examples of screw anchors and lines on Bed 17.

and many other lines will be removed as they are encountered (See Figure 12).

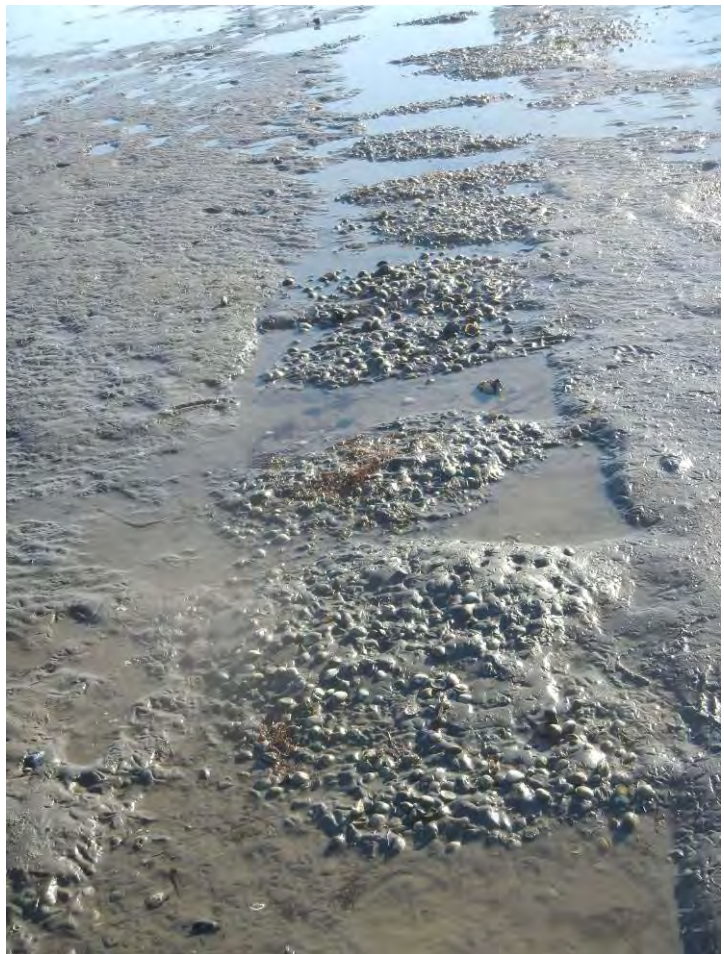
Figure 13: Remains of dead and live manila clams from spilled clam bags near bed 17. January 2015. See Figures 8 and 10 for location.

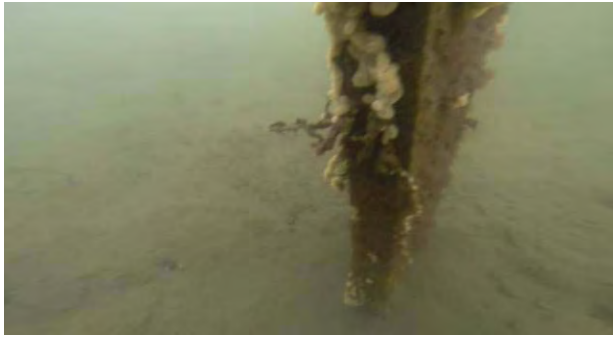
No eelgrass. Rack 6E on 1/29/2015

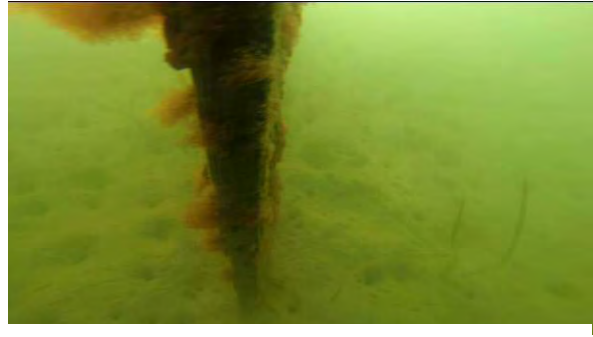
Very Low (<5%) eelgrass coverage. Post in sediment on Rack 11I on 1/30/2015. Note single eelgrass plant approximately 18" from post.

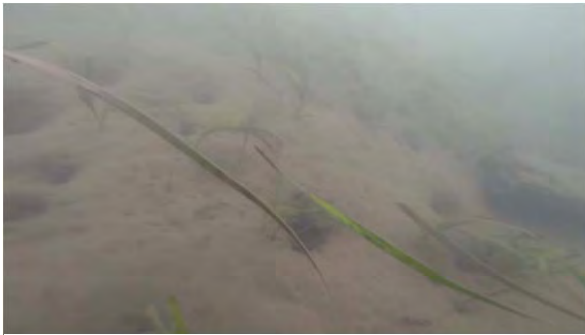
Light (5-25%) eelgrass coverage under rack 11H on 1/30/2015

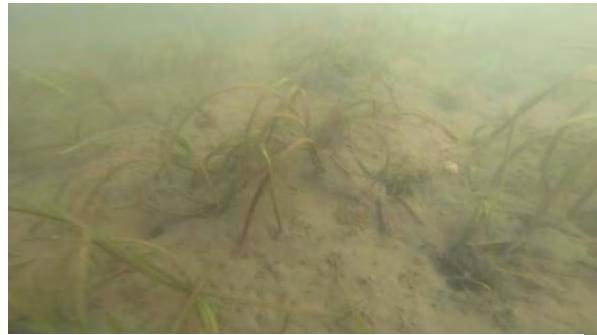
Moderate (25-75%) eelgrass coverage under rack 8P on 01/28/2015.

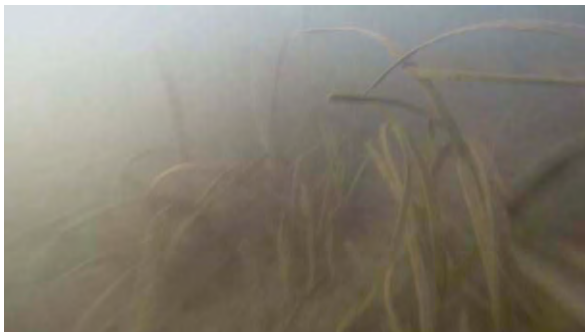
Dense (>75% cover) eelgrass. This density only occurred under part of rack 41. All other racks surveyed were <75%, but racks 22E and 22F are close to 75%.

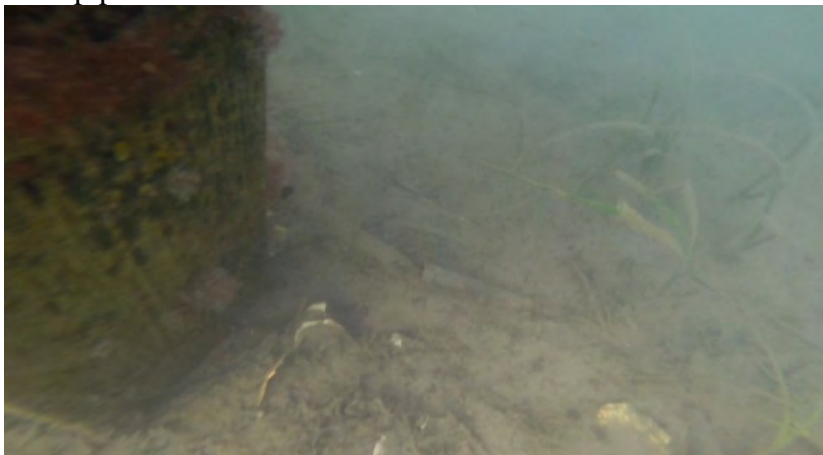
Minor debris by post under rack 22D on 1/30/2015. Note plastic spacer tubes with wire and scattered oyster shell.

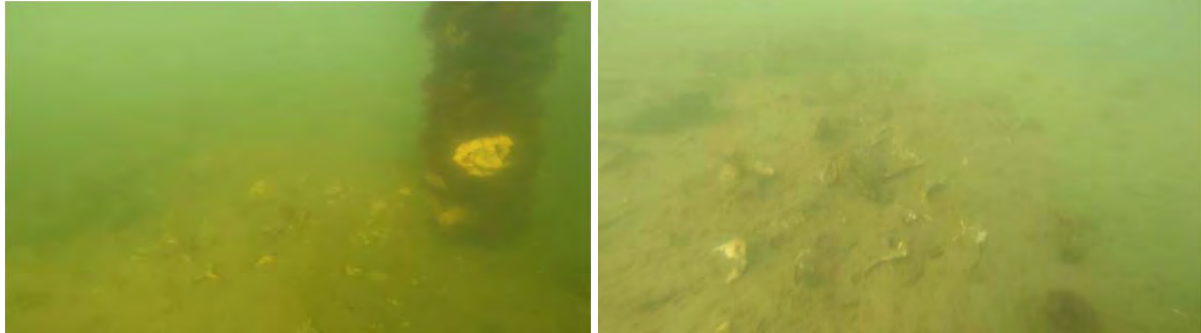
Moderate shell debris under rack 9C on 1/1/2015.

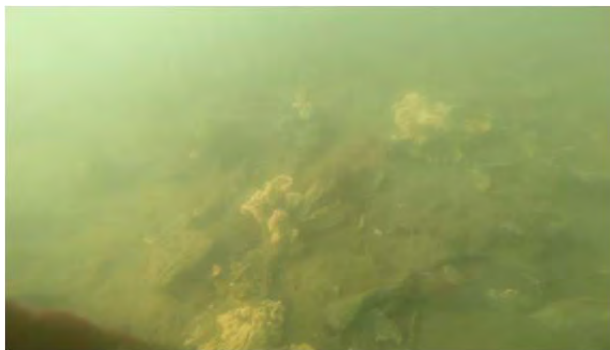
Upper end of moderate class of debris under rack 9C on 1/29/2015

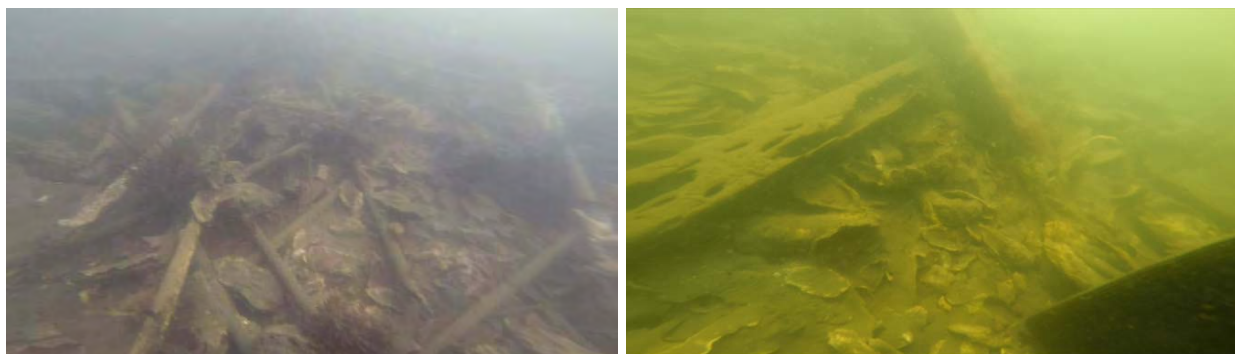
Examples of heavy debris: (Left) oyster shell and French tubes under rack 6B on 1/29/2015, (Right) oyster shell under rack 22B on 1/30/2015.

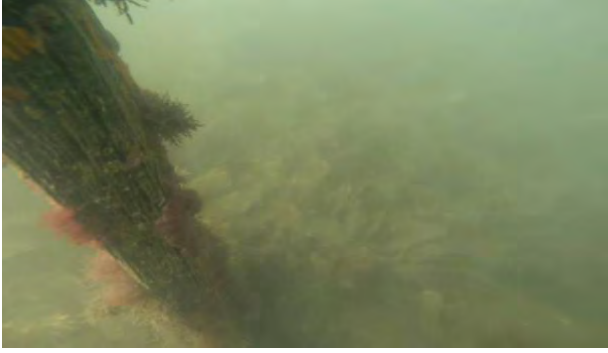
Heavy debris on rack 9C on 1/29/2015.

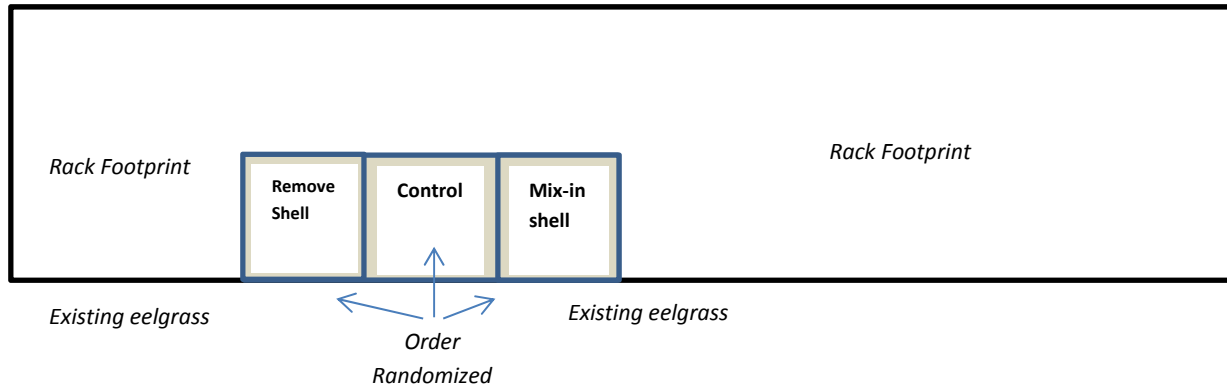
Figure 1. Experimental design showing treatments within the footprint of an oyster rack surrounded by existing eelgrass. Racks are 12' wide and each plot will be 3'X3" (Not to scale). This design will be replicated 10 times each in in areas of heavy and moderate oyster shell coverage.

All treatment plots will be conducted in a split plot design in groups of 3 (removal/mixing/control) to minimize location effects. The linear order of the treatments will be randomized and in no case be at the end of a rack, since the ends of racks could have existing eelgrass on 3 sides of the plot, whereas non-end plots would have pre-experiment eelgrass at most on two sides of the plot. Racks suitable for treatment 1, treatment 2, and control split plots are listed in Table 1. There are 11 potential racks that meet the needs for a heavy shell treatments, and 10 potential racks that meet the needs of the moderate shell treatments. Note that there is some variation in shell coverage classes under single racks, meaning that a heavy treatment may occur in one section of a rack, and a moderate in another section. Each plot will have the 4 corners marked with white ¾” PVC pipe that protrudes approximately 1.5 feet above and 3 feet below the bay floor to ensure easy and accurate relocation of plots. The top of the pipe marker will still be 2 feet below the water surface at most low tides. WAAS GPS will also be used to record all plot locations for relocation.

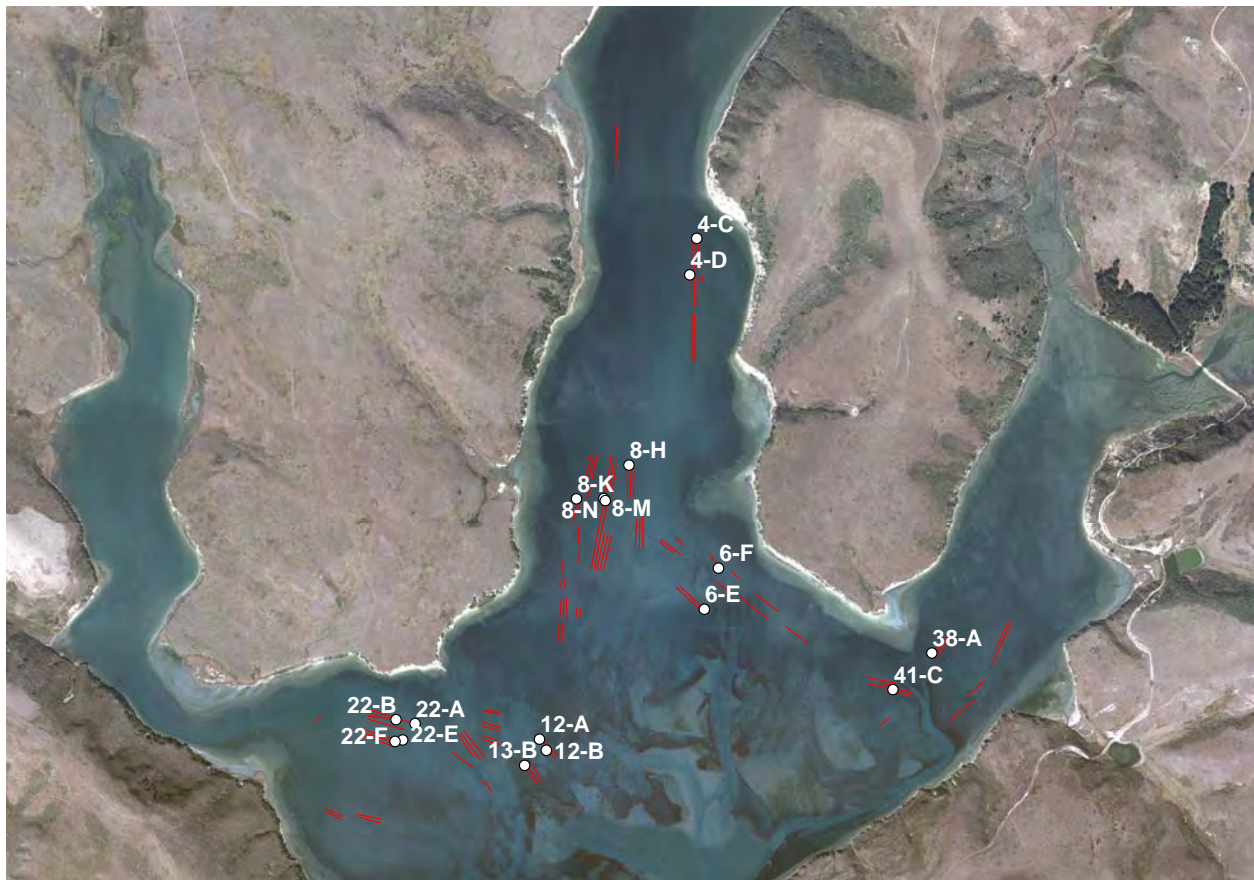
Figure 2: Rack Locations suitable (shell debris under racks and eelgrass growing adjacent) for potential experimental shell removal, shell mixing and controls. See Table 1 and text for details.

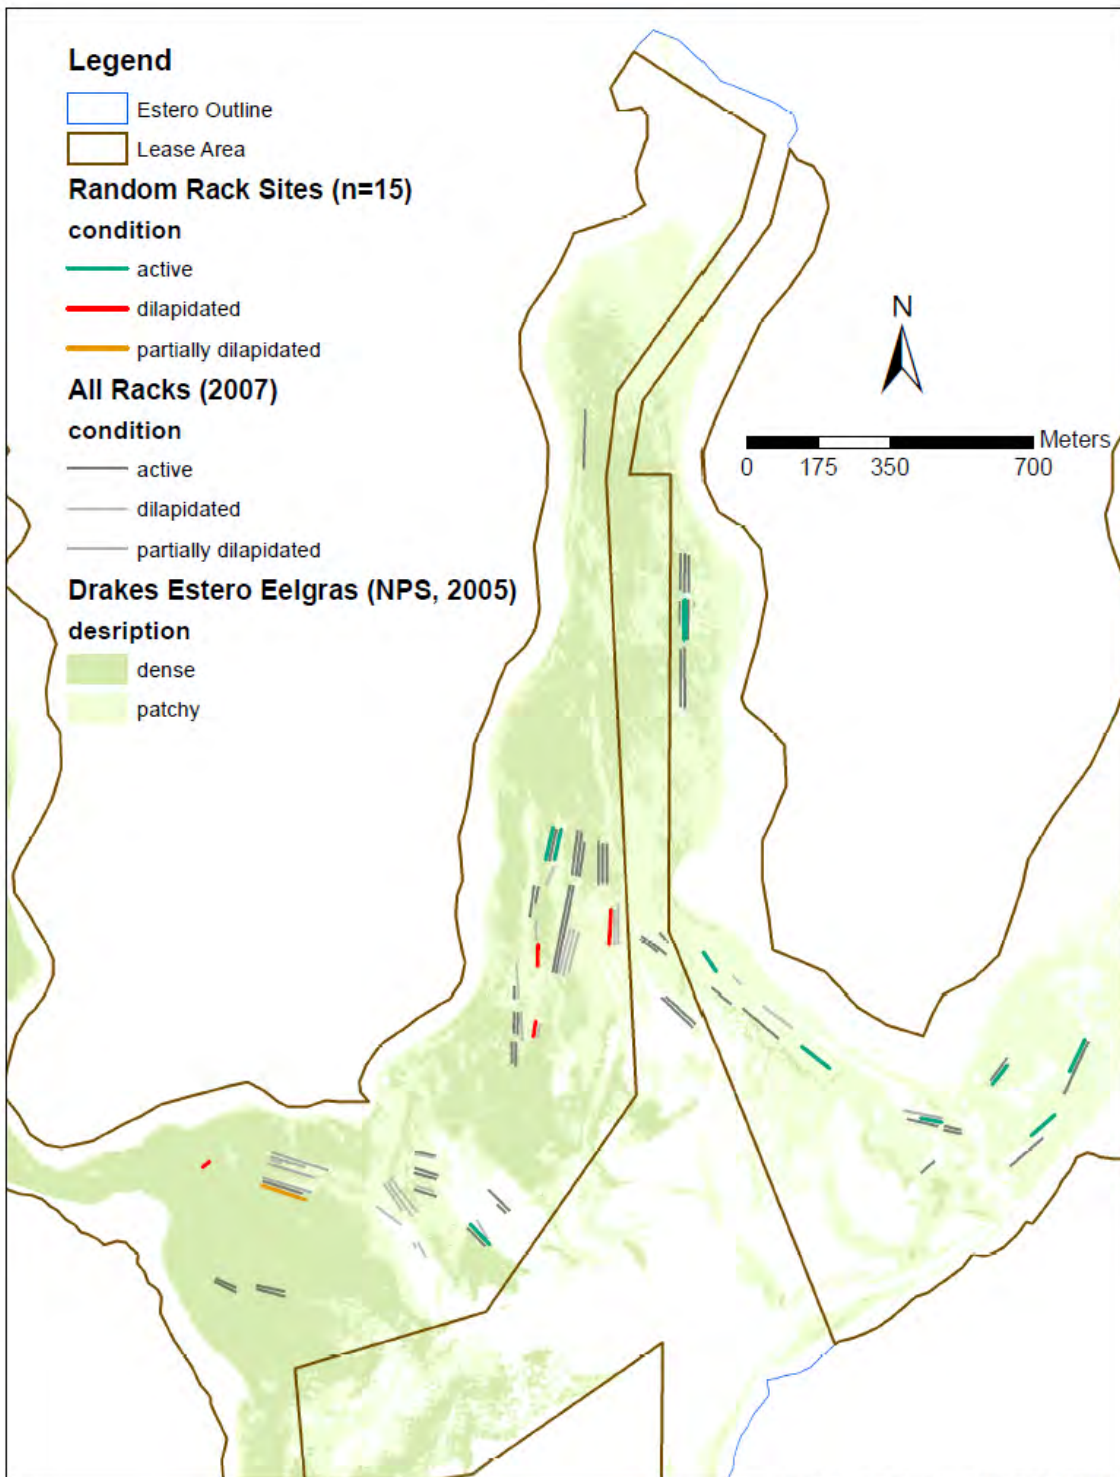
Figure 1. An example of 15 randomly selected survey sites including racks in good (Green) and poor (Red) conditions. Control sites will be randomly placed near treatment racks to ensure a valid comparison.

An example of a selection of oyster racks for survey is in Figure 1.
