The following text was adapted from: “Mourning Glory: Preserving Historic Cemeteries,” published in 2011 and part of *Terra Firma: Putting Historic Landscape Preservation on Solid Ground* a publication series developed by the Massachusetts Department of Conservation and Recreation.

## CEMETERY ISSUES

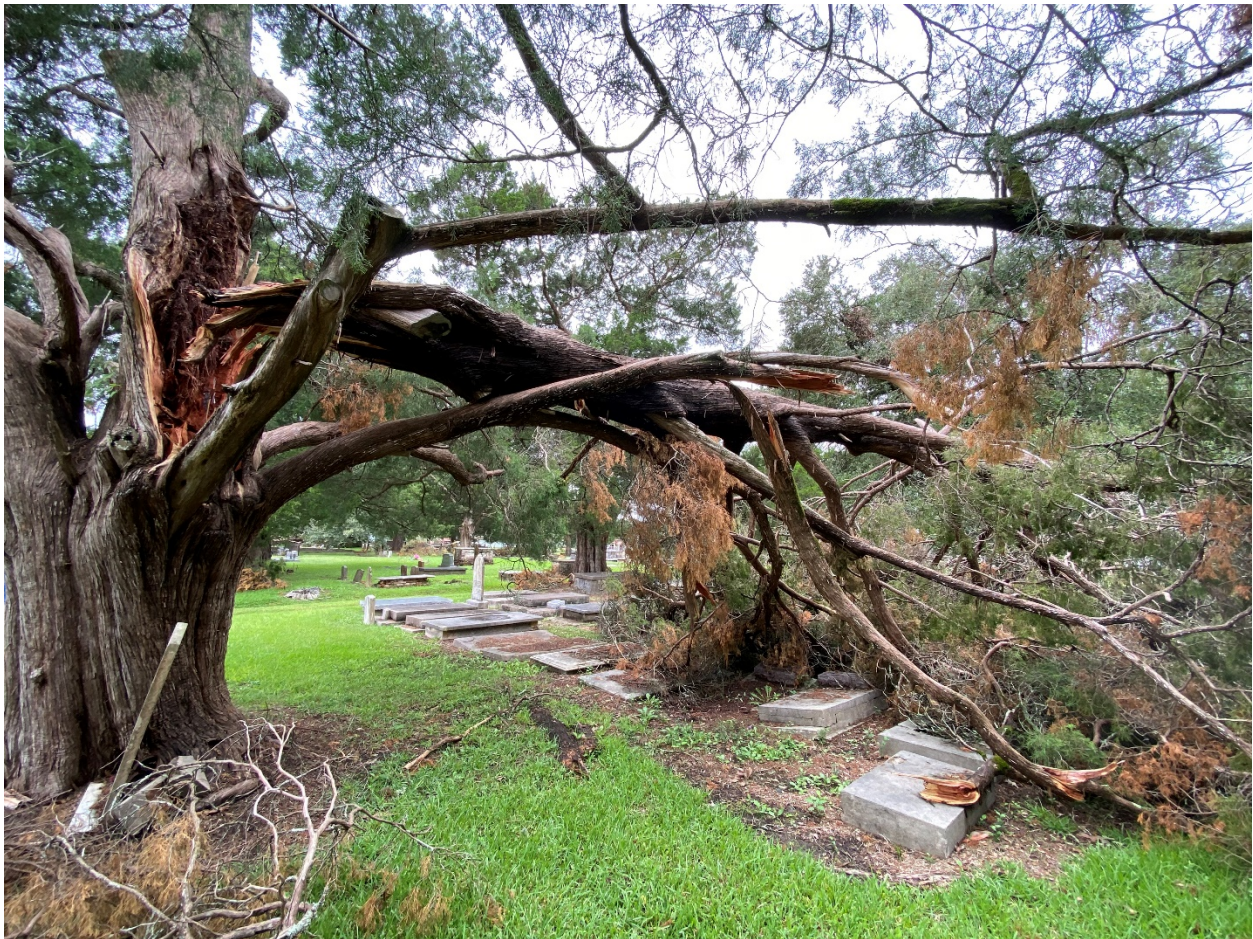
*Tree damaged by during Hurricane Laura. Catholic Cemetery, Natchitoches Louisiana.*

Older trees are particularly vulnerable. Without adequate maintenance, these plants become tall and top heavy, easily toppled by wind. Regular pruning and replacement can avoid catastrophic damage to historic plantings, the restoration of which may not be eligible for emergency funding.

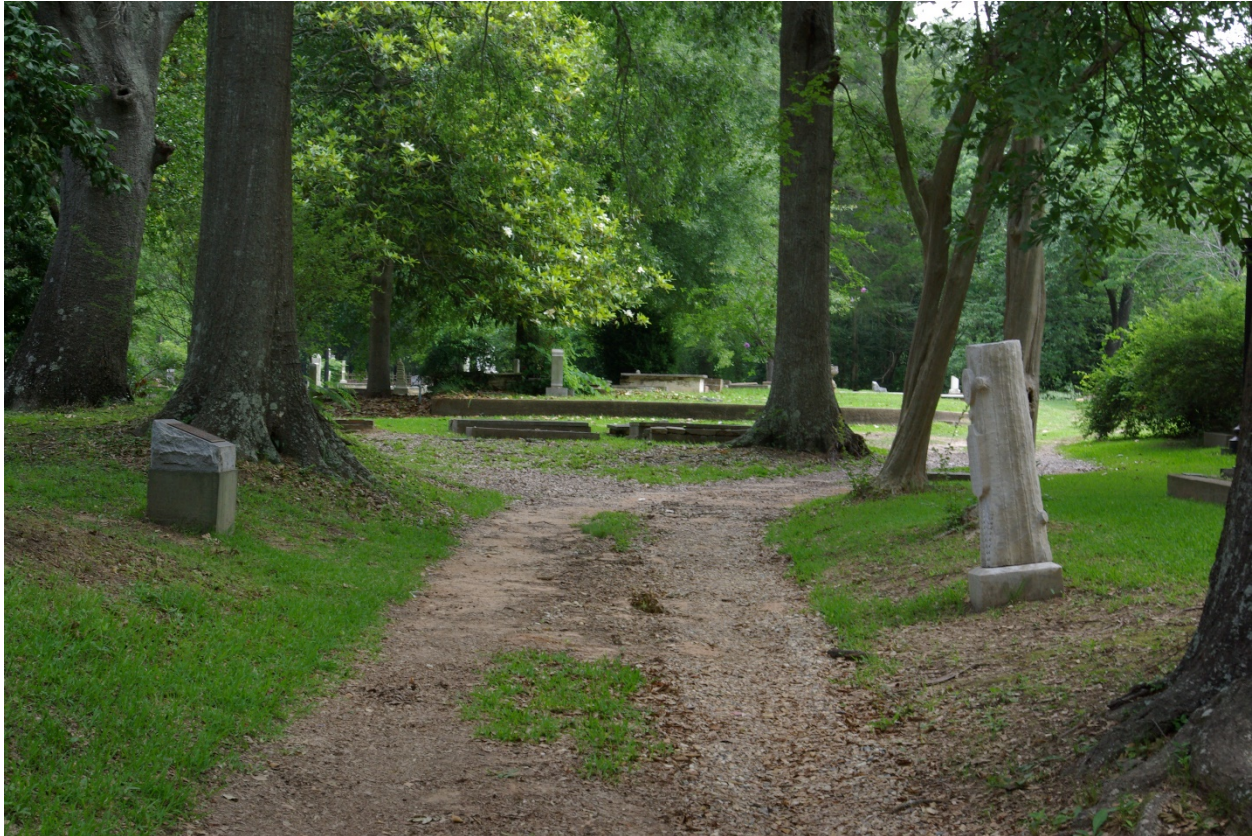
*Narrow road American Cemetery, Natchitoches, Louisiana. The road, originally designed for horse and buggy, is not wide enough to easily accommodate automobiles.*

Older cemeteries often do not have the generous turning radii at intersections that our contemporary vehicles require. Planned rerouting of traffic and/or provision of unobtrusive protective devices like bollards, wheel stops, or wood guardrails may be required.

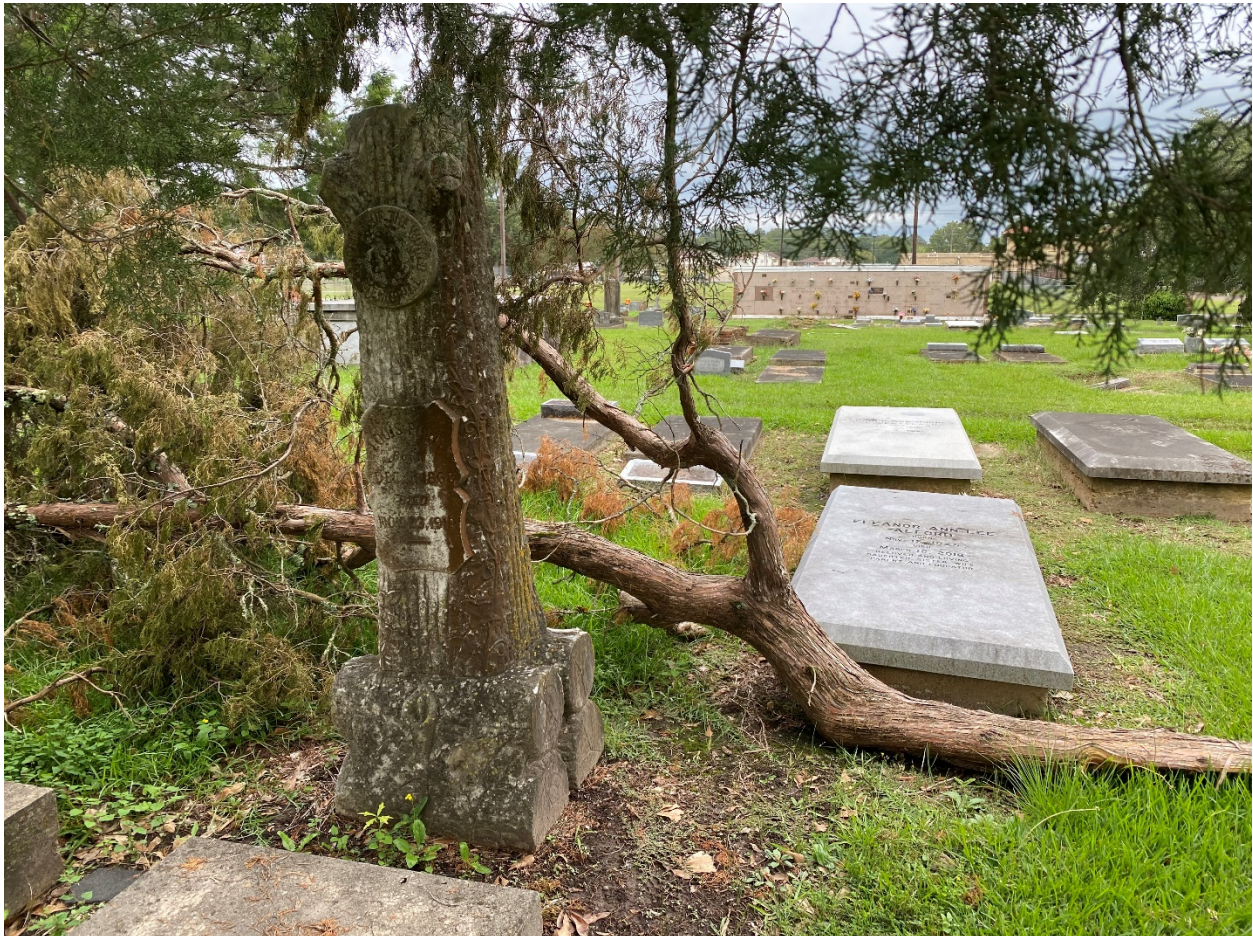
*Dead wood should be pruned yearly to avoid potentially falling and damaging grave markers. Catholic Cemetery, Natchitoches, Louisiana*

Trees, shrubs and hedges often contribute significantly to the character of the cemetery landscape. Over time, woody plants mature and decline due to age and disease. Dead branches in specimen trees can pose threats to visitors, monuments and structures. Proper maintenance, including pruning, integrated pest management, and periodic replacement ensures that character-defining vegetation remains a part of the cemetery. The periodic pruning of trees in historic burial places is essential to plant health and can allow light and air to reach the ground, instead of creating shaded, wet microclimates that might kill turf or foster biological growth on stones. Potentially hazardous dead wood should be removed every year, with safety pruning occurring every five years. Early removal of volunteer growth and invasive plants can prevent roots from damaging built features or crowding out historic plantings.

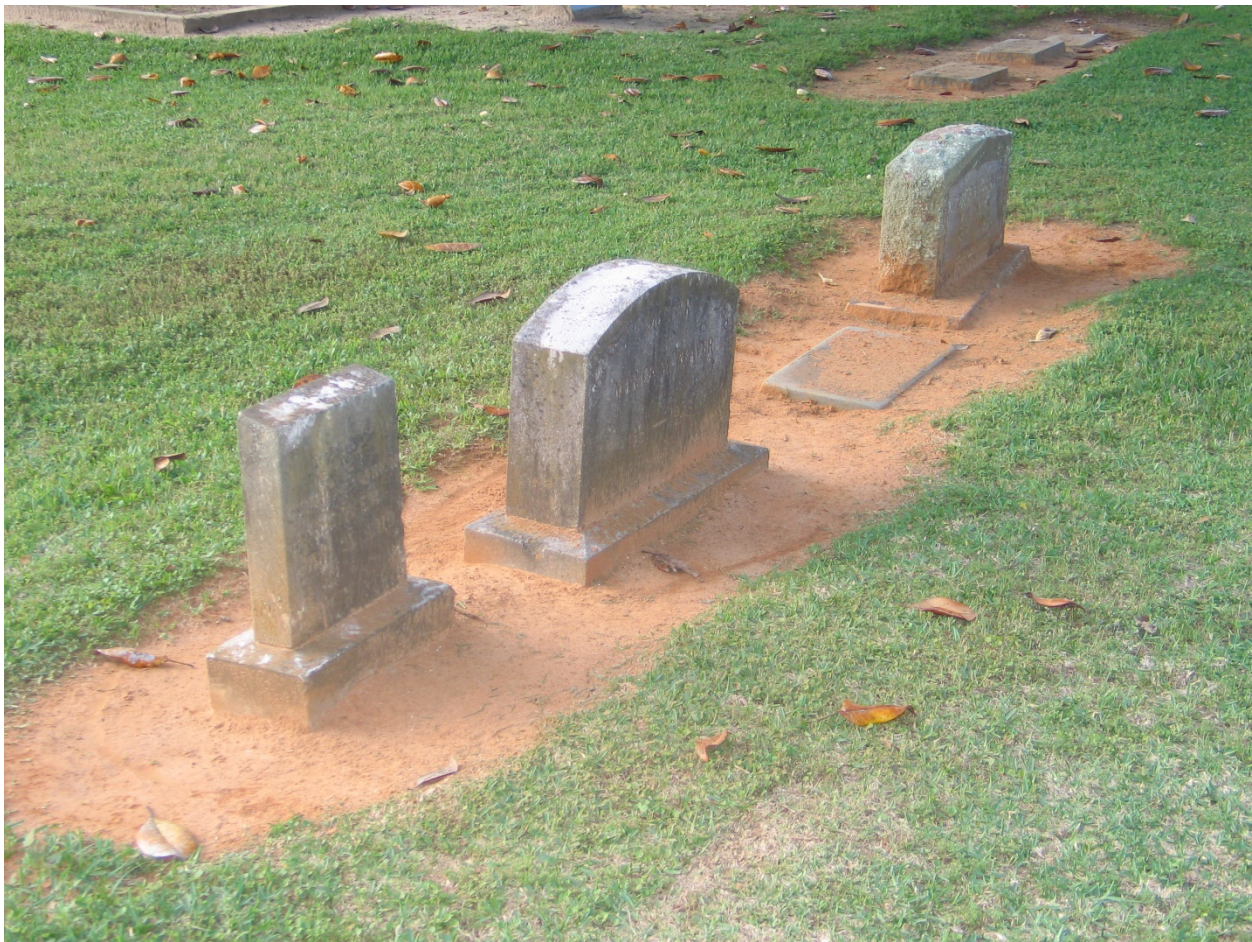
*“Dead zone” surrounding grave markers where herbicides were used to control grass growth.*

To control weeds, diseases and insects, utilize alternatives to chemicals and establish a monitoring system for early detection in accordance with Integrated Pest Management (IPM) practices. Exercise caution when using herbicides and pesticides as many of them also have a high salt content that can damage stone markers and create unsightly “dead zones” in a historic landscape.

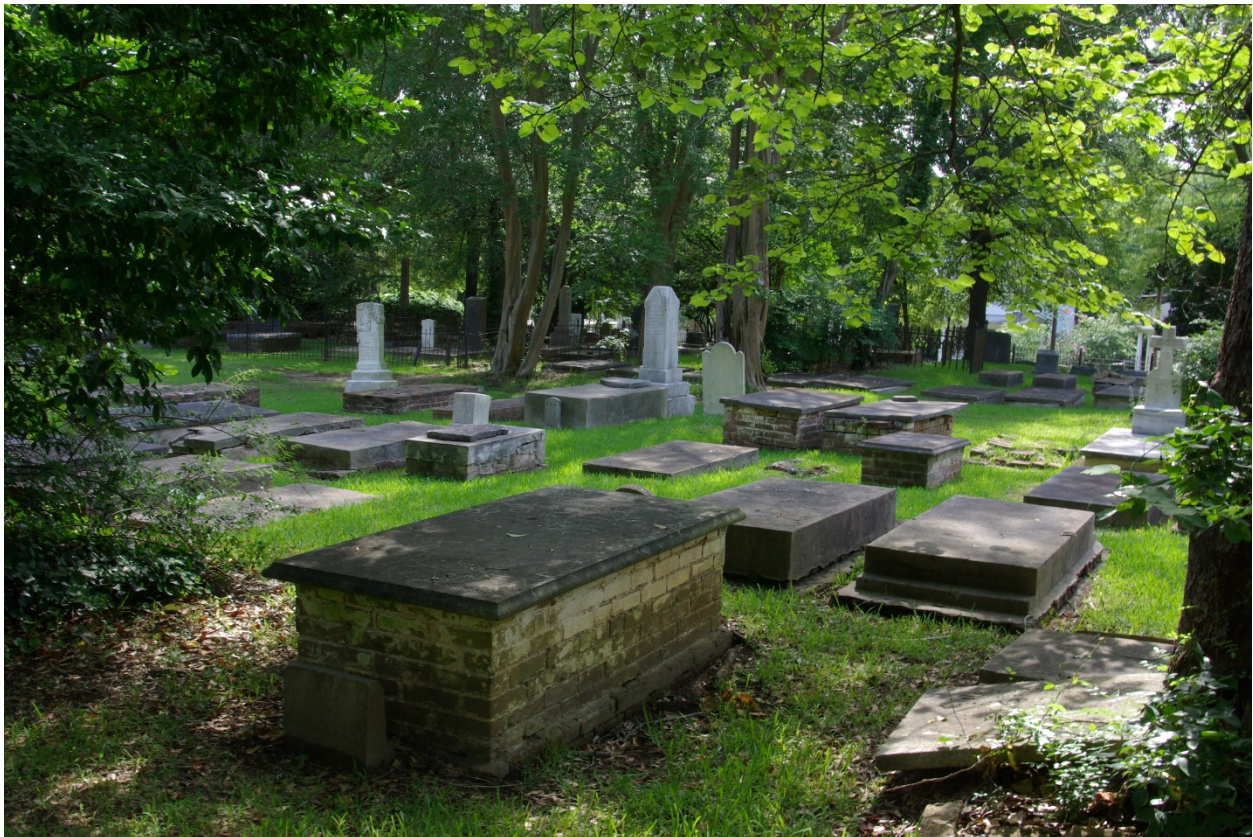
*Grave markers and vault tombs in American Cemetery, Natchitoches, Louisiana*

Tombs, vaults and mausoleums can be difficult to maintain, and the conservation of stone structures should be undertaken in consultation with professionals. Table tombs can be unstable, creating a safety concern, or they can collapse and become embedded in turf. Mausoleums and vaults should be monitored for signs of frost heaves and moisture such as displaced stones, sinkholes on earthen roofs, icicles forming at mortar joints, or water seepage through walls. Only a structural engineer, architect or architectural conservator experienced with historic masonry structures should assess these burial structures, with work carried out according to preservation standards by skilled masons and conservators.

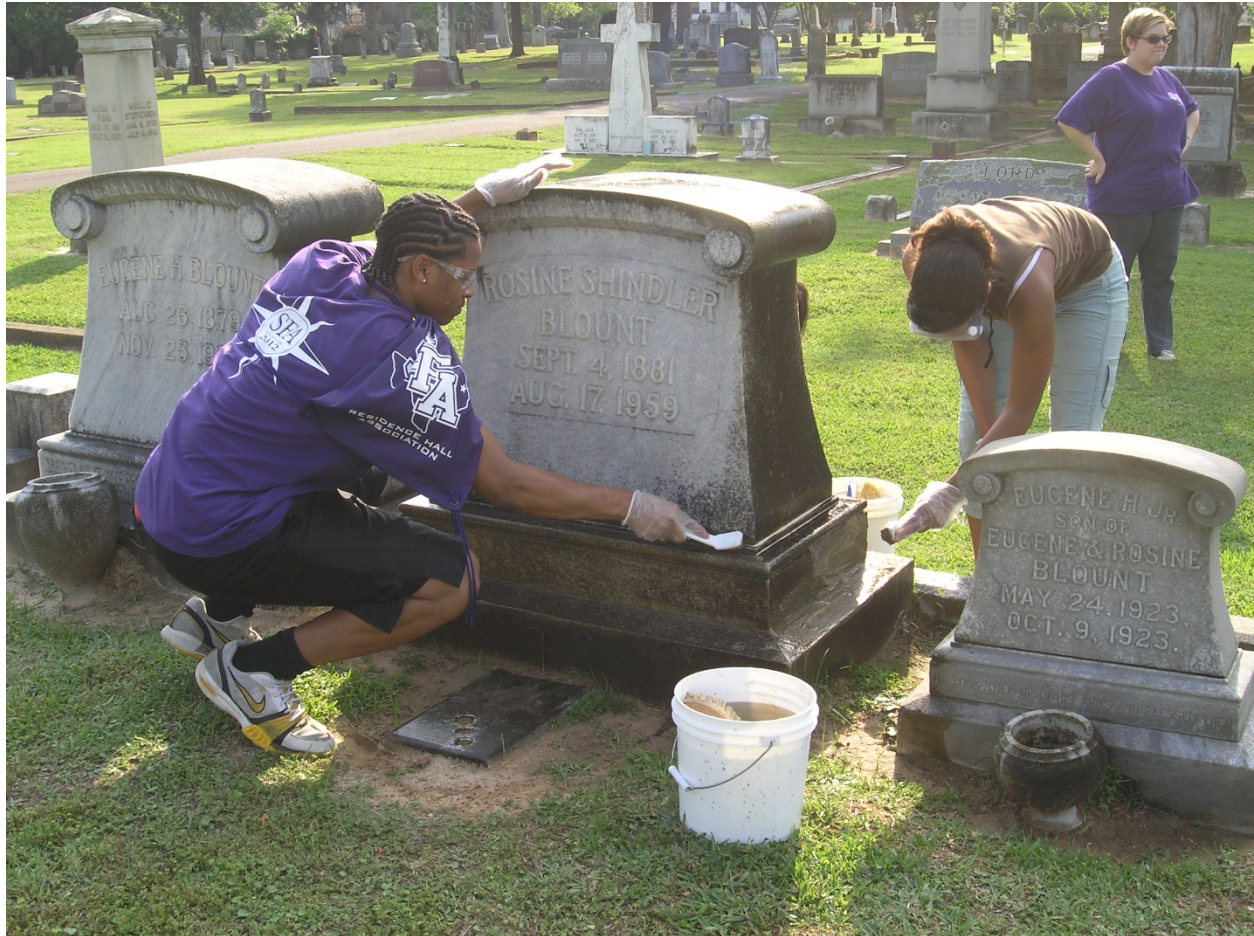
*Cleaning grave markers in Oak Grove Cemetery, Nacogdoches, Texas.*

Cleaning stones should be done with the gentlest means possible. It should never be the intent to make a grave marker look “new.” Even with the most careful technique, cleaning may accelerate deterioration or cause loss of original material. Only use soft brushes and gentle cleaners, such as water or a non-ionic cleaner (neutral pH of 7). Never use wire brushes, power washers, or harsh cleaners, such as bleach.

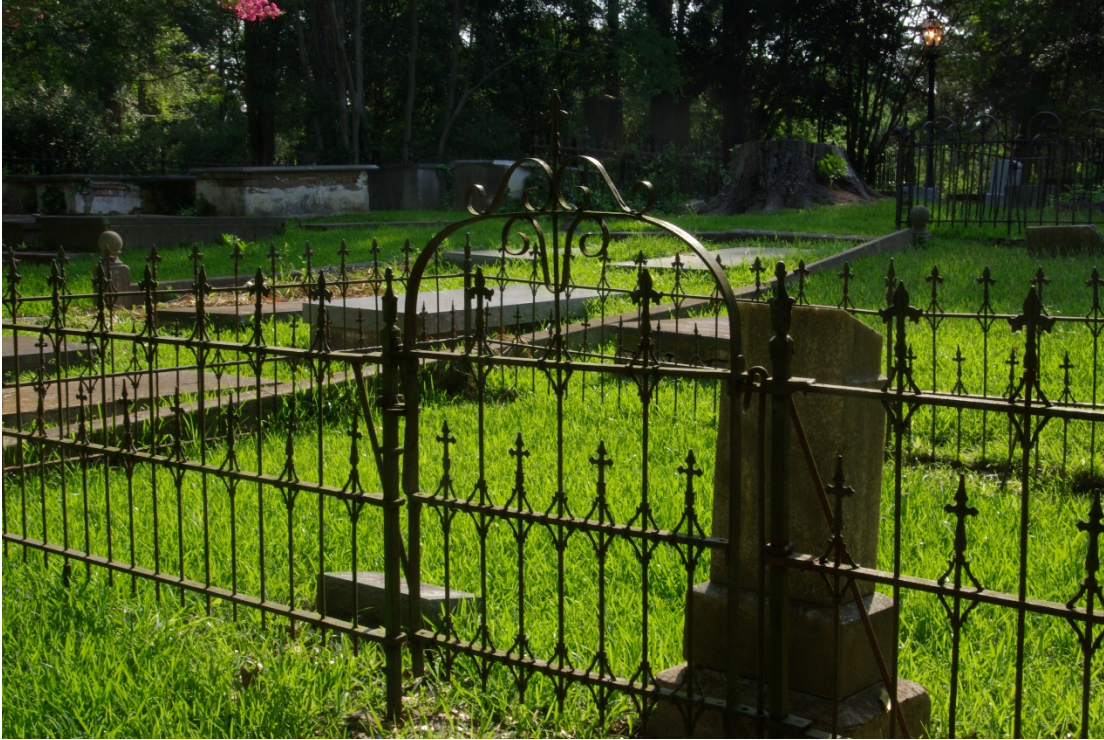
Iron fence surrounding family plot in American Cemetery, Natchitoches, Louisiana

Painting inhibits rust formation, one of the leading causes of iron fence deterioration. The best practice is to remove all loose rust by hand with a wire brush, apply a coat of rust converter (available at hardware stores), followed by a coat of primer and several coats of paint. All primer and paint should be designed for outdoor metal surfaces.
