**Repair and Upgrade Washington Monument Elevator –
Washington, DC**

NAMA-224923

**Pre-Design Report
Final Submission**

CH2M HILL, Inc.

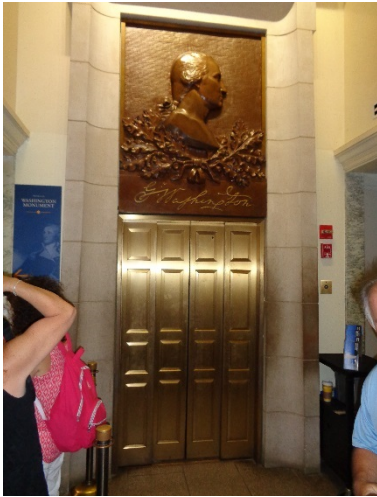
1. Existing lobby entrance doors to be retained.

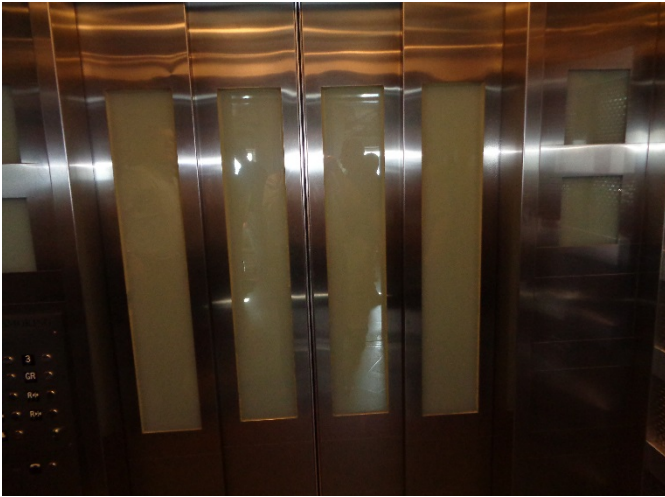
5. Existing observation doors to be retained.
