# CULTURAL LANDSCAPE REPORT • HISTORIC STRUCTURE REPORT

*Apostle Islands National Lakeshore – Bayfield, Wisconsin*

## **VOLUME II OF VI: MICHIGAN ISLAND CLR/HSR**

**JULY 2011**

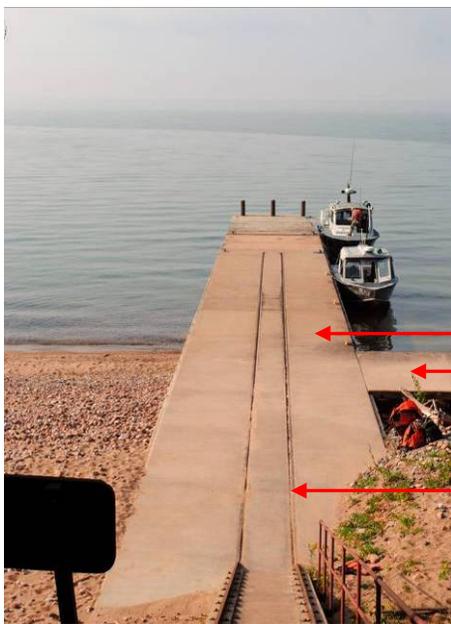
Site Image MI-37: Boat dock, 2009 (Source: MBD DSC\_0036.jpg)

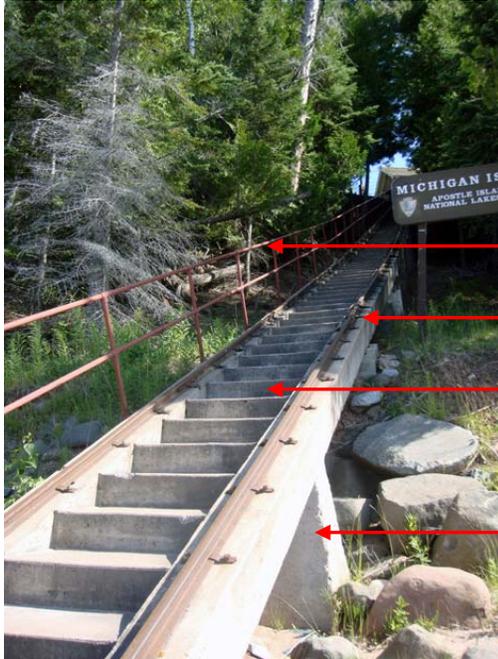
The tramway is in good condition and retains all of its original elements of the upper portion including: concrete footings and stairs, steel handrail, and cast iron tram rails.

Site Image MI-38: Lower section of tramway, 2009 (Source: MBD DSC00574.JPG)

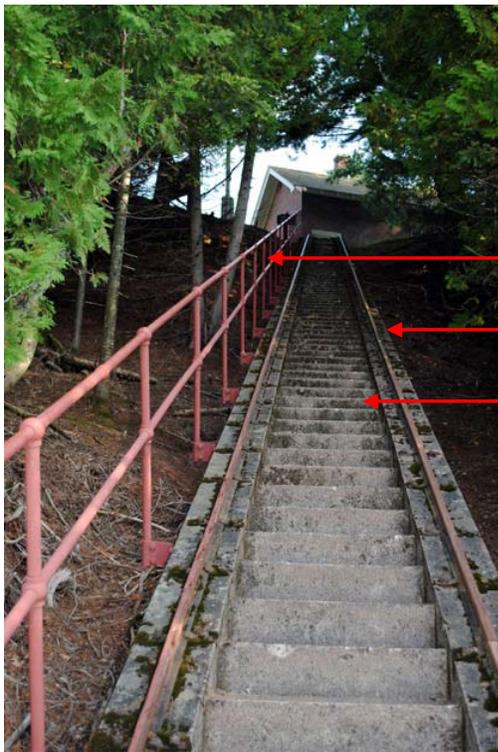
Site Image MI-39: Upper section of tramway, 2009 (Source: MBD DSC\_0037.jpg)

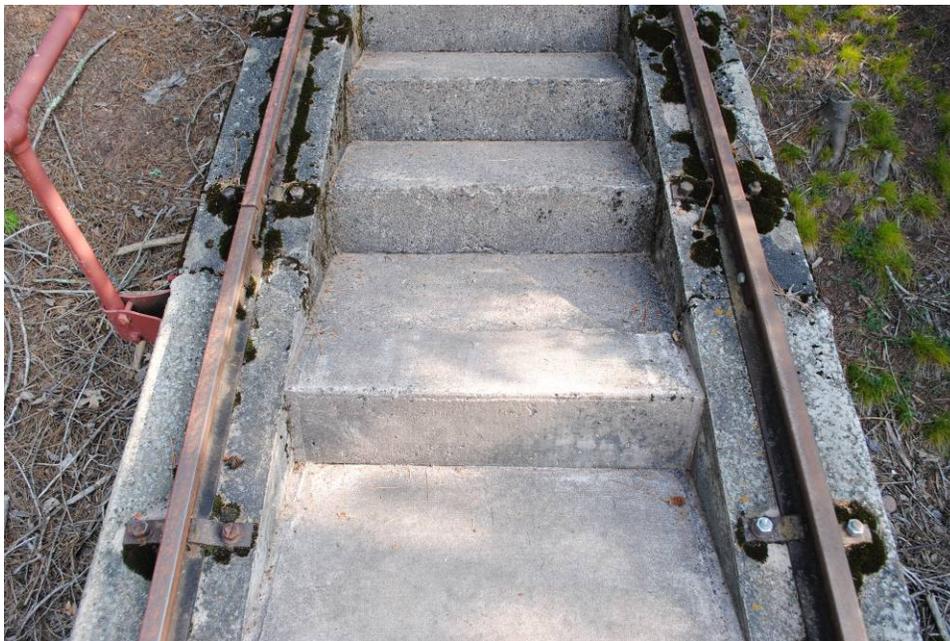
Site Image MI-40: Upper section of tramway, tram tracks, and railing, 2009 (Source: MBD DSC\_0037.jpg)

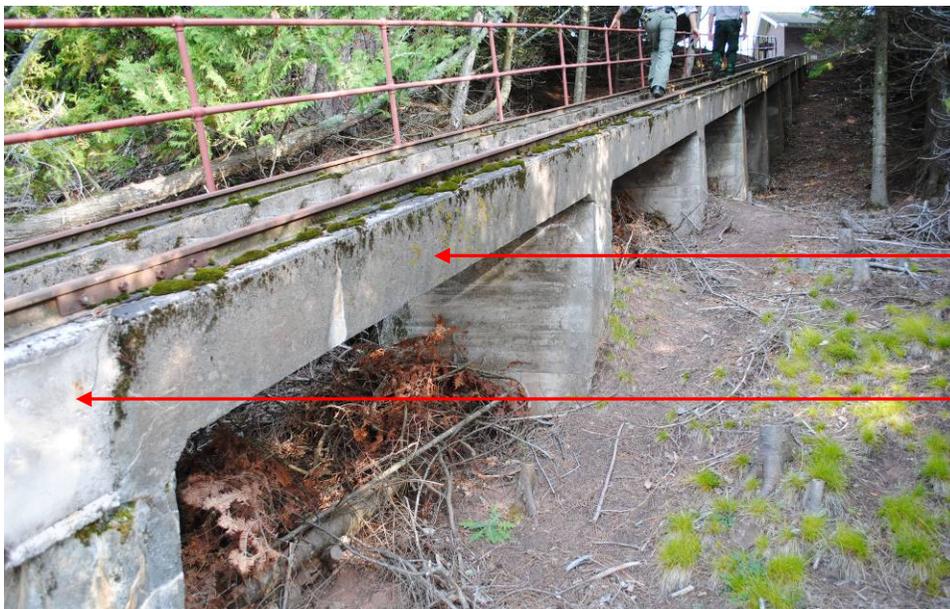
The original lower 34-foot section was removed sometime following automation in 1943. It was reconstructed in 1993, and replaced an elevated, wooden landing platform and directly connecting the tramway to the boat dock (c. 1987). The tracks were extended onto the boat dock at this time. The 1993 reconstruction was done using the existing footings and compatible materials in a form similar to the original construction. The tramway presents several issues with regard to ABAAS and code compliance. The width of the steps, at 28", falls short of the required 36" width; the railing is too far from the edge of the steps (currently 12", should be directly adjacent to function as a handrail); and a handrail and guardrail are lacking on the east side of the structure. The riser to tread ratio of the upper portion of the tramway, at 40 degrees, exceeds ABAAS standards. The tramway is considered a contributing feature.

Site Image MI-41: Tramway, railing, and footings, 2009 (Source: MBD DSC\_0037.jpg)

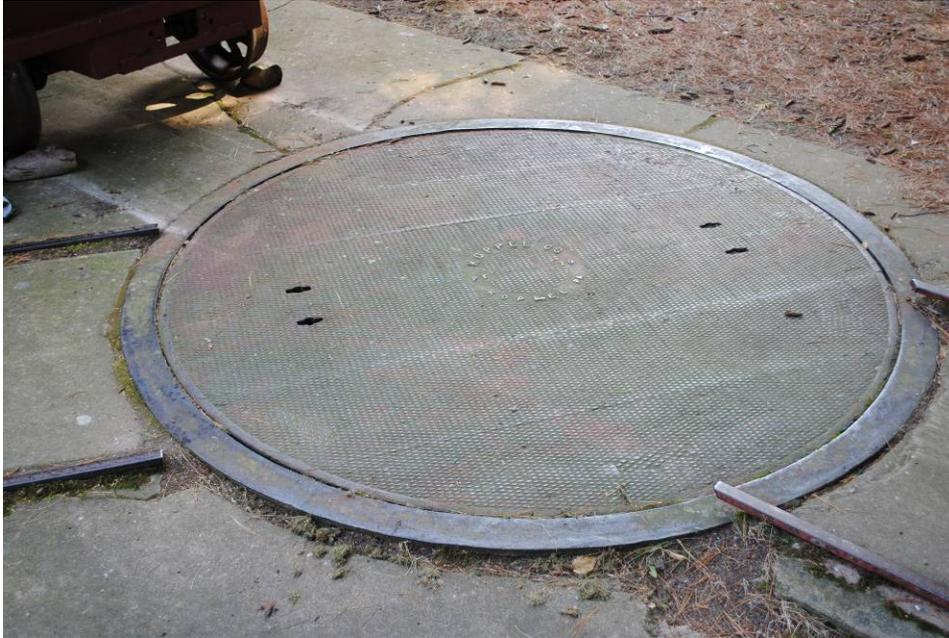
**Existing Condition.** At the top of the tramway is a manufactured steel turntable used to turn carts and connect them to the tram tracks that extend into the light station grounds. The turntable is 5' in diameter and is covered with a large cast iron plate stamped "KOPPEL CO PF 79, KOPPEL, PA." The turntable is currently locked in one position, nonfunctional, and in poor operating condition.

Site Image MI-42: Tram turntable, 2009 (Source: MBD DSC00599.JPG)

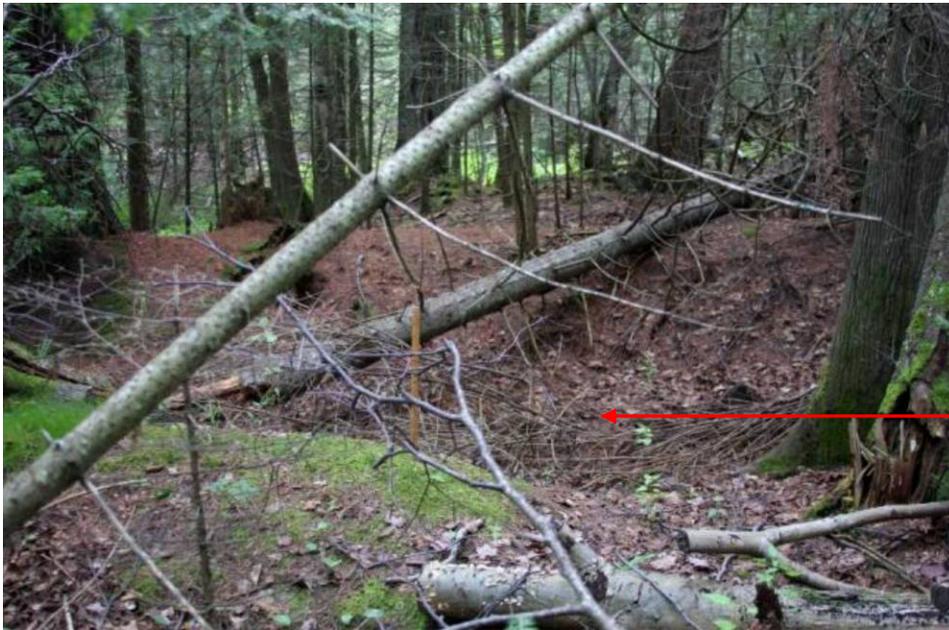
**Existing Condition.** The root cellar at the Michigan Island Light Station was located approximately 100' north of the Privy on the east side of the station. It is nonextant; however, there is evidence of its location in the form of a 10' x 14' rectangular depression in the ground where it once existed. The depression is bordered by four earth mounds, approximately 2' to 4' high.

Site Image MI-44: Root cellar depression 100' north of historic Privy, 2010 (Source: Rubin Stenseng, Michigan Island Light Station Summer 2010 Volunteer)

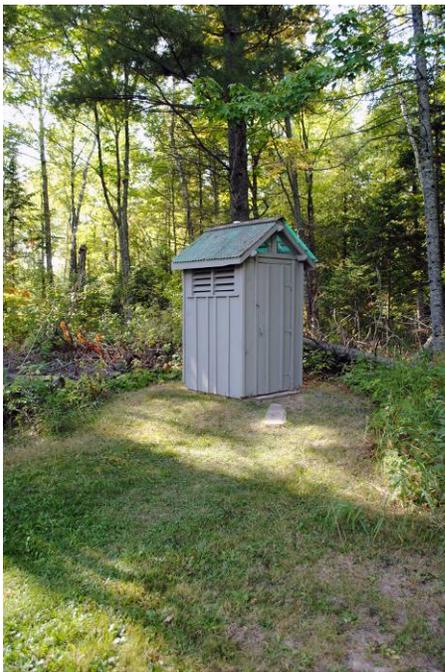
**Existing Condition.** The NPS Vault Toilet is a wood-framed structure and vault located northeast of the Assistant Keepers Quarters. The Vault Toilet is not an accessible structure.

Site Image MI-45: NPS Vault toilet in northwest corner of light station grounds, 2009 (Source: MBD DSC\_0106.jpg)

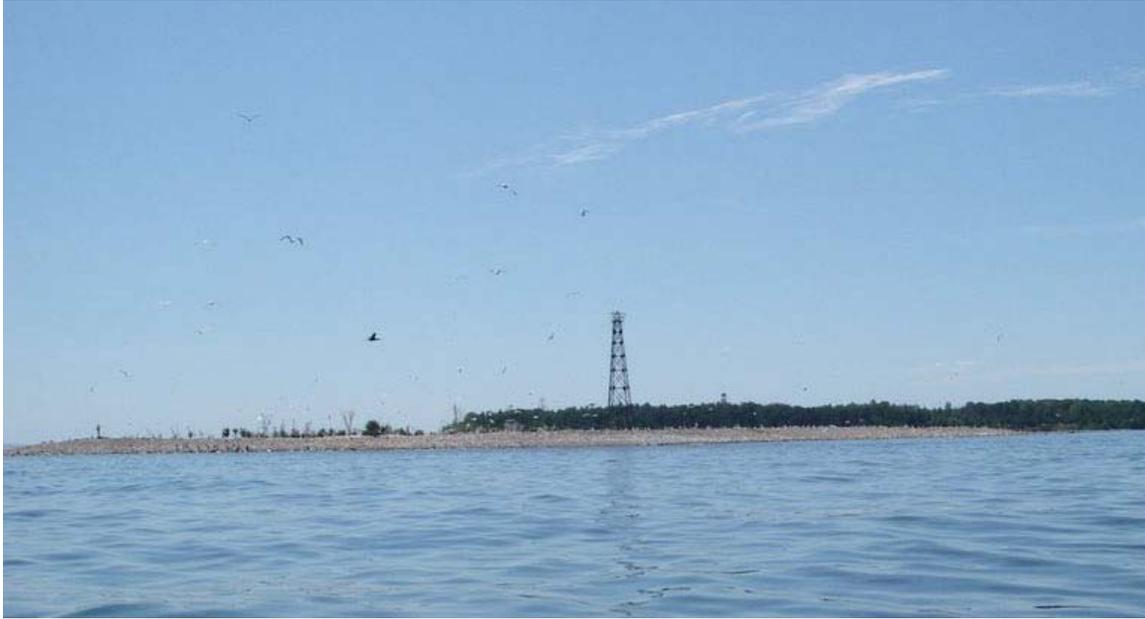
**Existing Condition.** The Gull Island Tower is a steel light located on Gull Island, northeast of Michigan Island. The island was not visited during the field work for the CLR, but the tower is fully operational and in good condition.<sup>37</sup>

*Site Image MI-46: Gull Island Tower, c. 2000 (Source: Picasa Web Albums)*

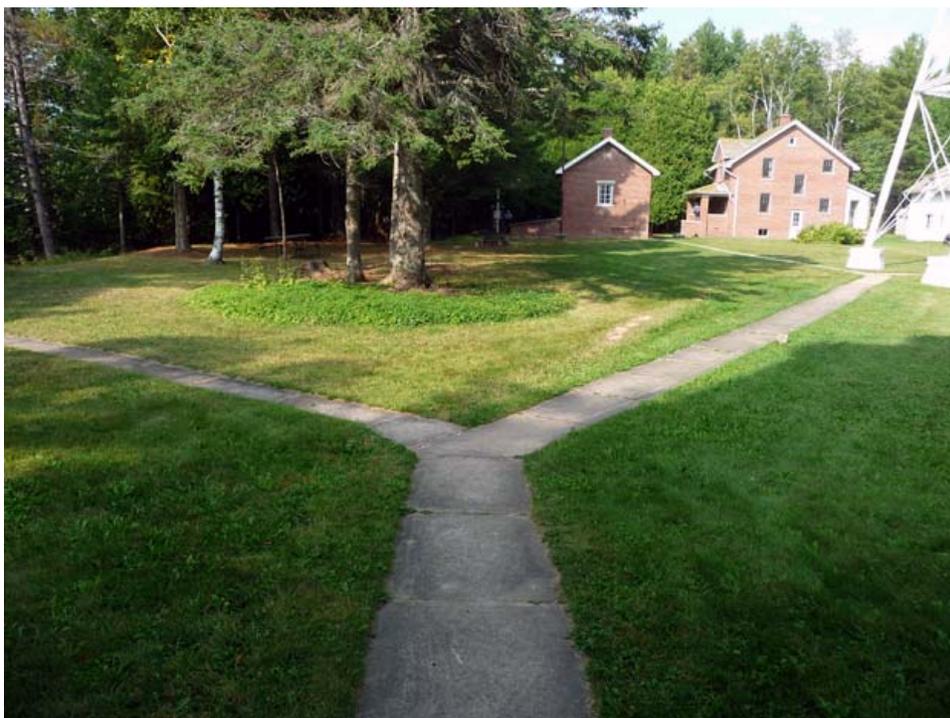
**Existing Condition.** The concrete walks on the grounds were installed during the Early Light Tower period (1929–1938) many of them following the previous layout of wood planks as was common on the light stations. Typical to several of the Apostle Islands light stations, the walks appear to be constructed of precast units 3' × 4' × 4" thick with some smaller units also installed. The units have a fine aggregate finish and tooled edges. Historic photographs indicate that the concrete units may have been placed on top of the ground surface rather than excavated and placed. Other portions of the concrete walks appear to have been poured in place to infill odd shapes and address building edges. Overall the concrete walks are in good condition with only a few slabs requiring replacement due to excessive cracking.

Site Image MI-47: Concrete walks – walk to left once led to former wooden staircase down bank, 2009 (Source: MBD P1010741.JPG)

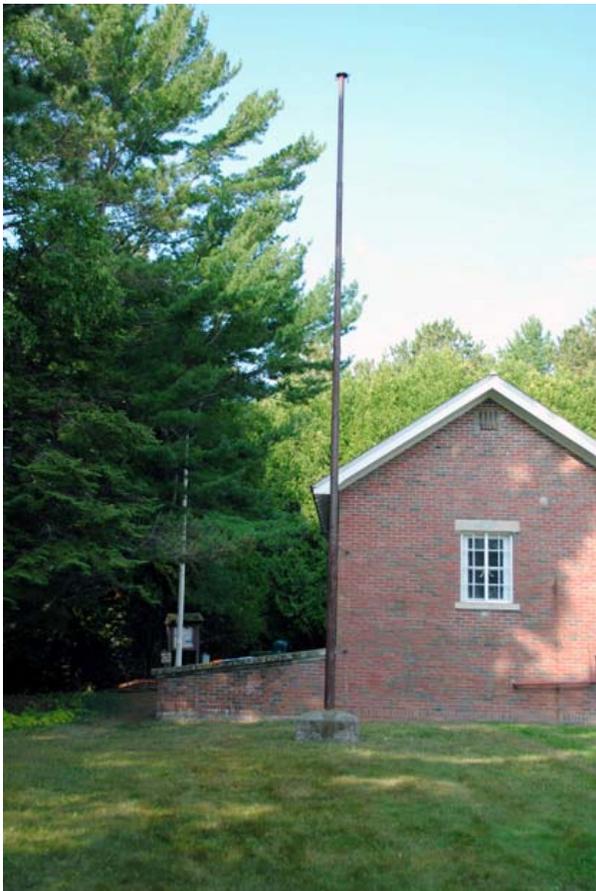
*Site Image MI-49: Radio antenna pole – south, 2009 (Source: MBD DSC\_0050.jpg)*

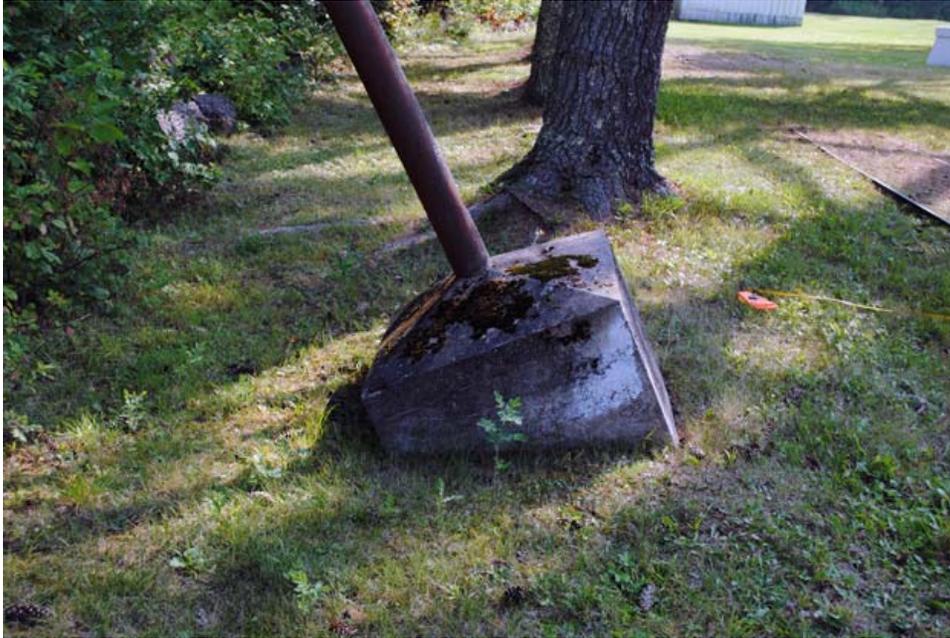
**Existing Condition.** The radio antenna poles (north and south) are features that were installed between 1929 and 1931 along with the other technological advances (Light Tower, Power House, and tramway) related to improvements in navigational aid. An annotated 1928 drawing from the APIS archives indicates that one or both of the poles were moved from their original locations once if not twice. They are currently located just east of the Power House, and another directly north from the first, near the tram tracks. They are cast iron poles, with a height of approximately 40', and identical concrete bases, approximately 18" tall, with a 36"×36" width. Radio Antenna Pole – South is in good condition. Radio Antenna Pole – North is in fair condition, the foundation needs to be reset as the pole is leaning to the north.

Site Image MI-50: Radio antenna pole – north (possibly relocated), 2009 (Source: MBD DSC\_0052.jpg)

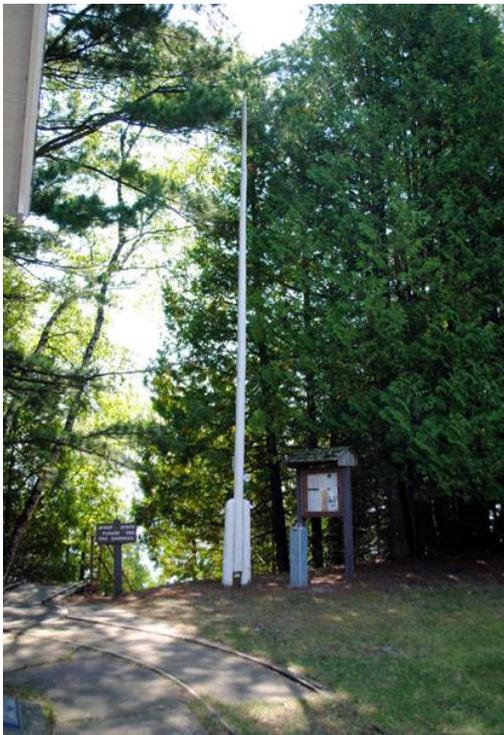
**Existing Condition.** The flagpole is at the top of the tramway, just south of the Keepers Quarters. The flagpole is constructed of a single wood pole, approximately 25' high mounted between two smaller base posts, with through bolt connections. The entire structure is painted white with a concrete footing. The flagpole was installed during the Light Tower period and is in good condition.

Site Image MI-51: Flagpole, 2009 (Source: MBD DSC\_0088.jpg)

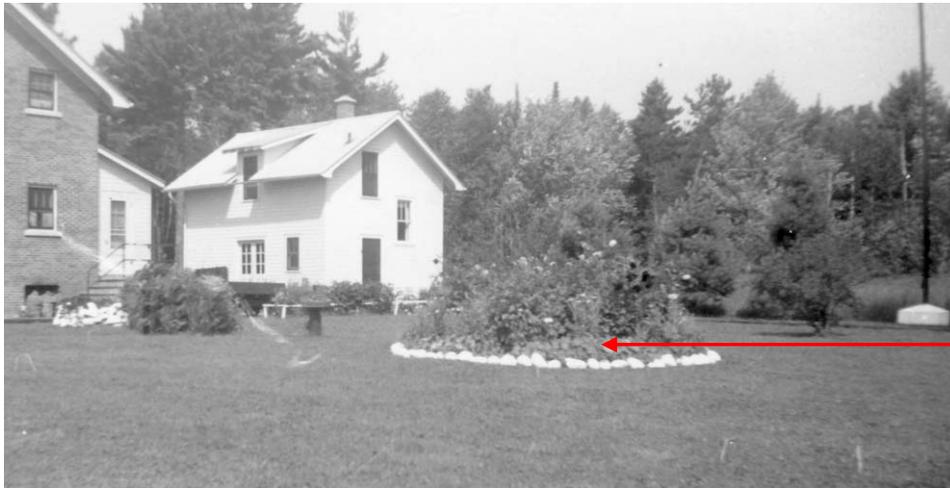
Circular depression in area of stone-edged planter

Site Image MI-69: Circular depression in area of stone edged planter; top, c. 1930; bottom, 2009; (Source: MBD P1010785.jpg)

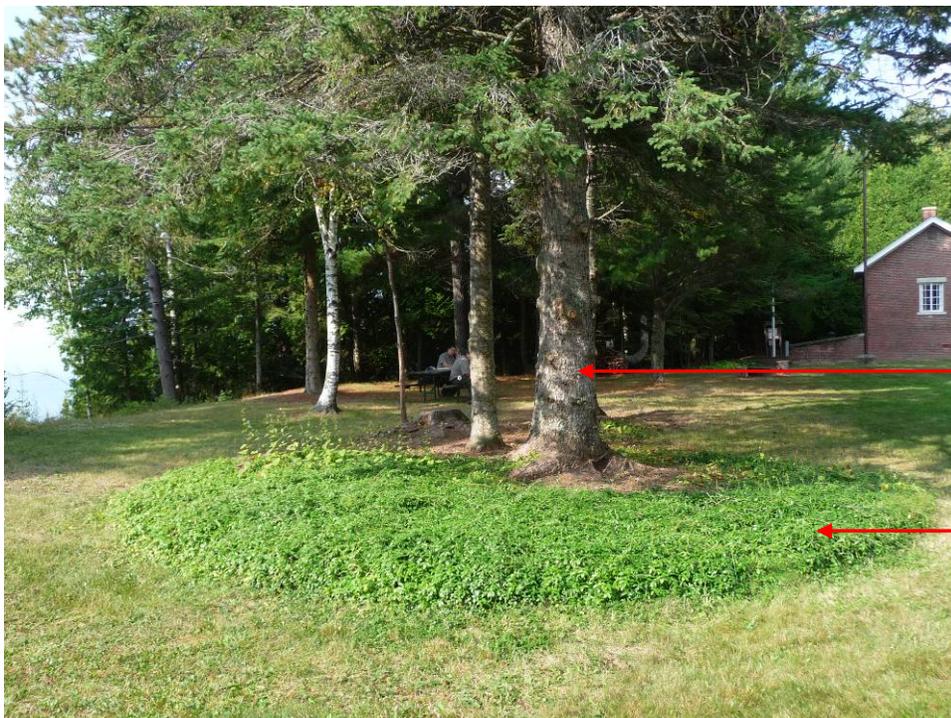
Site Image MI-75: Periwinkle plantings at light station grounds, 2009 (Source: MBD P1010757.jpg)

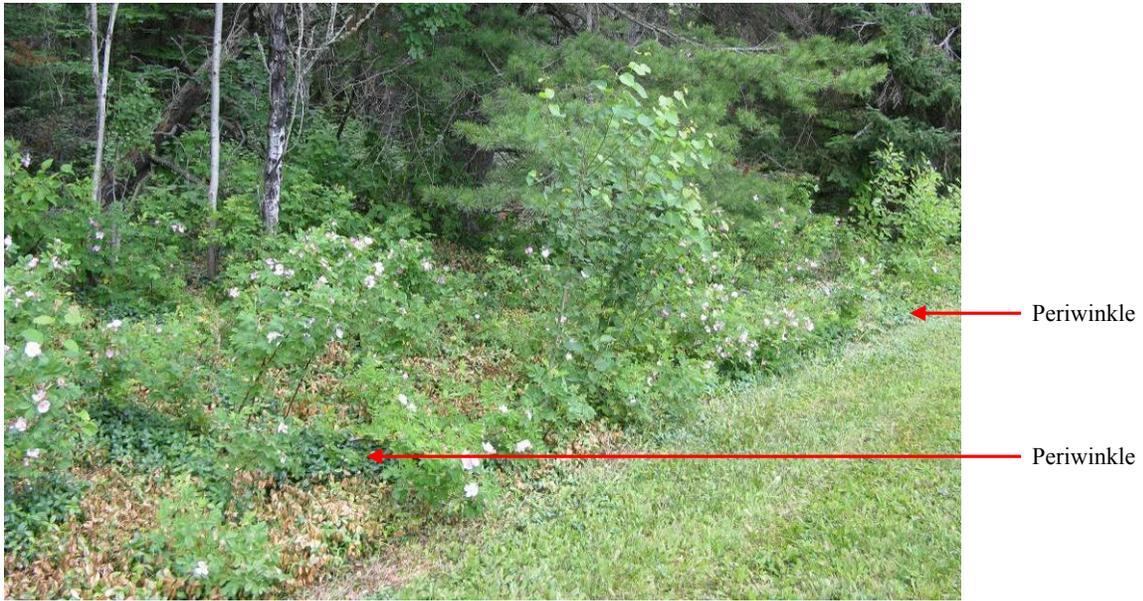
Some domestic plantings, primarily Periwinkle (*Vinca minor*), have been introduced to the island and have encroached into the forest area. Periwinkle, considered an invasive plant species, was planted during the period of significance and is extant in a planting bed beneath the contributing spruce tree west of the Old Michigan Island Lighthouse. Periwinkle is also found in the forest adjacent to the grounds and has spread into the surrounding forest. Periwinkle (or blue myrtle) was also planted at adjacent homesteads on Michigan Island.<sup>40</sup>

*Site Image MI-76: Invasive Periwinkle growing north of Old Lighthouse on edge of current woods, 2009 (Source: Susan Mackreth Cherry Trees a 2009.JPG)*

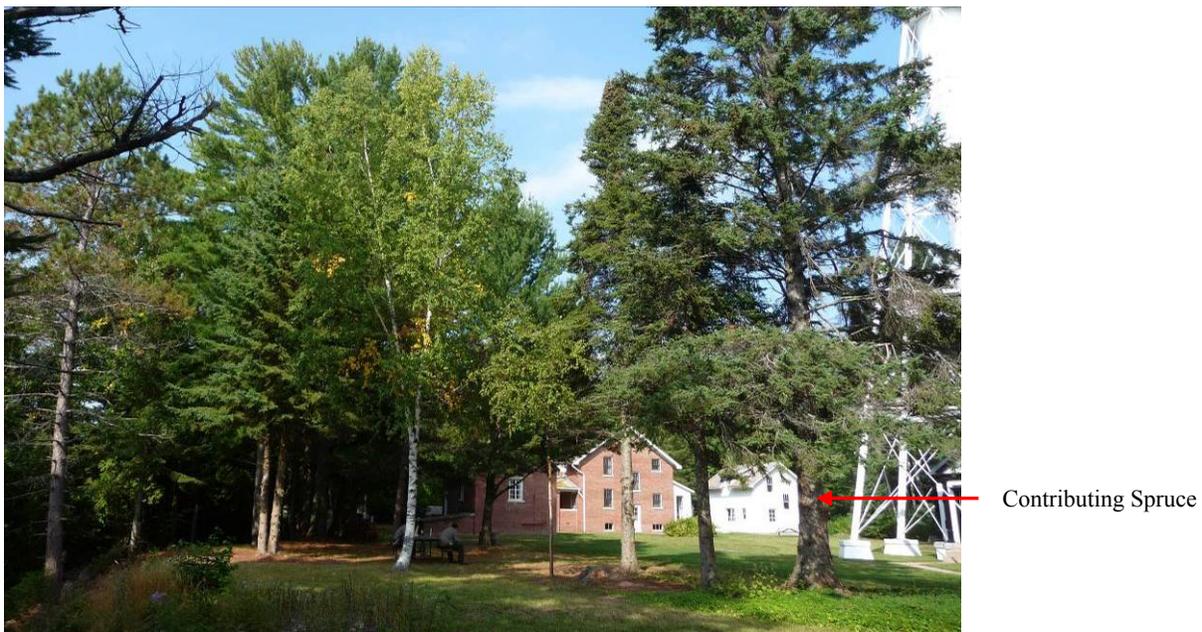
Site Image MI-78: White spruce tree west of Old Michigan Island Lighthouse before and after recent damage: left, 2009 (Source: MBD P1010758.JPG); right, 2011 (Source MBD DSC00882.JPG)

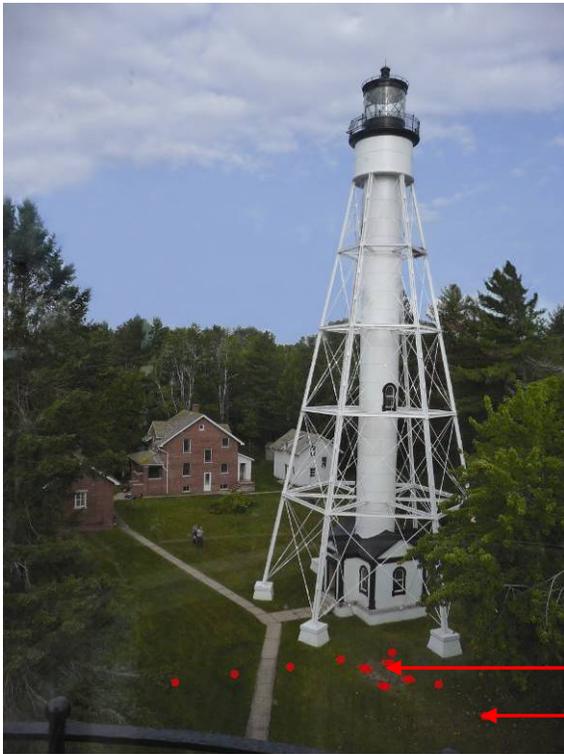
Location of Nonextant Oil Building

Location of Nonextant Fence

*Site Image MI-84: Mark the location of the nonextant oil building and fencing, 2010  
(Source: MBD P1010698\_annotated.JPG)*

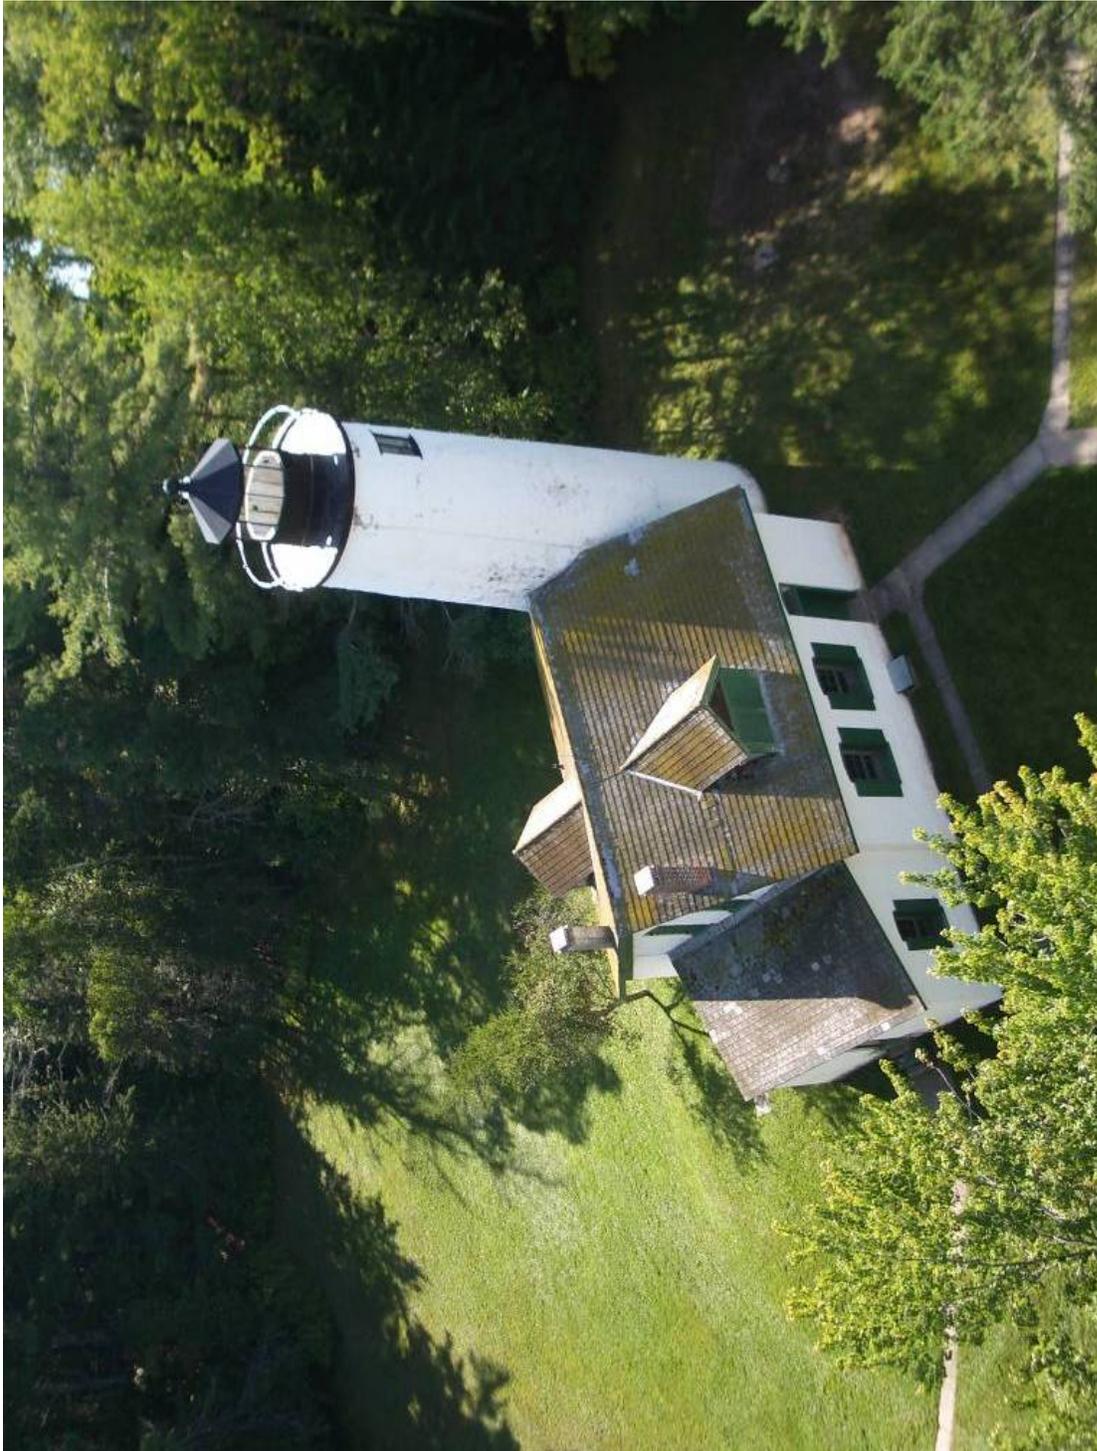
*MI-OLH-01: Aerial, 2009 (Source: AH DSC00604)*

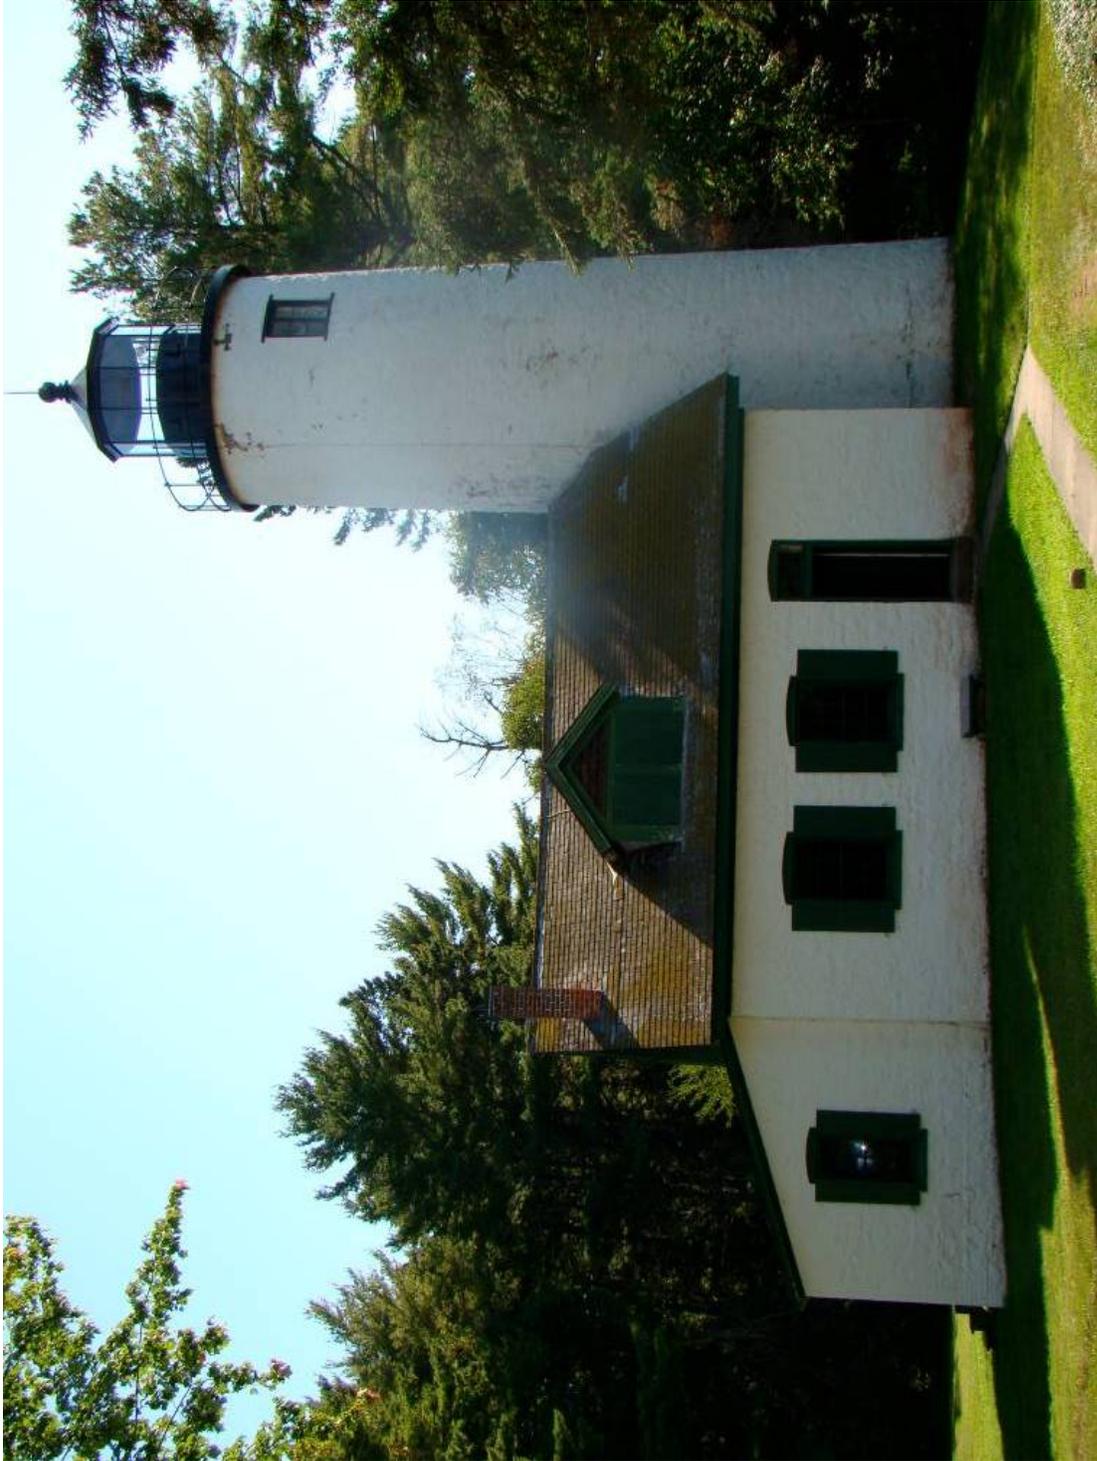
MI-OLH-02: West elevation, 2009 (Source: AH DSC00672)

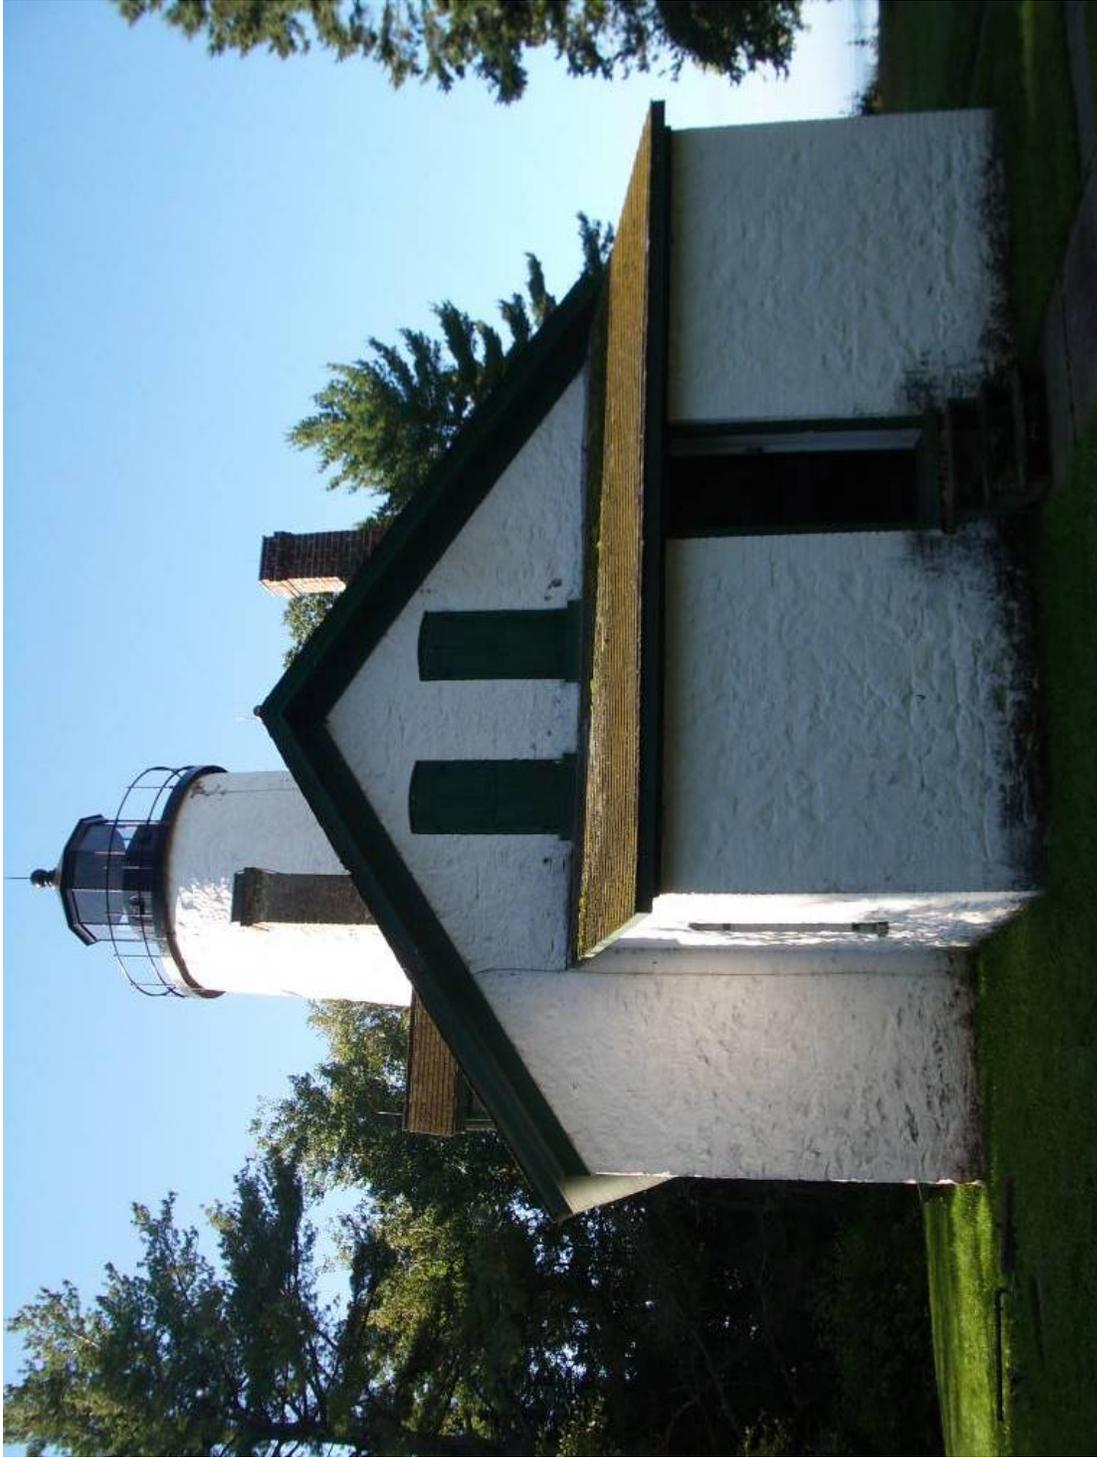
*MI-OLH-03: North elevation, 2009 (Source: AH DSC00673)*

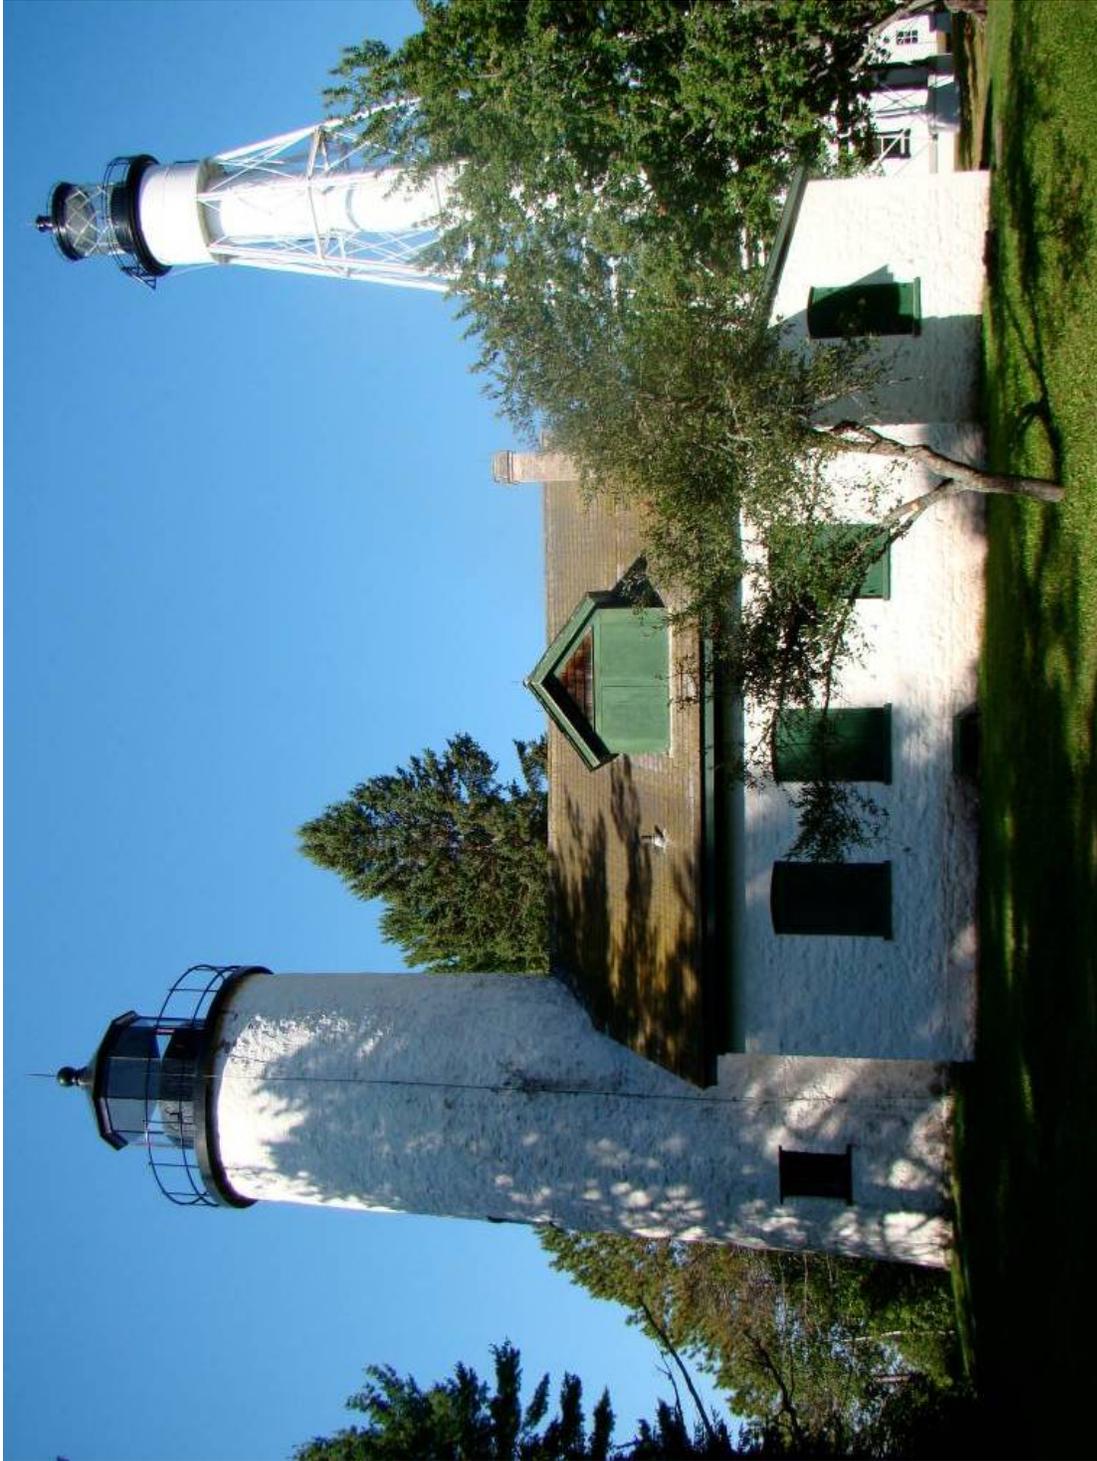
MI-OLH-04: East elevation, 2009 (Source: AH DSC00675)

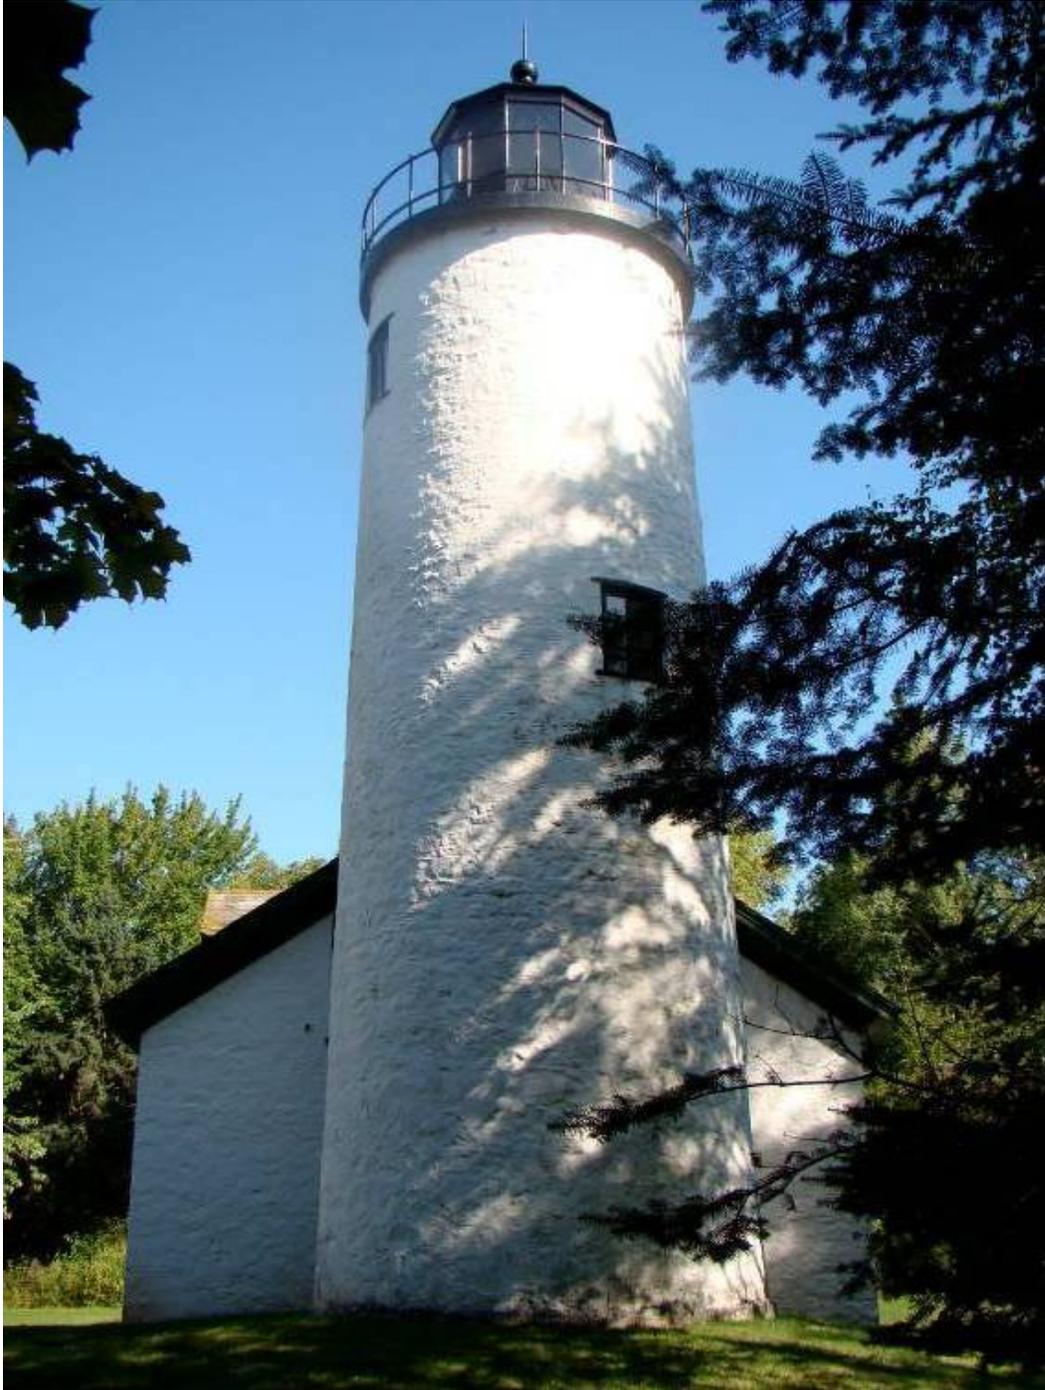
*MI-OLH-05: South elevation, 2009 (Source: AH DSC00677)*

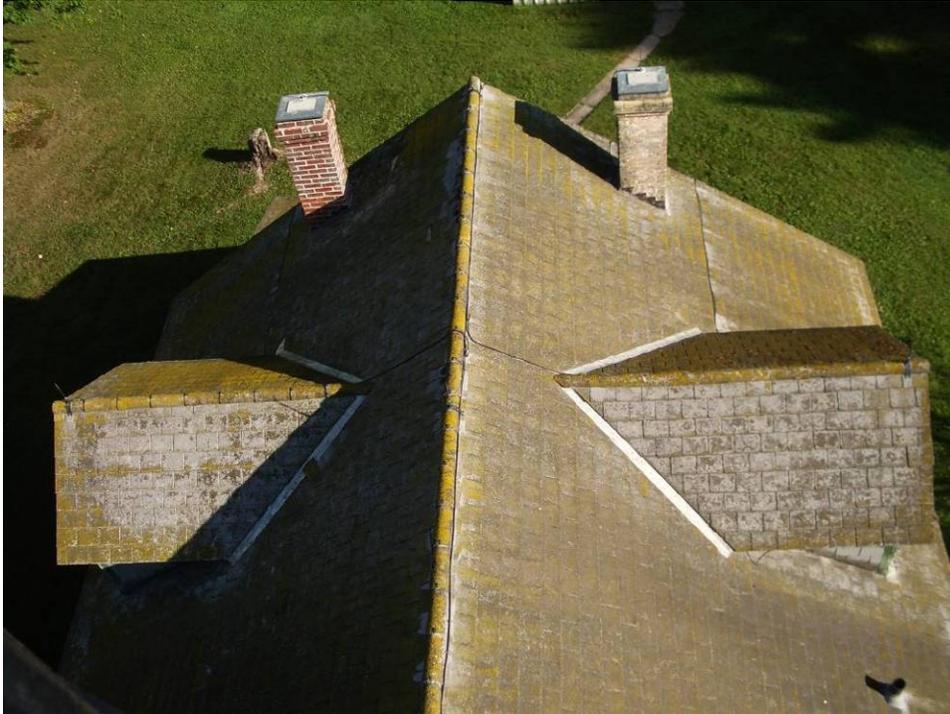
There are two original brick chimneys flanking either side of the ridge of the main gable. The east chimney may have had a parge coating applied at the time as it is a whitish color versus the clear red brick coloration of the west chimney. There are bricks located in the west second floor bedroom near the west chimney that suggest recent masonry work. A cap of galvanized sheet metal and what appears to be one of the composite replacement roof shingles have been installed at both chimneys (MI-OLH-06).

*MI-OLH-06: Dormers, roof, and chimneys from the Tower, looking north (Source: AH IMGP2761)*

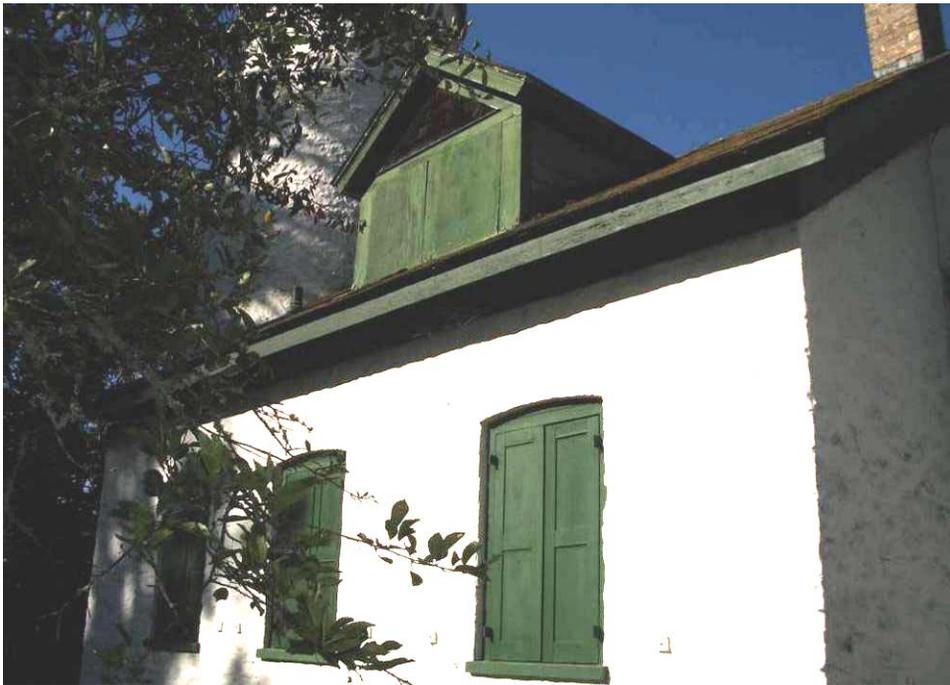
*MI-OLH-07: East dormer, trim, chimney, and shutters (Source: AH IMGP2764)*

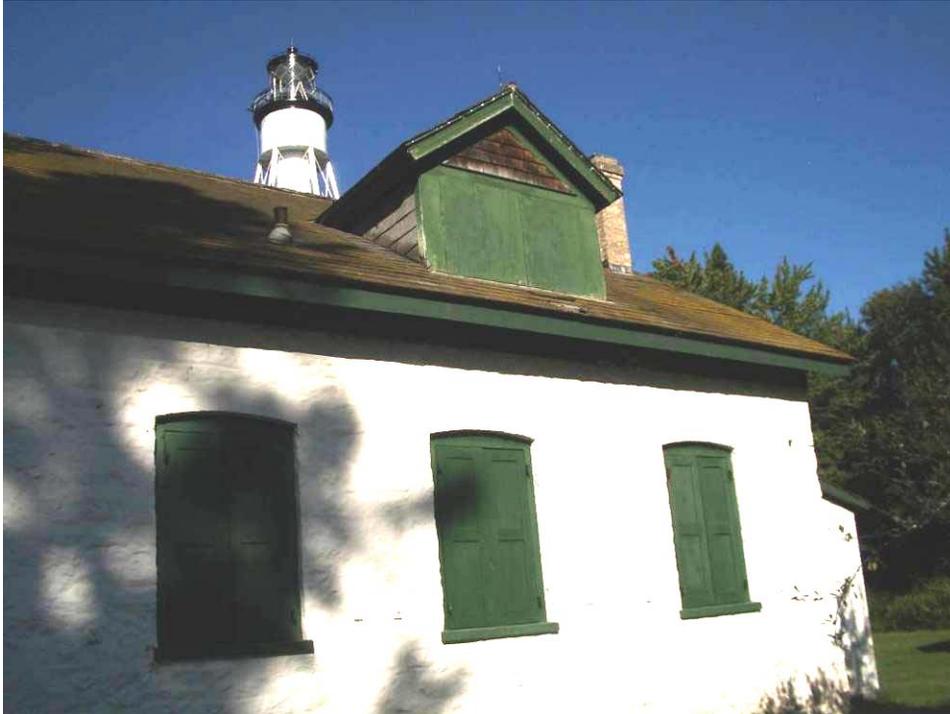
*MI-OLH-08: East dormer siding, windows, and roof (Source: AH IMGP2766)*

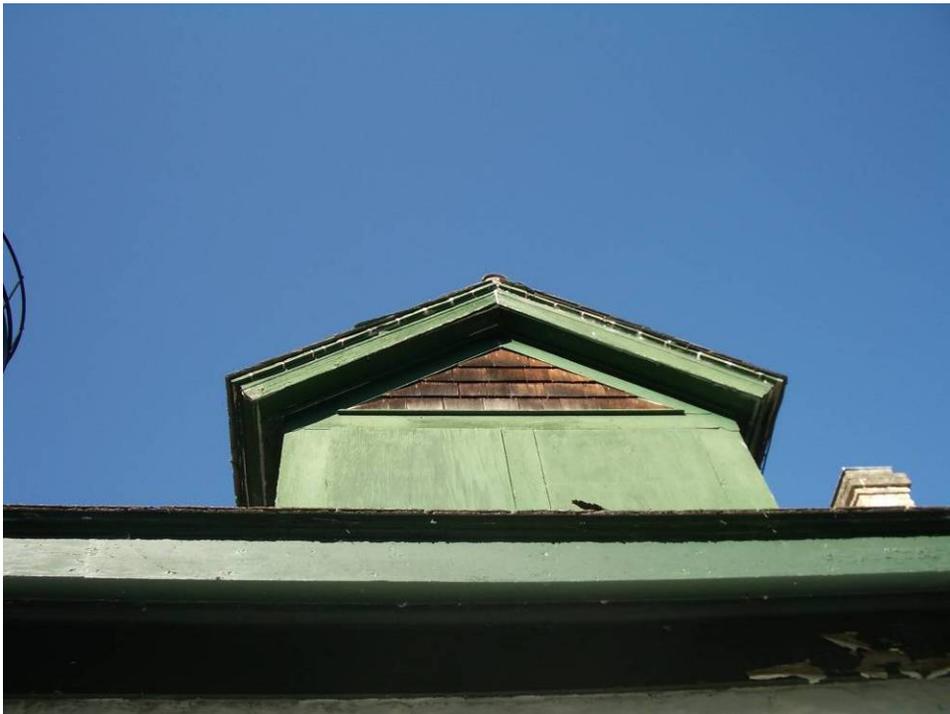
*MI-OLH-09: East dormer siding and exterior trim (Source: AH IMGP2767)*

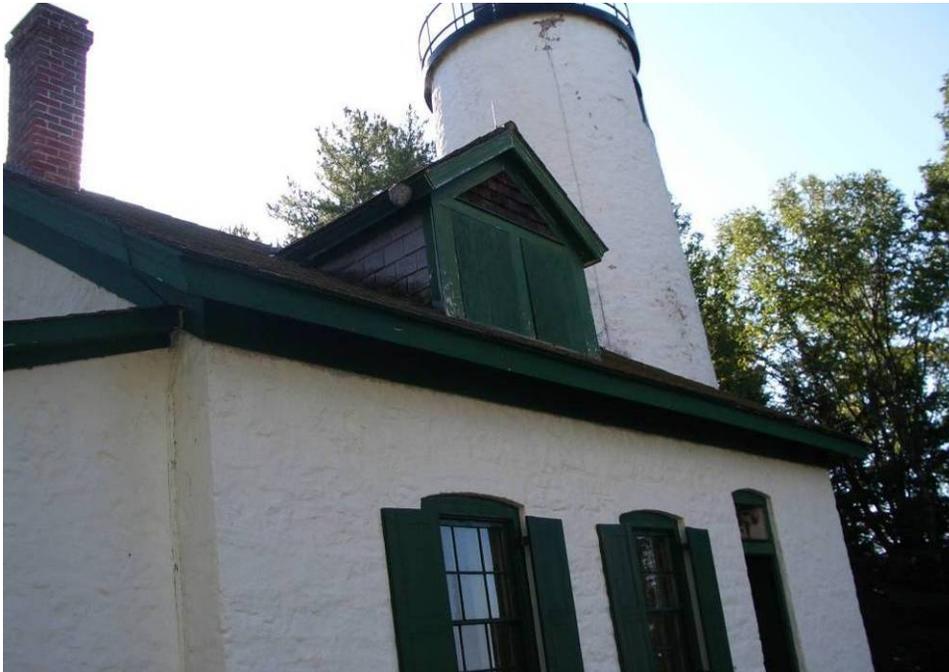
*MI-OLH-10: West dormer siding, chimney, windows, and exterior trim (Source: AH IMG2768)*
