# CULTURAL LANDSCAPE REPORT • HISTORIC STRUCTURE REPORT

*Apostle Islands National Lakeshore – Bayfield, Wisconsin*

## **VOLUME II OF VI: MICHIGAN ISLAND CLR/HSR**

**JULY 2011**

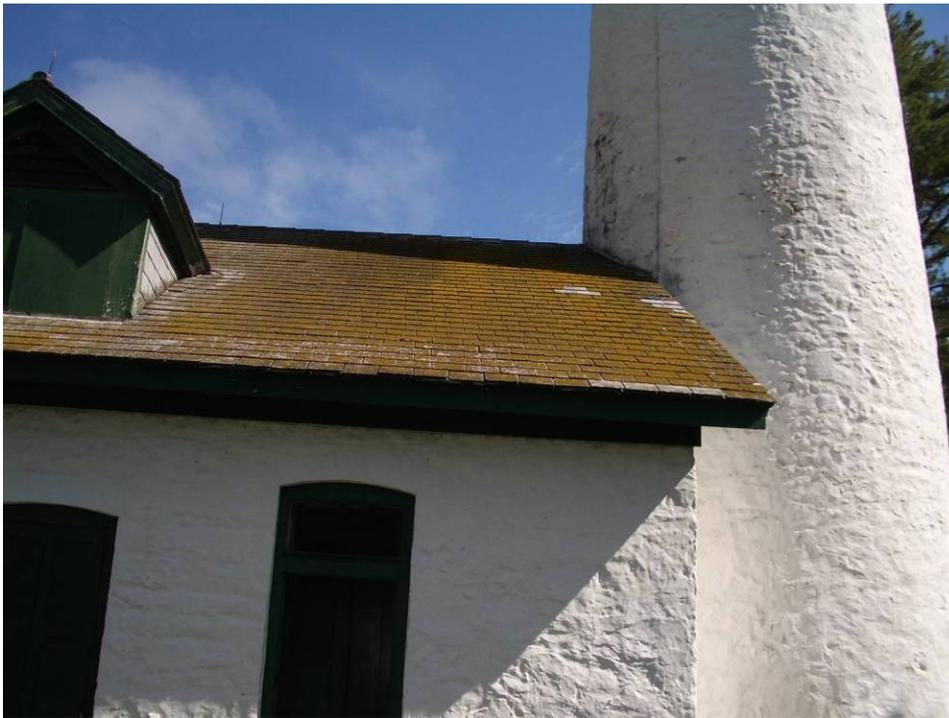
*MI-OLH-11: West dormer siding, roof, trim, and Tower integration (Source: AH IMG2851)*

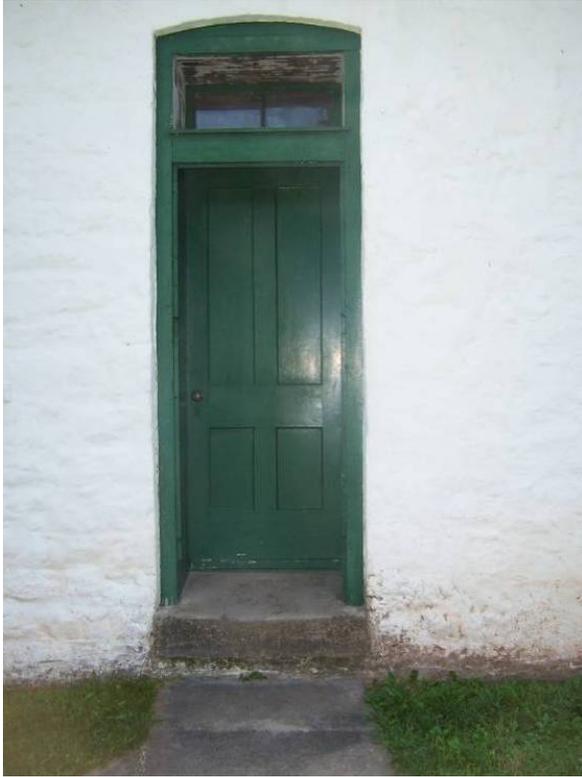
*MI-OLH-12: West entry door (primary) (Source: AH 102\_9512)*

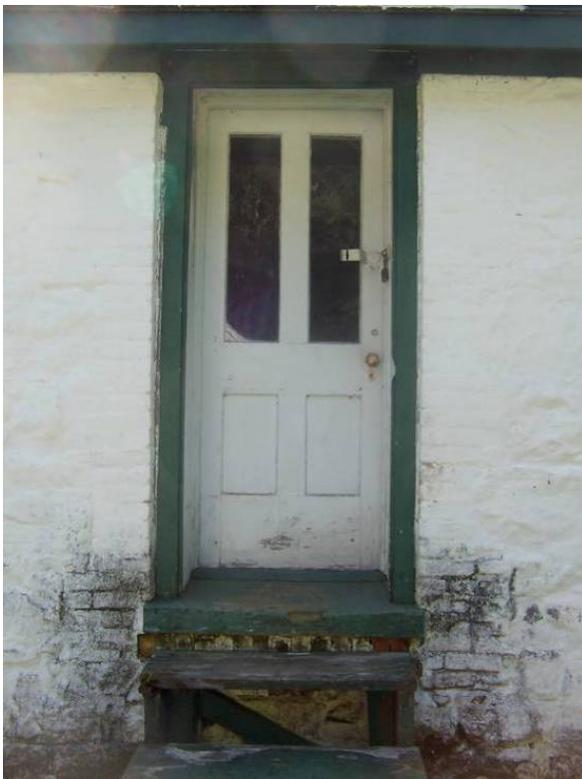
*MI-OLH-13: North entry door (kitchen entrance) (Source: AH 102\_9511)*

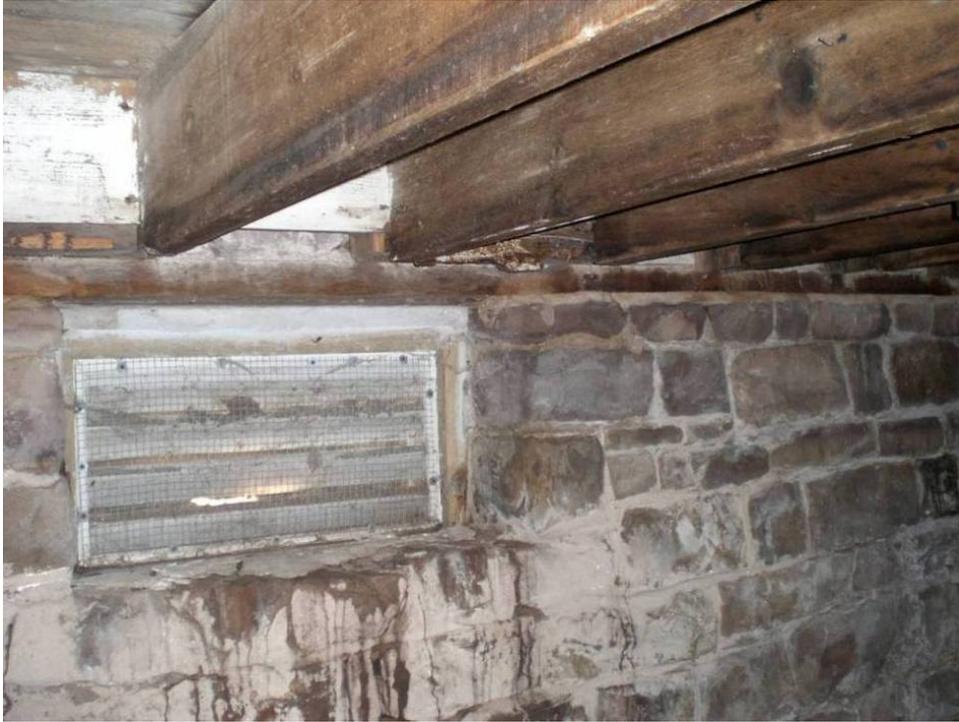
*MI-OLH-14: Basement window 1 (Source: AH CIMG3442)*

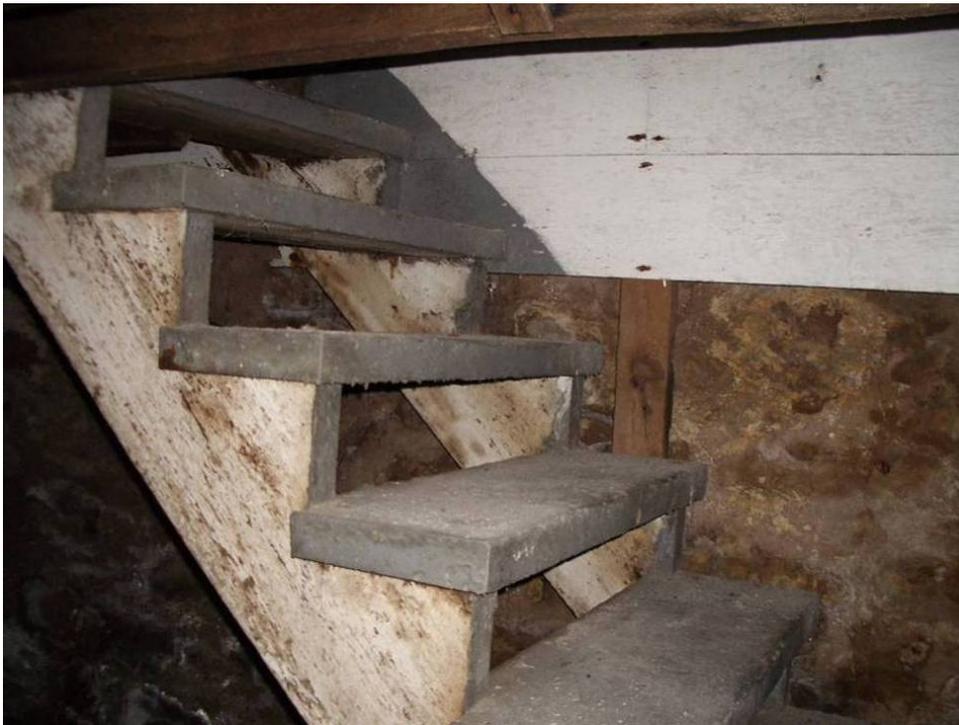
*MI-OLH-15: Basement stair (Source: AH IMG2818)*

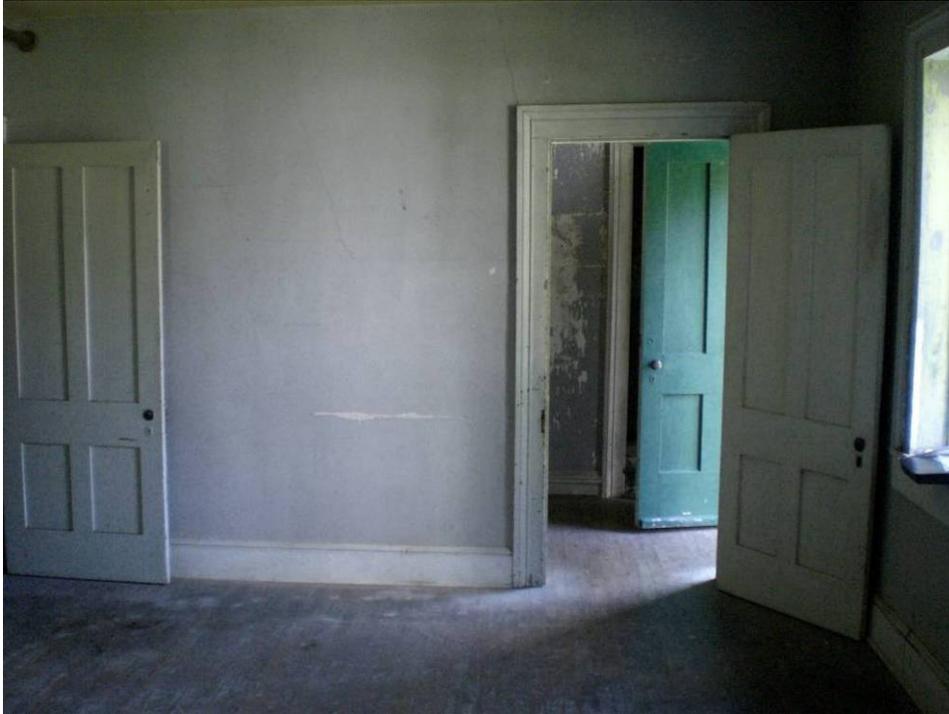
MI-OLH-16: Living room south elevation (Source: AH CIMG3288)

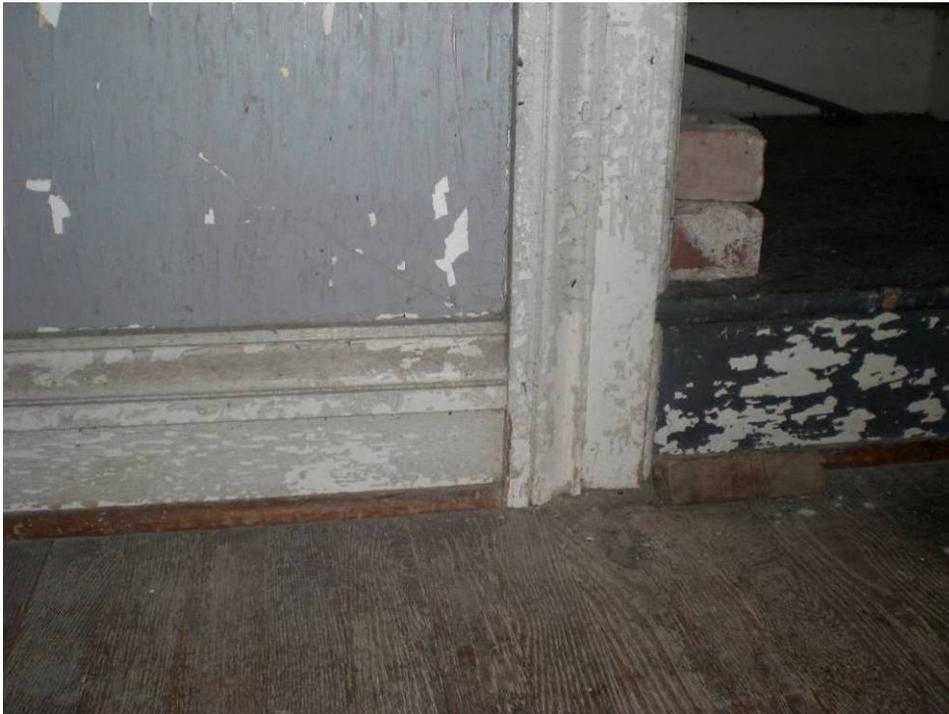
MI-OLH-17: Entry, south wall door, and base trim, detail (Source: AH CIMG3320)

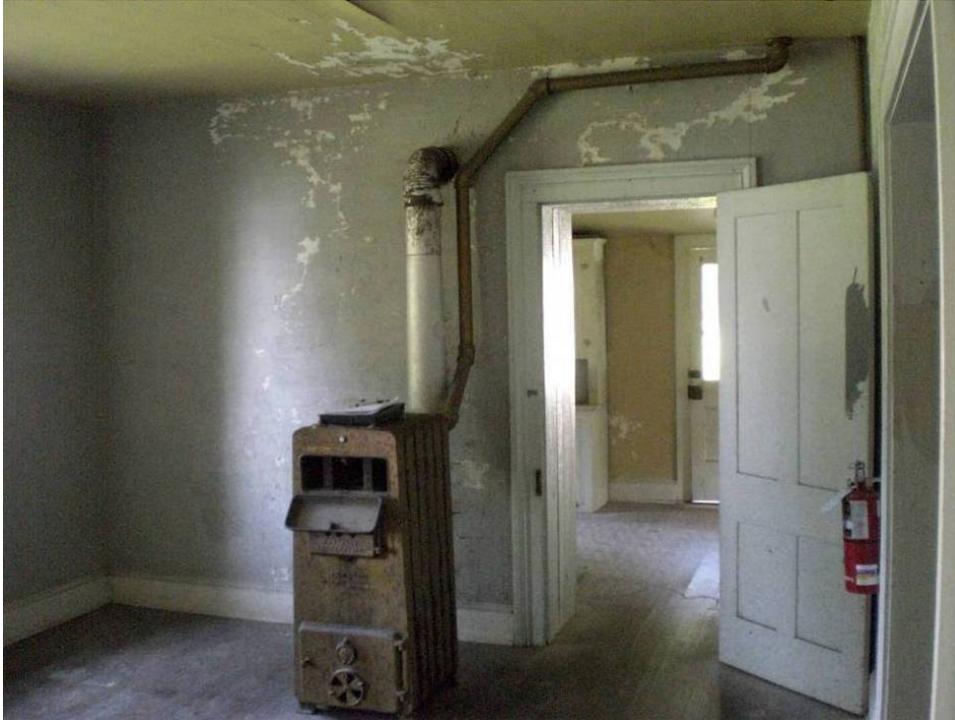
*MI-OLH-18: Living room north elevation (Source: AH CIMG3292)*

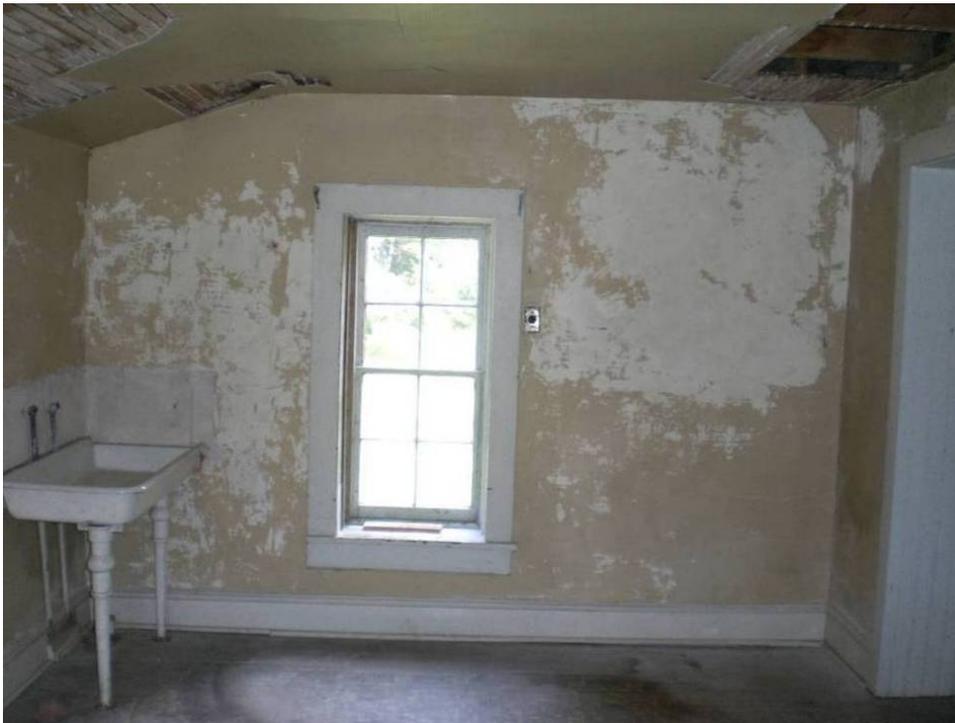
*MI-OLH-19: Kitchen east elevation (Source: AH CIMG3324)*

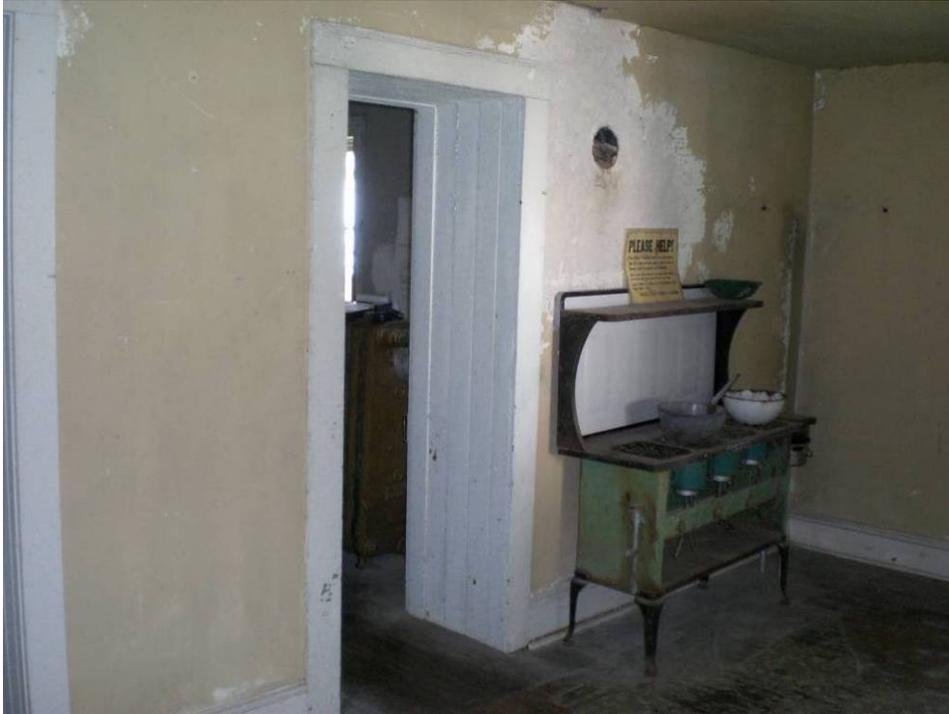
MI-OLH-20: Kitchen southwest elevation (Source: AH CIMG3328)

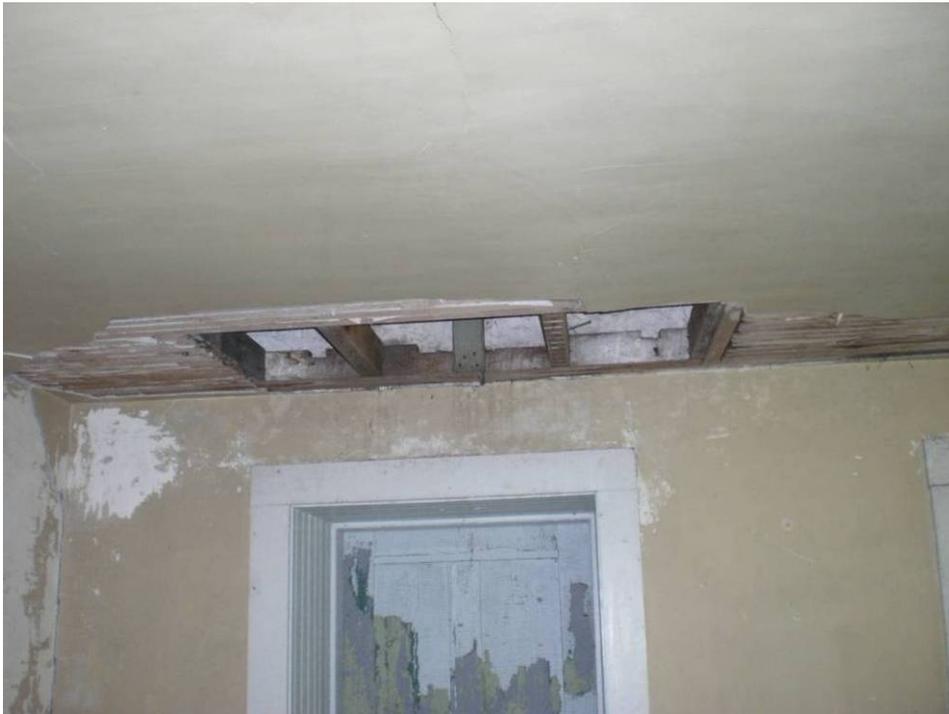
MI-OLH-21: Kitchen southeast door ceiling (Source: AH CIMG3326)

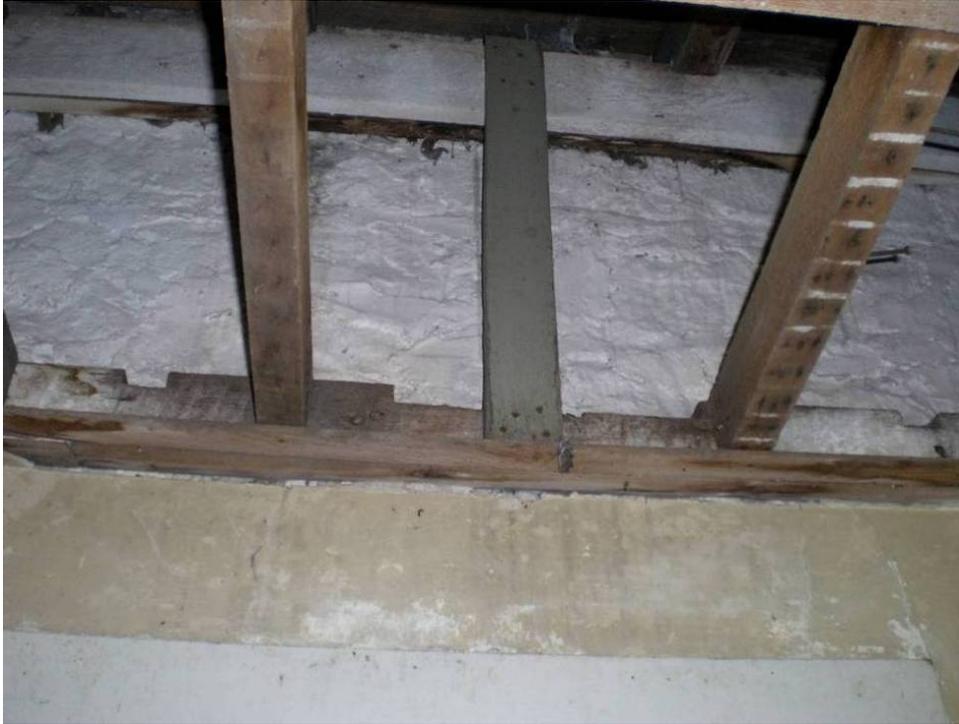
*MI-OLH-22: Kitchen southeast door ceiling detail (Source: AH CIMG3327)*

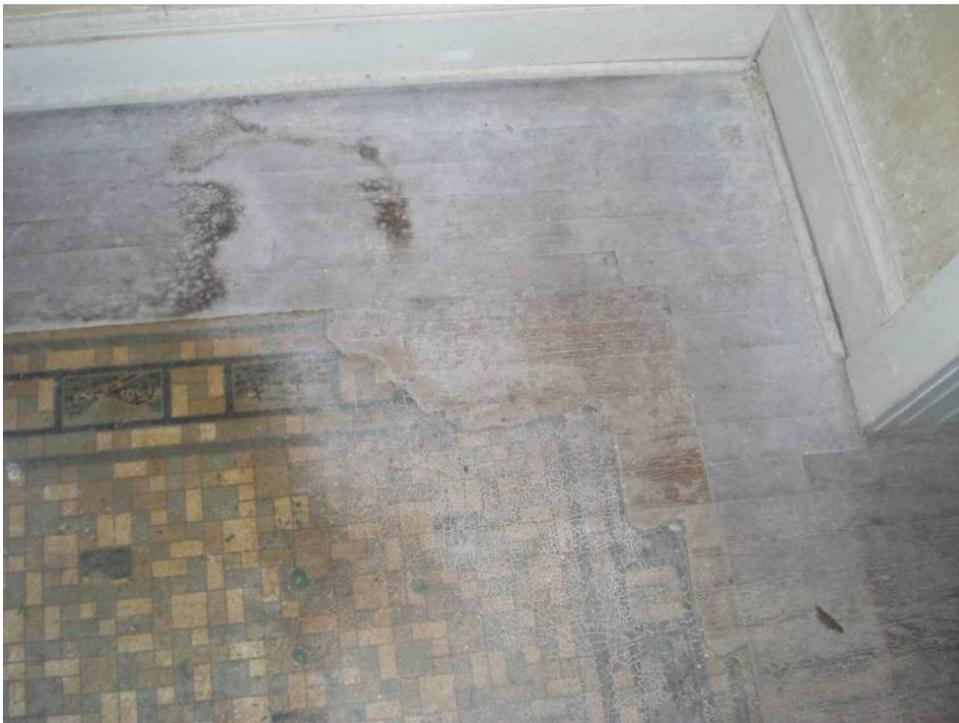
*MI-OLH-23: Kitchen floor and c. 1920 base trim (Source: AH CIMG3333)*

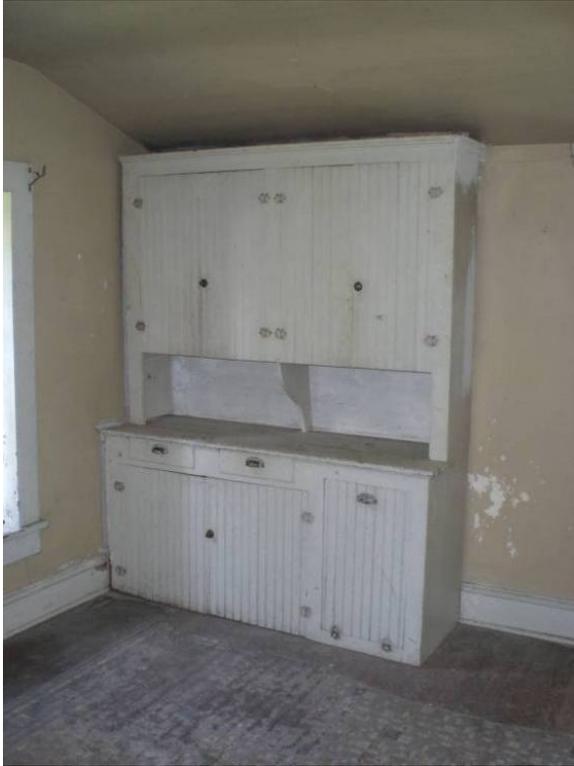
*MI-OLH-24: Kitchen built-in cabinet on north wall (Source: AH CIMG3335)*

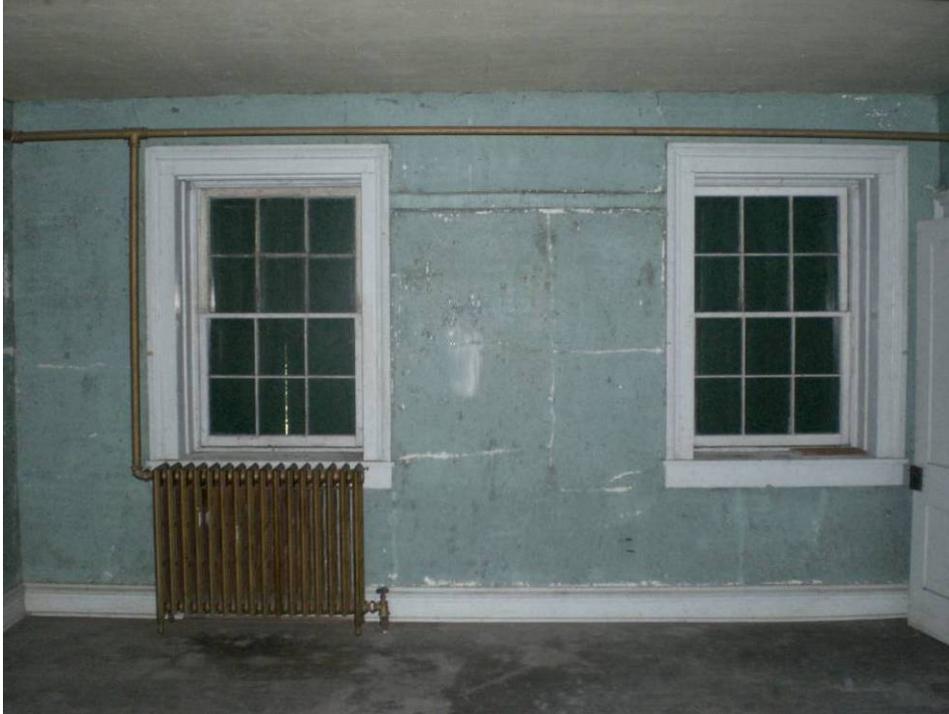
*MI-OLH-25: Dining room east elevation (Source: AH CIMG3345)*

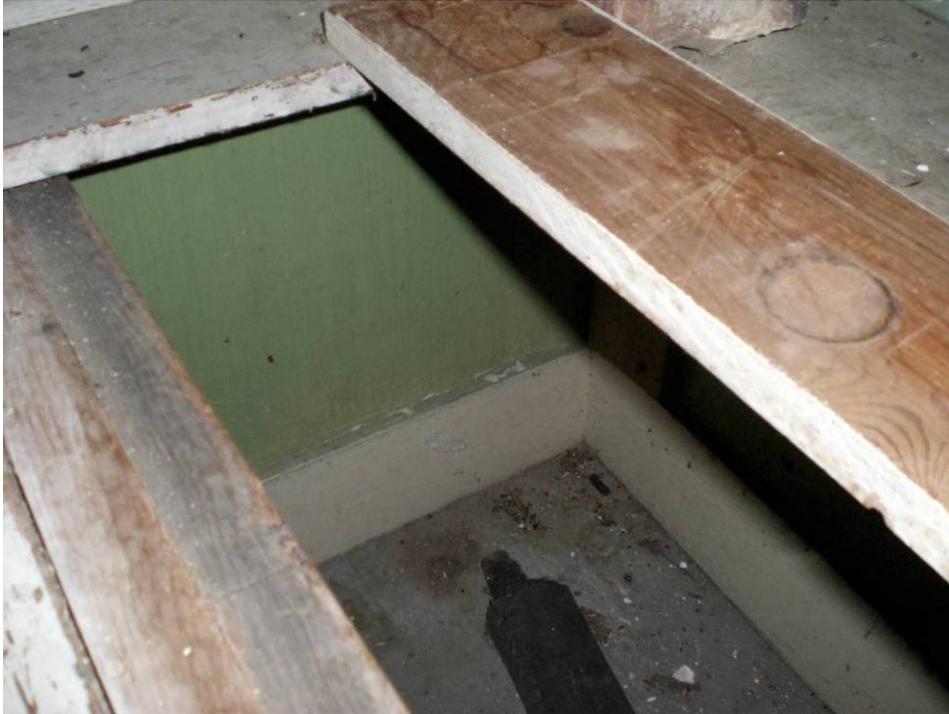
*MI-OLH-30: West bedroom window seat, view of wall, trim, and floor beneath (Source: AH CIMG3470)*

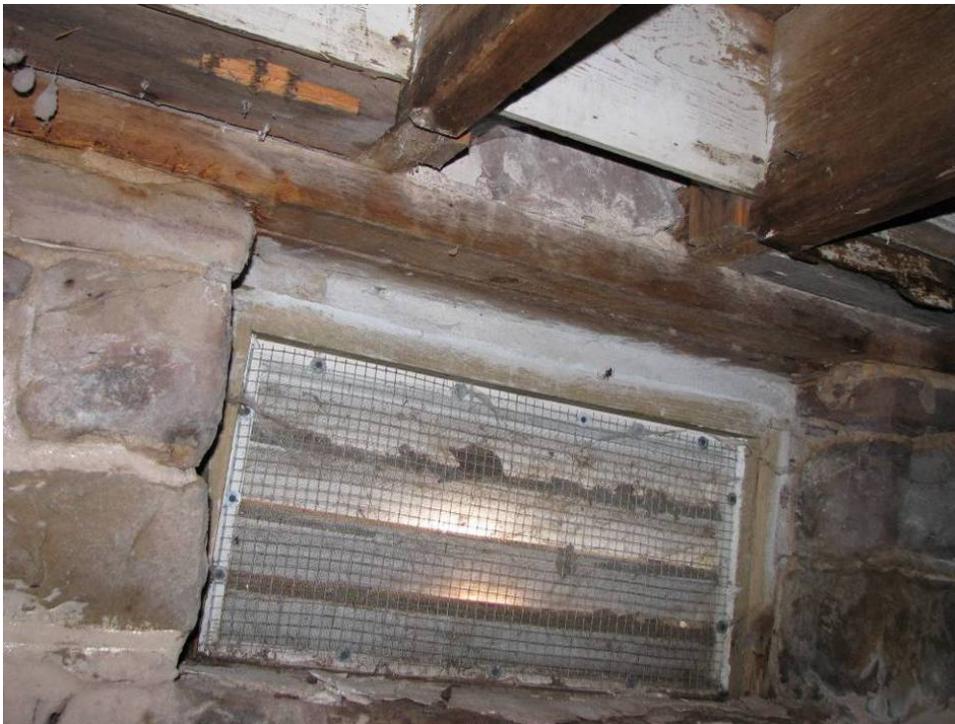
*MI-OLH-43: Joist header above basement window (Source: Martin/Martin)*

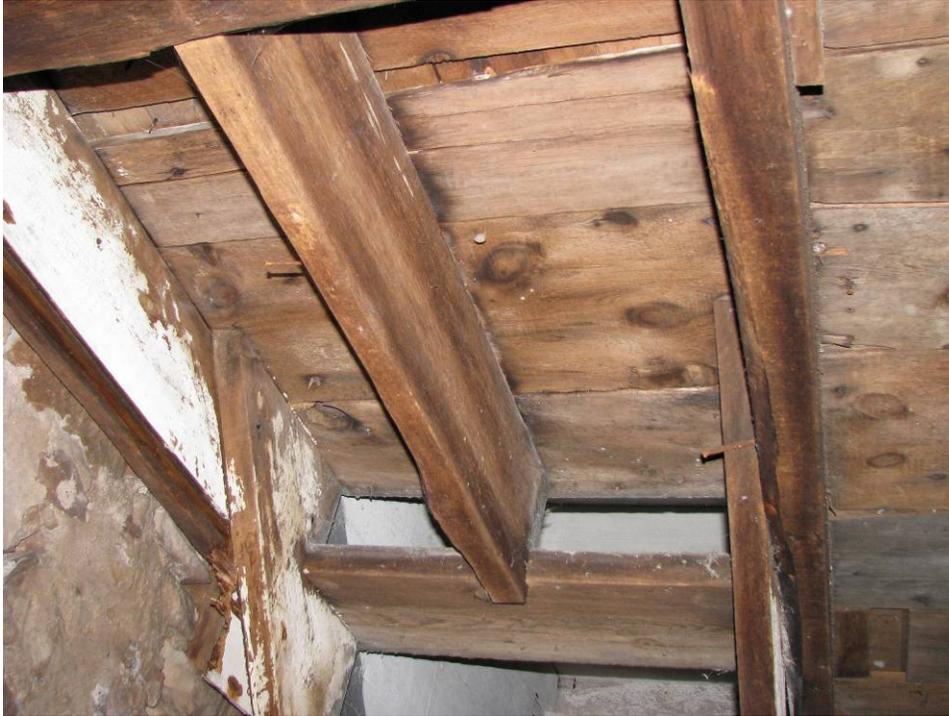
*MI-OLH-44: Joists at stair (Source: Martin/Martin)*

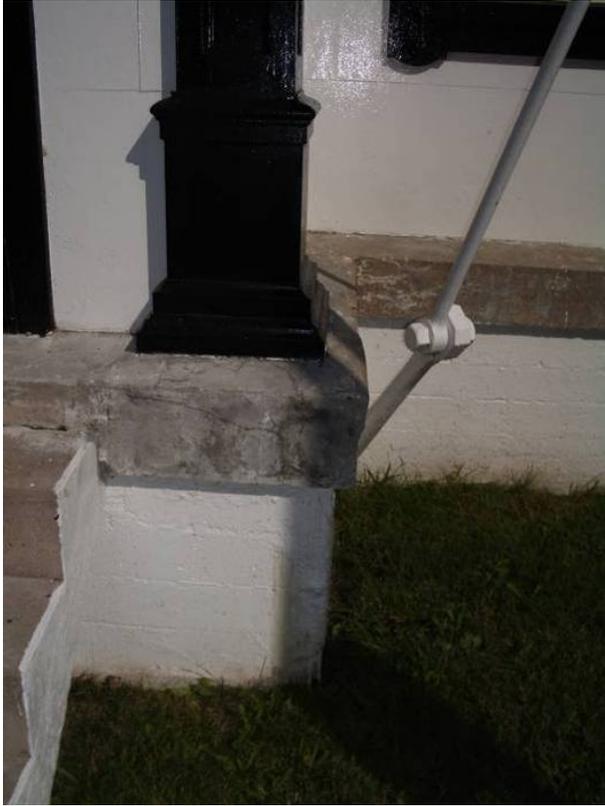
*MI-ST-07: Entry stair foundation and column base (Source: AH IMG2789)*

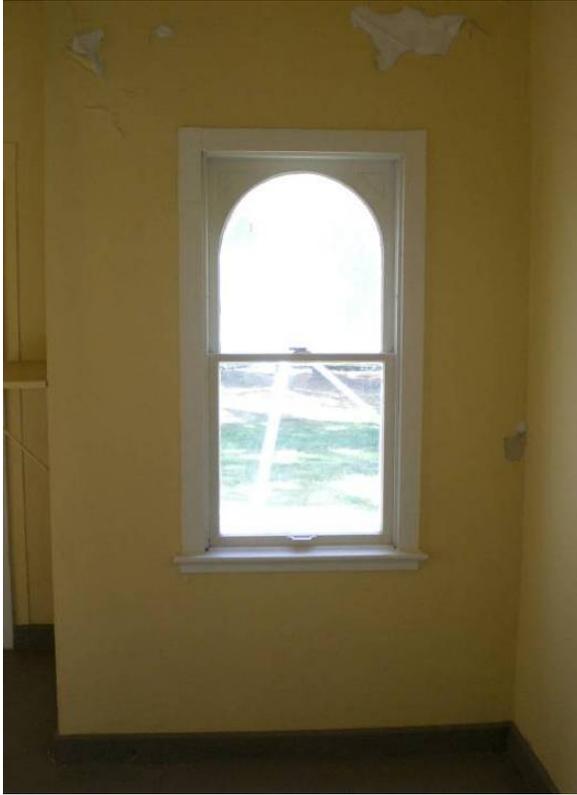
The windows for the Second Tower are arched top, one-over-one, double-hung windows. The window sash are wood, painted white on the interior and exterior. The trim, frame, and sills are cast iron, riveted into place and painted black. Each window has an arched hood trim of metal on the exterior, accented in black. This style of shroud is consistent with Italianate architecture. The glazing in most of the sash is Plexiglas (or a similar product) and the hardware appears to be replacement lifts and sash locks. The pulleys are extant for the lower windows but not visible at the upper tower windows. There is a hole through the cast structures evidencing that pulleys used to exist on these windows as well. The frame and trim are original but the sash ages are unknown (MI-ST-11).

*MI-ST-11: Typical window, interior face (Source: AH CIMG3596-A)*

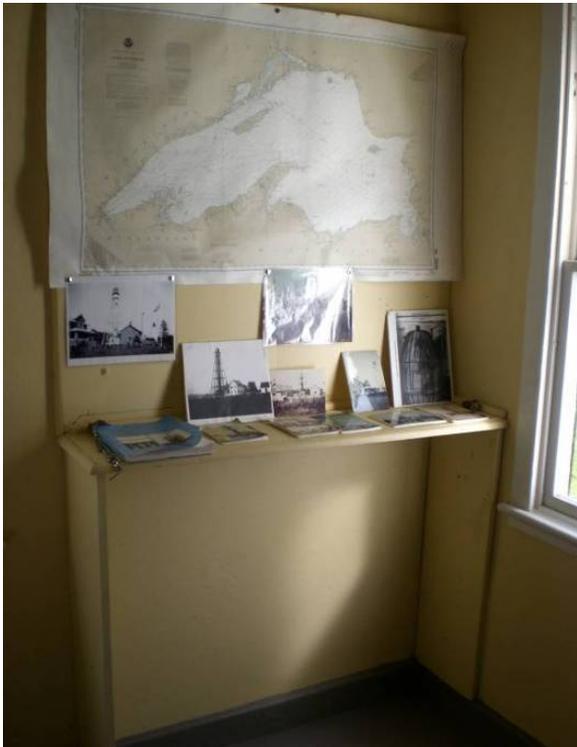
*MI-ST-12: Current exhibit along east wall (Source: AH CIMG3586)*

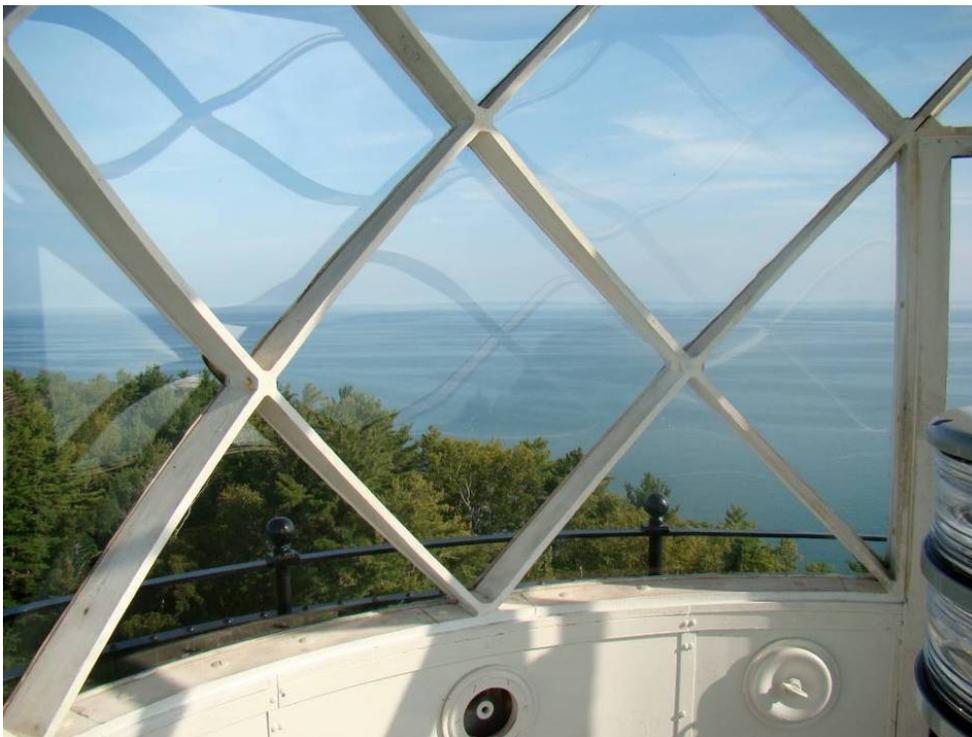
*MI-ST-19: Lantern, looking southeast (Source: AH DSC00619)*

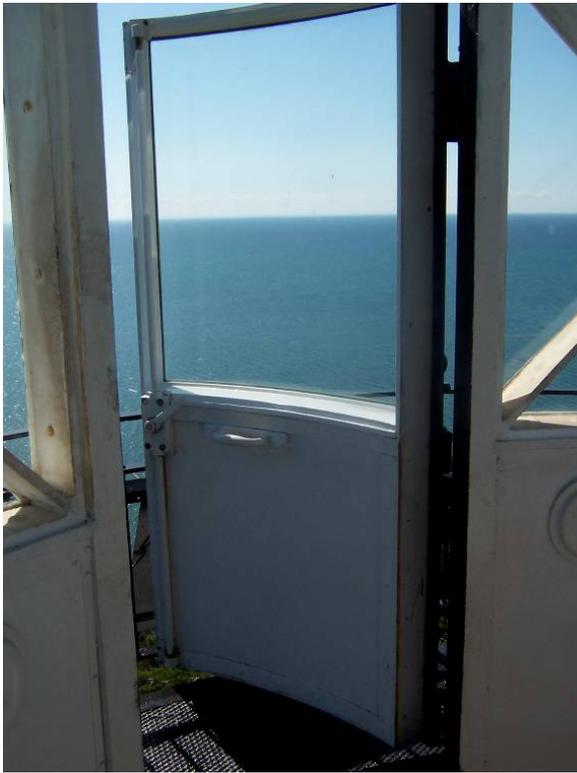
MI-ST-20: Lantern door (Source: AH 100\_9640)

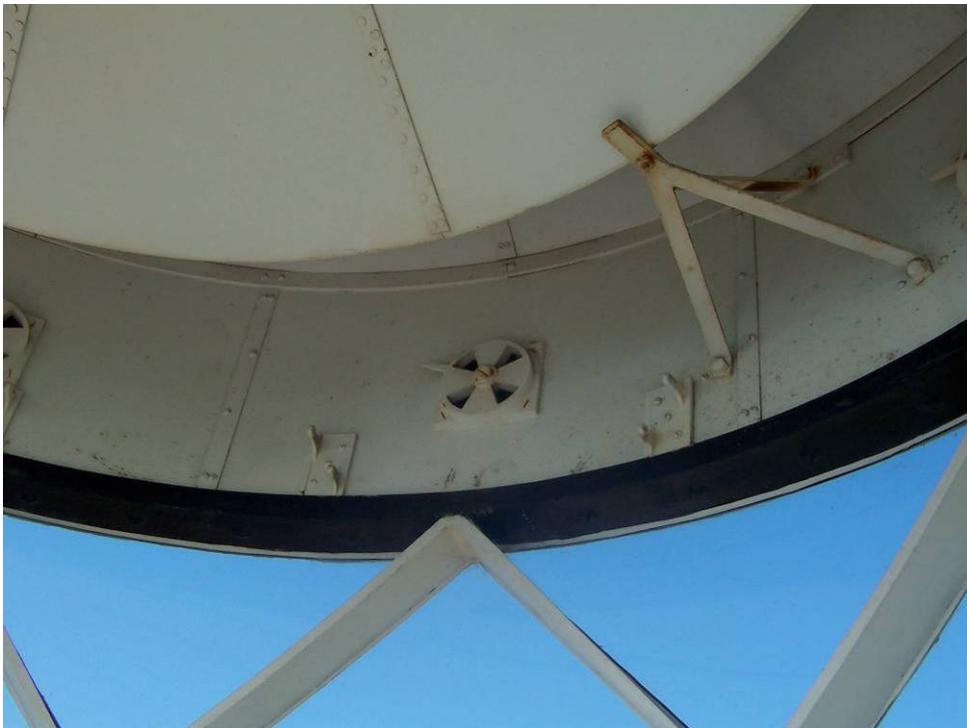
MI-ST-21: Lantern ceiling (Source: AH 100\_9632)

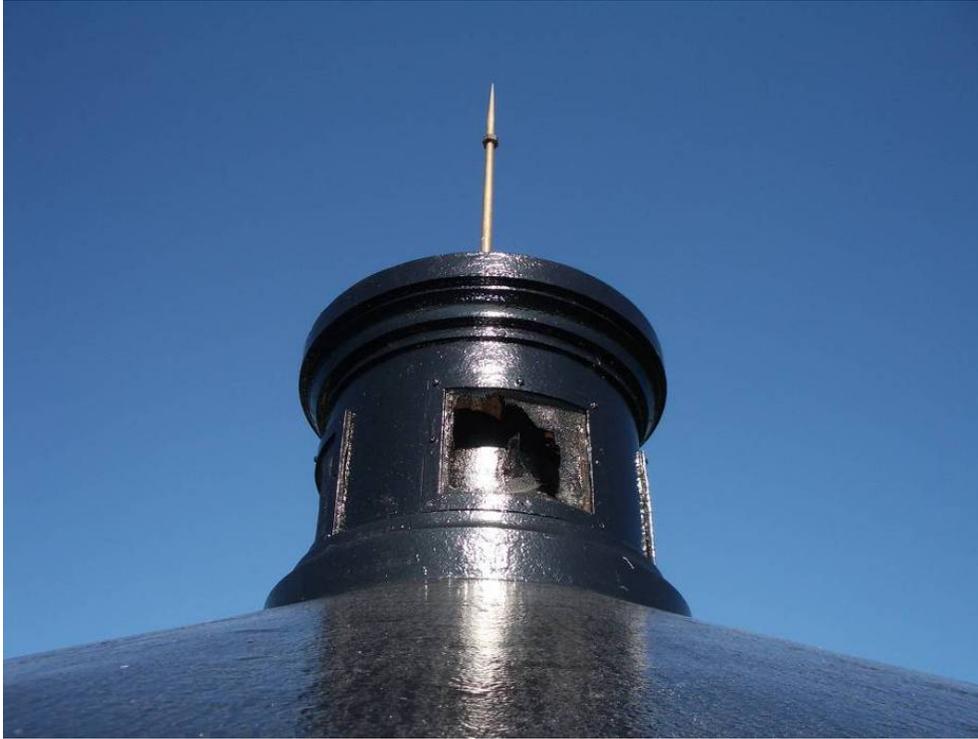
*MI-ST-22: Lantern roof (Source: AH IMG2769)*

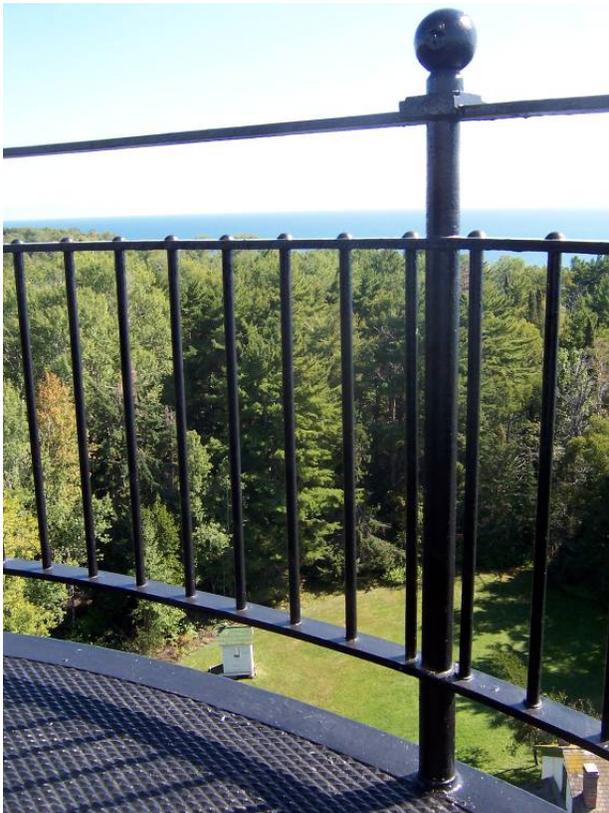
*MI-ST-23: Lantern railing and walkway (Source: AH 100\_9638)*

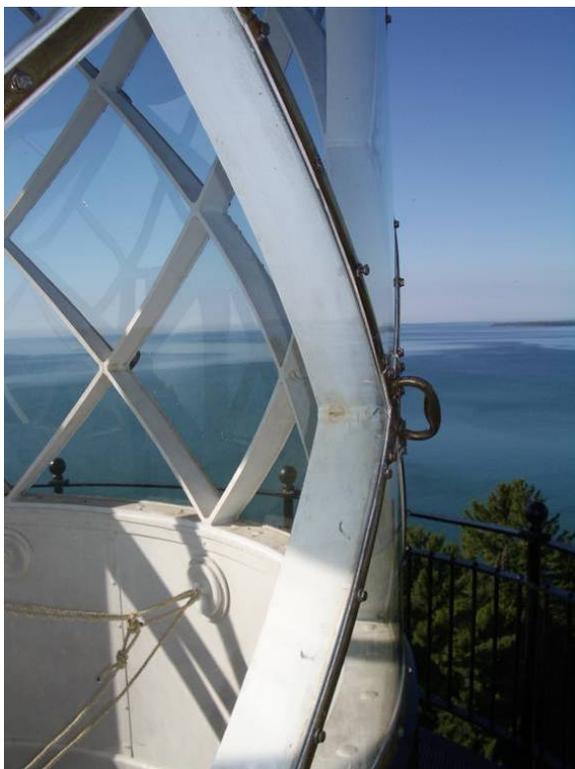
*MI-ST-24: Lantern glazing, walkway, and railing (Source: AH IMGP2782)*

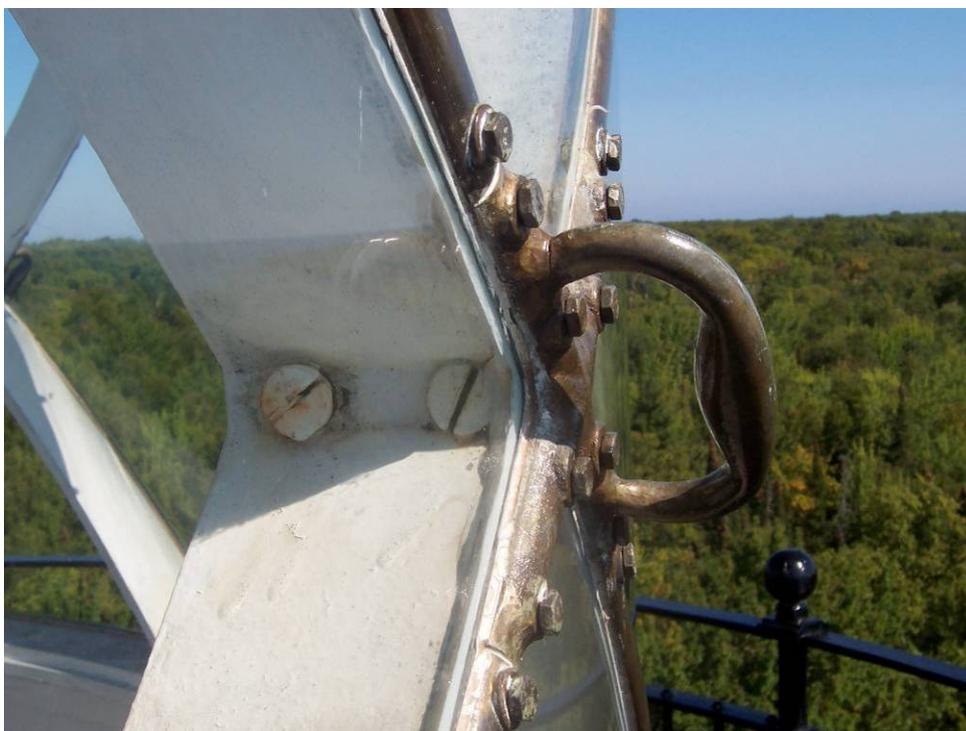
*MI-ST-25: Lantern glazing and brass stop detail (Source: AH 100\_9637)*

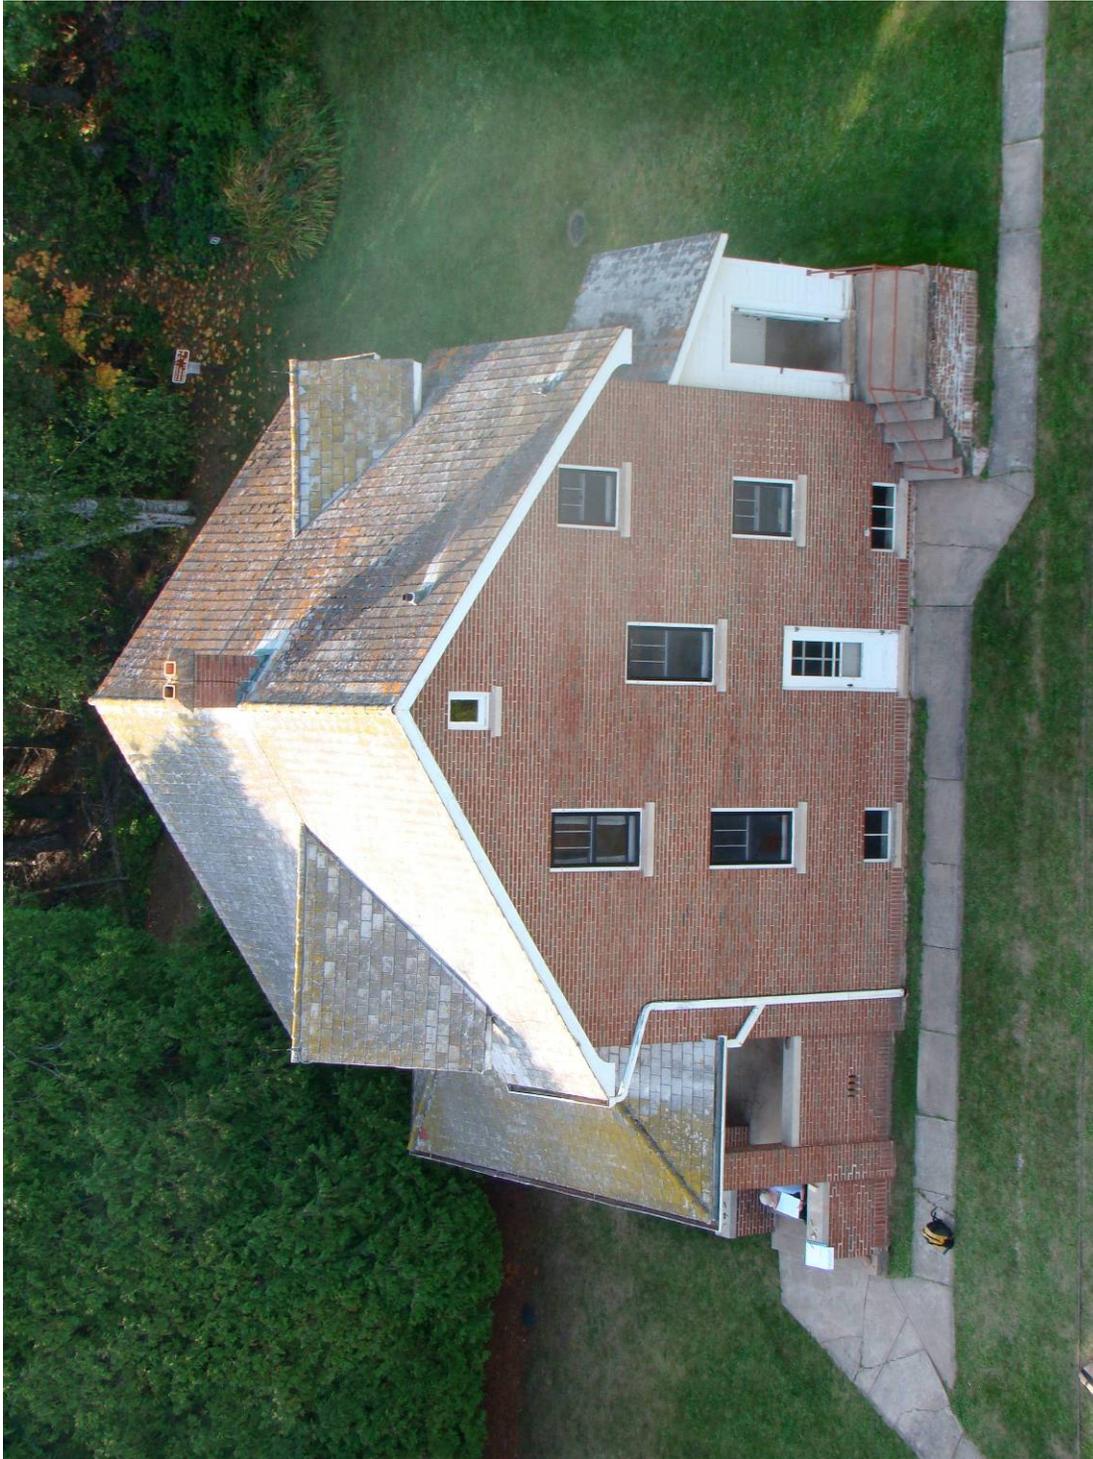
*MI-KQ-01: Aerial, 2009 (Source: AH DSC00609)*

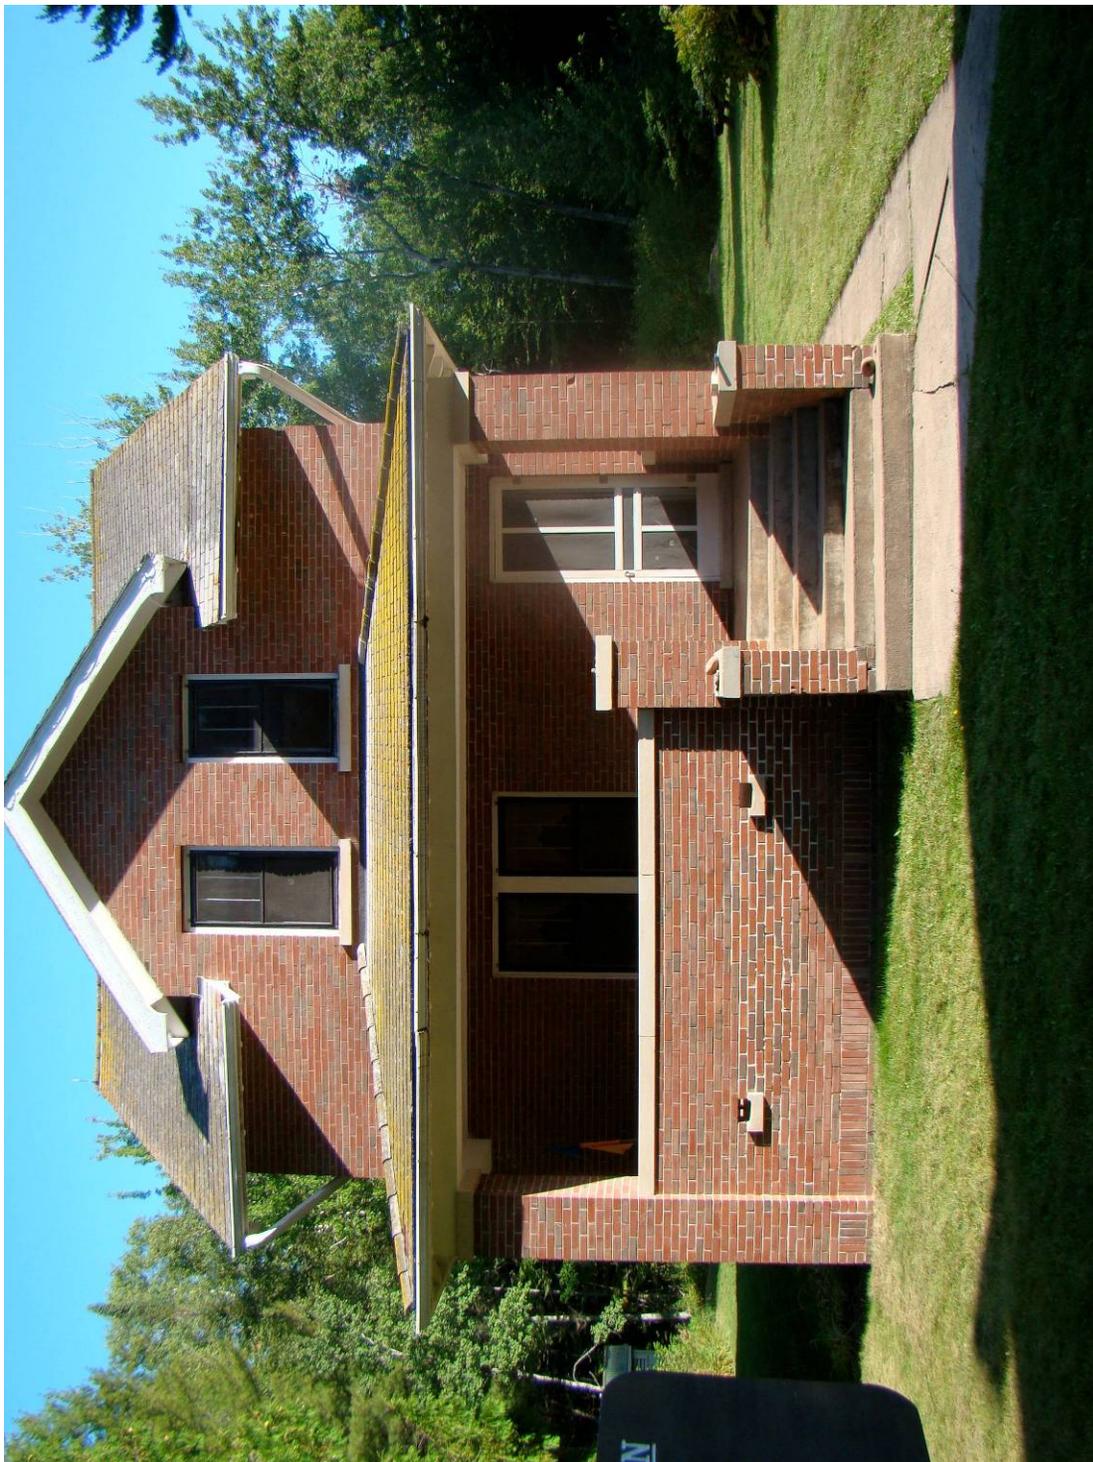
MI-KQ-02: South elevation, 2009 (Source: AH DSC00635)

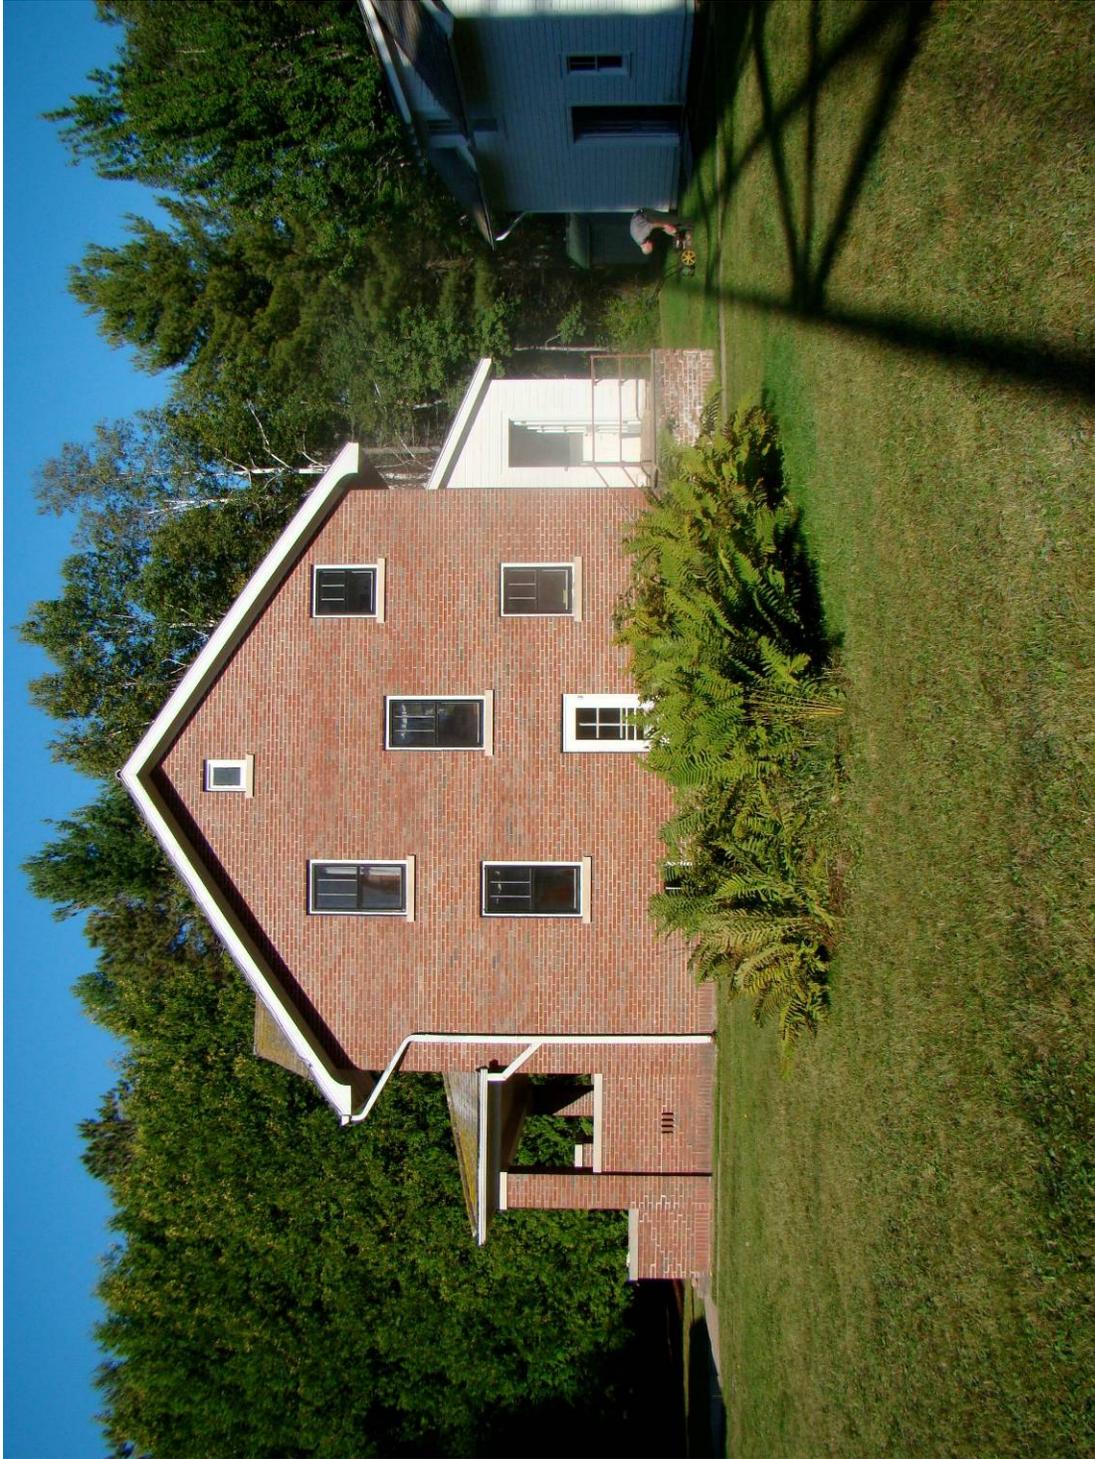
*MI-KQ-03: East elevation, 2009 (Source: AH DSC00636)*
