# CULTURAL LANDSCAPE REPORT • HISTORIC STRUCTURE REPORT

*Apostle Islands National Lakeshore – Bayfield, Wisconsin*

## **VOLUME II OF VI: MICHIGAN ISLAND CLR/HSR**

**JULY 2011**

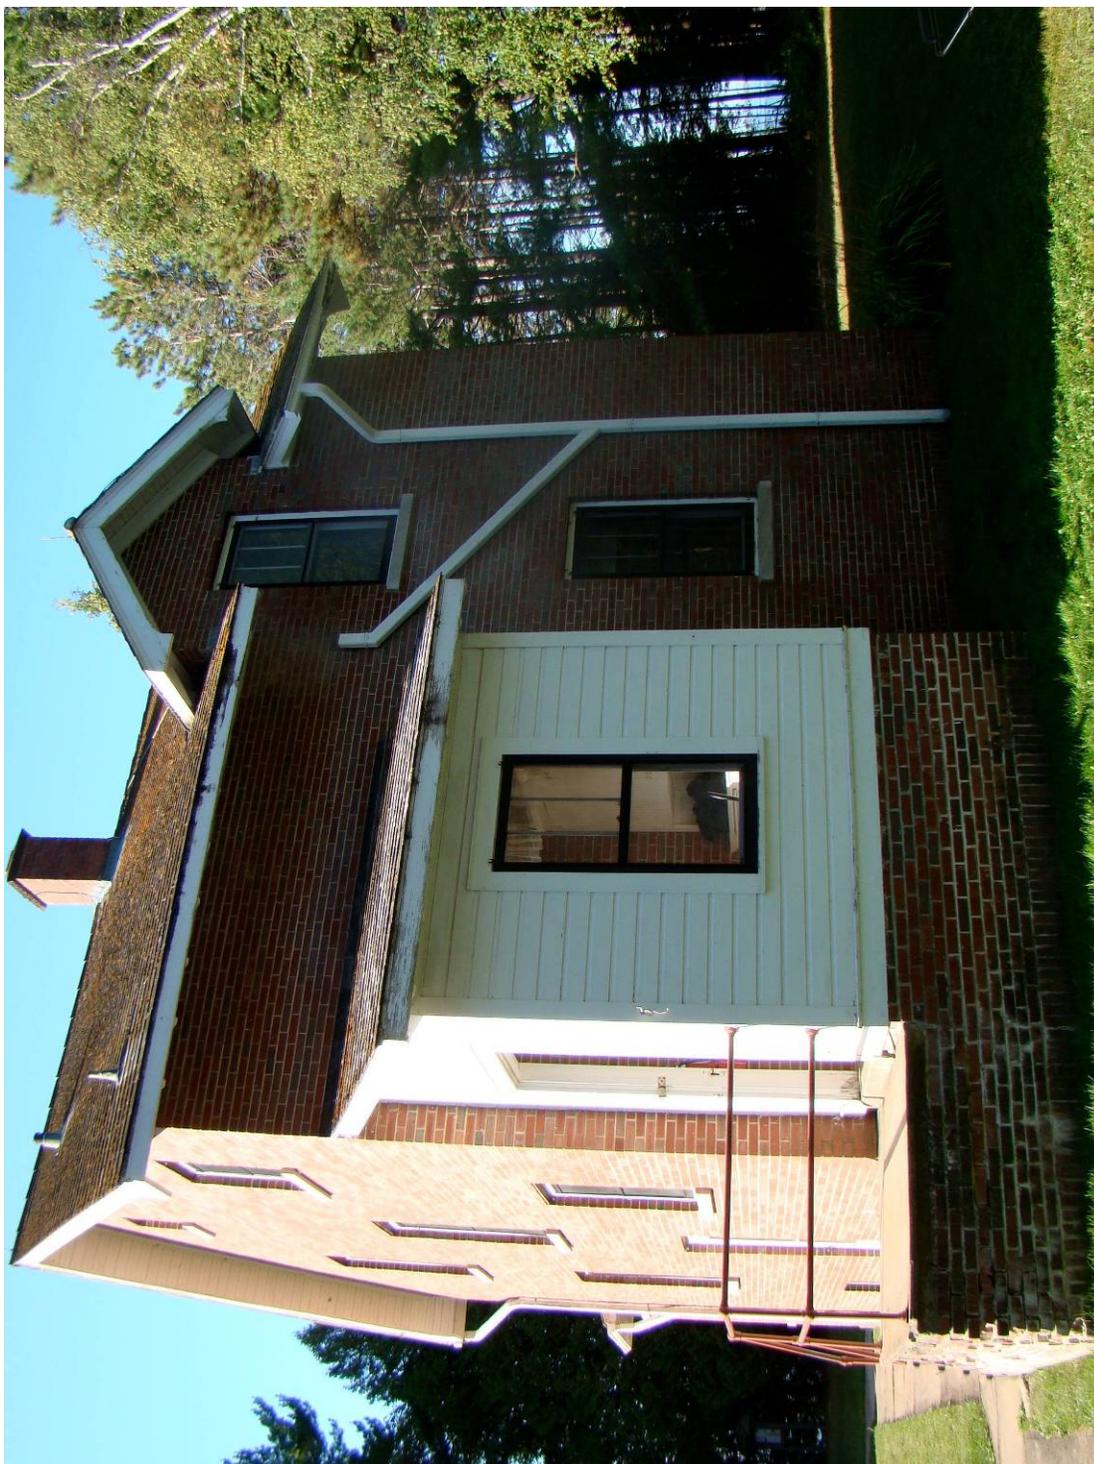
MI-KQ-04: North elevation, 2009 (Source: AH DSC006640)

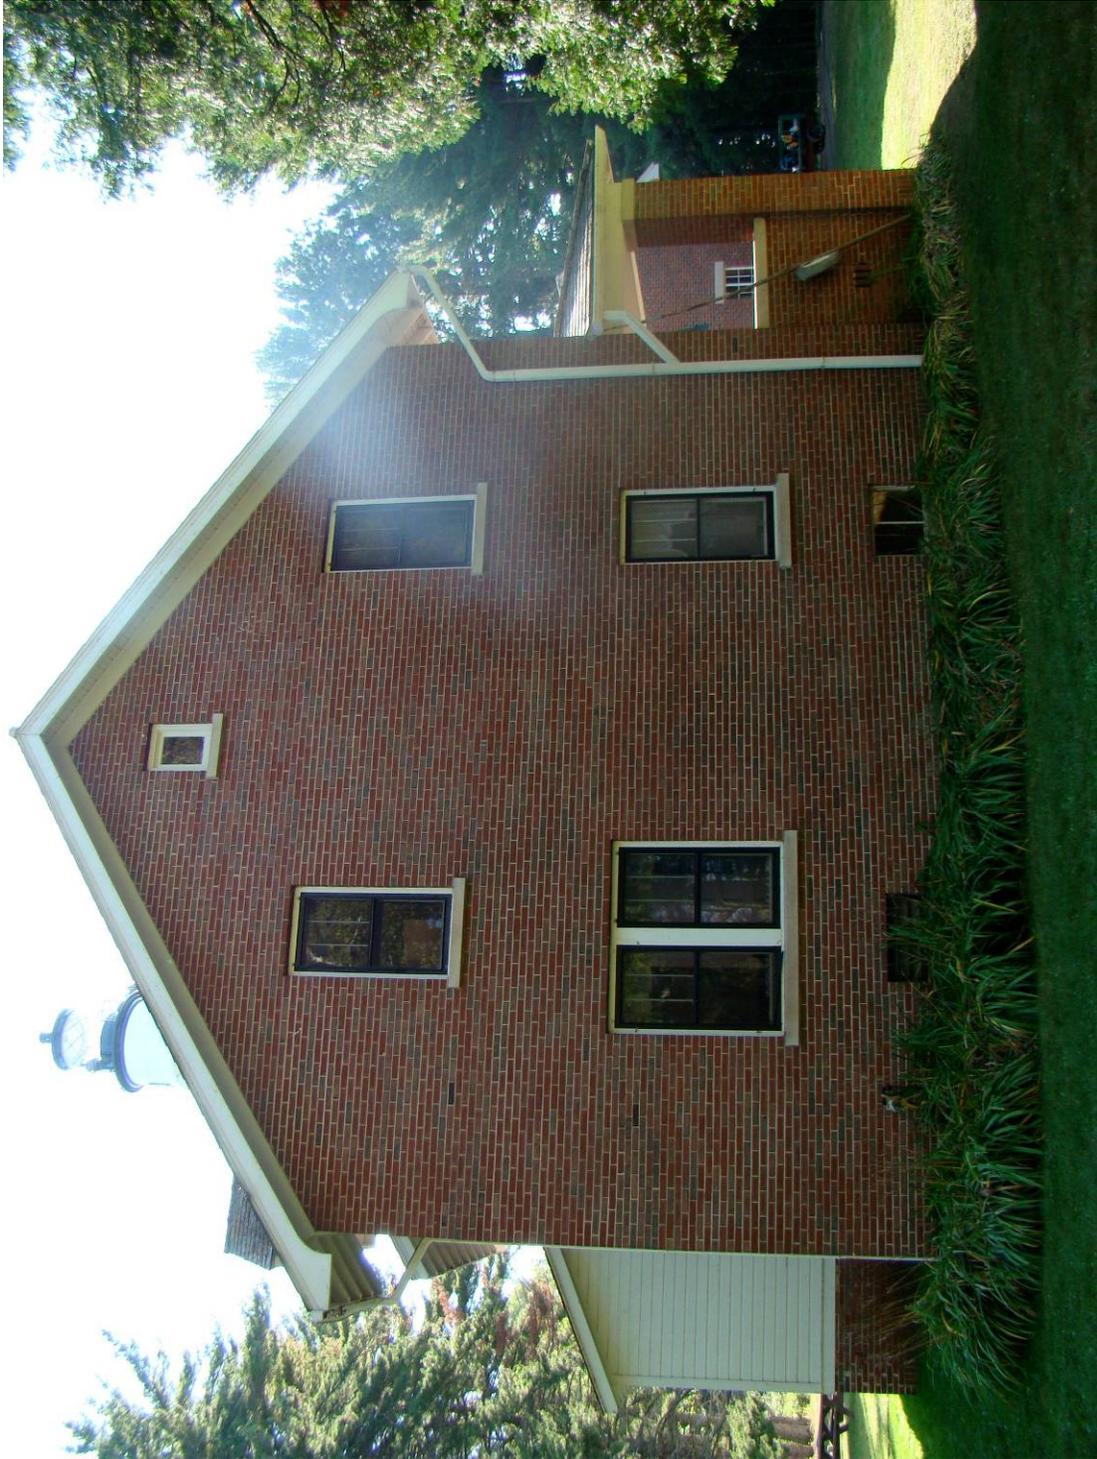
MI-KQ-05: West elevation, 2009 (Source: AH DSC006637)

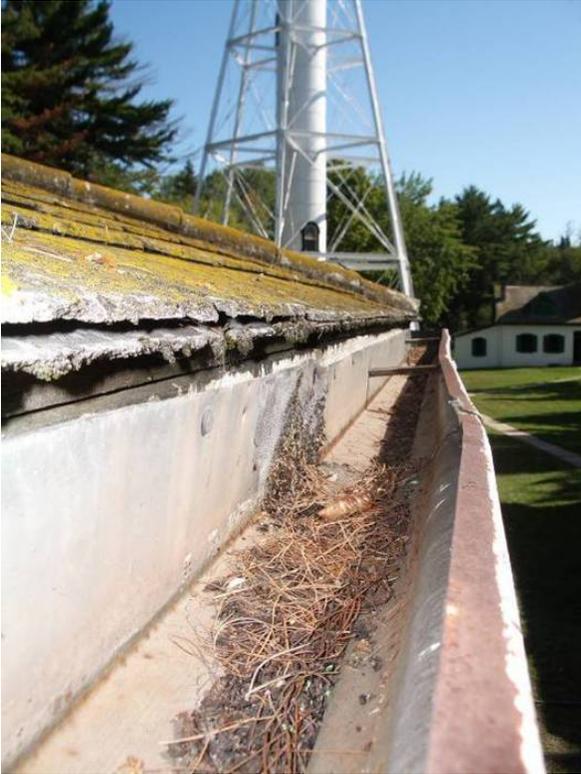
*MI-KQ-06: East gutter and roof detail (Source: AH IMG2804)*

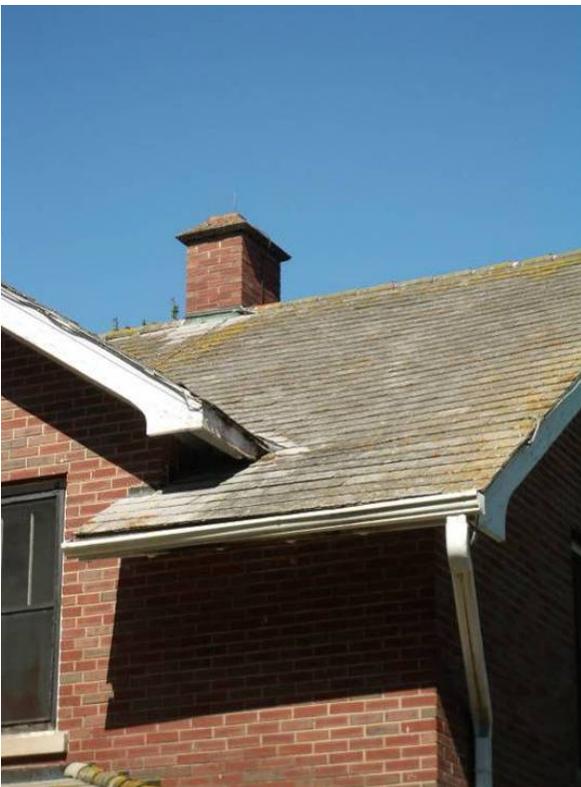
*MI-KQ-07: South roof, trim, gutter, and chimney detail (Source: AH IMG2826)*

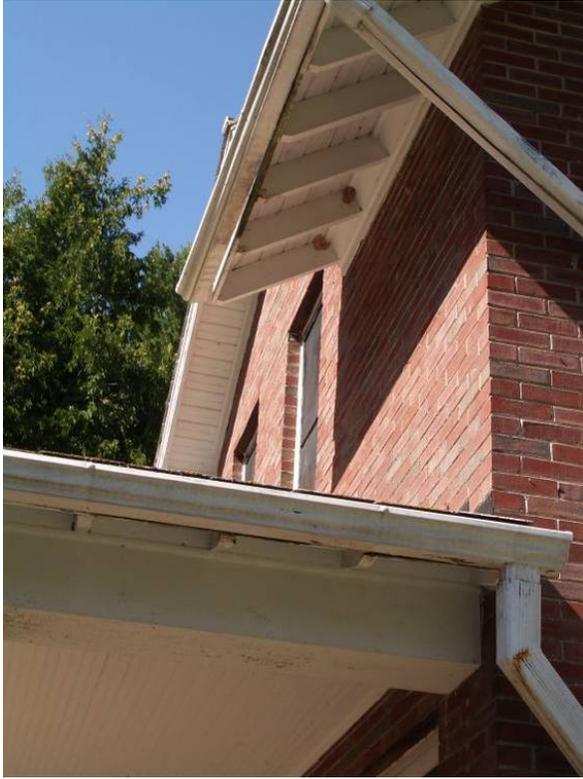
*MI-KQ-08: Porch roof, gutters, downspouts, trim and eaves, looking northwest (Source: AH IMG2828)*

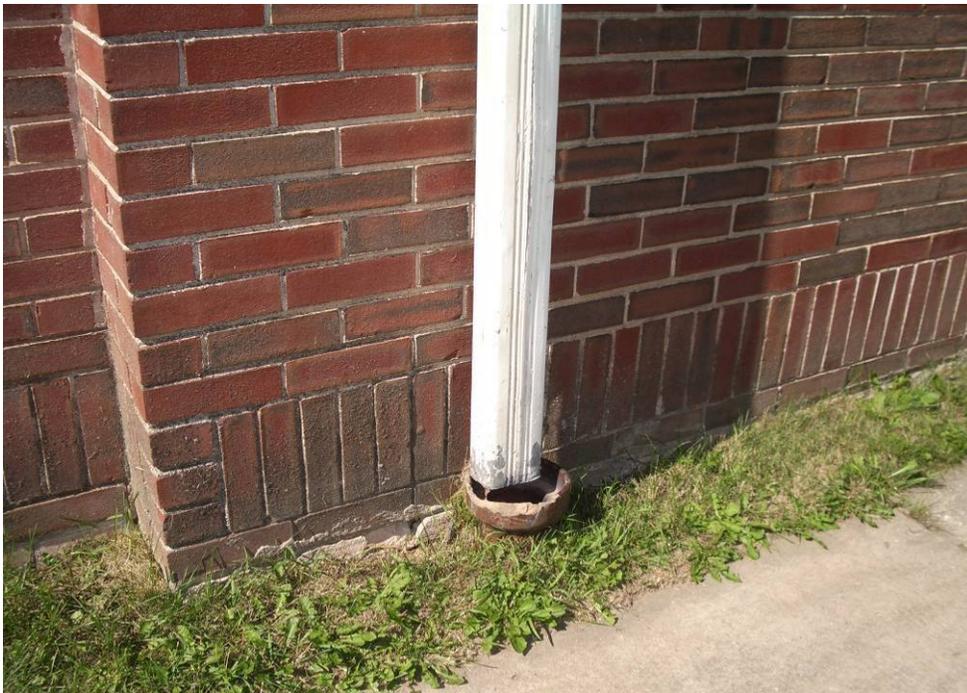
*MI-KQ-09: Downspout and underdrain detail (Source: AH IMG2829)*

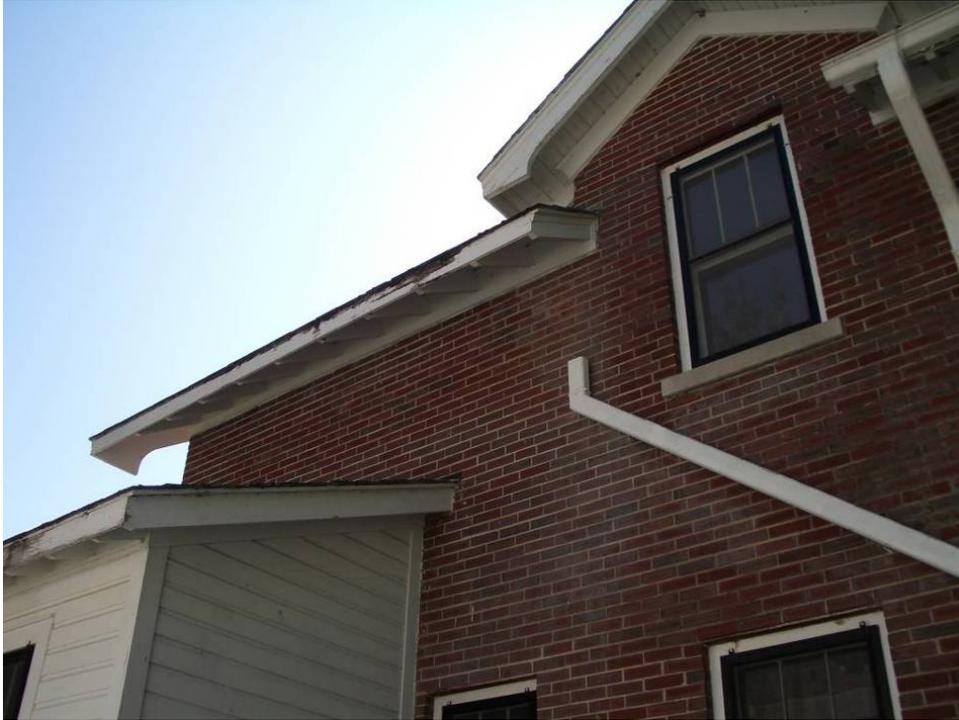
*MI-KQ-10: North elevation downspout, eaves, and roof (Source: AH IMGP2801)*

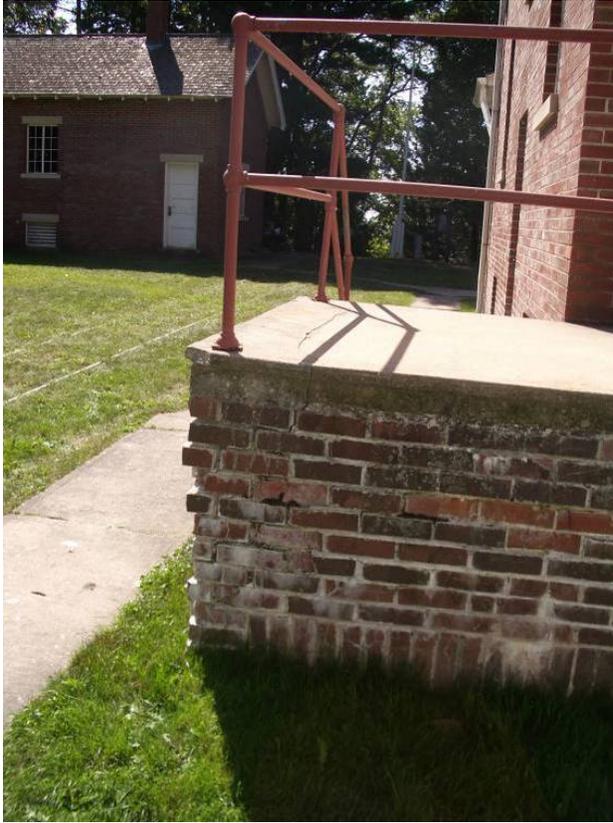
*MI-KQ-12: East porch detail, north elevation (Source: AH IMGP2798)*

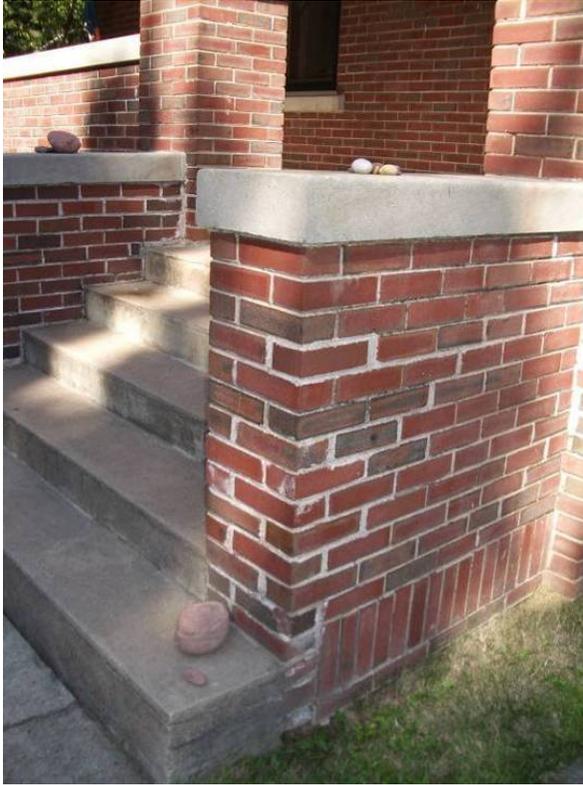
*MI-KQ-14: Front porch detail, looking west (Source: AH IMG2795)*

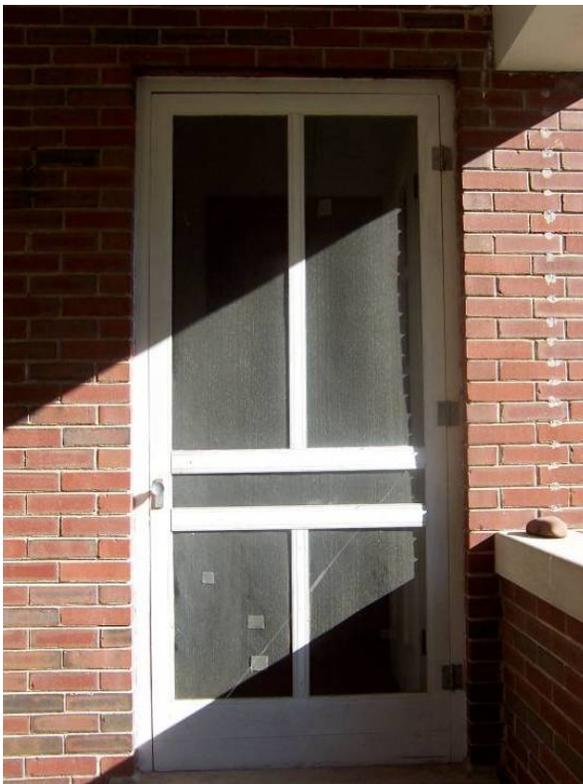
*MI-KQ-15: South entry (primary) screen door (Source: AH 100\_9594)*

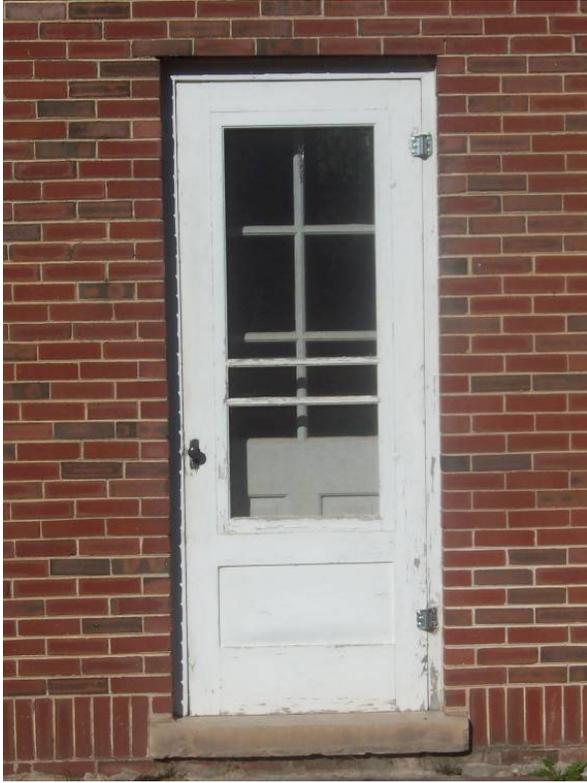
*MI-KQ-16: East entry screen and wood doors (Source: AH 100\_9606)*

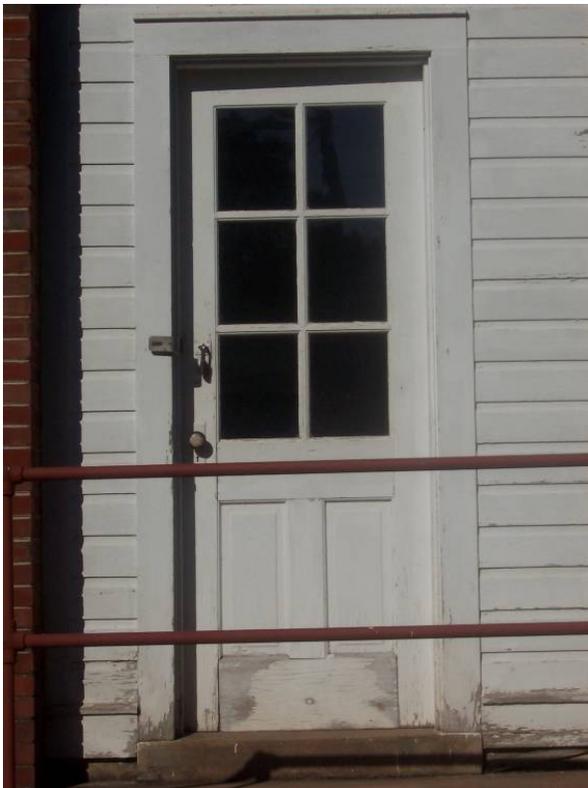
*MI-KQ-17: North entry wood door (Source: AH 100\_9607)*

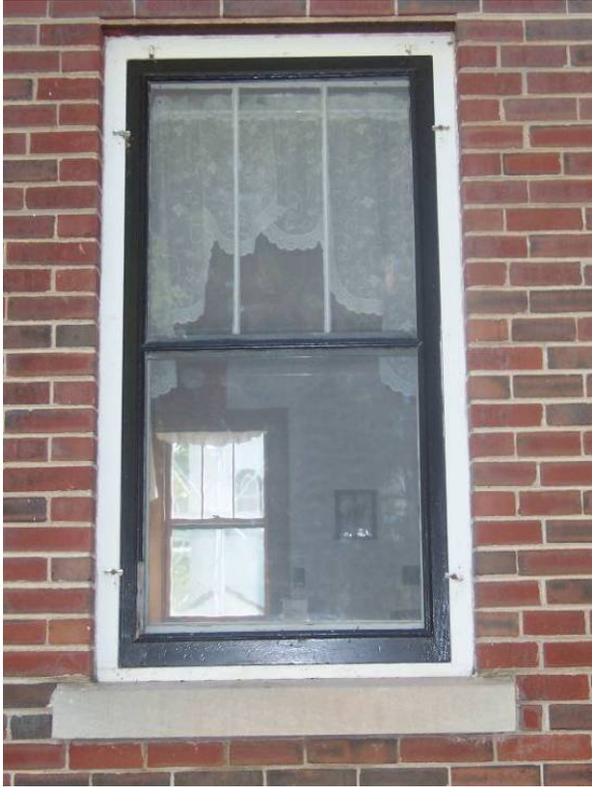
*MI-KQ-18: Typical exterior window (Source: AH 100\_9596)*

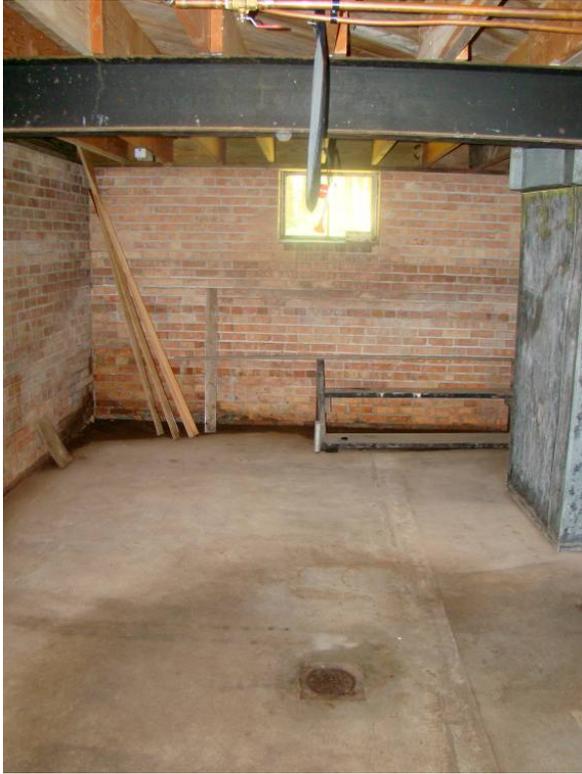
*MI-KQ-20: Basement and window (Source: AH CIMG3739)*

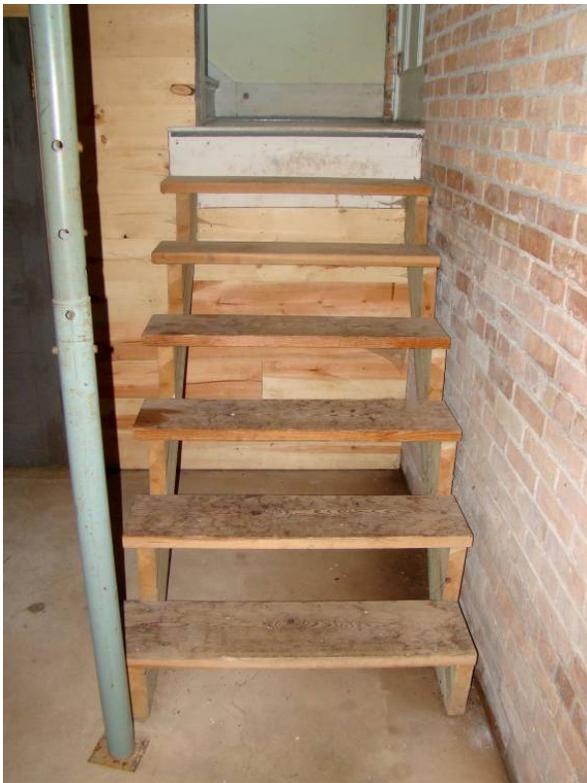
*MI-KQ-21: Basement stairs (Source: AH DSC00841)*

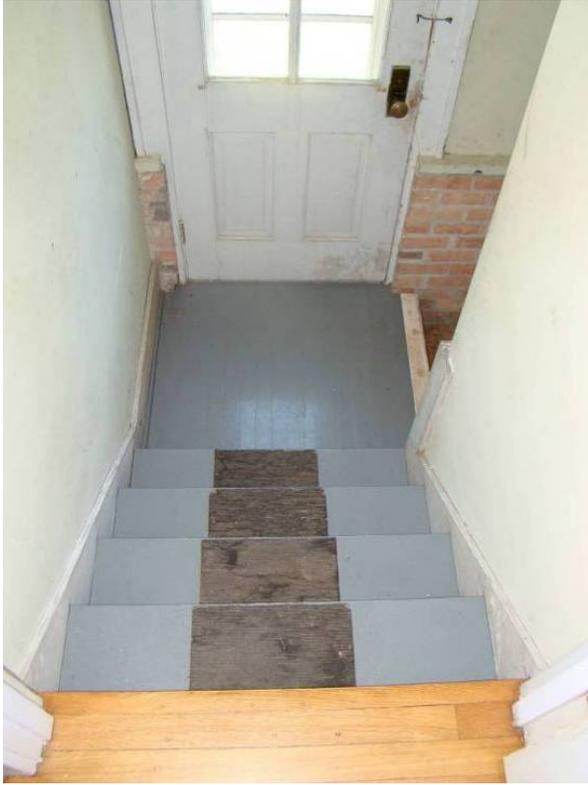
*MI-KQ-22: Stairs from basement entry to kitchen (Source: AH DSC00844)*

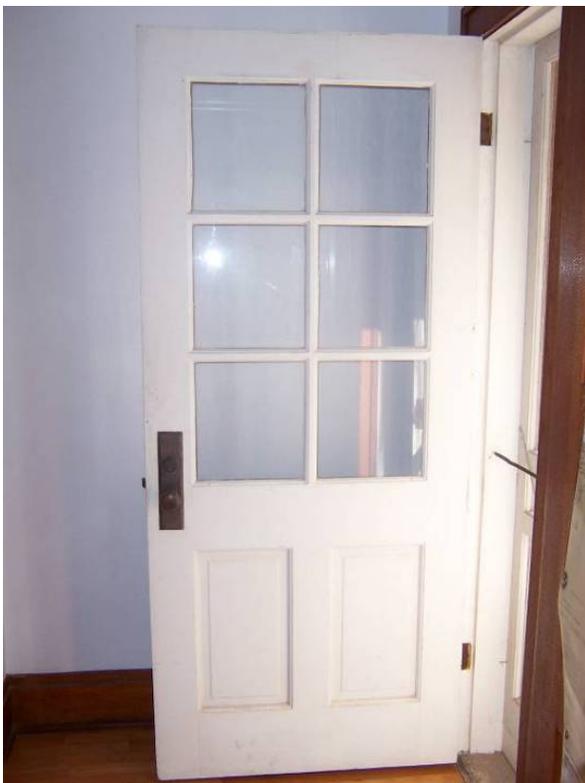
*MI-KQ-23: South entry door (primary) (Source: AH 100\_9593)*

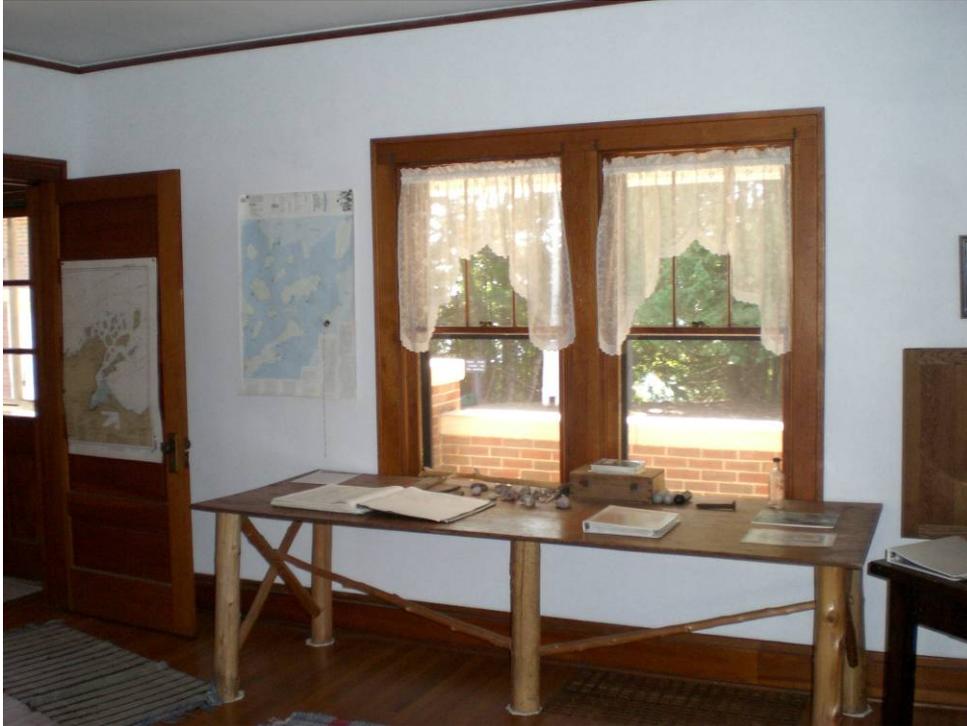
The living and dining room have wood picture rails, about 2" from the ceiling, stained. These moldings appear to be original (MI-KQ-24). The second floor south bedrooms also have picture rails, but only about 1" from the ceiling and with an almost cove-shaped profile, unlike the more traditional "S" shaped profiles for picture rails. These are also stained wood and appear to be contemporary (MI-KQ-43, 44, and 45).

*MI-KQ-24: Living room south elevation (Source: AH CIMG3678)*

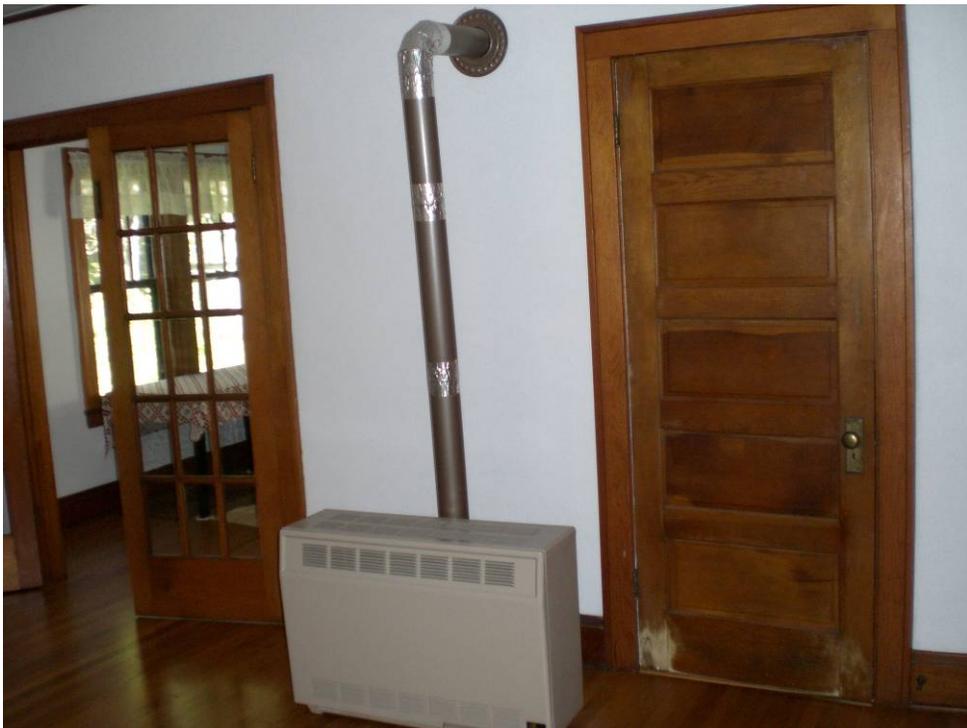
*MI-KQ-25: Living room north elevation (Source: AH CIMG3675)*

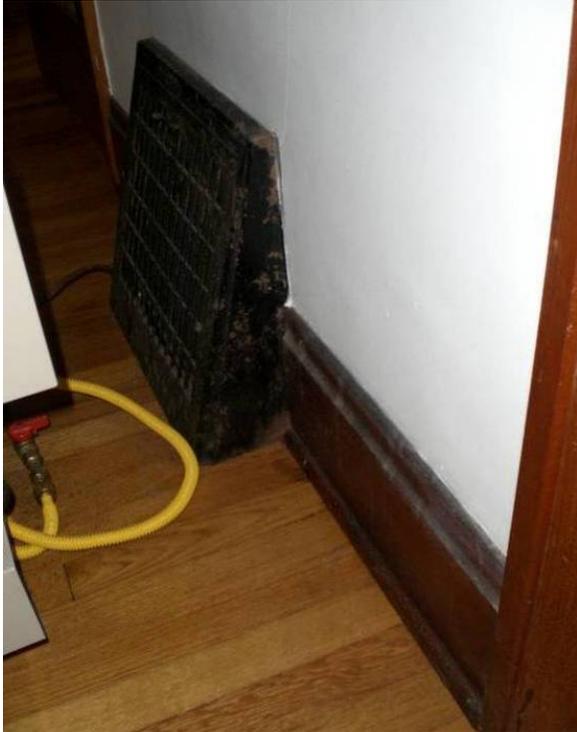
*MI-KQ-26: Living room metal register on north wall and base trim (Source: AH CIMG3682)*

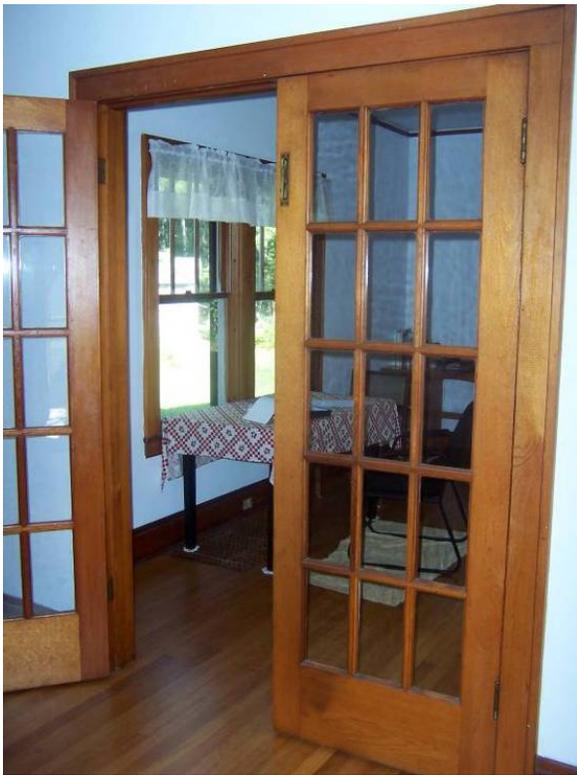
*MI-KQ-27: Living room double doors into dining room (Source: AH 100\_9616)*

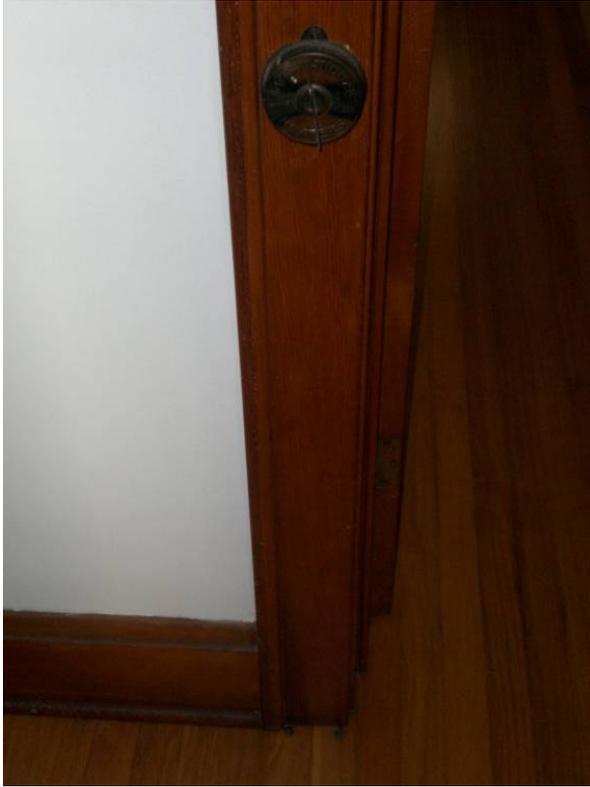
*MI-KQ-28: Dining room early vent control system (Source: AH CIMG3700)*

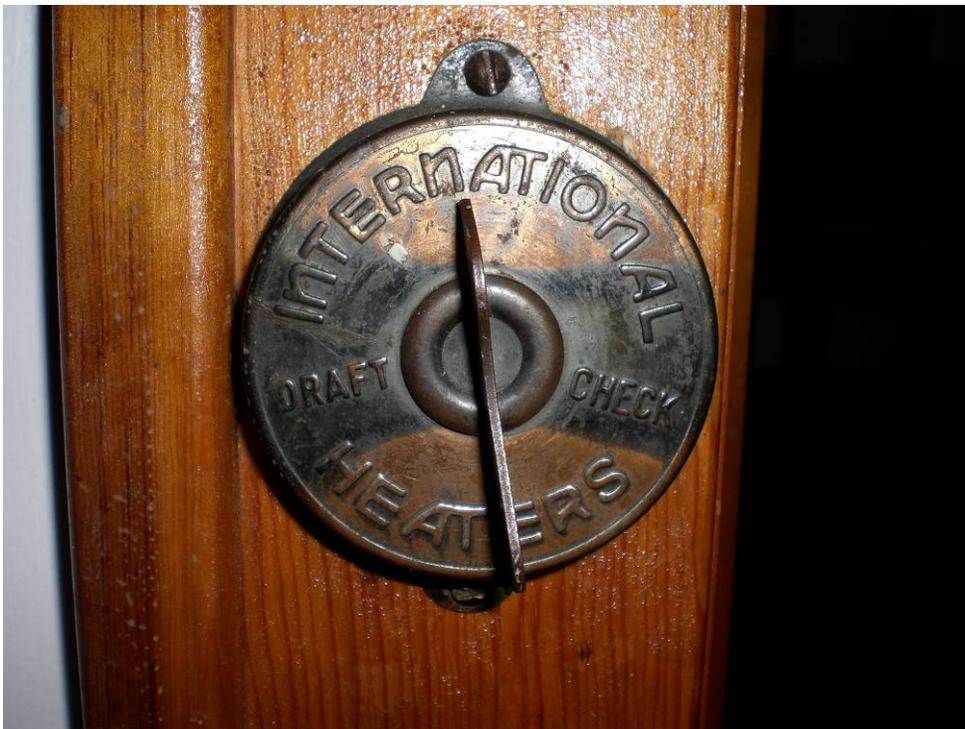
*MI-KQ-29: Detail of vent control (Source: AH 100\_9614)*

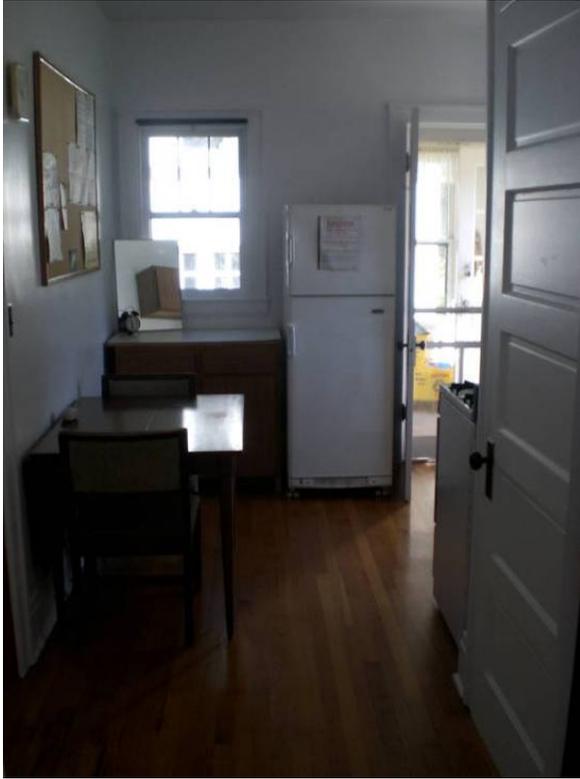
*MI-KQ-30: Kitchen north elevation (Source: AH CIMG3705)*

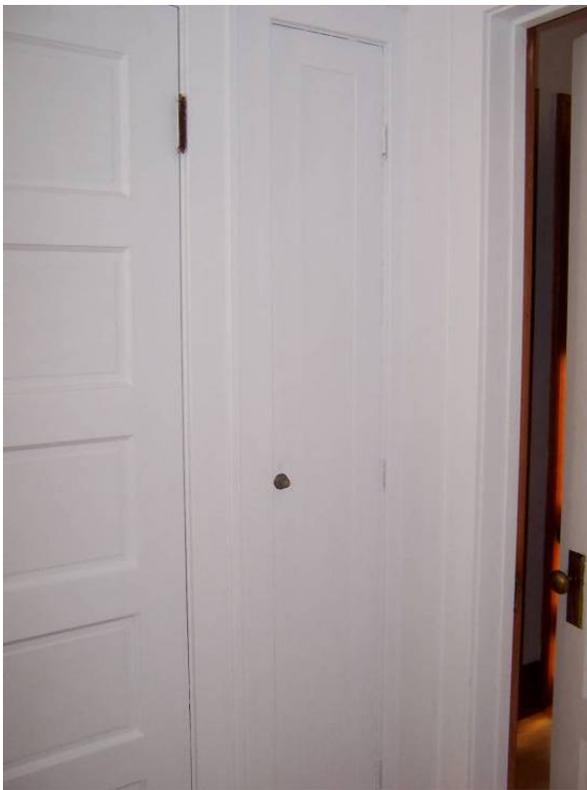
*MI-KQ-31: Kitchen broom closet door, east wall (Source: AH 100\_9611)*

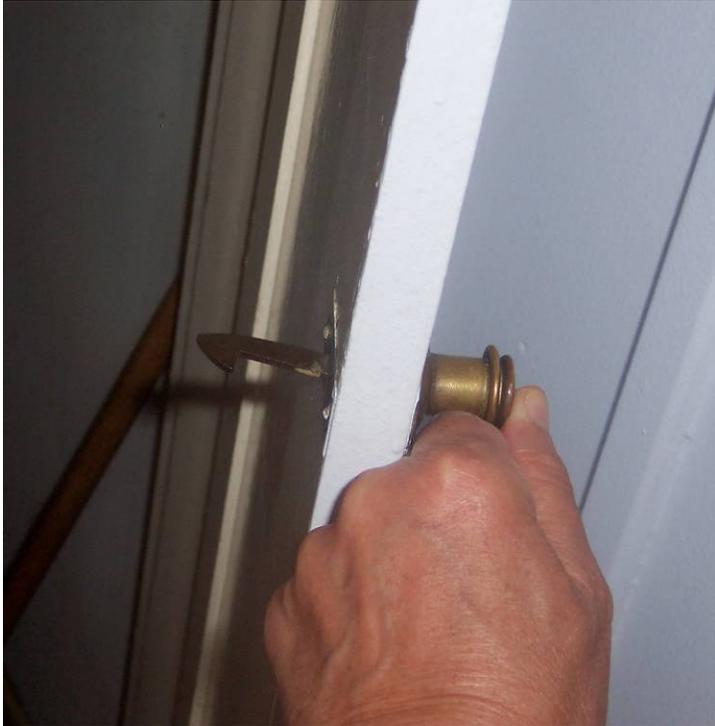
*MI-KQ-32: Kitchen broom closet latch (Source: AH 100\_9610)*

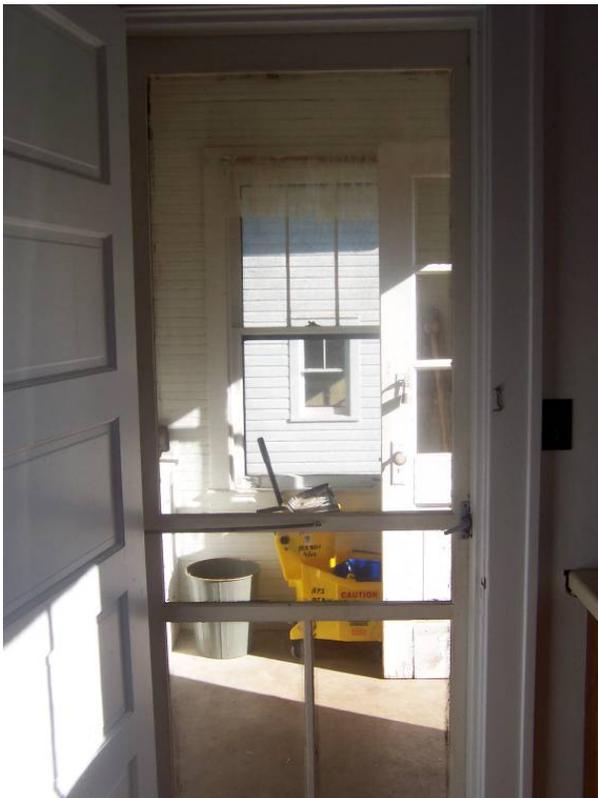
*MI-KQ-33: Kitchen wood door and screen to kitchen entry (Source: AH 100\_9608)*

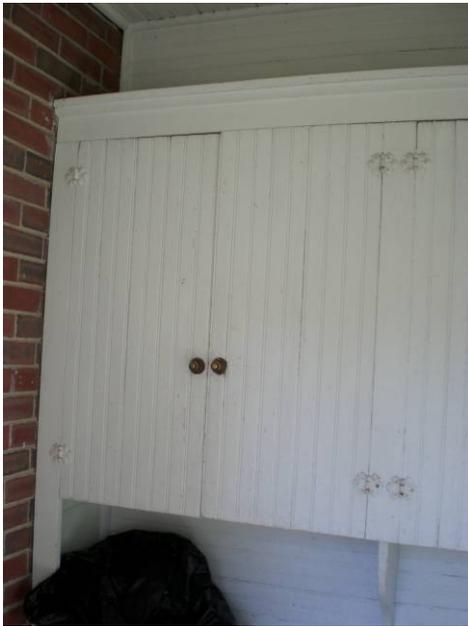
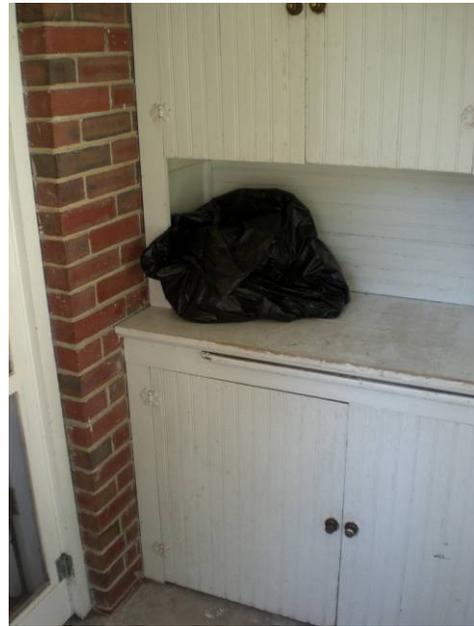
MI-KQ-34 and 35: Kitchen entry wood cabinet, south side (Source: AH CIMG3733 and CIMG3732)

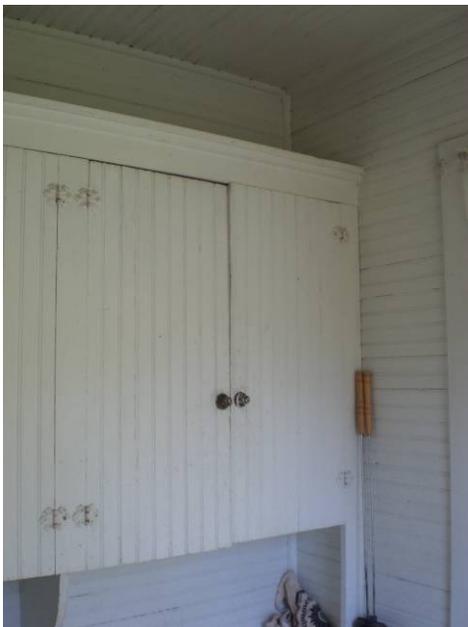
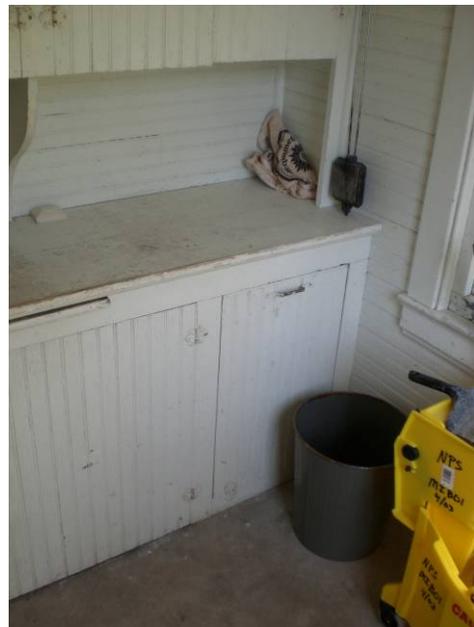
MI-KQ-36 and 37: Kitchen entry wood cabinet, north side (Source: AH CIMG3734 and CIMG3735)

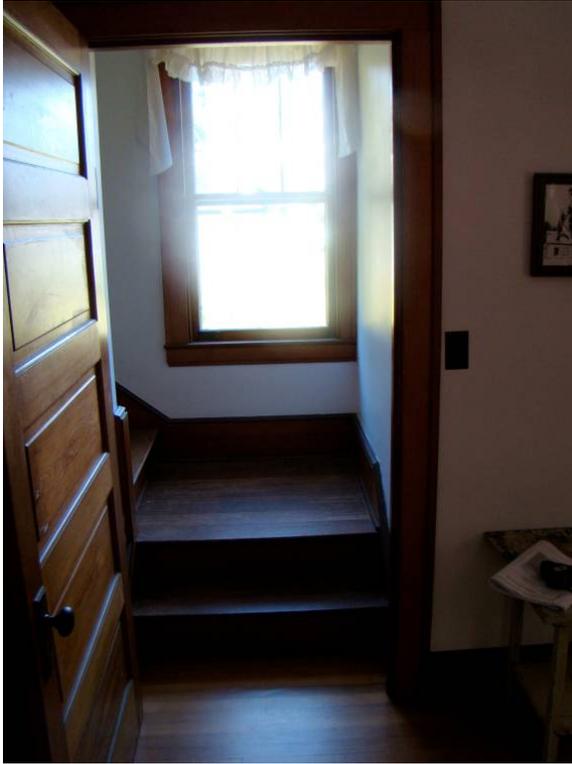
*MI-KQ-38: Stairs from living room to second floor (Source: AH DSC00830)*

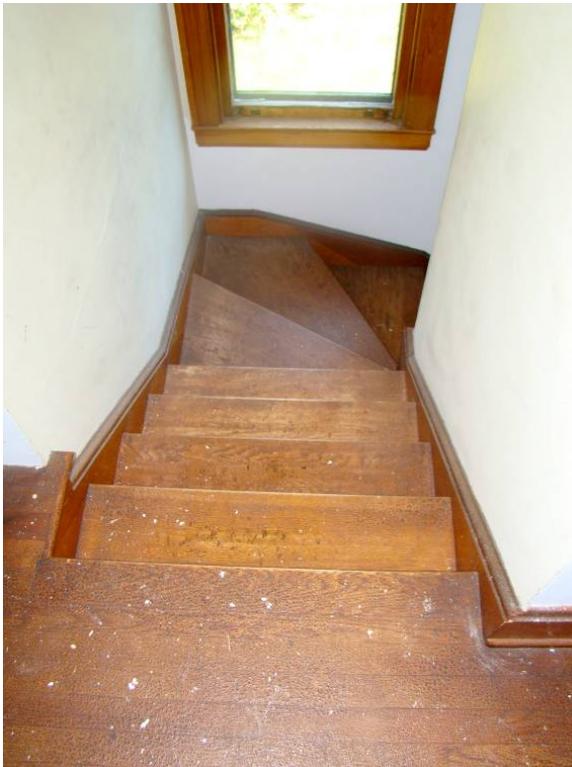
*MI-KQ-39: Stairs from living room to second floor (Source: AH DSC00835)*

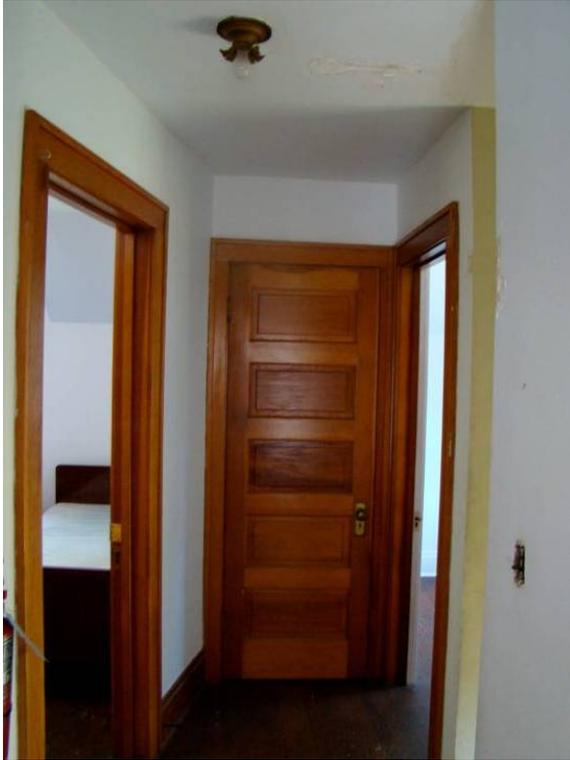
*MI-KQ-40: Second floor hall, north elevation (Source: AH DSC00717)*

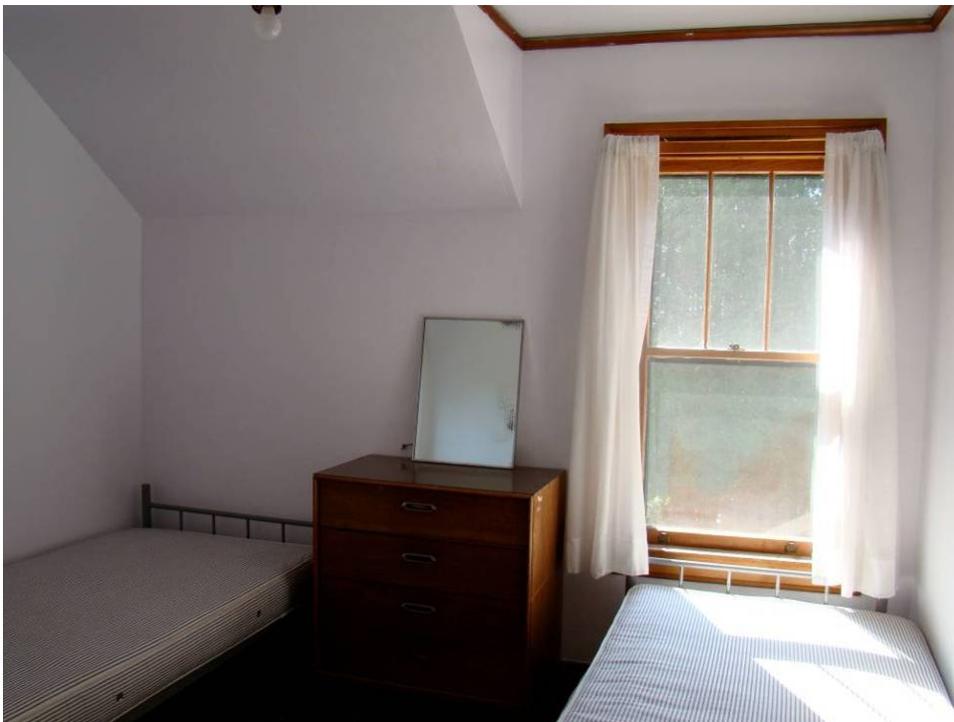
*MI-KQ-41: Southeast bedroom, south elevation (Source: AH DSC00724)*

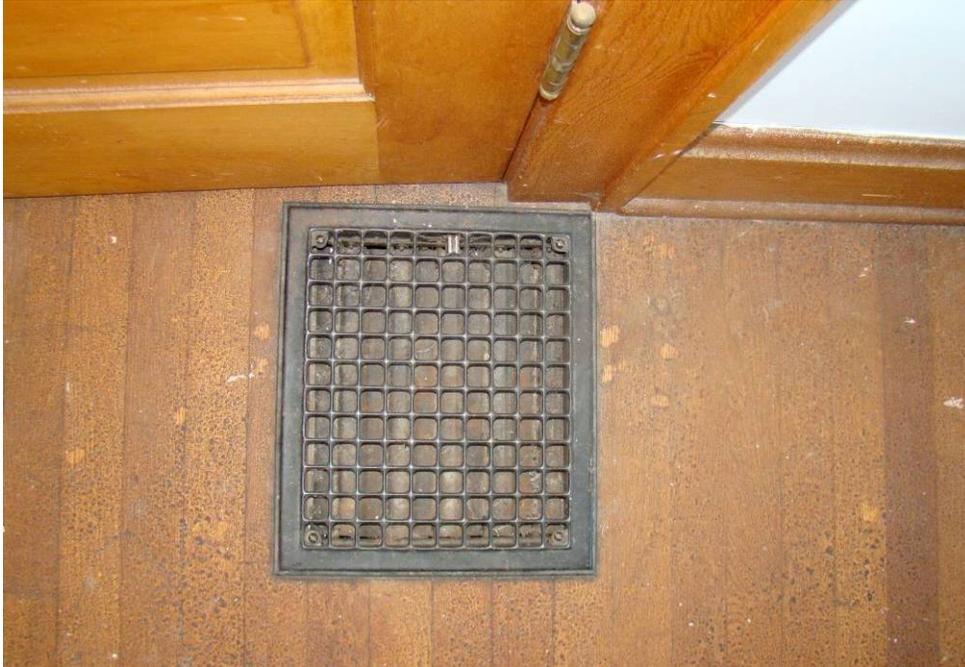
*MI-KQ-42: Southeast bedroom, metal floor register, floor and base trim (Source: AH DSC00731)*

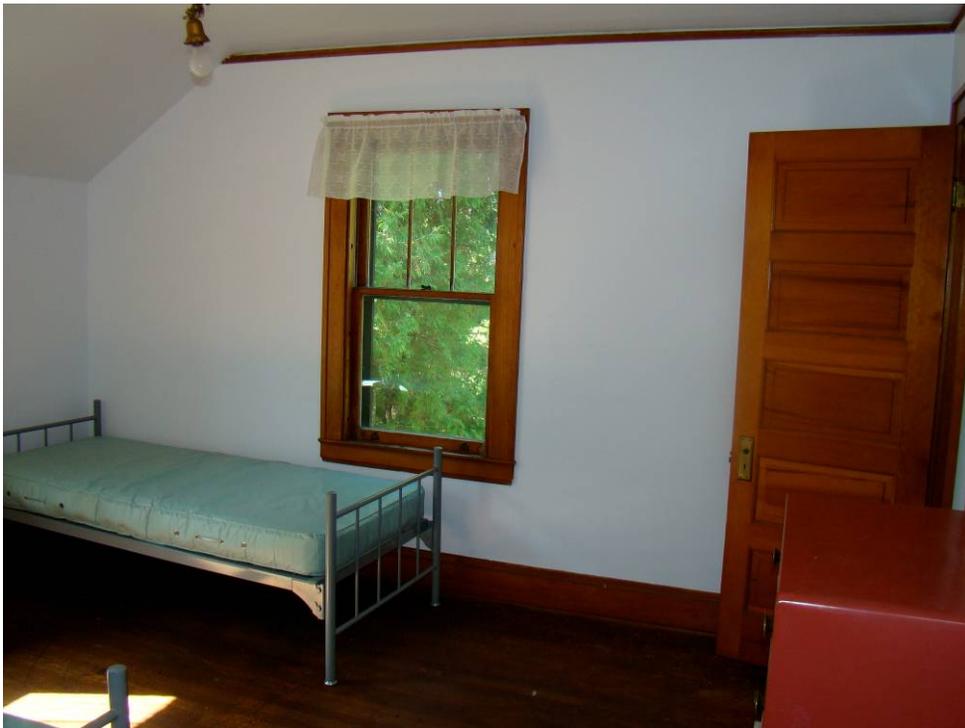
*MI-KQ-43: Southwest bedroom, west elevation (Source: AH DSC00743)*

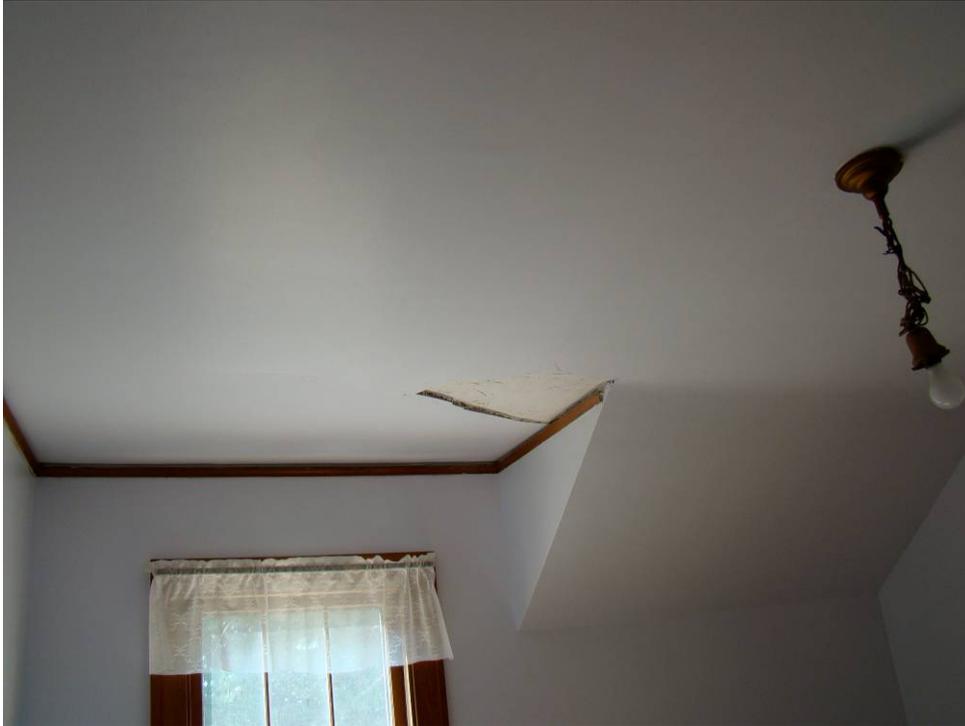
*MI-KQ-44: Southwest bedroom ceiling, looking south (Source: AH DSC00749)*

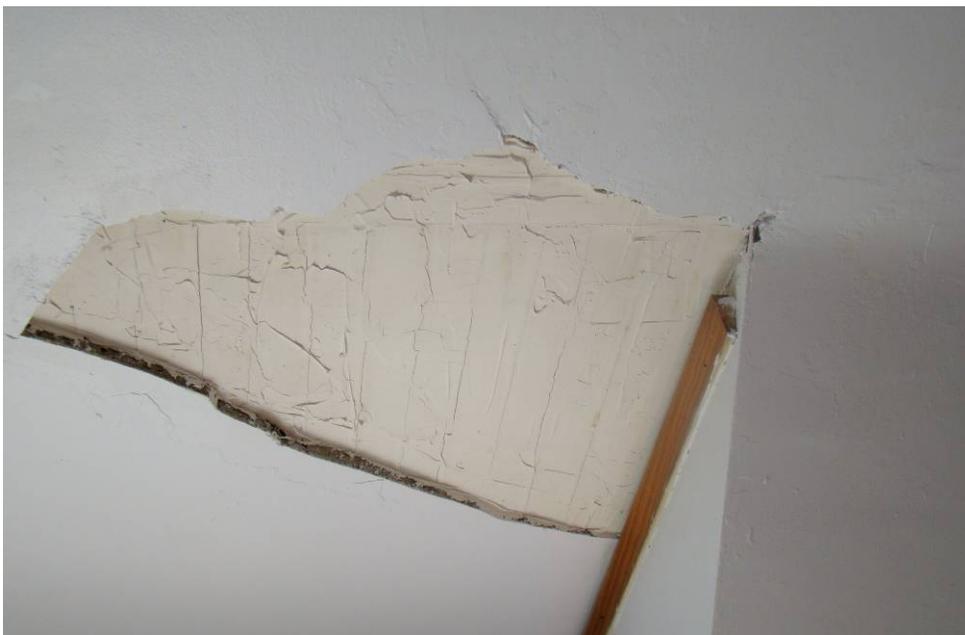
*MI-KQ-45: Southwest bedroom, south ceiling detail and picture rail profile (Source: AH DSC00750)*

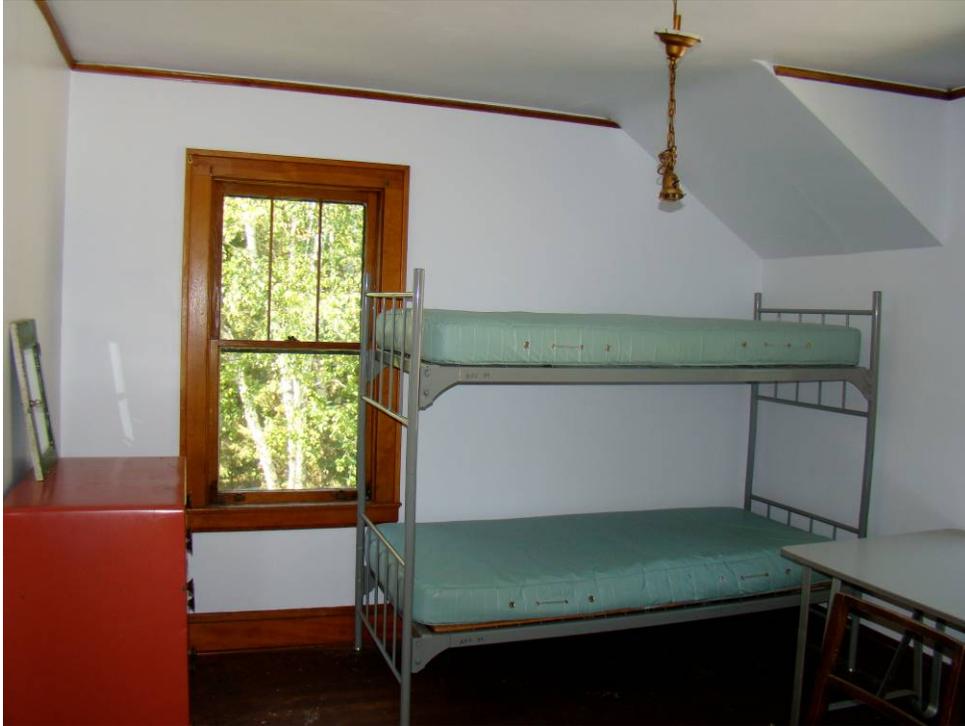
MI-KQ-46: North bedroom, west elevation (Source: AH DSC00763)
