# CULTURAL LANDSCAPE REPORT • HISTORIC STRUCTURE REPORT

*Apostle Islands National Lakeshore – Bayfield, Wisconsin*

## **VOLUME II OF VI: MICHIGAN ISLAND CLR/HSR**

**JULY 2011**

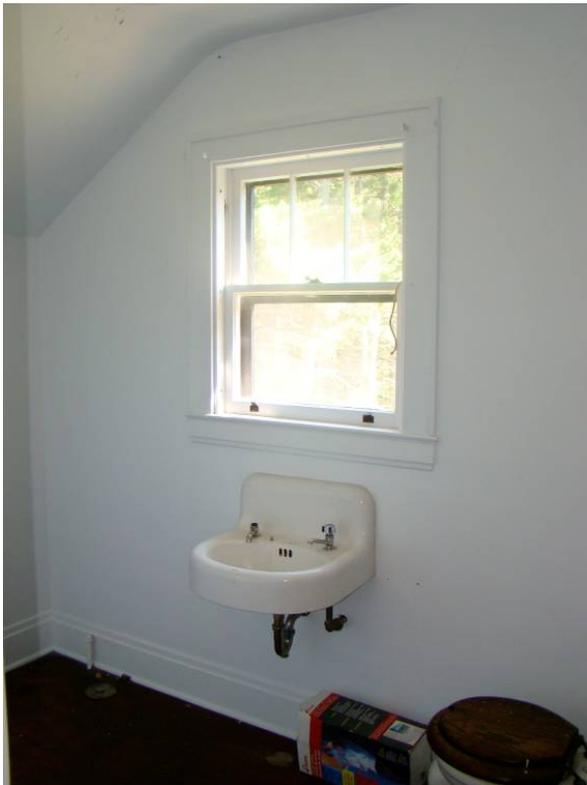
MI-KQ-47: Bath, east elevation (Source: AH DSC00786)

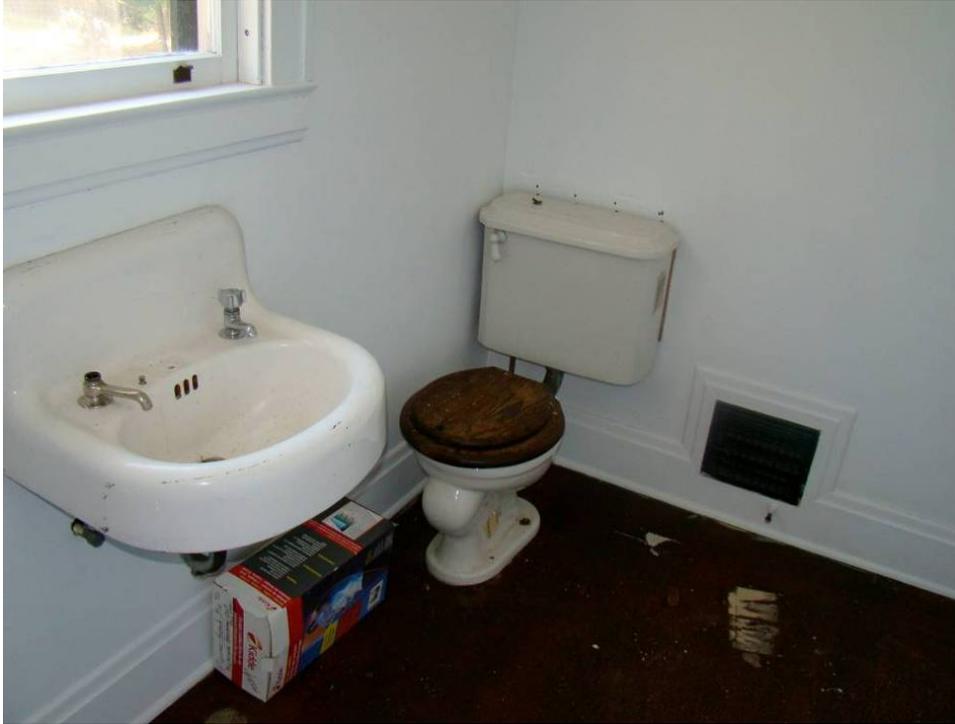
MI-KQ-48: Bath, looking southeast (Source: AH DSC00787)

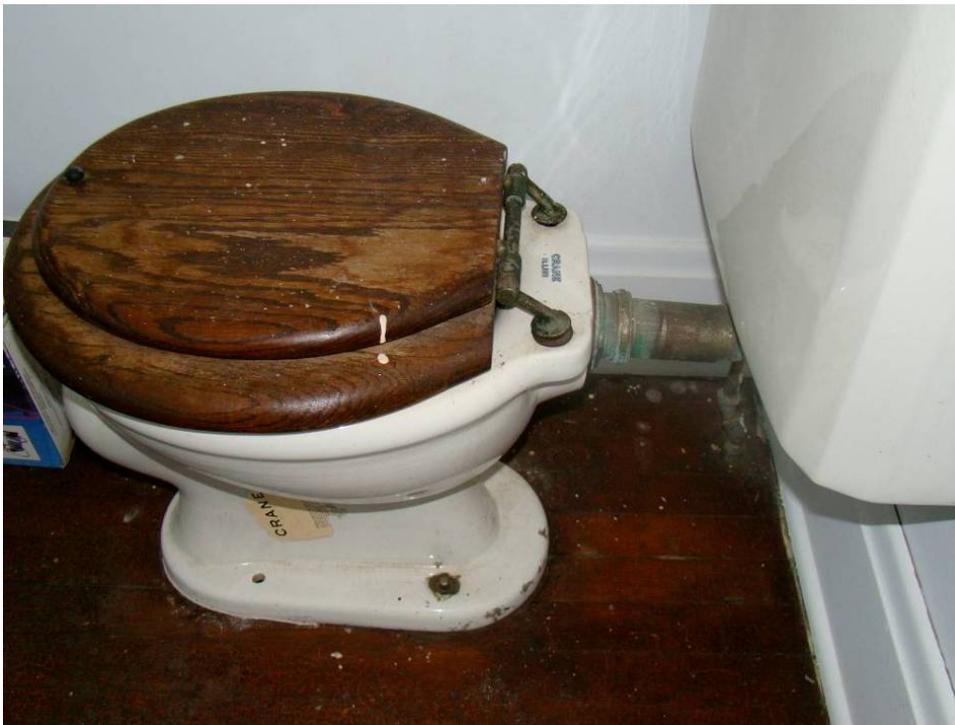
MI-KQ-49: Bath, toilet detail (Source: AH DSC00800)

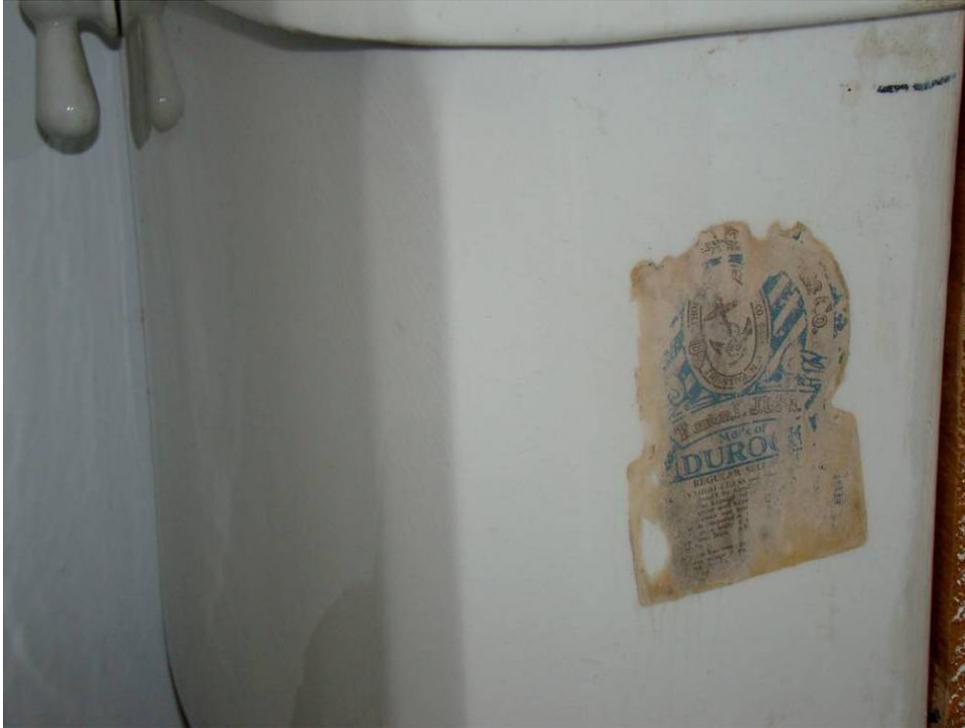
MI-KQ-50: Bath, toilet detail (Source: AH DSC00799)

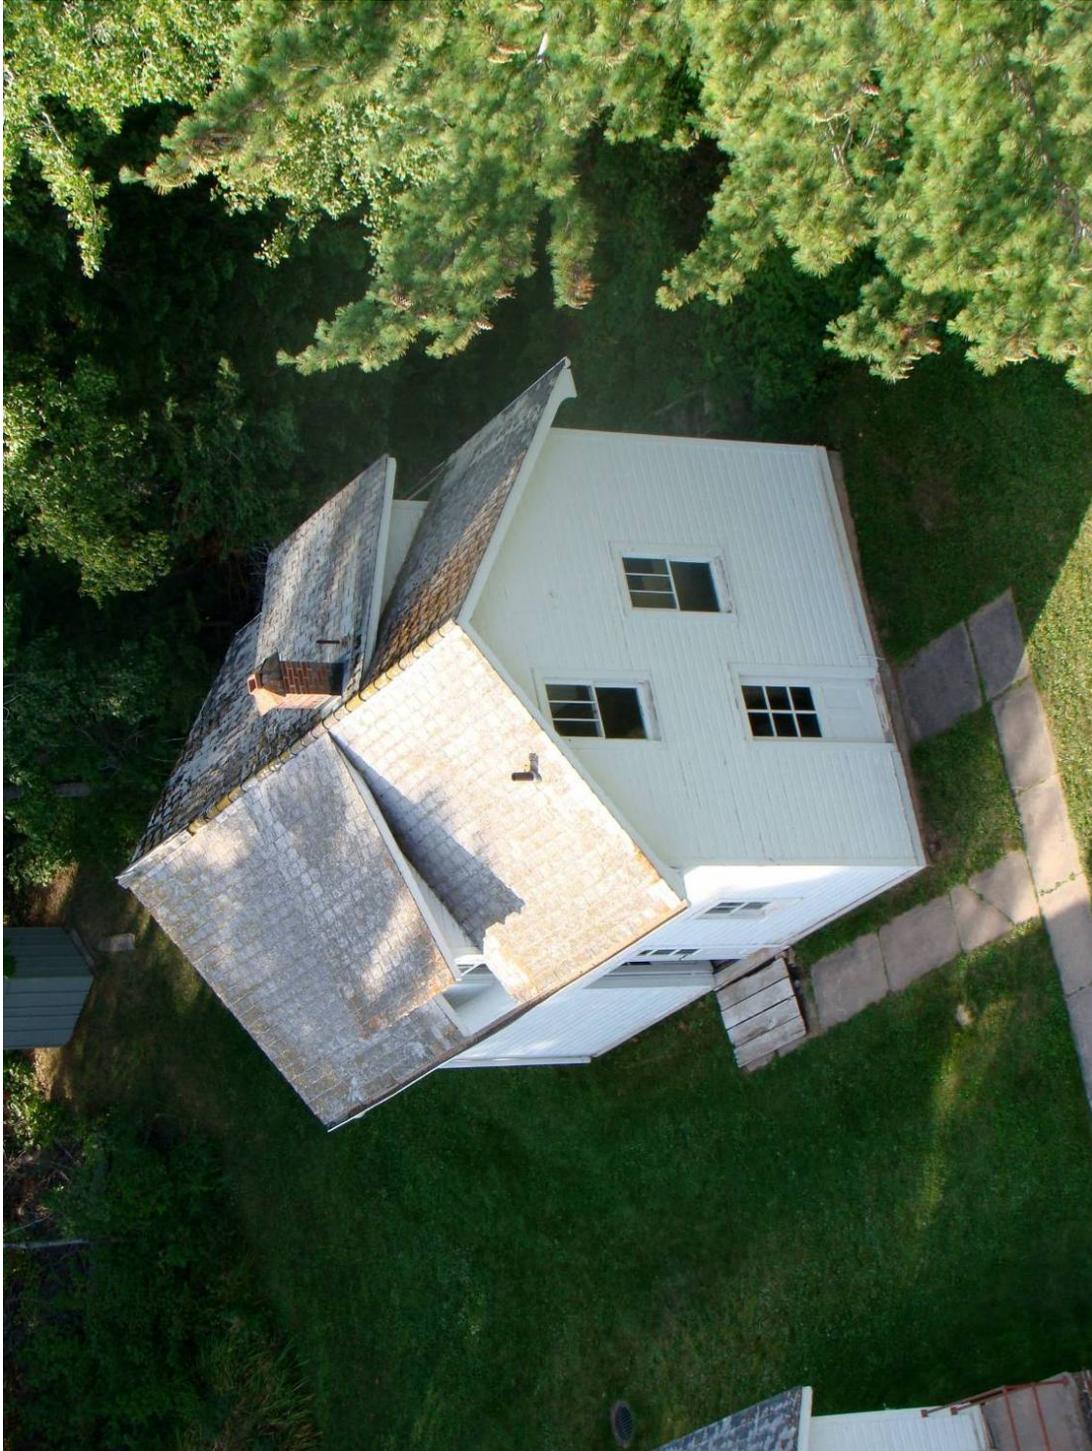
*MI-AKQ-01: Aerial, 2009 (AH DSC00610)*

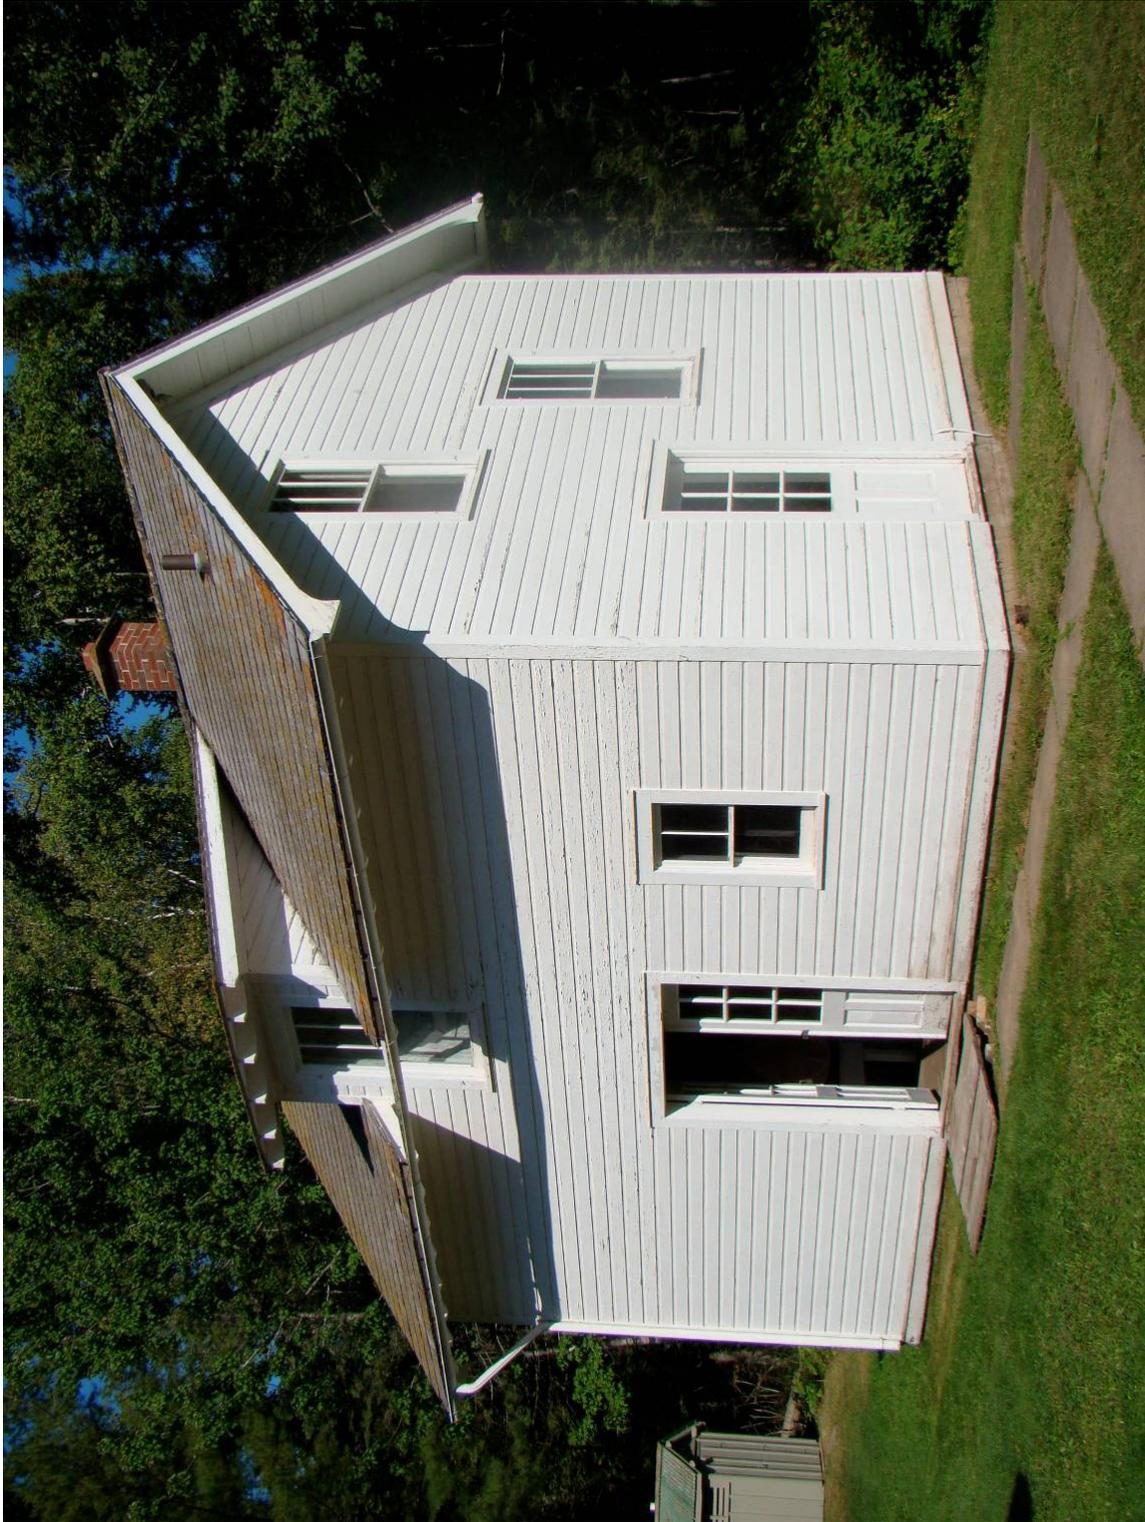
MI-AKQ-02: South elevation, 2009 (Source: AH IMG2830)

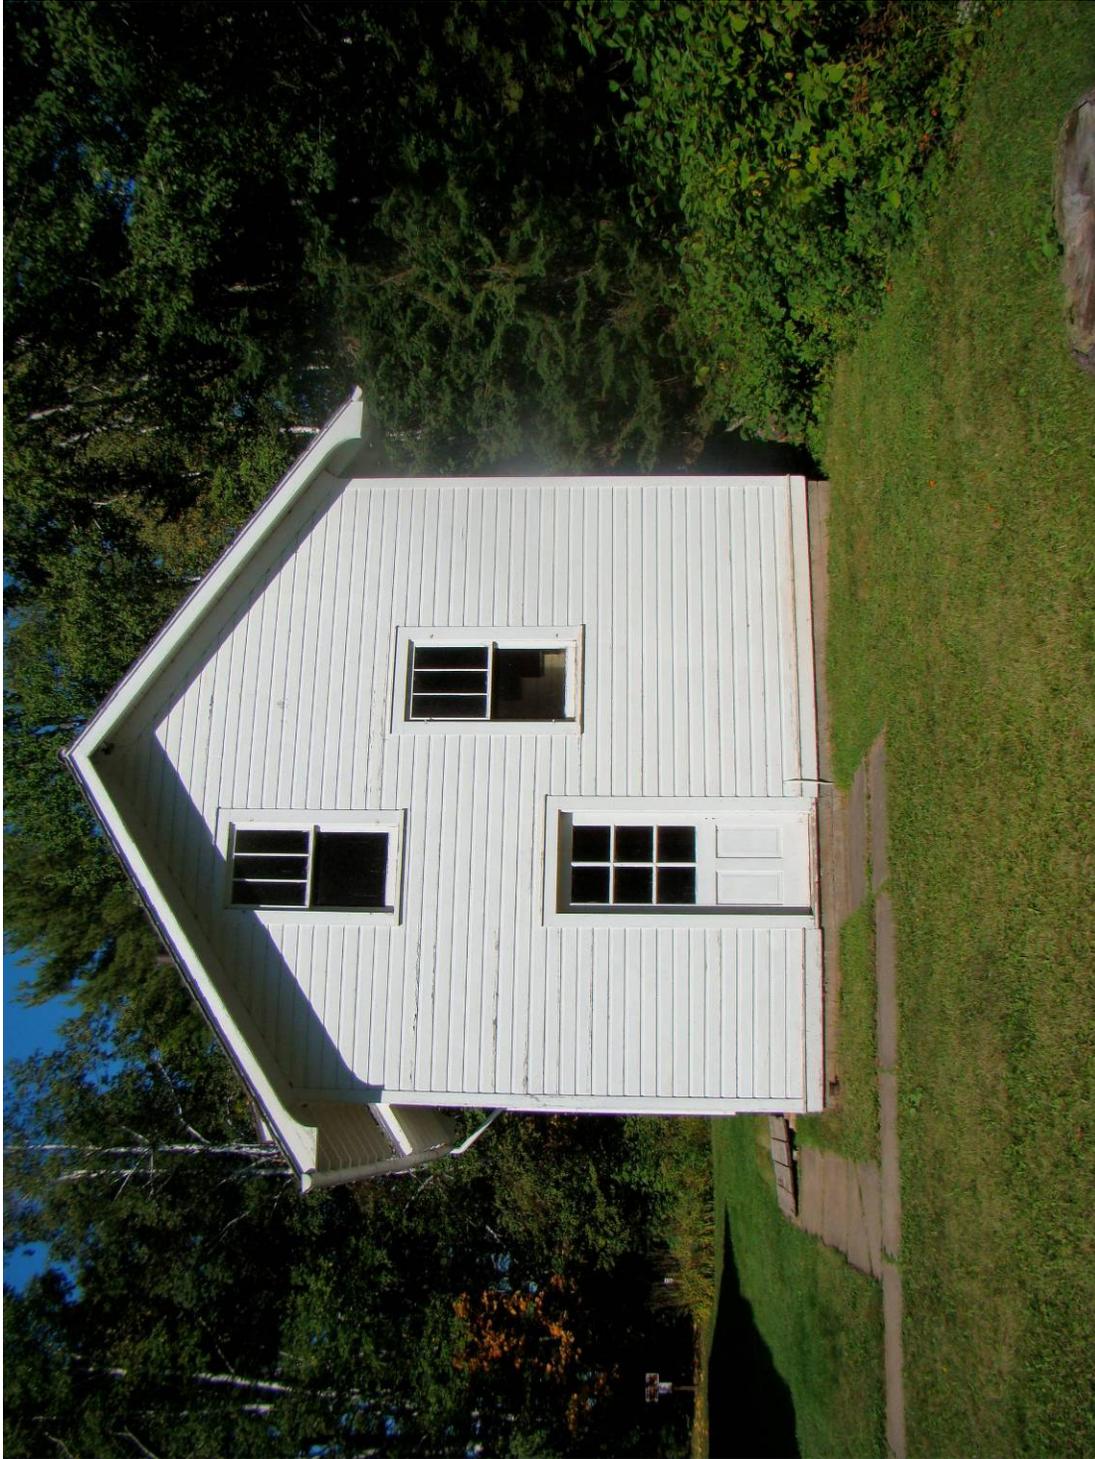
*MI-AKQ-03: East elevation, 2009 (Source: AH DSC00665)*

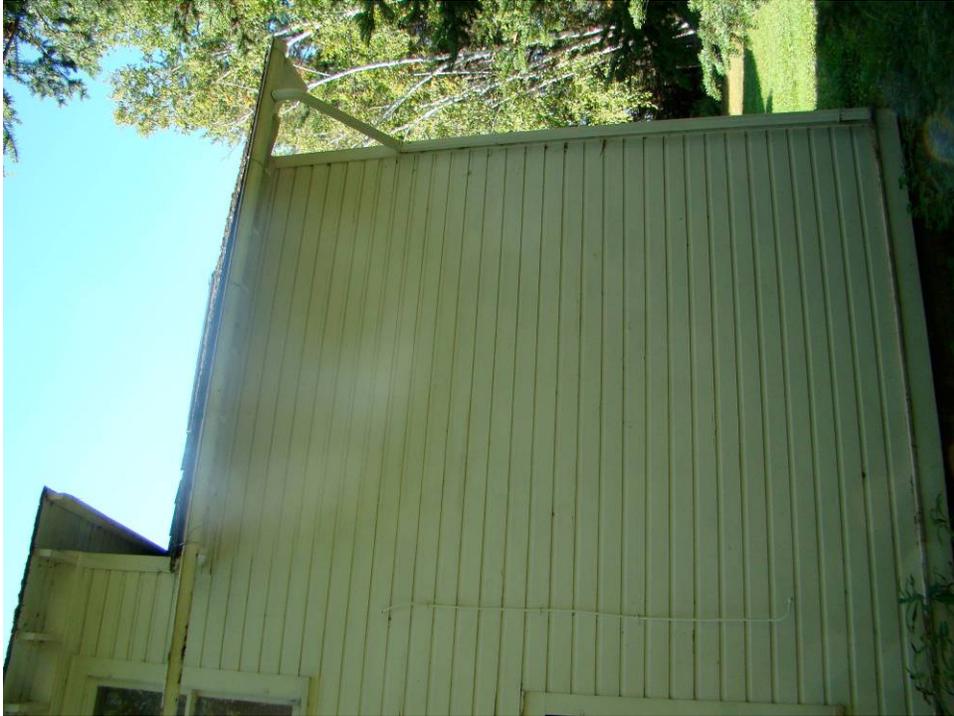
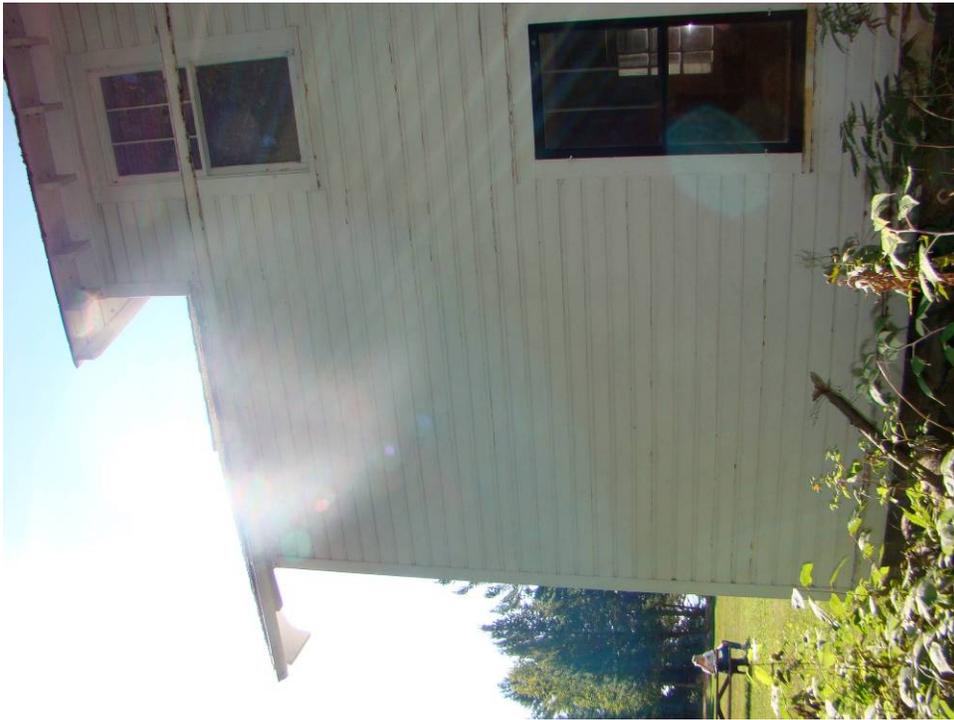
*MI-AKQ-04 & 05: North elevation, 2009 (Source: AH DSC006670 and DSC006669)*

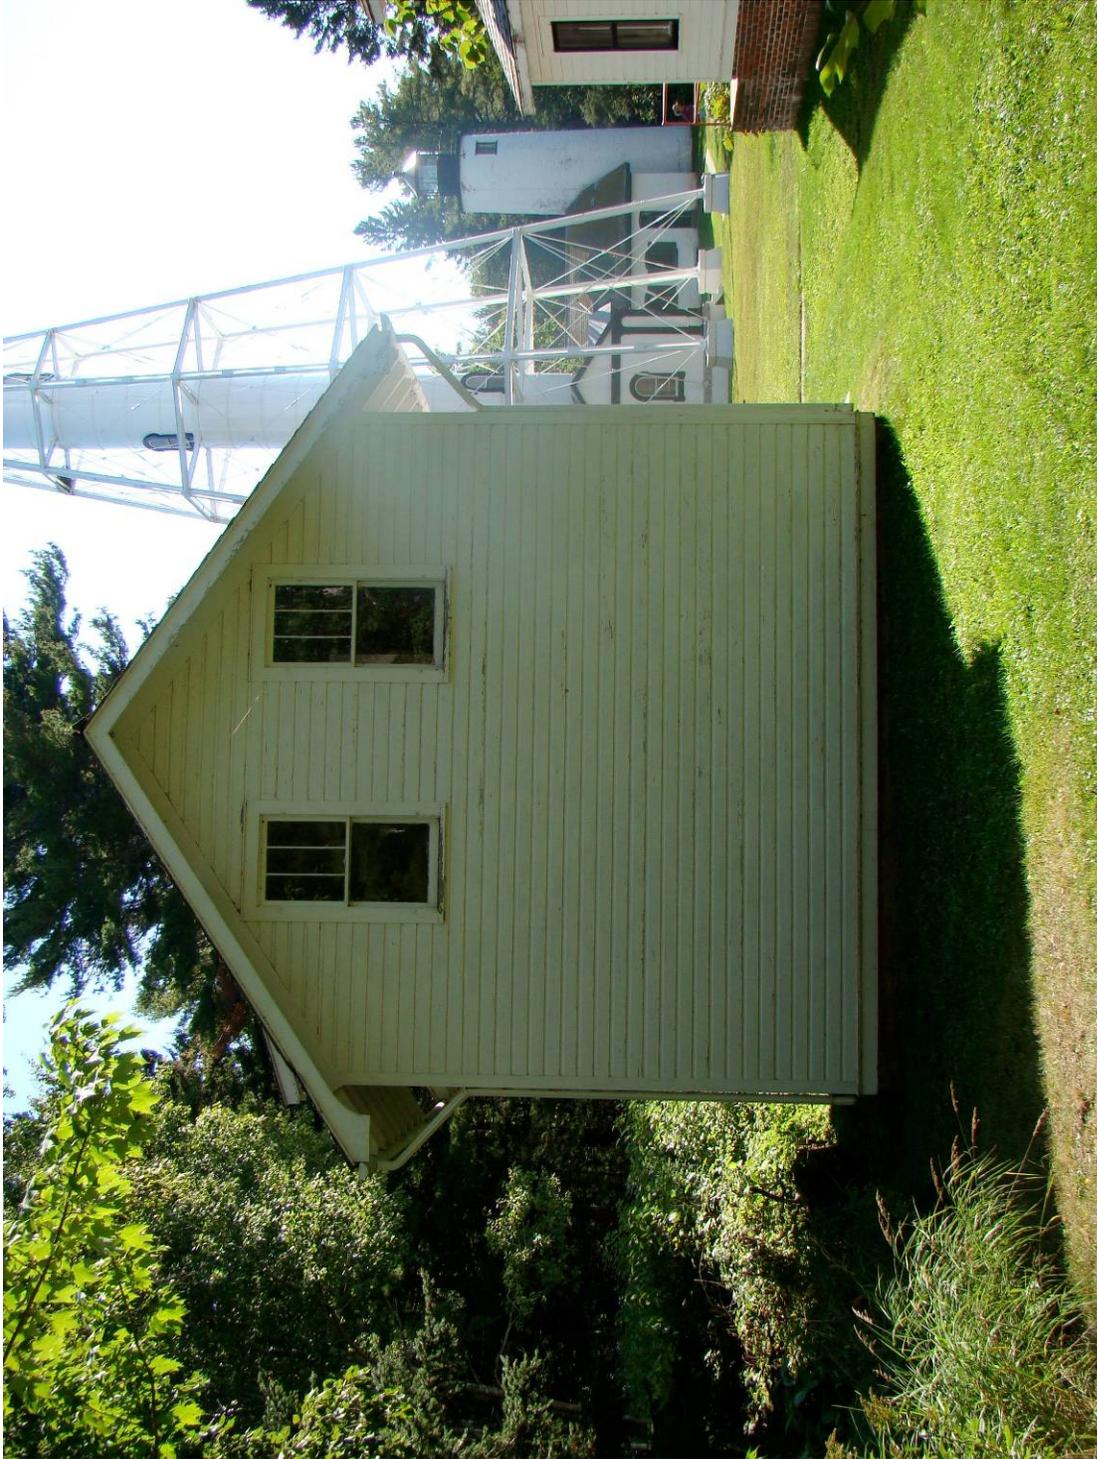
MI-AKQ-06: West elevation, 2009 (Source: AH DSC006663)

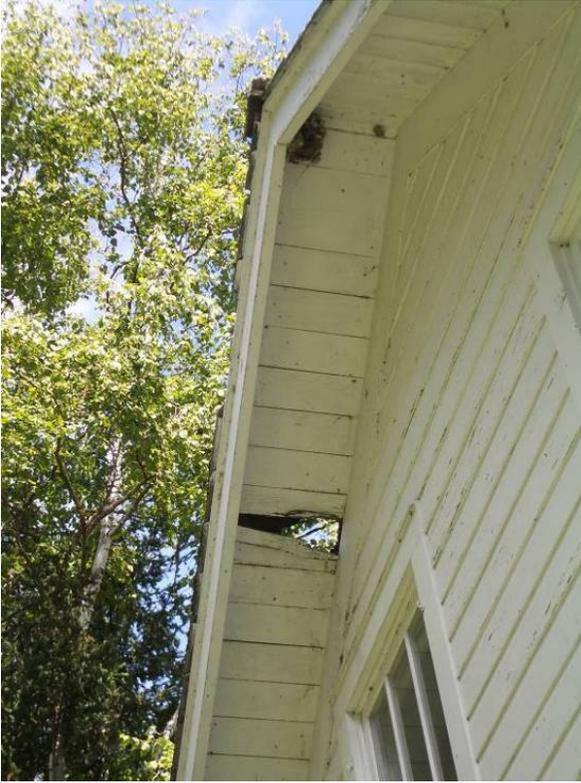
The existing roofing is asbestos roof shingles 9" wide × 7" exposure. There is a hole in the roof (northwest), perhaps due to a tree fall. The ridge trim is missing at the west end (likely due to the same

damages that caused the hole at the roof) and has been repaired with wood. There does not appear to be any extant flashing. The roof appears to be original to the structure as it is consistent with the notes on the original construction drawings (MI-AKQ-07). The eave consists of exposed rafter tails and tongue and groove soffit which extends 2'0". The fascia at the gable end matches the Keepers Quarters and is painted white. There is no fascia trim at the eave of the main roof or shed dormers.

*MI-AKQ-07: West eave, trim, and roof (Source: AH IMG2832)*

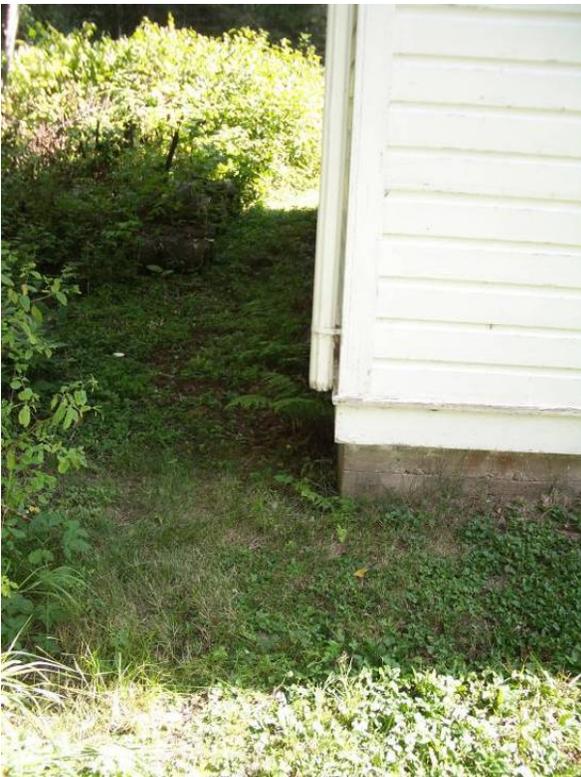
*MI-AKQ-08: Northwest corner downspout and foundation (Source: AH IMG2833)*

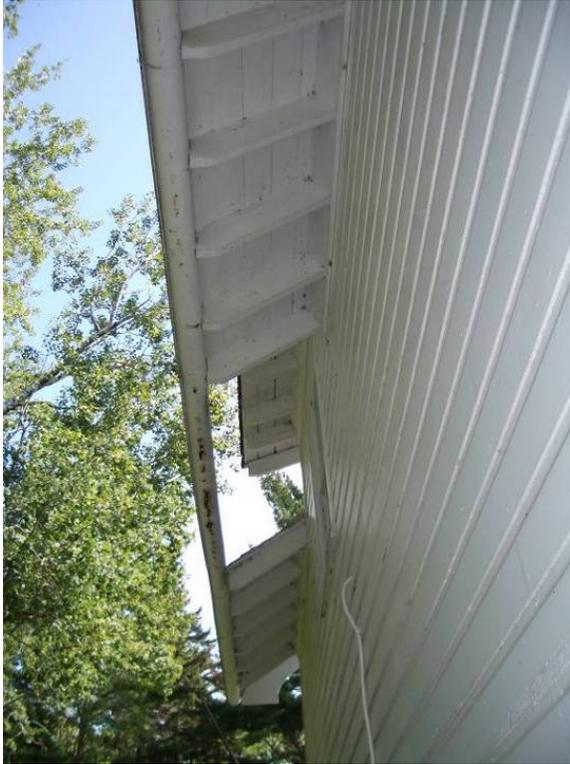
*MI-AKQ-09: North elevation eave, roof, and gutter (Source: AH IMG2834)*

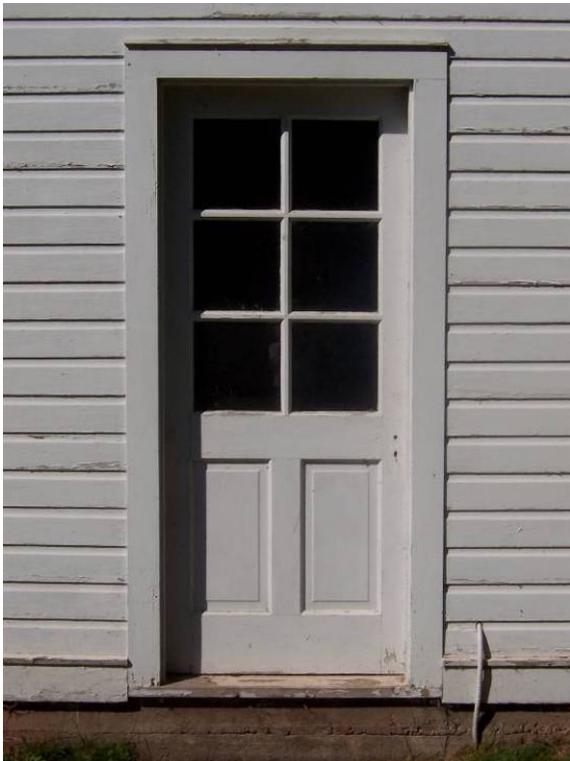
*MI-AKQ-10: East entry door (Source: AH 100\_9625)*

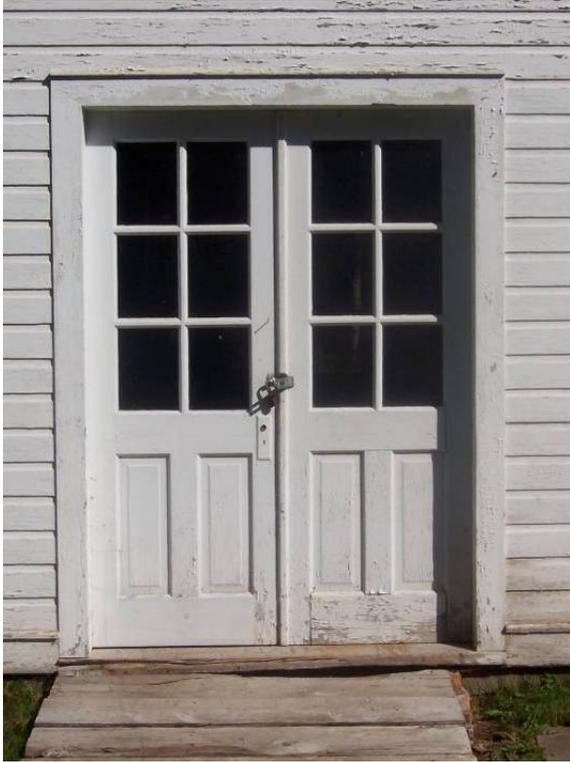
*MI-AKQ-11: South entry (primary) doors (Source: AH 100\_9622)*

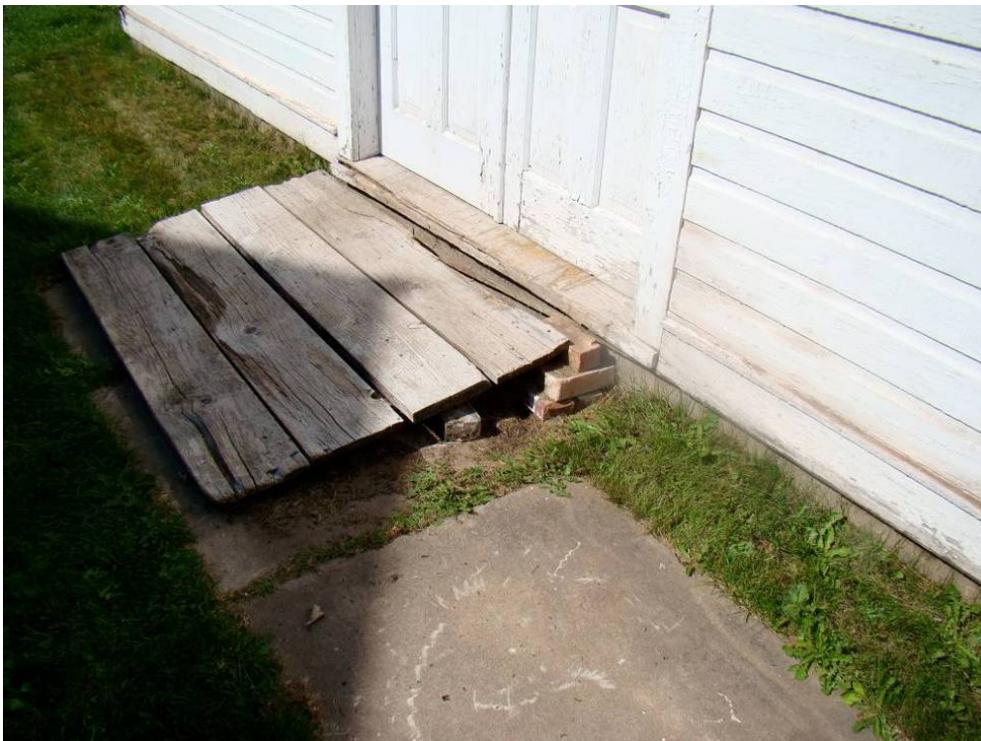
*MI-AKQ-12: South entry ramp (Source: AH DSC00852)*

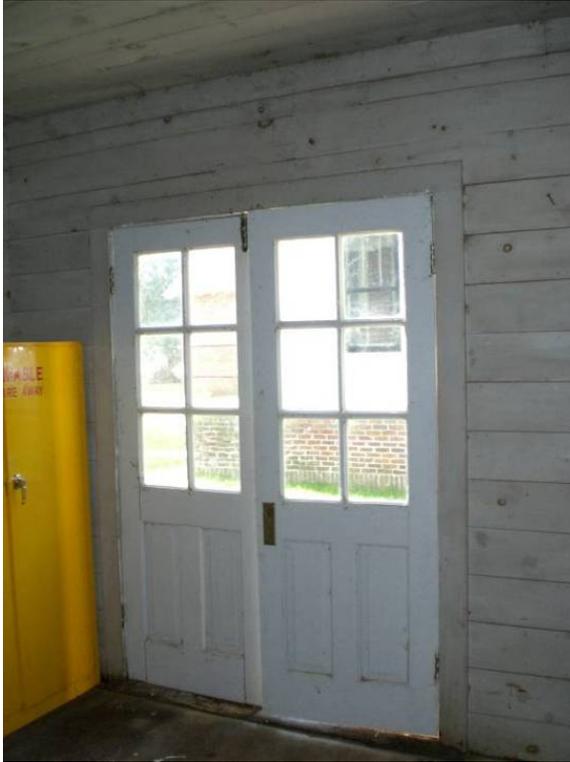
*MI-AKQ-13: Storage room south entry doors, interior view (Source: AH CIMG3449)*

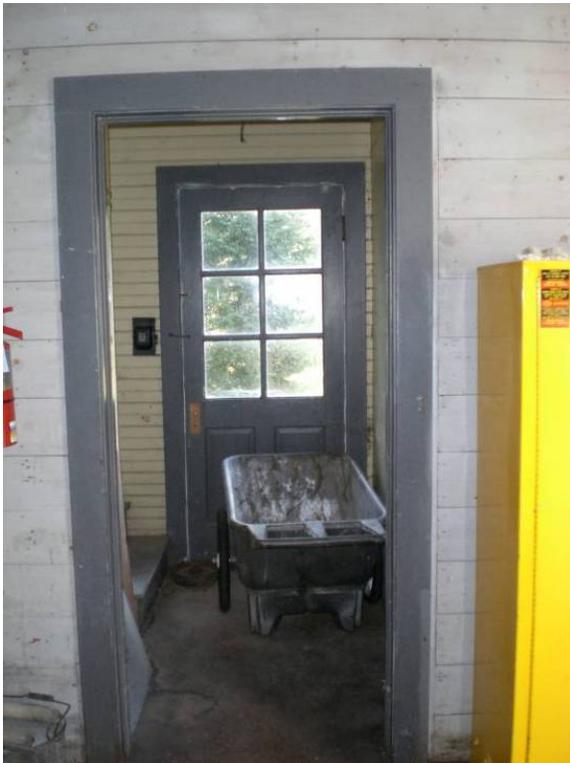
*MI-AKQ-14: Storage room, looking east to east entry (Source: AH CIMG3466)*

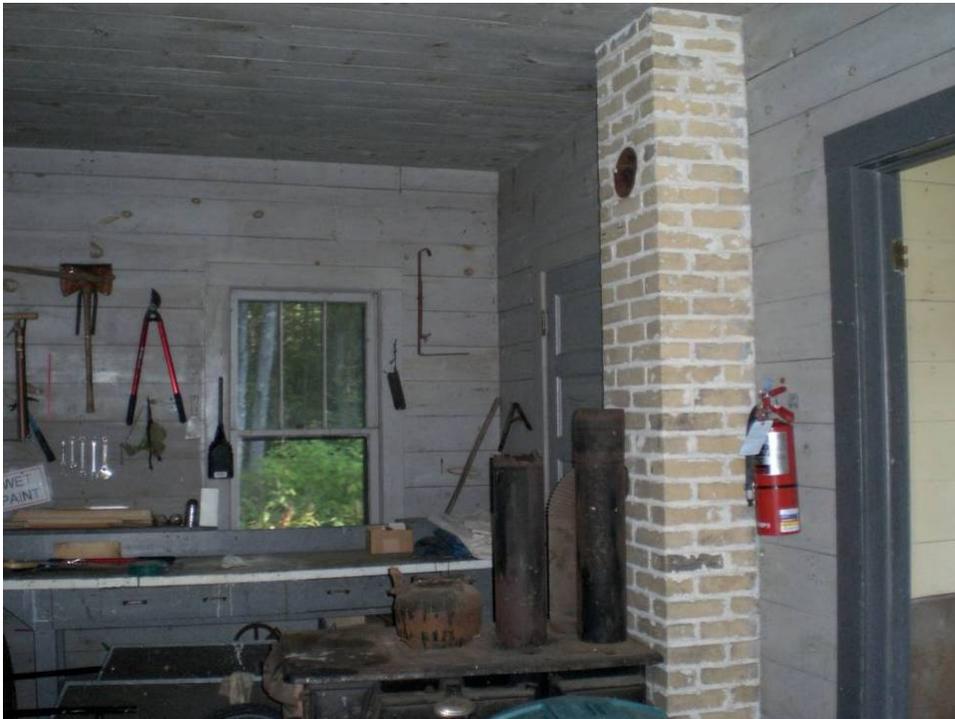
MI-AKQ-15: Storage room, looking northeast (Source: AH CIMG3444)

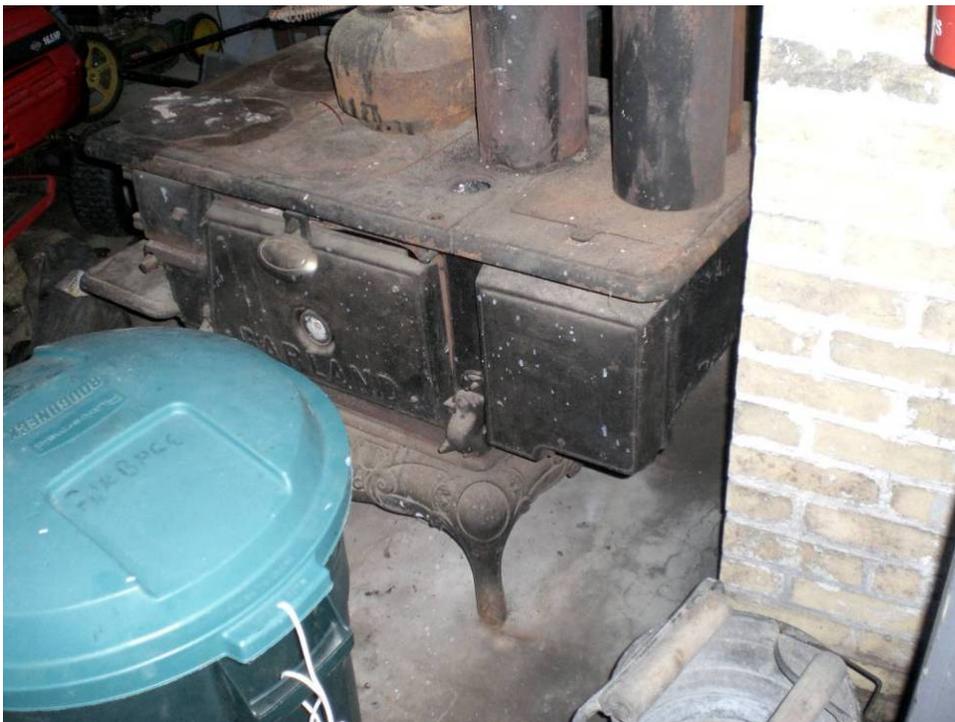
MI-AKQ-16: Stove at chimney (Source: AH CIMG3450)

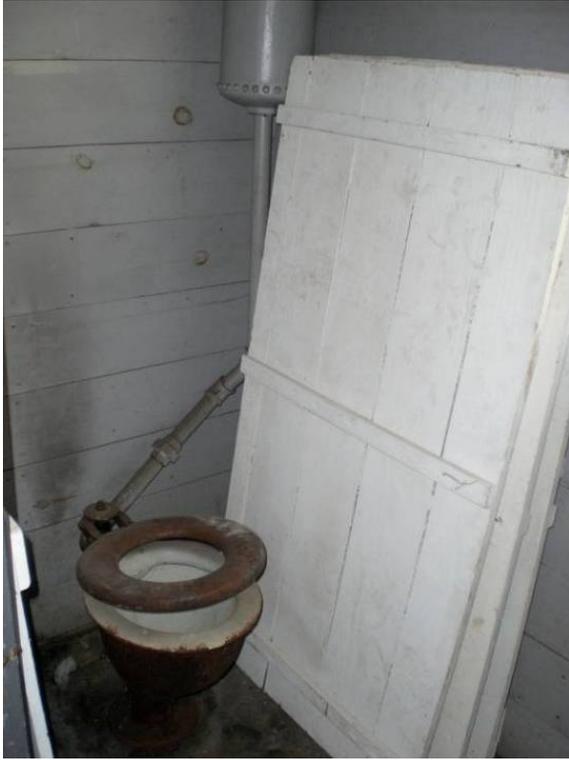
*MI-AKQ-17: Water closet, looking east (Source: AH CIMG3486)*

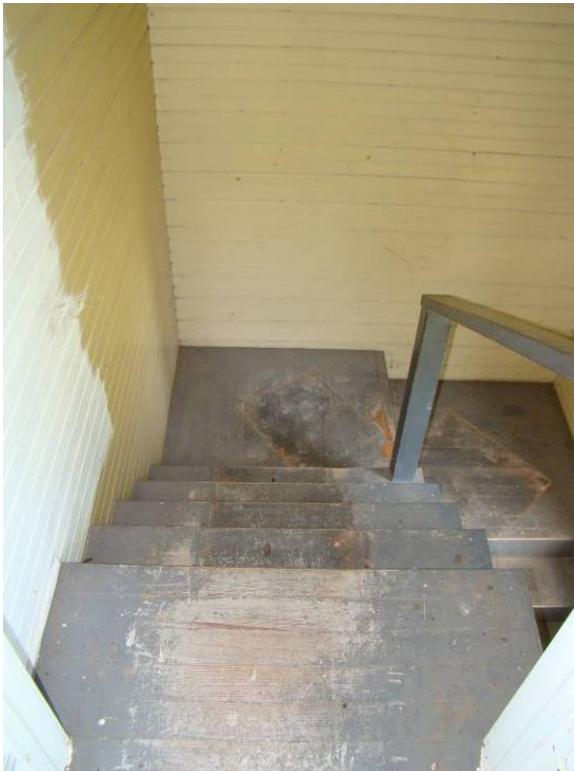
*MI-AKQ-18: Stairs to second floor living quarters, looking down (Source: AH DSC00846)*

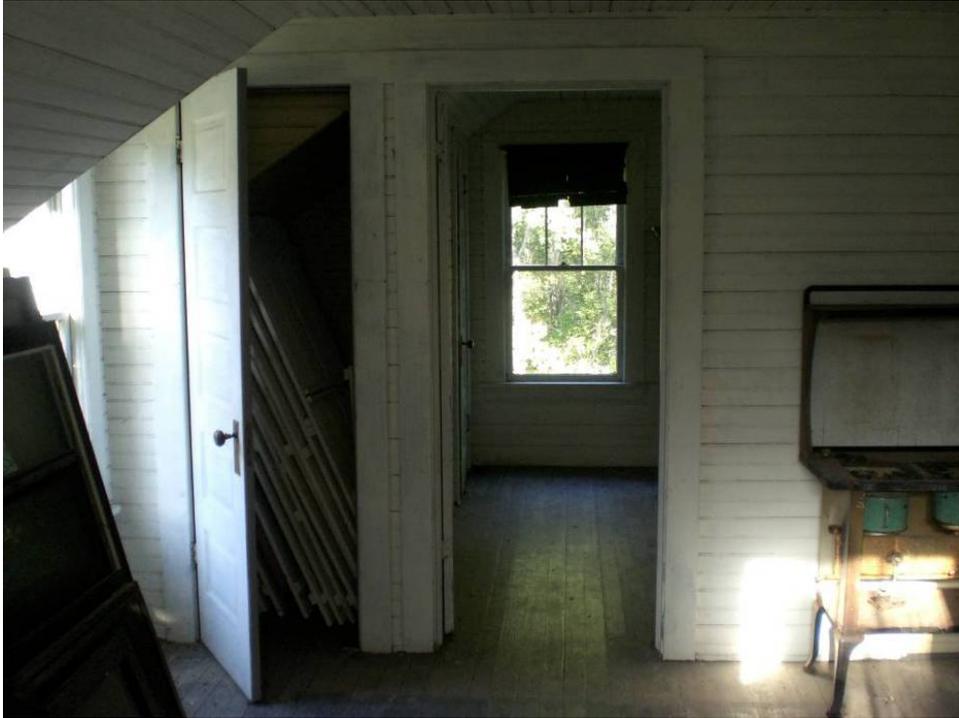
*MI-AKQ-19: Living room, west elevation (Source: AH CIMG3504)*

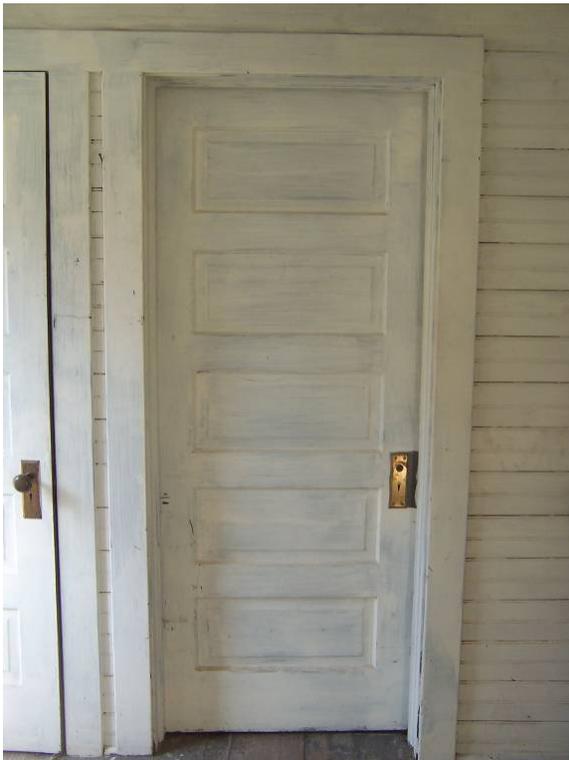
*MI-AKQ-20: Living room door to bedroom (Source: AH 100\_9621)*

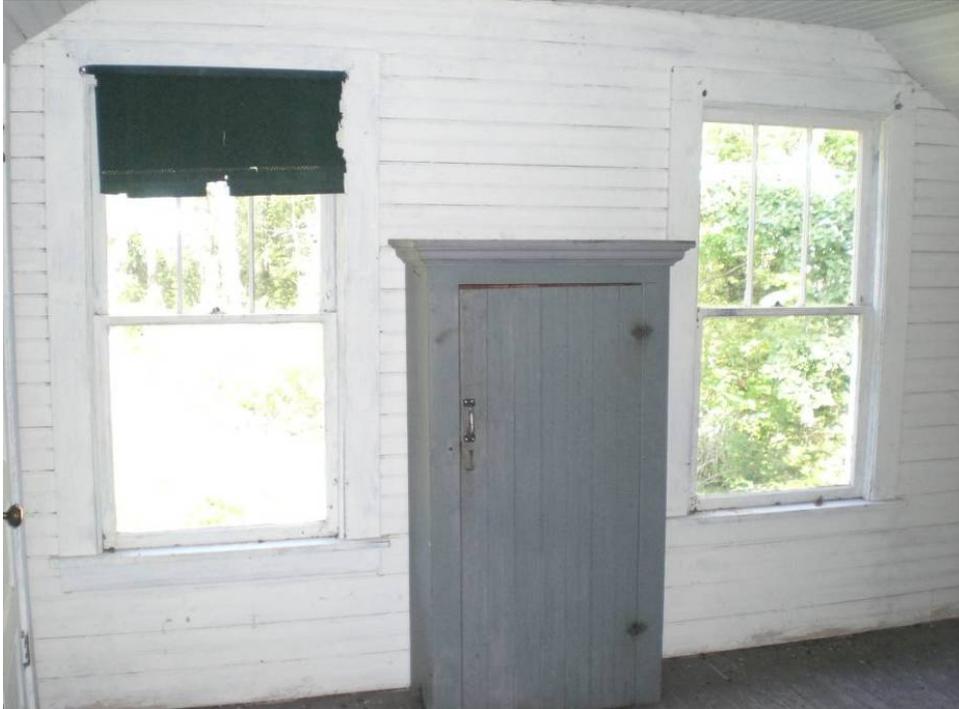
*MI-AKQ-21: Bedroom, west elevation (Source: AH CIMG3520)*

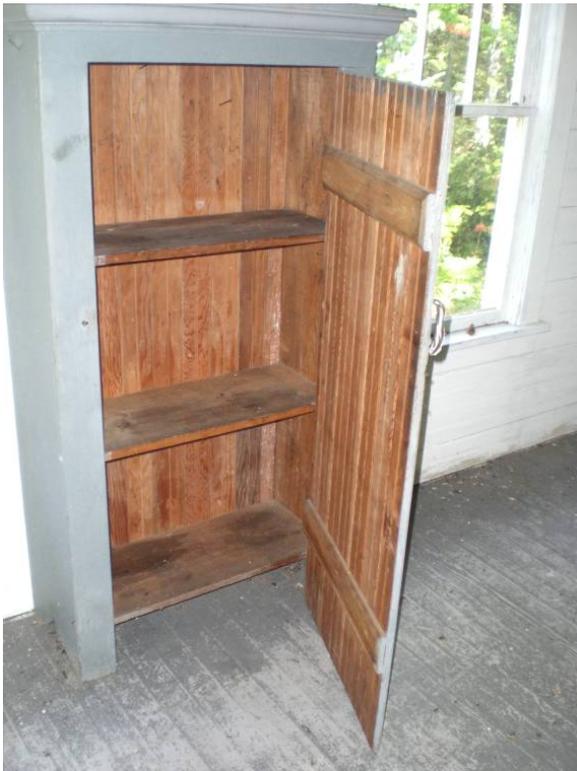
*MI-AKQ-22: Bedroom, cabinet detail and floor (Source: AH CIMG3535)*

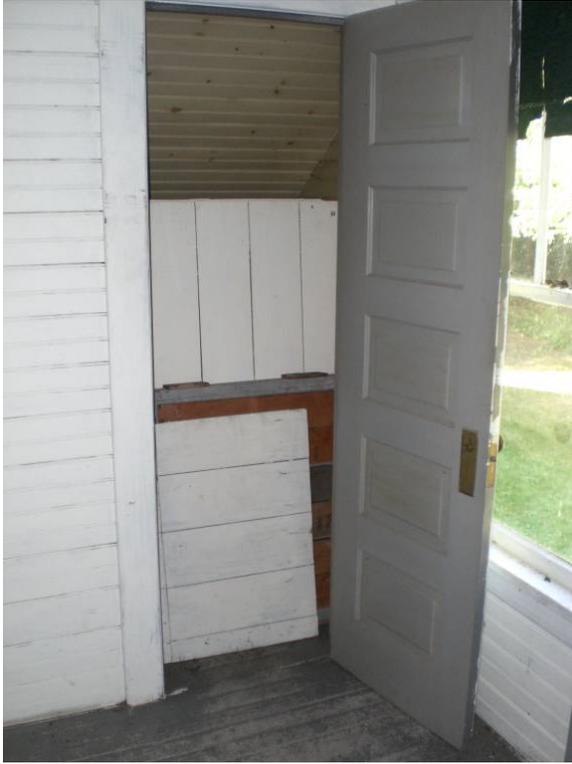
*MI-AKQ-23: South bedroom closet with windows and doors stored (Source: AH CIMG3540)*

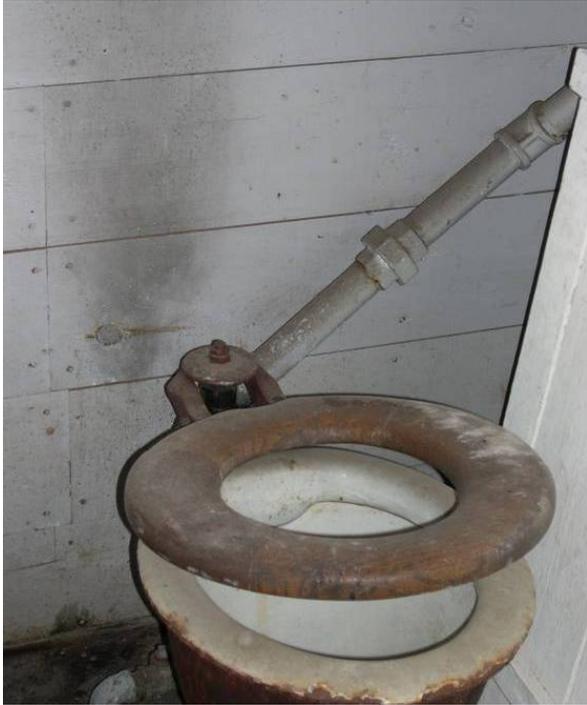
*MI-AKQ-29: Vogel seat activated toilet flush valve, in water closet (Source: RMH)*

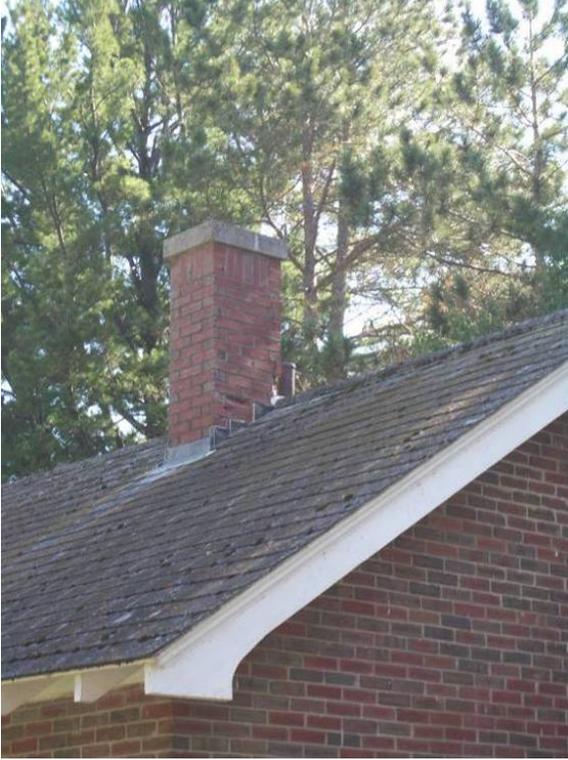
*MI-PH-06: Chimney, trim, and roof (Source: AH IMG2836)*

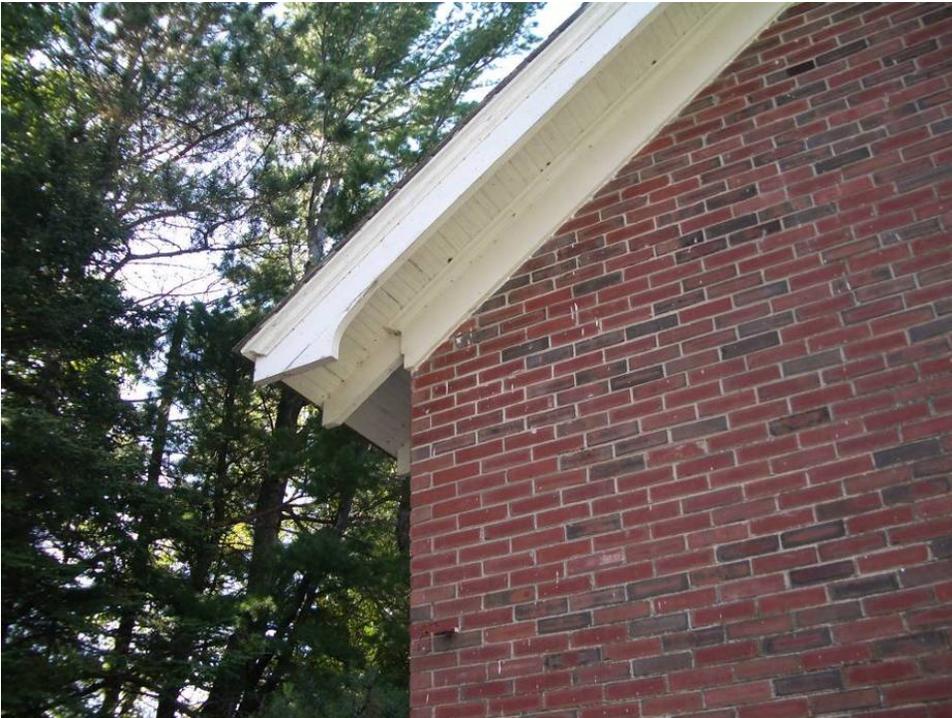
*MI-PH-07: Roof, trim, and eaves (Source: AH IMG2837)*

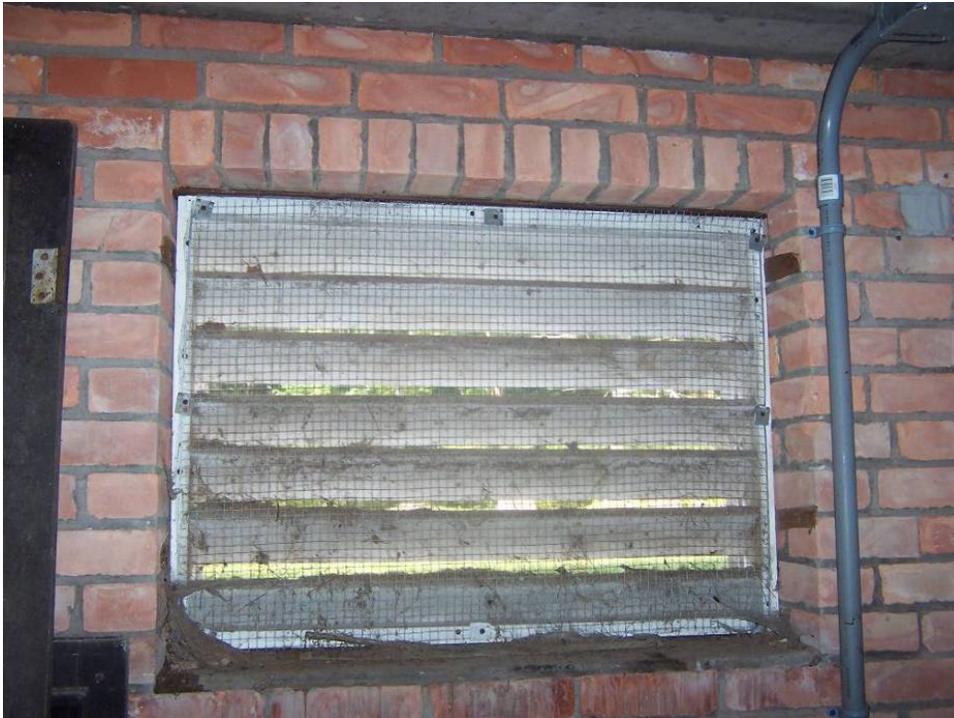
MI-PH-09: Basement vent (Source: AH 102\_9578)

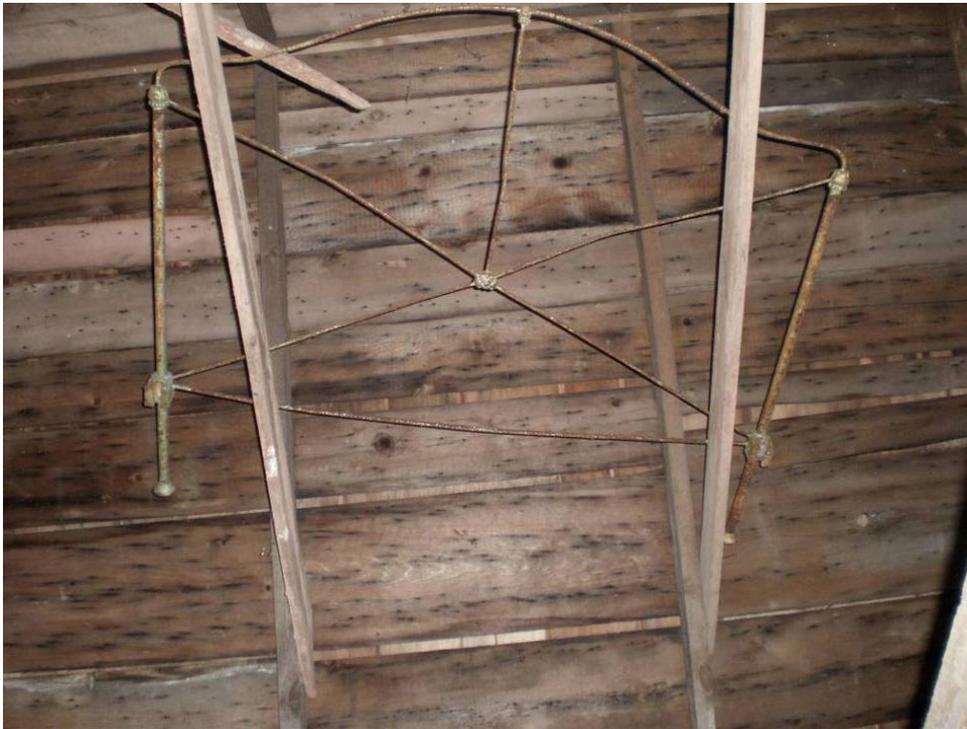
*MI-S-16: Roof structure interior, historic headboard storage (Source: AH CIMG3267)*
