# CULTURAL LANDSCAPE REPORT • HISTORIC STRUCTURE REPORT

*Apostle Islands National Lakeshore – Bayfield, Wisconsin*

## **VOLUME II OF VI: MICHIGAN ISLAND CLR/HSR**

**JULY 2011**

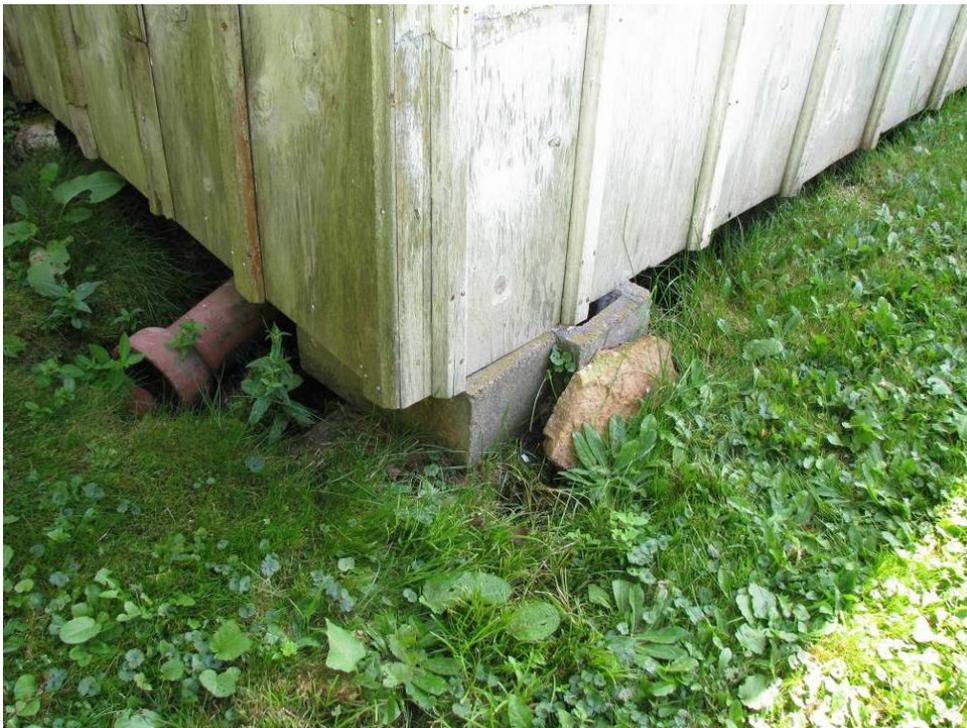
*MI-S-17: Foundation blocks (Source: Martin/Martin)*

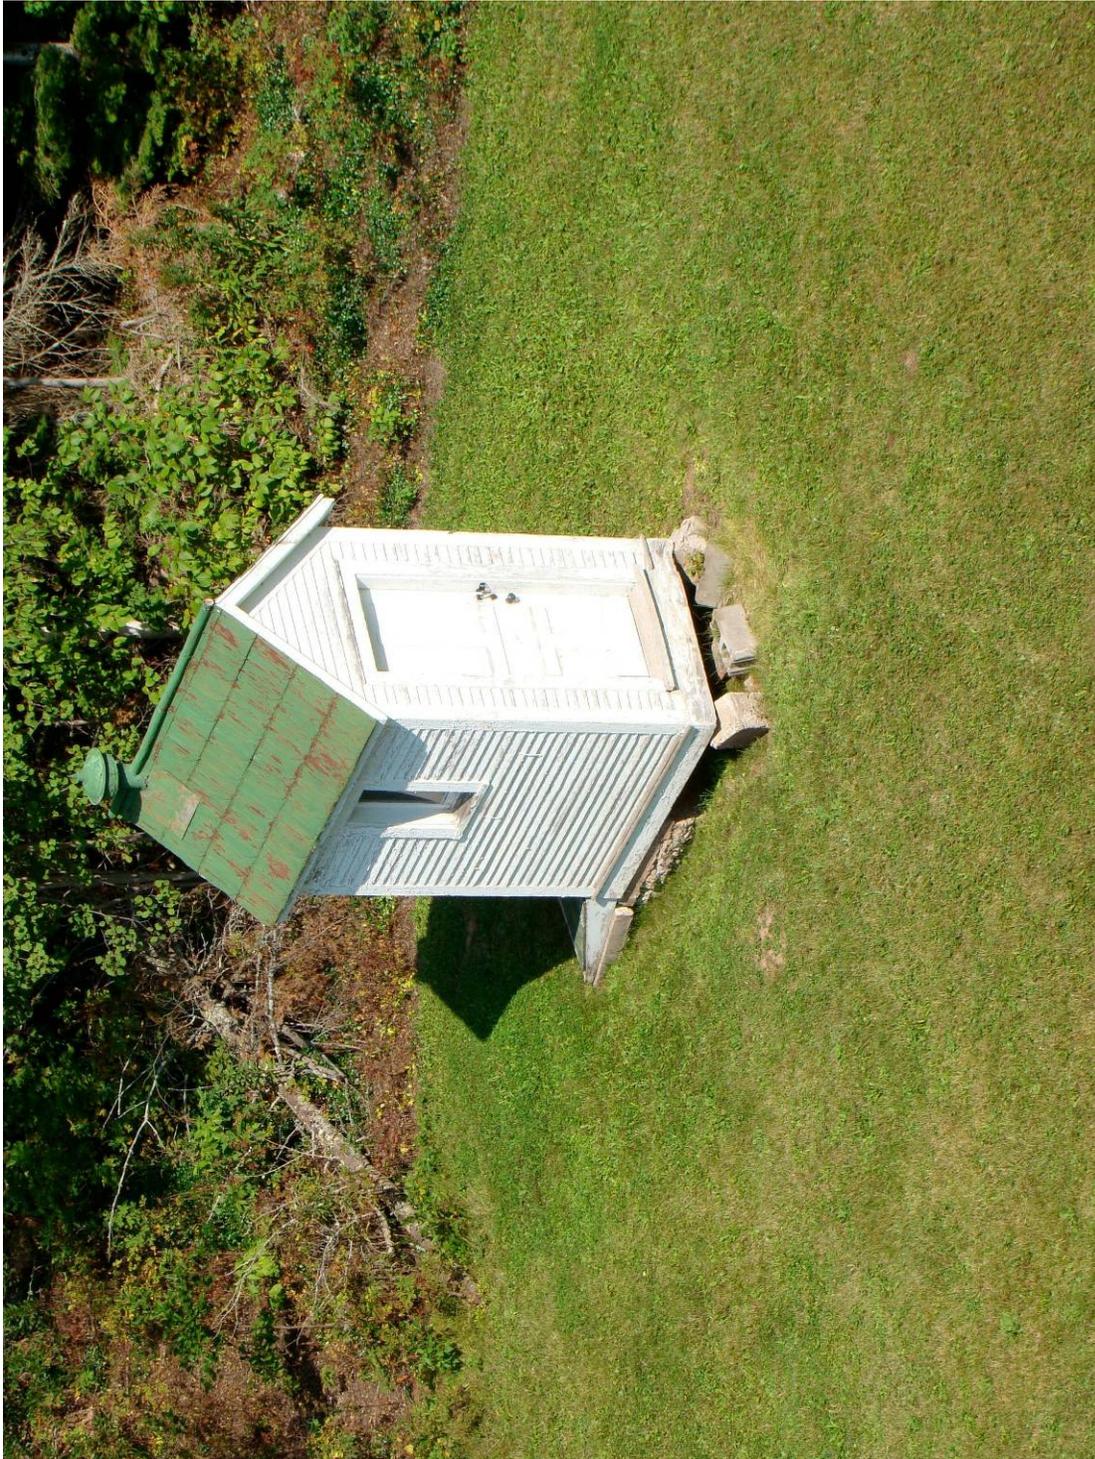
*MI-P-01: Aerial, 2009 (Source: AH DSC00580)*

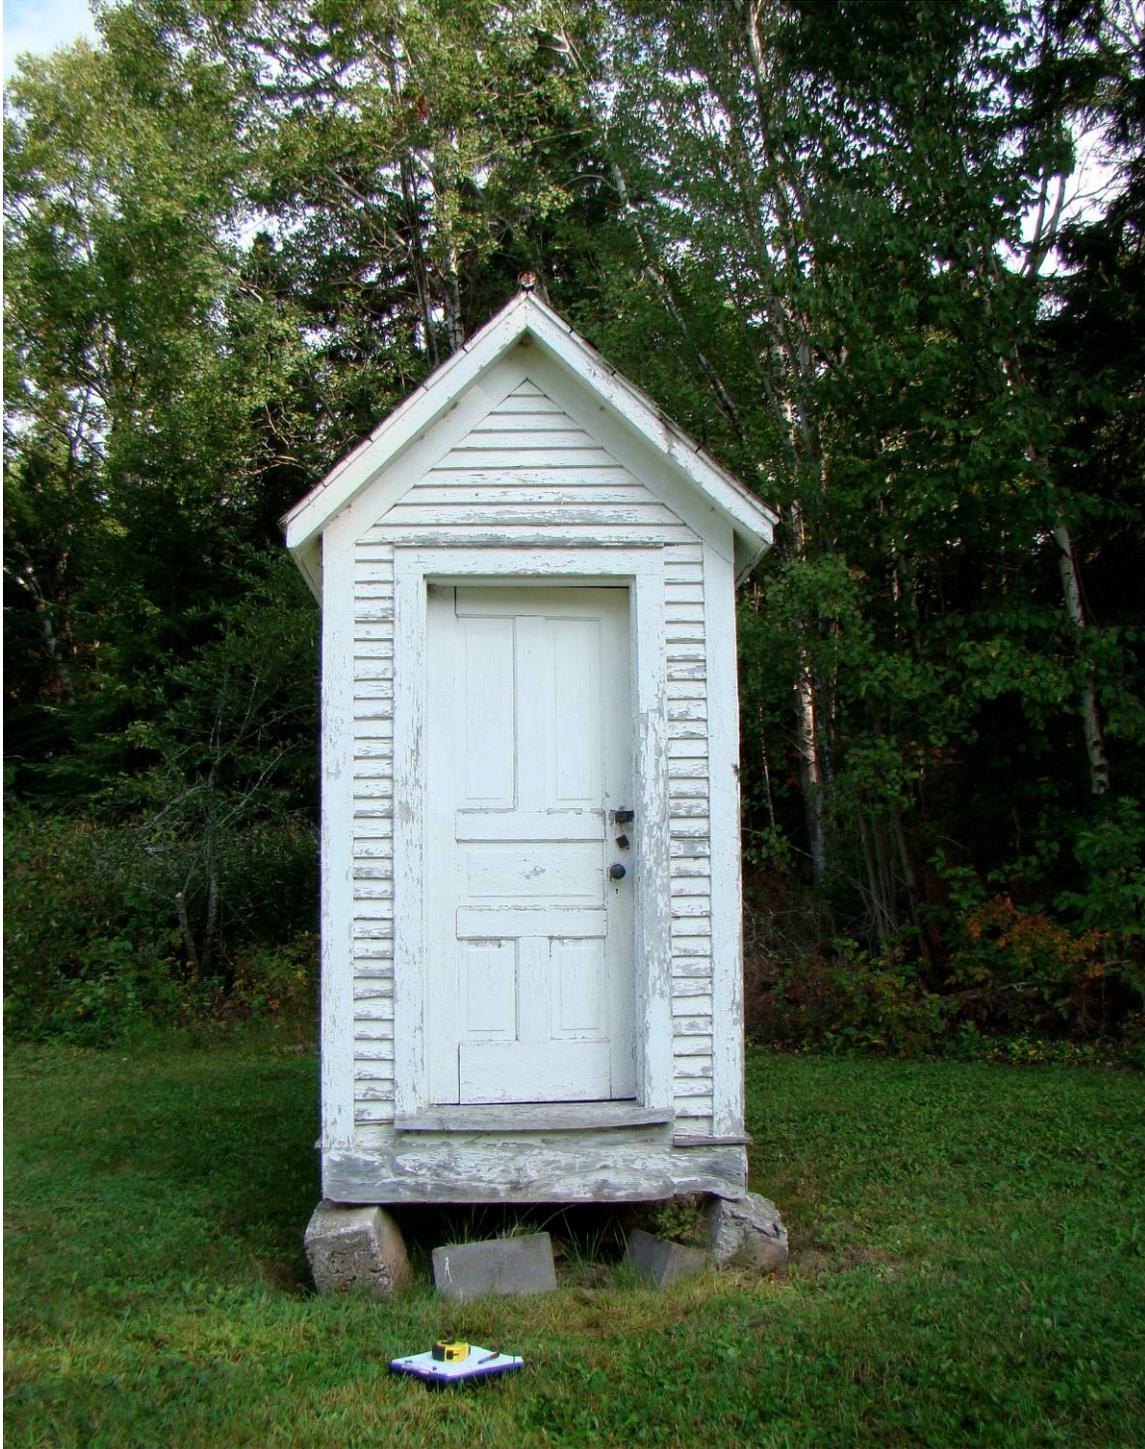
*MI-P-02: South elevation, 2009 (Source: AH DSC00538)*

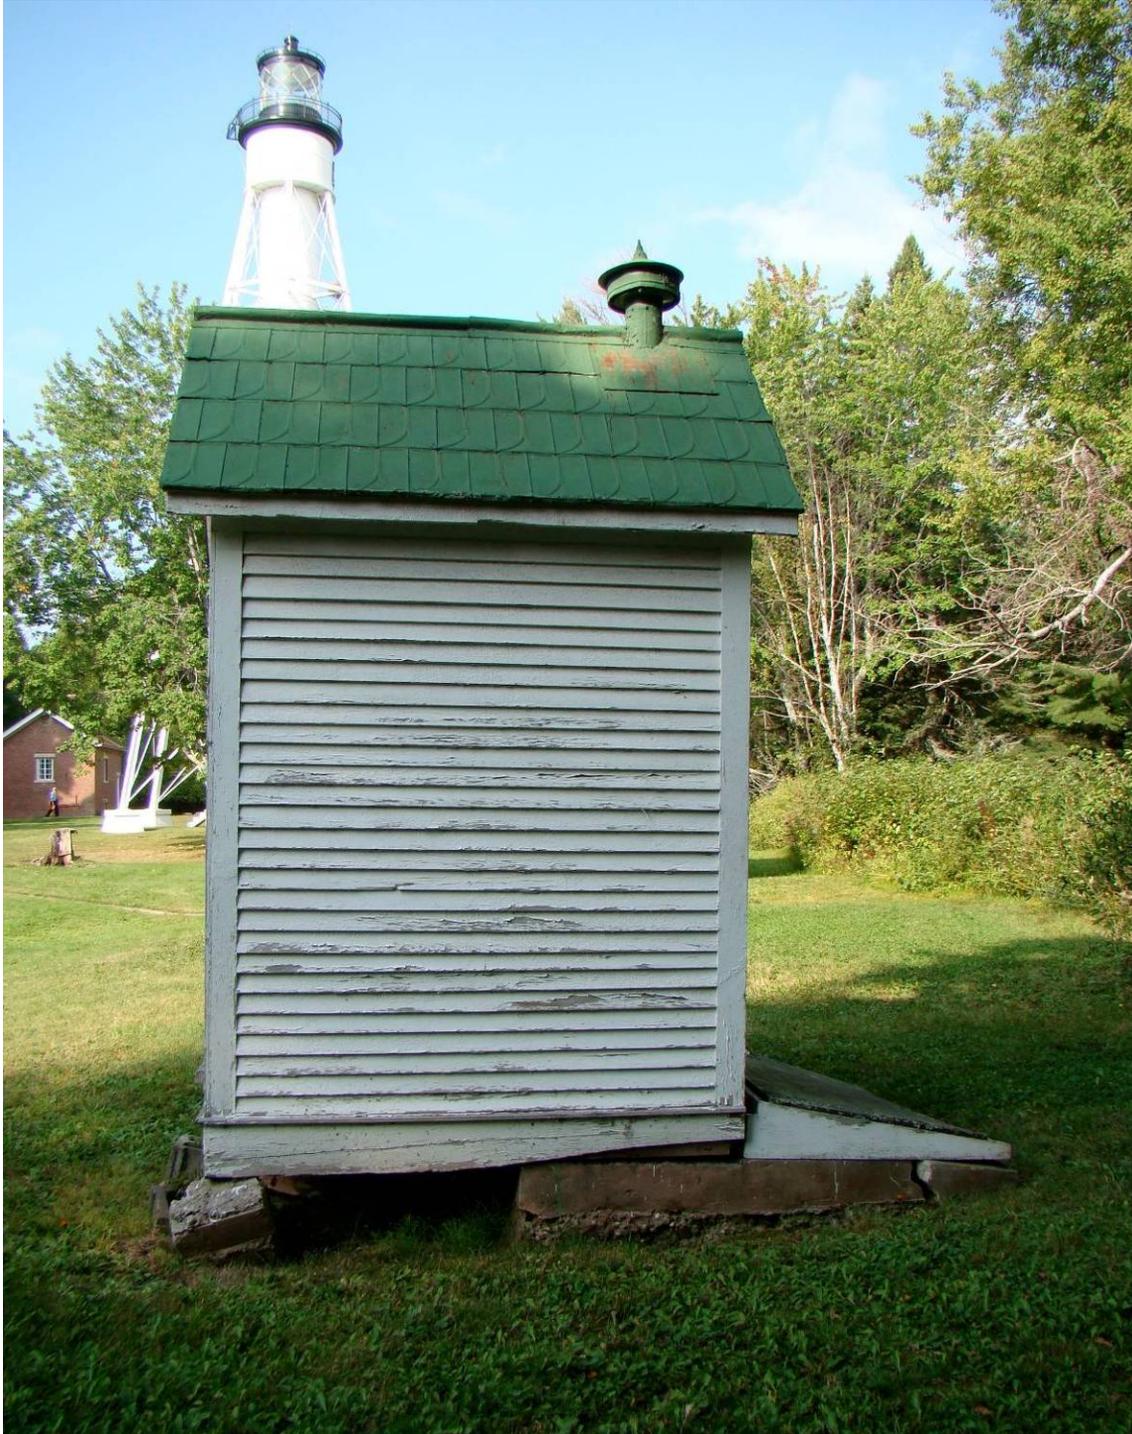
*MI-P-03: East elevation, 2009 (Source: AH DSC00539)*

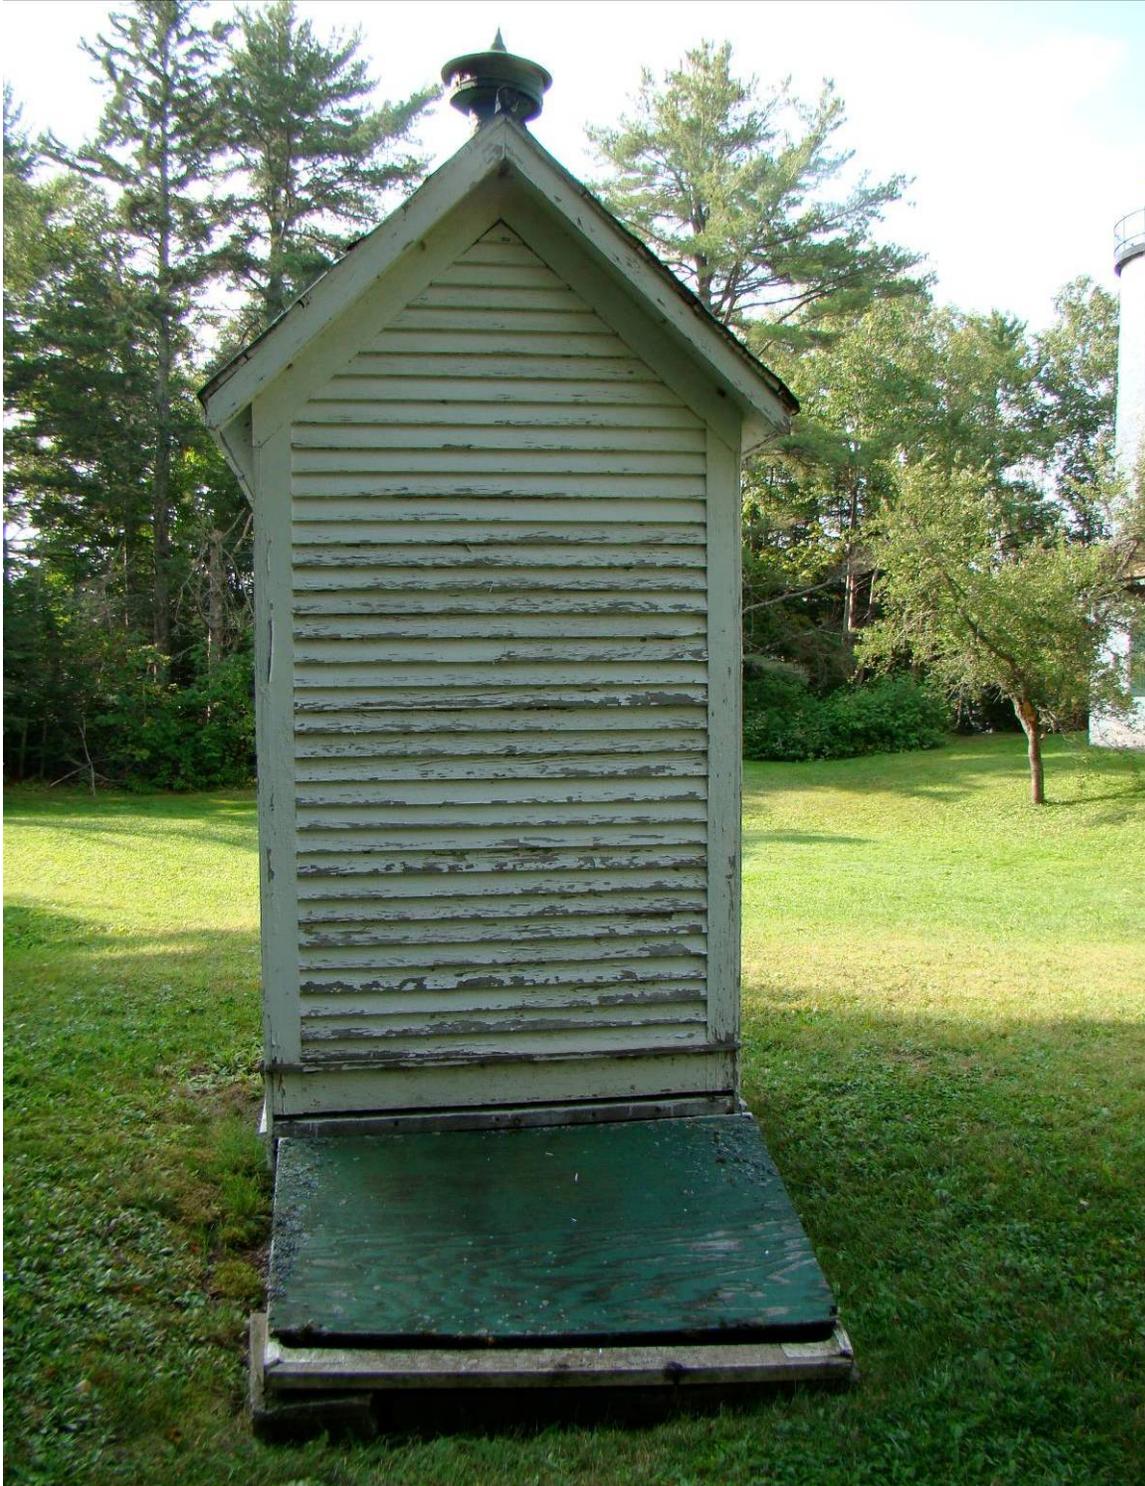
*MI-P-04: North elevation, 2009 (Source: AH DSC00541)*

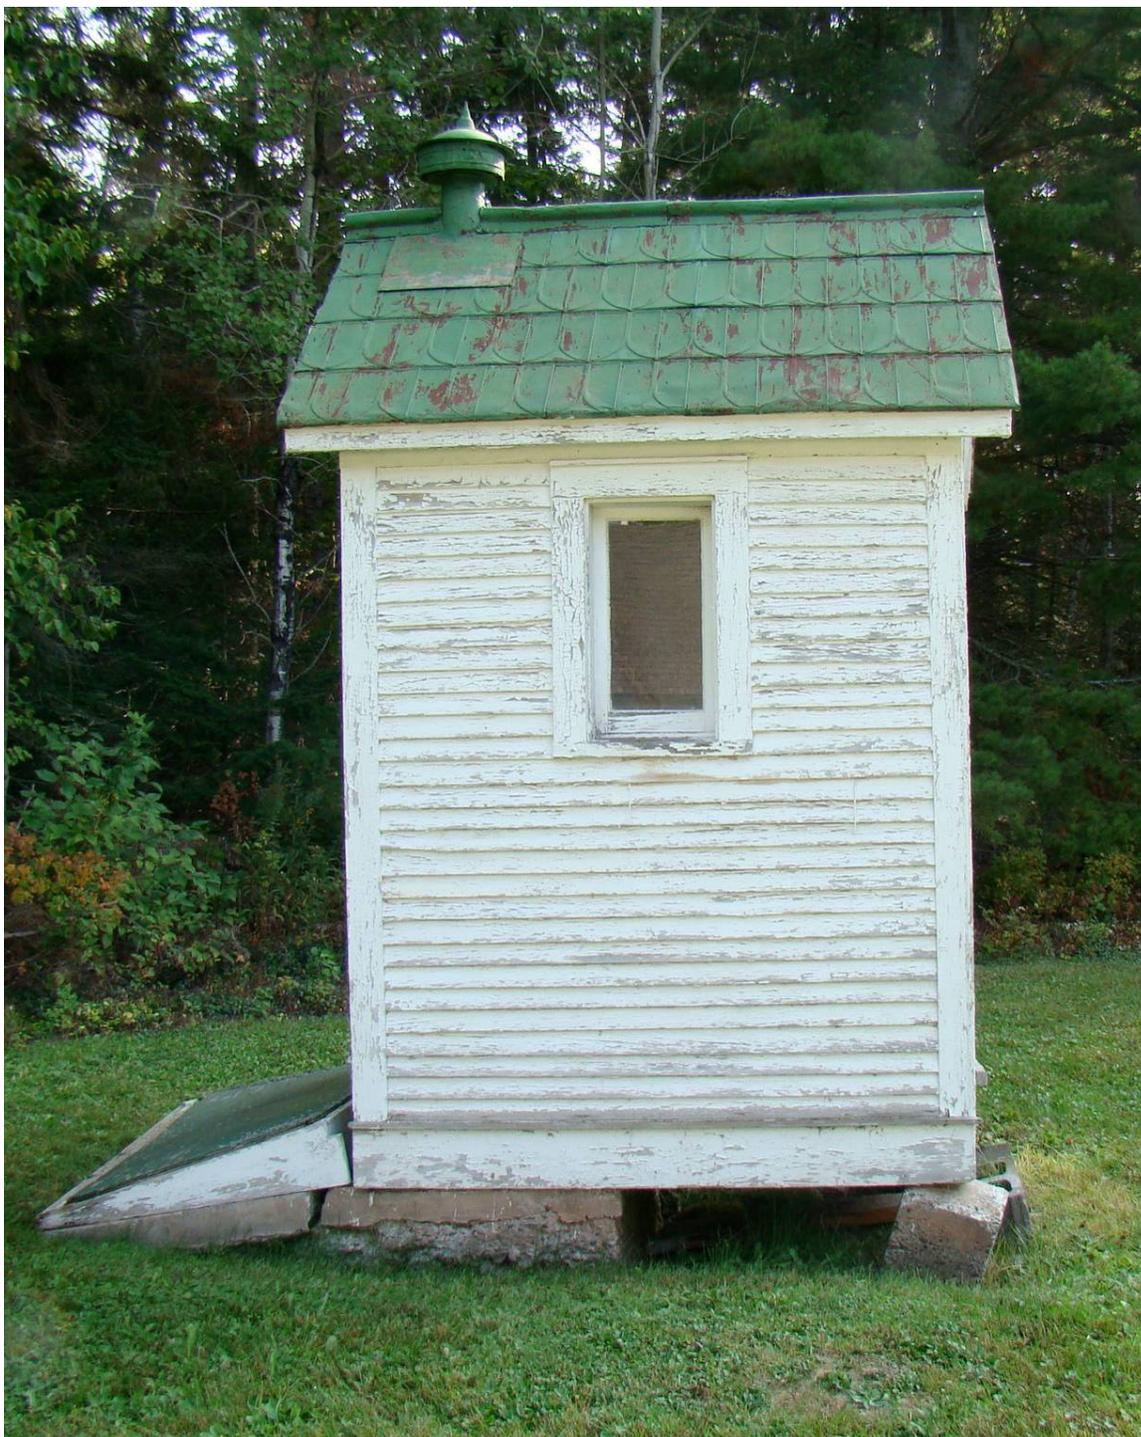
*MI-P-05: West elevation, 2009 (Source: AH DSC00536)*

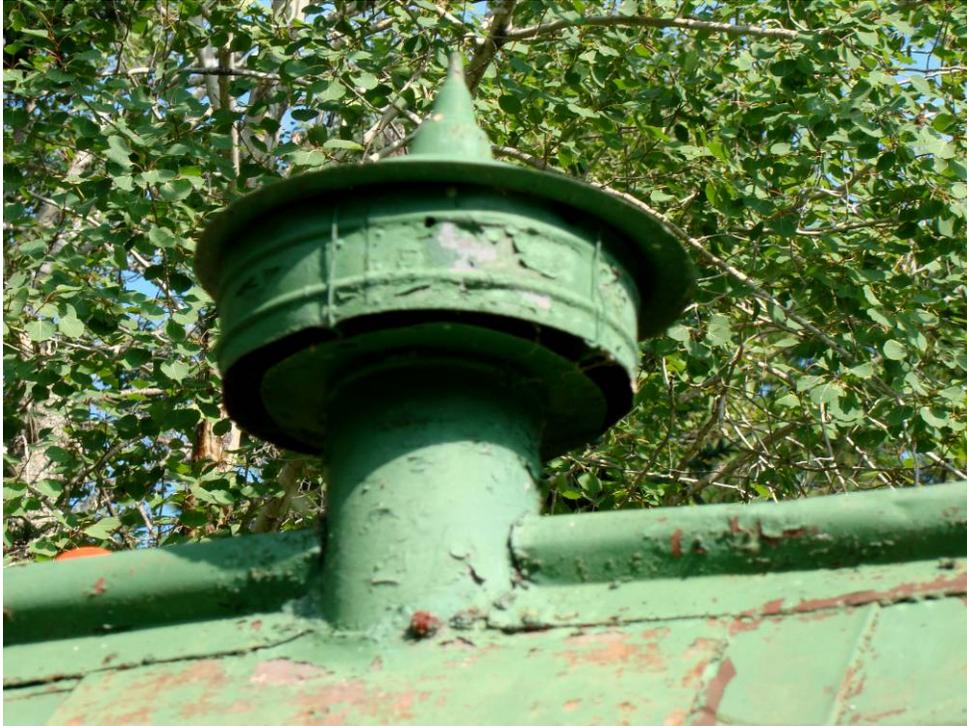
MI-P-06: North roof vent (Source: AH DSC00597)

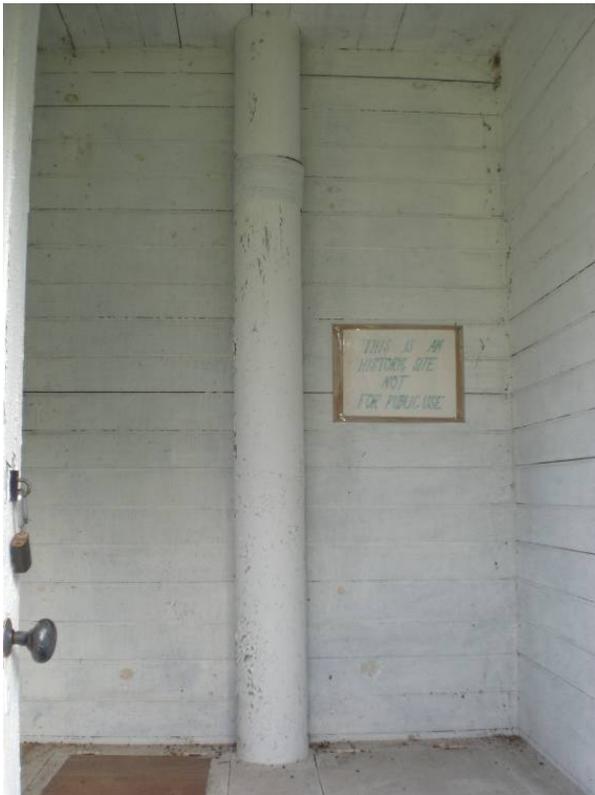
MI-P-07: North elevation (Source: AH CIMG3271)

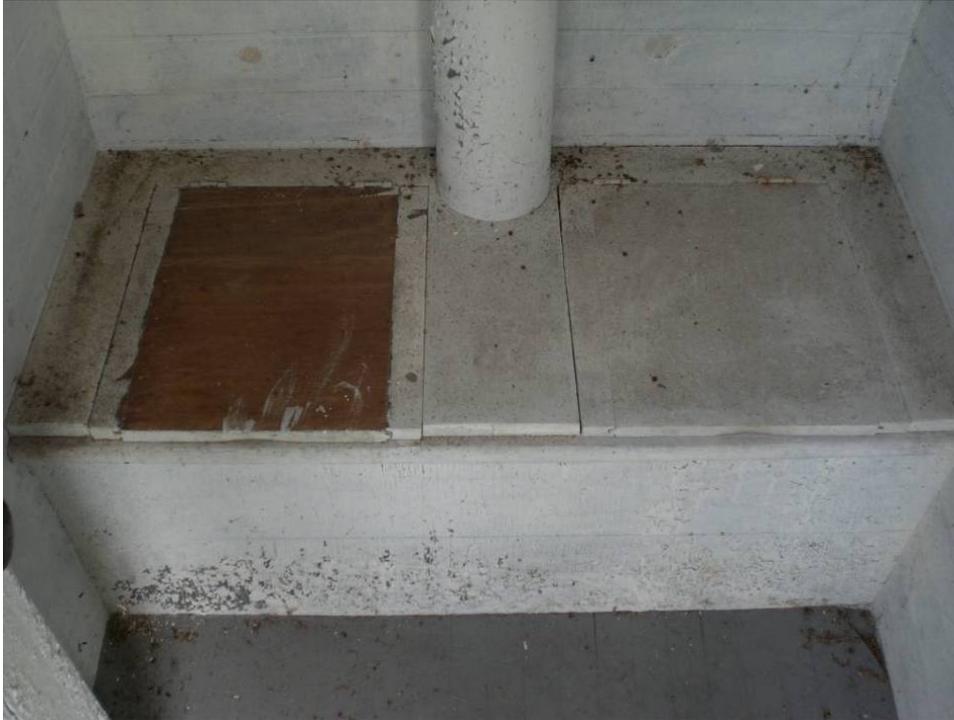
*MI-P-08: Seat detail (Source: AH CIMG3287)*

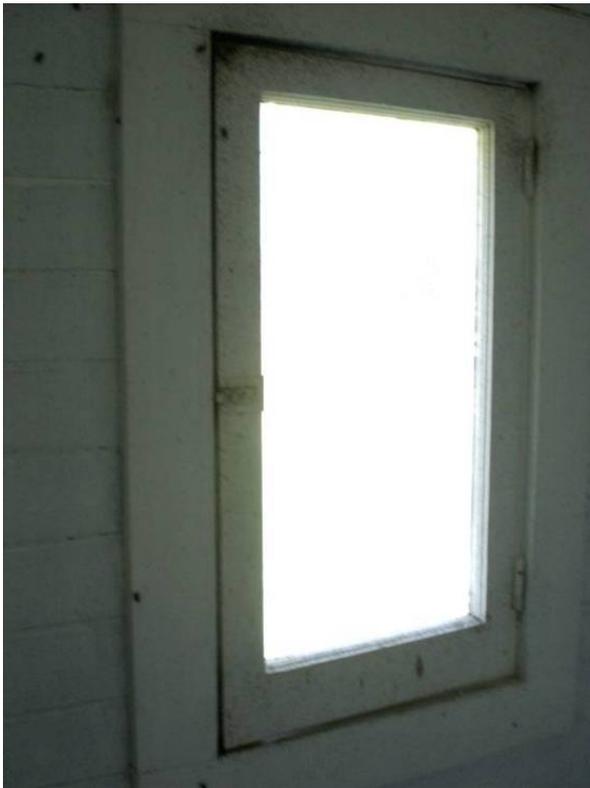
*MI-P-09: Window (Source: AH CIMG3278)*

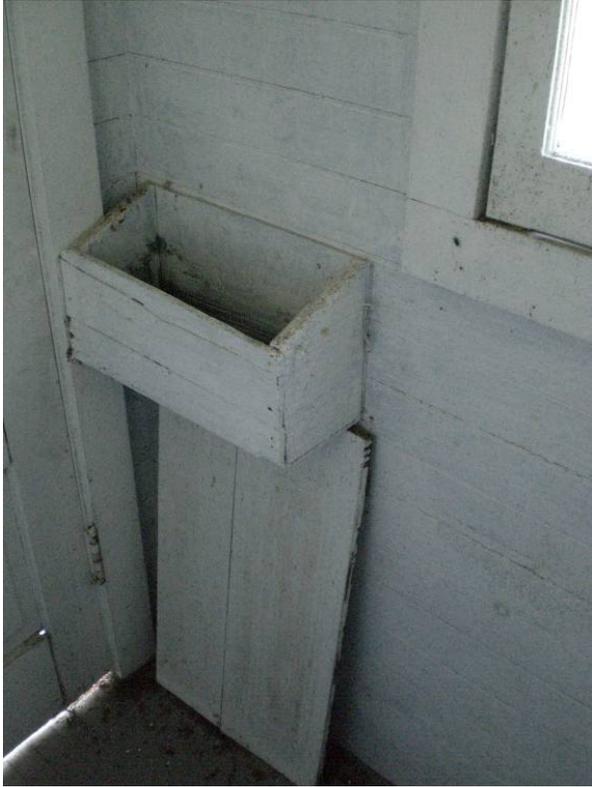
*MI-P-10: Window and built-in box (Source: AH CIMG3282)*
