# Beaver Creek No. 10

## Grand Teton National Park Wyoming

### Historic Structure Report

*Prepared by*  
Colorado State University  
Architectural Preservation Institute  
Christopher Koziol, Principal Investigator

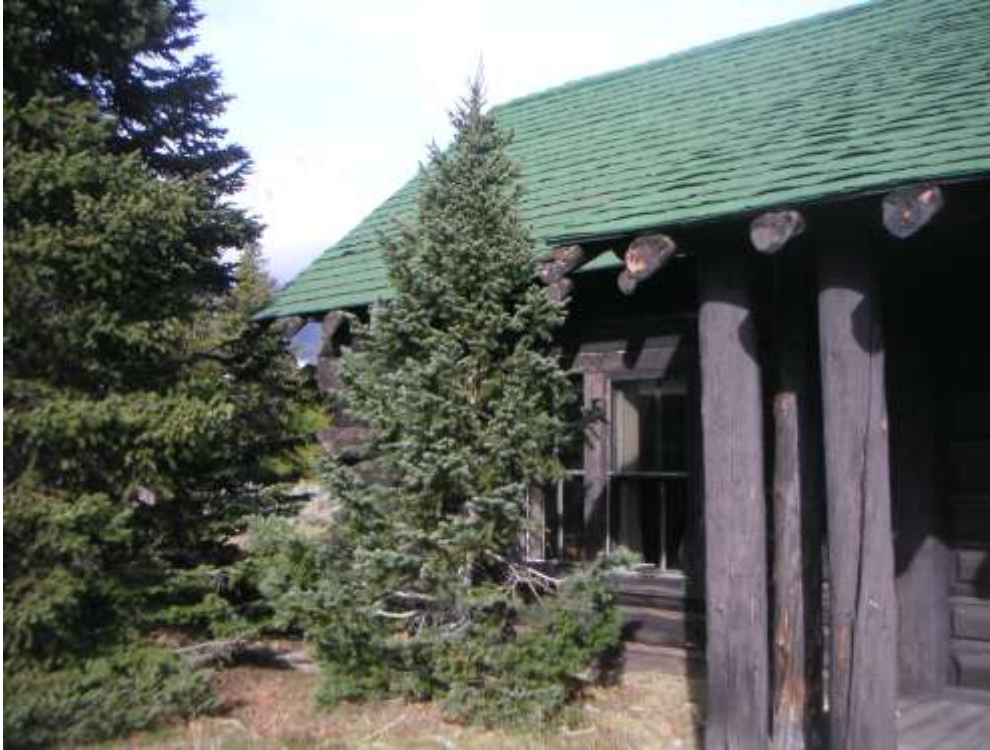
Figure 21 Vegetation at southwest corner

Also of note is the radical change in the density and maturity of vegetation currently around the building, as compared to that during the period of significance. Today, the building is bracketed to the east and west by two large spruces, and there are several other conifers very close to the foundation of the building.

The log walls appear in **good** condition. Areas of concern are the east elevation walls, the west elevation log wall and the north elevation. As mentioned above, large spruce trees at the southwest and southeast corners have enabled moisture to collect at the vulnerable log joints. Rot has set in at the beaver tails, necessitating past repairs of several tails. Testing indicates core rot up to 2' from the ends of several beaver tails (see Drill Test Chart, Appendix C). Only one sill log (south elevation, D14) appears to be affected by moisture, having a 3.5" internal void. One additional sill log has been replaced (North elevation, east corner).

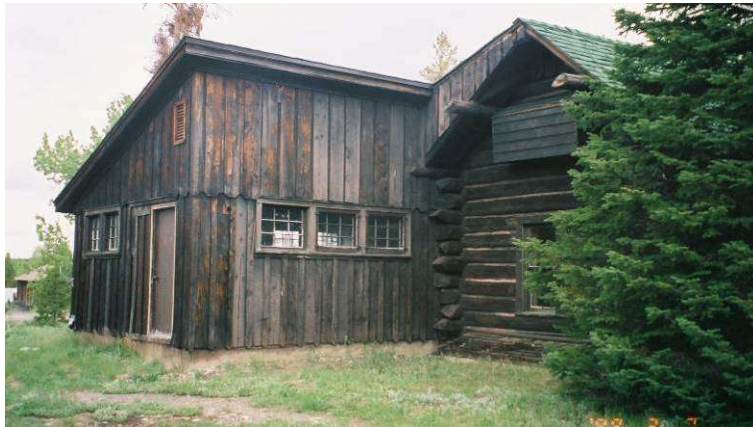
**Figure 23 1956 addition**

This portion of the building is just to the north and west of the log west elevation. There are three nine-light hopper windows located about sixty-five inches from the ground. On the lower half of the wall there is board and batten siding and on the upper half there is reverse board and batten; six of these boards on either side of the windows have their lower corners clipped, creating a scalloped effect. There are three animal/bird holes in the upper section of this elevation (see Figure 23).

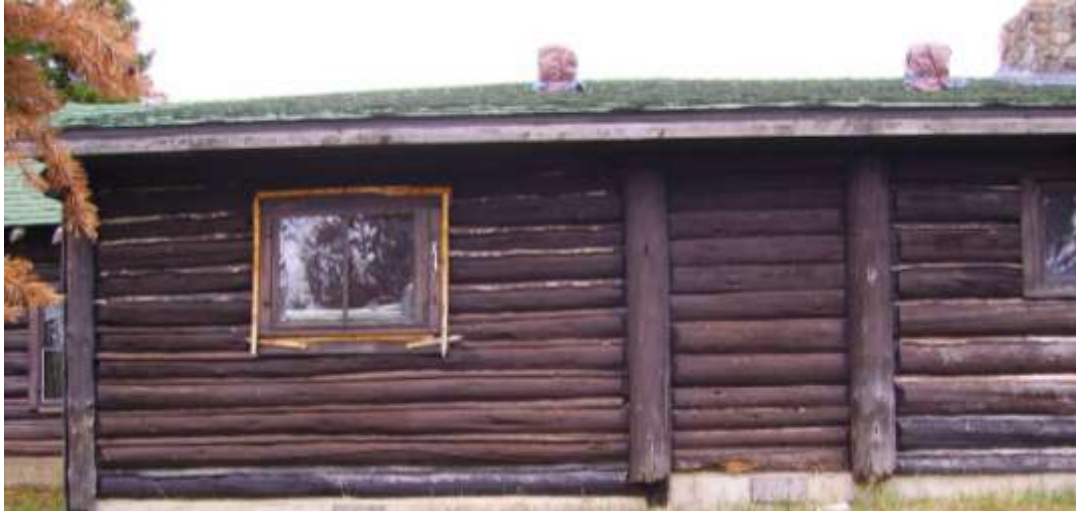
Figure 27 East part of north elevation

The section shown in Figure 27 is the original ranger station (Rm. #13) which was joined to the other cabin before 1929. Where its square-notched original log corners meet the half-log siding on the small enclosed section there is, again, a vertical half-log cover as also seen on the corner. The window in this section is a fixed single-light and its storm window covering is a fixed two-light. On the bottom log of this wall there is a spliced log with two different wood grains, indicating a replacement.

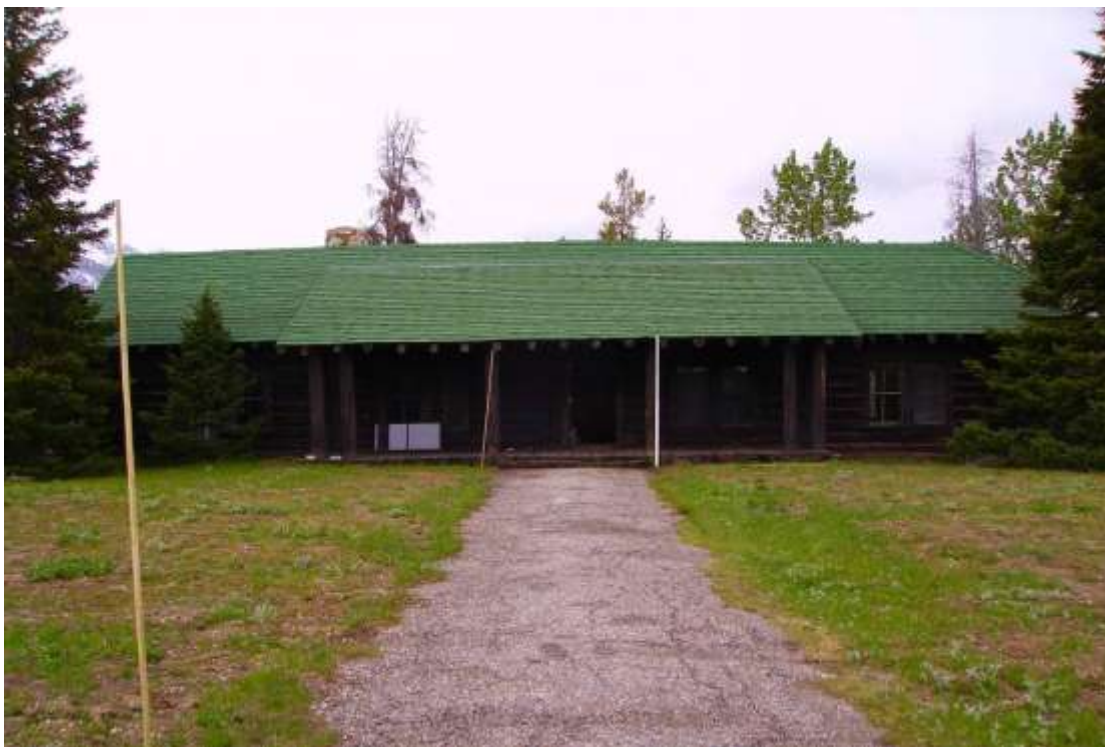
Figure 37 South elevation

When taken as a whole, the building is generally in **fair** physical condition. The exterior walls have been stained brown and seem sound with several exceptions. Resistance drill testing (combined with visual and hand probe inspection) at several locations reveal wood rot primarily at exposed beaver, rafter and purlin tails. Several tests reveal 1-2" voids in wall logs (see Drill Test Chart, Appendix C), with the most serious (50% void) at D2. Large, historically insignificant spruce trees at the southeast and southwest corners of the building seem to be creating microclimates which retain moisture which enters the logs through the end grain and saddle notches.

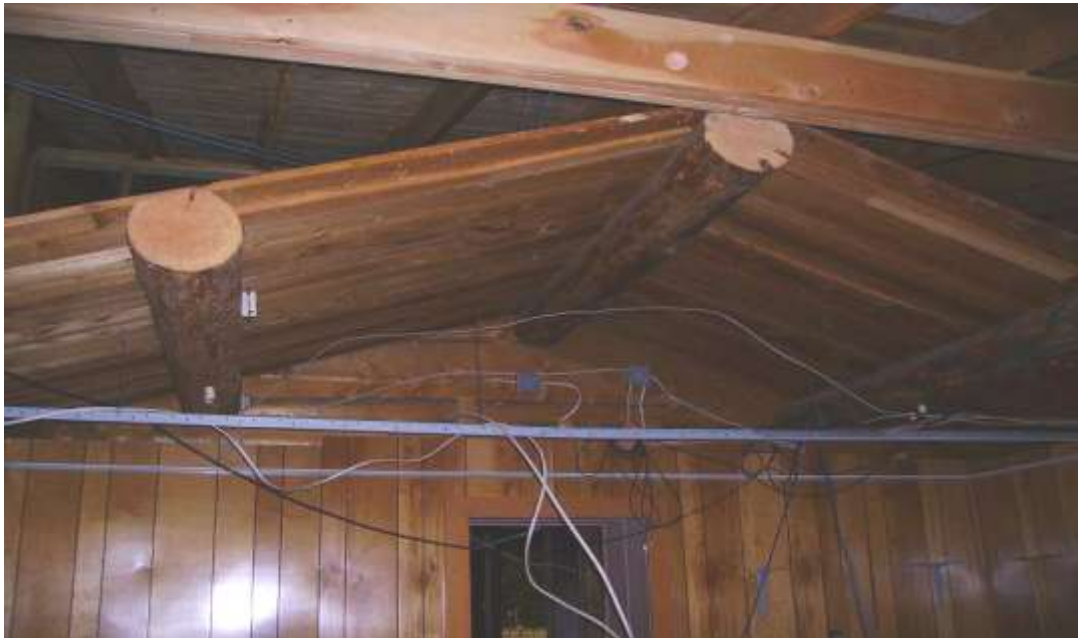
Figure 45 Exposed purlins and shed roof rafters above

The dropped ceiling’s removal exposed log purlins, roof sheathing, and metal flashing and log rafters from three previous building alterations. Most interesting is the exposed roof, with full hips, from the Stewart Ranger Station.

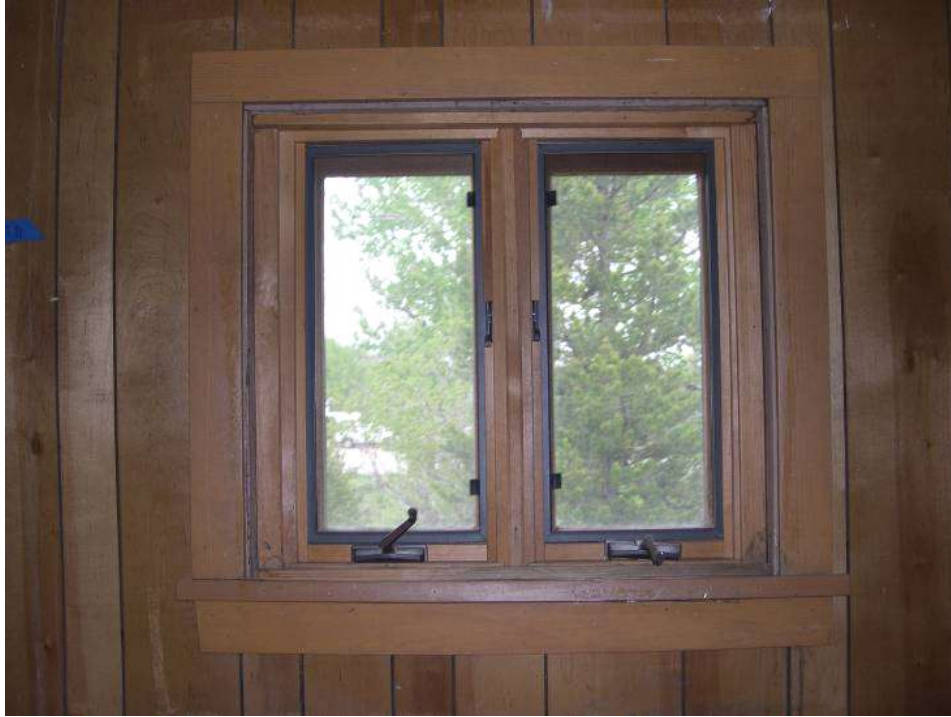
Most of the interior doors have been removed. The two that remain are in good condition. Interior partition walls, covered in veneer paneling, are in fine condition yet are historically incompatible.

Figure 48 Non-historic wood veneer paneling and casement window

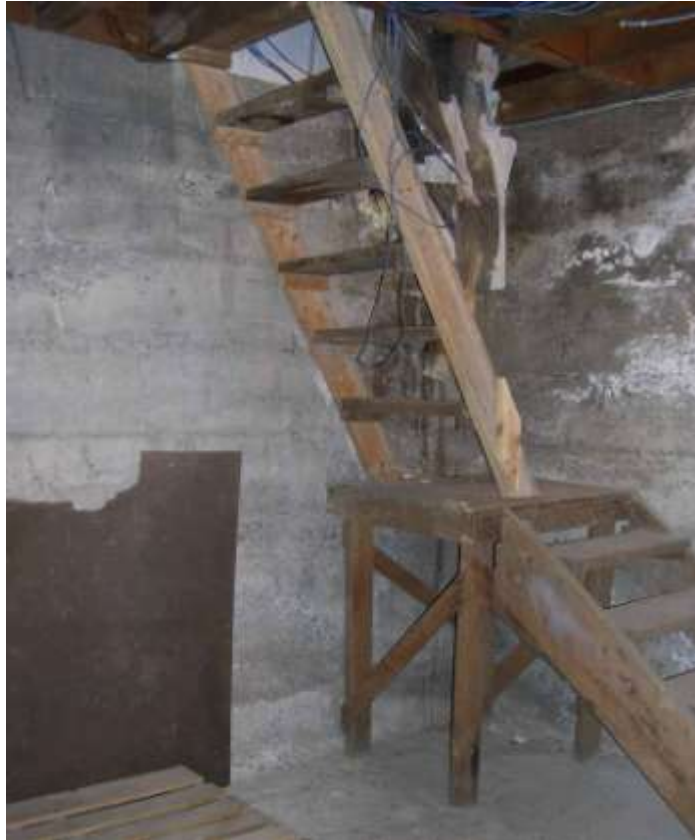
Basement, basement stairs, and interior walls-all in good condition
